KASSABIAN PROTECTED TREE REPORT

Job Site: 2331 Ramsay Drive, Glendale CA 91206

May 28, 2009

Prepared by:
Mellinger Tree and Landscape Service
P.O. Box 1135
Pacific Palisades, CA 90272
(310) 454-2033
(310) 454-6915 fax
© 2009 Carl Mellinger - All rights reserved

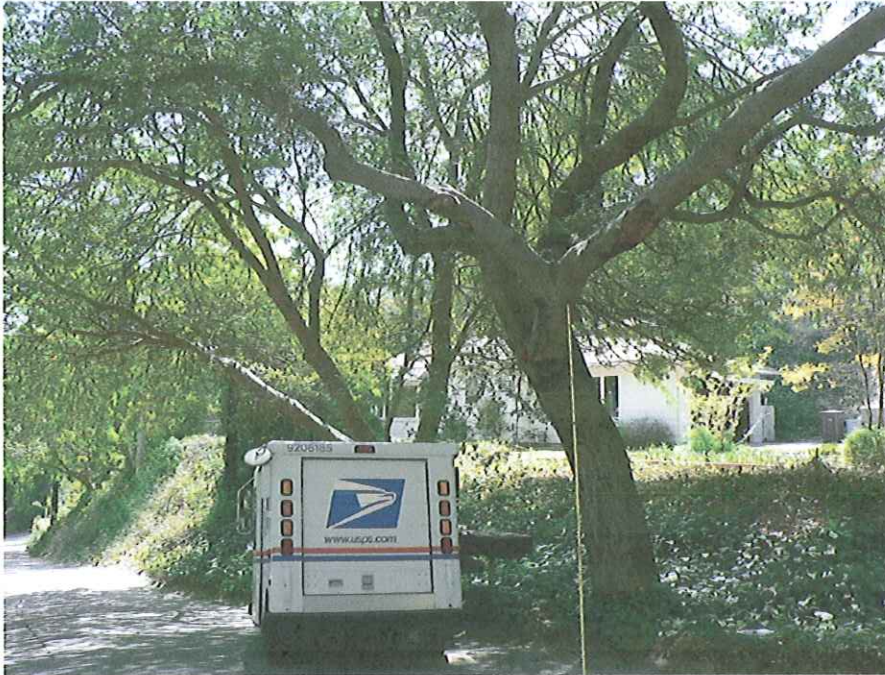
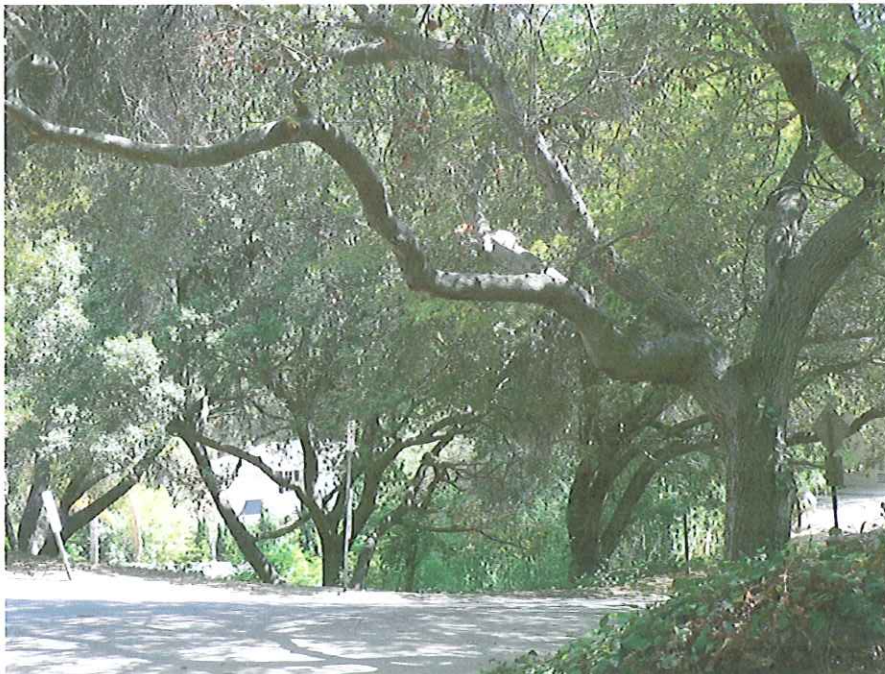
Tree #1OP – The eleven-inch diameter branch over Ramsay Drive will need to be removed for overhead clearance. Proposed road paving as shown on the plan, at two feet from the trunk, would likely to result in root removal. As previously discussed, the applicant intends to reduce road width to the minimum allowed by the City in order to protect the oak. Root removal will need to be controlled to keep this oak from becoming unsafe. This determination can be made only when the limits of road construction are marked and the area manually excavated to inspect for roots. **Impact: moderate to major.**

TREE #10P, LOOKING WEST - MODERATE TO MAJOR IMPACTS DUE TO
ROAD IMPROVEMENTS

TREE #10P CLEARANCE OVER EXISTING UNPAVED ROAD, LOOKING SOUTH

- The root crown of Trees #1OP, 5OP and 6OP may be lower than the finished grade of the road. The trunks and root crowns of these trees shall be left exposed and not buried below grade. If needed, retaining walls shall be built between the road and the trees (without causing root crown damage) to keep soil off the trees.

- Road paving details shall be reviewed with the project arborist prior to installation.
- Overhead clearance shall be reviewed after road paving is completed. Branch pruning shall be done as recommended by the project arborist only.

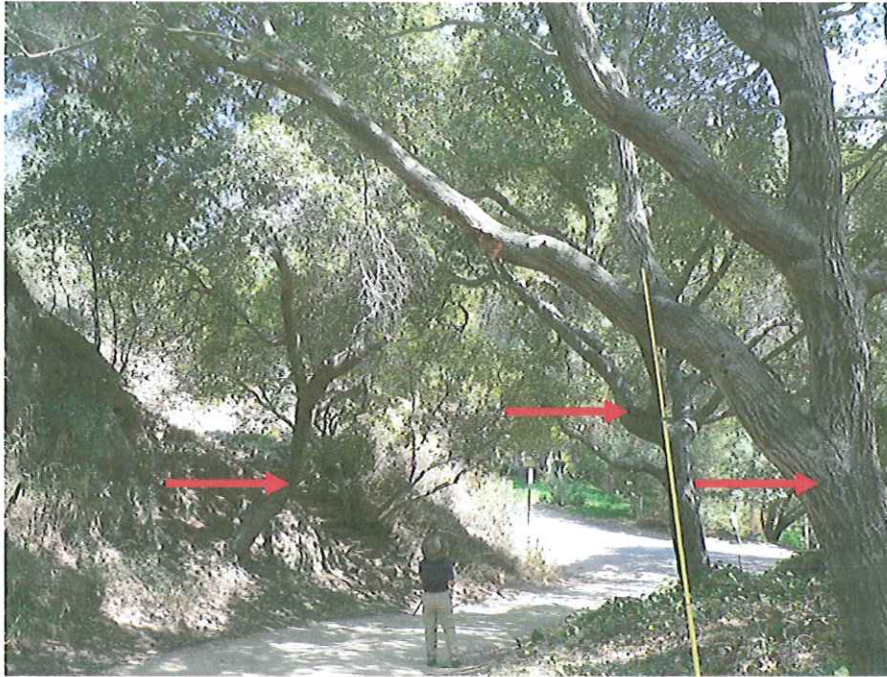
L TO R: TREES #2OP, 4OP (TO BE REMOVED), AND 5OP

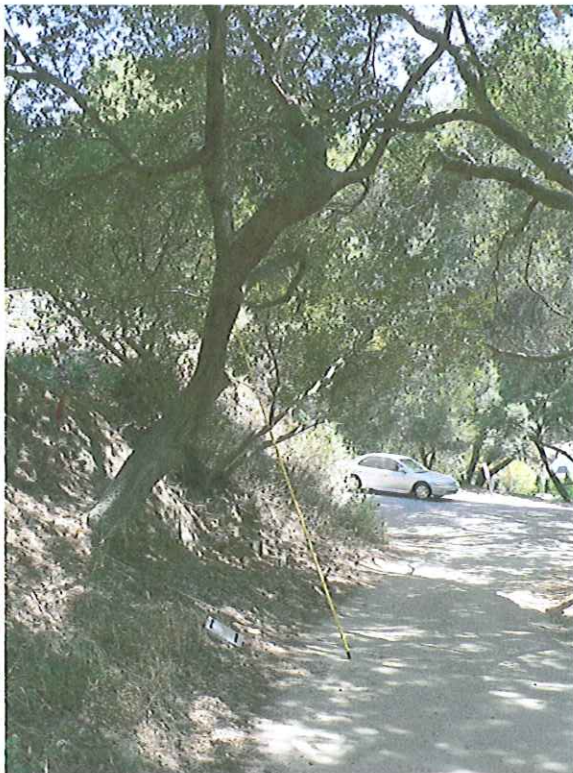
TREE #2OP - MODERATE IMPACTS DUE TO ROAD IMPROVEMENTS

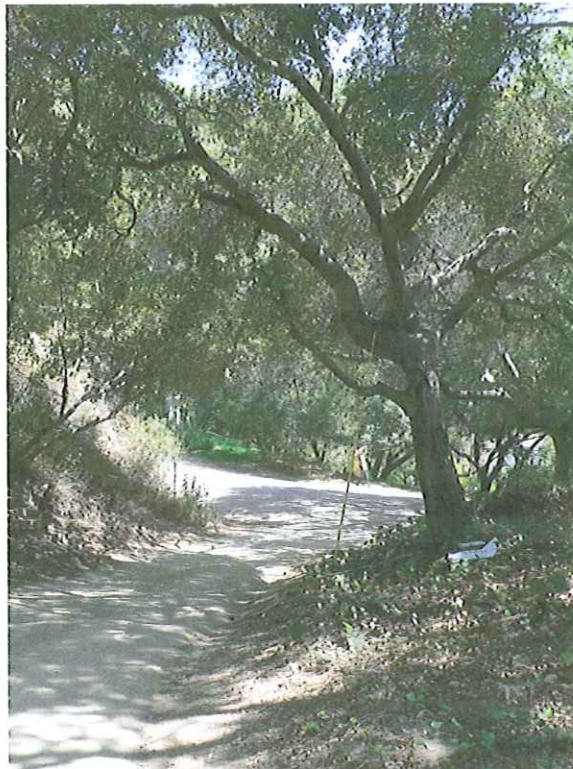
TREE #4OP – TO BE REMOVED

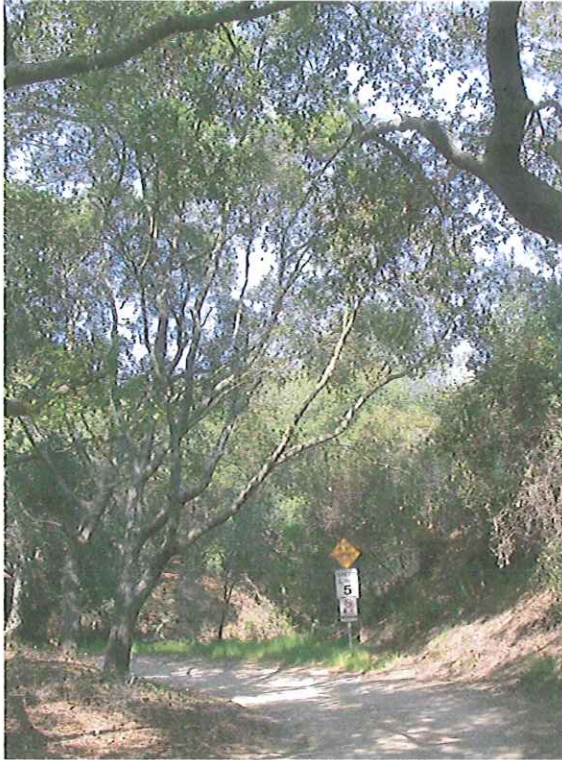
Tree #5OP – If the road were to be paved less than two feet from the root crown as shown on the Protected Tree Plan, there would be a major loss of viable root zone on the east side of the oak. This impact will be reduced if the applicant is able to move road paving away from the trunk as previously discussed. The applicant will be preserving roots on the east side of the tree that were observed through manual excavation, in order to avoid excessively damaging the oak. The nine-inch diameter limb to the east will probably need to be removed for overhead clearance.

This oak is expected to survive construction. However it should be noted that predictions about tree responses to construction impacts generally have a wide range of uncertainty. If any changes are made to this tree from construction not mentioned in this report then it is not known what this oak's long term health would be. **Impact: moderate to major.**

**TREE #5OP – MODERATE TO MAJOR IMPACTS DUE TO ROAD
IMPROVEMENTS**

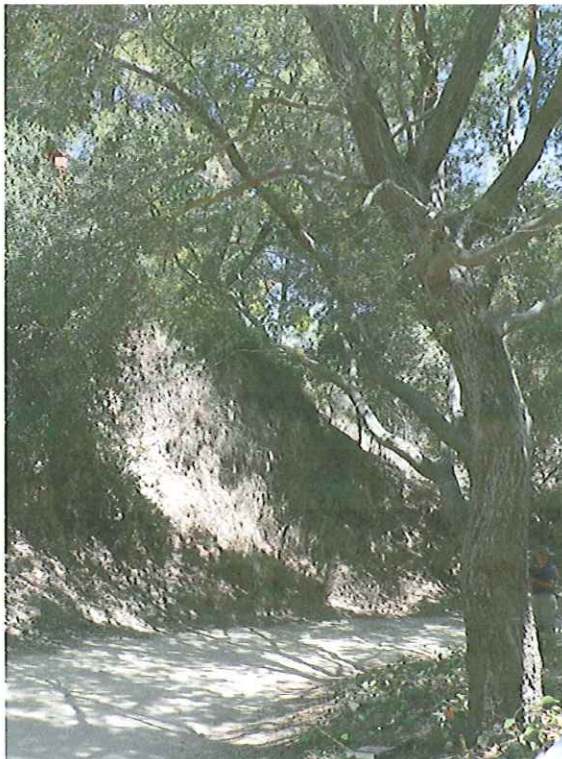
**TREE #6OP – MODERATE TO MAJOR IMPACTS DUE TO ROAD
IMPROVEMENTS**

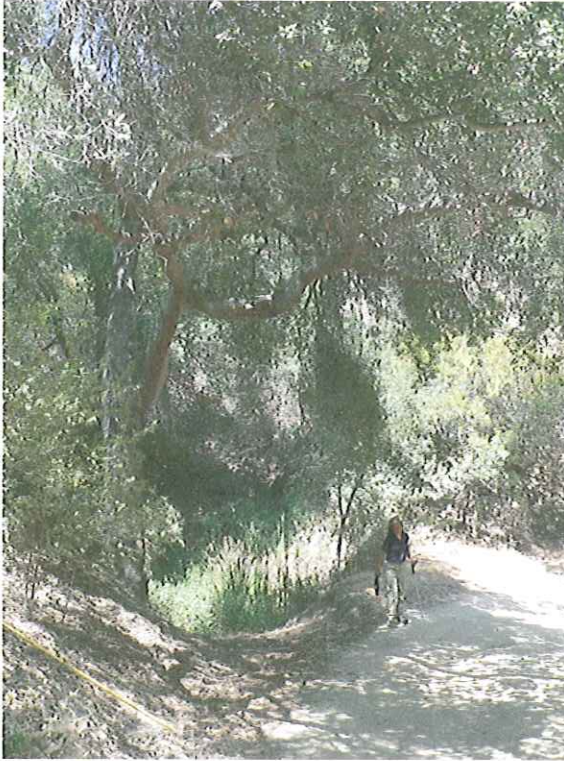
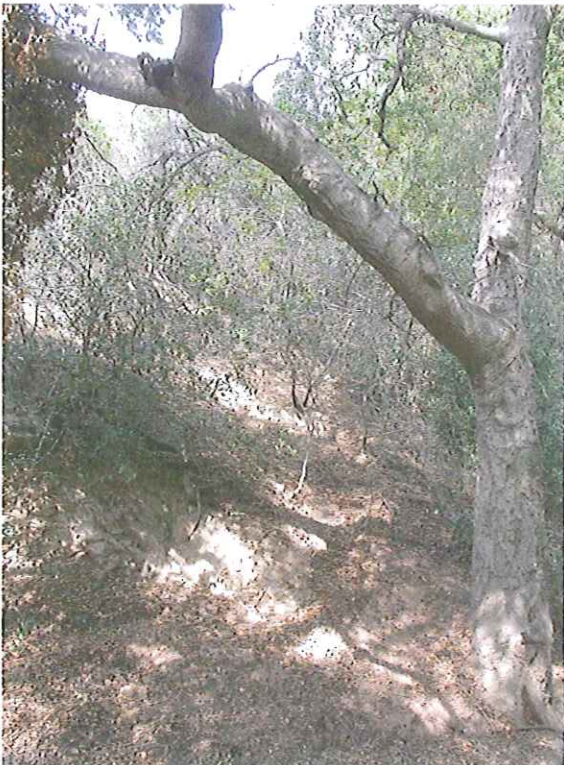
Tree #7 – A seventeen-inch branch located thirteen-feet above grade has excessive canopy weight at the ends, and may have decay at the point of attachment to the trunk. This oak has two wounds on the lower trunk facing the road, probably due to mechanical damage. One wound is nine inches wide; the second is three inches wide and eight inches tall. A large diameter root on the south side of the root crown was previously cut and calloused over.

The seventeen-inch diameter branch that is about eleven or twelve feet above the proposed driveway cannot be removed at its point of attachment at the trunk without resulting in excessive damage to the tree. An alternative would be to remove the low seven-inch and nine-inch branches from this larger branch and provide some additional clearance that way. Root and branch loss due to driveway construction probably is a major impact. This tree is expected to survive construction impacts; however it may remain stressed for a longer period after construction. Extra steps in caring for this tree during construction will need to be taken to improve the rate at which it overcomes construction stress. **Impacts: moderate to major.**

TREE #7, LOOKING EAST – MODERATE TO MAJOR IMPACTS

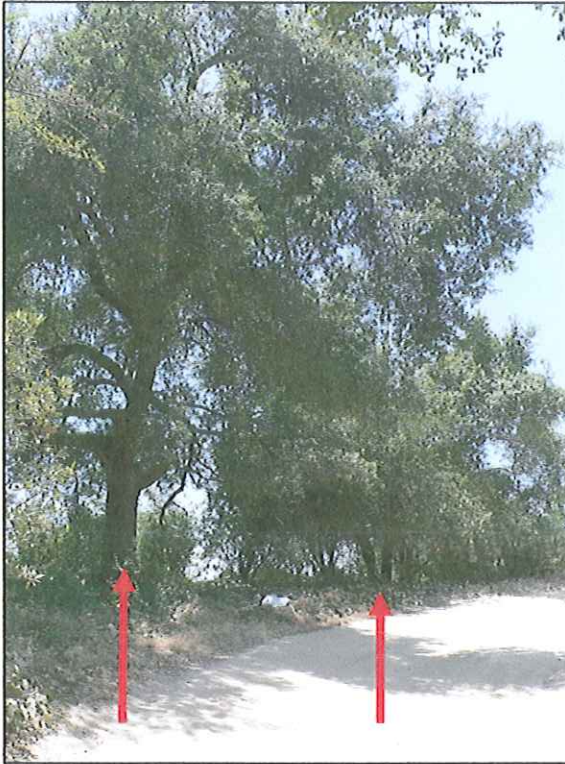
FROM LEFT TO RIGHT, TREES #90P AND 100P – LOOKING WEST – MINOR IMPACTS DUE TO CLEARANCE PRUNING, VEHICLE PARKING AND OTHER ANCILLARY ACTIVITIES

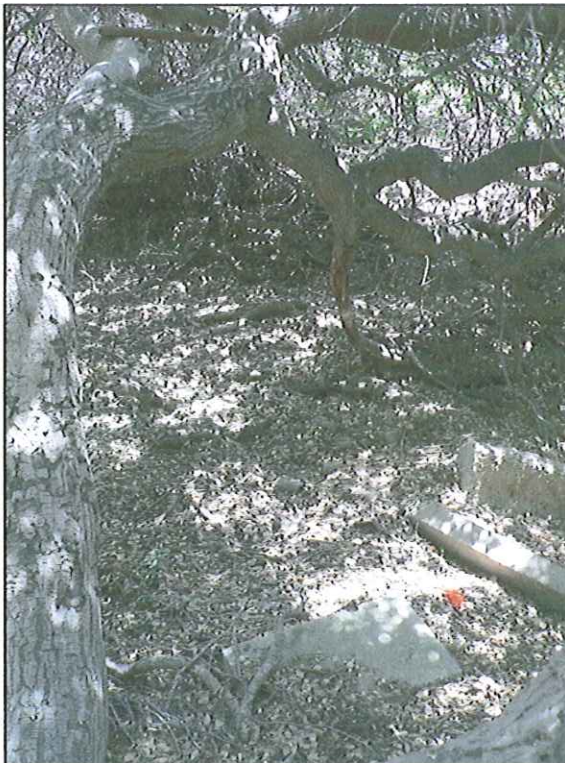
Tree #11OP – The oak has a severely unbalanced canopy and leaning trunk. It is at an elevated risk of failing.

TREE #110P – MINOR IMPACTS JUST OUTSIDE DRIPLINE

Tree #11OP: All grading at the top of the bluff within five feet of this oak's dripline shall be done manually to avoid damage to the canopy. Soil shall be kept out of the PZ of the oak.

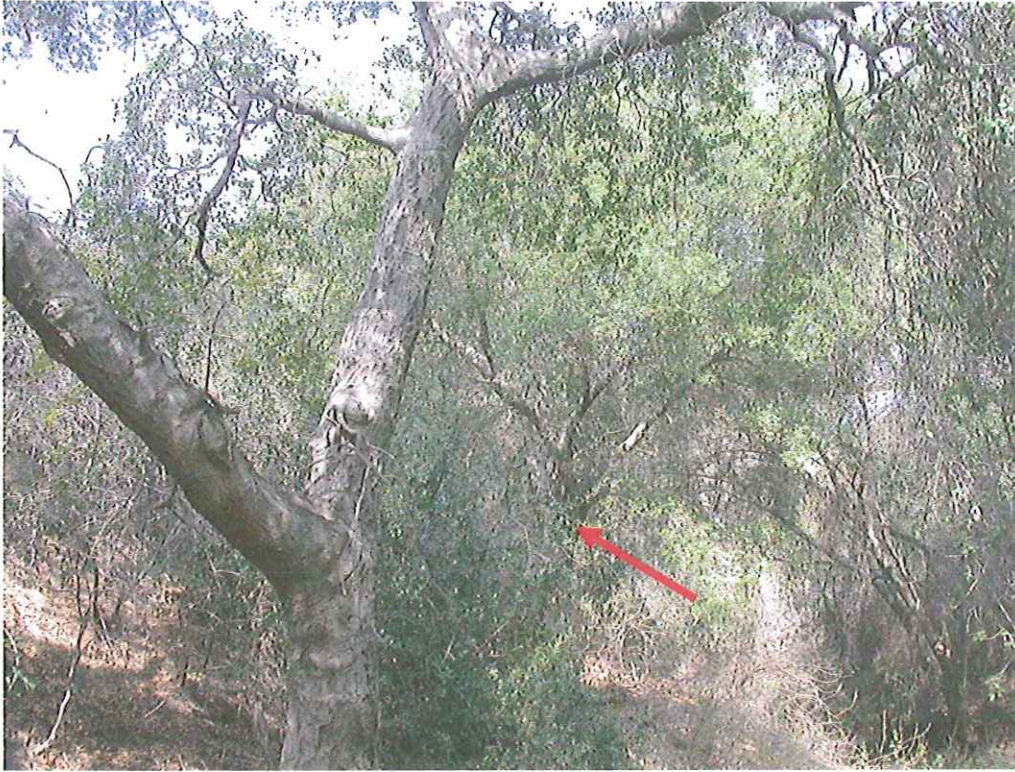
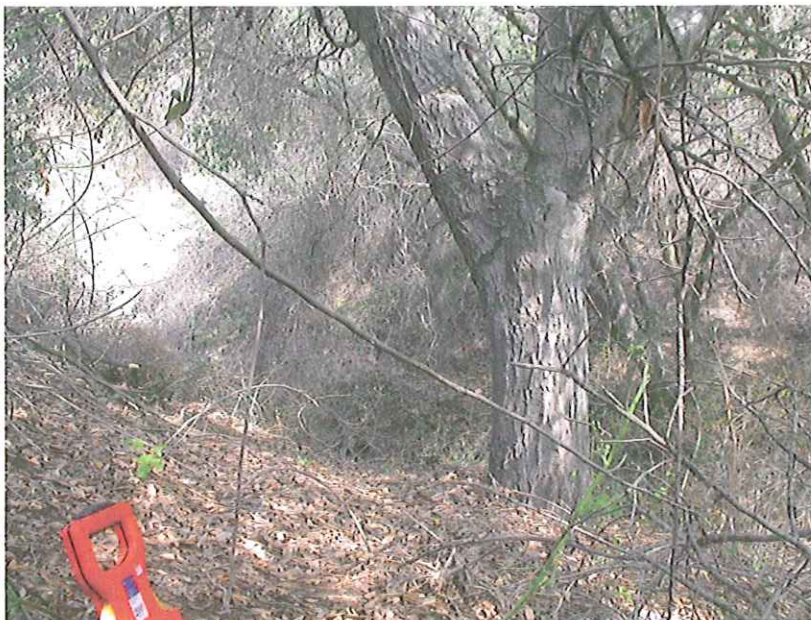
TREE #15, LOOKING NORTH/NORTHEAST

Trees #15 – The codominant main branches have developed swellings at the point of attachment, suggesting the possibility of internal cracking.

TREE #15 (ARROW), LOOKING NORTH (TREE #7 IN FOREGROUND)

- Trees #15 has excessive soil buildup against the root crown. The soil shall be removed and the root crown inspected for disease or structural issues.
- Removal of soil shall be done manually only. The bark shall not be damaged in the process of clearing the root crown.

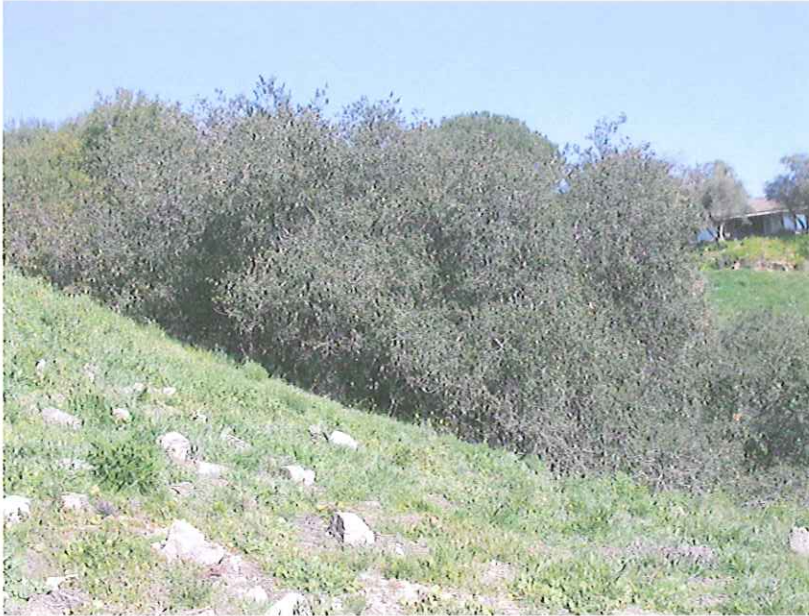
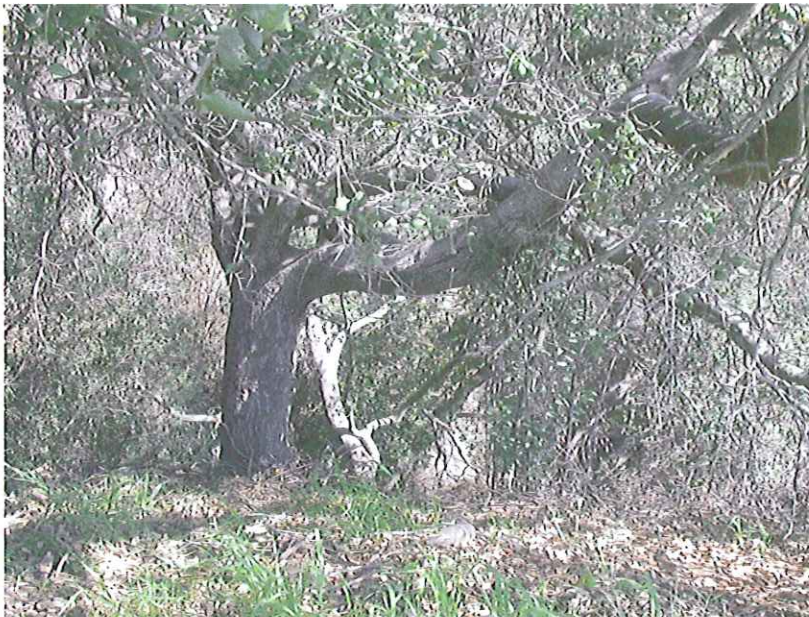
TREE #18 – LOOKING EAST – MINOR IMPACTS

TREE #18, TRUNK DETAIL

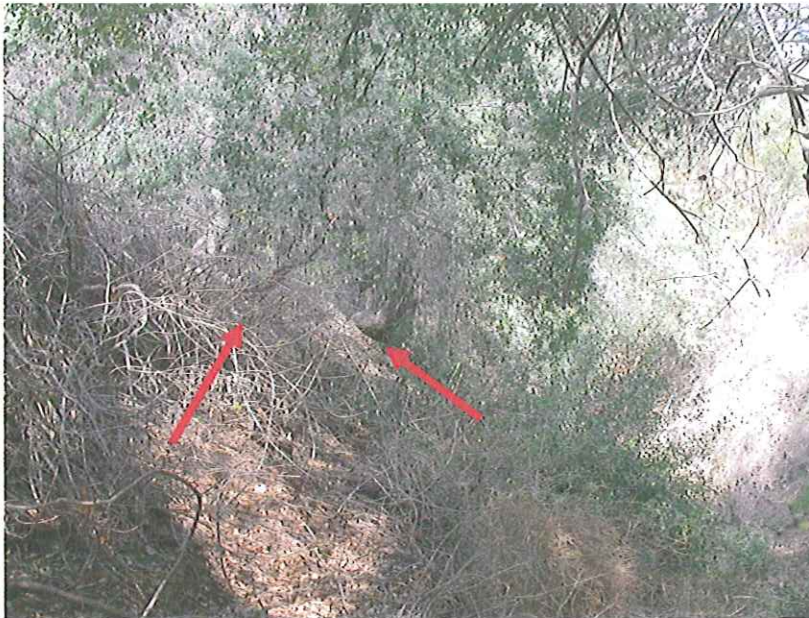
Tree #20 – The upright trunk has a basal cavity with decay.

TREE #21 AND 20, LOOKING NORTH FROM TREE #5

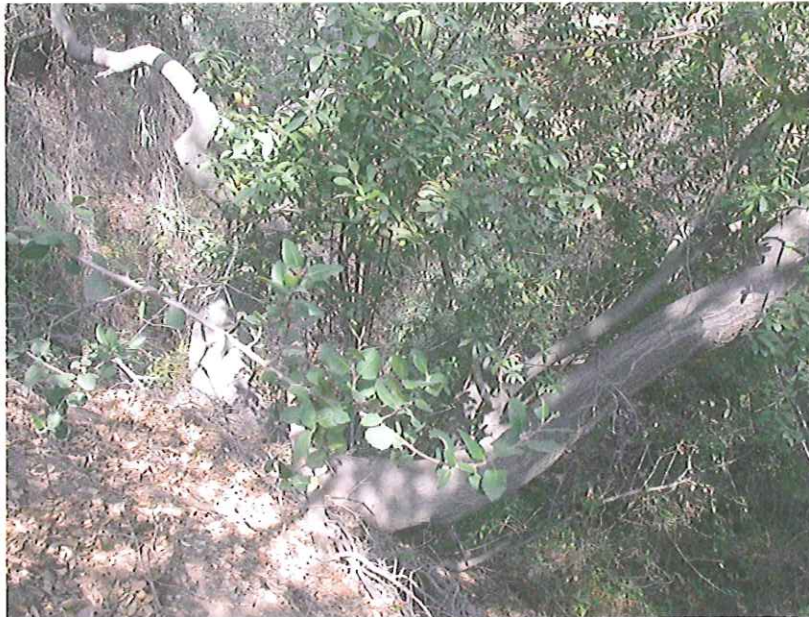
TREE #21 – MINOR IMPACTS
