KASSABIAN PROTECTED TREE REPORT

**Prepared Exclusively For:
Hratch Kassabian**

Job Site: 2331 Ramsay Drive, Glendale CA 91206

May 28, 2009

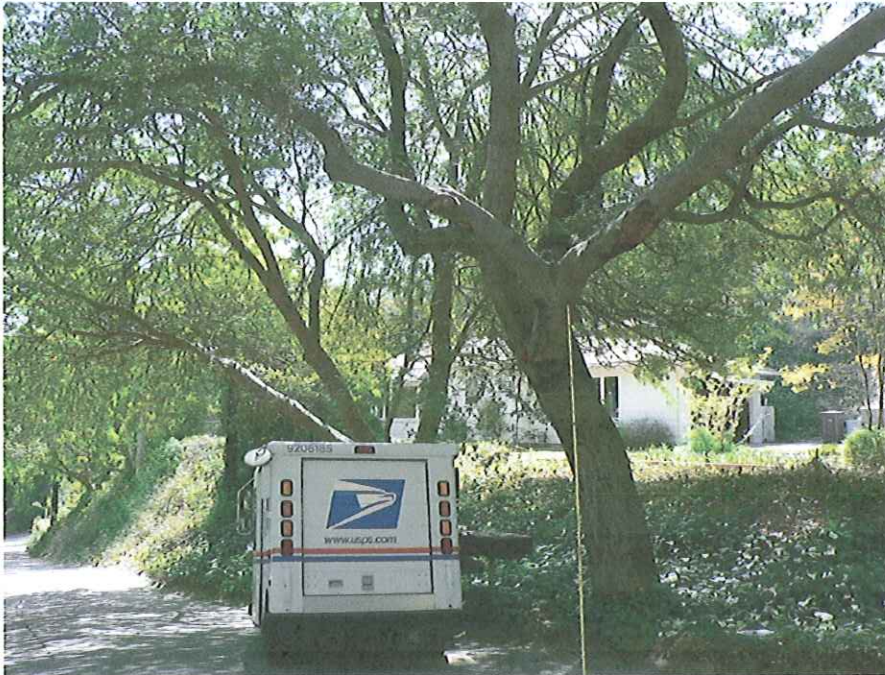
Tree #1OP – The eleven-inch diameter branch over Ramsay Drive will need to be removed for overhead clearance. Proposed road paving as shown on the plan, at two feet from the trunk, would likely to result in root removal. As previously discussed, the applicant intends to reduce road width to the minimum allowed by the City in order to protect the oak. Root removal will need to be controlled to keep this oak from becoming unsafe. This determination can be made only when the limits of road construction are marked and the area manually excavated to inspect for roots. **Impact: moderate to major.**

TREE #10P, LOOKING WEST - MODERATE TO MAJOR IMPACTS DUE TO ROAD IMPROVEMENTS

- The root crown of Trees #1OP, 5OP and 6OP may be lower than the finished grade of the road. The trunks and root crowns of these trees shall be left exposed and not buried below grade. If needed, retaining walls shall be built between the road and the trees (without causing root crown damage) to keep soil off the trees.

- Road paving details shall be reviewed with the project arborist prior to installation.
- Overhead clearance shall be reviewed after road paving is completed. Branch pruning shall be done as recommended by the project arborist only.

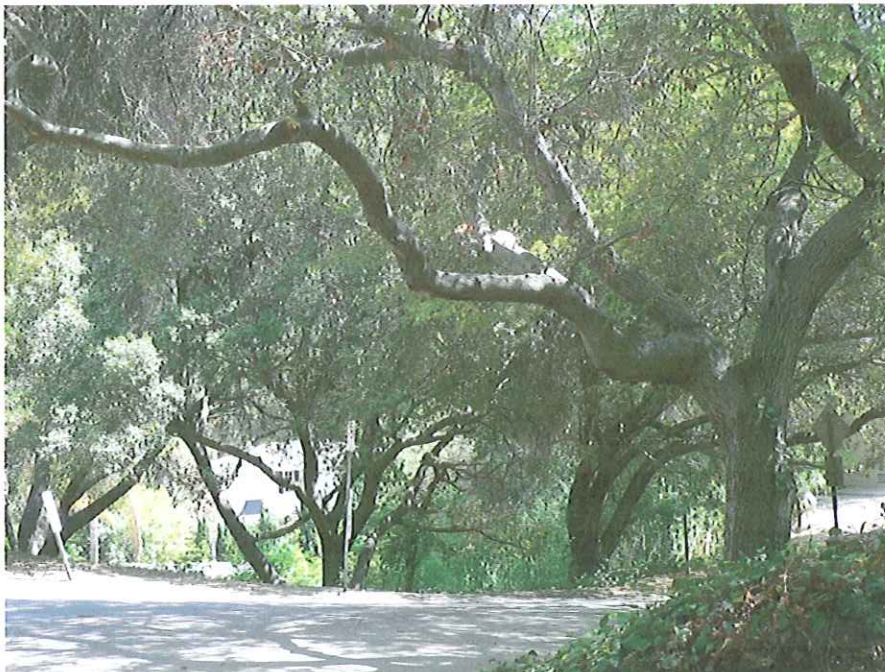
TREE #10P CLEARANCE OVER EXISTING UNPAVED ROAD, LOOKING SOUTH

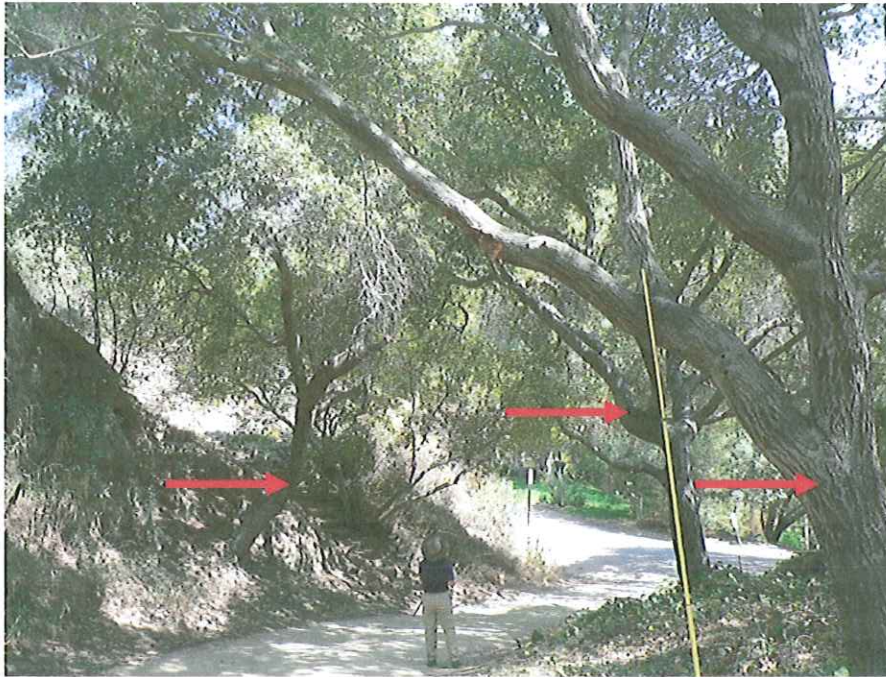
L TO R: TREES #2OP, 4OP (TO BE REMOVED), AND 5OP

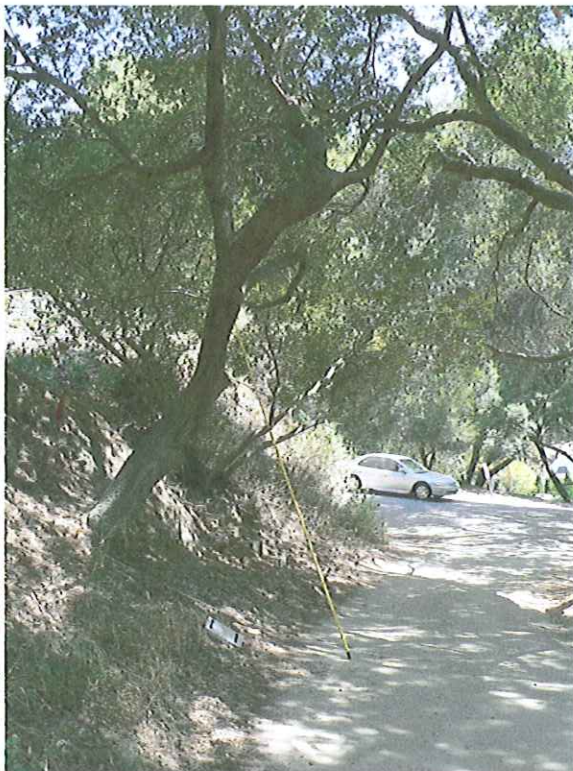
TREE #2OP - MODERATE IMPACTS DUE TO ROAD IMPROVEMENTS

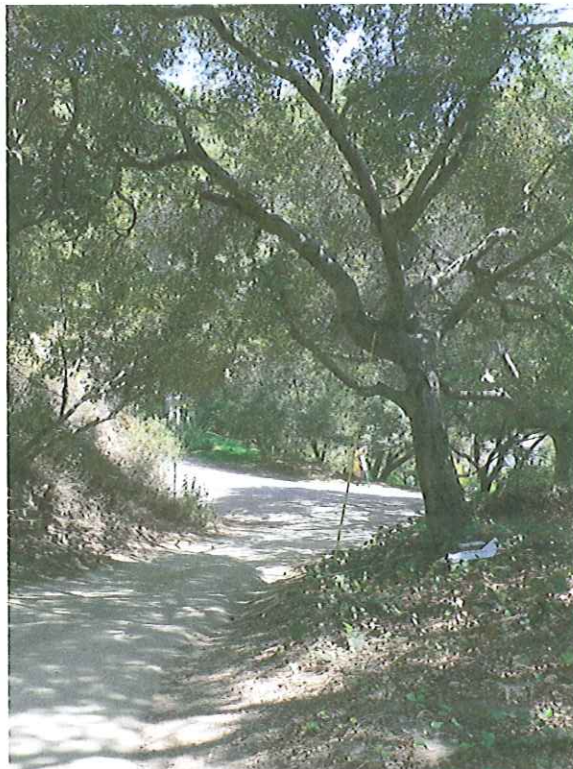
TREE #40P – TO BE REMOVED

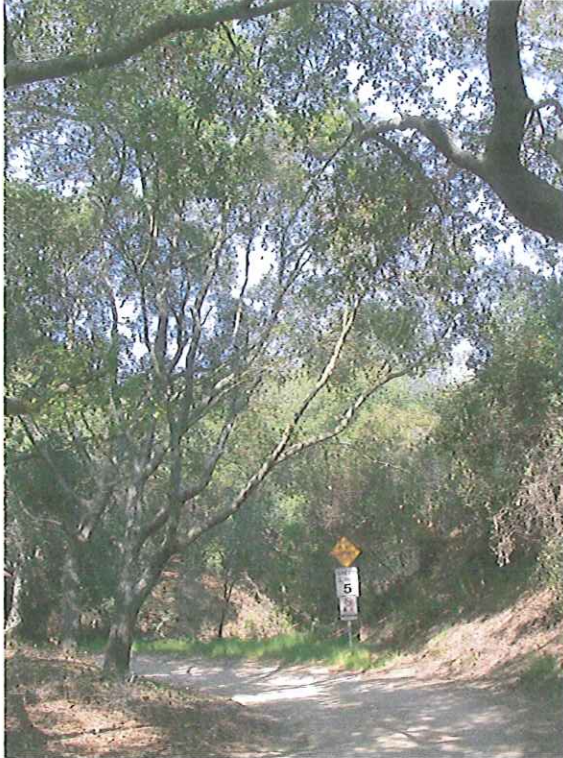
Tree #5OP – If the road were to be paved less than two feet from the root crown as shown on the Protected Tree Plan, there would be a major loss of viable root zone on the east side of the oak. This impact will be reduced if the applicant is able to move road paving away from the trunk as previously discussed. The applicant will be preserving roots on the east side of the tree that were observed through manual excavation, in order to avoid excessively damaging the oak. The nine-inch diameter limb to the east will probably need to be removed for overhead clearance.

This oak is expected to survive construction. However it should be noted that predictions about tree responses to construction impacts generally have a wide range of uncertainty. If any changes are made to this tree from construction not mentioned in this report then it is not known what this oak's long term health would be. **Impact: moderate to major.**

TREE #5OP – MODERATE TO MAJOR IMPACTS DUE TO ROAD IMPROVEMENTS

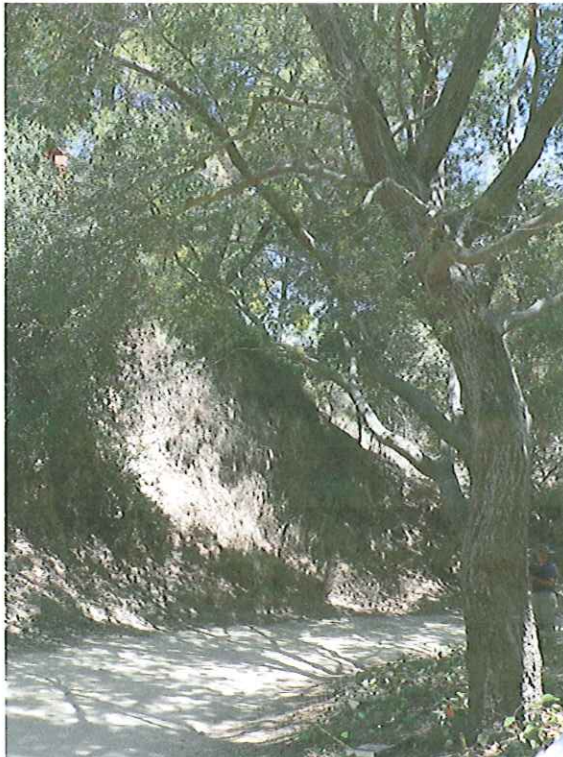
TREE #6OP – MODERATE TO MAJOR IMPACTS DUE TO ROAD IMPROVEMENTS

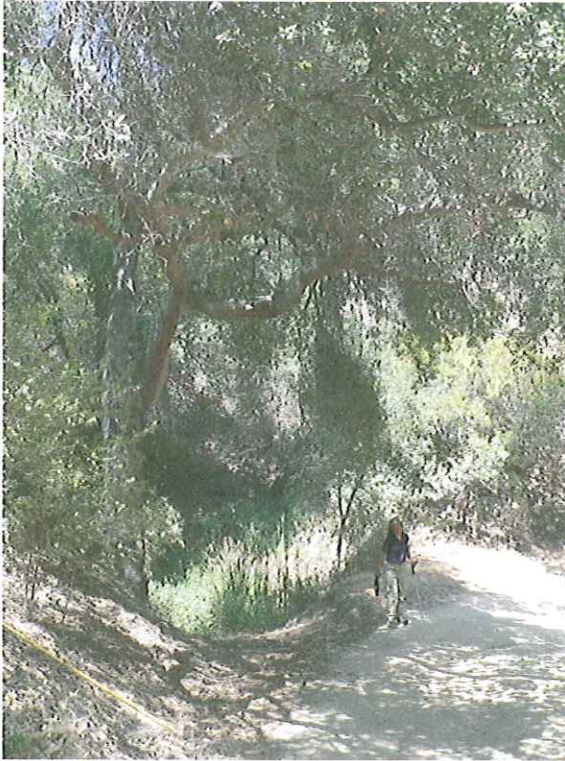
Tree #7 – A seventeen-inch branch located thirteen-feet above grade has excessive canopy weight at the ends, and may have decay at the point of attachment to the trunk. This oak has two wounds on the lower trunk facing the road, probably due to mechanical damage. One wound is nine inches wide; the second is three inches wide and eight inches tall. A large diameter root on the south side of the root crown was previously cut and calloused over.

TREE #7, LOOKING EAST – MODERATE TO MAJOR IMPACTS

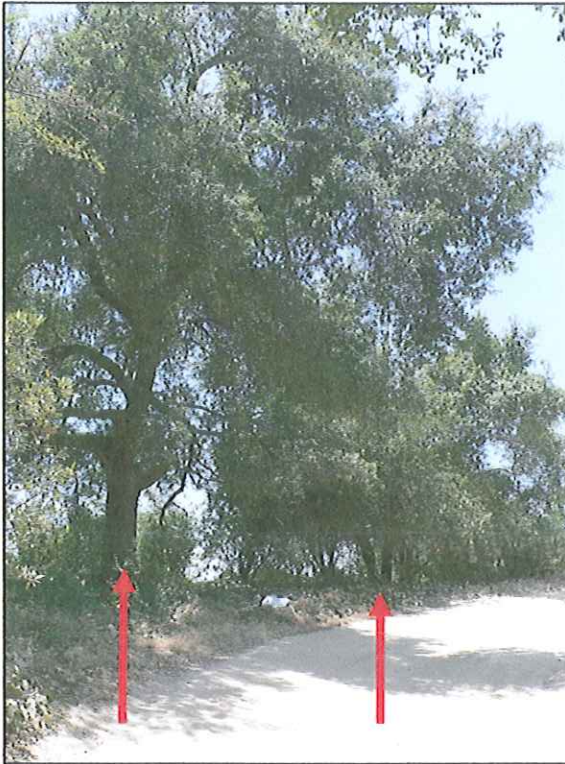
FROM LEFT TO RIGHT, TREES #9OP AND 10OP – LOOKING WEST –MINOR IMPACTS DUE TO CLEARANCE PRUNING, VEHICLE PARKING AND OTHER ANCILLARY ACTIVITIES

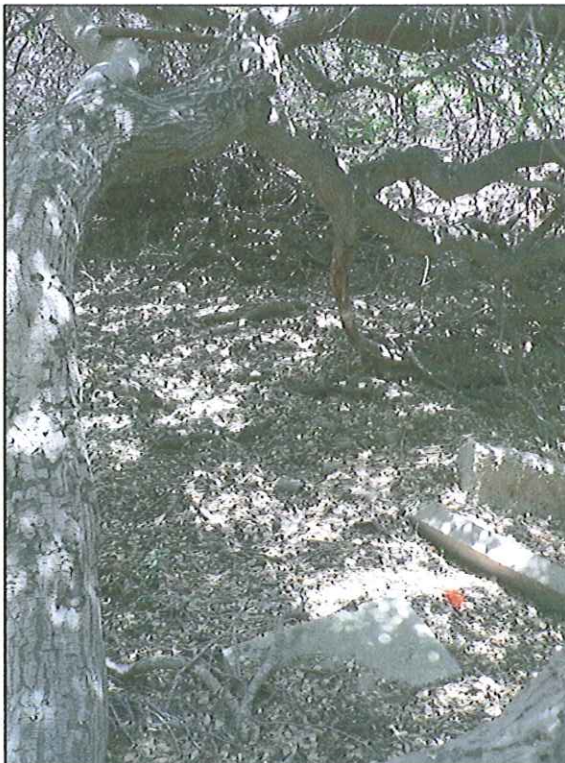
Tree #11OP – The oak has a severely unbalanced canopy and leaning trunk. It is at an elevated risk of failing.

TREE #11OP – MINOR IMPACTS JUST OUTSIDE DRIPLINE

Tree #11OP: All grading at the top of the bluff within five feet of this oak's dripline shall be done manually to avoid damage to the canopy. Soil shall be kept out of the PZ of the oak.

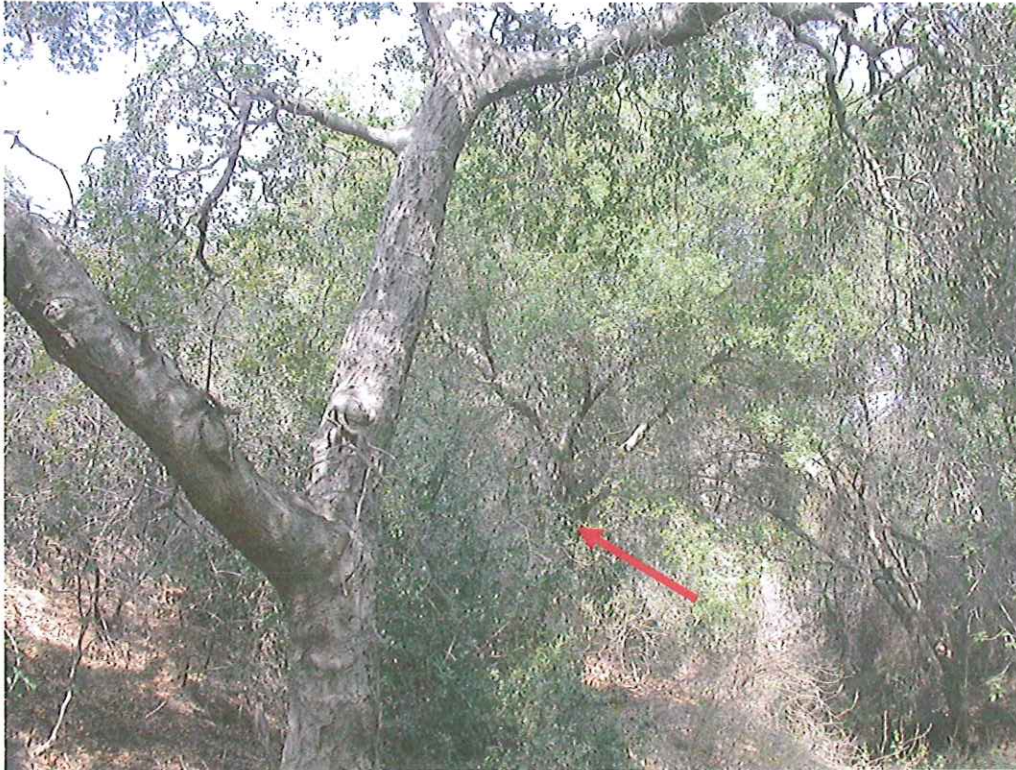
TREE #15 (ARROW), LOOKING NORTH (TREE #7 IN FOREGROUND)

Trees #15 – The codominant main branches have developed swellings at the point of attachment, suggesting the possibility of internal cracking.

- Trees #15 has excessive soil buildup against the root crown. The soil shall be removed and the root crown inspected for disease or structural issues.
- Removal of soil shall be done manually only. The bark shall not be damaged in the process of clearing the root crown.

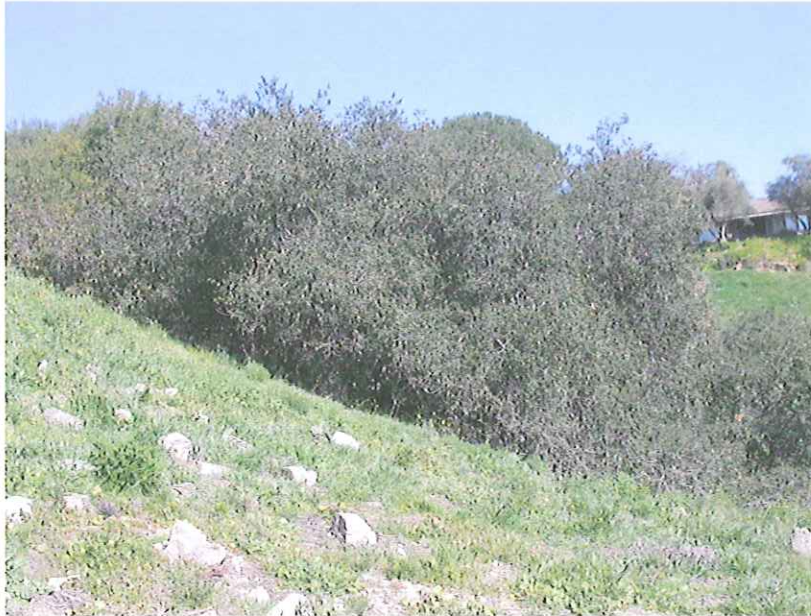
TREE #18 – LOOKING EAST – MINOR IMPACTS

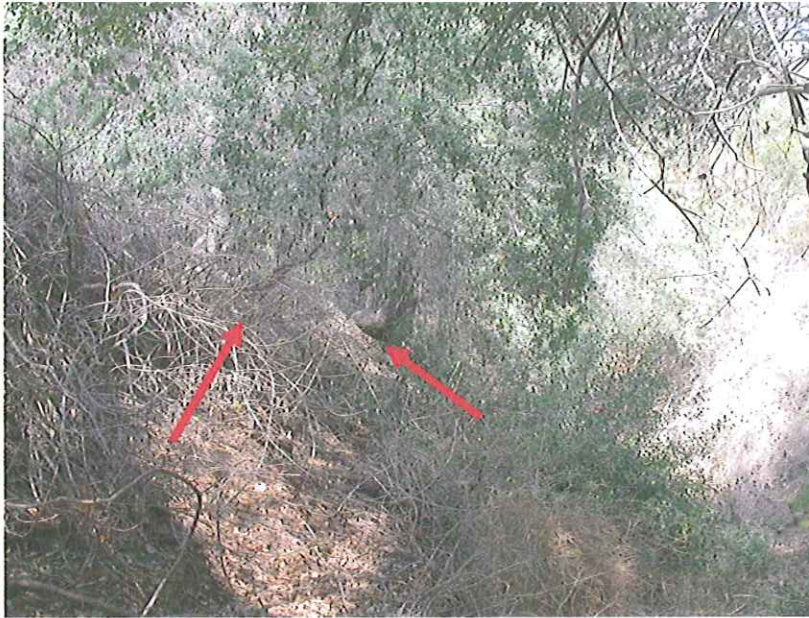
TREE #21 AND 20, LOOKING NORTH FROM TREE #5

Tree #20 – The upright trunk has a basal cavity with decay.

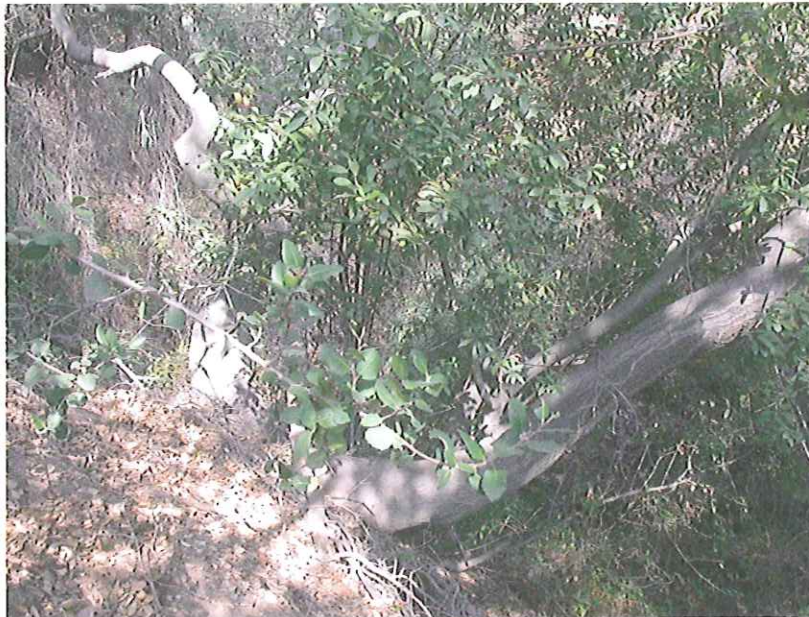
TREE #21 – MINOR IMPACTS
