Julie Bush
Certified Arborist # WE-7770A
12202 Foster Road
Los Alamitos, CA 90720

February 19, 2016

Report for:
3160 Linda Vista rd.
Glendale, CA 91206

INDIGENOUS TREE REPORT

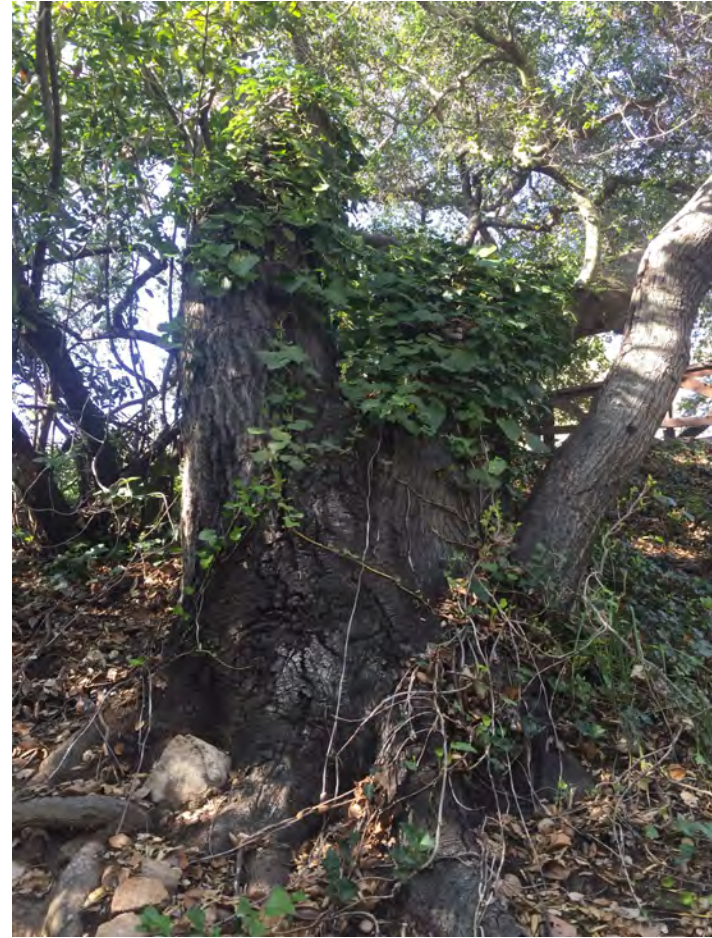
TREE #1

Observations: Multilimbed, oak has a severe lean towards driveway.

Recommendations: Pruning near driveway access, remove Ivy growth.

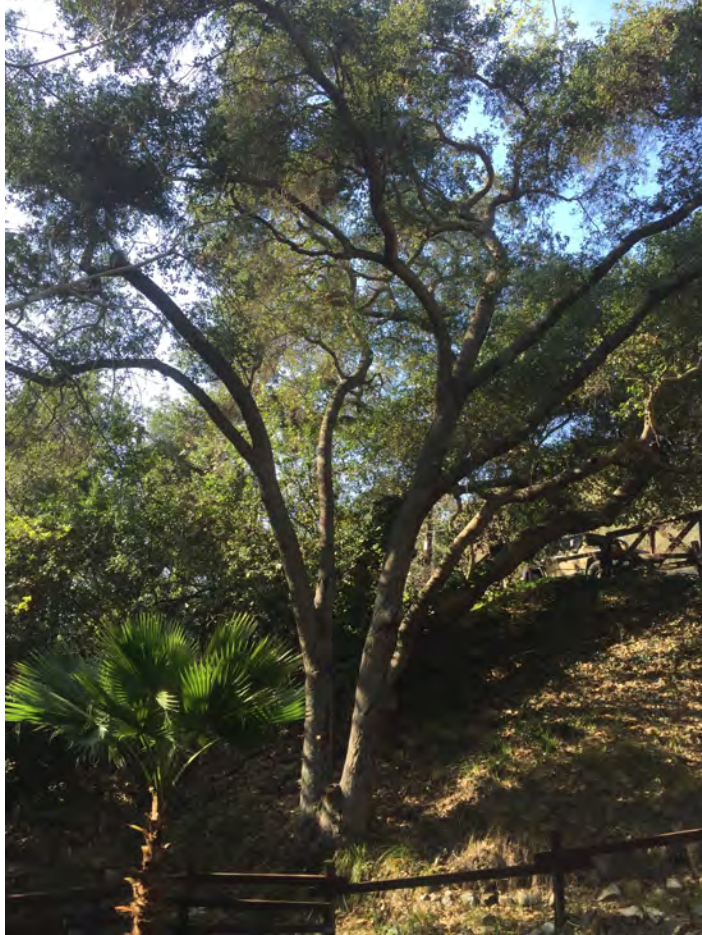
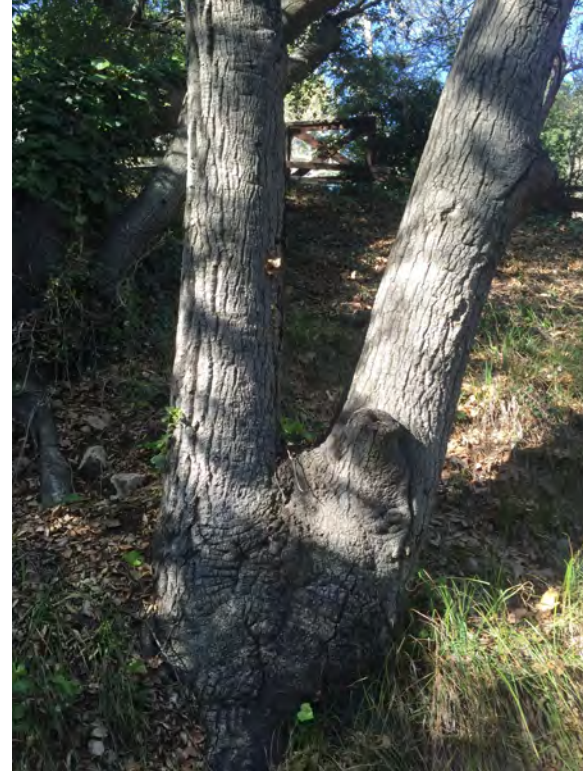
TREE #2

Observations: Multilimbed, Good Health.

Recommendations: Minor Pruning

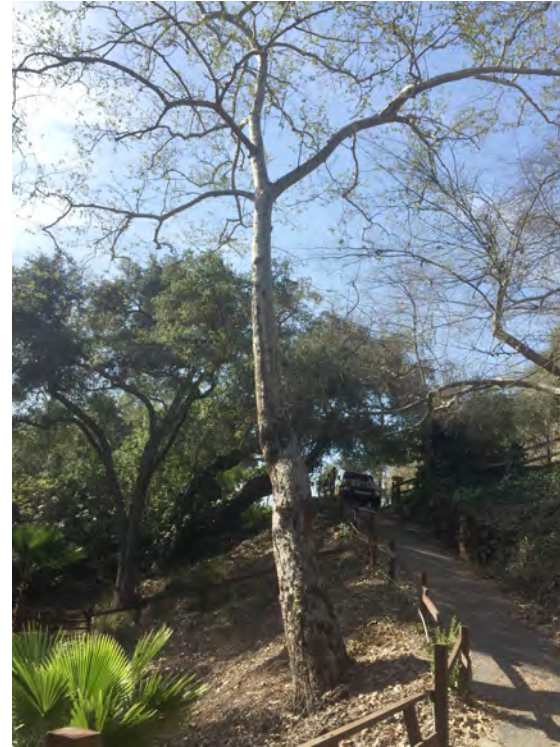
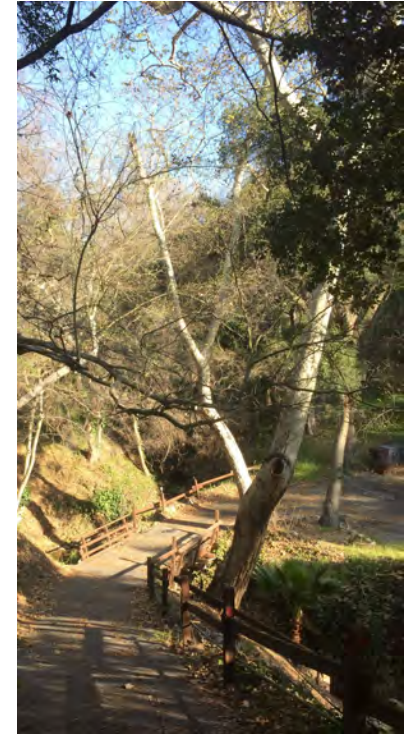
TREE #3

Good Health, Tree is close to driveway 20 degree lean.

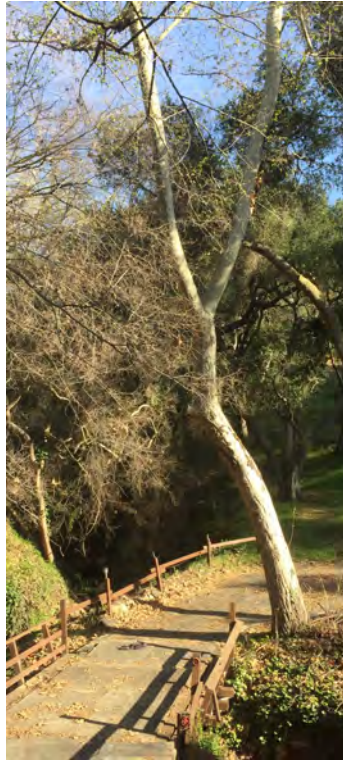
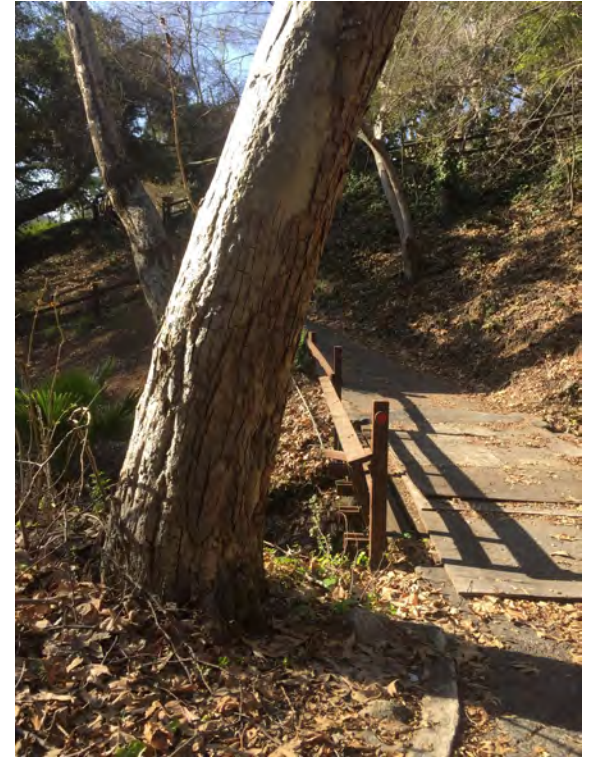
TREE #4

Good Health, Tree is close to driveway and bridge , slight lean towards driveway.

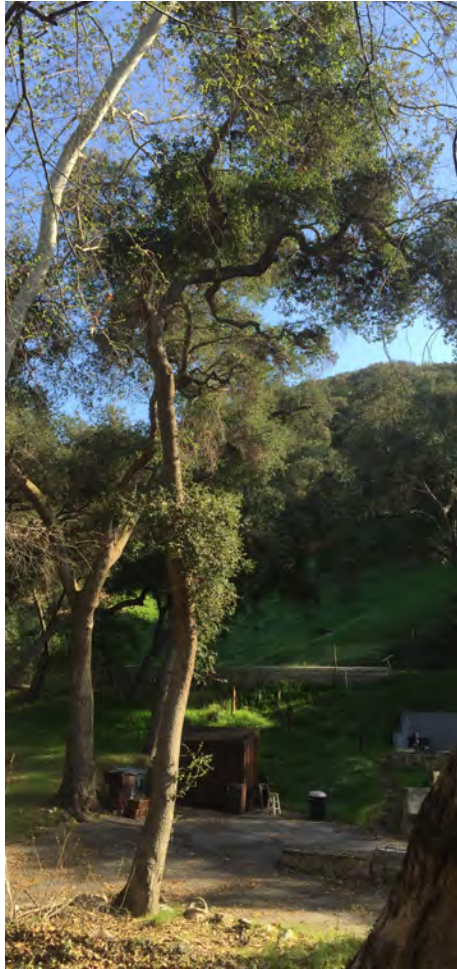
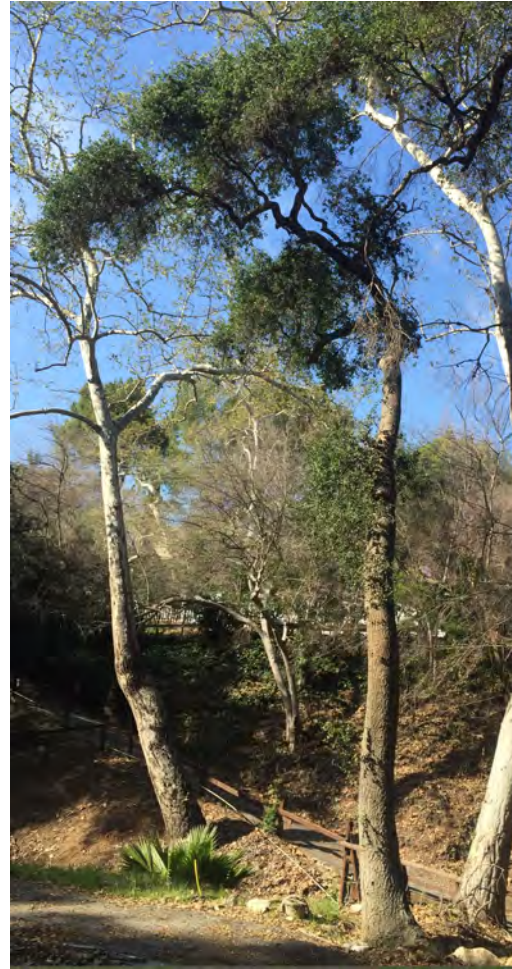
TREE #5

Good Health, Tree is close to driveway, sparse foliage

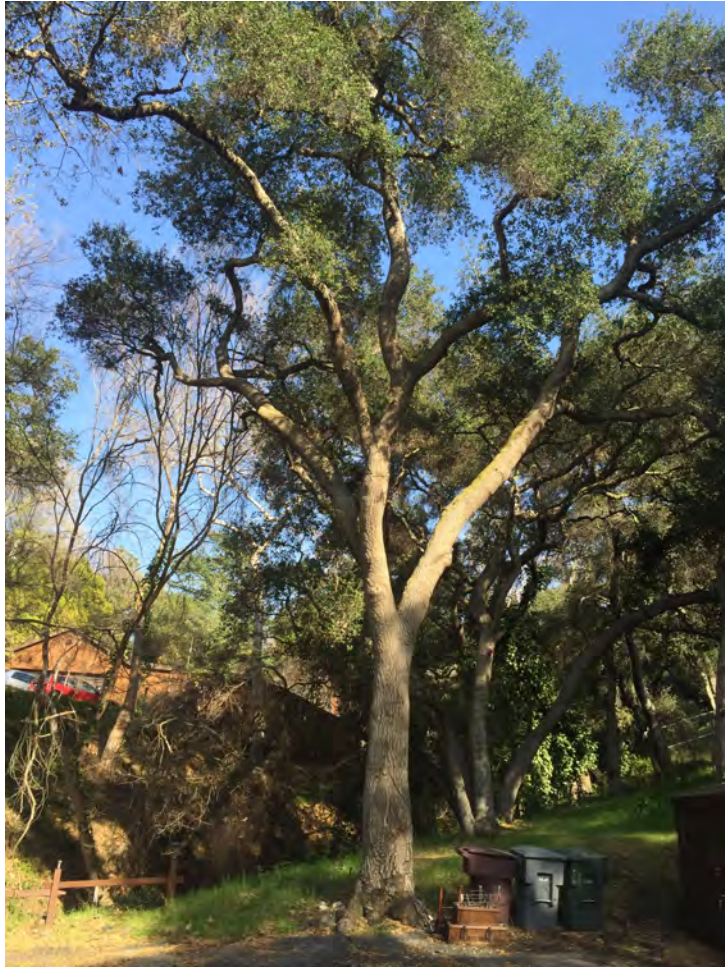
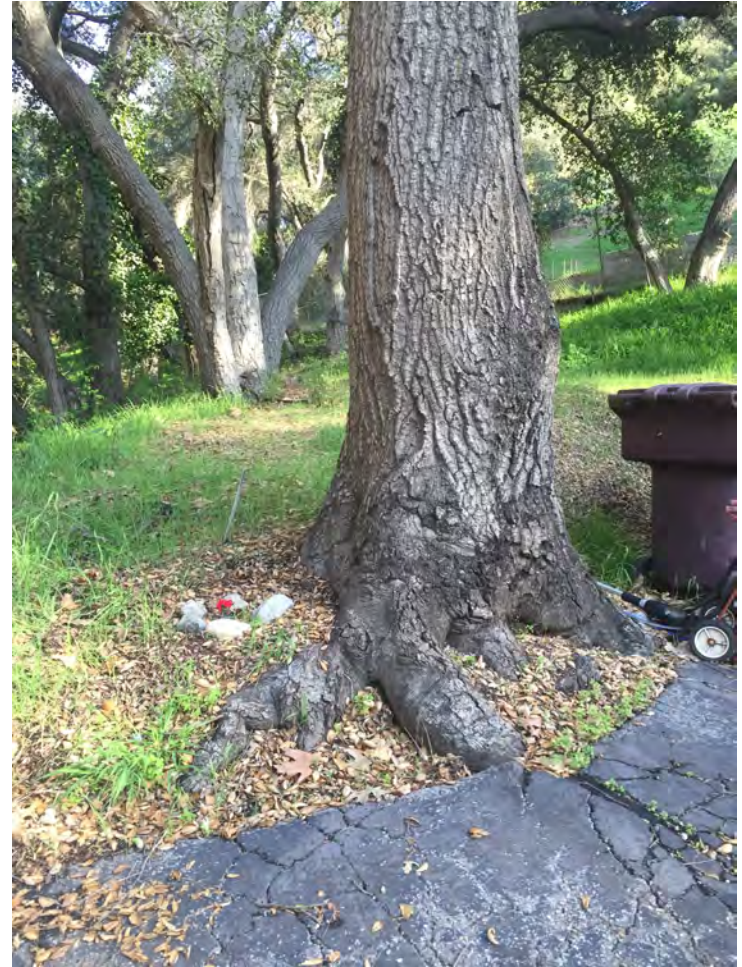
TREE #6
Blue Tag (27)

Observations: Good Health, Tree is close to driveway

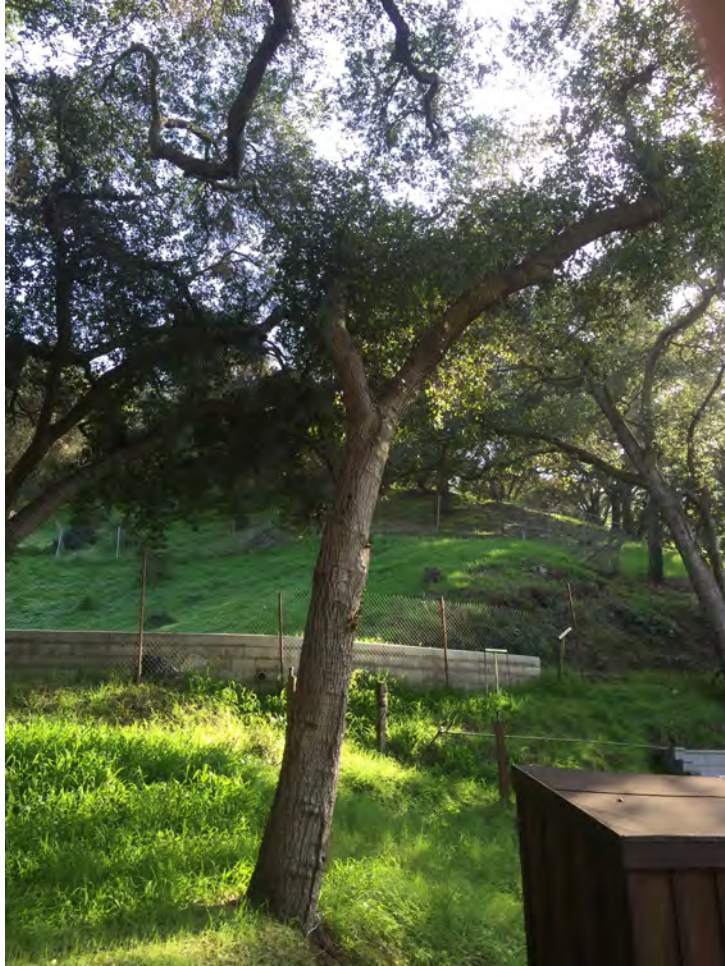
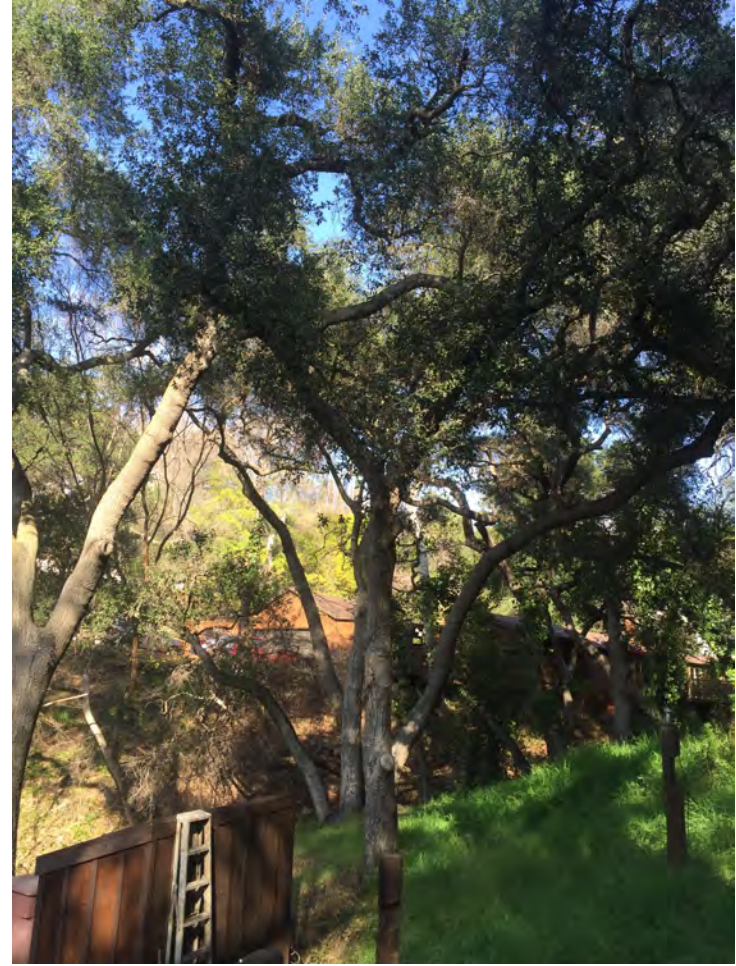
TREE #7
Blue Tag (26)

Observations: Good Health,

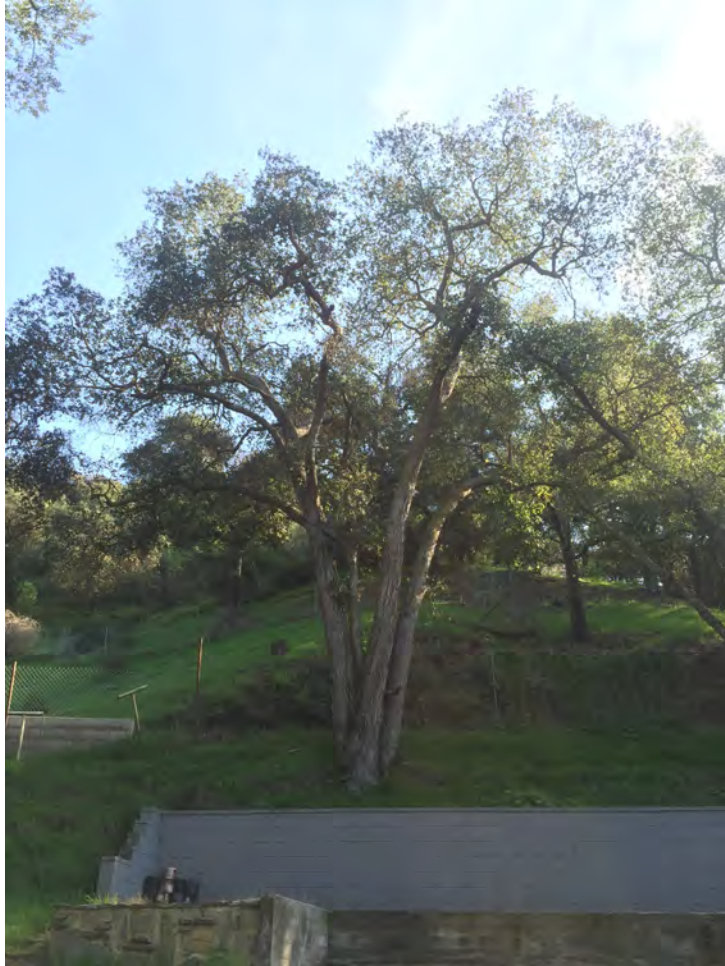
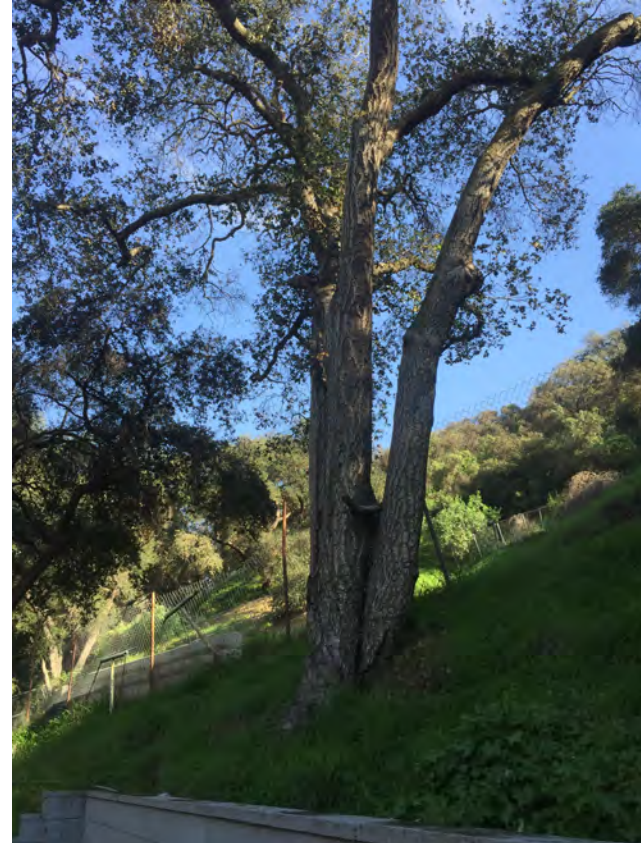
TREE #8

Observations: Good Health, Multilimbed, Tree is just outside property line.

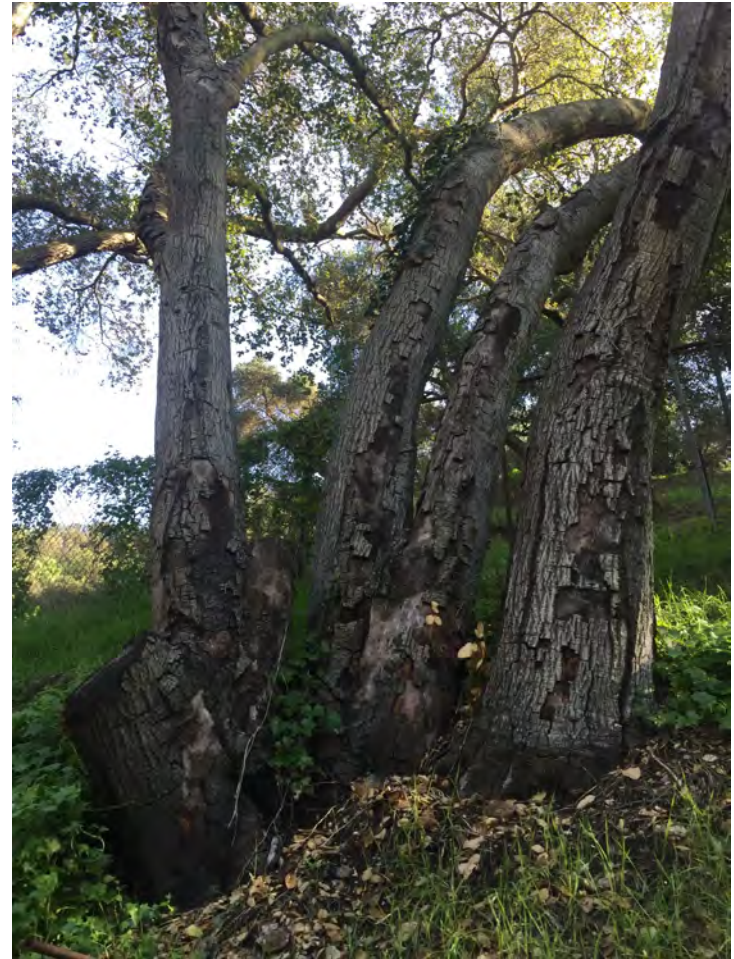
TREE #9

Observations: Generally good Health although evidence of being scorched from fire, Limbs have been removed, Multilimbed tree.

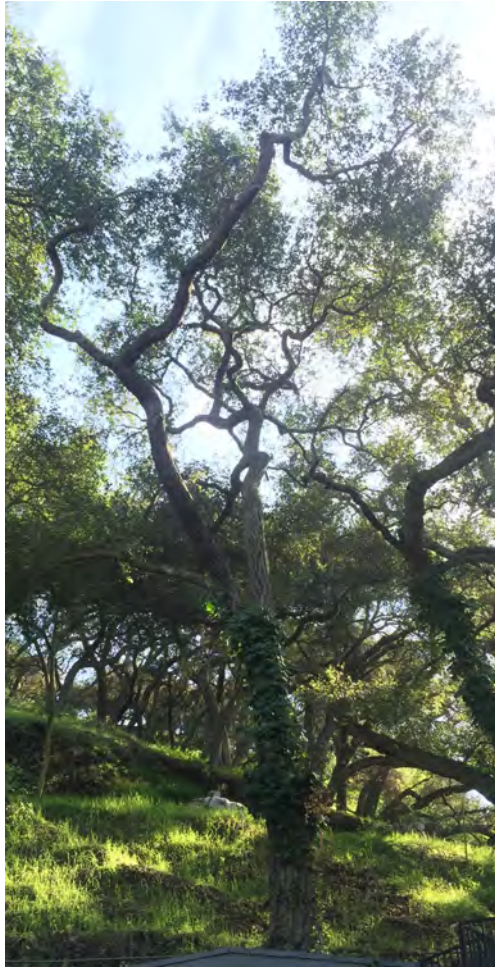
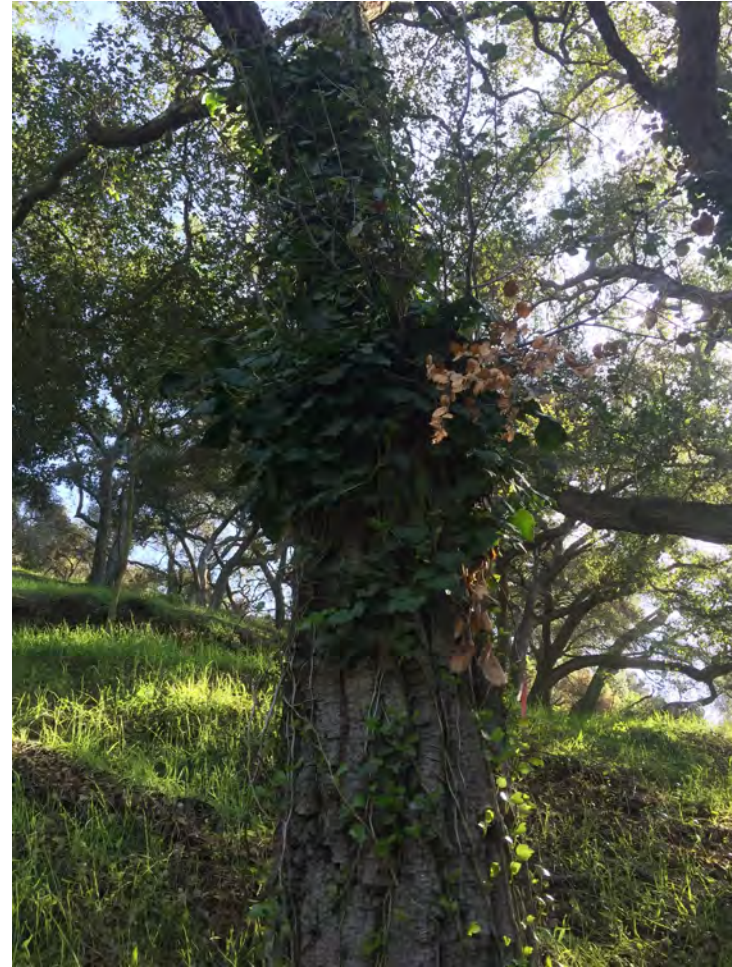
TREE #10

Observations: Good Health

Recommendations: Remove Ivy growth

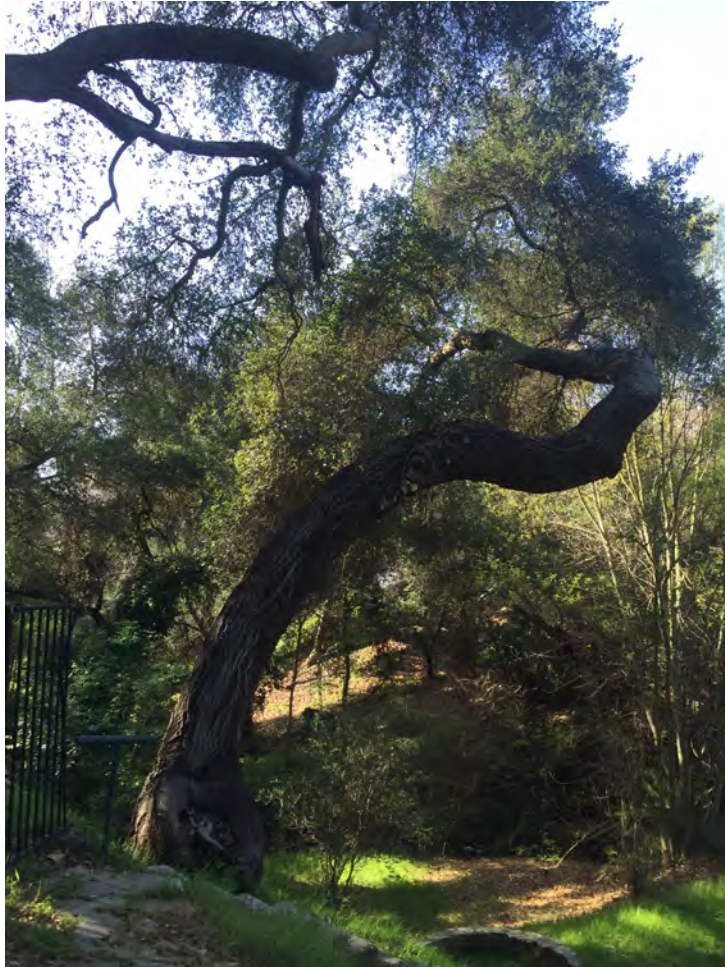
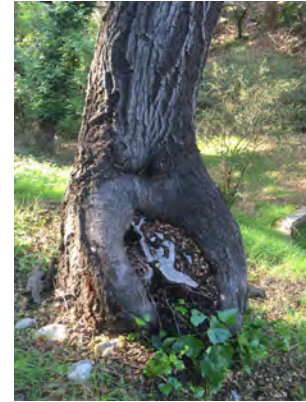
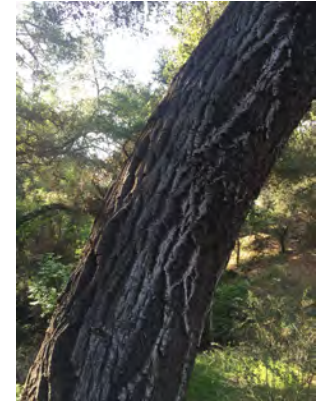
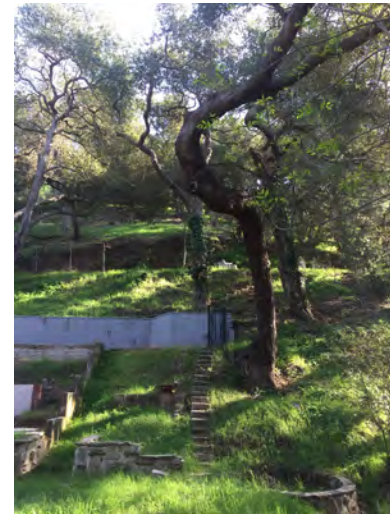
TREE #11

Observations: Generally good Health although evidence of being scorched from fire, Limbs have been removed, Slight Lean, Multilimbed tree. Strong curve in upper trunk.
