**CRAIG CROTTY  
ARBOR CULTURE LLC**

**Regarding:** Proposed subdivision for four single family residence parcels  
at Oak Glen, Glendale, CA 91206

**INDIGENOUS TREE REPORT**

**Subject:** This study is to identify ordinance regulated indigenous trees located in and around a proposed subdivision and construction site. The property is to be divided into four parcels. Indigenous trees located within the site are identified, measured, rated for health and structure, discussed for potential encroachment, and located on a tree plan. Subdivision encroachment is due to construction of a new roadway terminus and planned demolition of the southerly residence. Appraisals are provided for trees with proposed encroachments.

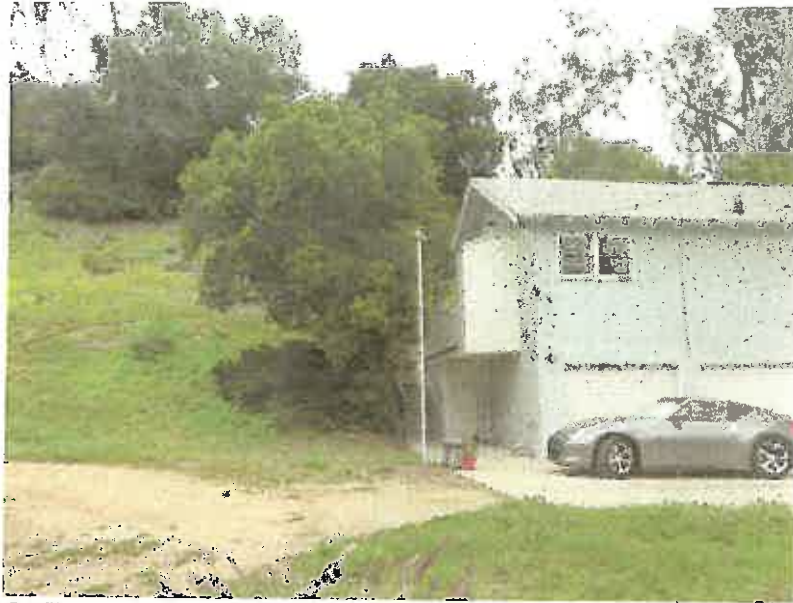
**Oak #1 is located adjacent to the south residence. The residence is proposed for removal to construct a new home. Demolition of the existing will encroach this tree. The tree should be fenced with chain link protection fencing before any site work begins. Work within tree protection zones monitored.**

Oak #1 is encroached by proposed demolition of the existing south residence and construction of two new homes. This tree should be fenced for protection prior to site work. It may require monitoring during demolition and new construction.

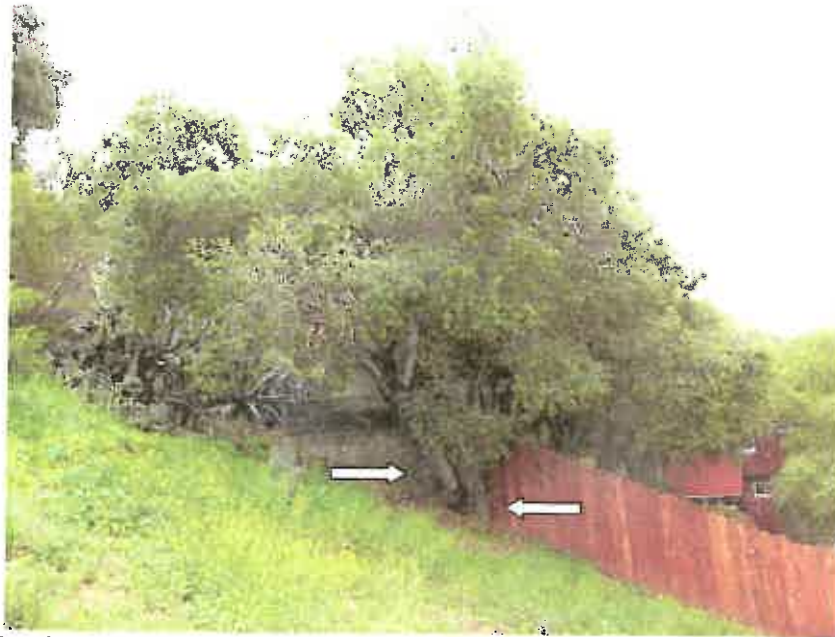
**Oaks #2 #3 are located within three feet of each other on the south property line. They are not likely to be impacted by site construction.**

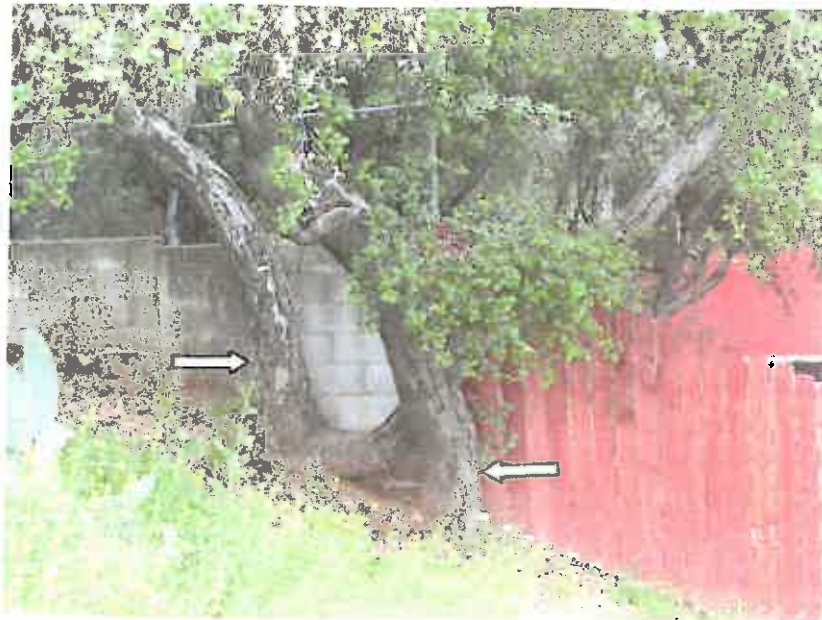
**#2 #3 Oaks are located on the south property boundary adjacent to a block wall and fence. They are above the south residence proposed for removal but beyond potential construction impact.**

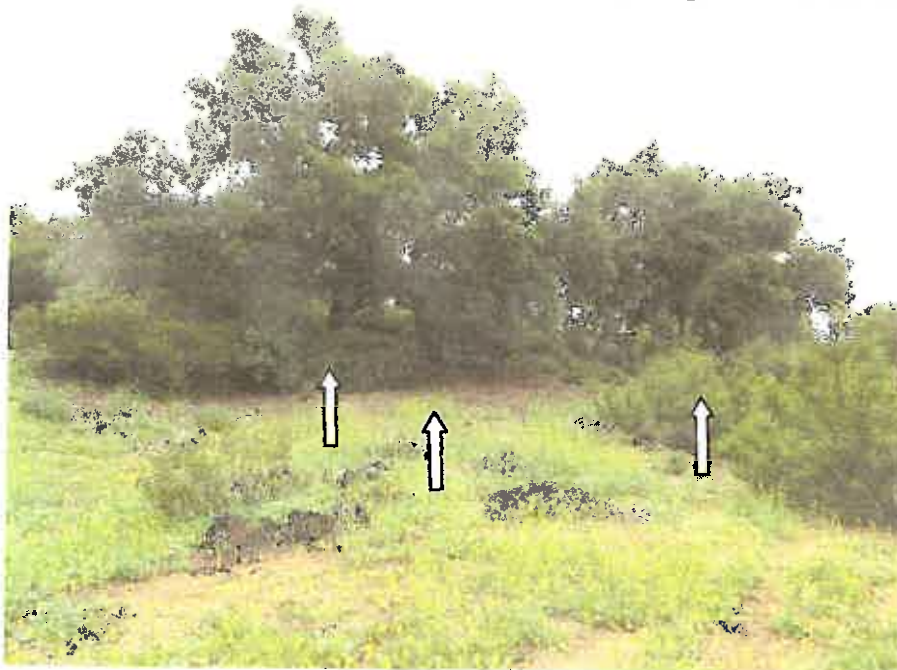
**#4 #5 #6 Oaks are shown from right to left. They are located at the top of slope beyond potential impacts from construction.**

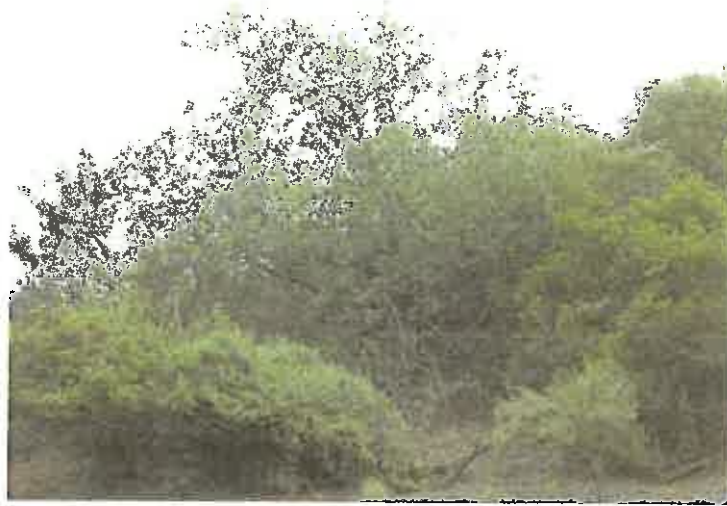
**Oak #7 is a small, low, tree crowded by native chaparral located at the top of slope beyond encroachment.**

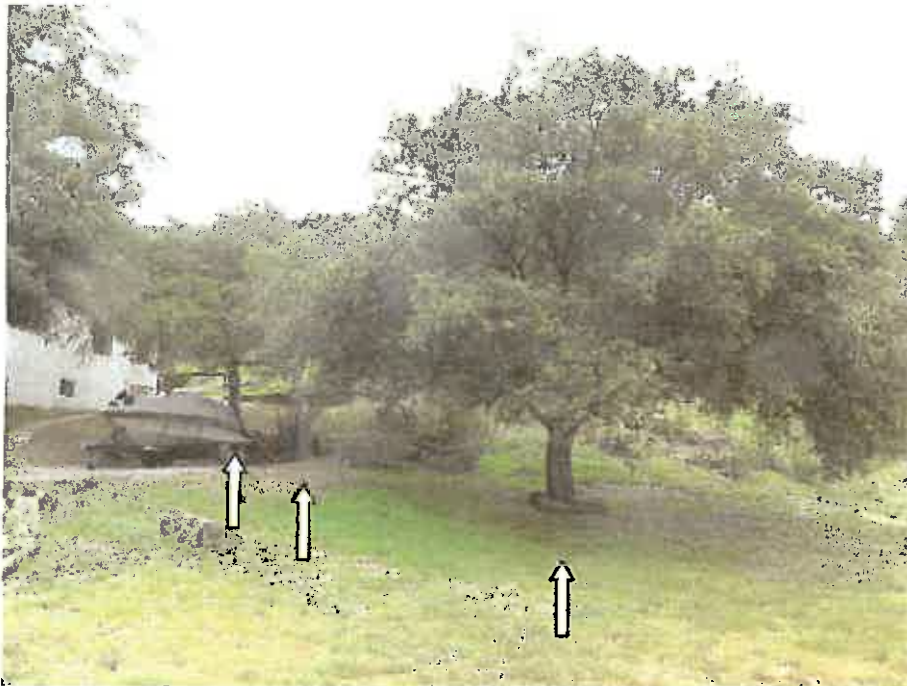
**Oaks #8 #9 #10 are shown from right to left. Lot splits are at right, the residence at left is to remain in place. Trees will require temporary chain link protection fencing when lots are developed.**

**Oaks #8 #10 appear to be in good condition. The middle Oak #9 is nearly dead; the top of the crown is dead with some live foliage persisting in the lower branches. Drought and insect infestation is suspected as the cause.**

Oaks (#8-#9) would be removed due to impact from proposed grading and placement of a proposed cul-de-sac roadway. Oak #8 is in reasonably good condition and should be mitigated if approved for removal. Oak #9 is in very poor condition, nearly dead. Oak #9 should be removed due to condition regardless of proposed construction.

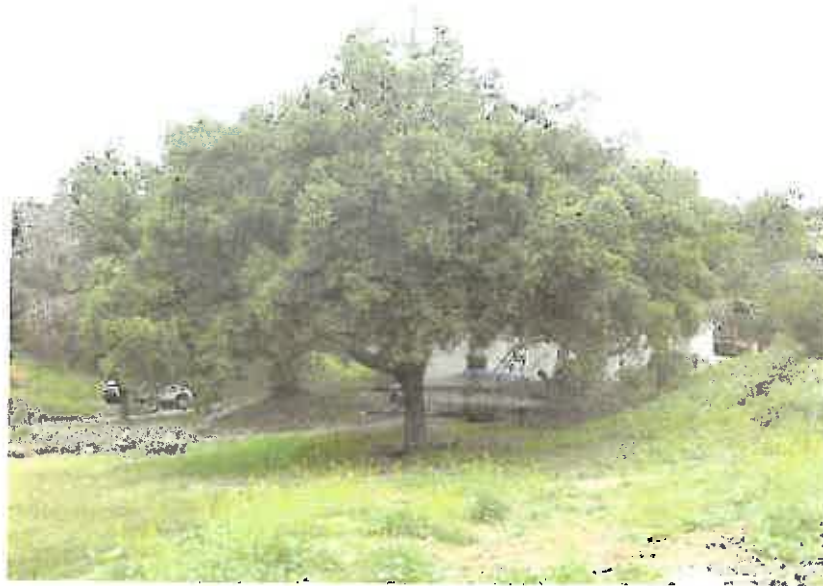
**#8 Oak is a good specimen worth protecting.**

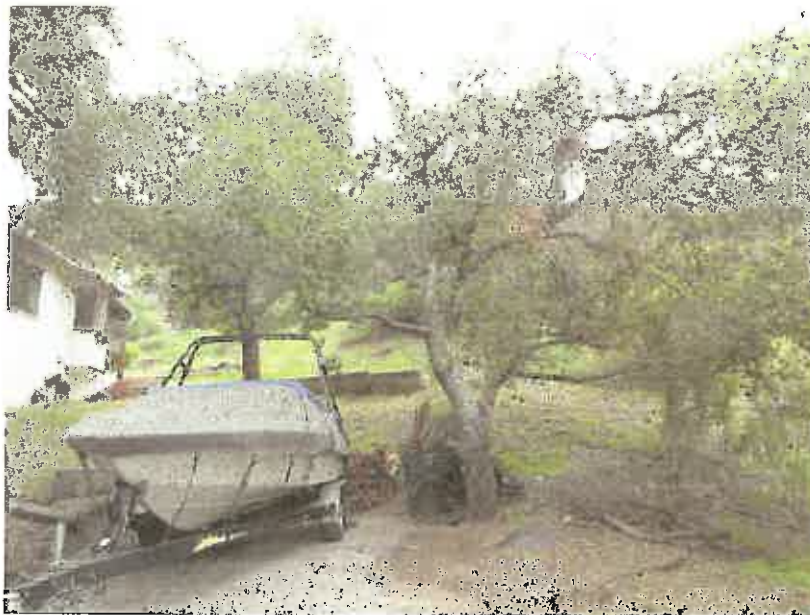
**Oak #9 (center) is mostly dead.  
Oak #10 is a good specimen to protect.**

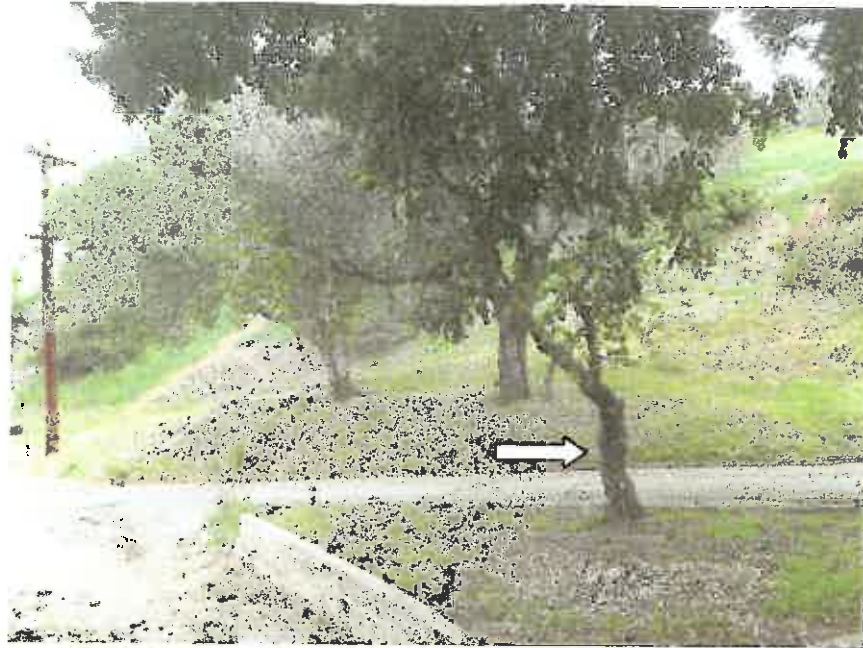
| TREE NUMBER | 11 | 12 | 13 | 14 | 15 |
|---|---|---|---|---|---|
| TREE NO. 11 | Quercus agrifolia Very poor condition, small, leaning, oozing trunk, frass. Possibly encroached by grading. | | | | |

**Oak #11 is a small tree in very poor condition (not encroached).  
Oak #12 is at left in back; a dead tree is center back in the photo.**

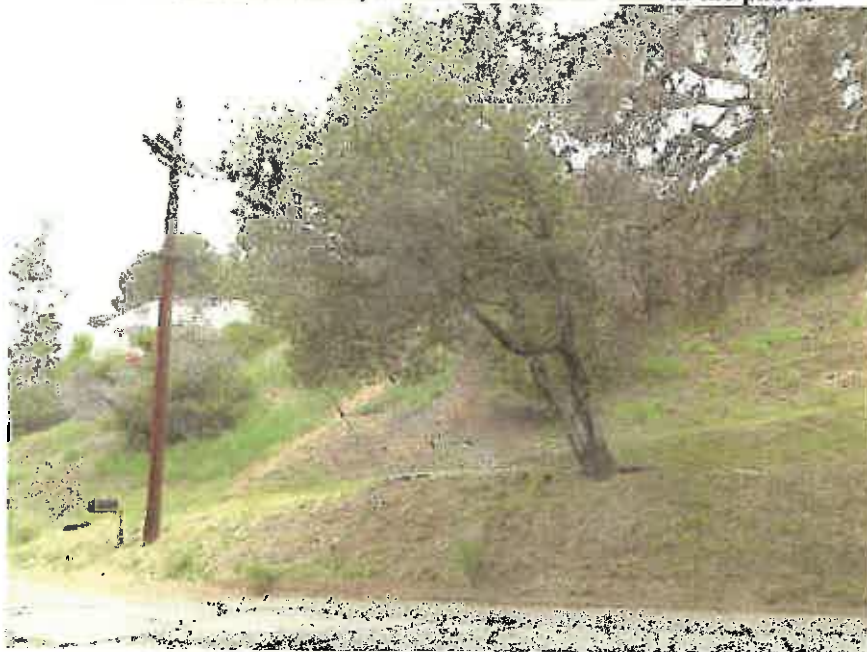
**Oak #12 is rated fair and likely beyond encroachment  
at the entrance drive to the residence to remain..**

**A larger Oak at right is entirely dead and excluded from this report.**

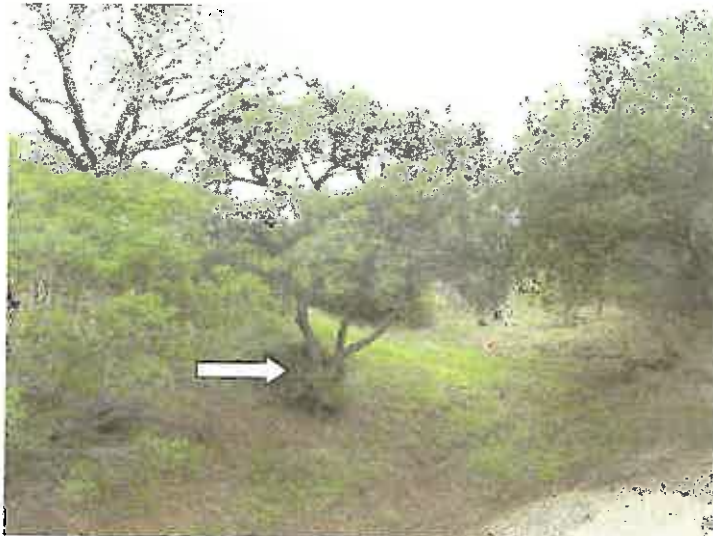
Oak #13-14

**Scrub Oak #13 is shown above the residence driveway; not encroached.**

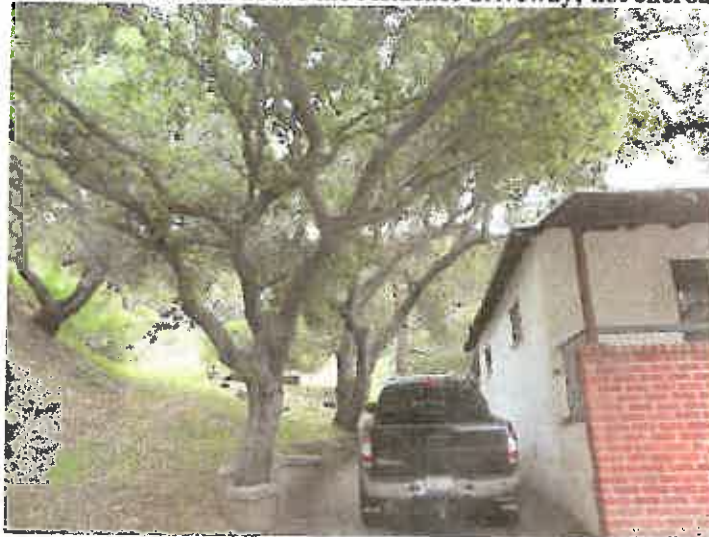
**Oaks #14 (front) #15 (back of truck) and #16 (above left) are shown behind the residence to remain. No work is proposed near this residence Tree sizes estimated due to private access concerns.**

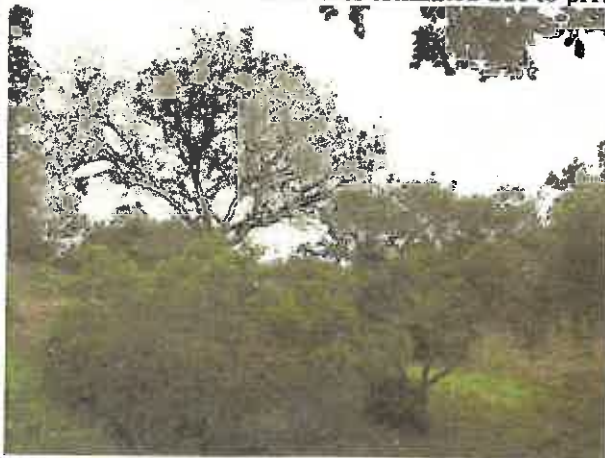
**Oak #17 is located above the north residence to remain; not encroached.**
