**INDIGENOUS TREE REPORT
for
Property
at
1829 Kirkby Road
Glendale, CA 91208**

November 24, 2017

Arsen Margossian, Consulting Arborist
Bardez Landscape Services, Inc.
ISA Certified Arborist # WE-7233A
Member, American Society of Consulting Arborists
ISA Tree Risk Assessment Qualified (TRAQ)
California Licensed Pest Control Adviser #071429
3512 Rosemary Avenue
Glendale, CA 91208
818 669 6469
arsenm@pacbell.net

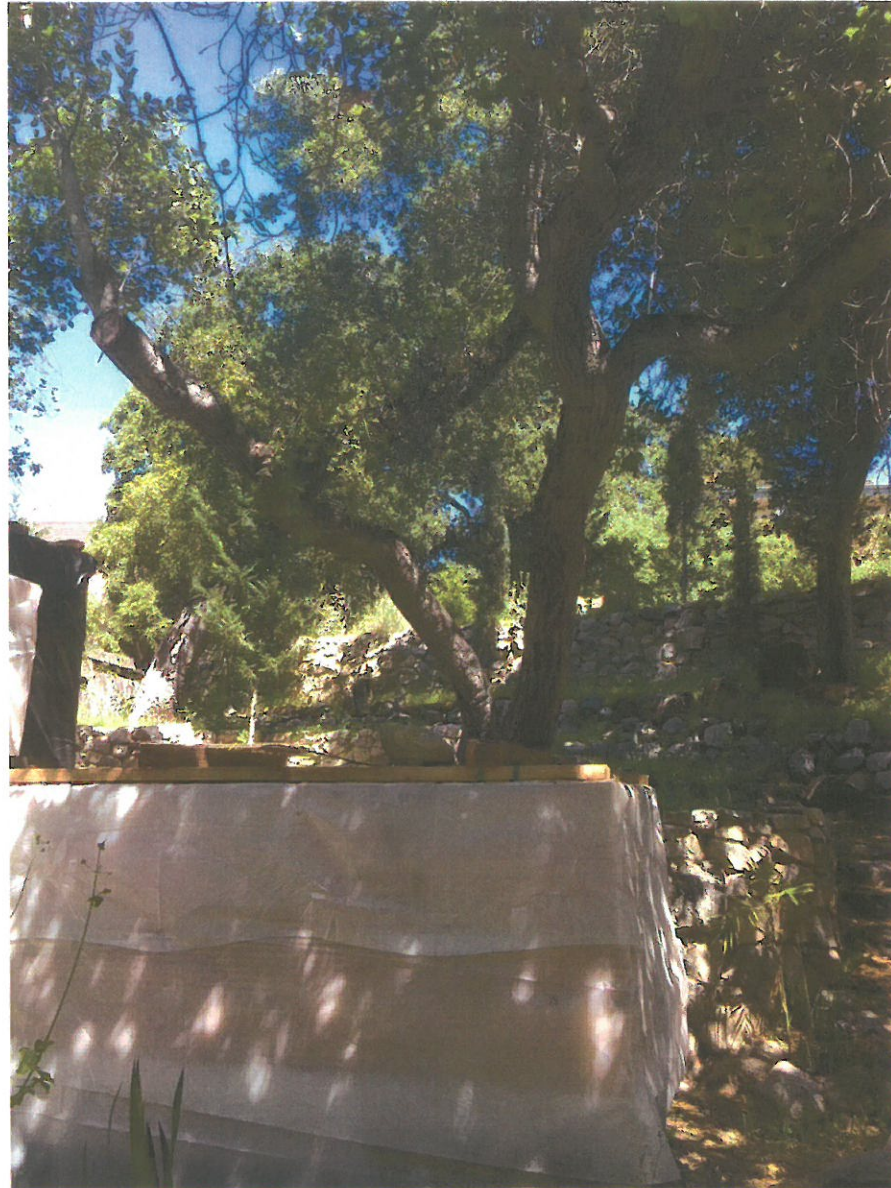
Tree #85.

This is a young tree, with two trunks; one has 9 and the other 6 inches DBH. The cumulative DBH of this tree is 15 inches. It is located on the west side, at the lowest grade of the property. As a result, its **crown** is under the crown of two other oak trees (#86 and #87), which are located at a higher grade.

Both trunks lean extensively southward and the resulting canopy is entirely away from the base of the trunks.

The smaller trunk has been cut back and a single branch has emerged from it. Most of the crown is on the other trunk. There is extensive **deadwood**, which is normal for a tree that has not been maintained.

The **foliage** is typical of this species. **Leaf scorch**, a fungal disease, is present in parts of the canopy, and **shot holes** are also observed on the leaves.

Buttress roots at the **root collar** area are covered with leaf litter and there is no presence of fungus or **conks**, which would have been an indication of rot and decay.

On a 0 to 5 scale (0 being dead and 5 being excellent), the **condition rating** for this tree is 3 (Average).

This tree is within the footprint of the construction site. It has to be removed.

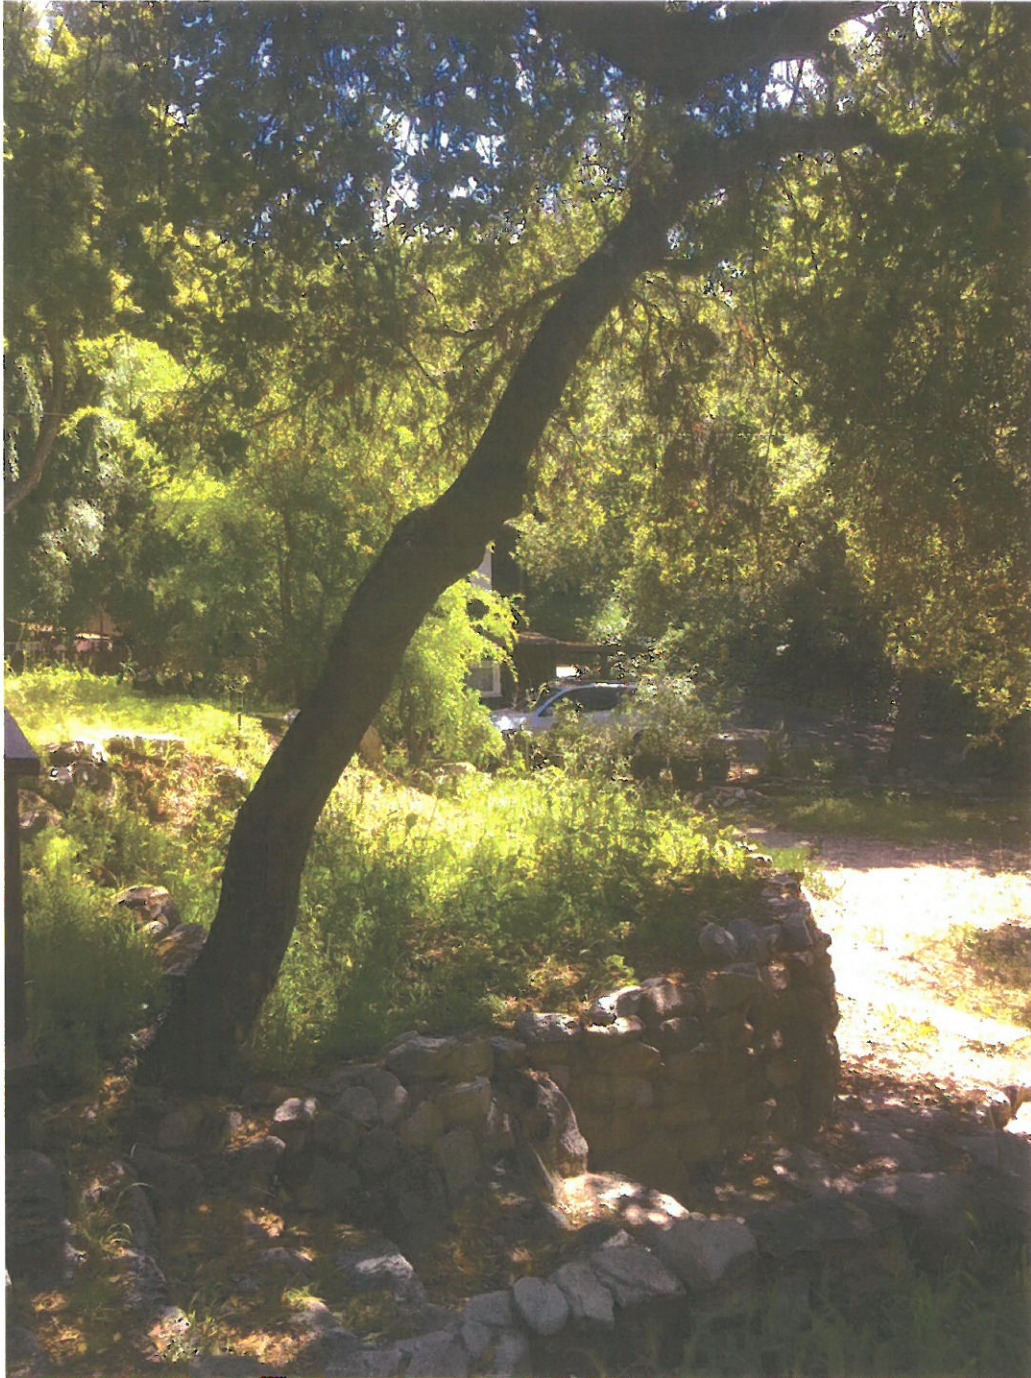
Tree #86.

The twisted trunk of the tree has a south lean, and as a result, the entire canopy is completely away from the base of the tree trunk. The farthest spread of the canopy is 24 feet.

This is a poorly-structured tree, under the canopy of Tree #87.

Same characteristics of Tree #85 apply to this tree also, with considerable deadwood and uneven crown. No buttress roots are visible on this tree also.

On a 0 to 5 scale (0 being dead and 5 being excellent), the condition rating for this tree is 3 (Average).

This tree is within the footprint of the construction site. It has to be removed.

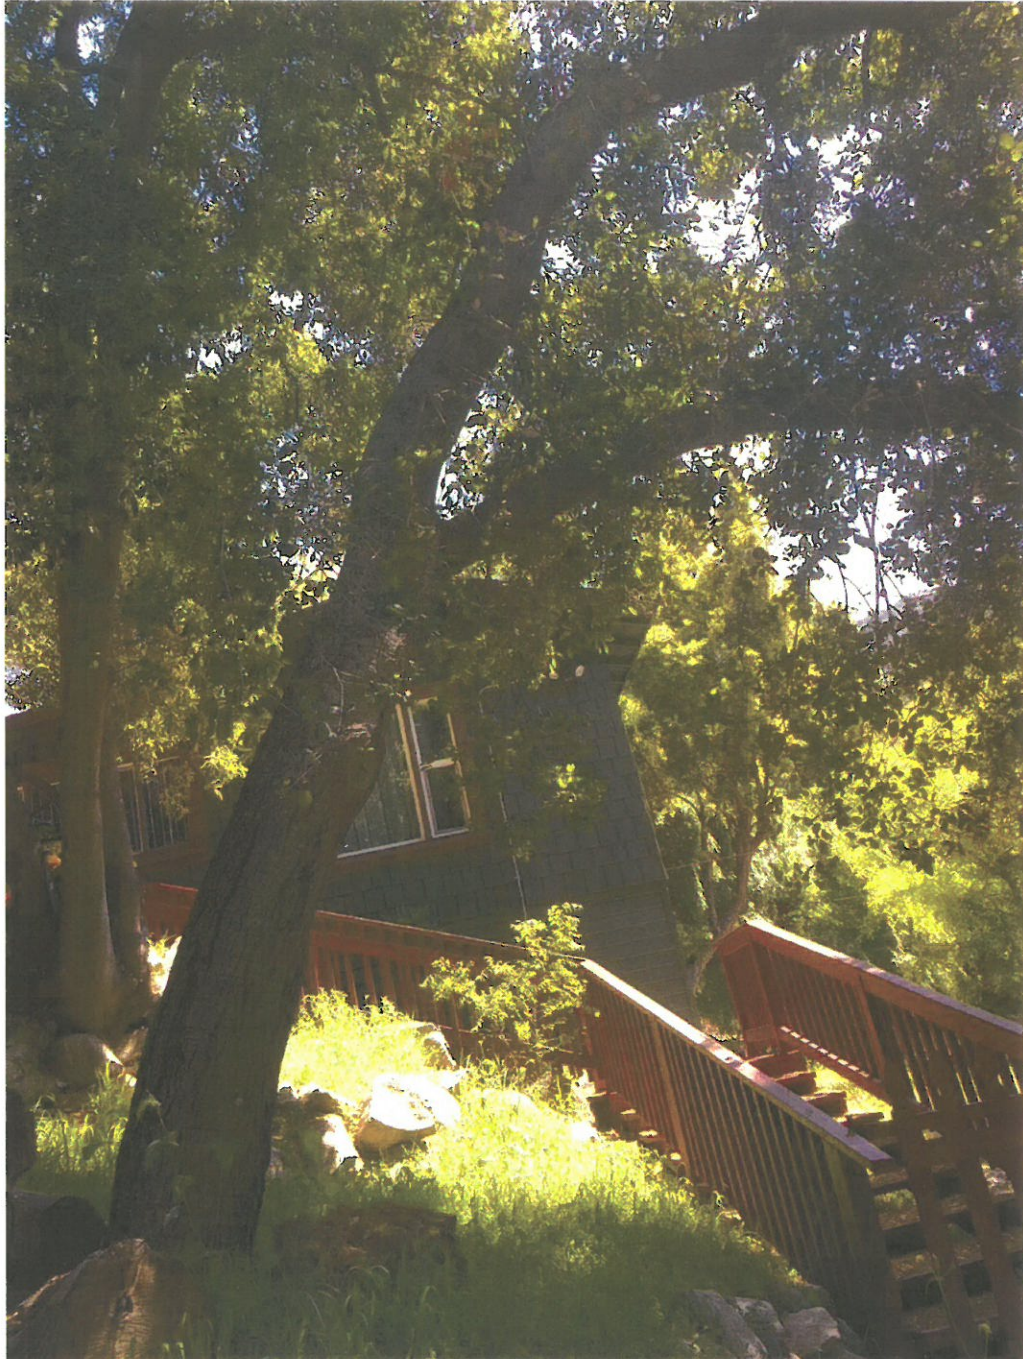
Tree #87.

The single trunk of the tree is leaning, because of its location under the canopy of a pittosporum tree and oak Tree #91.

The trunk divides to two at nine feet from grade, and both secondary trunks head southward in considerable lean.

The crown of this tree is also completely away from the base of the trunk, and the spread of the canopy reaches 30 ft south of the tree base.

This tree sends its branches over Tree #85 and Tree #86. Deadwood is present in the undergrowth of the tree, and same characteristics as the previous trees is visible on this tree also.

On a 0 to 5 scale (0 being dead and 5 being excellent), the condition rating for this tree is 3 (Average).

This tree also is within the footprint of the proposed new dwelling and it has to be removed.

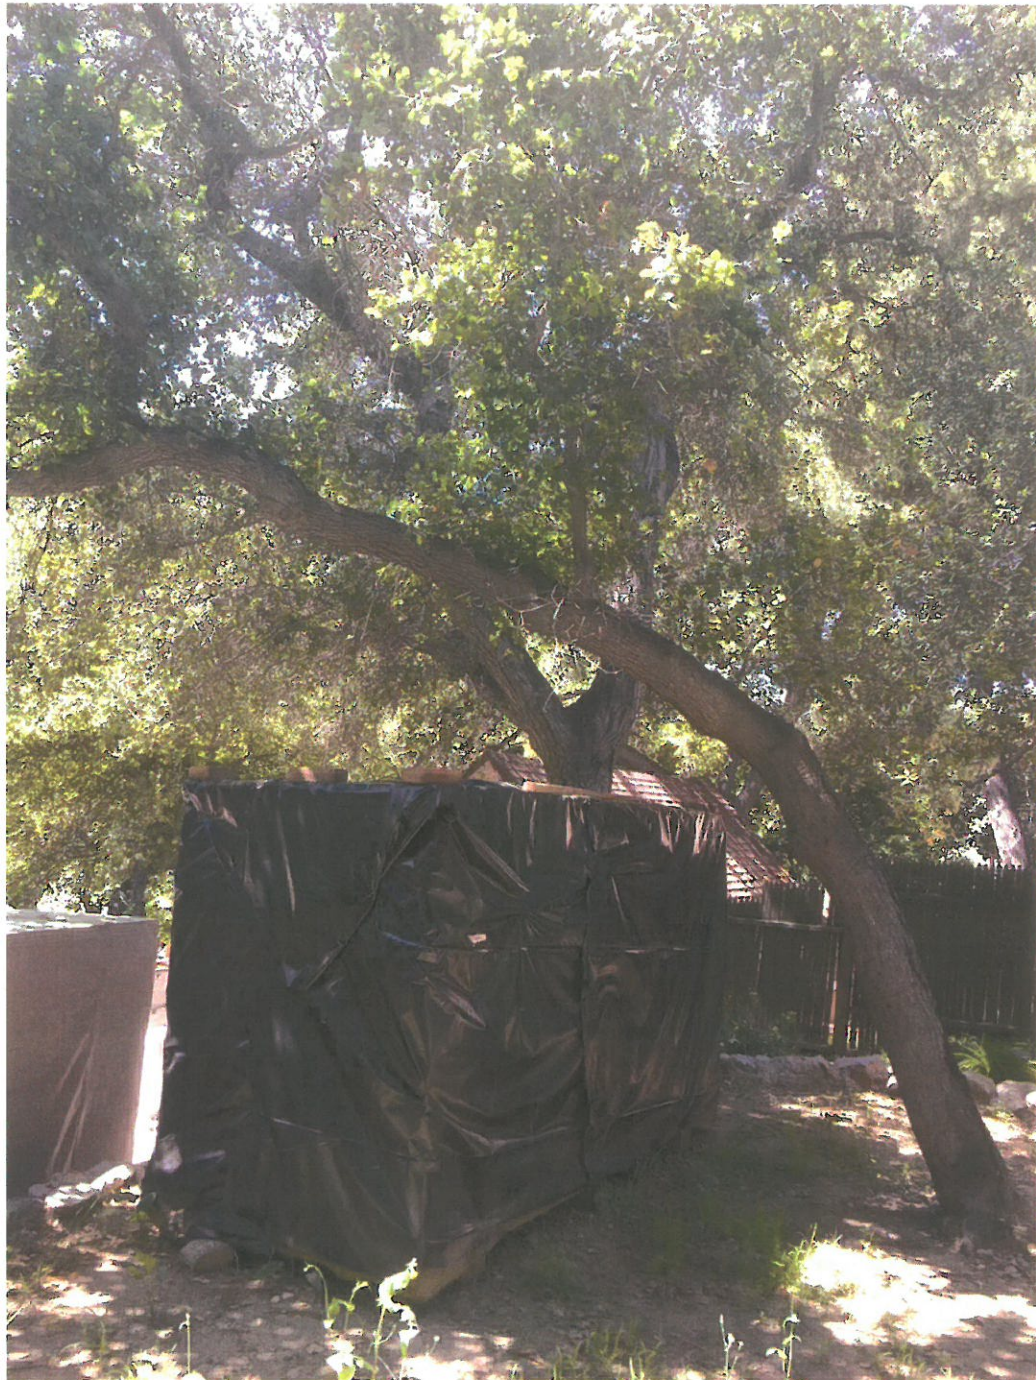
Tree #88.

The single trunk of the tree, as all the previous trees, is leaning south. The crown of the tree extends up to 25 feet away from the base of the trunk.

This tree has some **cavities** on the main trunk, an indication of failed branches.

As the previous trees, this tree also has leaf scorch, deadwood and poor structure.

On a 0 to 5 scale (0 being dead and 5 being excellent), the condition rating for this tree is also 3 (Average).

This tree is close to the footprint of the proposed new dwelling but it can be preserved. Some pruning will be necessary to provide clearance.

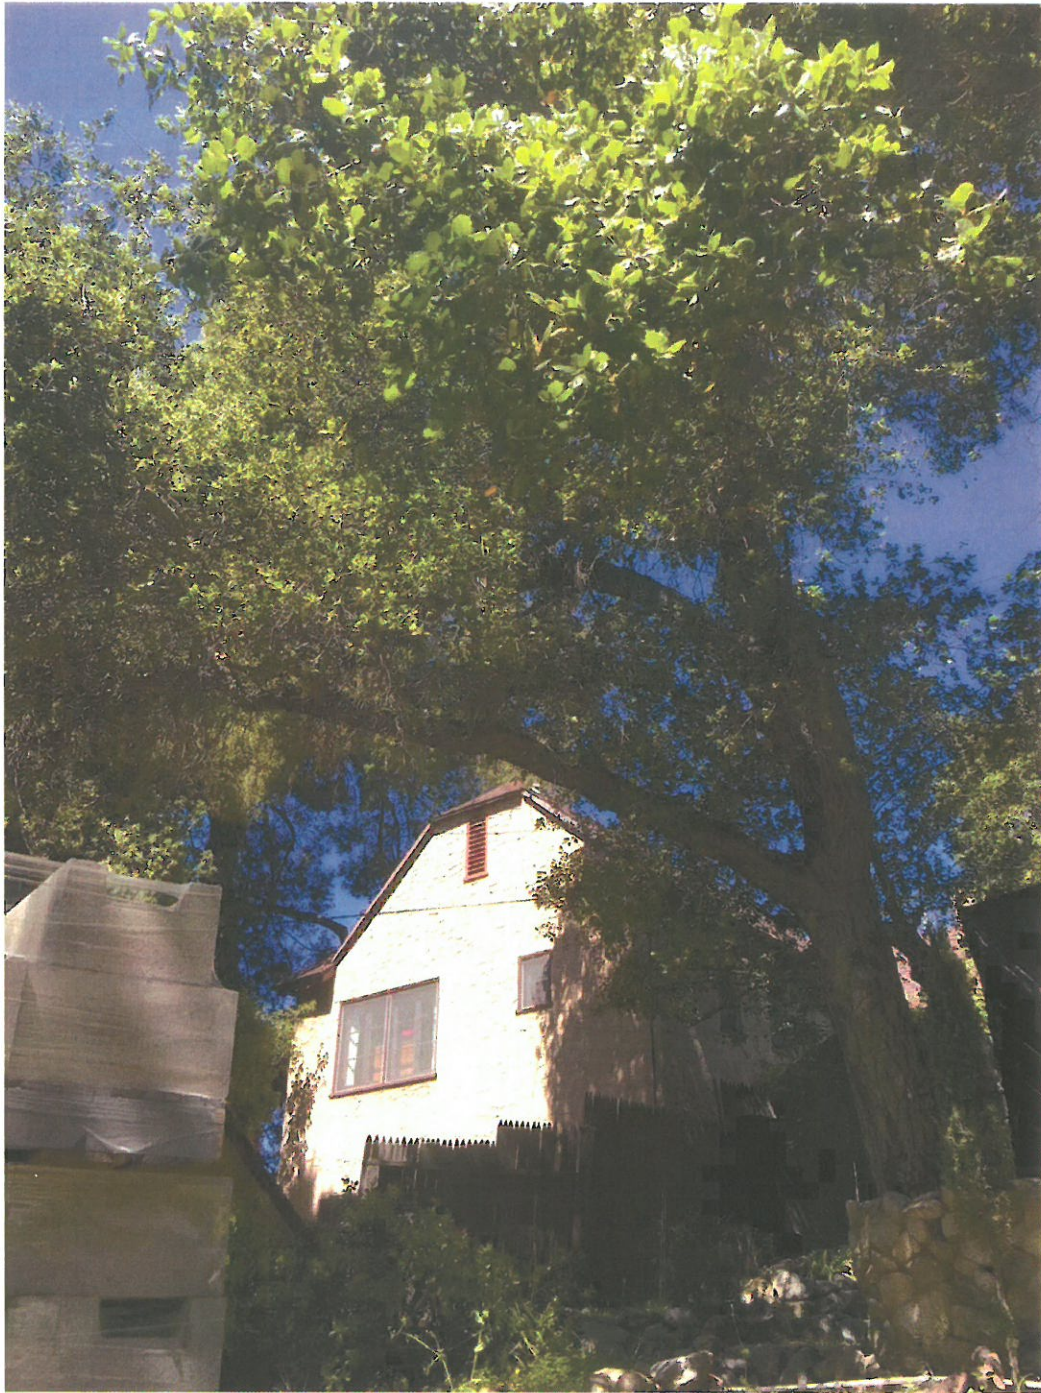
Tree #89.

This tree is in better condition, with somehow more evenly spread crown, because of well-balanced **scaffold branches**. The branches spread up to 30 feet from the base of the trunk.

Some leaf scorch and deadwood are visible on the tree, but no major health issues or structural weaknesses are present.

On a 0 to 5 scale (0 being dead and 5 being excellent), the condition rating for this tree is 4 (Good).

This tree is about ten feet from the edge of the proposed new house, and should not be impacted substantially. Some pruning will be needed for clearance.

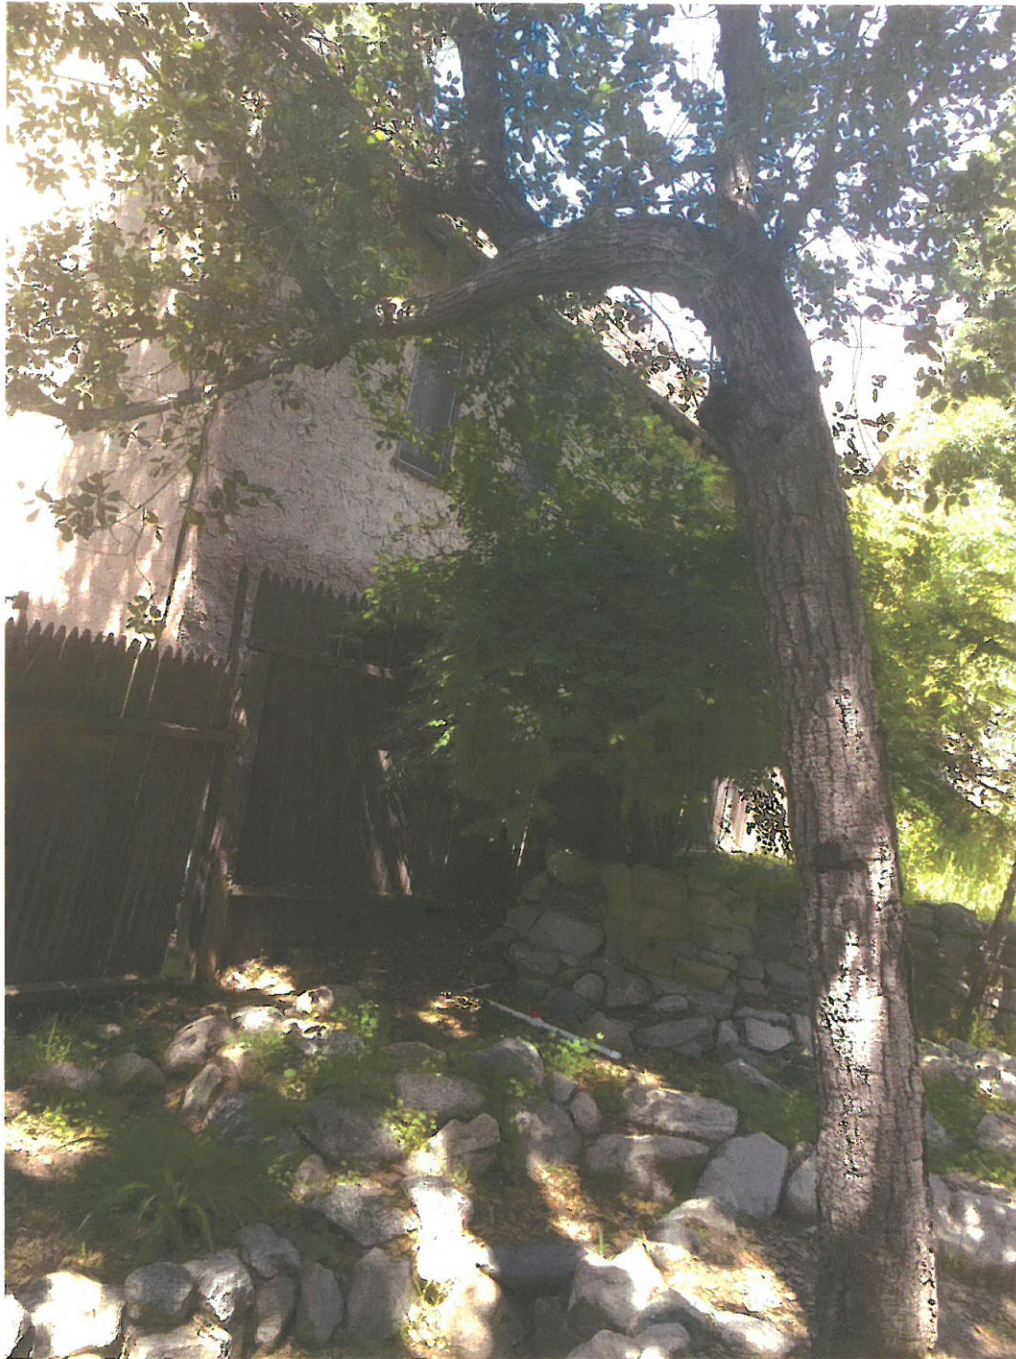
Tree #90.

The single trunk has a DBH of 9.5 inches and it leans considerably toward the west side.

Over the years, the main branches have been cut back away from the neighboring property, and as a result, the canopy spread is only of 12 feet in that direction.

The thin crown of the tree due to its presence under the crown of Tree #89.

On a 0 to 5 scale (0 being dead and 5 being excellent), the condition rating for this tree is 3 (Average).

This tree is outside the footprint of the proposed new dwelling and it can be preserved in place.

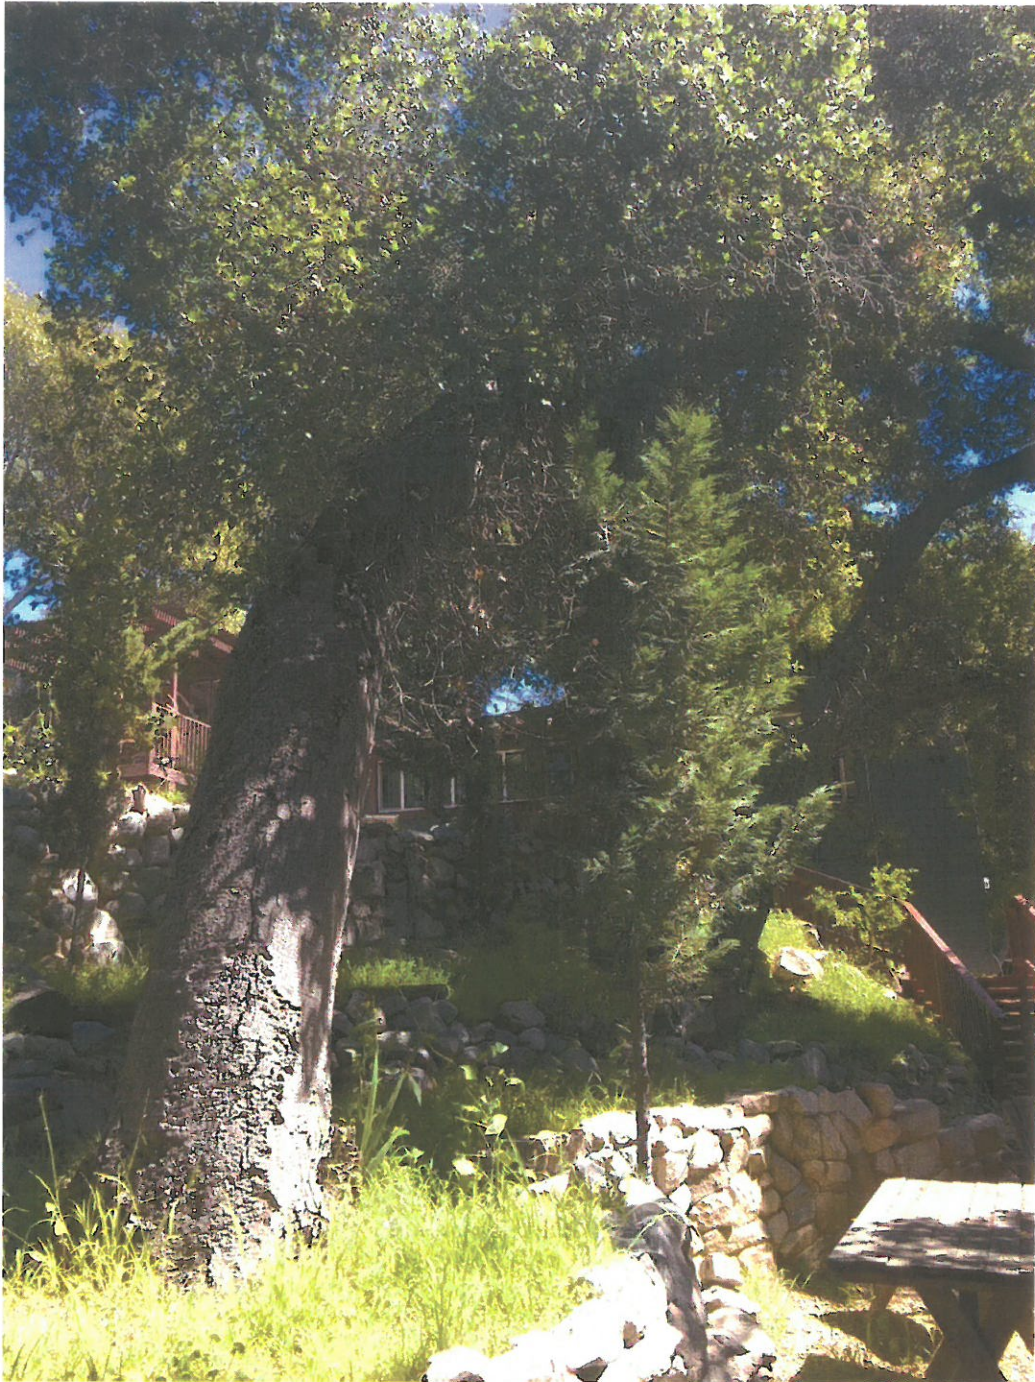
Tree # 91.

The main trunk leans toward the east side and extends almost up to 25 feet with no main scaffold branches. At the end of the main trunk, there are only two main branches that form the principal crown. The rest of the dripline consists of small branches of four to five feet length.

Some leaf scorch and deadwood are visible on this tree too.

On a 0 to 5 scale (0 being dead and 5 being excellent), the condition rating for this tree is 1 (Poor).

Although this tree can be preserved, since it is away from the construction footprint, but given its health condition, it is advised to be removed.

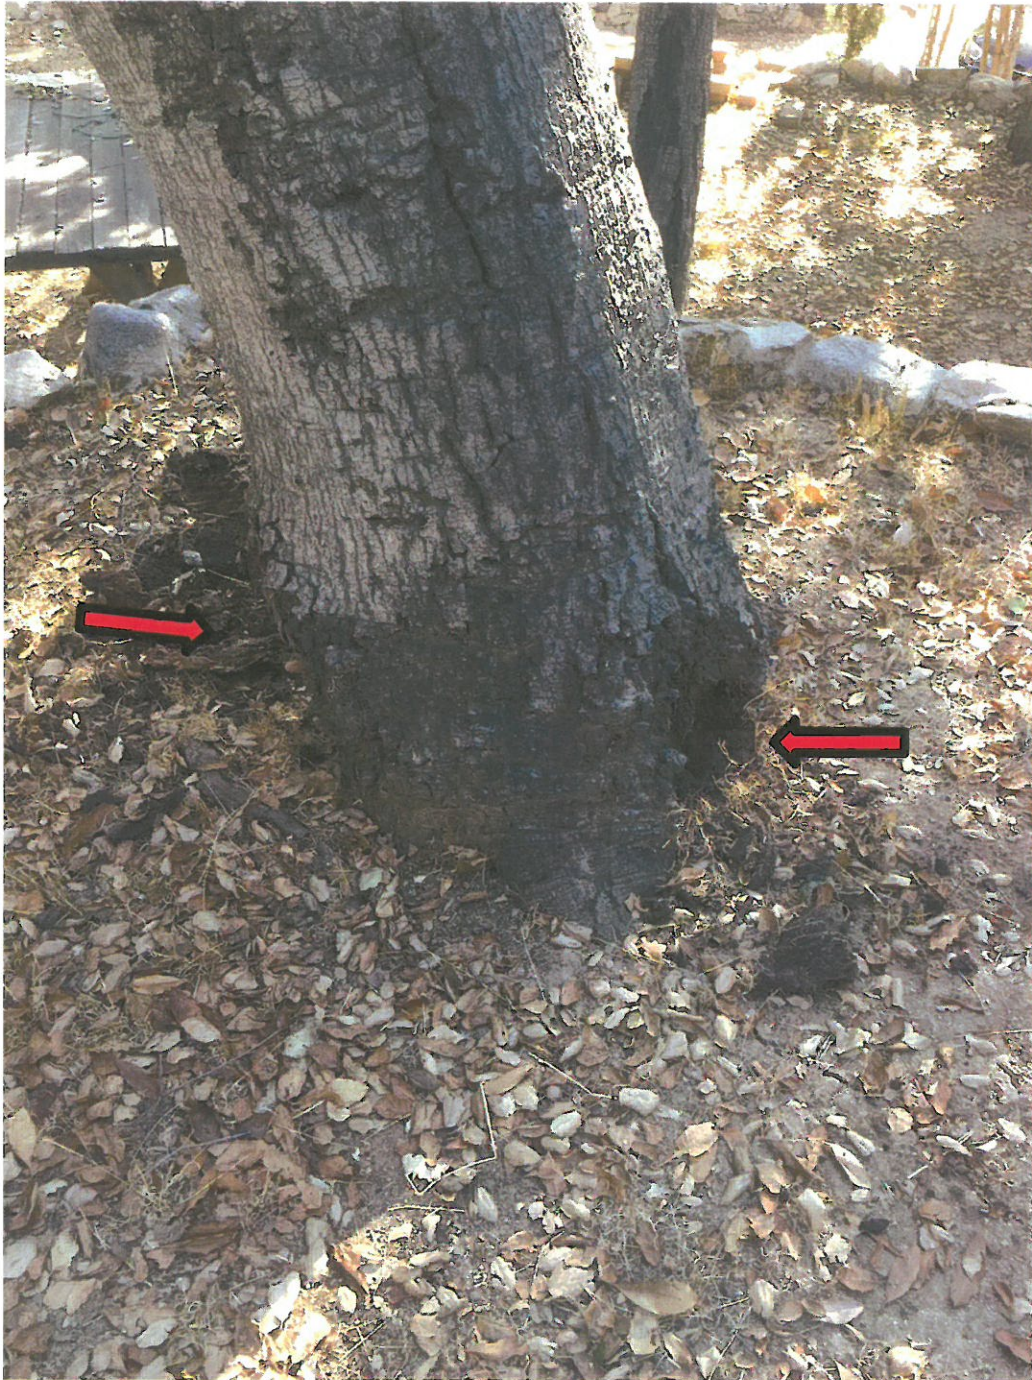
Apparently, in the past year, some surface **decay** has progressed at the trunk flare; an eight inches deep cavity is seen on the southeast side and another three inches deep cavity on the northwest side. Since the diameter of the trunk flare is about 25 inches, the sum of the two cavities, which adds up to 11 inches, is above the accepted threshold of 33%. Therefore, the structural stability of this tree will be greatly reduced in the coming years, especially that the tree's single trunk has substantial lean toward the southeast side.

Tree #91 is in poor structural form, because of decay cavity at the base of the trunk, and it is being proposed to be removed.

Red arrows indicate decay cavities at trunk flare of Tree #91.

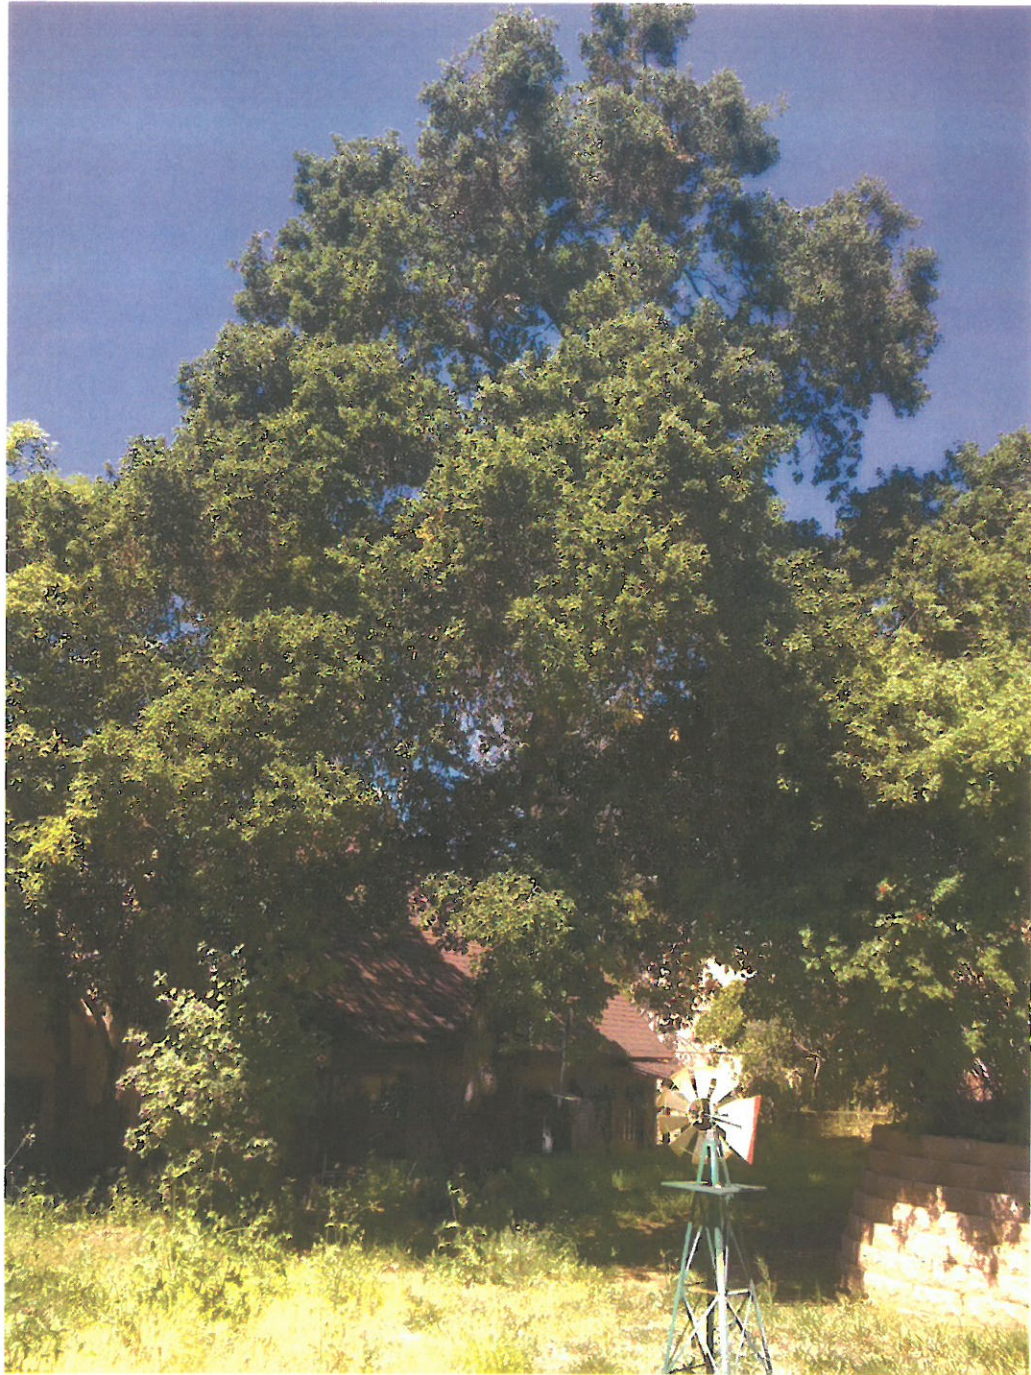
Tree #92.

The main trunk has a DBH of 26 inches, and the height of the tree is about 38 feet. The main trunk extends vertically up, branching out evenly and creating almost an evenly spread crown.

The tree is in good condition and its vigor also is good.

On a 0 to 5 scale (0 being dead and 5 being excellent), the condition rating for this tree is 4 (Good).

A small section of the pool's surrounding hardscape is within the drip line. Since it is being proposed to use paving stones for this area, impact will be minimal to the tree.

This tree is outside the footprint of the proposed new dwelling and it can be preserved in place.

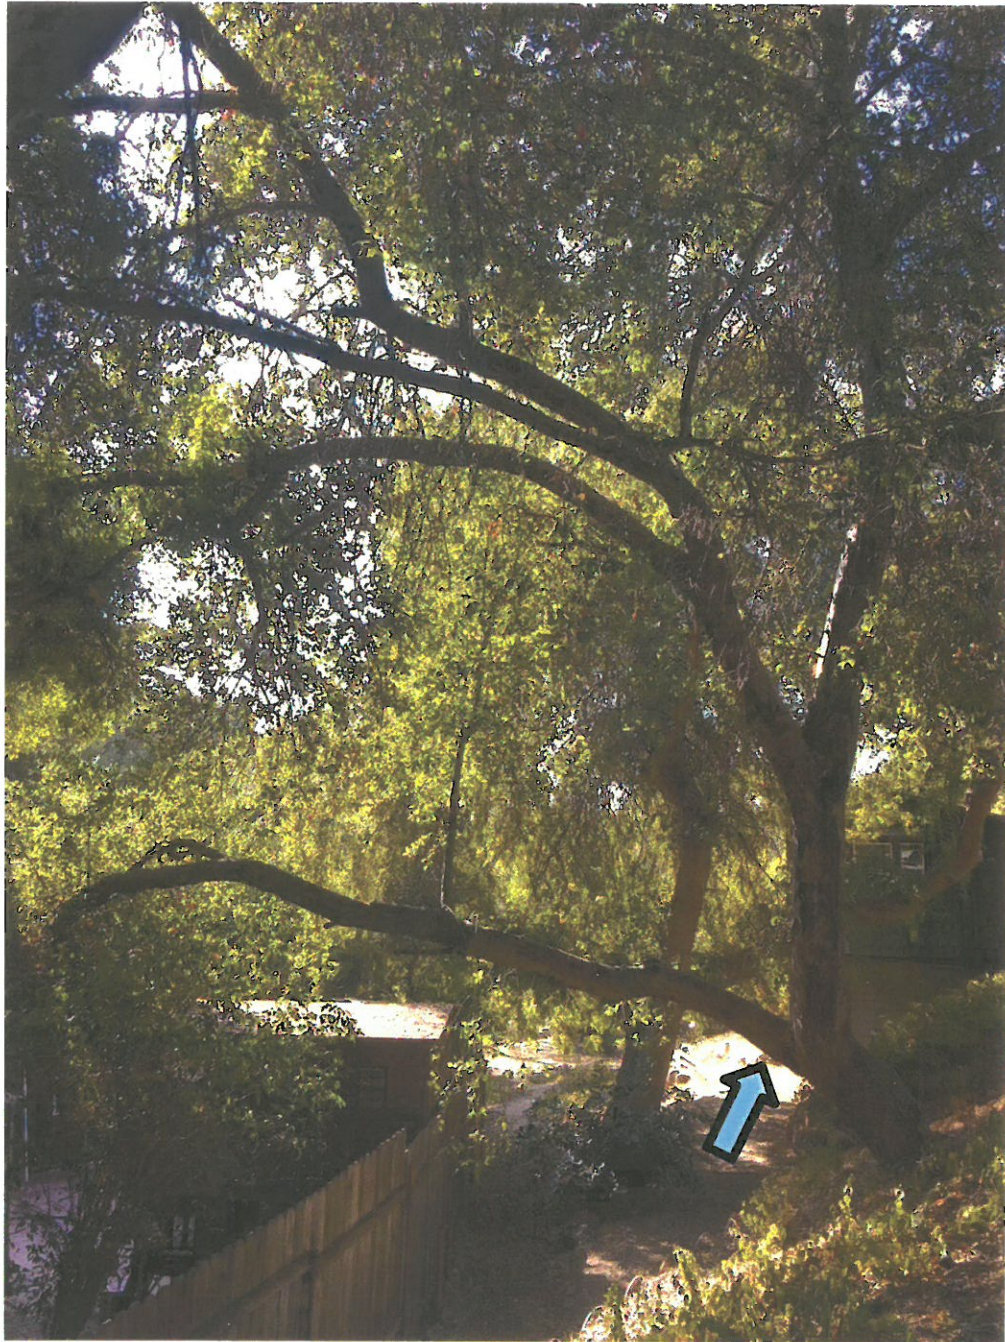
This tree is located on the east side of the property, south of the existing driveway. It has a single trunk that has a considerable lean toward the southeast side and its DBH is of 24 inches.

This tree also has the same characteristics of the other trees on site with leaning trunks; thin foliage, some deadwood, a poor structural form.

The main trunk of the tree divides to two at about five feet from grade. The smaller secondary trunk, which has a starting diameter of 12 inches, extends with the same lean of the main trunk over the neighboring property, which has the 1841 Kirkby Road address. Although this secondary trunk looks healthy, but for the property owner, it is a concern, and he requested its removal.

And a secondary trunk of Tree #93 is being proposed to cut back, for fear of substantial property damage and personal injury in case of its failure.

Tree #93.
Blue arrow indicates location of cut of leaning stem.

It is my opinion that cutting back this stem will not jeopardize the stability and structural integrity of the tree, while damage to property and injury to people will be eliminated.

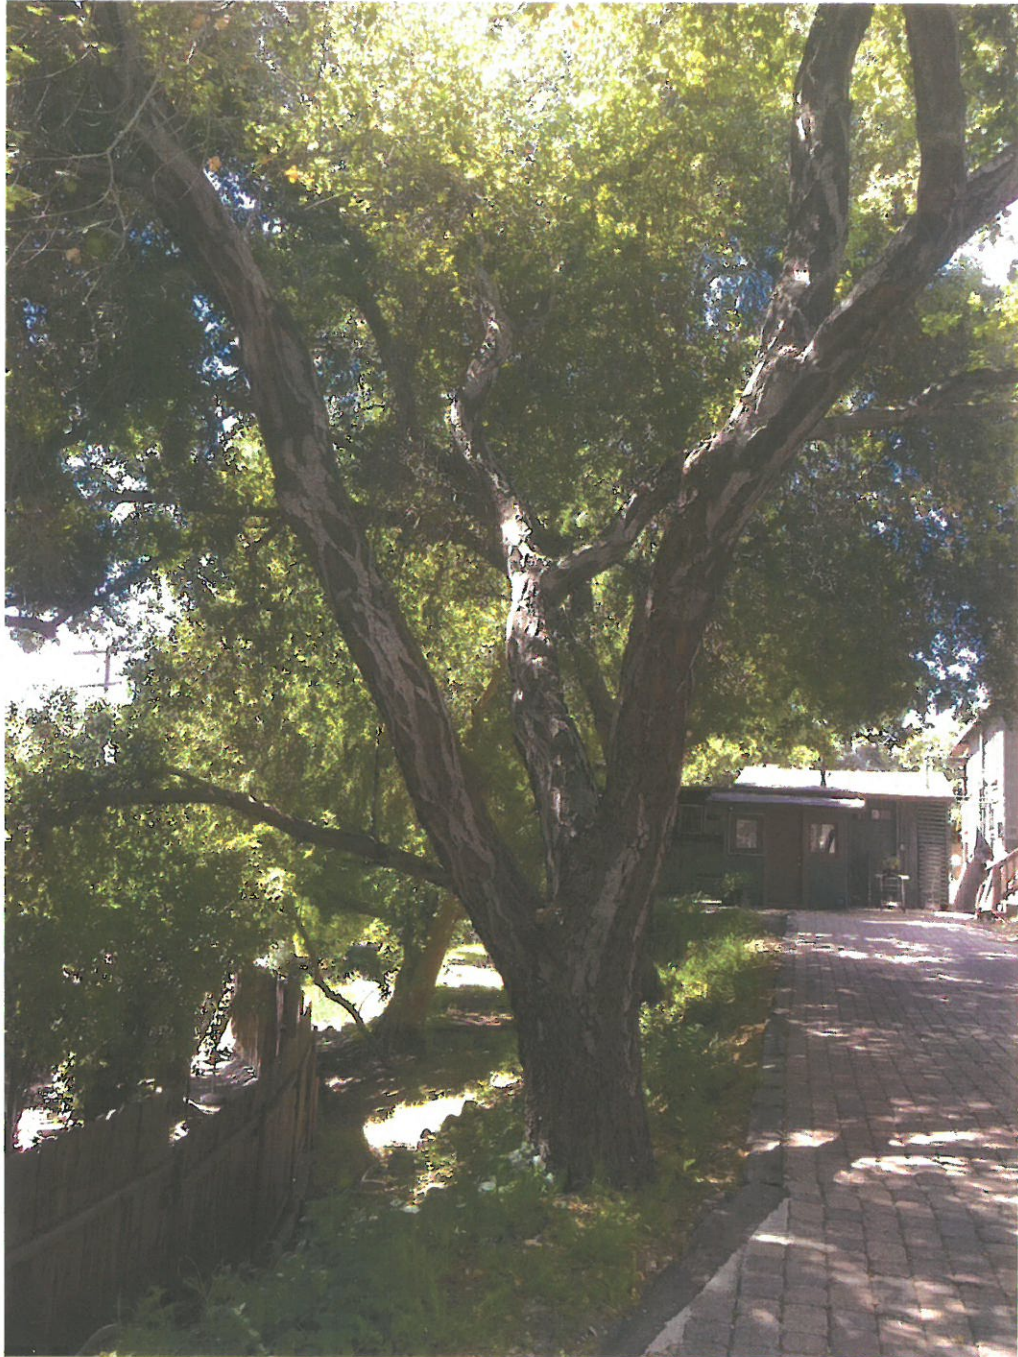
Tree #94.

This tree is well structured, with well-spaced scaffold branches and almost evenly spread crown.

The tree is healthy, with no signs of disease or structural weaknesses. Only some light deadwood in the upper canopy and some leaf scorch are visible.

On a 0 to 5 scale (0 being dead and 5 being excellent), the condition rating for this tree is 4 (Good).

This tree is outside the footprint of the proposed new dwelling and it can be preserved in place.

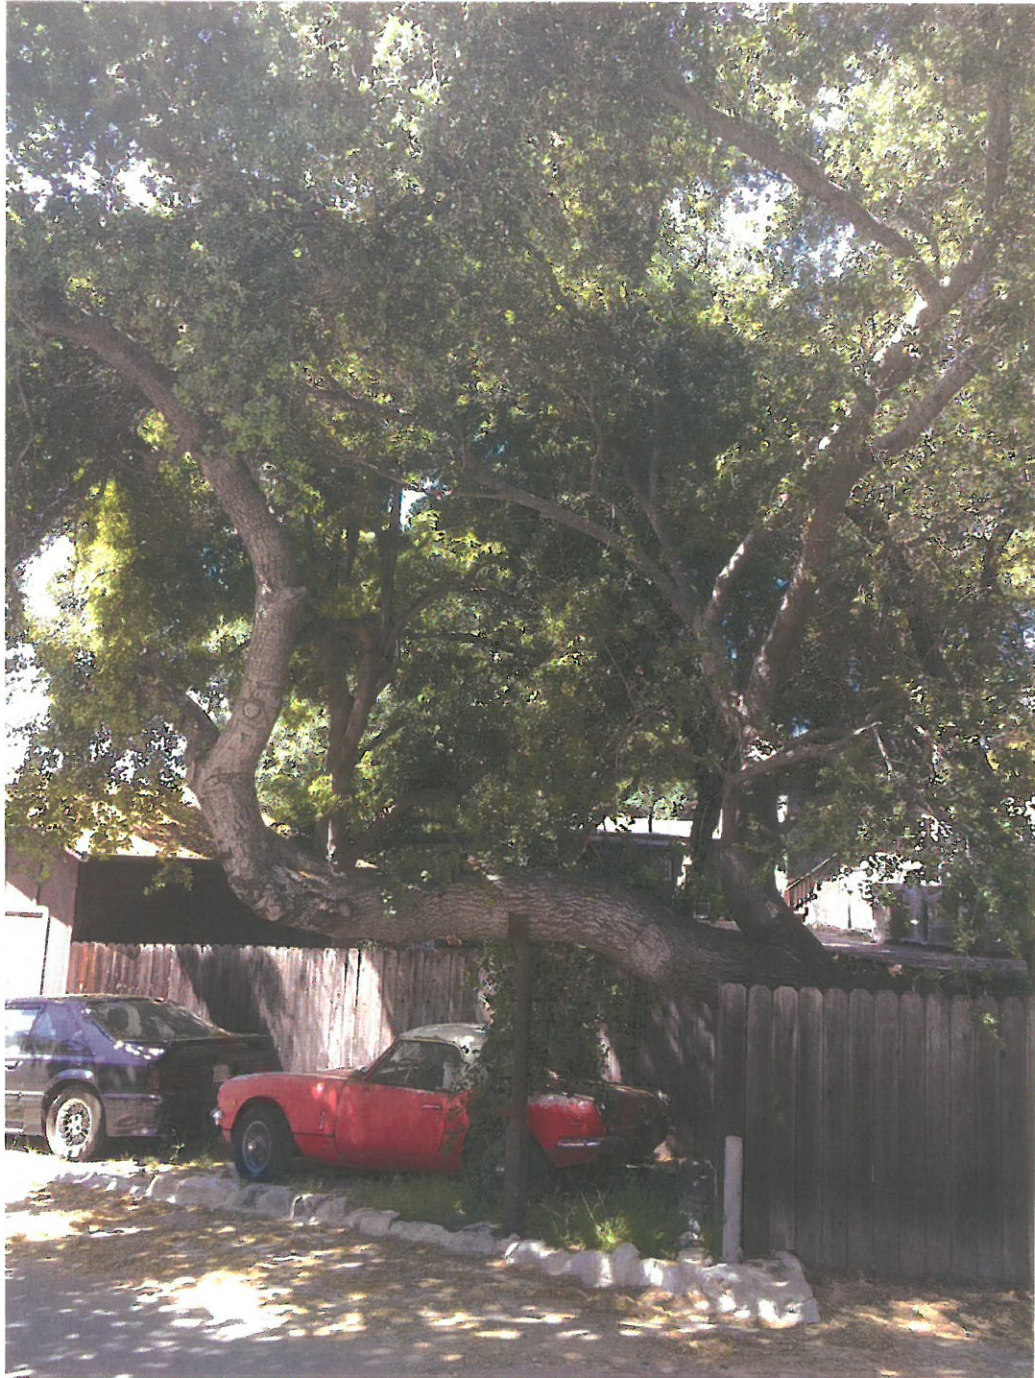
Tree #95

The tree is supported by two **props**, because of the lean of the main and one of the secondary trunks.

The crown spread is quite uneven, extending 33 feet toward the south side, only 8 feet toward the west side, 14 feet toward the north side and 23 feet toward the east side.

On a 0 to 5 scale (0 being dead and 5 being excellent), the condition rating for this tree is 3 (Average).

This tree is outside the footprint of the proposed new dwelling and it can be preserved in place.

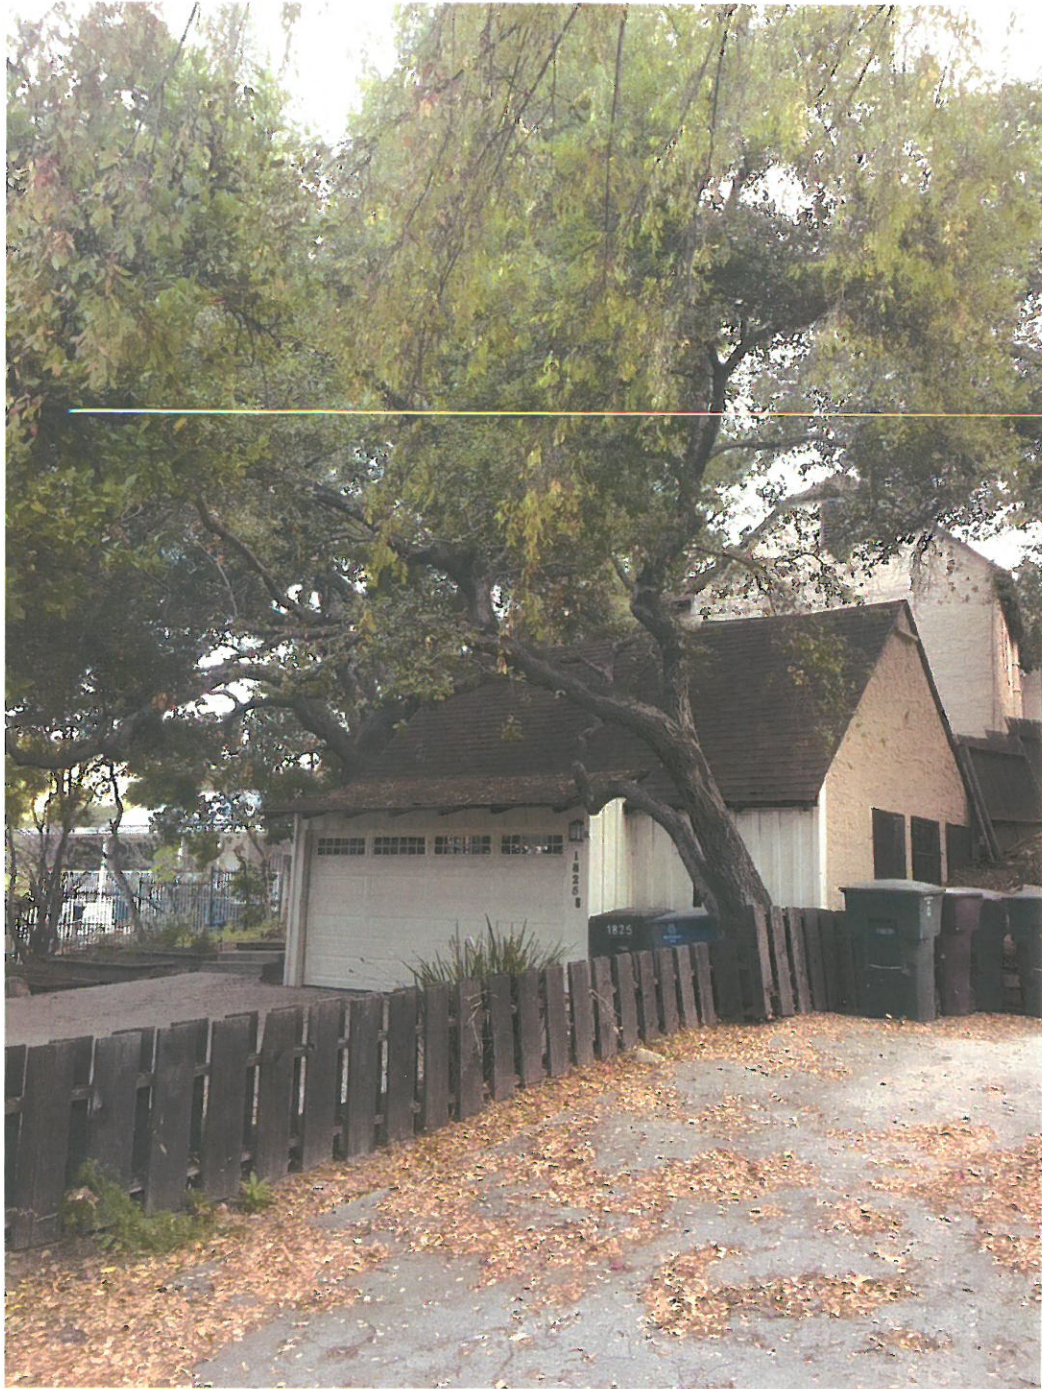
Off-Site Tree #1.

OS Tree #1 is located next to the property line between the two driveways of both properties. The grade on the 1825 Kirkby side is lower than the grade of 1829 Kirkby Rd.

As proposed, the existing driveway is being replaced with new landscaped area, therefore, no construction impact should happen to this tree, except when planting shrubs. The location of the latter can be slightly moved in order not to severe roots of the oak tree.

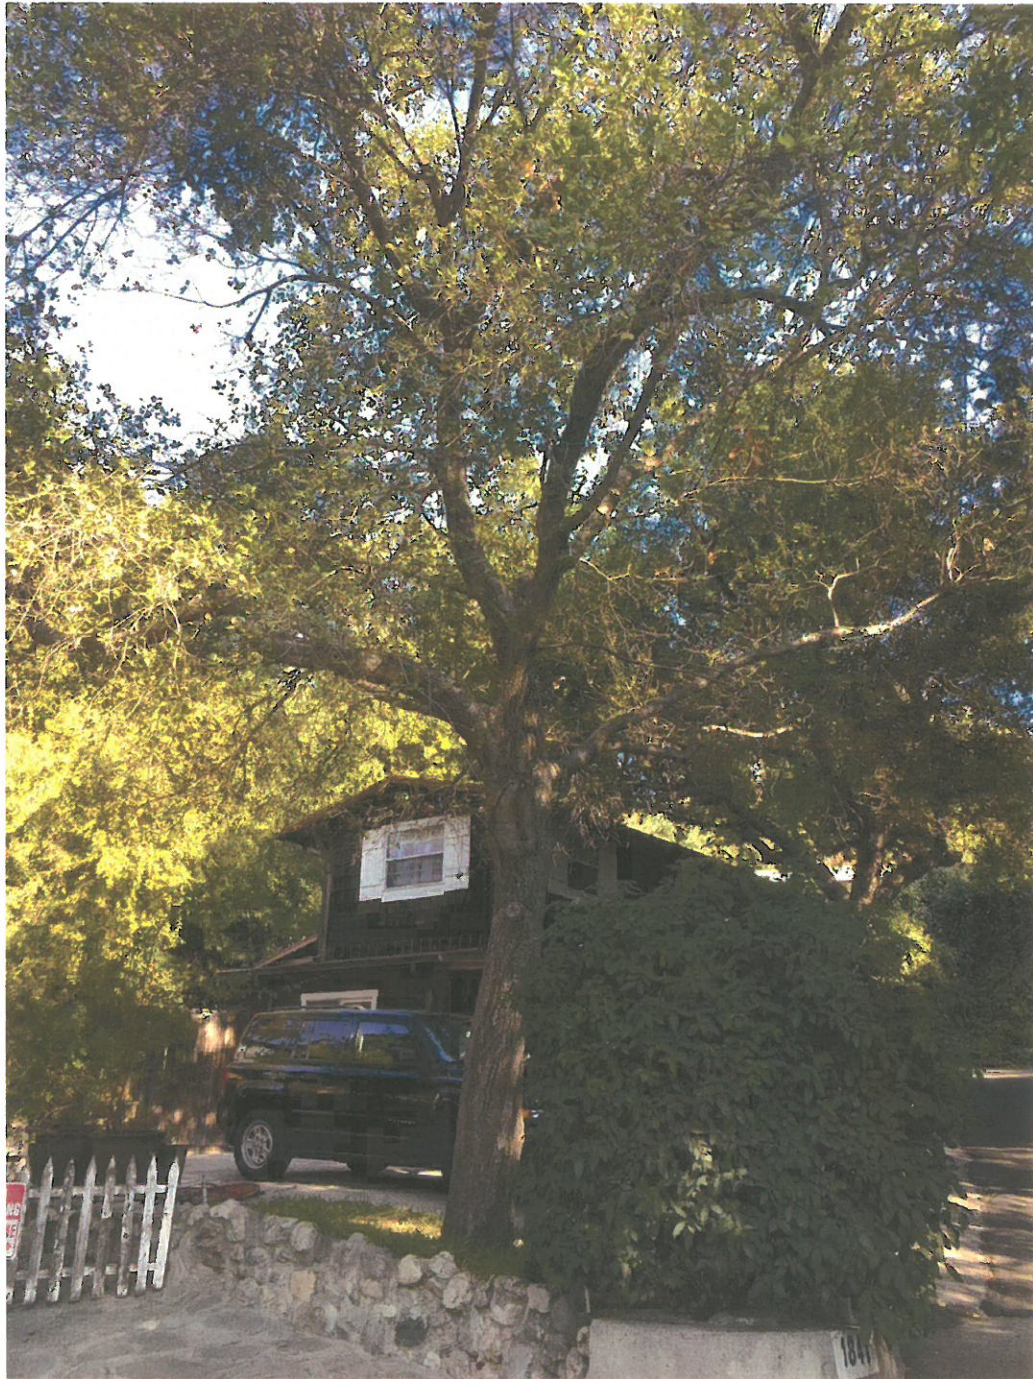
Off-Site Tree #2.

OS Tree #2 is far from any construction footprint and should not be impacted.
