**PRESERVATION PLAN:
401 HAWTHORNE STREET, 141 S. COLUMBUS AVENUE,
AND SHARED GARAGE FOR A PROPOSED RENOVATION
PROJECT IN THE CITY OF GLENDALE, LOS ANGELES
COUNTY, CALIFORNIA**

Prepared by:
Justin Castells, M.A. and M. Colleen Hamilton, M.A.
Applied EarthWorks, Inc.
3550 East Florida Avenue, Suite H
Hemet, California 92544-4937
(951) 766-2000

November 2017

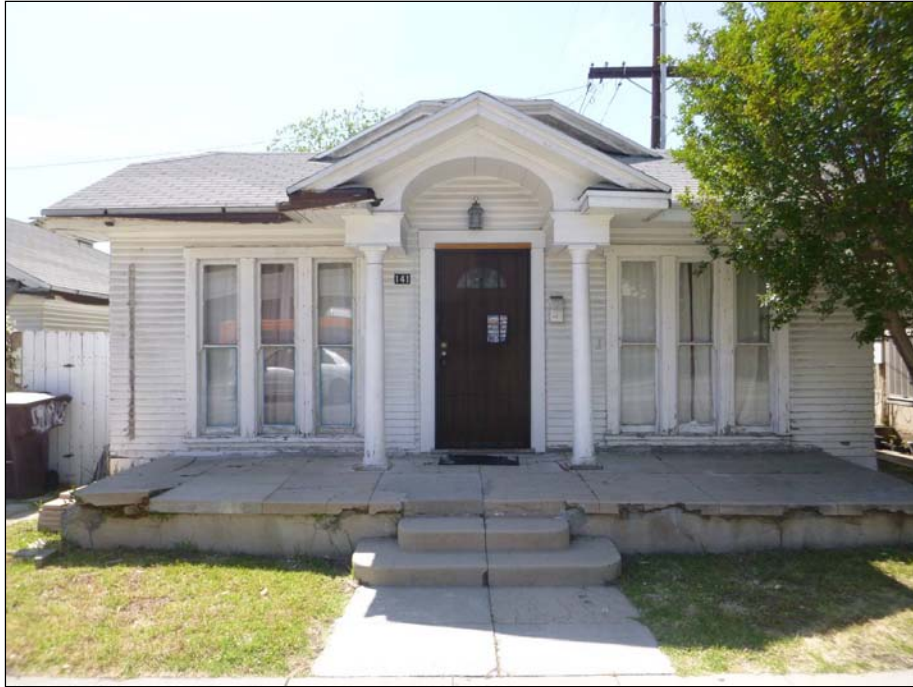
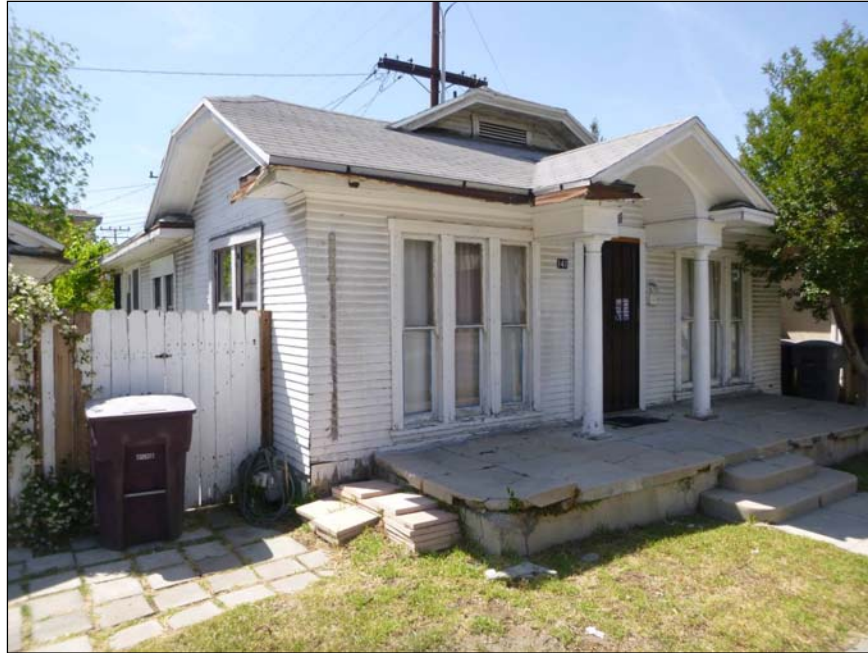
Figure 4 East elevation of 141 Columbus Avenue (view to the west; photograph taken April 21, 2016).

Figure 5 North and east elevations of 141 Columbus Avenue (view to the west; photograph taken April 21, 2016).

Figure 6 South and east elevations of 141 Columbus Avenue (view to the west; photograph taken April 21, 2016).

The character-defining features of 141 S. Columbus Avenue are generally in need of repair and maintenance; however, some elements such as the aluminum-frame windows will need to be replaced. Areas needing the most repair include deteriorated trim along the roof-wall junction, flashing along dormer, the deteriorated concrete porch, casing around rear door, stucco on the west elevation addition, and roof repair along roof-wall junction at the addition.

- Damage and deterioration occurring on wood siding will be repaired with like materials whenever possible; however, should portions of the wood siding be beyond repair or have extensive dry rot making it structurally unsound, replacement is permissible provided the materials and design including dimensions of replacement boards are consistent with the existing clapboard siding on the building.

- Replace the two sets of aluminum-frame windows and window trim on the south elevation with wood-frame double-hung windows consistent with materials and style of existing historic windows on the building.

- Repair two double-hung wood-frame windows on the south elevation using in-kind materials.
- Replace vinyl windows on the west elevation with wood-frame double-hung or solid-pane window consistent with materials and style of existing historic windows on the building.

- Replace vinyl window on the north elevation with wood-frame double hung window consistent with materials and style of existing historic windows on the building.

- Repair wood-frame tripartite windows on the east elevation by using in-kind materials. Original glazing shall be protected from breakage and replaced following repairs.

- Repair, in as far as possible the deteriorating concrete porch. Where replacement is necessary the original design should be replicated as described in *Preservation Brief #15 Preservation of Historic Concrete* (Gaudette and Slaton 2007).

- Repair façade columns using in-kind materials.
- Repair areas of deterioration along roof junctions, including to fascia, soffit, entablature, and boxed eaves. In instances where the existing historic material cannot be restored, replace with in-kind materials matching the historic design.

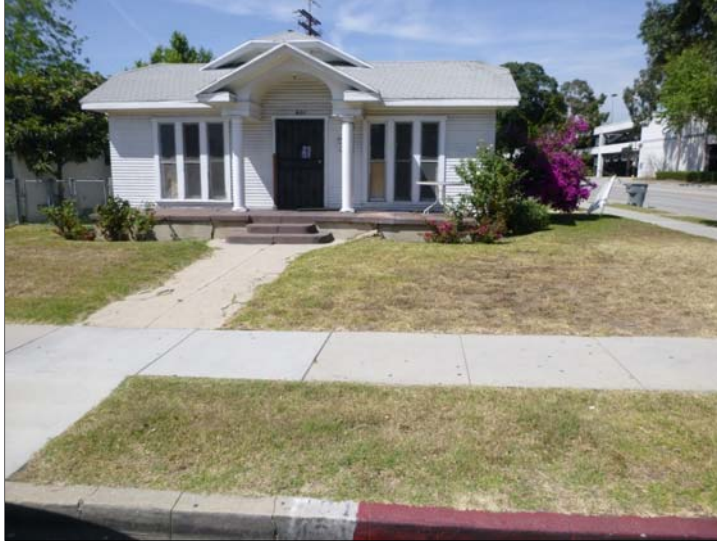
Figure 7 South elevation of 401 Hawthorne Street (view to the north; photograph taken April 21, 2016).

Figure 8 East elevation of 401 Hawthorne Street (view to the north; photograph taken April 21, 2016).

The character-defining features of 401 Hawthorn Street generally are in need of repair and maintenance; however, some elements, such as portions of the siding, may need to be replaced. Areas of particular concern include casing and trim on the façade entrance, repair of the arched pediment, roof-wall junctions, vents on the roof, boxed eaves, rafter sand beams on porch, and southeast corner of the north elevation where side porch appears to be separating from the house. For the exact location of deteriorated features see Appendix A, Figure A-2.

- Damage and deterioration occurring on wood siding will be repaired with like materials whenever possible; however, should portions of the wood siding be beyond repair or have extensive dry rot making it structurally unsound, replacement is permissible provided the materials and design including dimensions of replacement boards are consistent with the existing clapboard siding on the building.

- Repair the deteriorating porch; where necessary replace with in-kind materials, and replicate the current design as described in *Preservation Brief #15 Preservation of Historic Concrete* (Gaudette and Slaton 2007).

- Repair façade columns using in-kind materials.
- Repair wood-frame windows on all elevations by using in-kind materials.
 - Window replacements, when necessary should be double-hung sash and should match the profile of the original window as closely as possible.

- Repair rafters, beams, and supports on east elevation.
- Remove pipe handrail on east elevation; if replacement is required by code, new railing should be compatible with the historic appearance of the structure.

- Inspect vents on roof and repair as necessary.
- Repair and re-attach porch connection to main building on southwest corner.
-

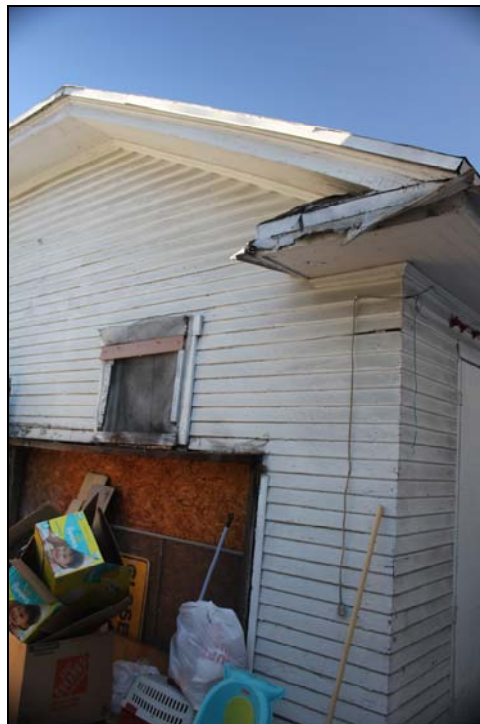
This is a wood-frame structure that is designed in the Clipped-Gable Colonial Craftsman-style of architecture (Figure 9). It is surmounted by a cross-hip-on-gable roof with boxed eave returns. The roof is covered with gray composition shingles. The exterior walls are clad with narrow clapboard siding painted white (likely lead based paint). The primary entrance is on the east elevation fronting S. Columbus Avenue. A wood-frame garage door with a fixed wood-frame window is centered on the upper third of the garage door. The window is a later-period addition and should be removed and replaced. This door accesses the southern portion of the garage. The east elevation access to the northern portion of the garage has been filled with plywood. The west elevation features a double-hung window frame with a missing window and portions of the siding have been removed (Figure 10).

Figure 10 Exterior shared garage, west elevation (view to the east; photograph taken November 11, 2016).

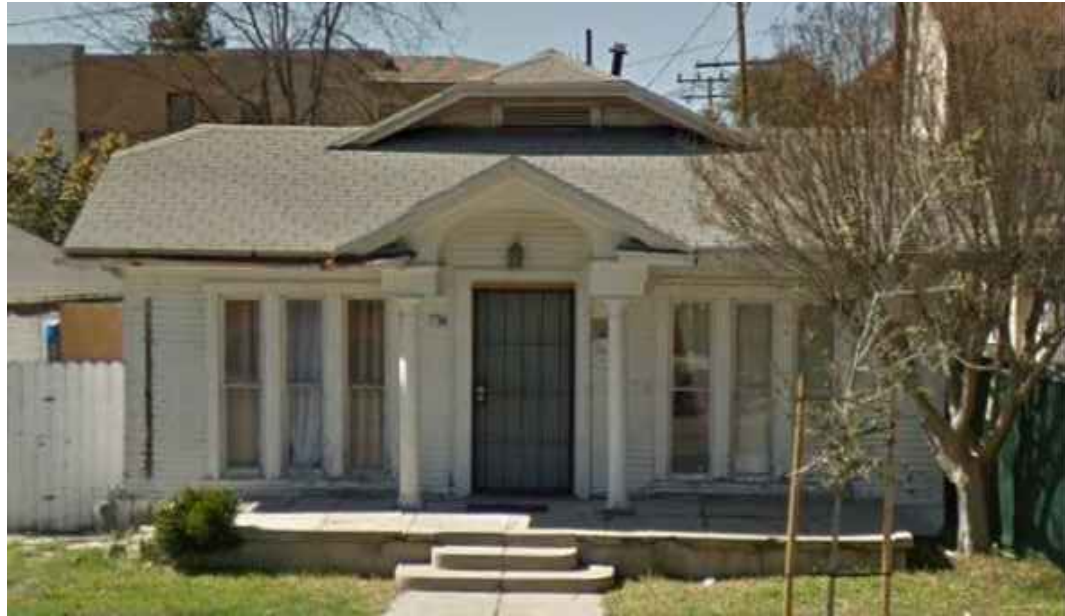
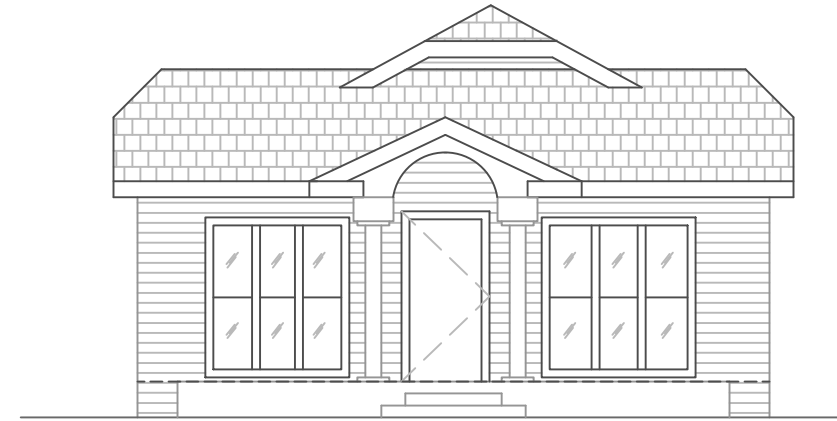
HOUSE 141 EAST ELEVATION—EXISTING

Figure 11. Existing condition of 141 S. Columbia Avenue and shared garage and proposed restoration of each structure.

Figure 11 illustrates existing condition of 141 S. Columbus Avenue and proposed restoration.

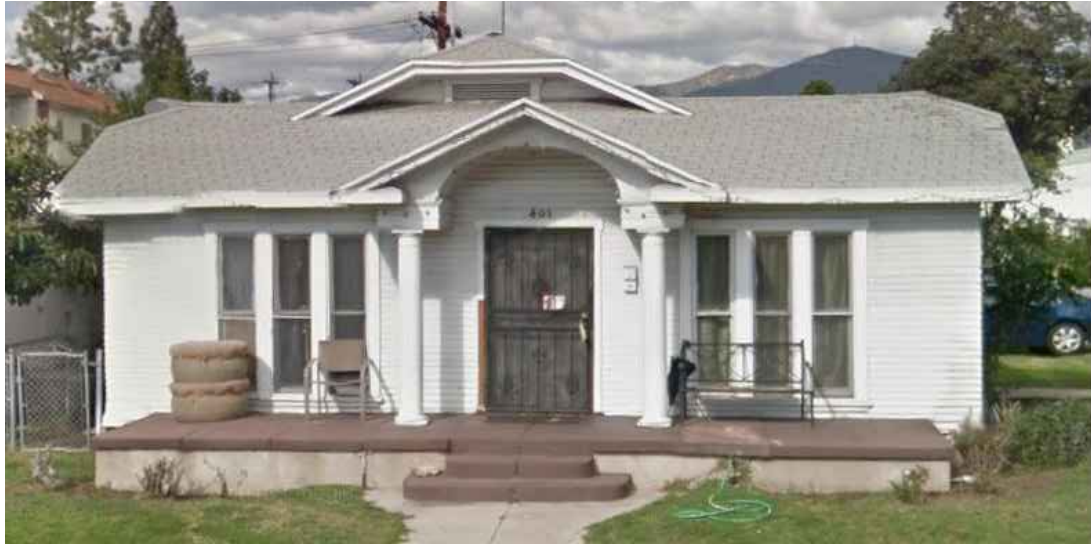
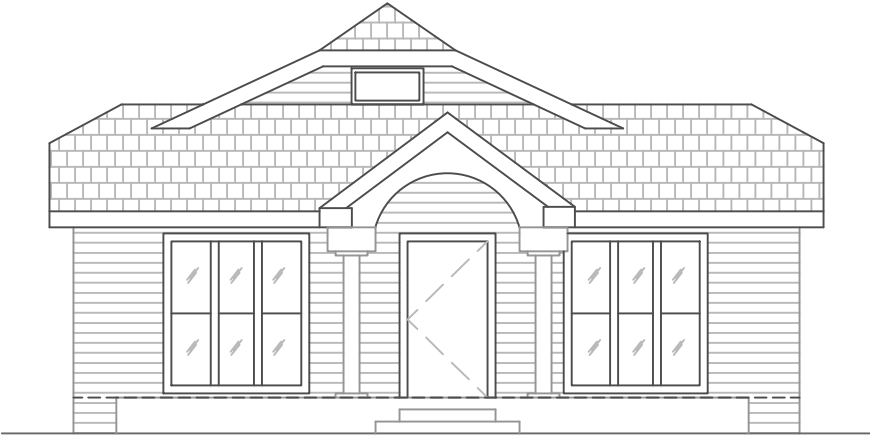
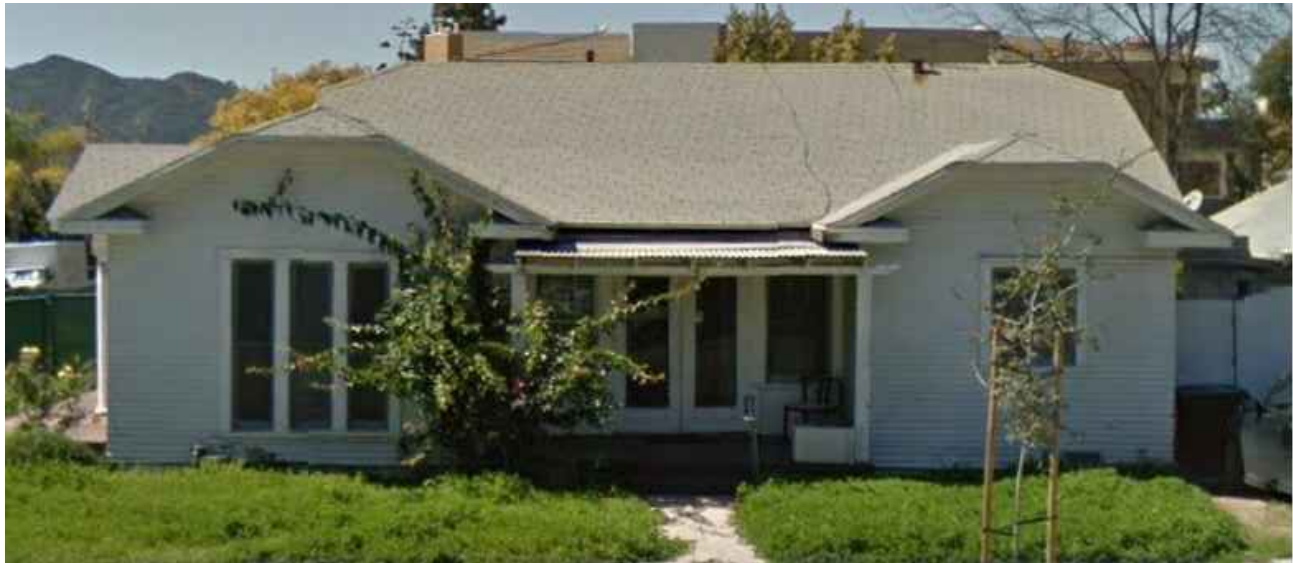
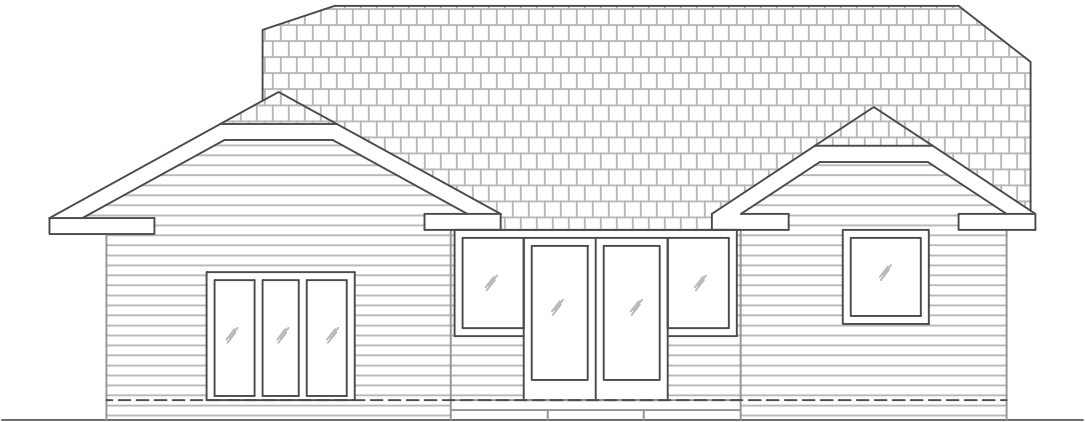
Figure 12. Existing condition of 401 Hawthorne Street and proposed renovation.

Figure 12 illustrates existing condition of 401 Hawthorne and proposed restoration.
