**PRESERVATION PLAN:  
401 HAWTHORNE STREET, 141 S. COLUMBUS AVENUE,  
AND SHARED GARAGE FOR A PROPOSED RENOVATION  
PROJECT IN THE CITY OF GLENDALE, LOS ANGELES  
COUNTY, CALIFORNIA**

Prepared by:  
Justin Castells, M.A. and M. Colleen Hamilton, M.A.  
**Applied EarthWorks, Inc.**  
3550 East Florida Avenue, Suite H  
Hemet, California 92544-4937  
(951) 766-2000

November 2017

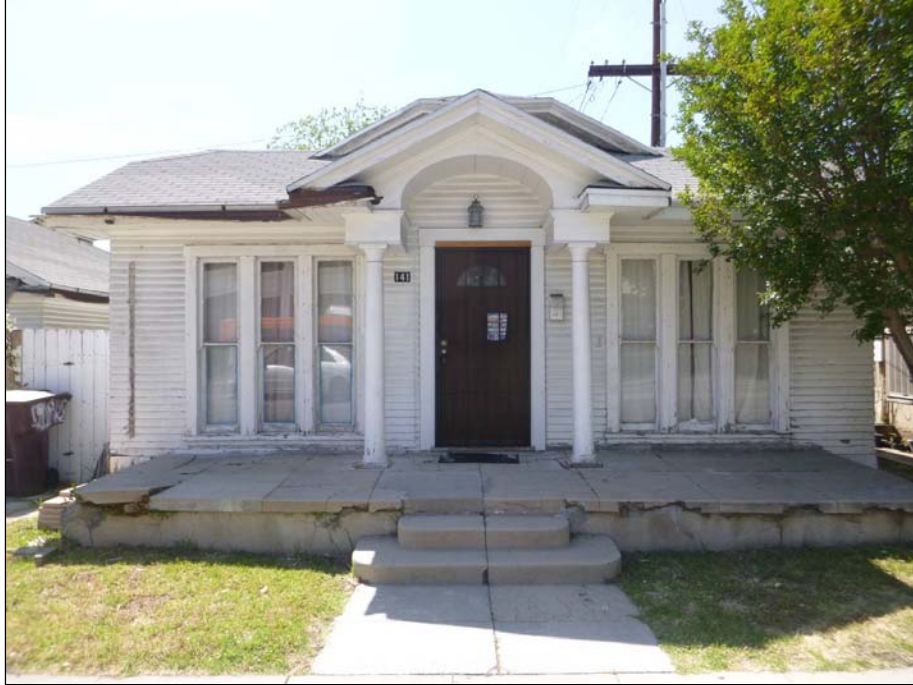
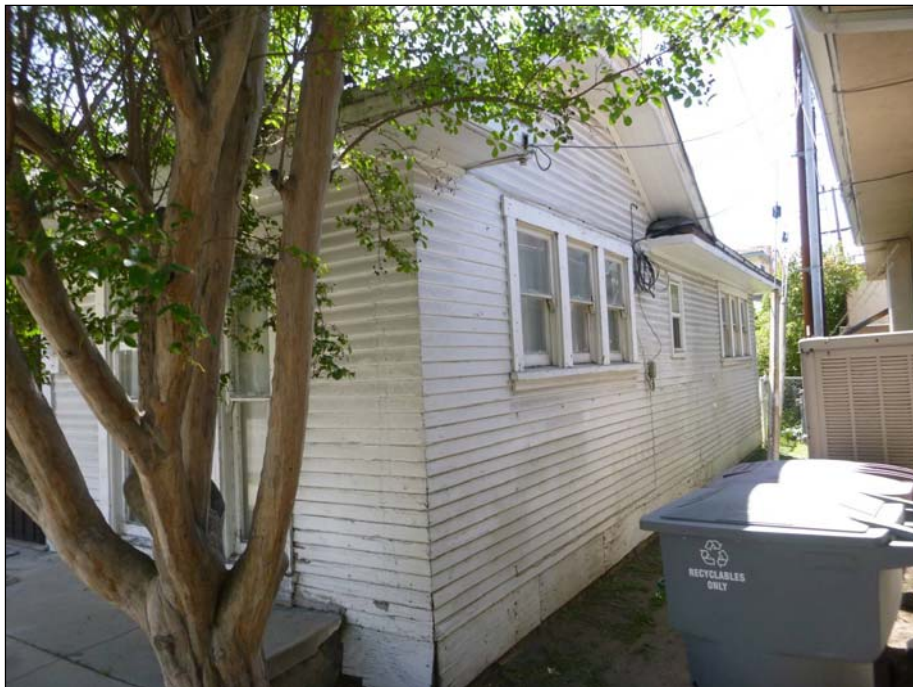
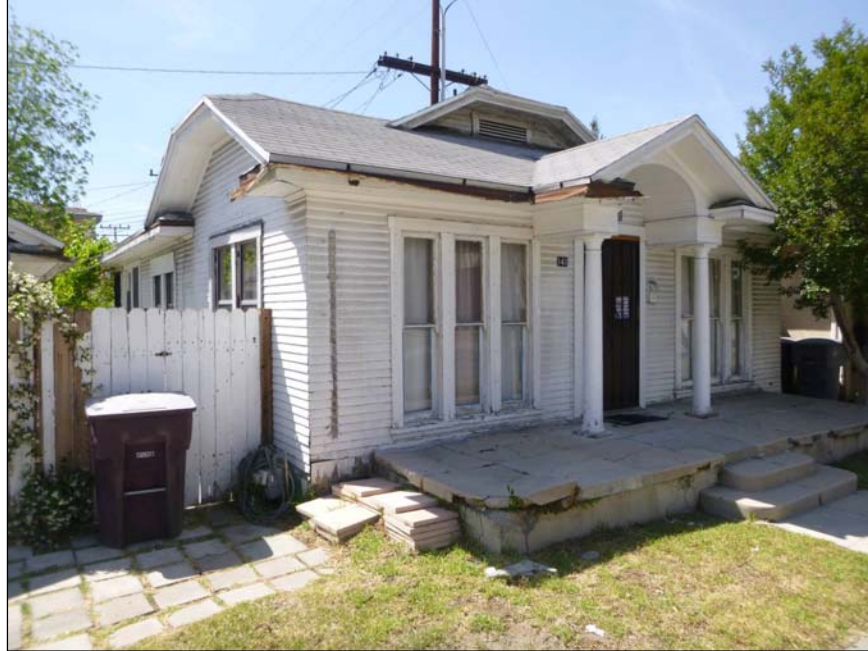
**Figure 4** East elevation of 141 Columbus Avenue (view to the west; photograph taken April 21, 2016).

The character-defining features of 141 S. Columbus Avenue are generally in need of repair and maintenance; however, some elements such as the aluminum-frame windows will need to be replaced. Areas needing the most repair include deteriorated trim along the roof-wall junction, flashing along dormer, the deteriorated concrete porch, casing around rear door, stucco on the west elevation addition, and roof repair along roof-wall junction at the addition.

- Damage and deterioration occurring on wood siding will be repaired with like materials whenever possible; however, should portions of the wood siding be beyond repair or have extensive dry rot making it structurally unsound, replacement is permissible provided the materials and design including dimensions of replacement boards are consistent with the existing clapboard siding on the building.

- Replace the two sets of aluminum-frame windows and window trim on the south elevation with wood-frame double-hung windows consistent with materials and style of existing historic windows on the building.

- Repair wood-frame tripartite windows on the east elevation by using in-kind materials. Original glazing shall be protected from breakage and replaced following repairs.

- Repair, in as far as possible the deteriorating concrete porch. Where replacement is necessary the original design should be replicated as described in *Preservation Brief #15 Preservation of Historic Concrete* (Gaudette and Slaton 2007).

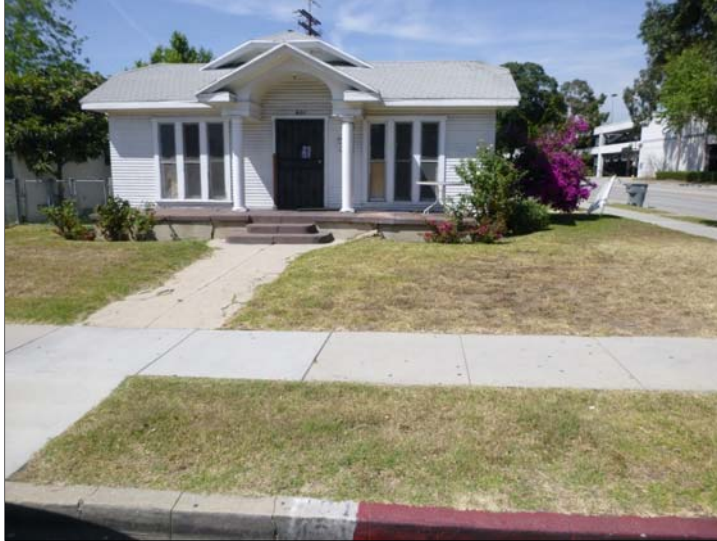
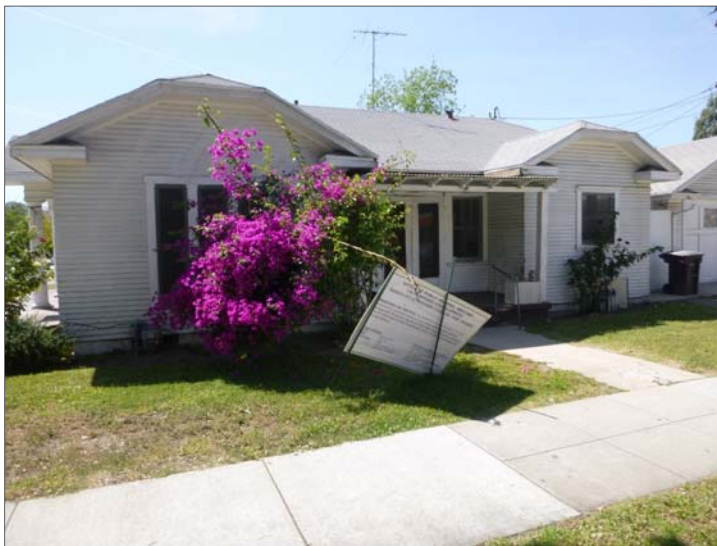
**Figure 7 South elevation of 401 Hawthorne Street (view to the north; photograph taken April 21, 2016).**

**Figure 8 East elevation of 401 Hawthorne Street (view to the north; photograph taken April 21, 2016).**

The character-defining features of 401 Hawthorn Street generally are in need of repair and maintenance; however, some elements, such as portions of the siding, may need to be replaced. Areas of particular concern include casing and trim on the façade entrance, repair of the arched pediment, roof-wall junctions, vents on the roof, boxed eaves, rafter sand beams on porch, and southeast corner of the north elevation where side porch appears to be separating from the house. For the exact location of deteriorated features see Appendix A, Figure A-2.

- Damage and deterioration occurring on wood siding will be repaired with like materials whenever possible; however, should portions of the wood siding be beyond repair or have extensive dry rot making it structurally unsound, replacement is permissible provided the materials and design including dimensions of replacement boards are consistent with the existing clapboard siding on the building.

- Repair the deteriorating porch; where necessary replace with in-kind materials, and replicate the current design as described in *Preservation Brief #15 Preservation of Historic Concrete* (Gaudette and Slaton 2007).

- Repair façade columns using in-kind materials.
- Repair wood-frame windows on all elevations by using in-kind materials.
  - Window replacements, when necessary should be double-hung sash and should match the profile of the original window as closely as possible.

- Repair rafters, beams, and supports on east elevation.
- Remove pipe handrail on east elevation; if replacement is required by code, new railing should be compatible with the historic appearance of the structure.

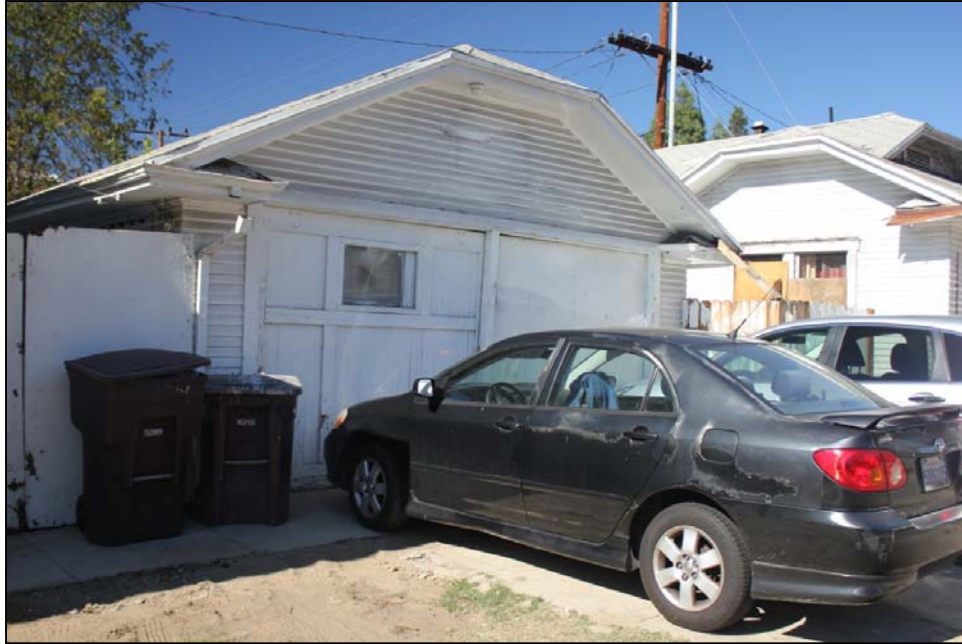
**Figure 9 Exterior shared garage (view to the west; photograph taken November 11, 2016).**

This is a wood-frame structure that is designed in the Clipped-Gable Colonial Craftsman-style of architecture (Figure 9). It is surmounted by a cross-hip-on-gable roof with boxed eave returns. The roof is covered with gray composition shingles. The exterior walls are clad with narrow clapboard siding painted white (likely lead based paint). The primary entrance is on the east elevation fronting S. Columbus Avenue. A wood-frame garage door with a fixed wood-frame window is centered on the upper third of the garage door. The window is a later-period addition and should be removed and replaced. This door accesses the southern portion of the garage. The east elevation access to the northern portion of the garage has been filled with plywood. The west elevation features a double-hung window frame with a missing window and portions of the siding have been removed (Figure 10).

The character-defining features of the shared garage generally are in need of repair and maintenance; however, some elements, such as portions of the wood siding, may need to be replaced. Areas of particular concern include west elevation where significant portions of the siding have been removed, replacement of the missing garage door, replacement and/or repair of the windows, repair or replacement as needed to the boxed eaves on the east and west elevations.

- Damage and deterioration occurring on wood siding will be repaired whenever possible; however, should portions of the wood siding be beyond repair, replacement is permissible provided the materials and design are consistent with the existing clapboard siding originally used on the building.

- Repair extant garage door with in-kind materials.
- Replace plywood on east elevation with garage door of in-kind material and design matching extant historic garage door. The added window will be removed from the original door.
