601 and 603 Bohlig Rd. Arborist Report

Prepared for Camille Neagu
601 Bohlig Road
Glendale, CA 91207

Prepared by James Komen
BCMA WE-9909B
RCA #555

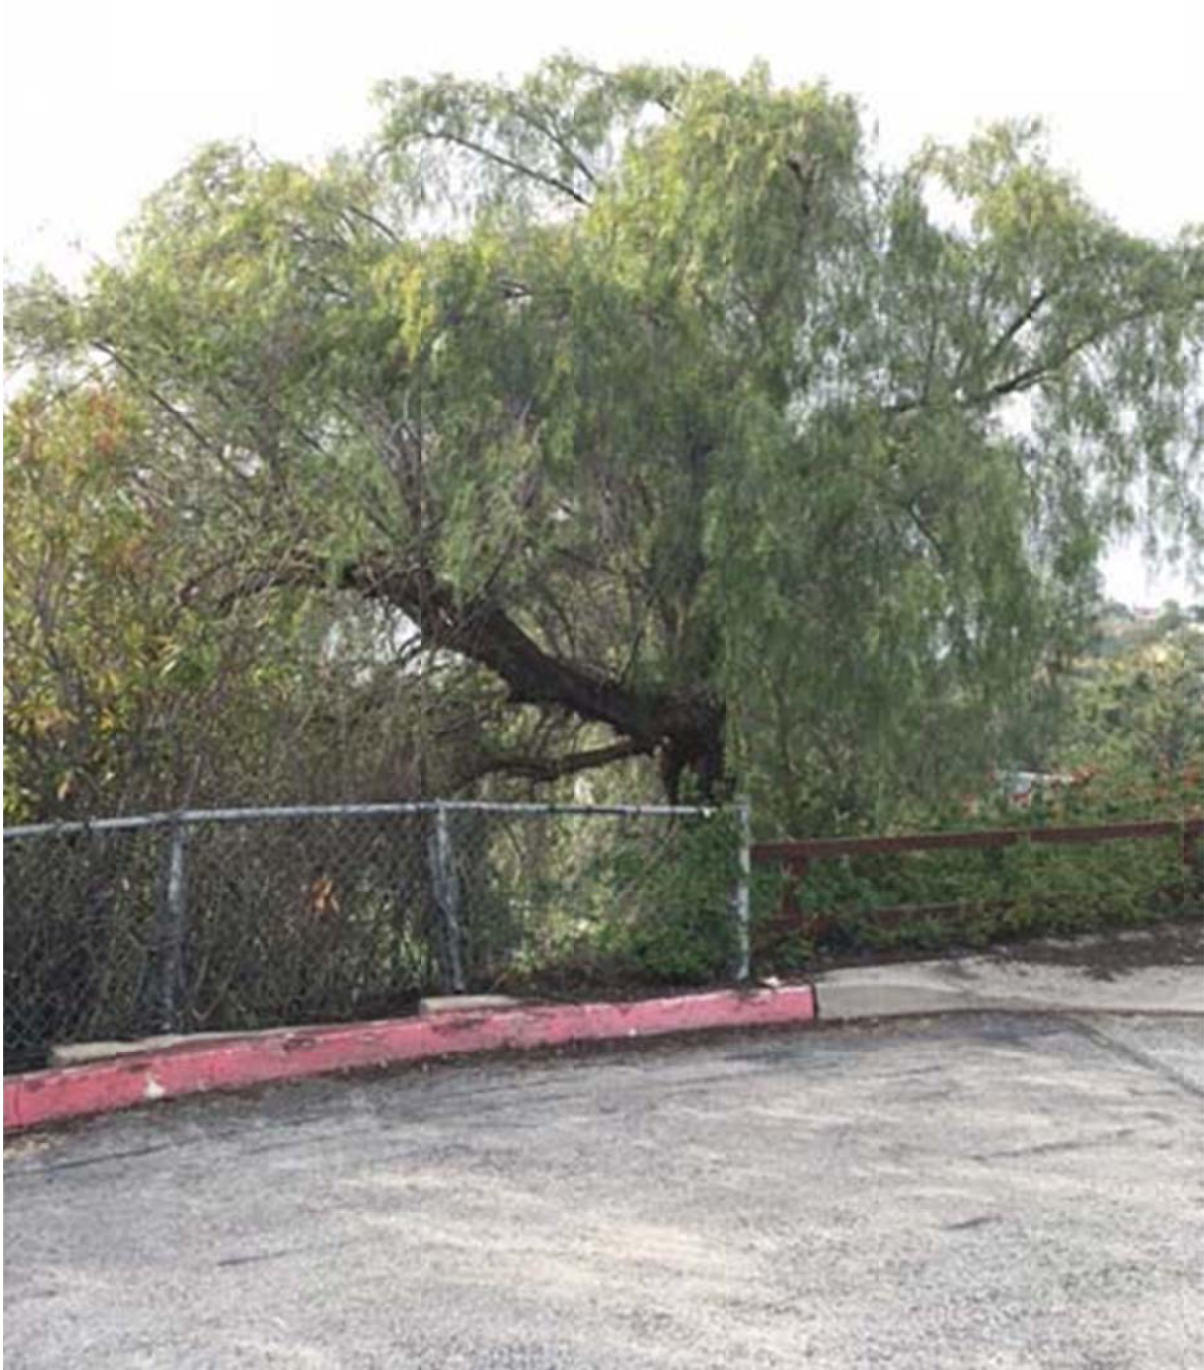
<p>Tree 1 <i>Schinus molle</i> – California Pepper Tree</p> <p>This tree is not protected by the City of Glendale Indigenous Tree Protection Ordinance. It will not likely be impacted by the proposed construction.</p>

Figure 2: Looking west at Tree 1. This tree will not likely be impacted by construction.

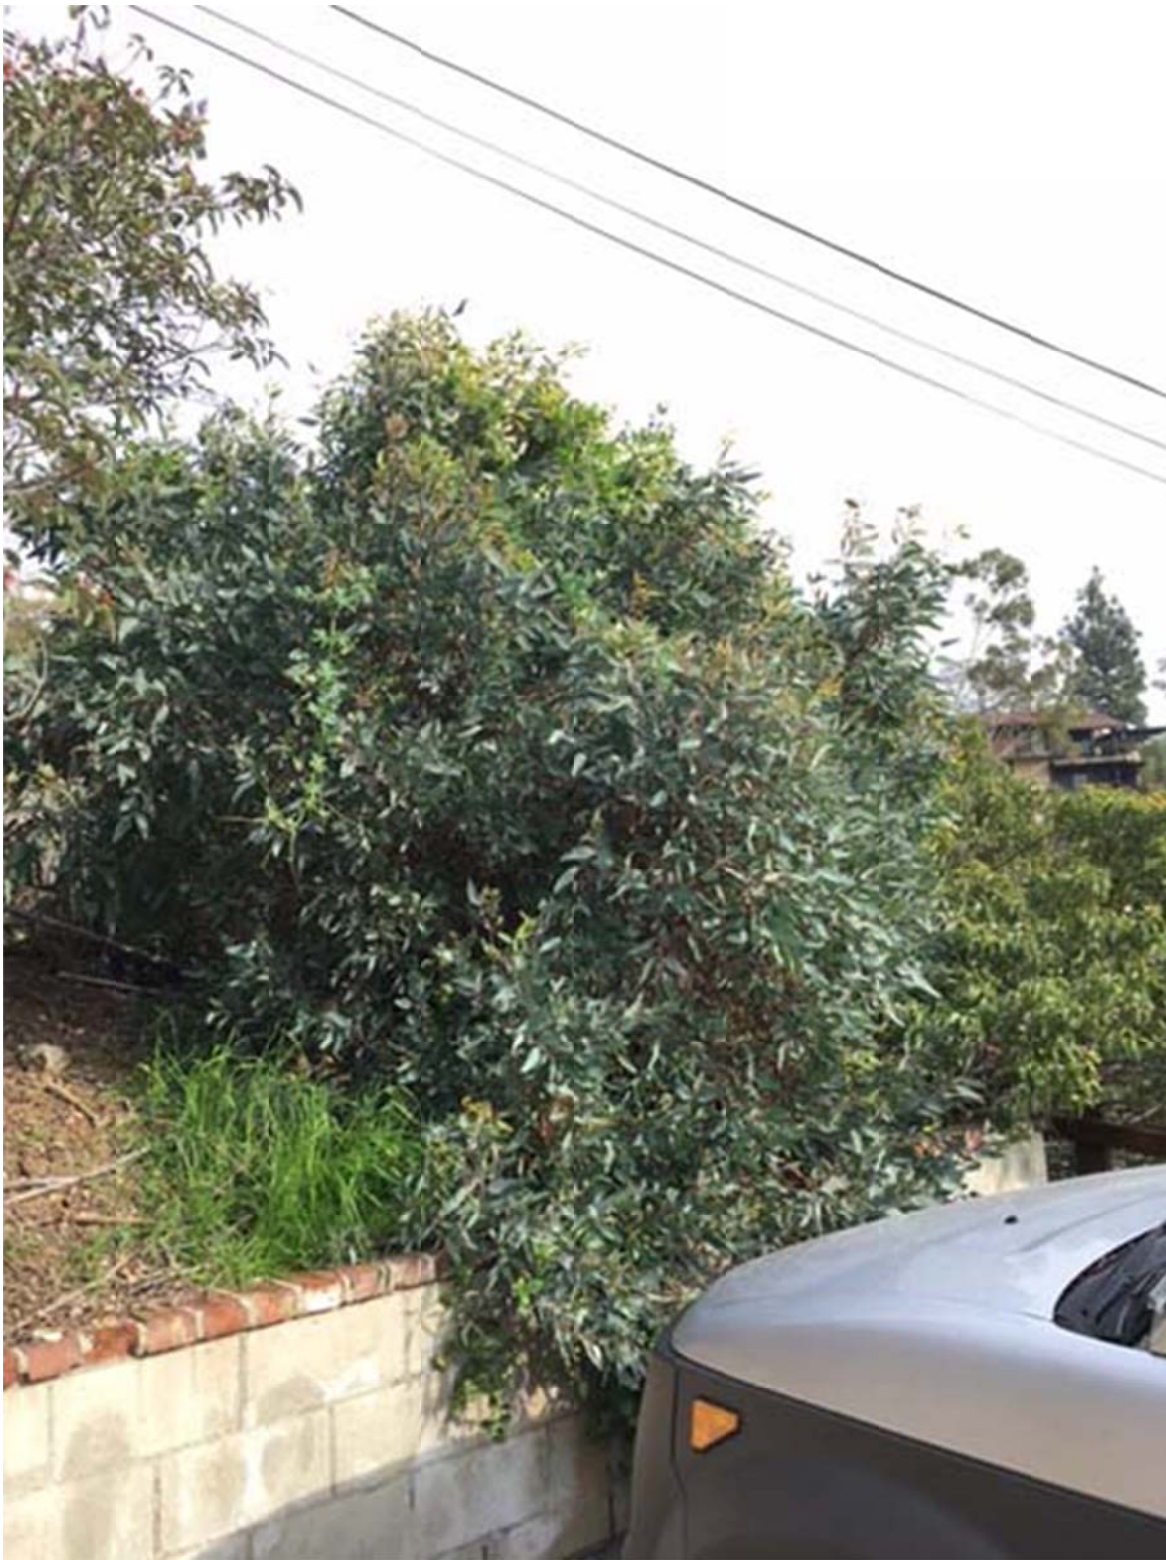
<p>Tree OP2 <i>Eucalyptus globulus</i> – Blue Gum Eucalyptus</p> <p>This tree is not protected by the City of Glendale Indigenous Tree Protection Ordinance. What remains are stump sprouts from the trunk of a former mature Eucalyptus tree that was removed several years ago. It is growing on the neighboring property to the northeast.</p>

Figure 3: Looking east at Tree 2. This tree will not likely be impacted by construction. It consists of stump sprouts from a former removed mature Eucalyptus tree.

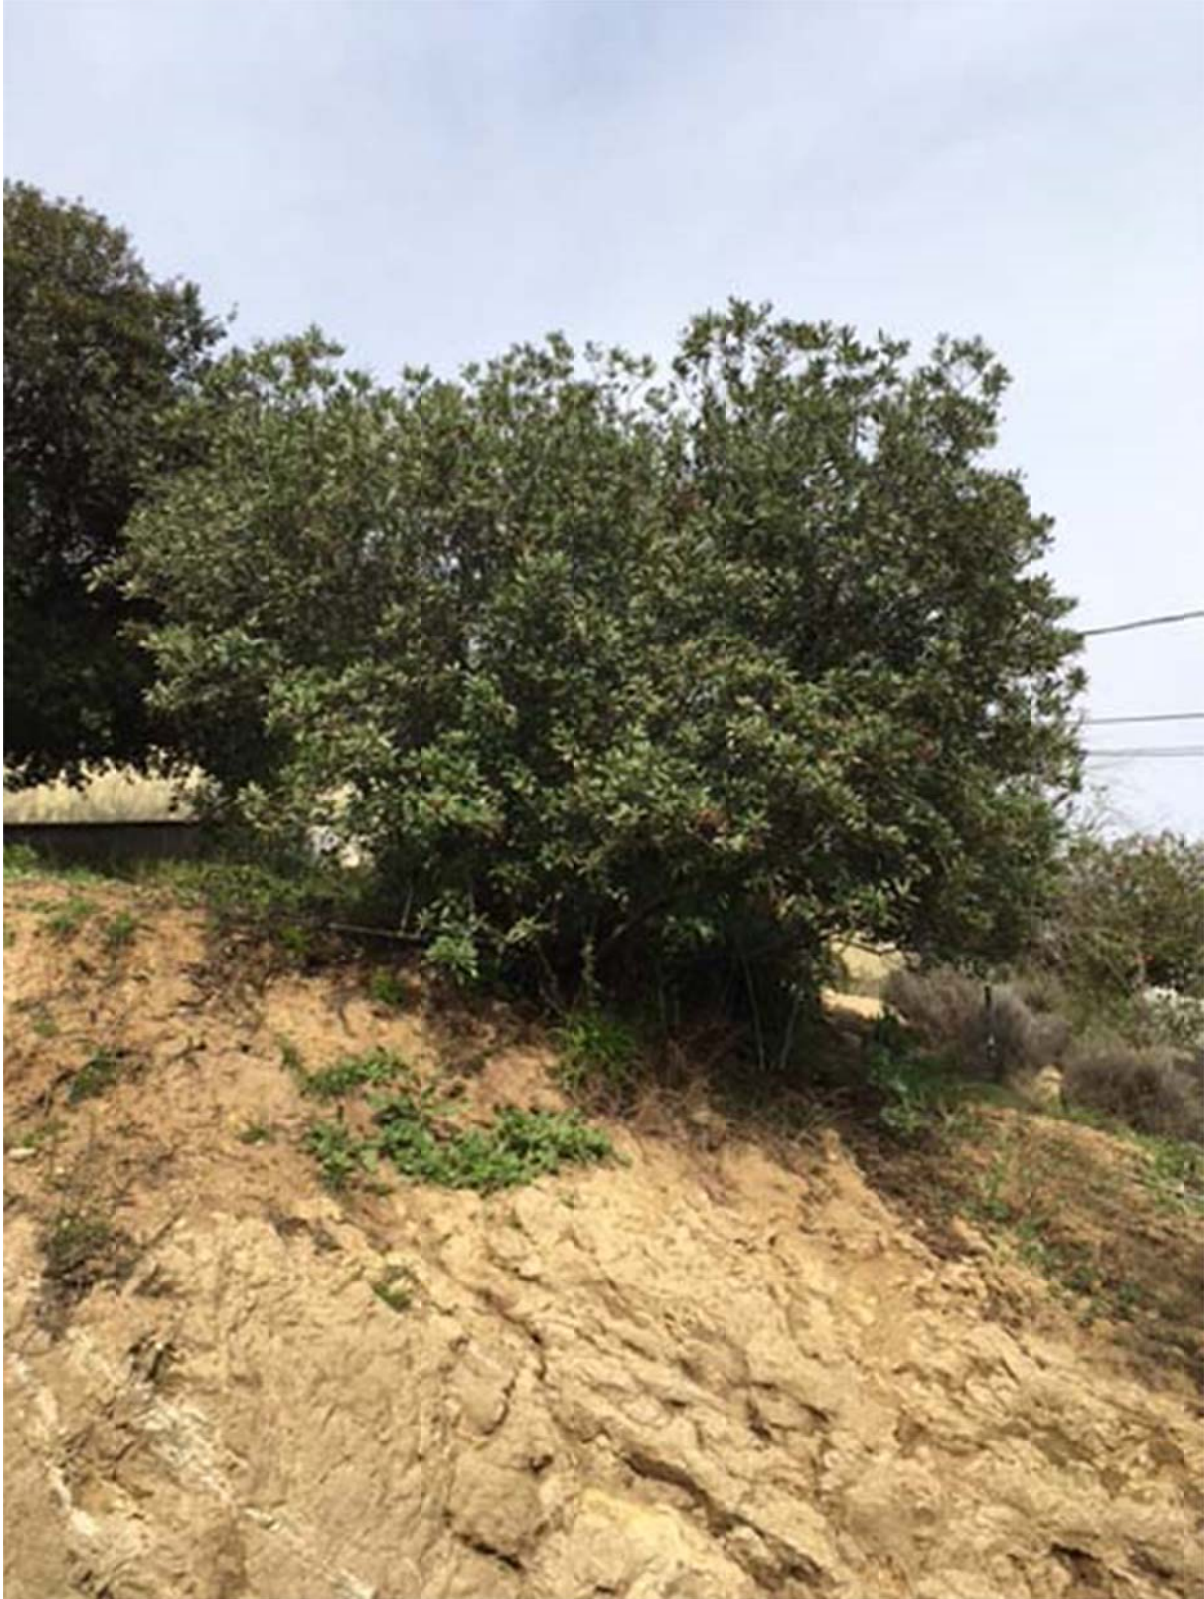
<p>Tree OP3 <i>Heteromeles arbutifolia</i> – Toyon</p> <p>This tree is not protected by the City of Glendale Indigenous Tree Protection Ordinance. It is unlikely to be impacted by the proposed construction. It is growing on the neighboring property to the northeast.</p>

Figure 4: Looking east at Tree 3. This tree will not likely be impacted by construction.

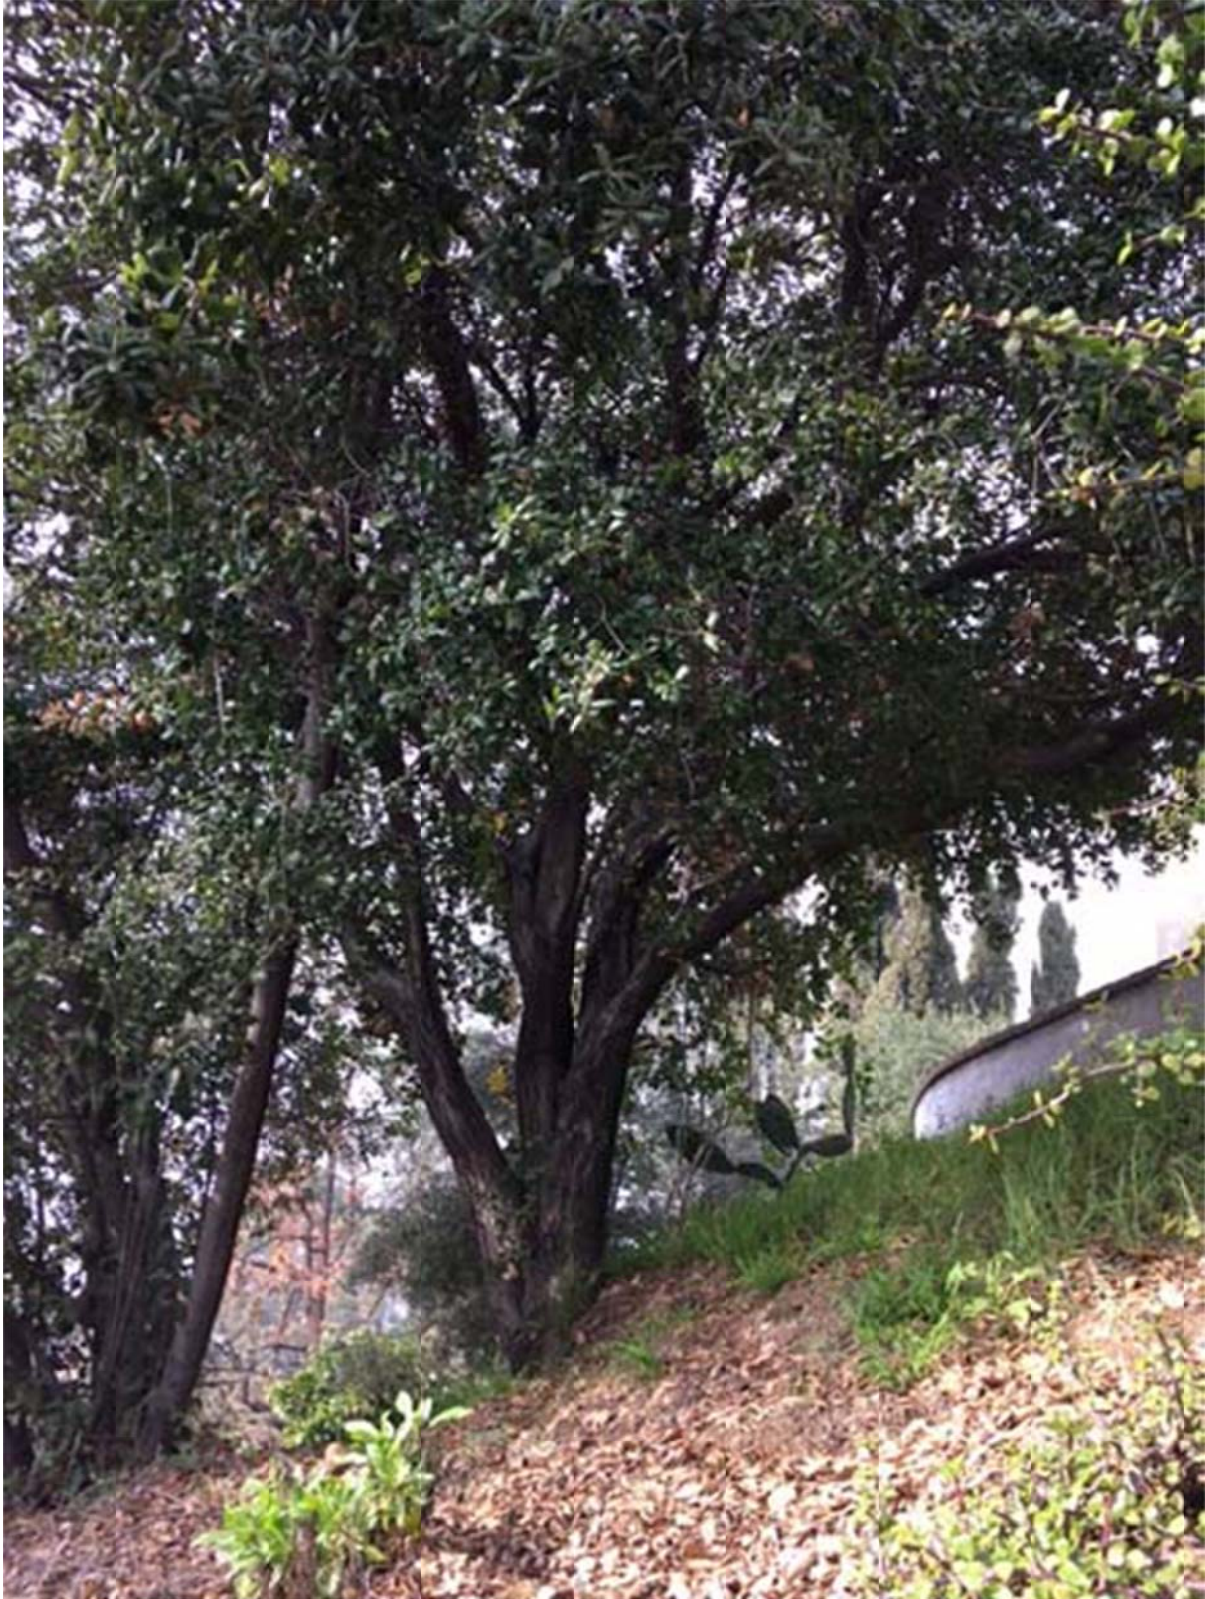
This multi-stem oak tree is growing on the hillside above the existing structure on the subject property. Due to its distance from and elevation above the house, it is unlikely to be impacted by the proposed construction.

The foliage appears healthy, and this naturally-occurring tree only has the common defect of narrow branch unions. No mitigation action is necessary.

Figure 5: Looking north at Tree 4. This tree will not likely be impacted by construction.

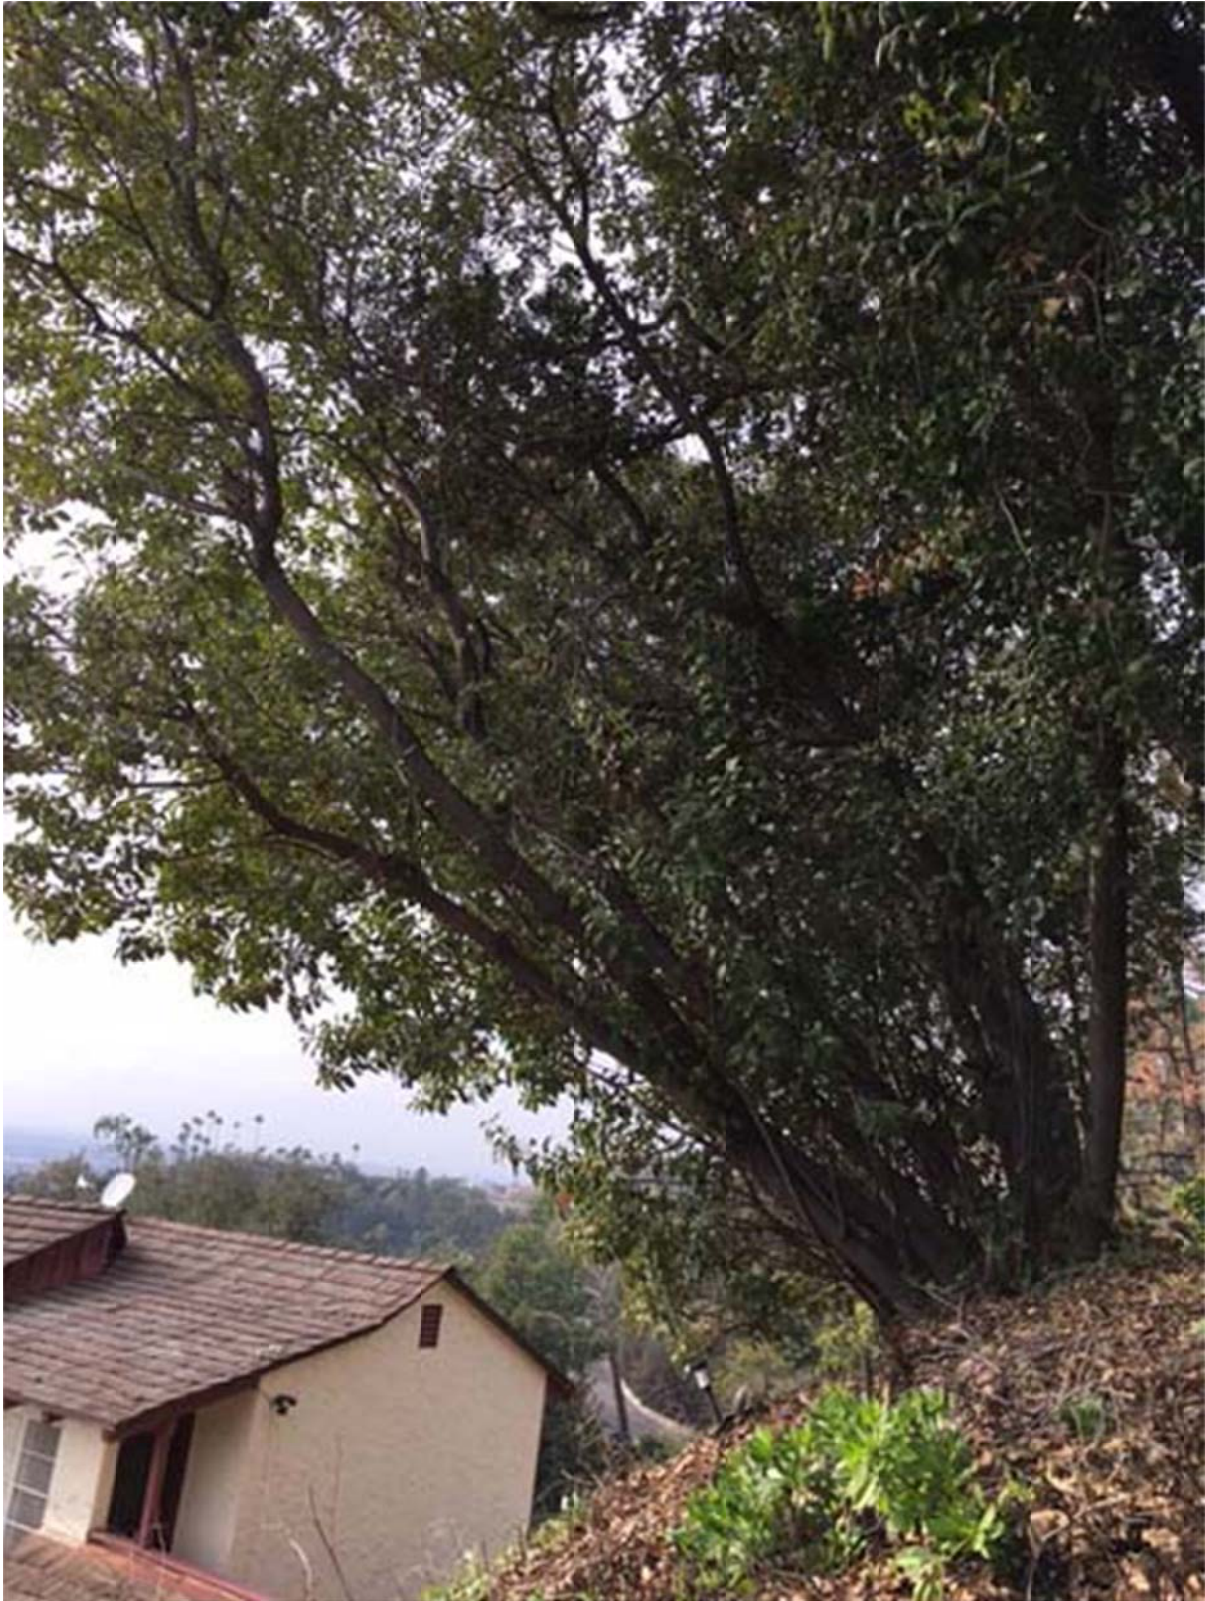
This tree is not protected by the City of Glendale Indigenous Tree Protection Ordinance. It will not likely be impacted by the proposed construction.

Figure 6: Looking north at Tree 5. This tree will not likely be impacted by construction.

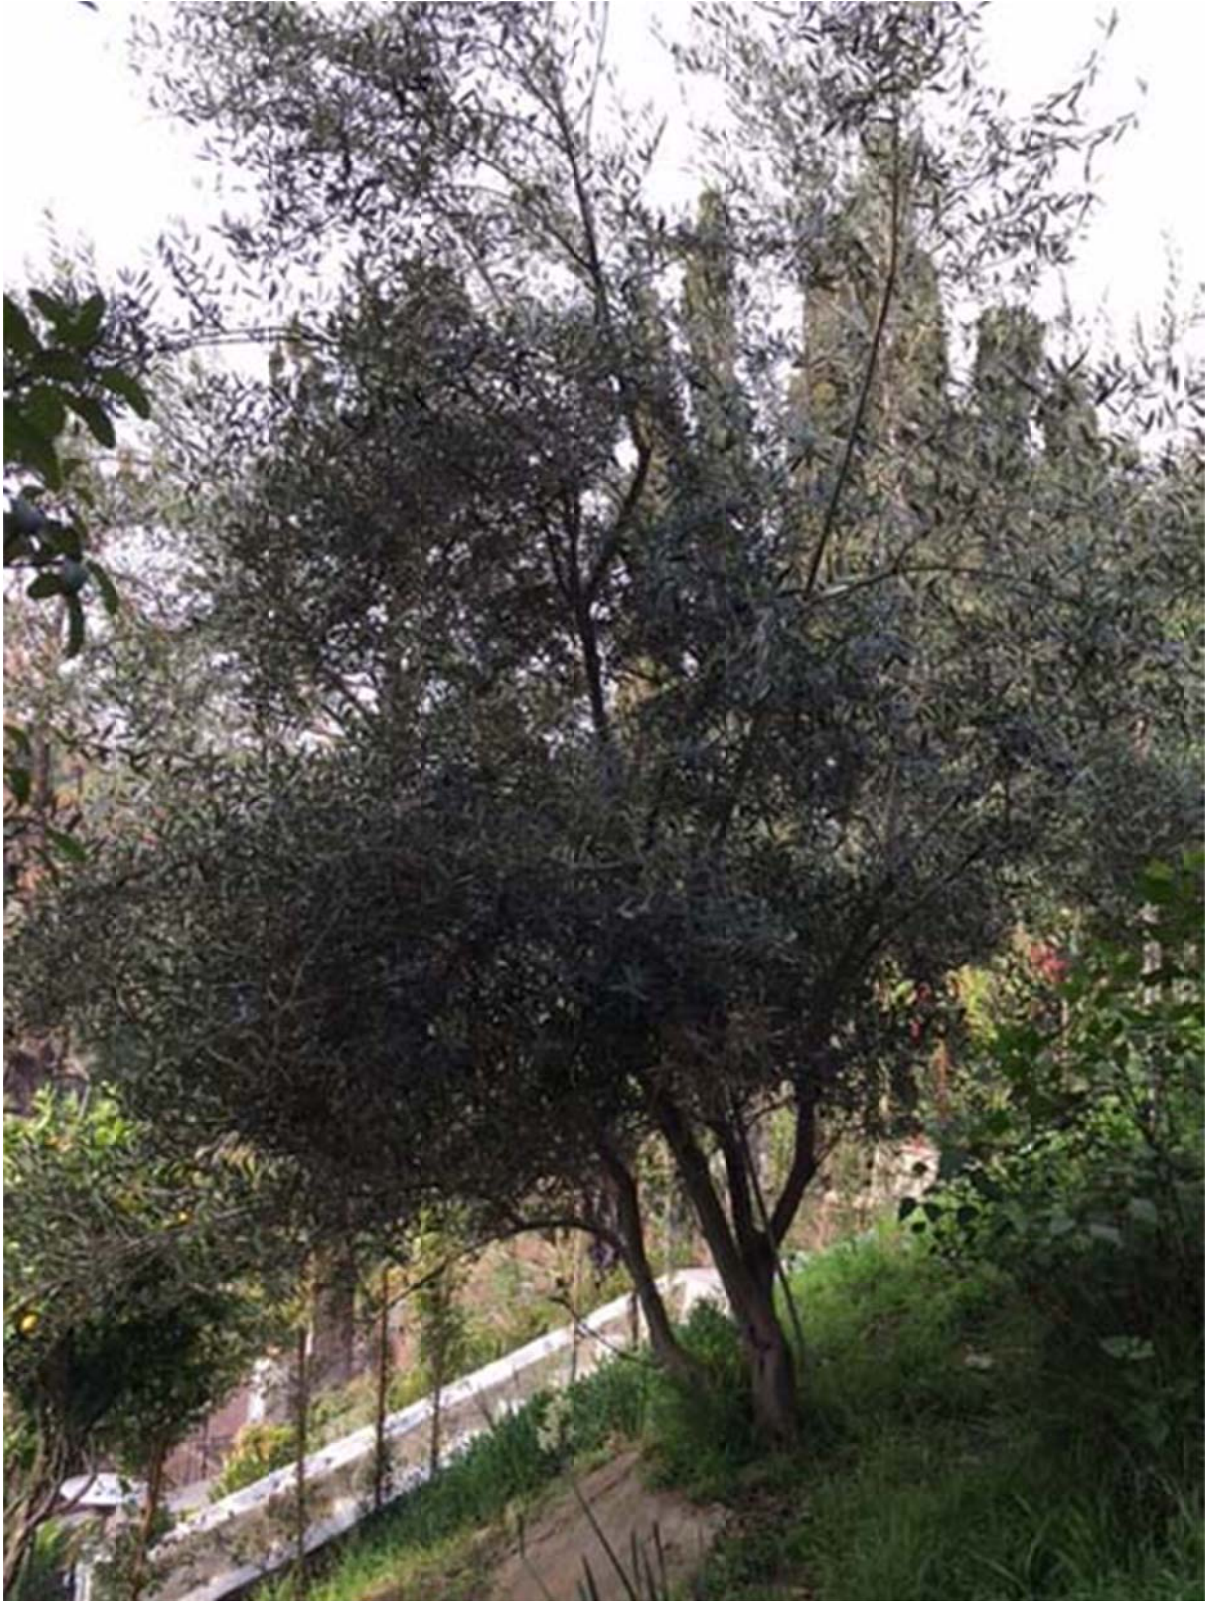
This tree is not protected by the City of Glendale Indigenous Tree Protection Ordinance. It will not likely be impacted by the proposed construction. It is growing along the property line with the neighboring property to the northeast.

Figure 7: Looking west at Tree 6. This tree will not likely be impacted by construction.

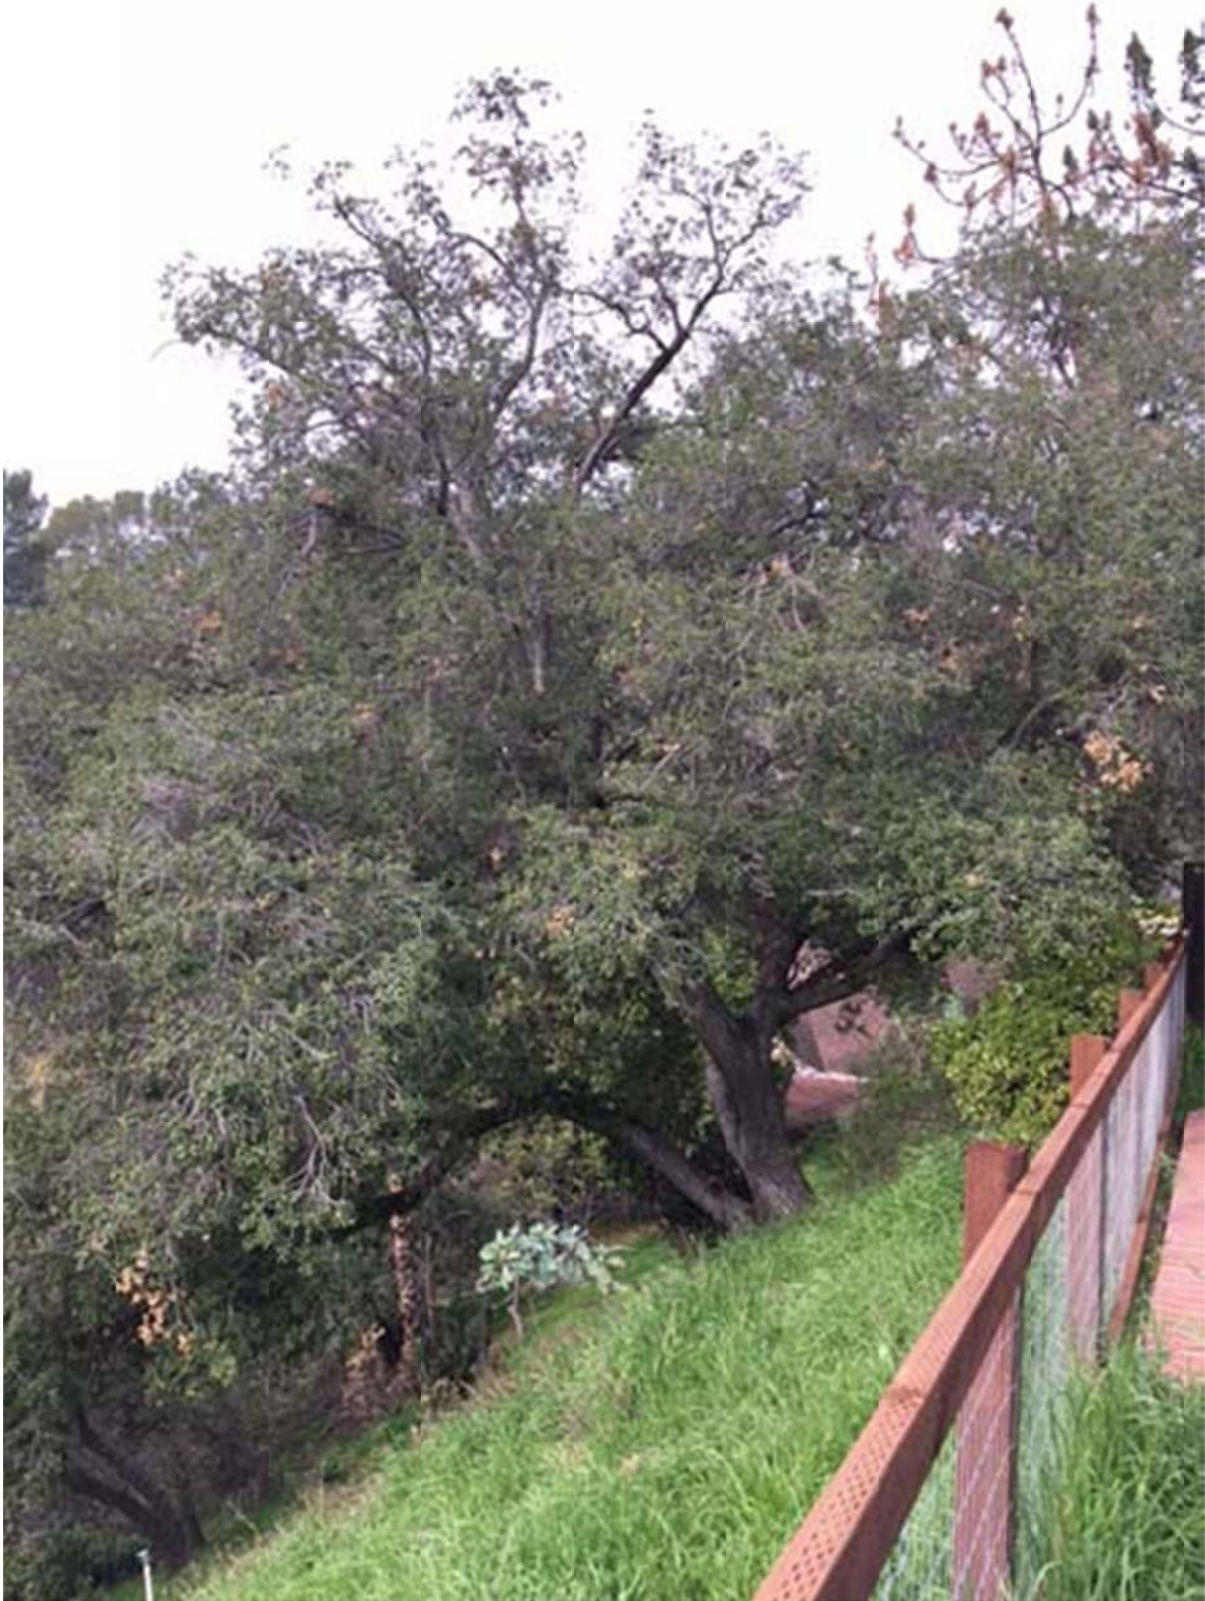
This protected mature Coast Live oak is in very good condition, and it provides valuable summer afternoon shade for the existing residence on the property. It is growing on the hillside to the west of the existing structure, slightly below the finished grade of the driveway. It has a full, healthy canopy with no apparent defects.

The proposed retaining wall will cut into the southwestern quadrant of the critical root zone of Tree 7. This is the only anticipated impact to the tree. Every effort will be made to preserve the remainder of its root system, but these root cuts are unavoidable if the proposed new structures and retaining wall will be constructed.

The most important roots of Tree 7 will remain untouched by excavation. Since the tree is growing on a slope, it likely developed tensile buttress roots to apply tension force to hold the tree up. These roots form on the uphill (east) side of the trunk, and this area of the critical root zone will not be impacted by construction.

Although some roots of Tree 7 will be cut, the tree has a good chance of being able to tolerate the impacts of construction.

Figure 8: Looking north at Tree 7. This tree is intended for preservation. It is a healthy, high-value specimen on site.

This tree is intended for preservation through any anticipated construction. No treatment is necessary for this tree at this time. Along the eastern half of the canopy, the proposed tree protection fencing will follow the path of an existing fence on site.

A retaining wall will be constructed along the southwestern quadrant of the dripline to retain the soil. According to the soils report, the soil in which Tree 7 is growing consists of loose fill that was pushed over the top of the hill when the pad for the existing structure was being constructed. As a result, the soil requires substantial structural support. The retaining wall is a necessity for the safety of the proposed structures. The proposed footprint of the retaining wall is the least damaging to Tree 7 while still allowing the reasonable development of the subject property.

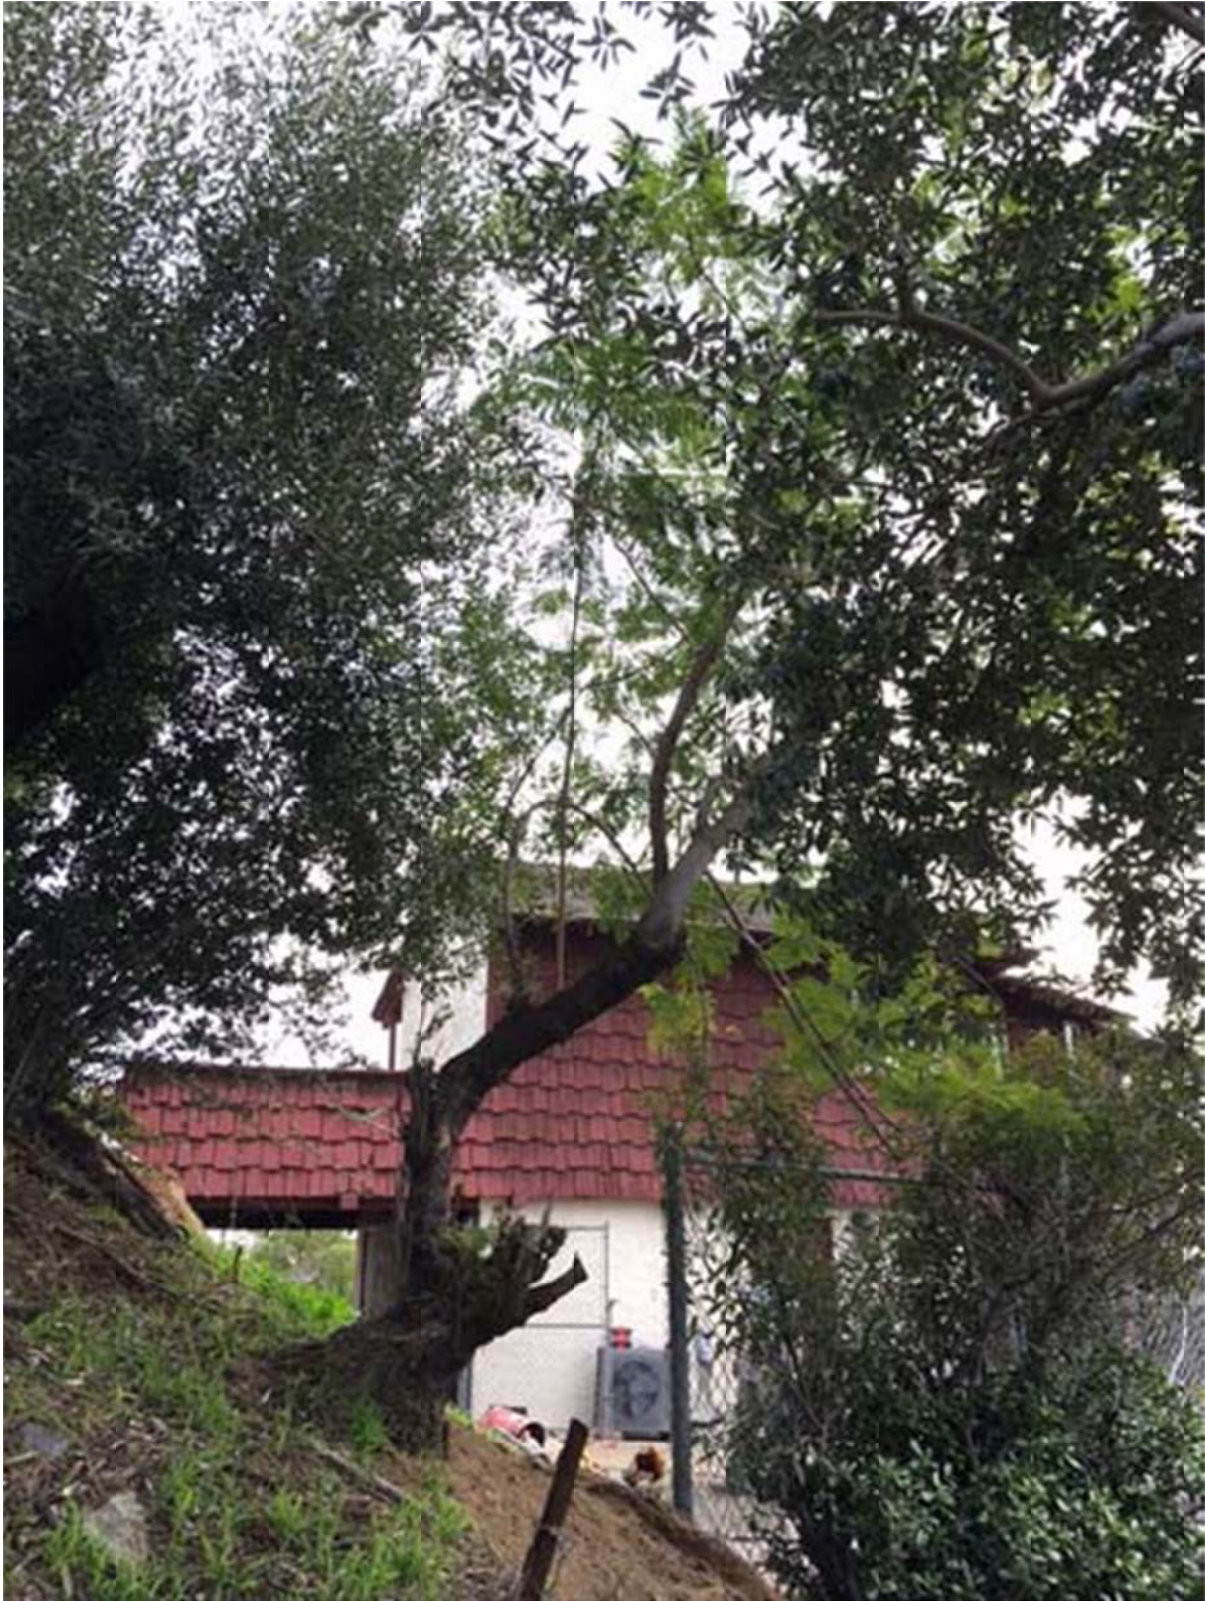
In the recent past, it was pruned very heavily on the western trunk. No action is necessary at this time. It can be allowed to grow on site.

Figure 9: Looking southeast at Tree 8. This tree will not likely be impacted by construction. It was severely pruned in the past.

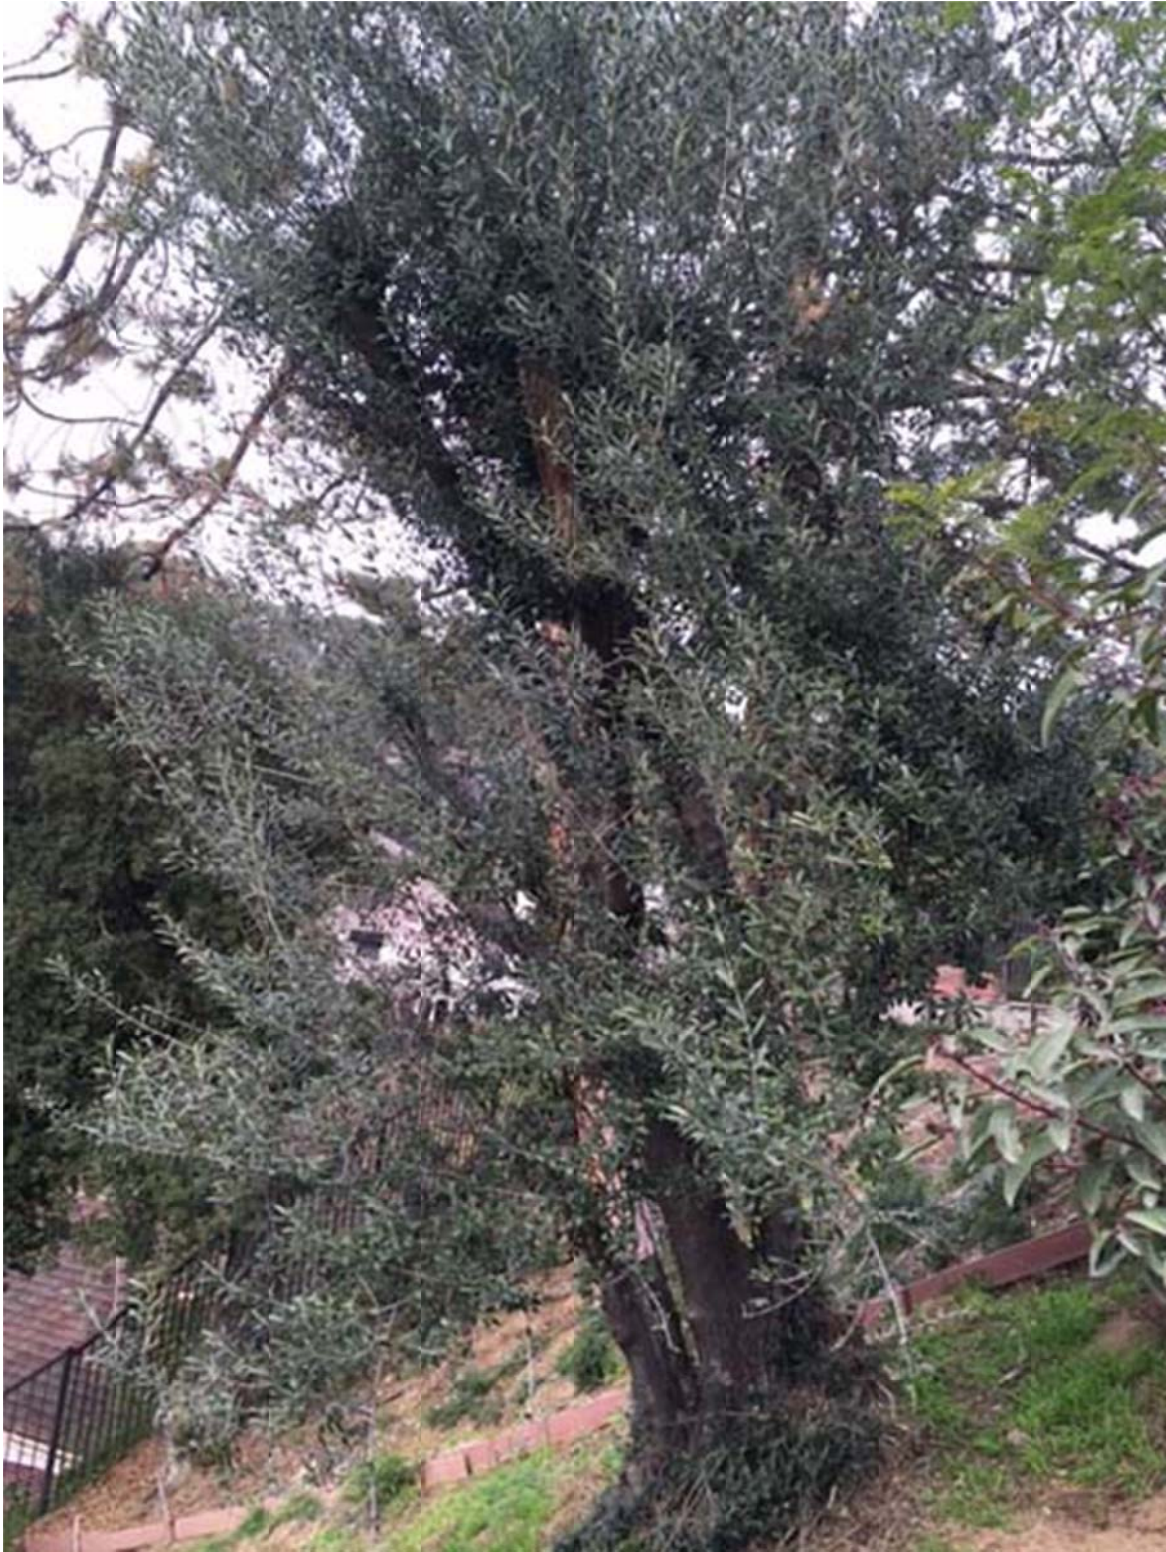
There is a prevailing lean to the west that is currently not problematic. A branch with a diameter of approximately 4” broke out of the upper canopy, presumably in a windstorm. No mitigation action is necessary at this time.

Figure 10: Looking north at Tree 9. This tree will not likely be impacted by construction. There was a branch tearout injury about 10 feet up in the canopy.

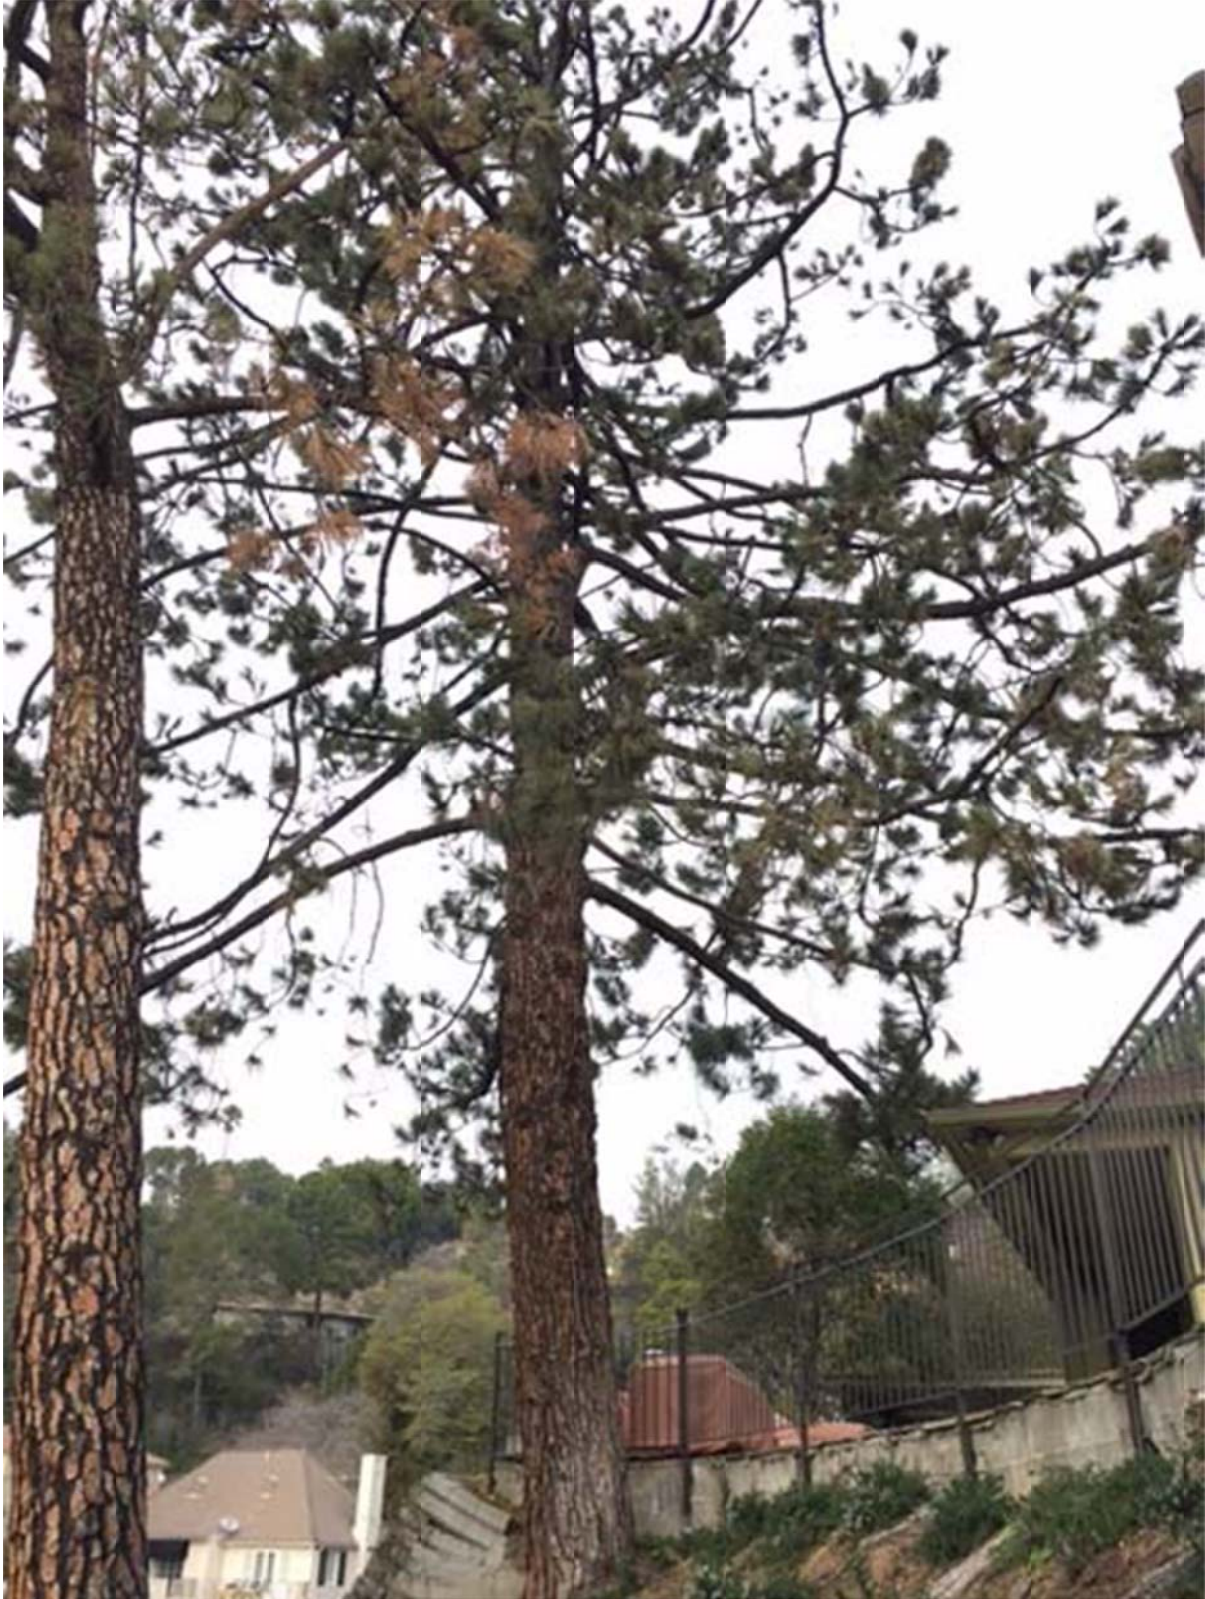
This tree is showing signs of drought stress. It was over-thinned in the past, and an excessive amount of foliage was removed, likely causing the tree to become stressed. I recommend applying a deep-soak irrigation to this tree to improve the foliage density.

Figure 11: Looking north at Tree OP10. This tree will not likely be impacted by construction. It was overpruned in the past and is suffering from drought stress.

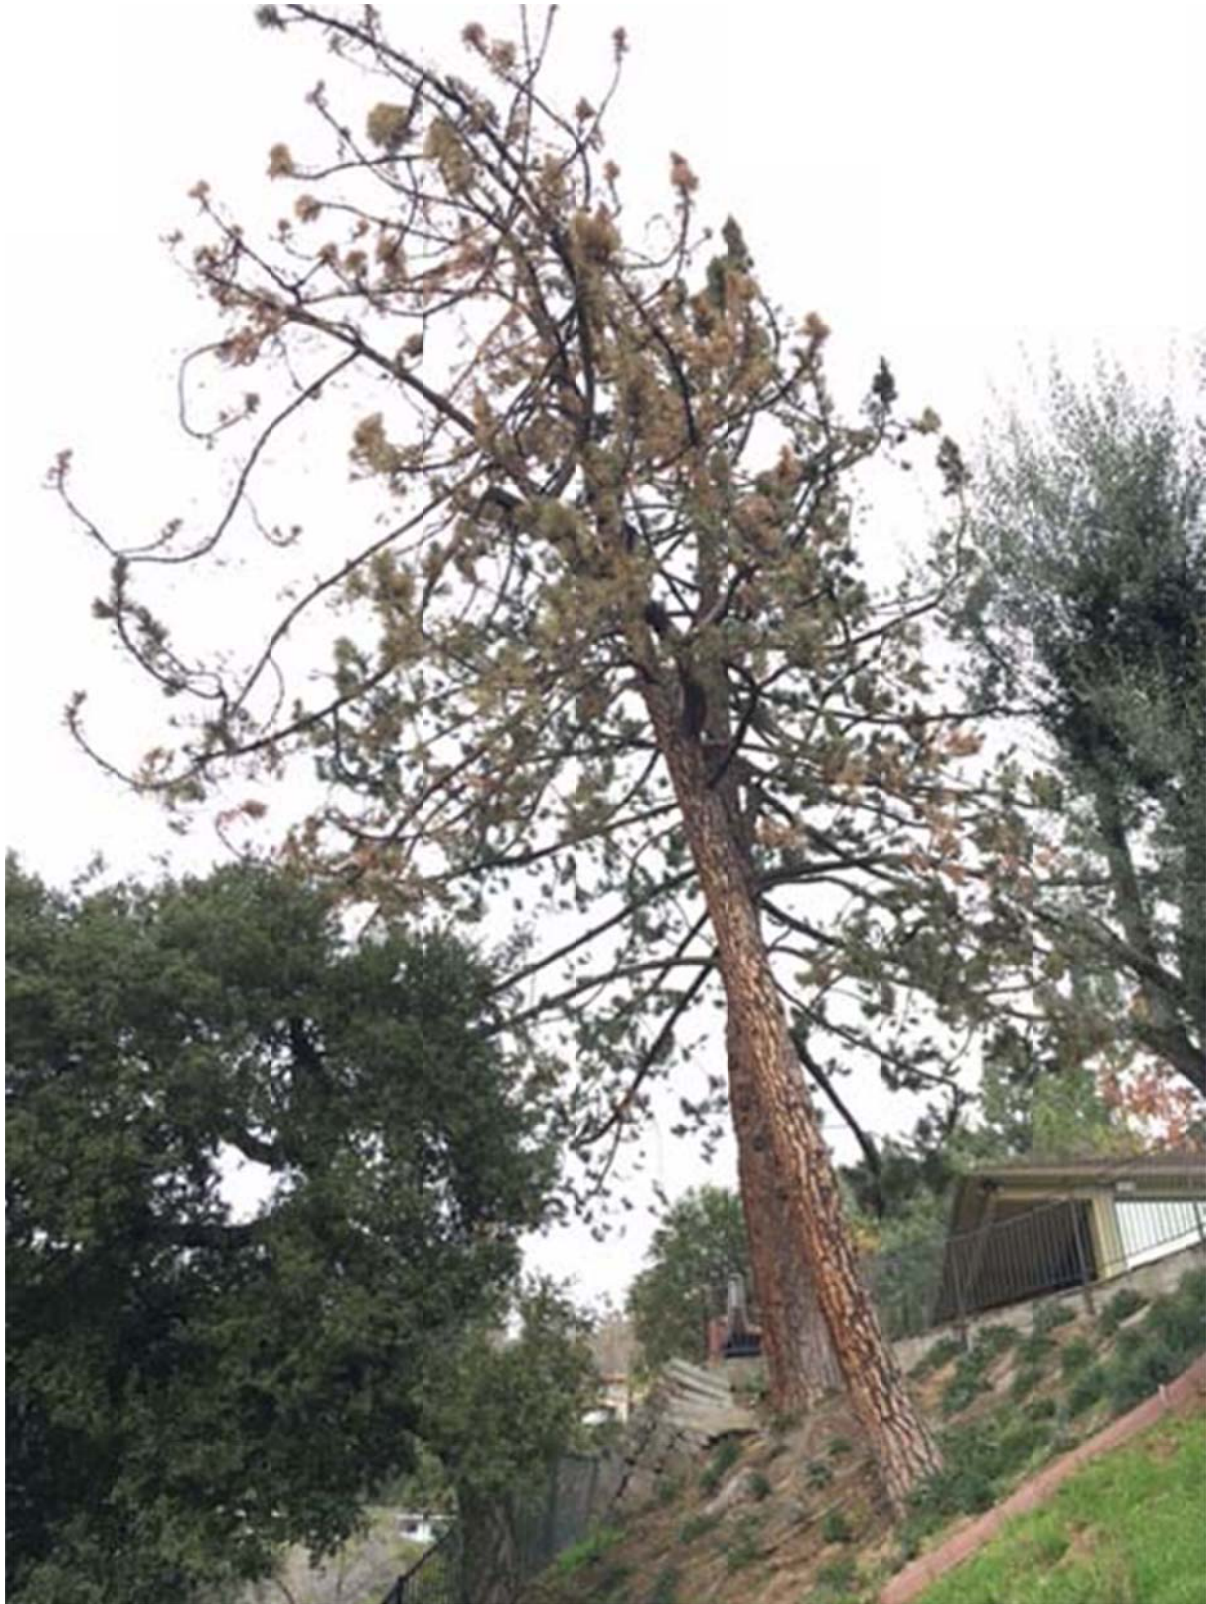
<p>Tree OP11 <i>Pinus canariensis</i> – Canary Island Pine</p> <p>This tree is not protected by the City of Glendale Indigenous Tree Protection Ordinance. It will not likely be impacted by the proposed construction. It is growing on the neighboring property to the north.</p> <p>This tree is showing signs of drought stress. It was over-thinned in the past, and an excessive amount of foliage was removed, likely causing the tree to become stressed. I recommend applying a deep-soak irrigation to this tree to improve the foliage density.</p>

Figure 12: Looking north at Tree OP11. This tree will not likely be impacted by construction. It was overpruned in the past and is suffering from drought stress.
