601 and 603 Bohlig Rd. Arborist Report

Prepared for Camille Neagu
601 Bohlig Road
Glendale, CA 91207

Prepared by James Komen
BCMA WE-9909B
RCA #555

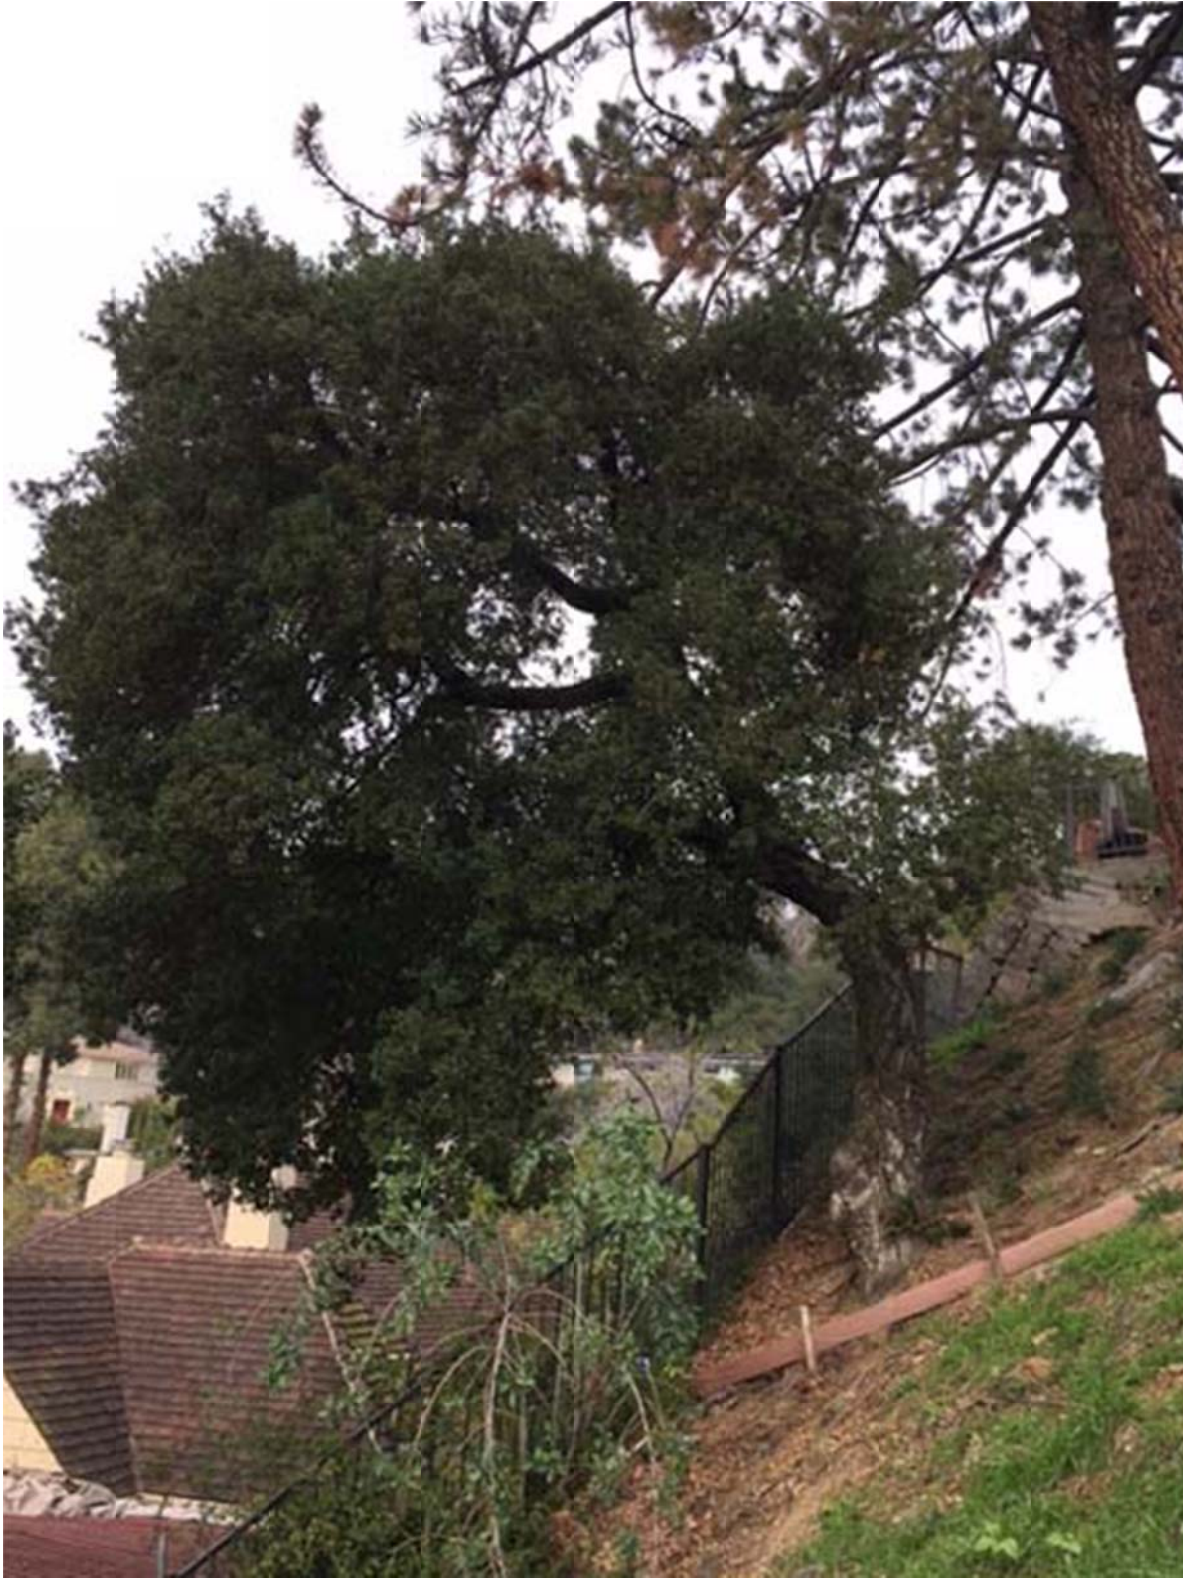
<p>Tree OP12 <i>Quercus agrifolia</i> – Coast Live Oak</p> <p>This oak tree is growing on the neighboring property to the north. Due to its distance from the house, it is unlikely to be impacted by the proposed construction.</p> <p>The foliage appears healthy. The whole tree has a prevailing lean to the west, but no mitigation action is necessary. Coast Live Oaks growing on hillsides are able to tolerate a substantial amount of cantilevered crown; this tree has an improbable likelihood of whole-tree failure within the next four years.</p>

Figure 13: Looking north at Tree OP12. This tree is intended for preservation through construction. It has a prevailing lean to the west, but it is not problematic. No mitigation action is necessary.

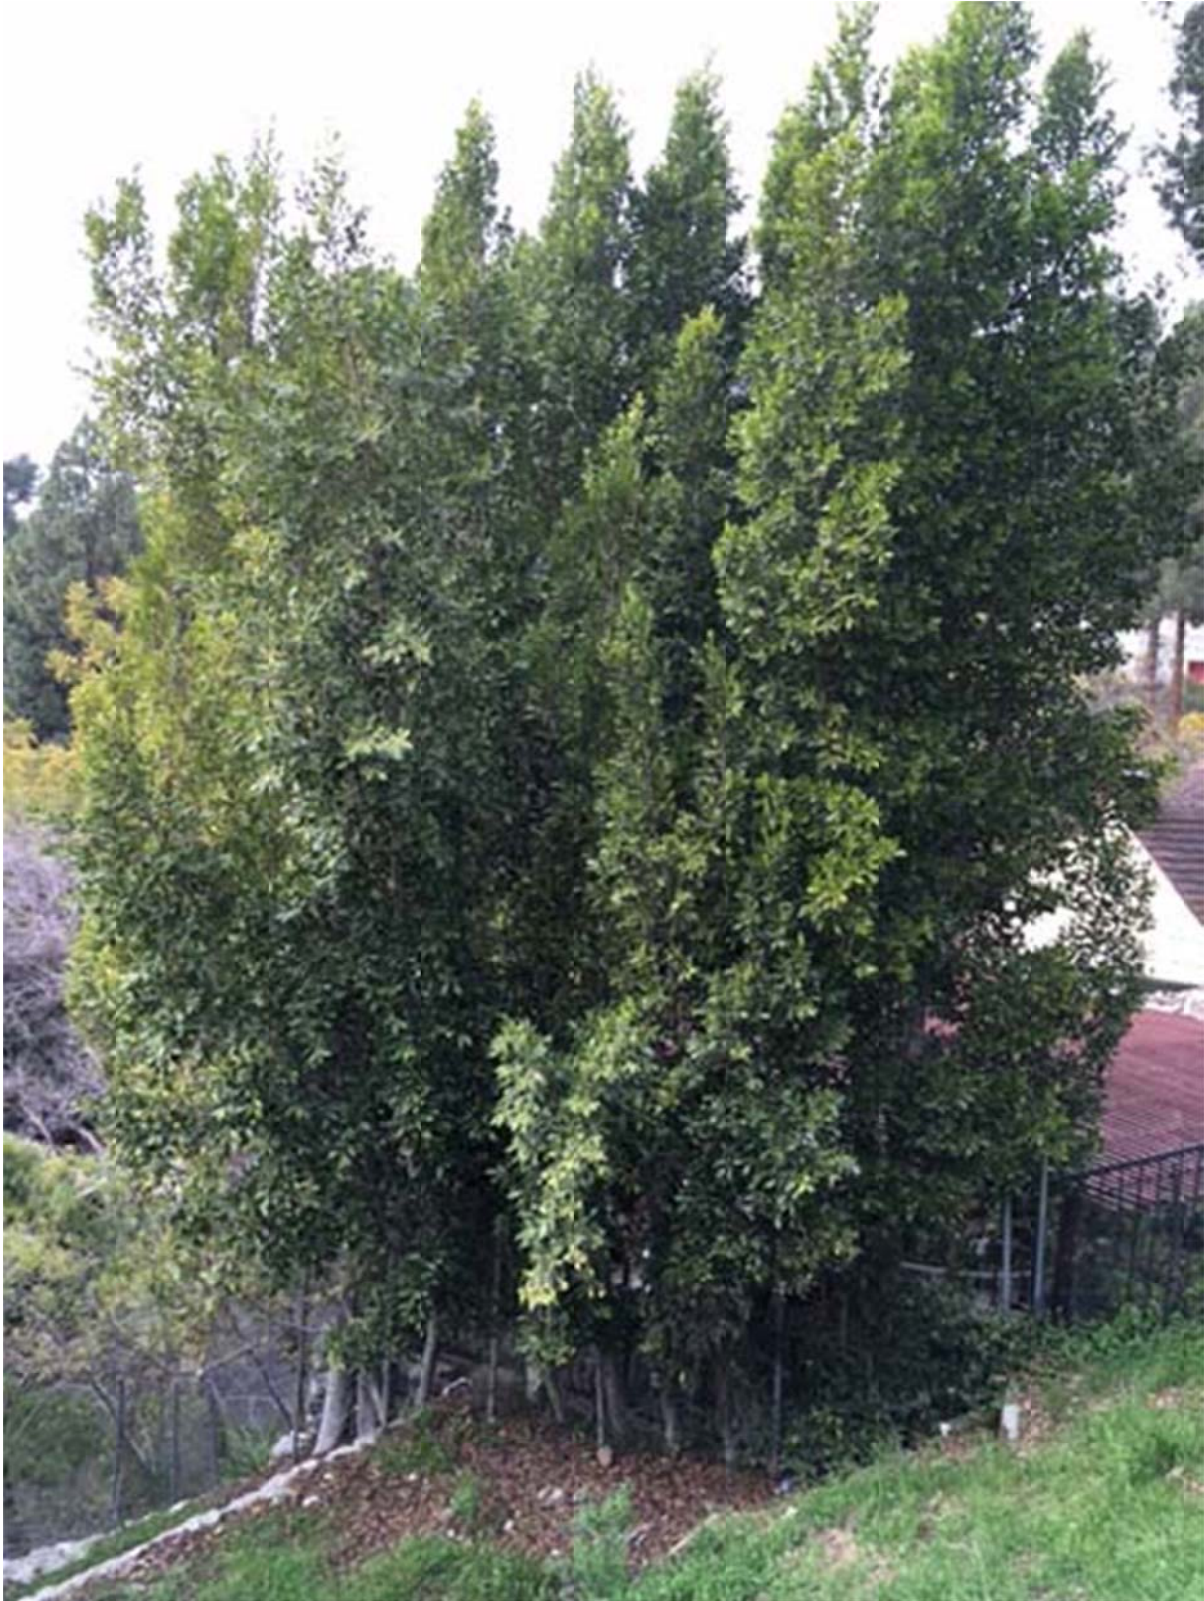
<p>Tree OP13 <i>Ficus microcarpa</i> – Indian Laurel Fig</p> <p>This hedge of <i>Ficus</i> trees was planted with the intention of giving a privacy screen to the patio of the neighbor to the north. They appear to be experiencing moderate water stress, and they would benefit from irrigation.</p> <p>These trees are growing on the neighbor's property and are not protected by the City of Glendale Indigenous Tree Protection Ordinance. The tree matrix on page 17 displays trunk measurements for the trunks along the hedge row in order from east to west.</p>

Figure 14: Looking north at Tree OP13. This hedge row of *Ficus* trees is intended to be preserved through construction. It is suffering from drought stress.

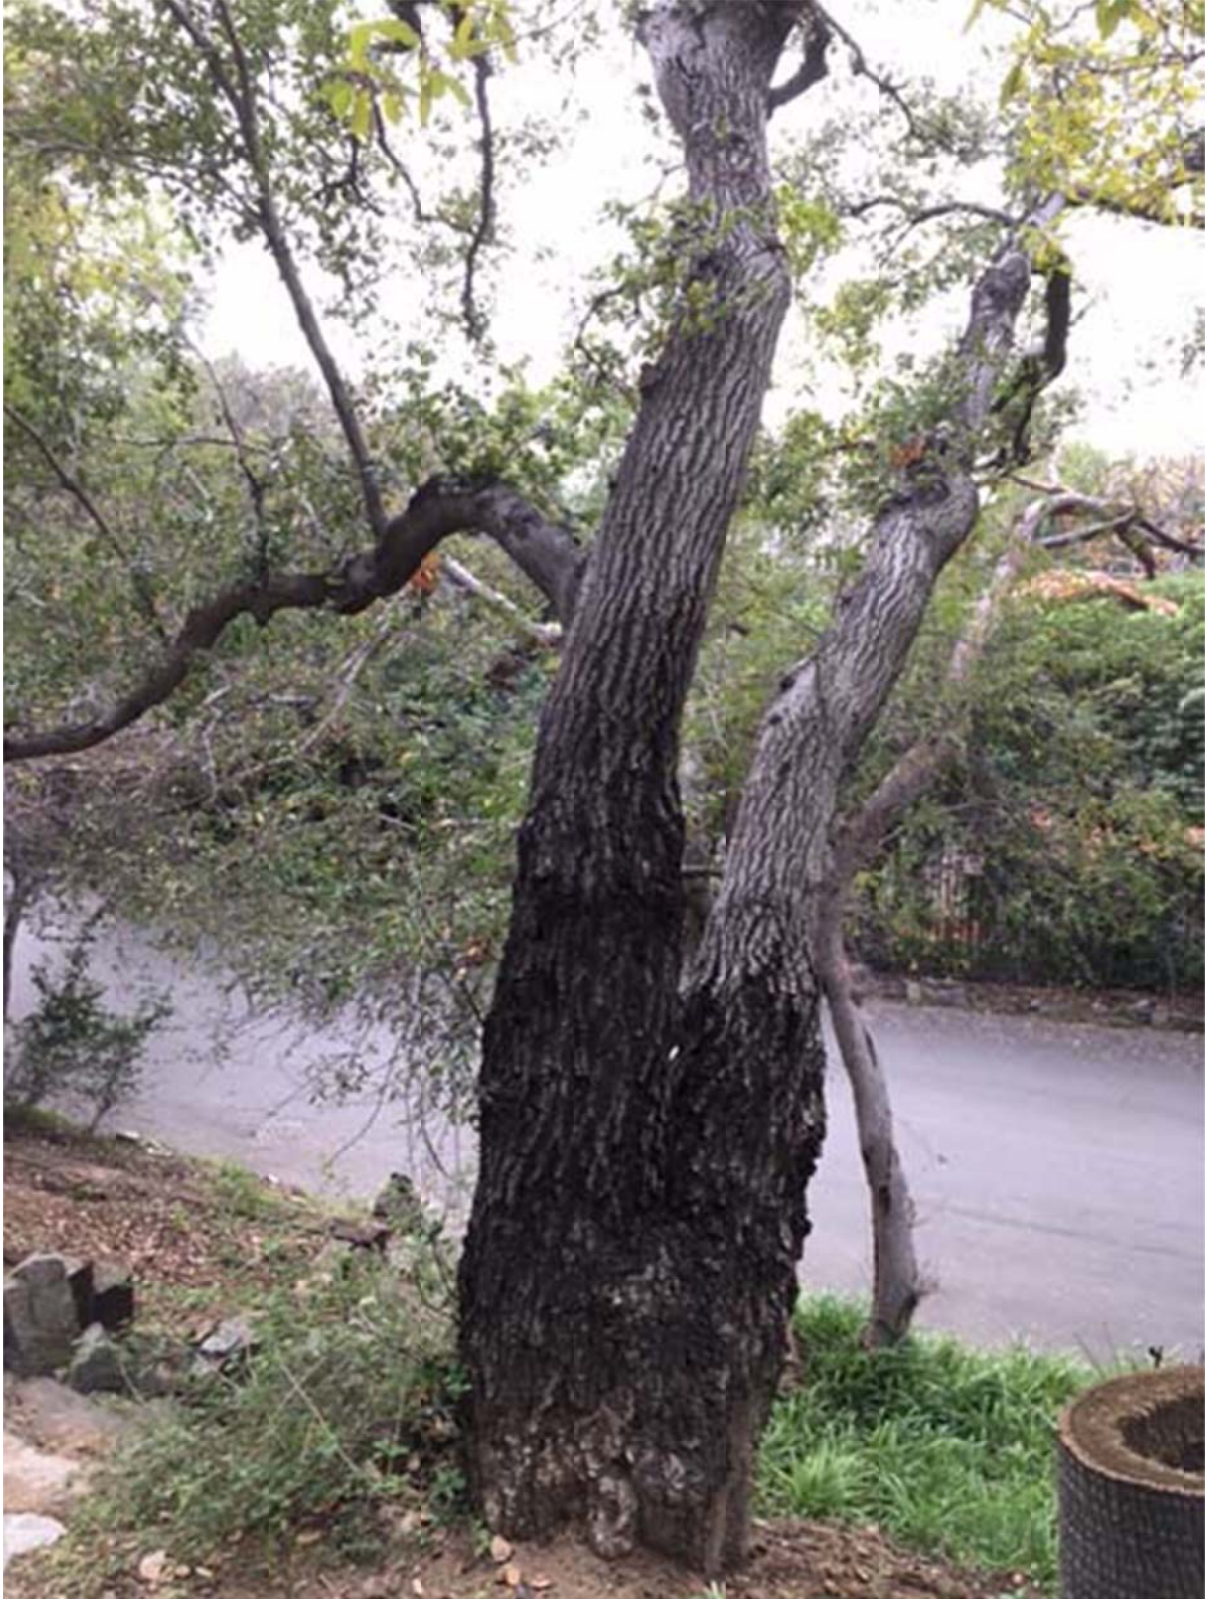
This oak tree is growing on the neighboring property to the north. It is showing signs of bark borer damage. There is evidence of dark frass recently deposited along the outer layer of bark on the lower trunk. There is a prevailing lean to the west, but it does not appear to pose an immediate risk in the landscape.

Figure 15: Looking west at Tree OP14. This tree is intended for preservation through construction. It has signs of bark beetle infestation in the lower trunk.

The bark borer infestation should be monitored, but no mitigation action is recommended at this time. If the proposed tree protection fencing is not crossed, this tree is not likely to be impacted by construction activity.

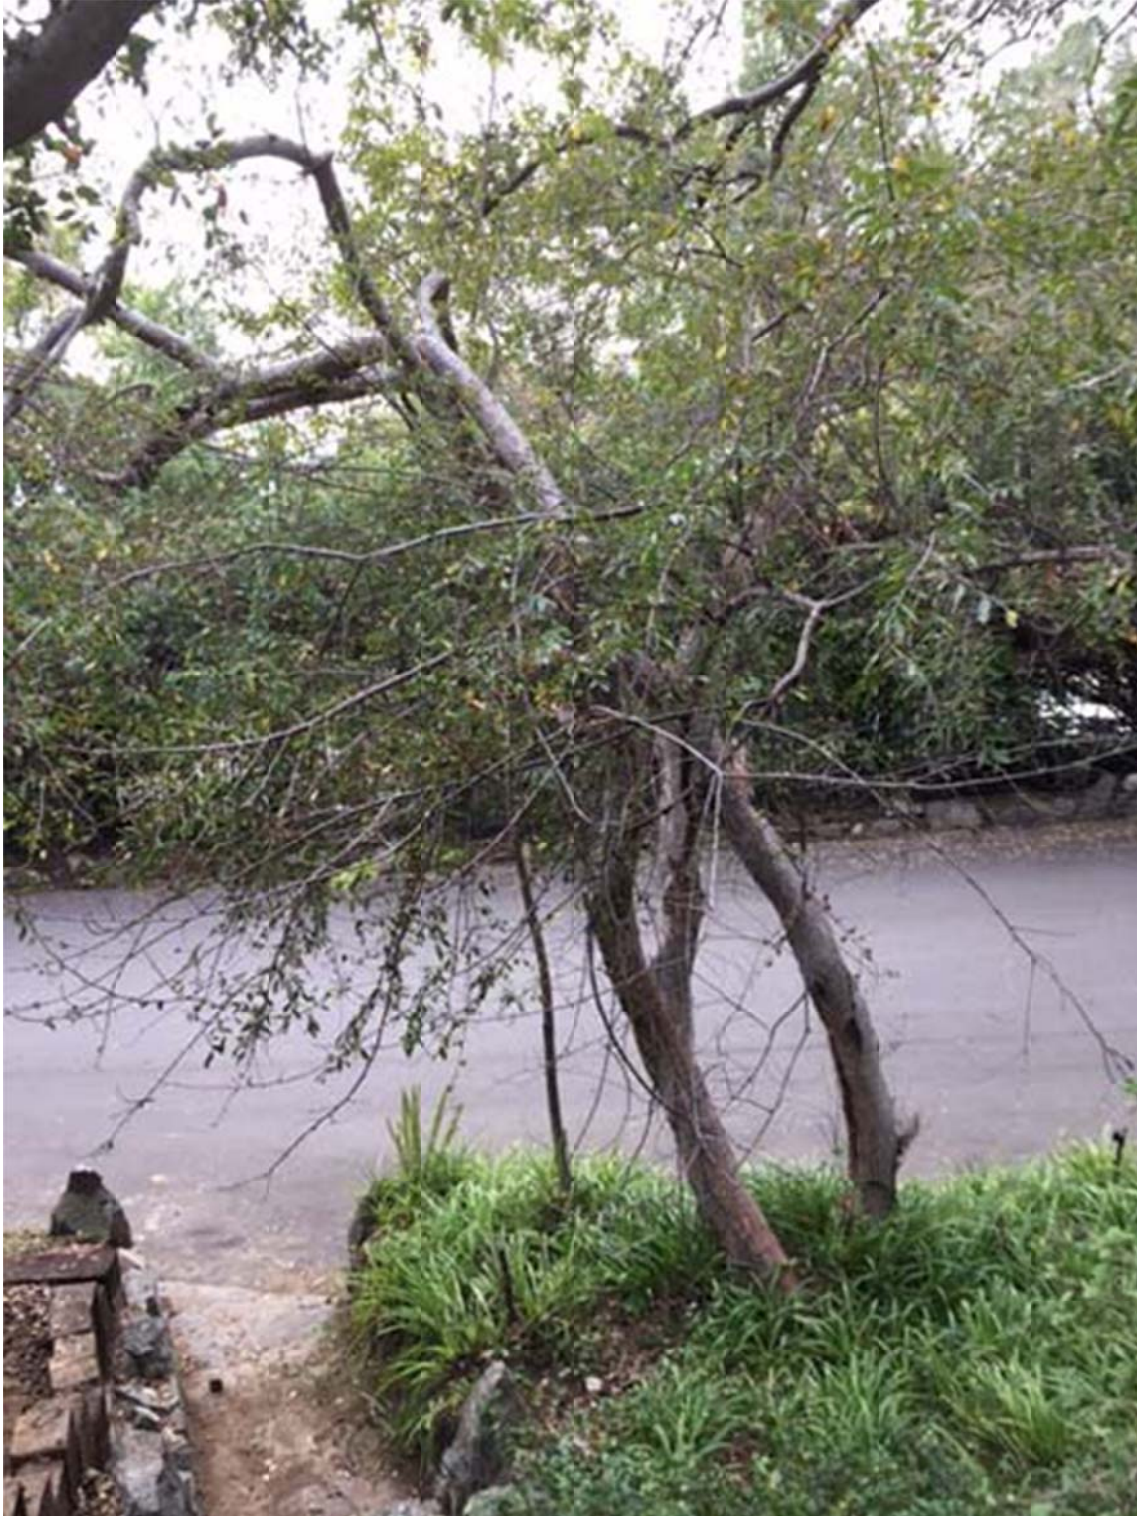
This tree is growing on the neighboring property to the north. It is not protected by the City of Glendale Indigenous Tree Protection Ordinance. Its canopy is partially suppressed by the neighboring oak to the east, but the amount of canopy cantilever is not problematic at this time.

It shows evidence of Chinese Elm anthracnose canker. This is a target-canker that prevents annual rings from completing the deposition of a protective barrier to cover the wound created by the fungus. At this time, there is no need to take action to mitigate this condition. Chinese Elm anthracnose fungus is common for this species. If the target canker becomes larger within the next five years, the tree may be considered for removal. Otherwise, it can be retained in the landscape.

Figure 16: Looking west at Tree OP15. This tree is intended for preservation through construction. Its canopy has been partially suppressed by Tree OP14. It has signs of Chinese elm anthracnose canker.

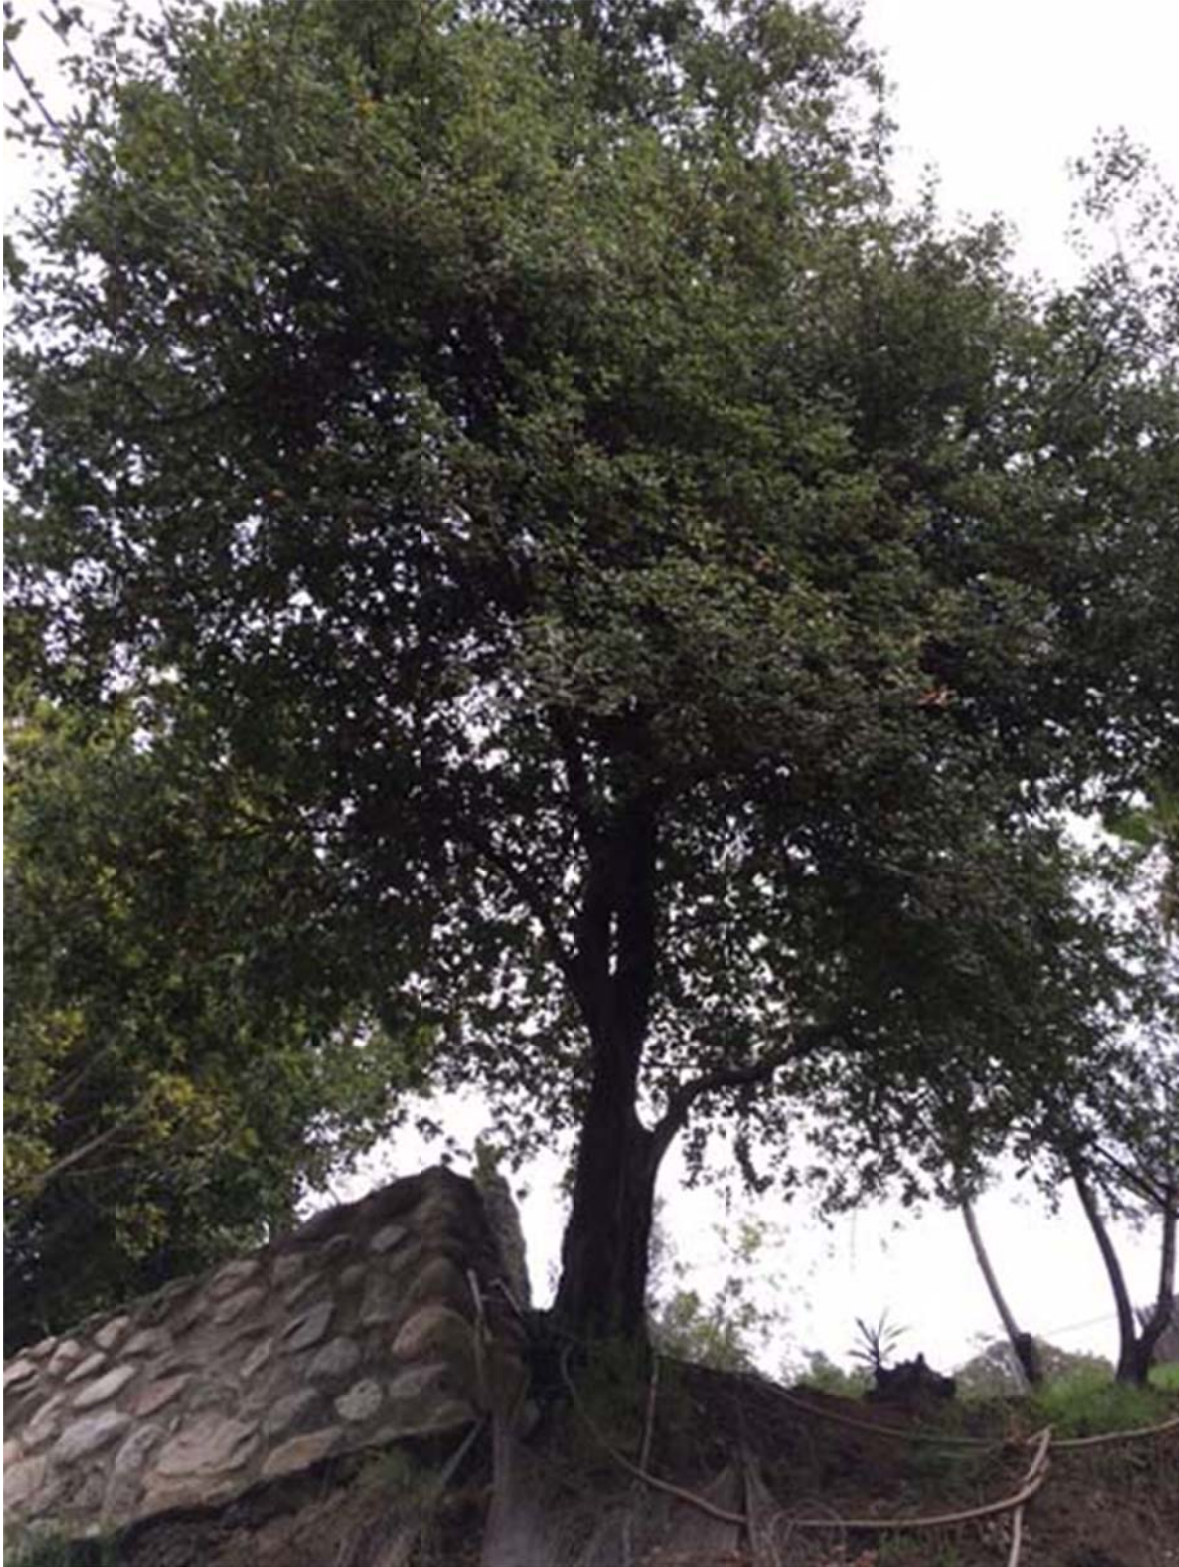
This tree is growing next to an old stone wall growing along the northern property line. The canopy is dense and healthy. I did not observe any defects in this tree.

Figure 17: Looking east at Tree 16. This tree will be retained through construction.

This tree will be retained through construction. This tree is unlikely to be affected by construction if the tree protection fencing shown in this report is not crossed.

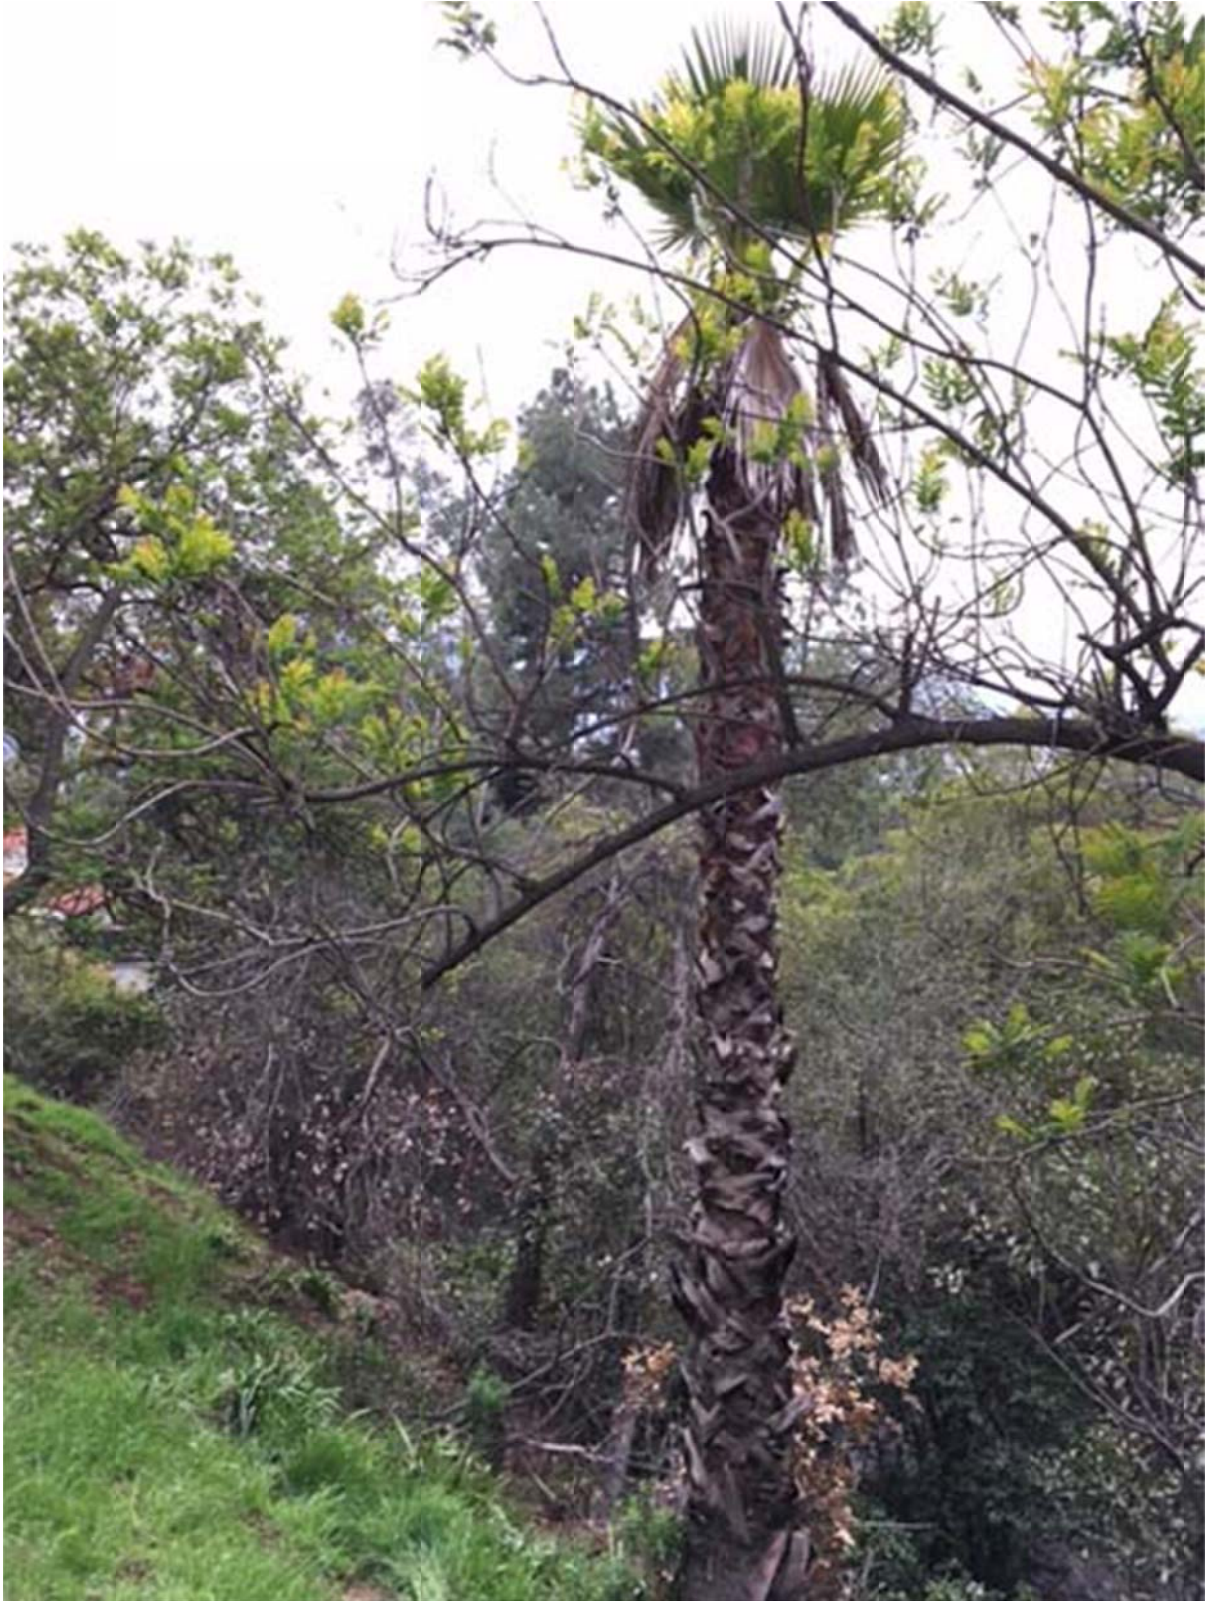
This tree is not protected by the City of Glendale Indigenous Tree Protection Ordinance. It will be removed because it is growing within the footprint of the grading activity necessary to construct the proposed retaining wall to the east.

Figure 18: Looking south at Tree 17. This tree is not protected by ordinance. It will be removed because it is growing within the footprint of the proposed grading activity.

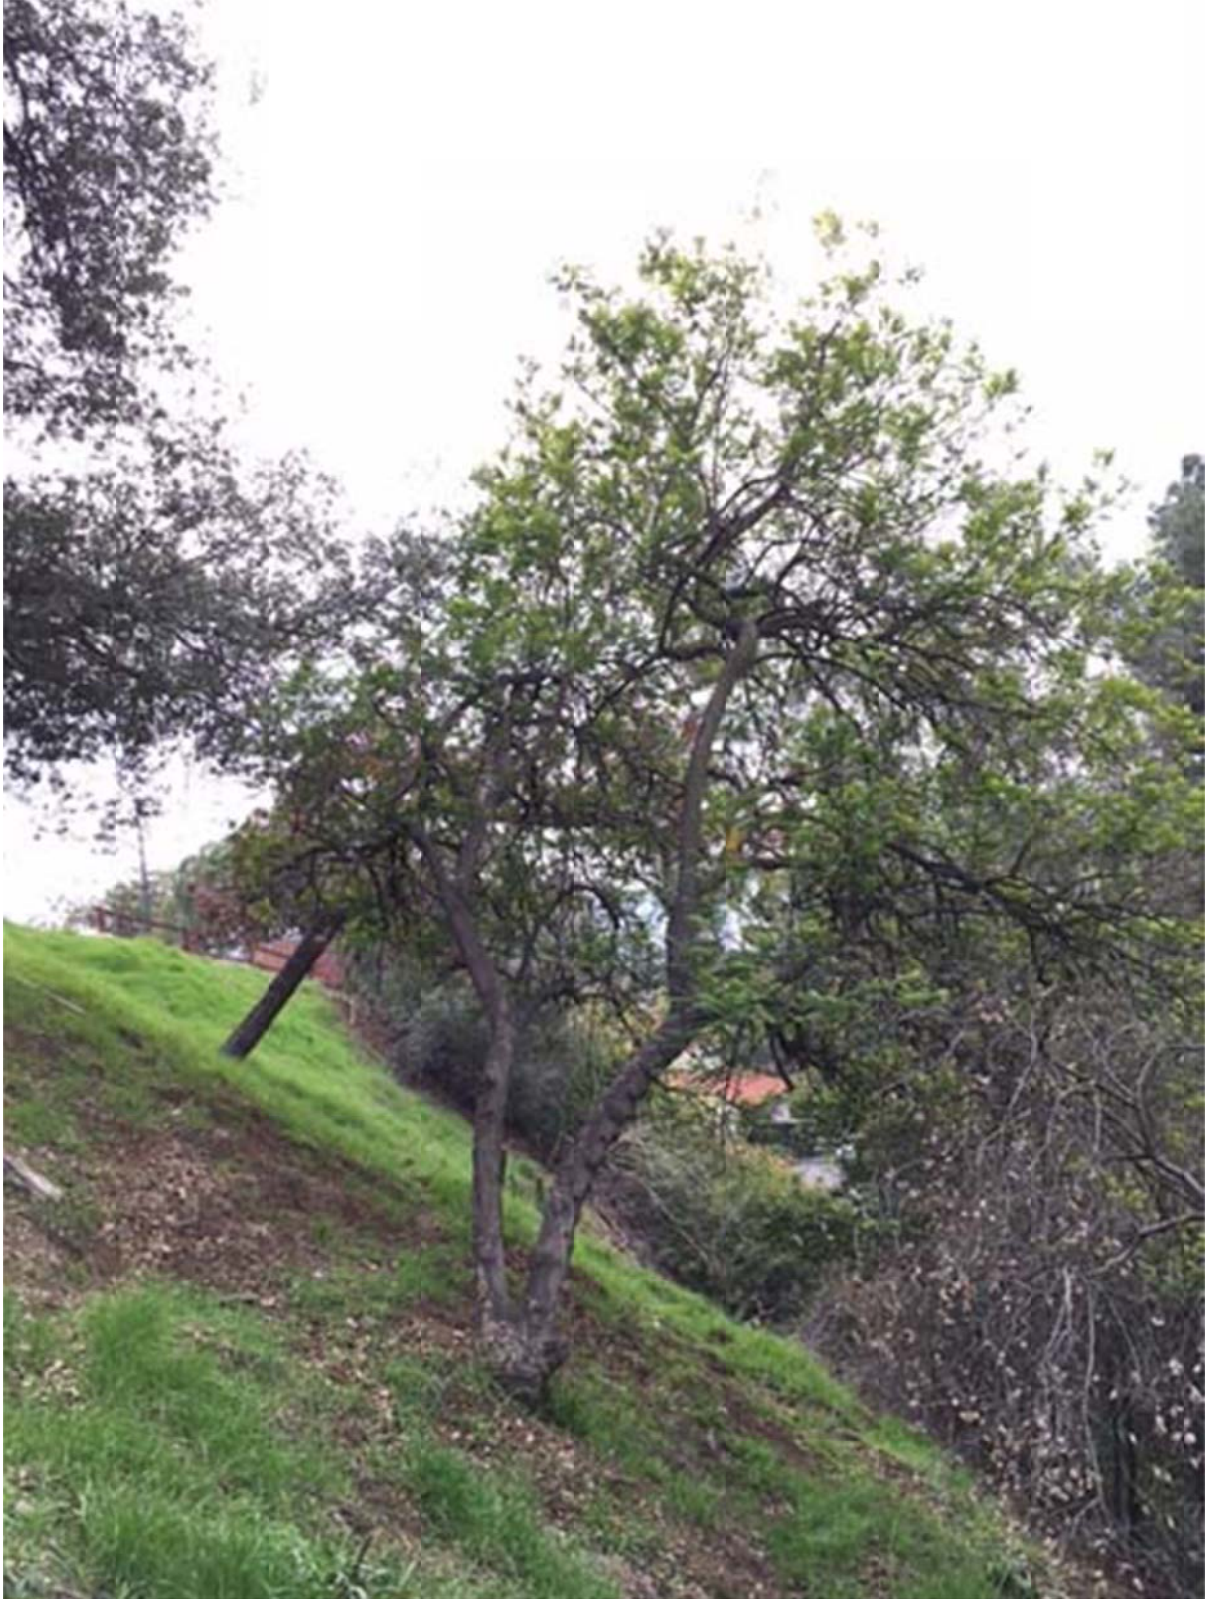
This tree is not protected by the City of Glendale Indigenous Tree Protection Ordinance. The proposed retaining wall will cut across its critical root zone, so this tree is proposed for removal.

Figure 19: Looking south at Tree 18. This tree is not protected by ordinance. It is proposed for removal.

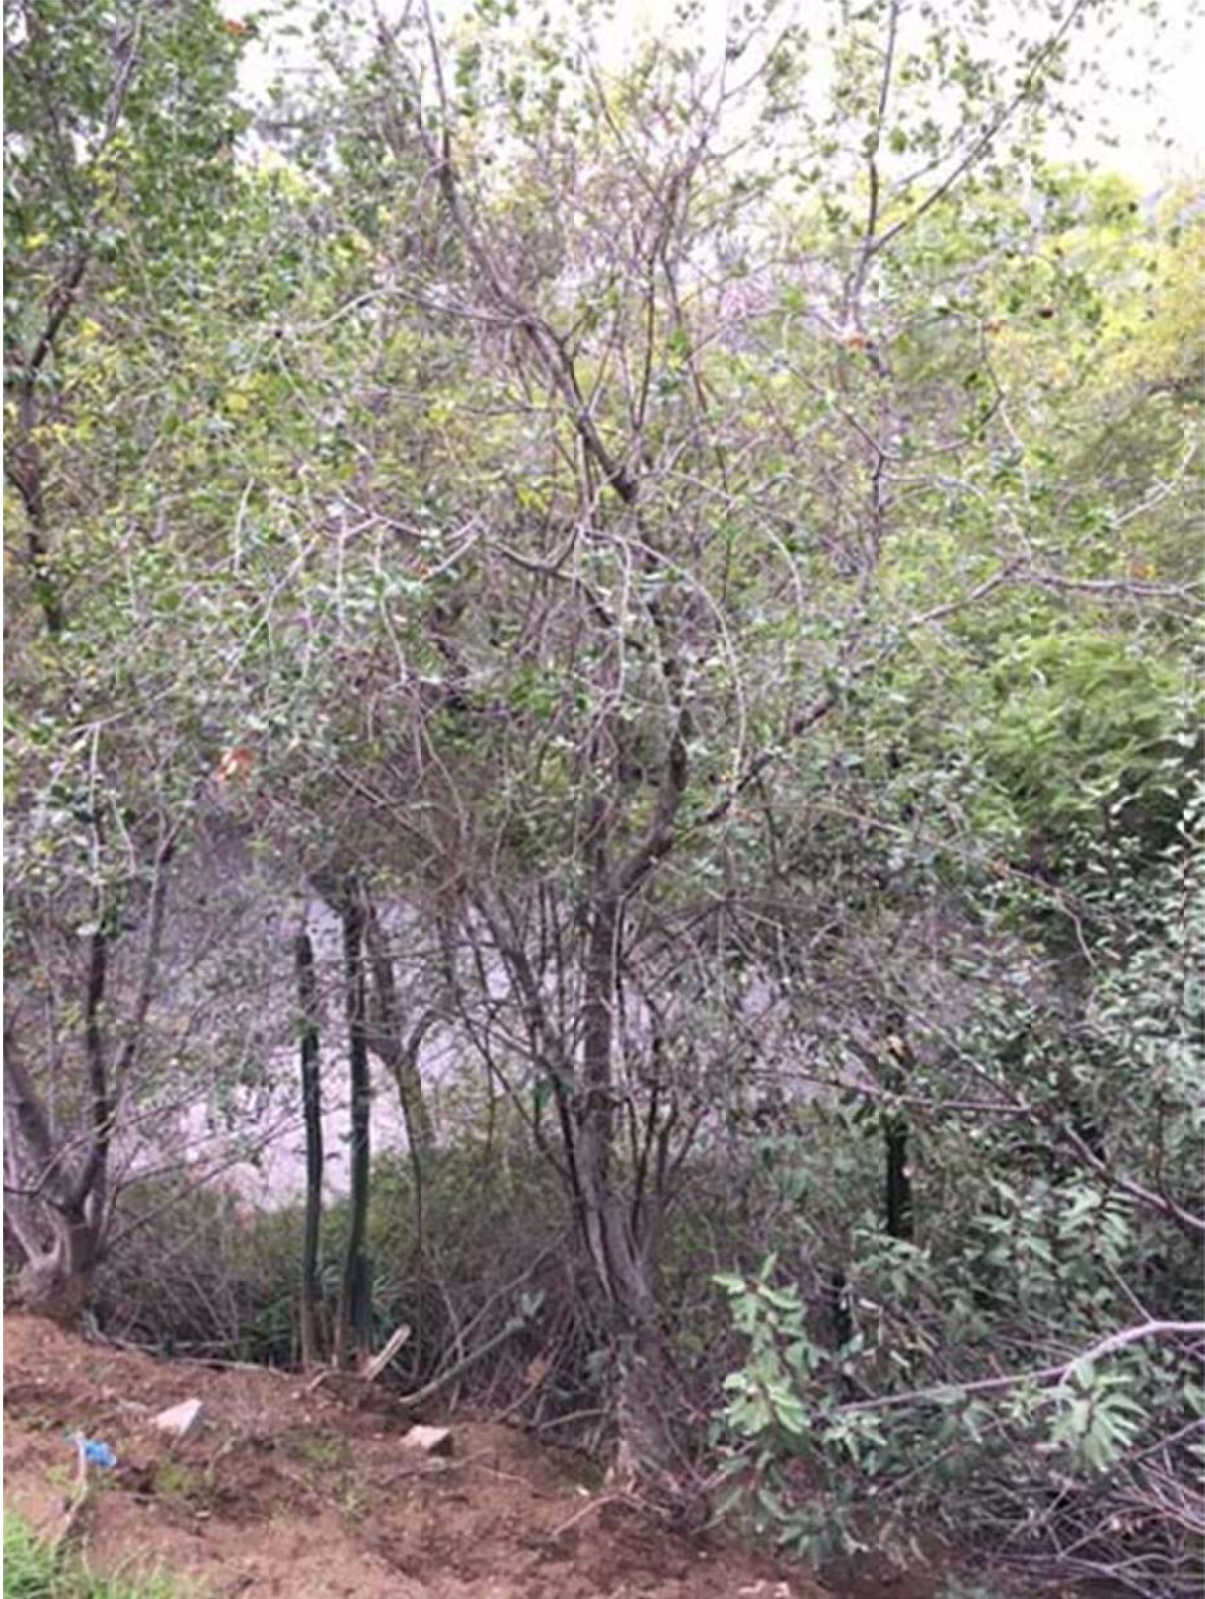
<p>Tree 19 <i>Quercus agrifolia</i> – Coast Live Oak</p> <p>This tree is not protected by the City of Glendale Indigenous Tree Protection Ordinance because it is smaller than the minimum protected size of 6” DBH. This tree is proposed for removal because it is within a proposed area of grading for Lot 2.</p>

Figure 20: Looking southwest at Tree 19. This tree will be removed for construction. It is less than 6" DBH, so it is not protected by ordinance.

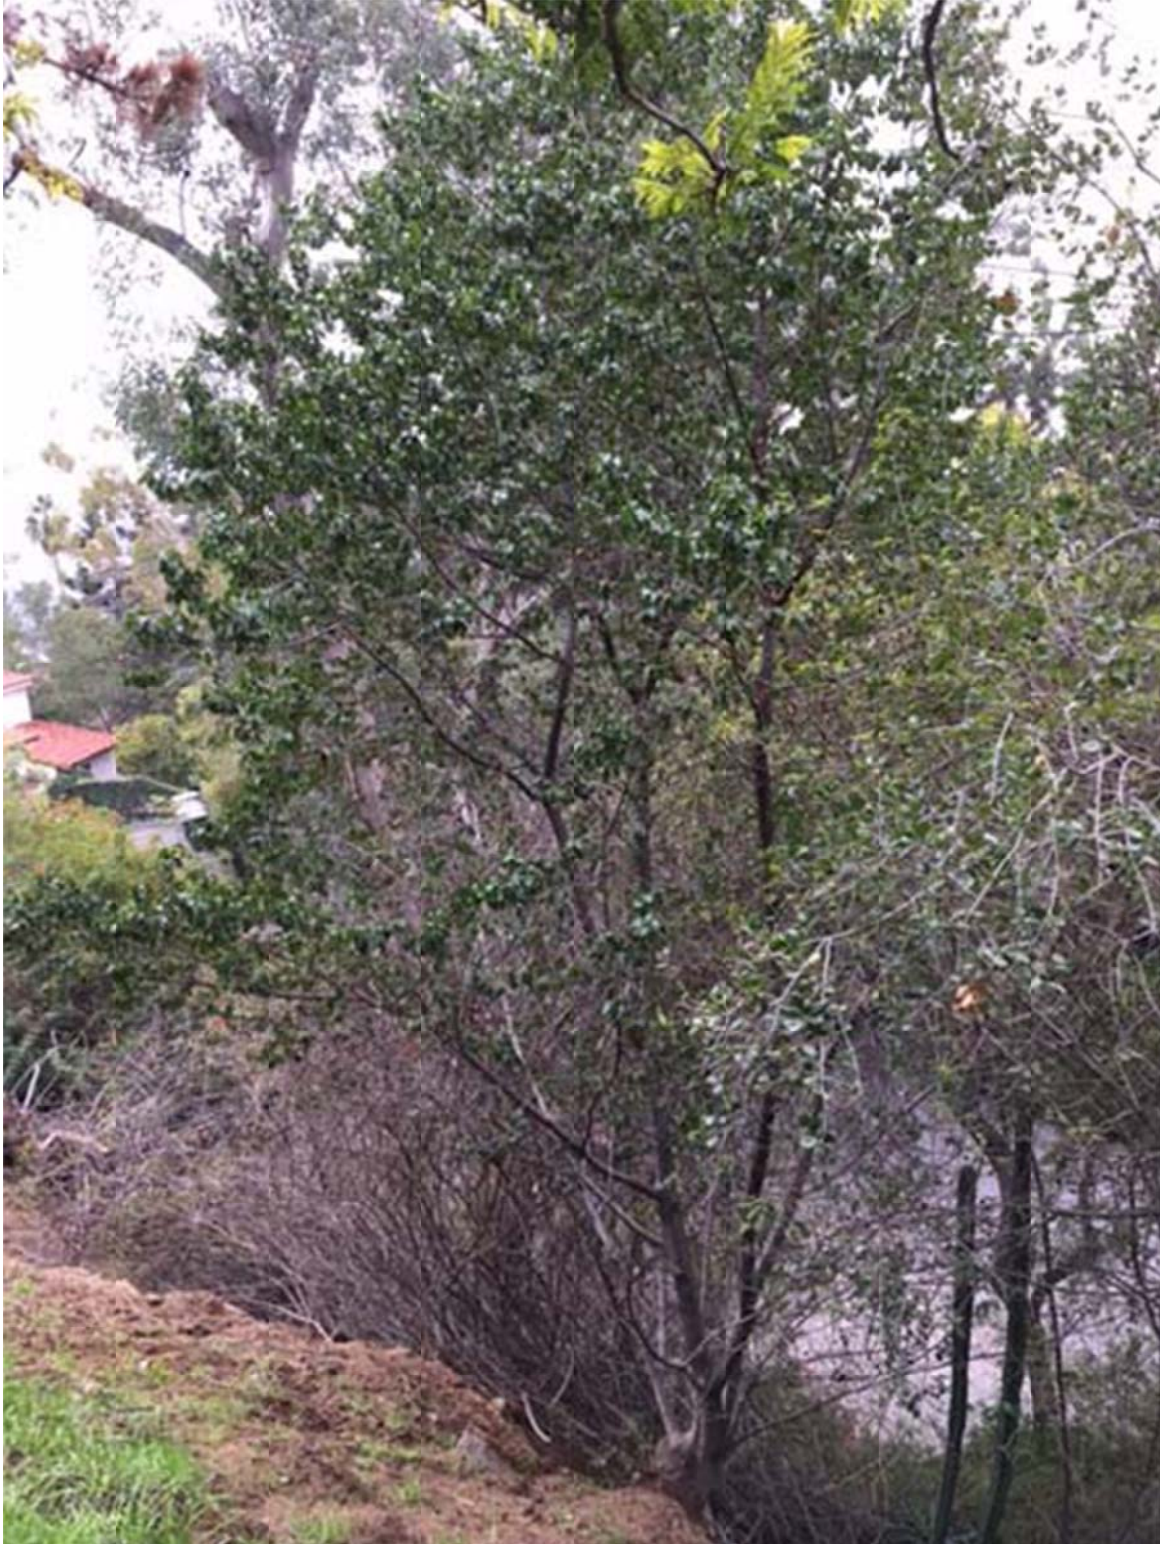
<p>Tree 20 <i>Prunus ilicifolia</i> – Holly Leaf Cherry</p> <p>This species has many visual characteristics of the protected Coast Live Oak, but it is not the protected species. Its leaves do not have fine hairs underneath, it produces small inedible cherries, and it has slightly different-looking bark. This species is often confused with the protected Coast Live Oak.</p> <p>This tree will be removed because it is within a proposed area of grading for Lot 2.</p>

Figure 21: Looking west at Tree 20. This tree will be removed for construction. Although it may look similar to Coast Live Oak, it is actually Holly Leaf Cherry, a species that is not protected by ordinance.

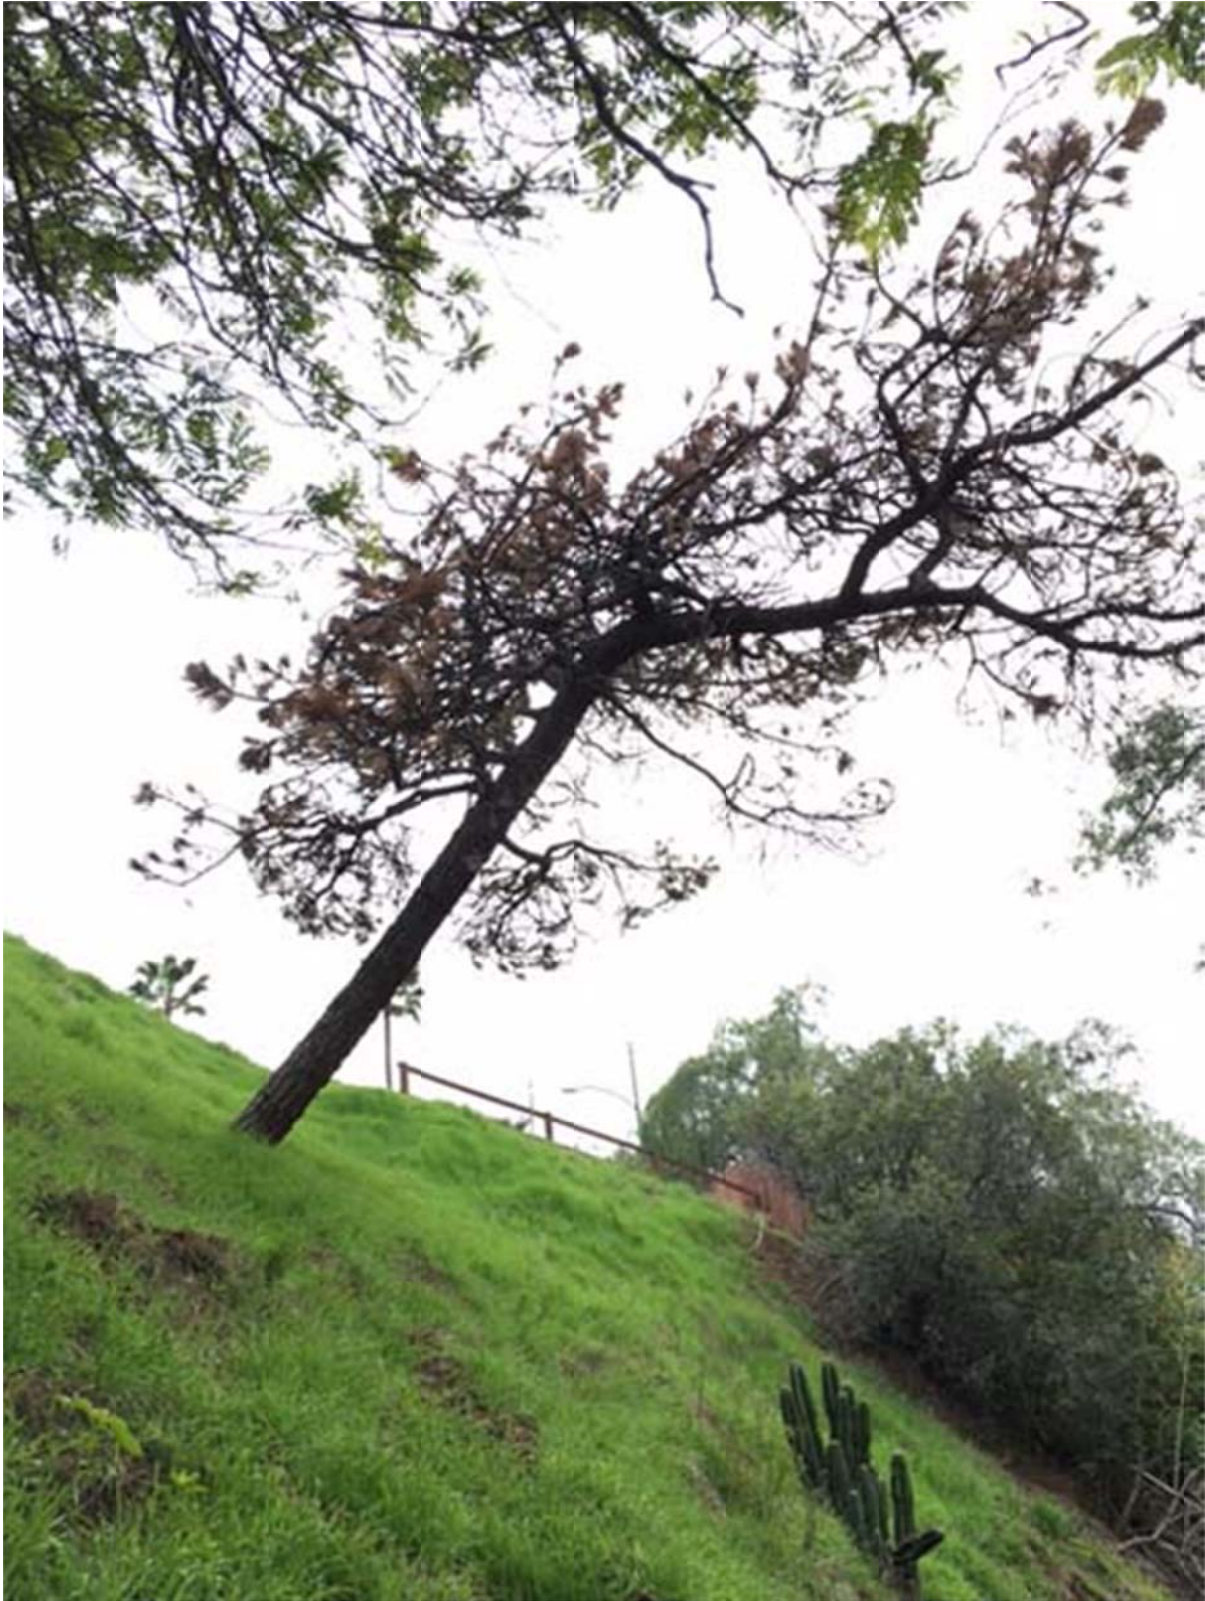
<p>Tree 21 <i>Pinus torreyana</i> – Torrey Pine</p> <p>This tree is dead and should be removed. It is not a protected species.</p>

Figure 22: Looking south at Tree 21. This tree is dead and should be removed.

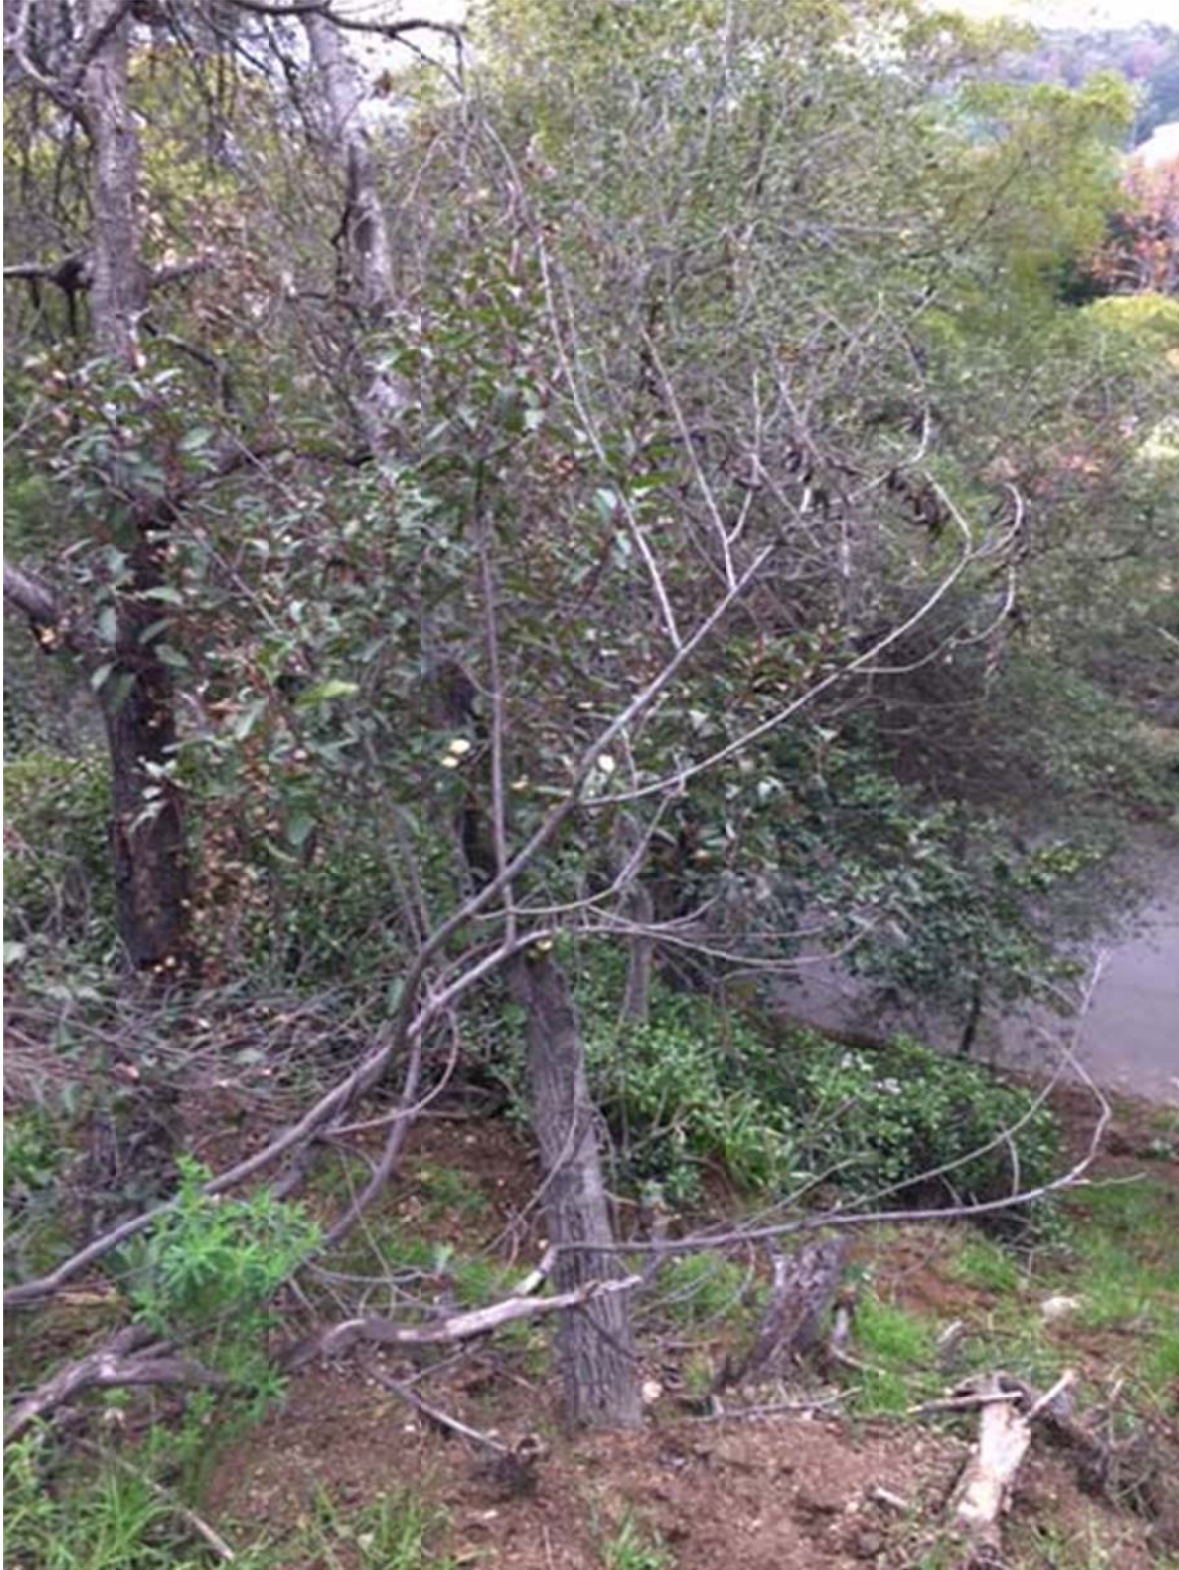
This tree is not protected by the City of Glendale Indigenous Tree Protection Ordinance because it is smaller than the minimum of 6” DBH. It is showing signs of drought stress, but there is no need to take action to mitigate it at this time.

There is evidence of moderately severe sunburn damage on the upper side of the trunk. This sunburn is likely a result of the neighboring Tree 23 dying – Tree 22 subsequently experienced an increase in solar exposure.

Figure 23: Looking west at Tree 22. This tree will be removed because it is growing within the footprint of the proposed grading activity. It is less than 6" DBH, so it is not protected by ordinance.

This tree will be removed because it is growing within a proposed area of grading for Lot 2.
