601 and 603 Bohlig Rd. Arborist Report

Prepared for Camille Neagu
601 Bohlig Road
Glendale, CA 91207

Prepared by James Komen
BCMA WE-9909B
RCA #555

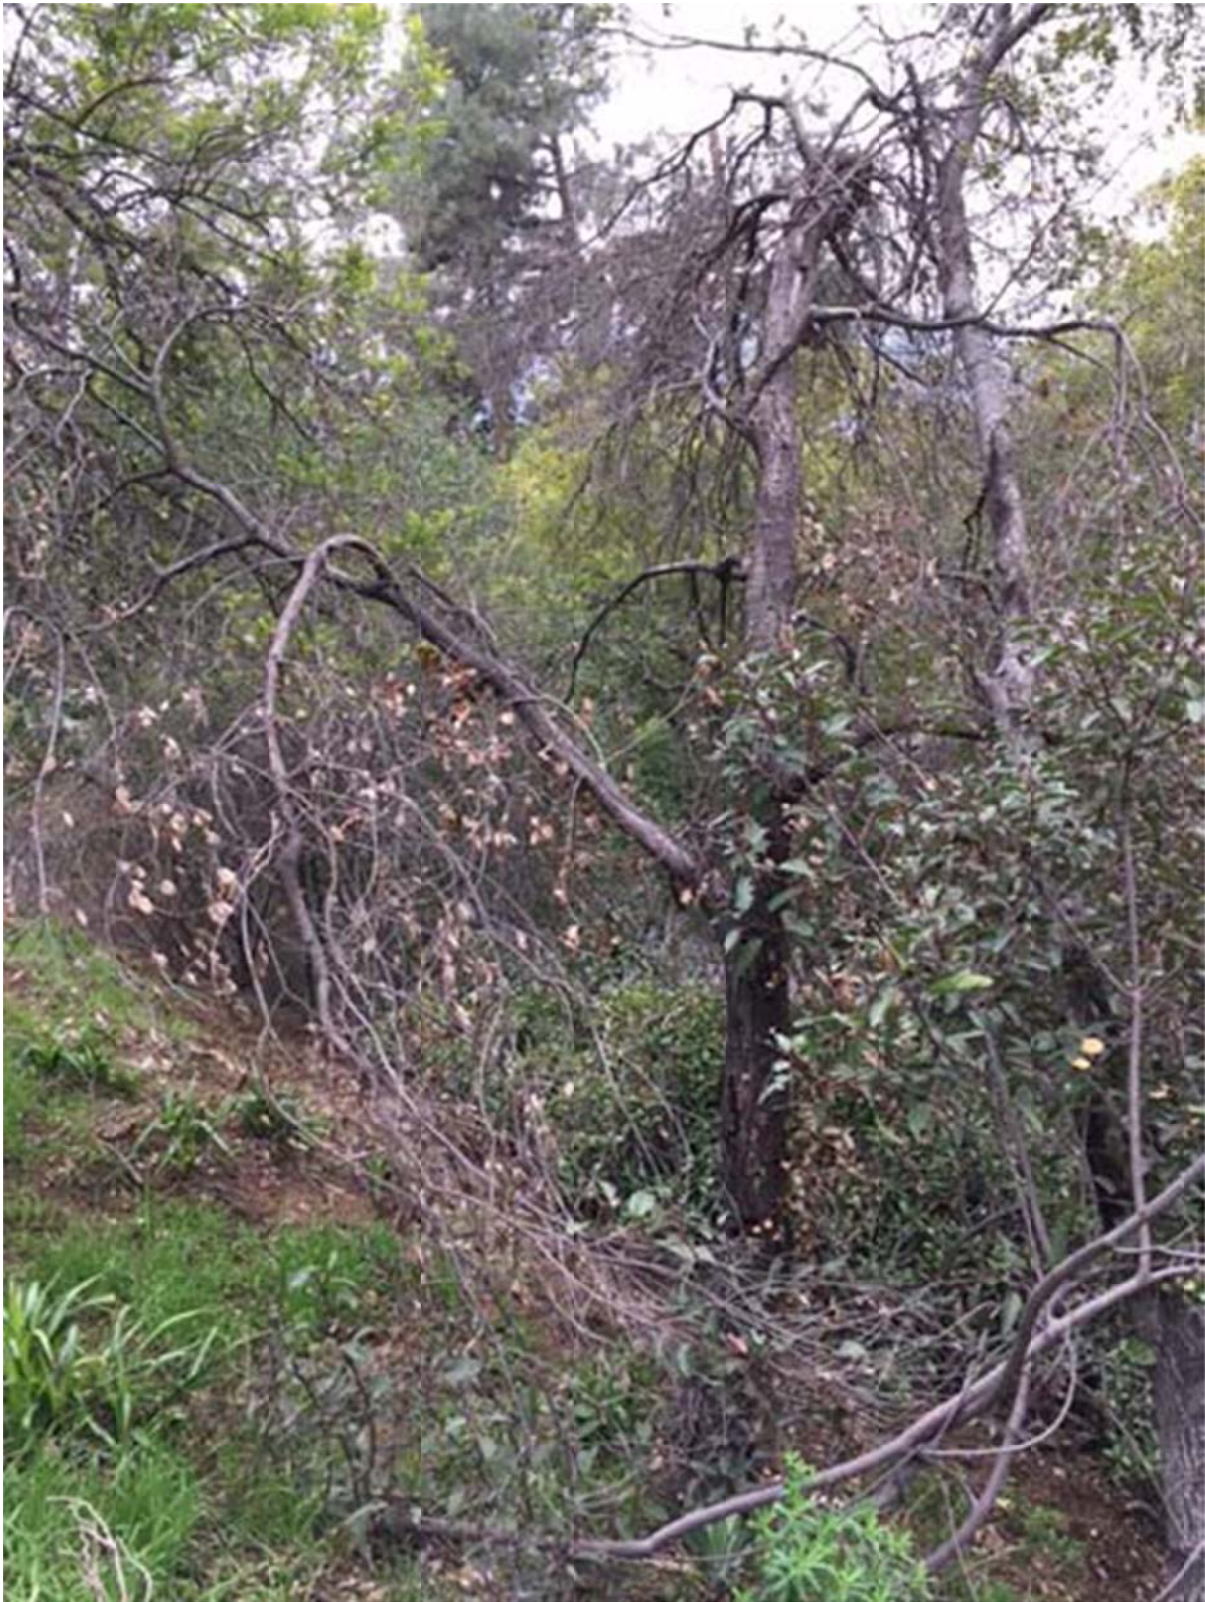
This tree is dead and should be removed. It is protected by the City of Glendale Indigenous Tree Protection Ordinance, so a removal permit must be obtained.

Figure 24: Looking west at Tree 23. This tree is dead and should be removed.

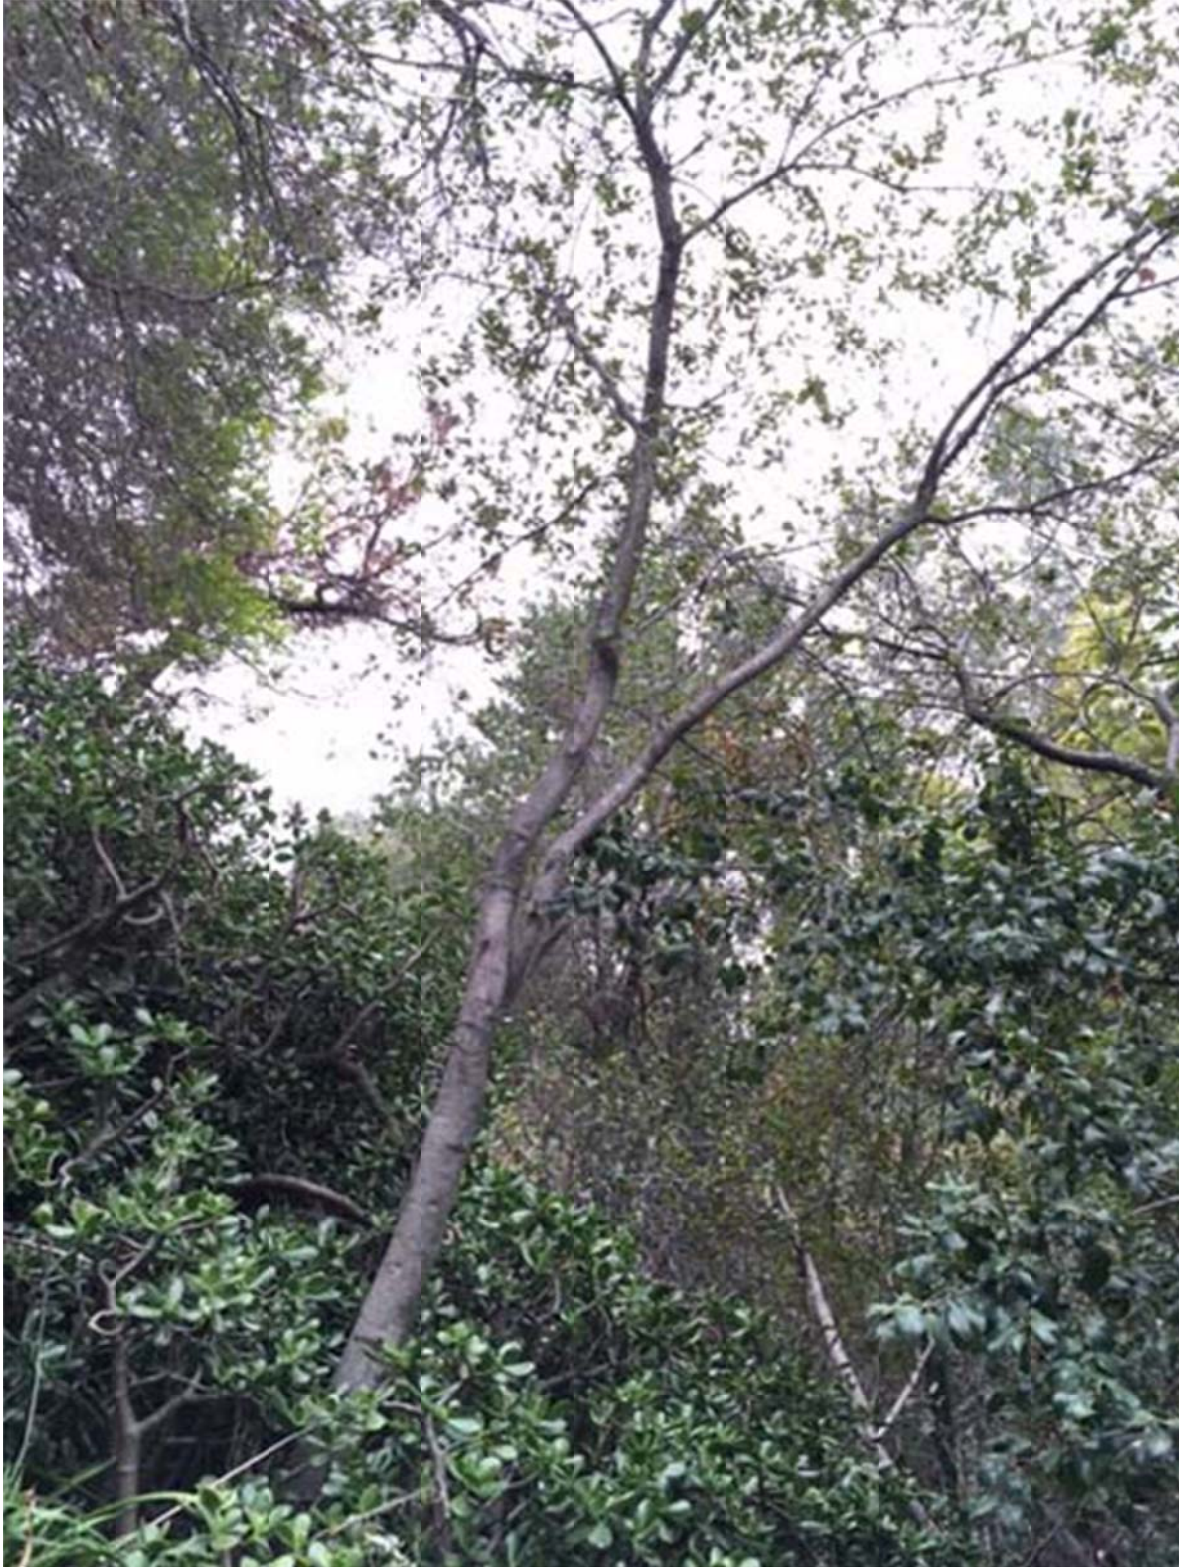
This tree is not protected by the City of Glendale Indigenous Tree Protection Ordinance because it is smaller than the minimum of 6” DBH. It is showing signs of drought stress, but there is no need to take action to mitigate it at this time.

This tree appears to have been suppressed by the neighboring trees to the east. It may increase its growth rate now that Tree 23 is dead and it has more space to grow.

Figure 25: Looking south at Tree 24. This tree will be removed because it is growing within the footprint of the proposed grading activity. It is less than 6" DBH, so it is not protected by ordinance.

This tree will be removed because it is growing within the footprint of the proposed grading activity on Lot 2.

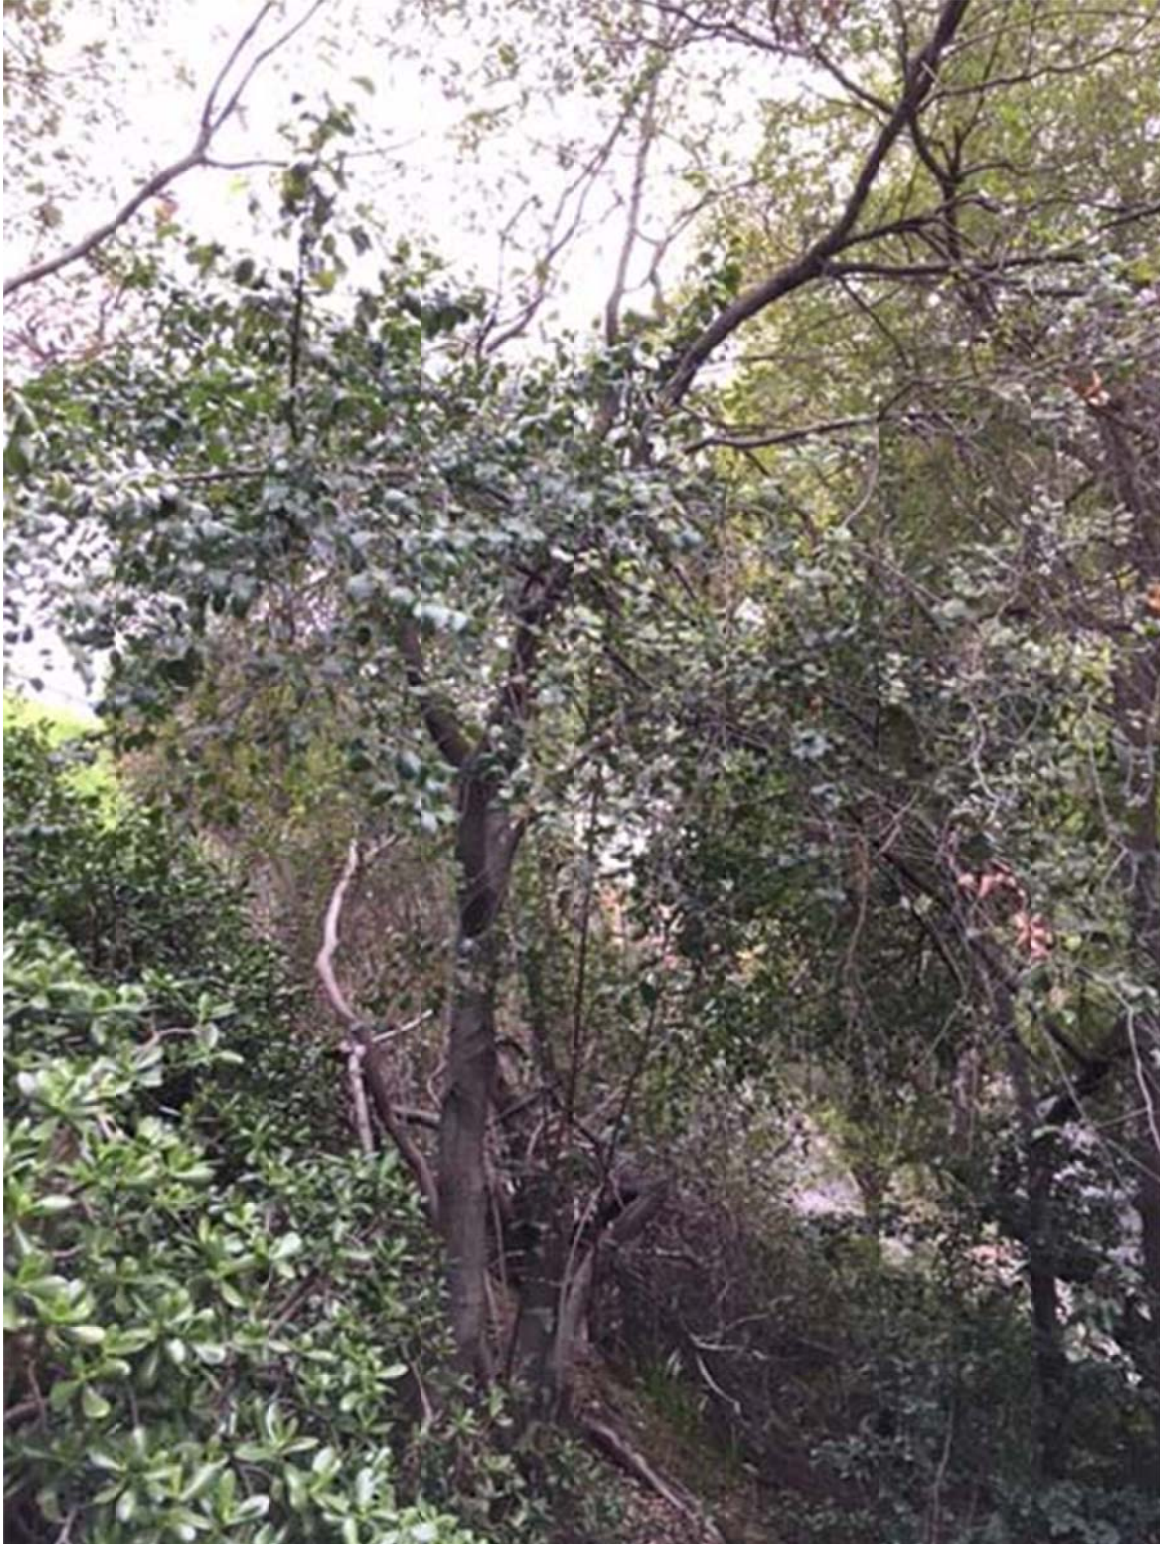
This tree is protected by the City of Glendale Indigenous Tree protection ordinance. It is reasonably healthy, but it appears to have a history of being partially suppressed by the neighboring trees.

Figure 26: Looking south at Tree 25. This tree will be removed because it is growing within the footprint of the proposed grading activity. It is protected by City of Glendale Ordinance, so a tree removal permit will need to be obtained.

This tree will be removed because it is growing within the footprint of the proposed grading activity on Lot 2.

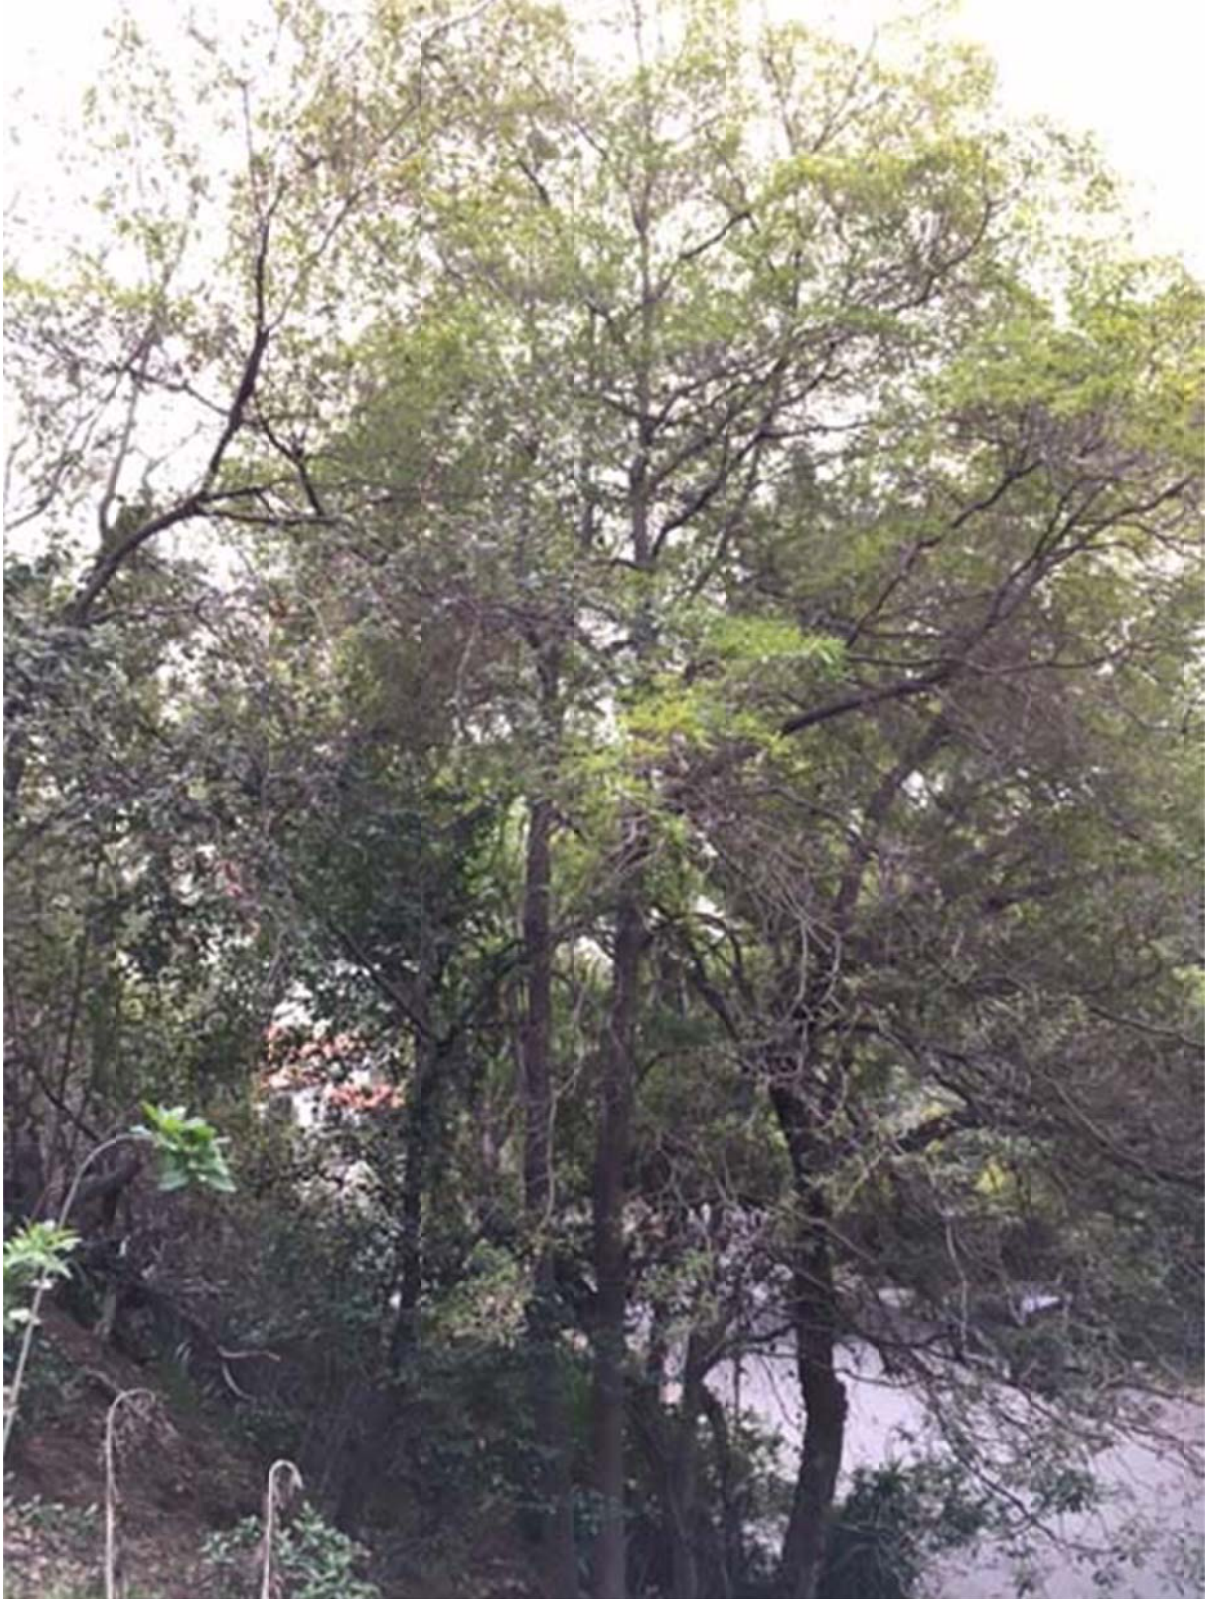
This tree is not protected by the City of Glendale Indigenous Tree Protection Ordinance. This tree will be removed because it is growing within the footprint of the proposed grading activity on Lot 2.

Figure 27: Looking south at Tree 26. This tree will be removed because it is growing within the footprint of the proposed grading activity.

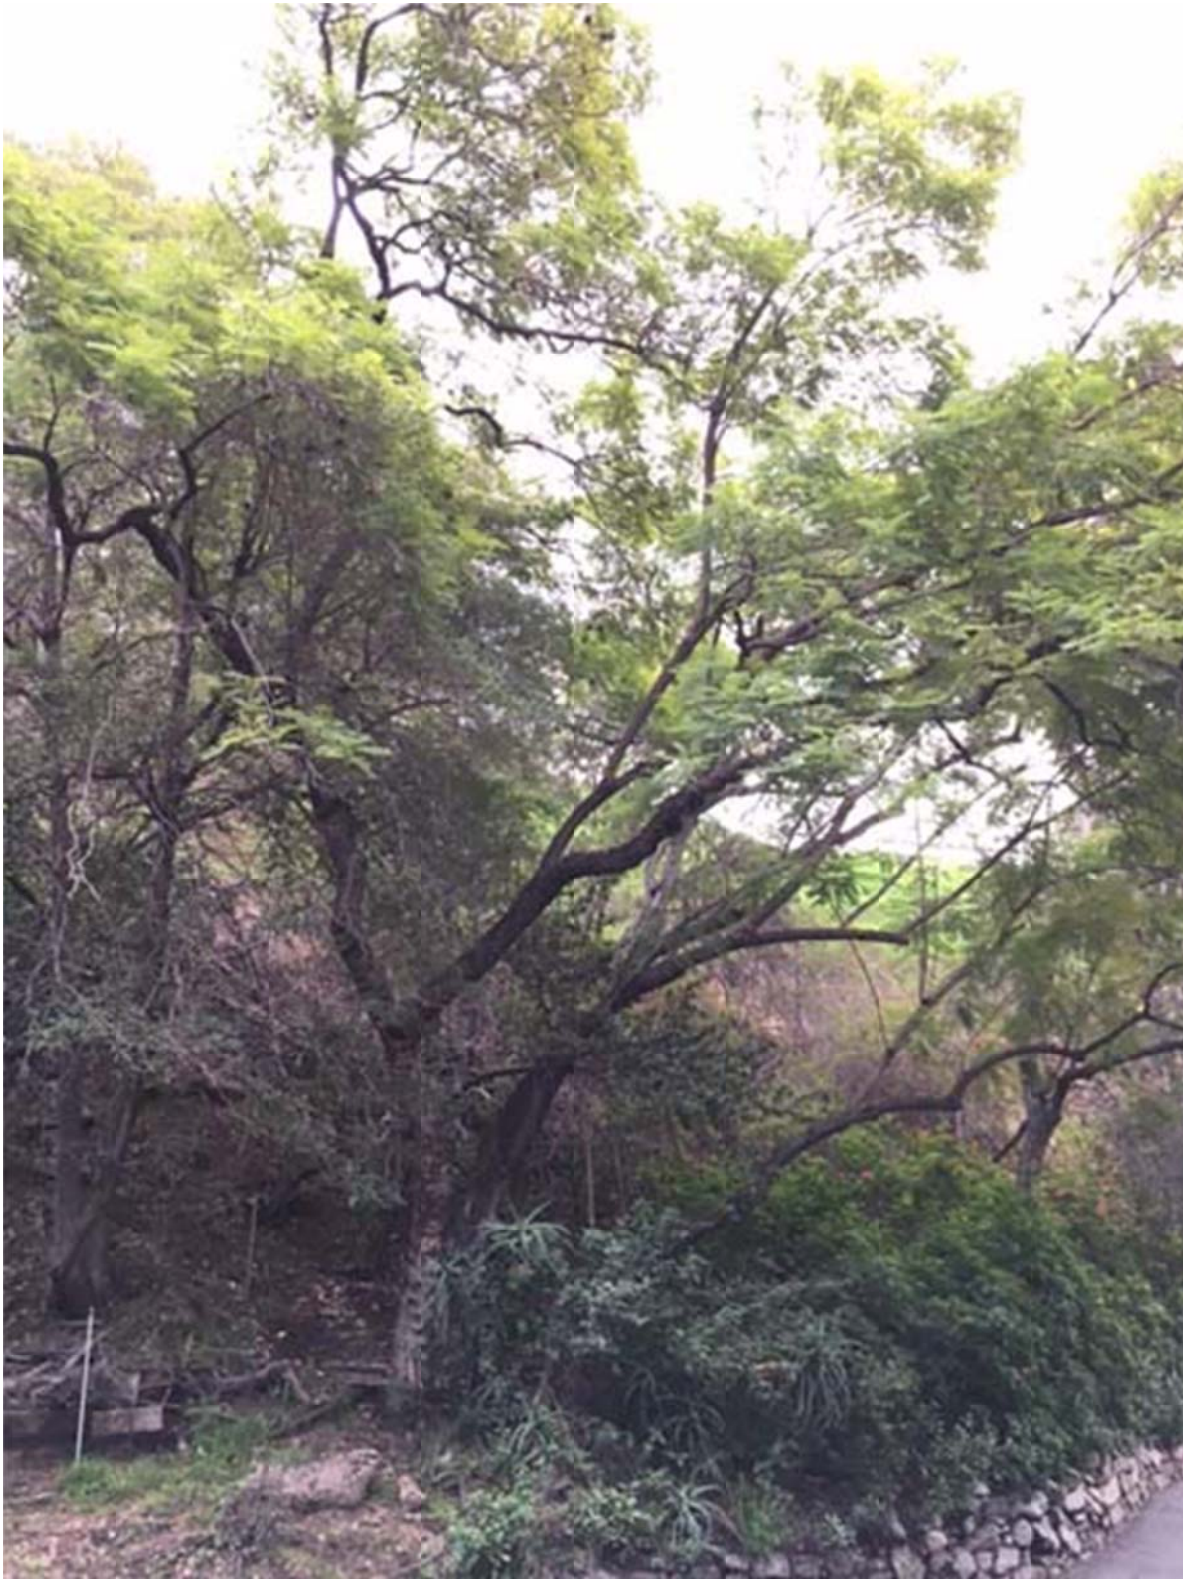
Figure 28: Looking east at Tree 27. This tree will be removed because it is growing within the footprint of the proposed grading activity.

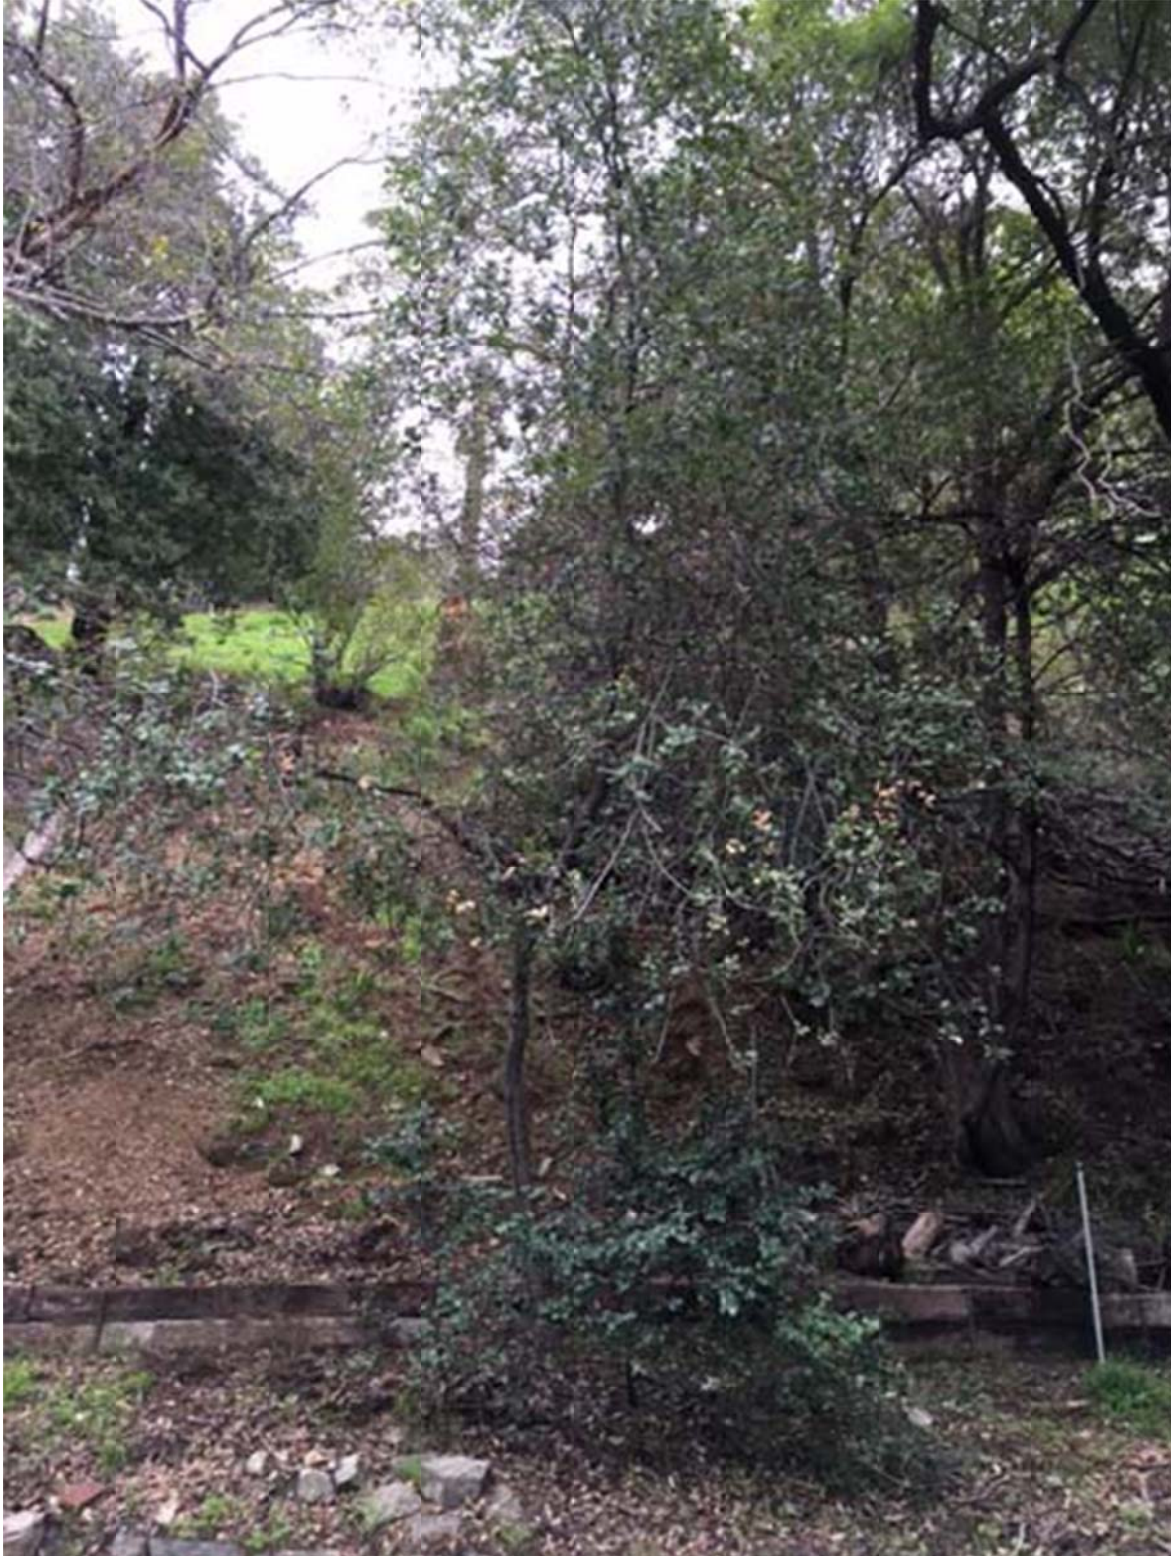
Figure 29: Looking east at Tree 28. This tree will be removed because it is growing within the footprint of the proposed grading activity. It is less than 6" DBH, so it is not protected by ordinance.

This tree will be removed because it is growing within the footprint of the proposed grading activity on Lot 2.

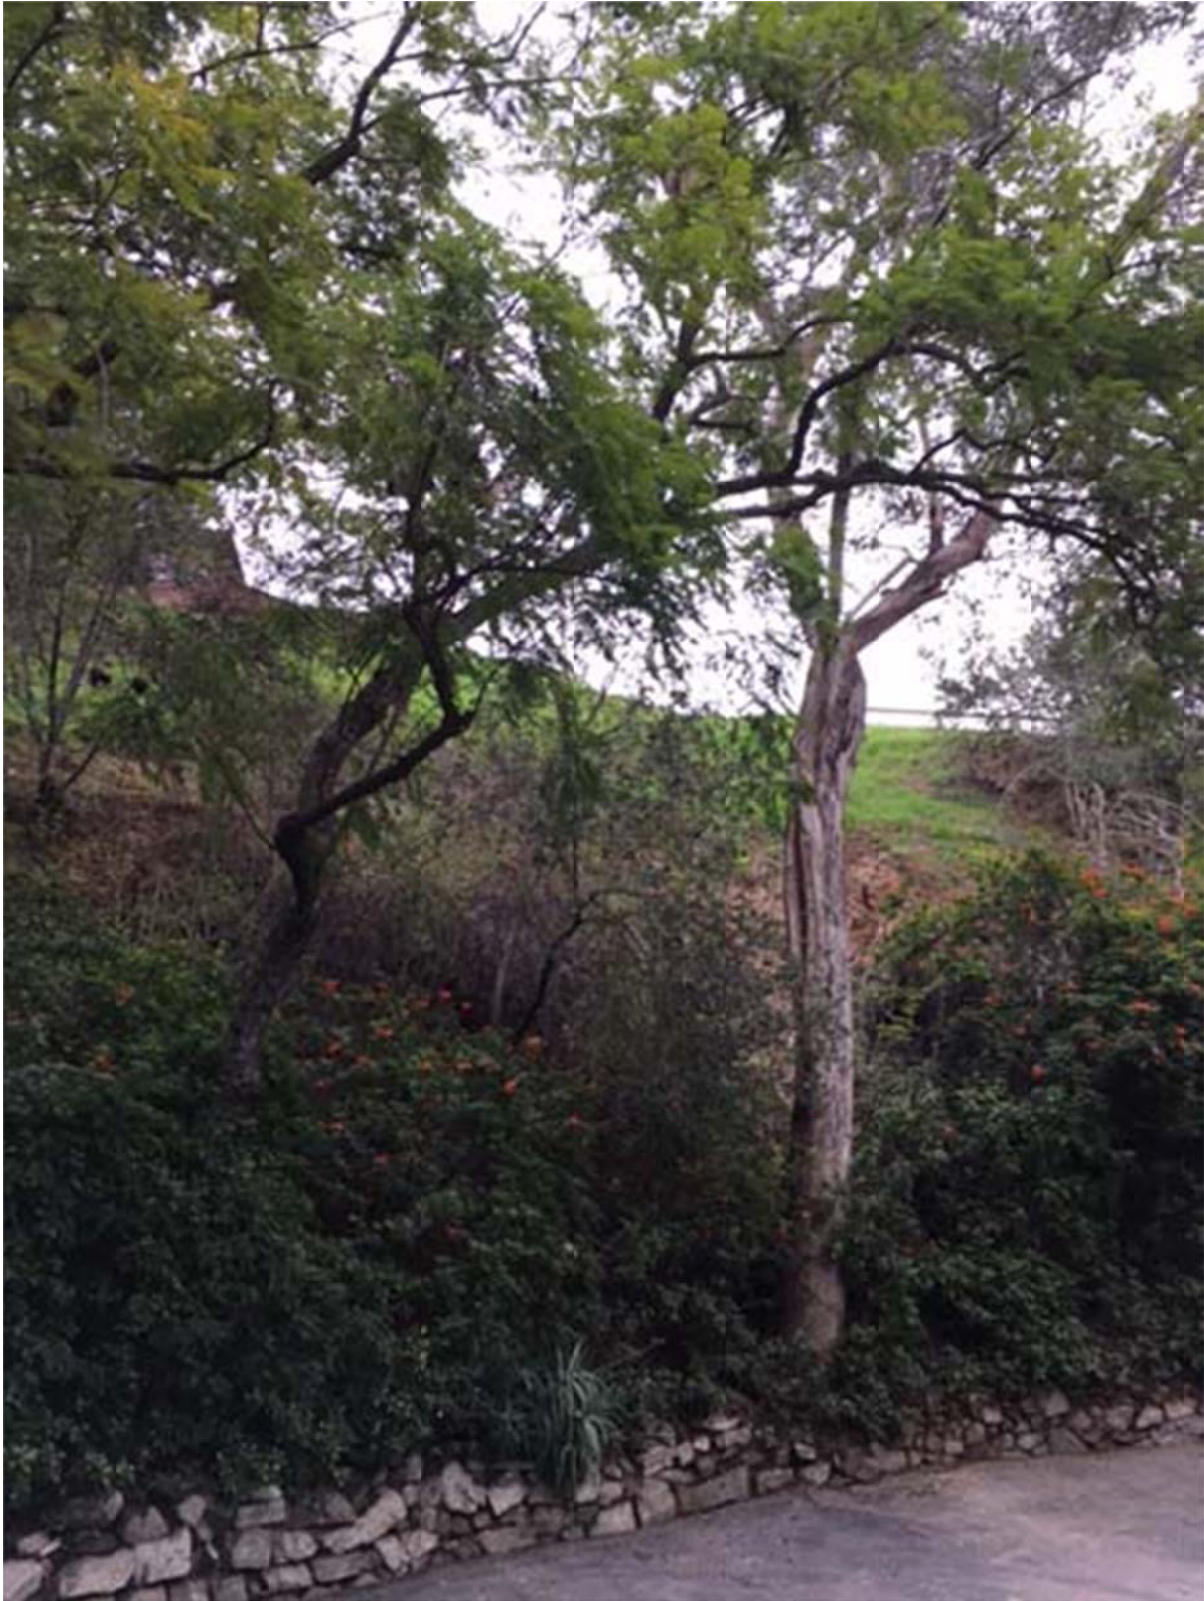
Figure 30: Looking east at Tree OP29. This tree is intended for preservation through construction.

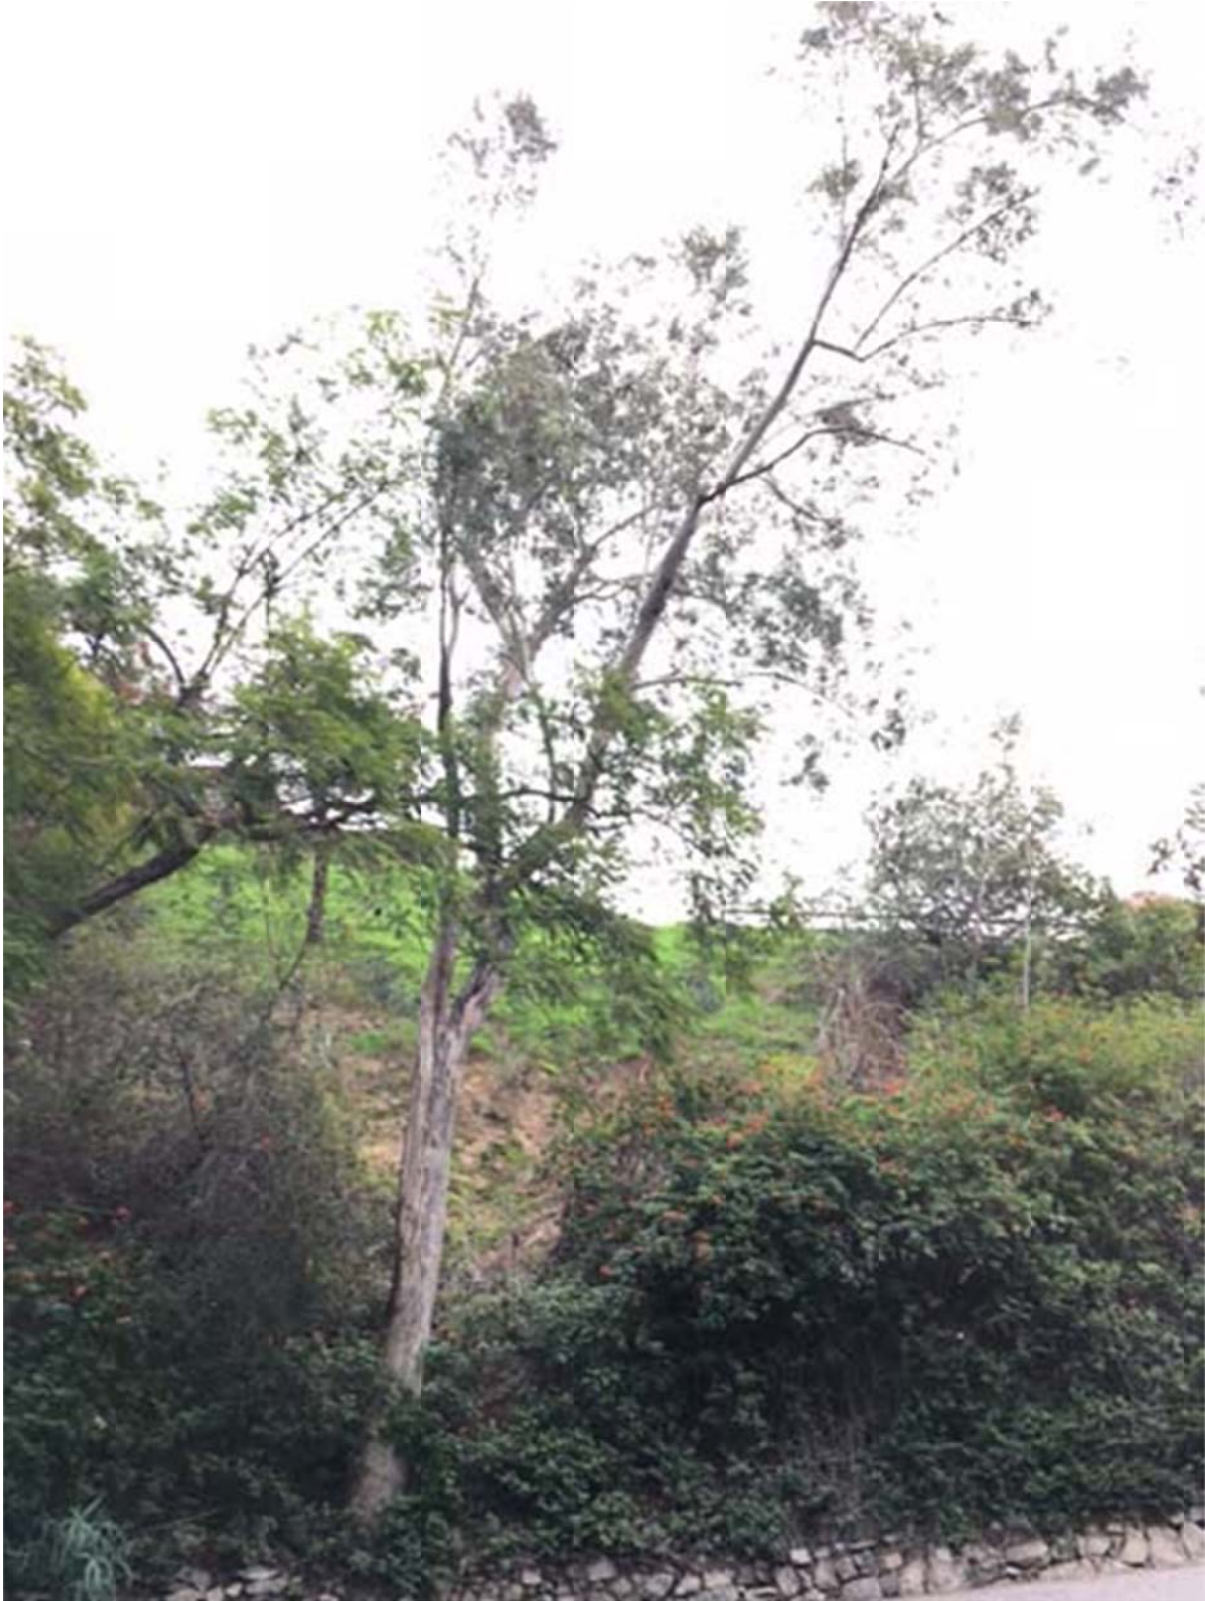
<p>Tree OP30 <i>Eucalyptus globulus</i> – Blue Gum Eucalyptus</p> <p>This tree is growing on the property of the neighbor to the southwest. It is not protected by the City of Glendale Indigenous Tree Protection Ordinance.</p> <p>It will not likely be impacted by construction activity if the proposed tree protection fencing is not crossed.</p>

Figure 31: Looking east at Tree OP30. This tree is intended for preservation through construction.

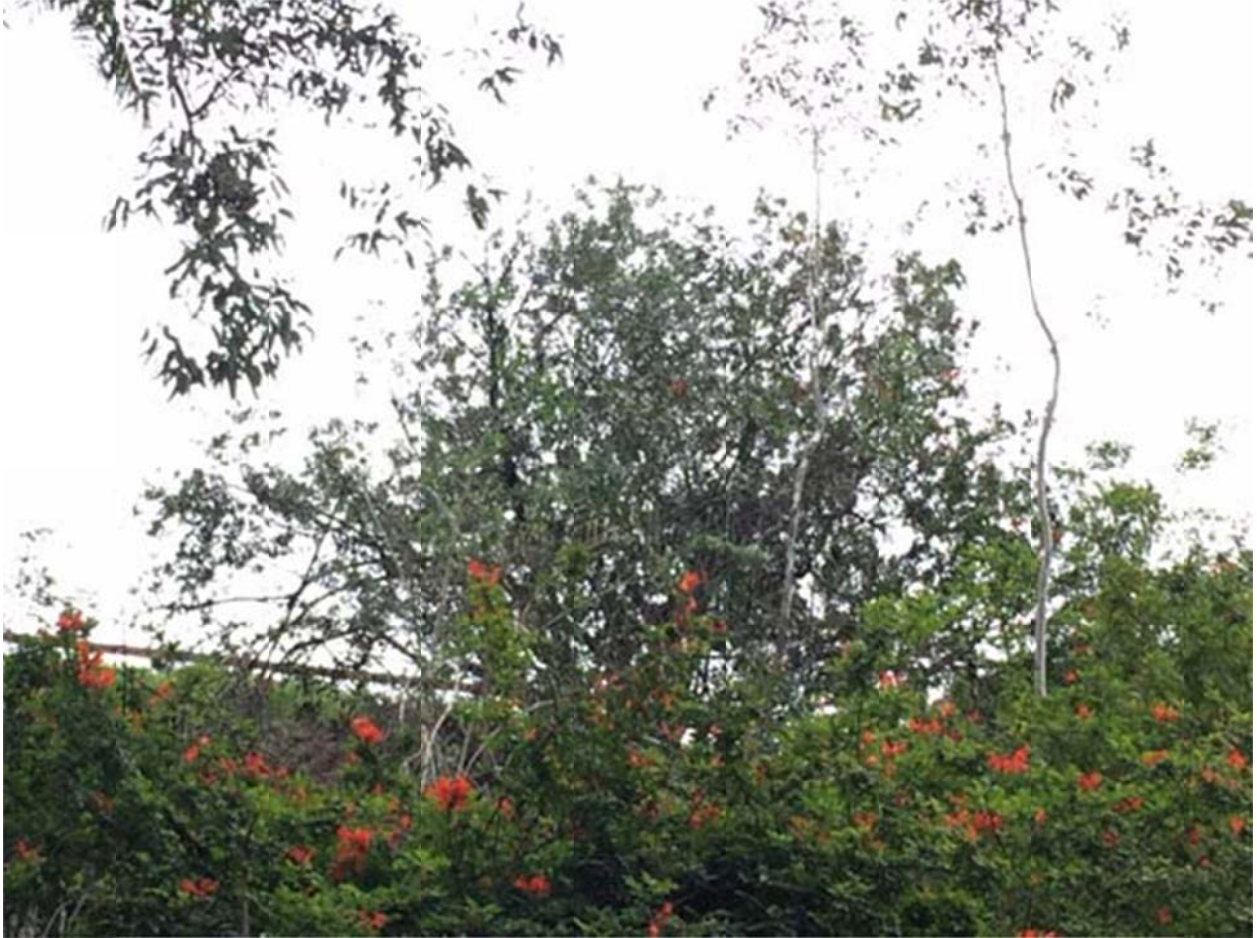
<p>Tree 31 <i>Rhus sp.</i> – Sumac</p> <p>This tree is not protected by the City of Glendale Indigenous Tree Protection Ordinance. It will not likely be impacted by the proposed construction.</p>

Figure 32: Looking southeast at Tree 31. This tree will not likely be impacted by construction.

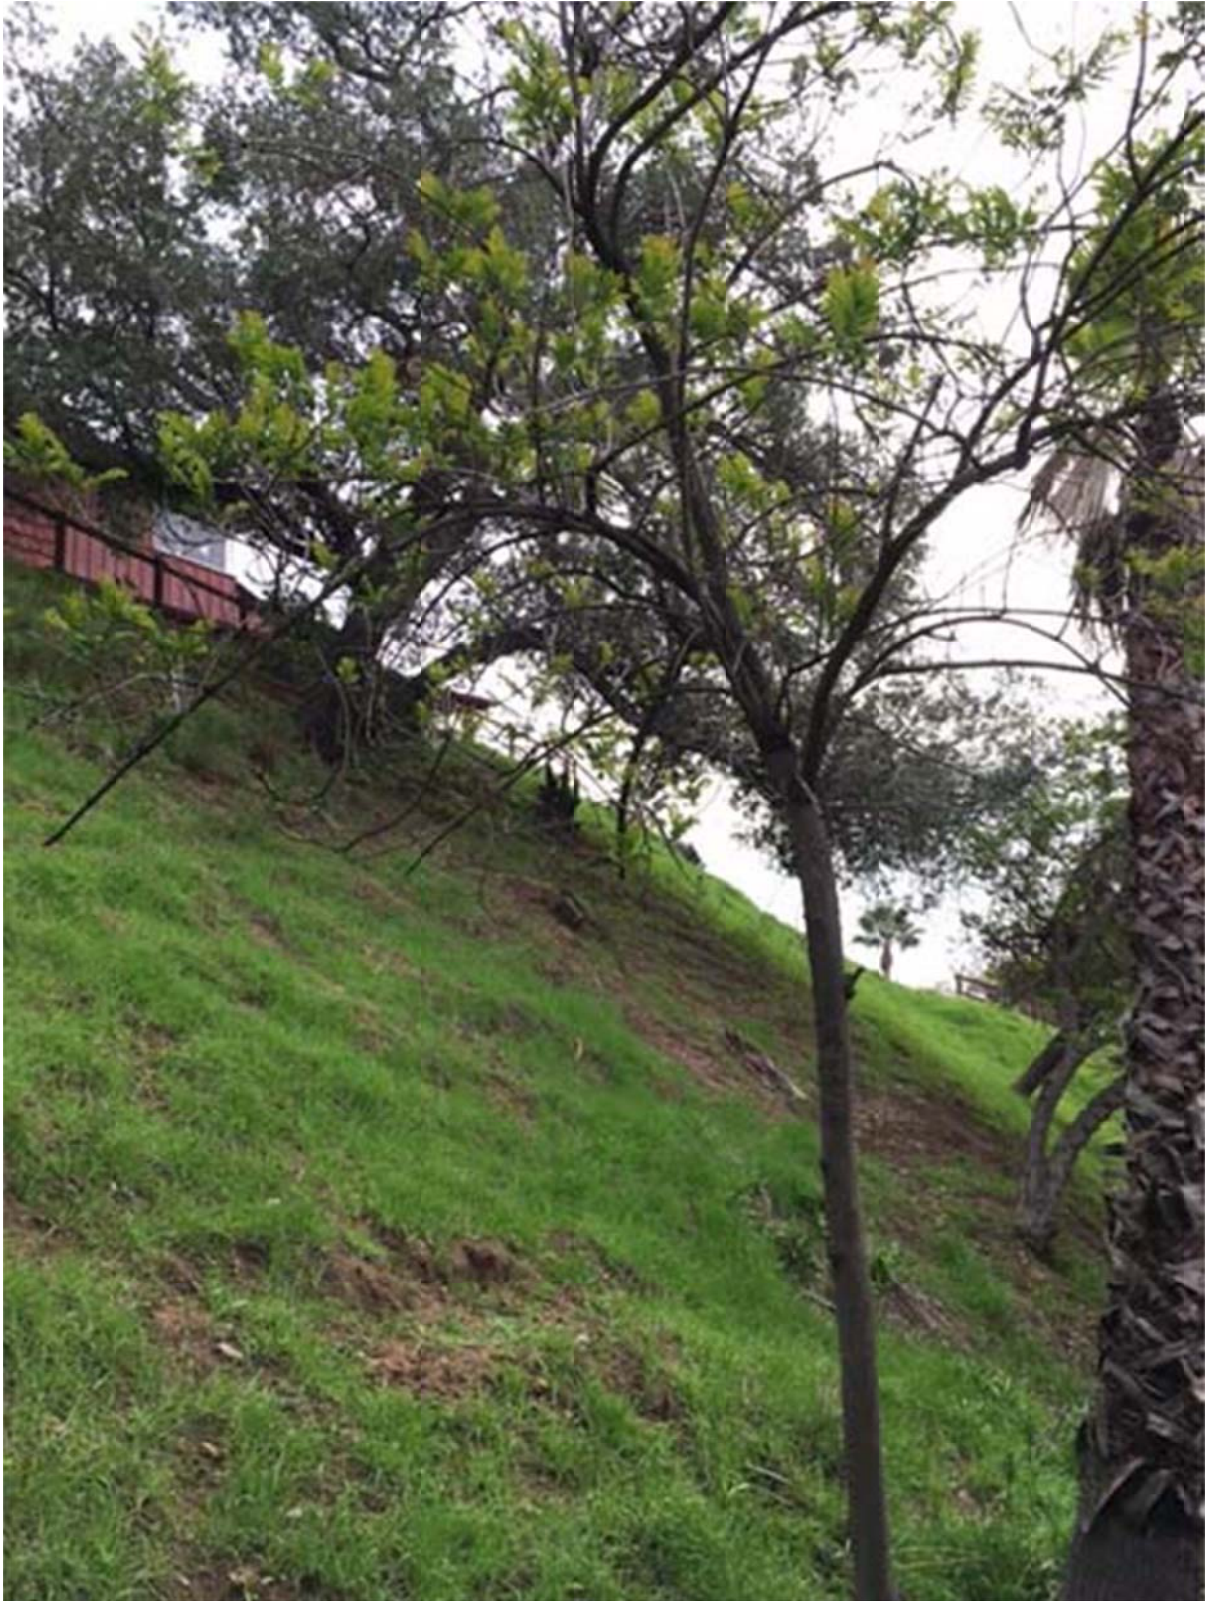
<p>Tree 32 <i>Jacaranda mimosifolia</i> – Mimosa Tree</p> <p>This tree is not protected by the City of Glendale Indigenous Tree Protection Ordinance. It will be removed because it is growing within the area proposed for re-grading.</p>

Figure 33: Looking south at Tree 32. This tree is not protected by ordinance. It will be removed because it is growing within the footprint of the proposed grading activity.

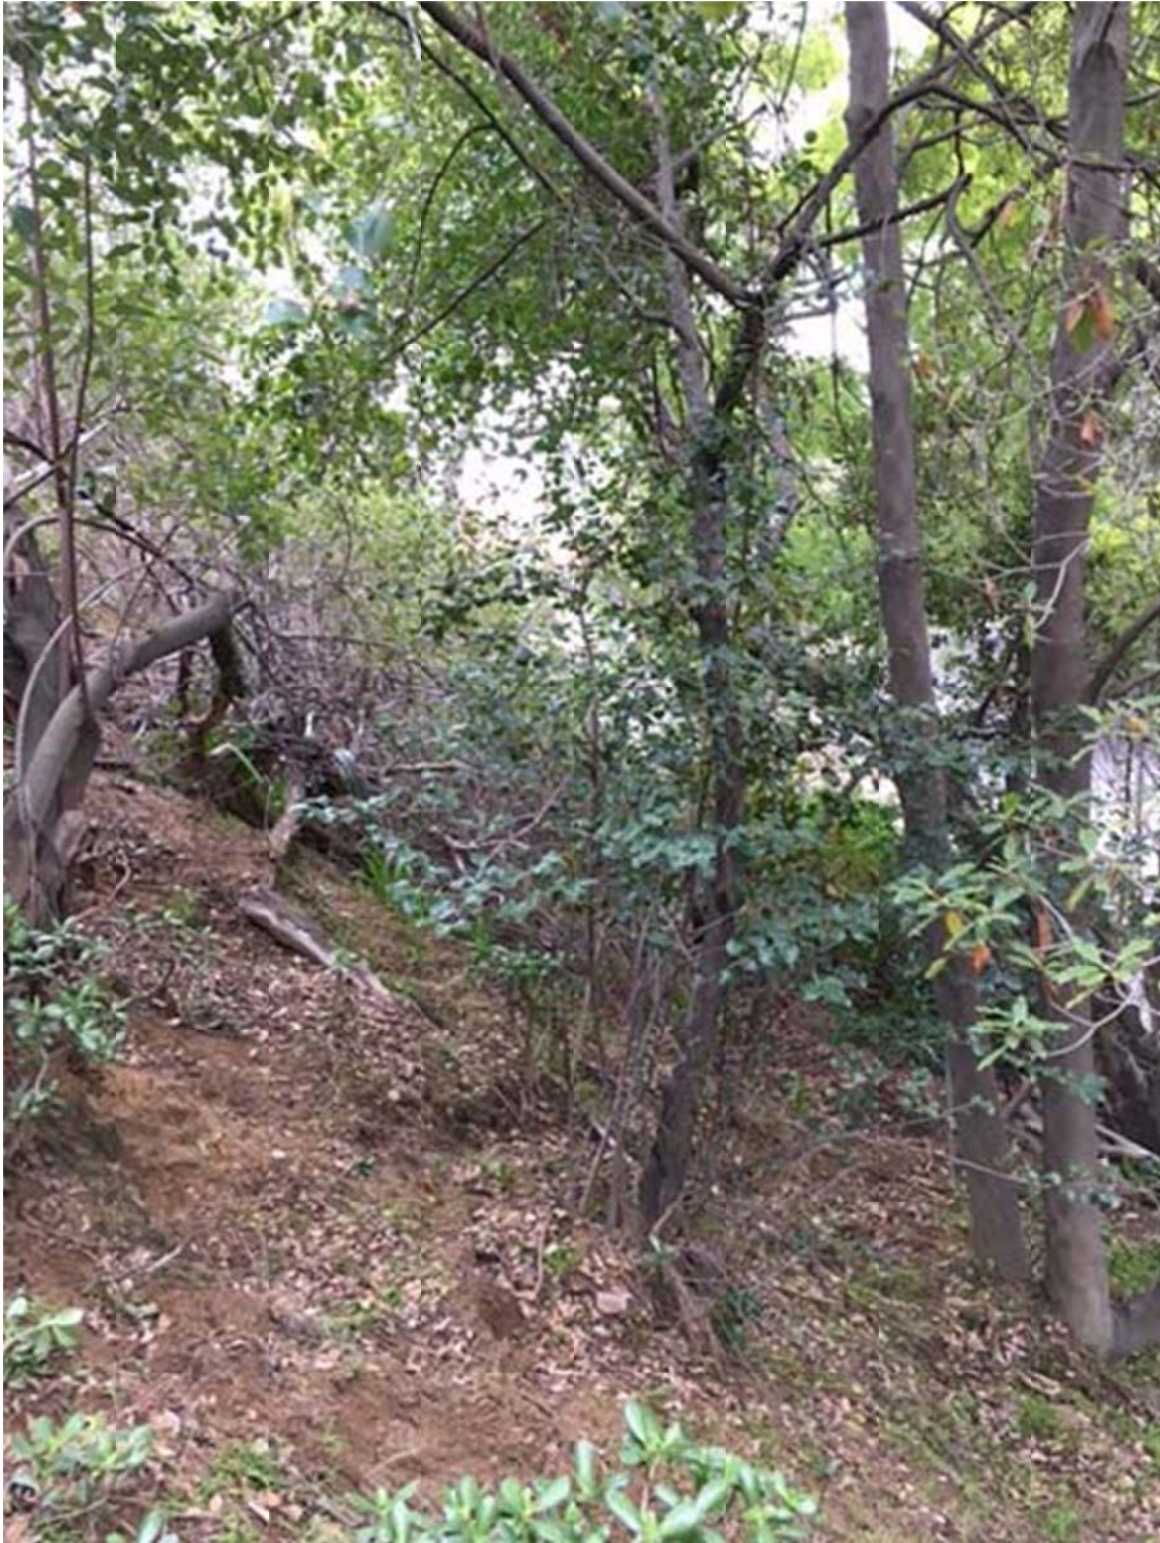
Figure 34: Looking south at Tree 33. This tree will be removed because it is growing within the footprint of the proposed grading activity. Although it may look similar to Coast Live Oak, it is actually Holly Leaf Cherry, a species that is not protected by ordinance.
