## Arborist Report

3100 Block Charing Cross Road  
Glendale, California

August 25, 2020

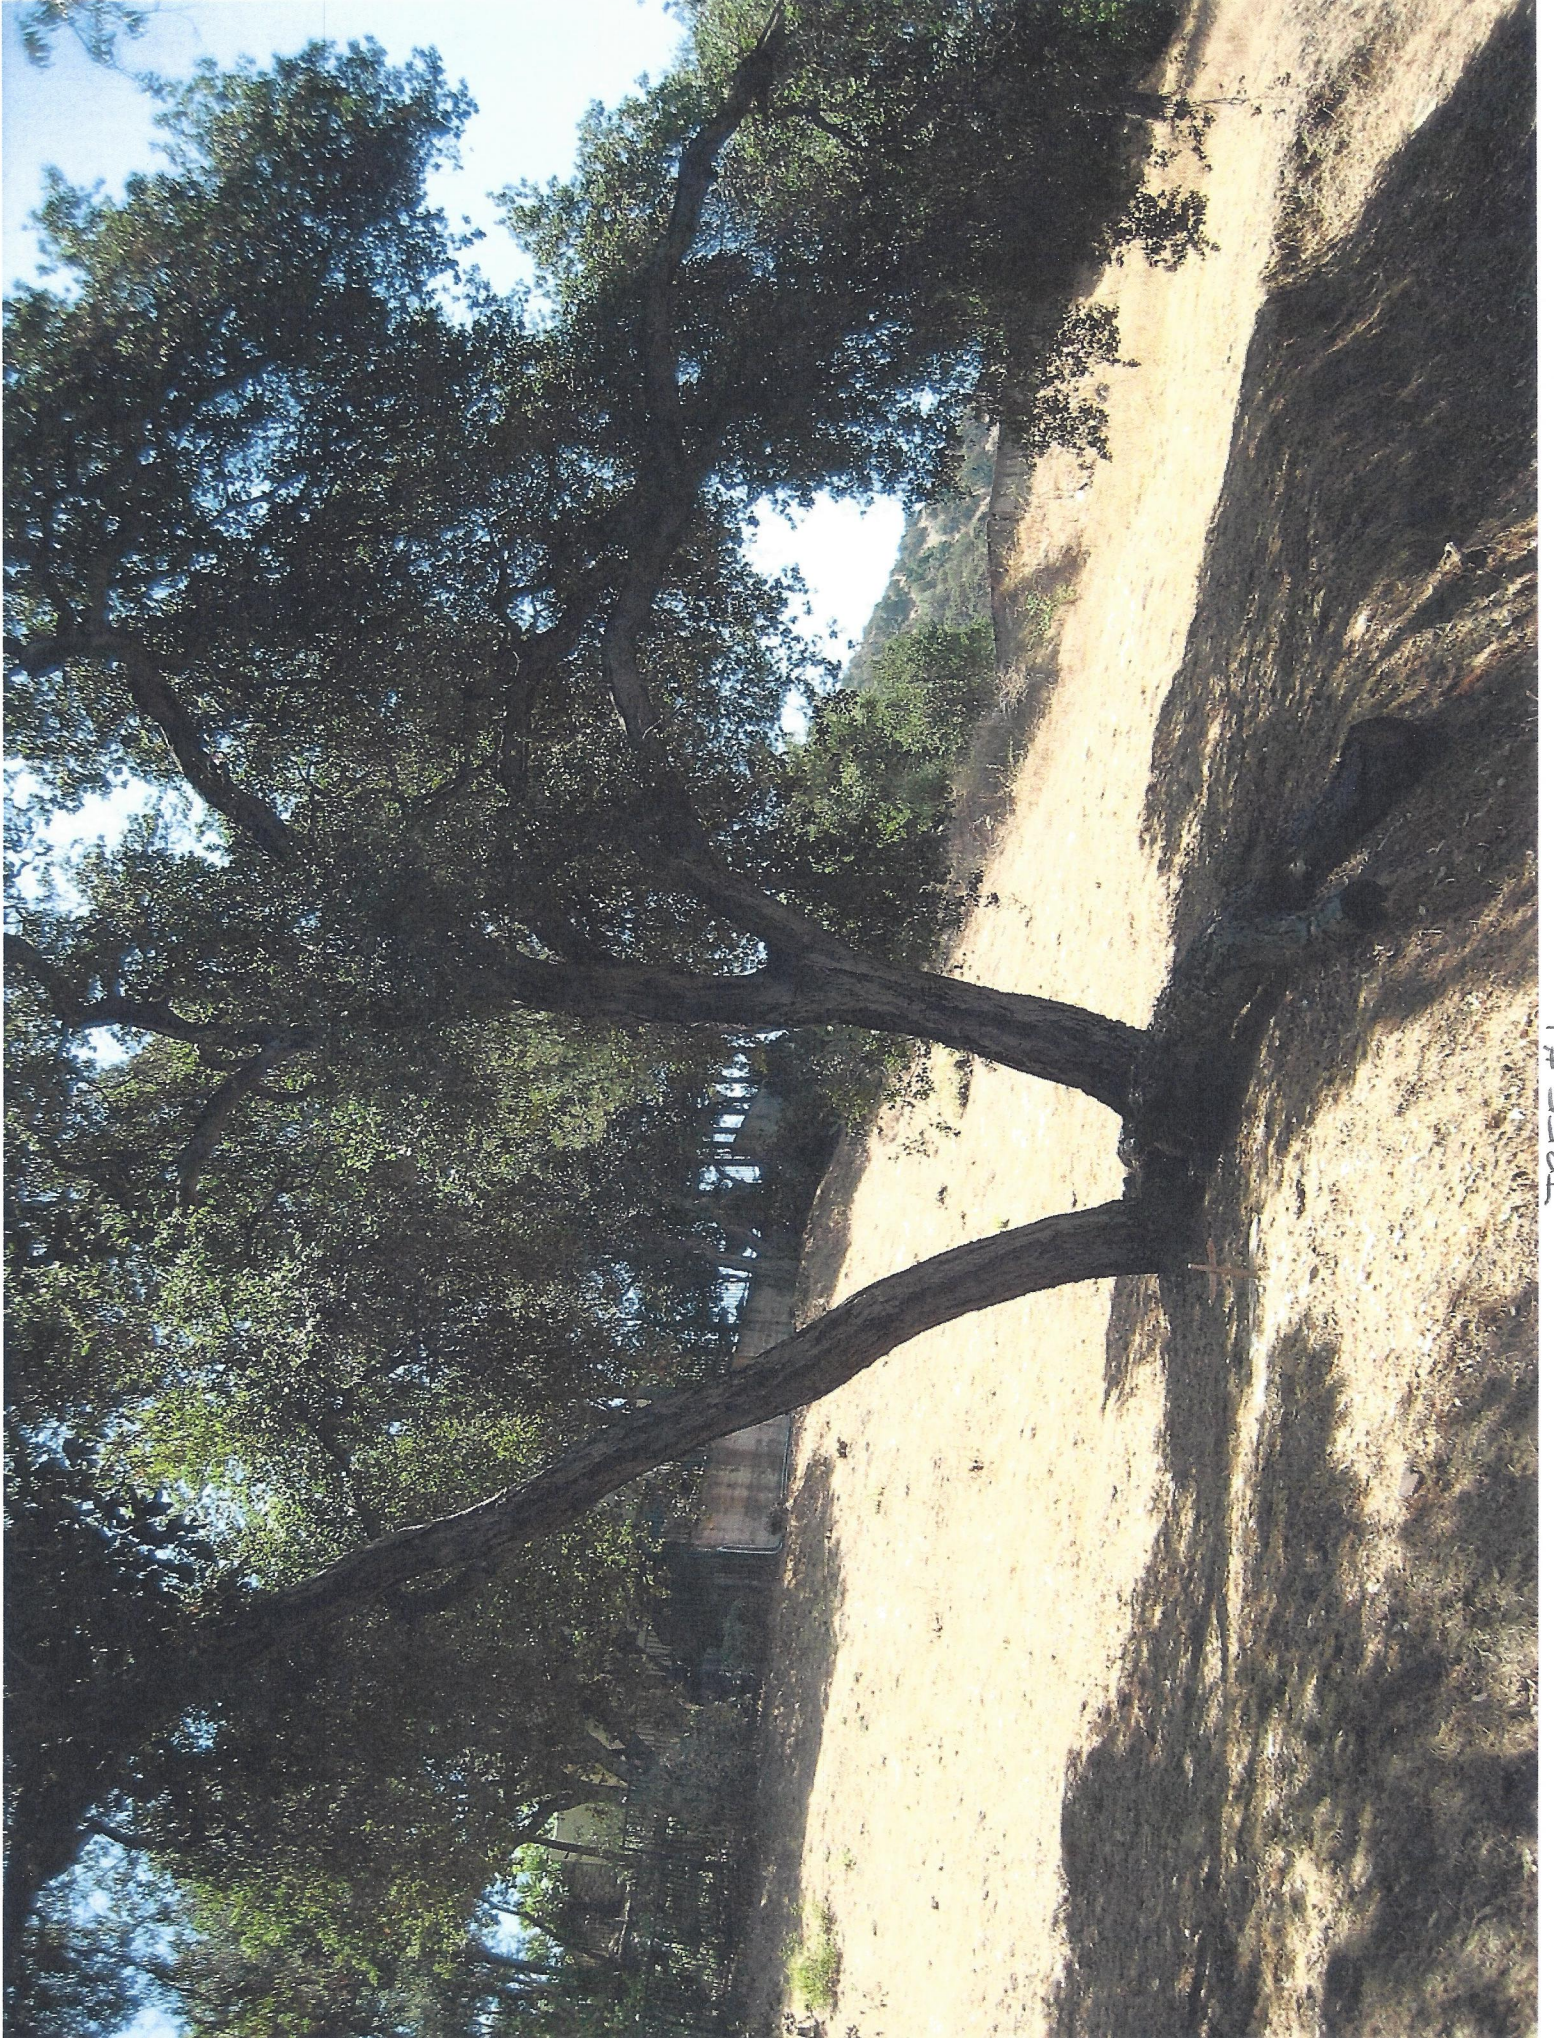
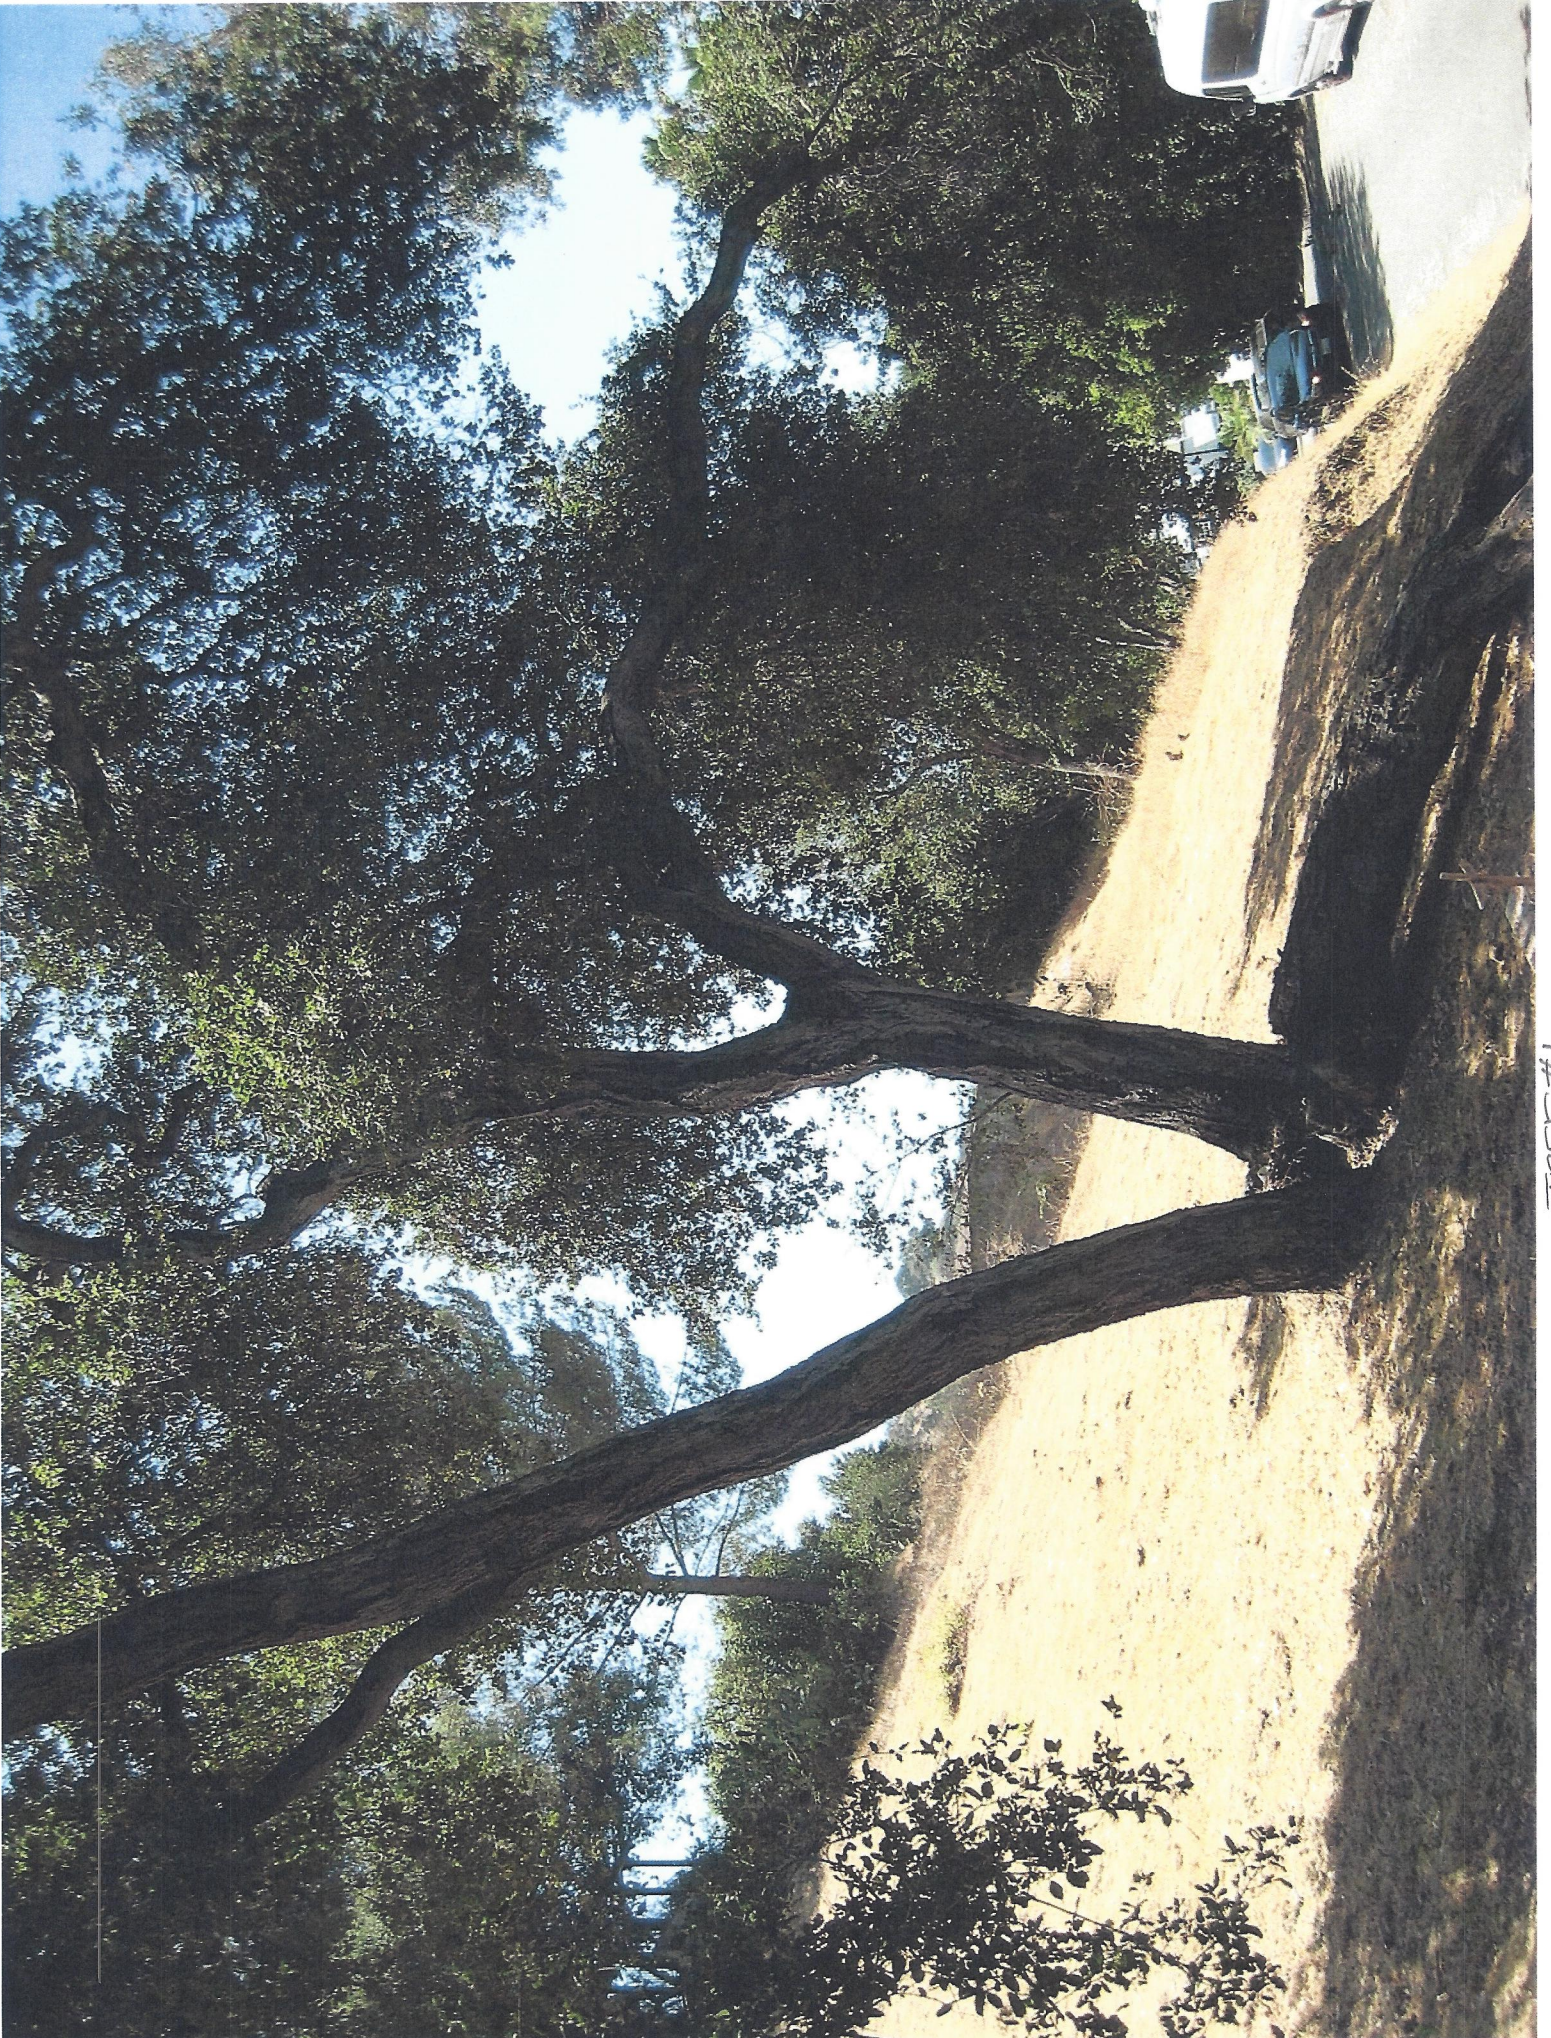
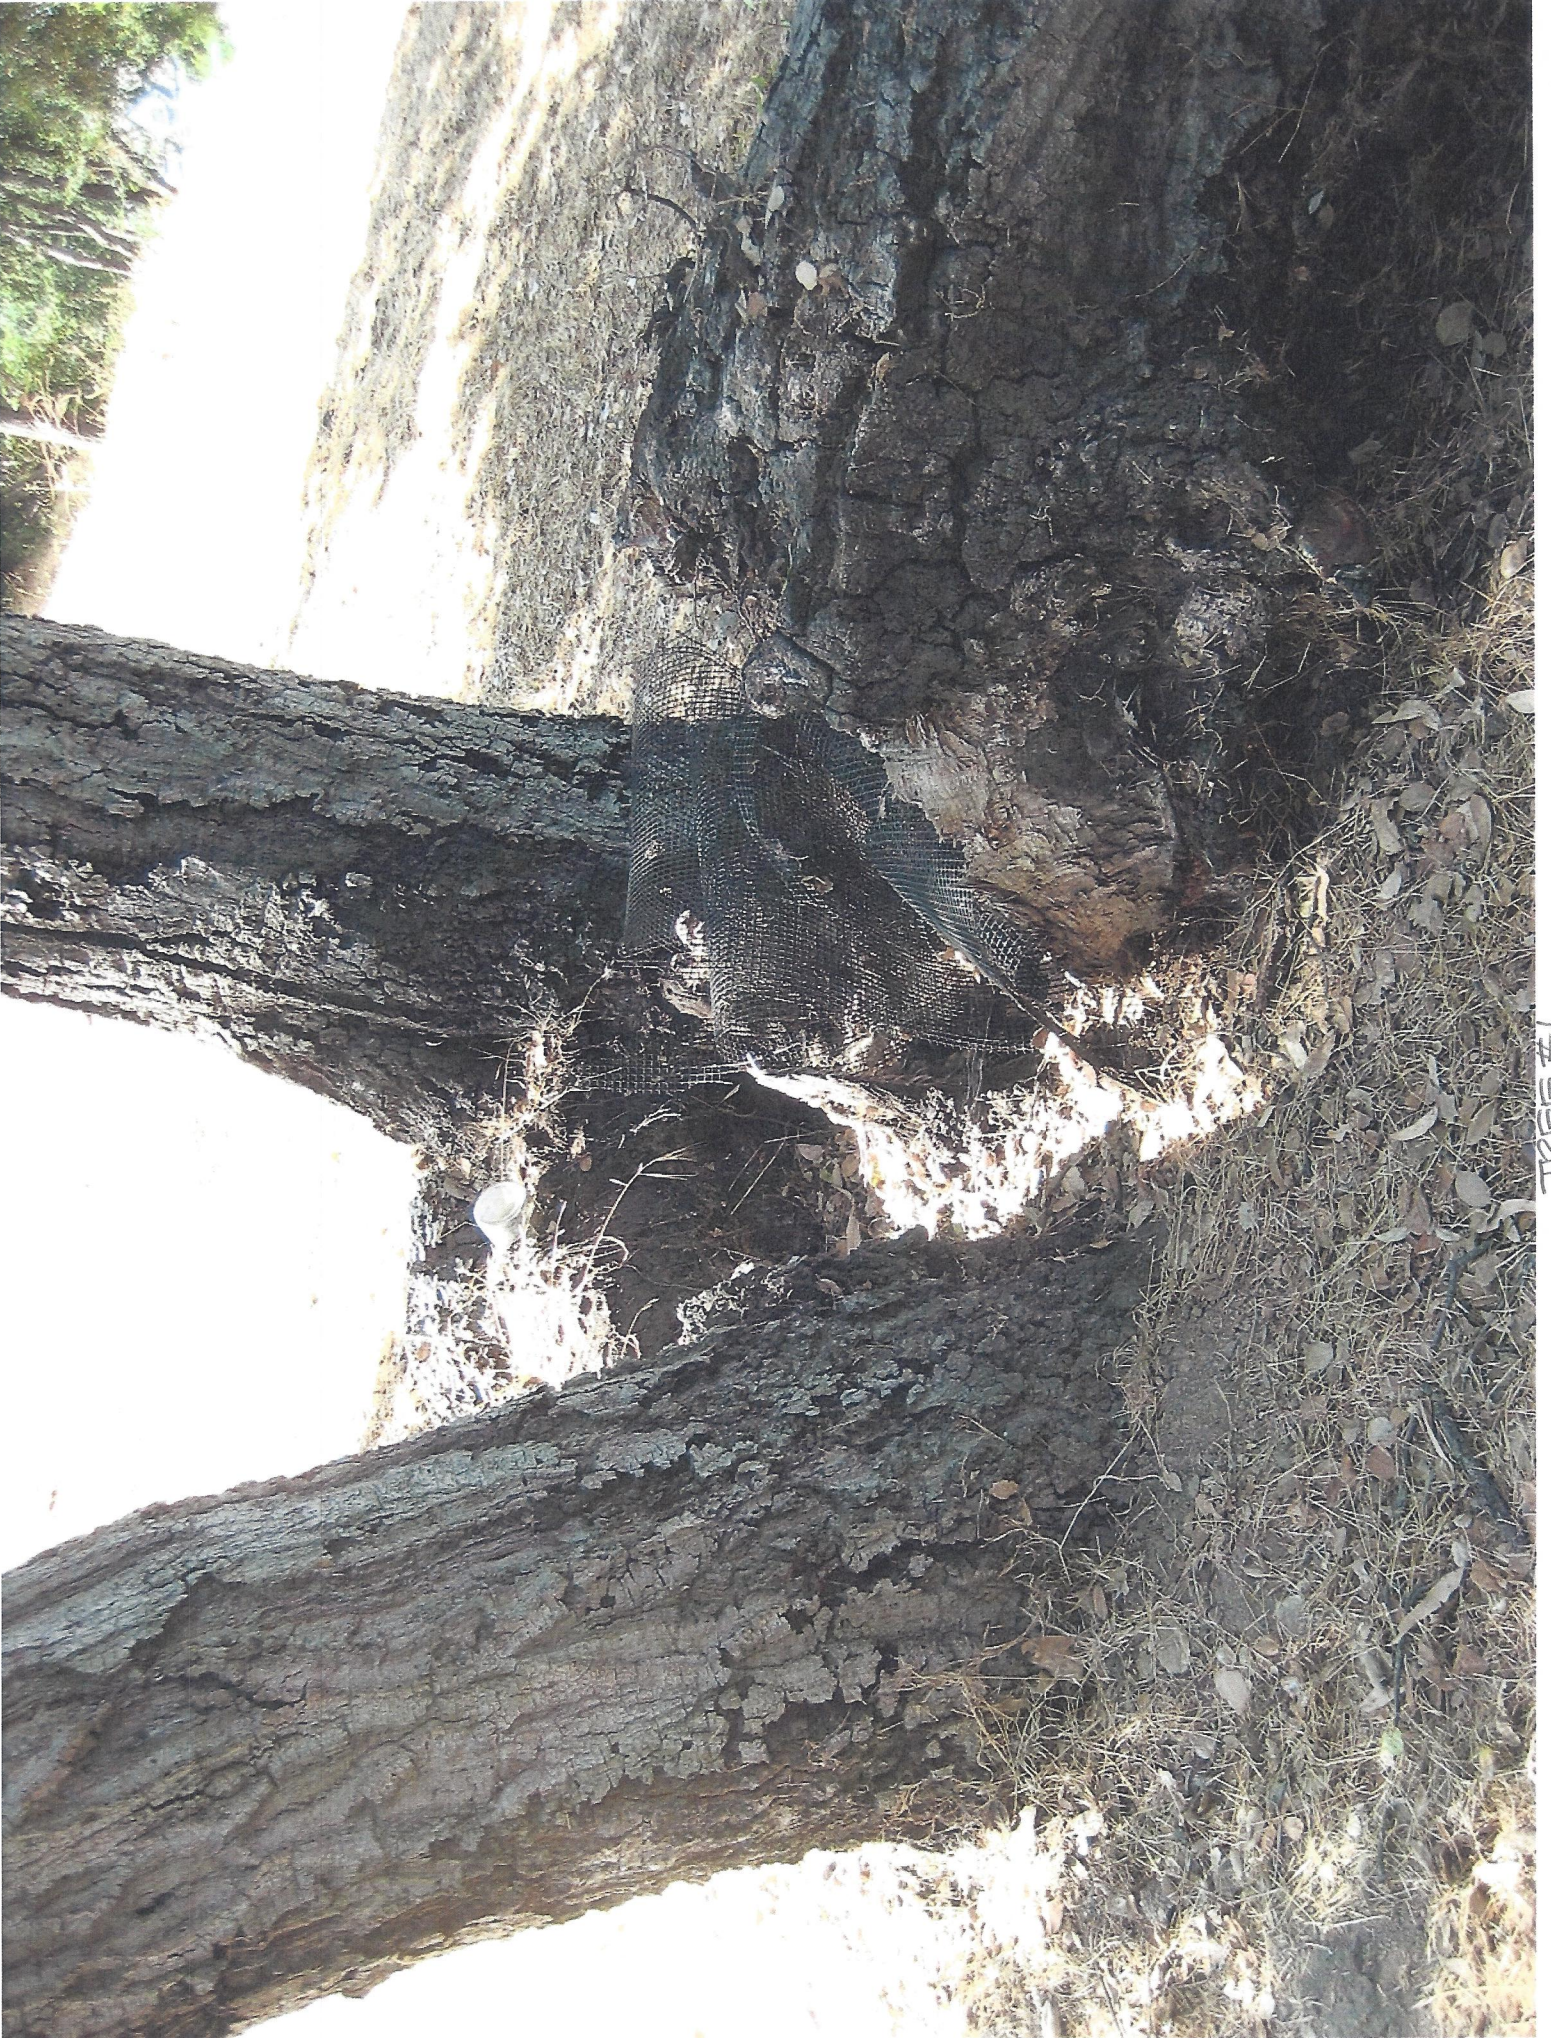
TREE #1

**Tree #1** is a Quercus agrifolia or Coast Live Oak. The tree measures 17, 18 and 19 inches in diameter at D.B.H. (Diameter Breast Height) as measured 54 inches above the soil grade. The tree has a drip line, which measures roughly 28 feet from the tree's trunk. The spread of the tree is approximately 56 feet. The height of the tree is estimated to be roughly 55 feet tall. The subject property is located between 3220 Chevy Chase Drive and 3130 Charing Cross Road. The tree is located 24 feet east and uphill from Charing Cross Road. The road cut is 5 feet lower than the uphill lot slope. The Oak tree's trunk is located 25 feet north of the property line of the vacant lot scheduled for development. There is no irrigation or landscape near the trunk of this tree. The subject tree is a multi-trunk native Oak. The tree previously had 3 co-dominant stems which join at a point 2 feet above the ground. On the east side of the tree I noted that 3 other trunks or stems had

been previously cut and removed. These measure 8, 20 and 22 inches in diameter just above ground level. There is a large cavity with decay through the center of the 22 inch diameter cut trunk. Turkey Trails fungus was observed growing on the sides of the 20 inch diameter cut trunk. There is epicormic sprouting or suckering taking place near the base of the remaining tree trunks. I observed 3 Ganoderma conks located near the base in the union area between the 17 inch and 18 inch diameter remaining trunks on the northwest side of the tree. There is included bark at the stem or trunk unions. The Oak leans slightly west. The crown appears balanced with minor asymmetry. It is crowded by another Coast Live Oak on the north side. The foliage size and color appears normal. The crown density is fair. Since my last inspection it appears that the 18 inch diameter trunk has failed and has fallen over. The tree is in poor health and condition. Rating: D

- 11) Structural and end weight reduction pruning on Tree #1 is recommended. The tree is structurally weak and decay is present in the lower trunk areas.

- 12) The proposed construction project should be supervised and monitored by an I.S.A. Certified Arborist. I would also recommend annual arborist inspections for Tree #1 to monitor the extent and level of decay in this Oak tree.

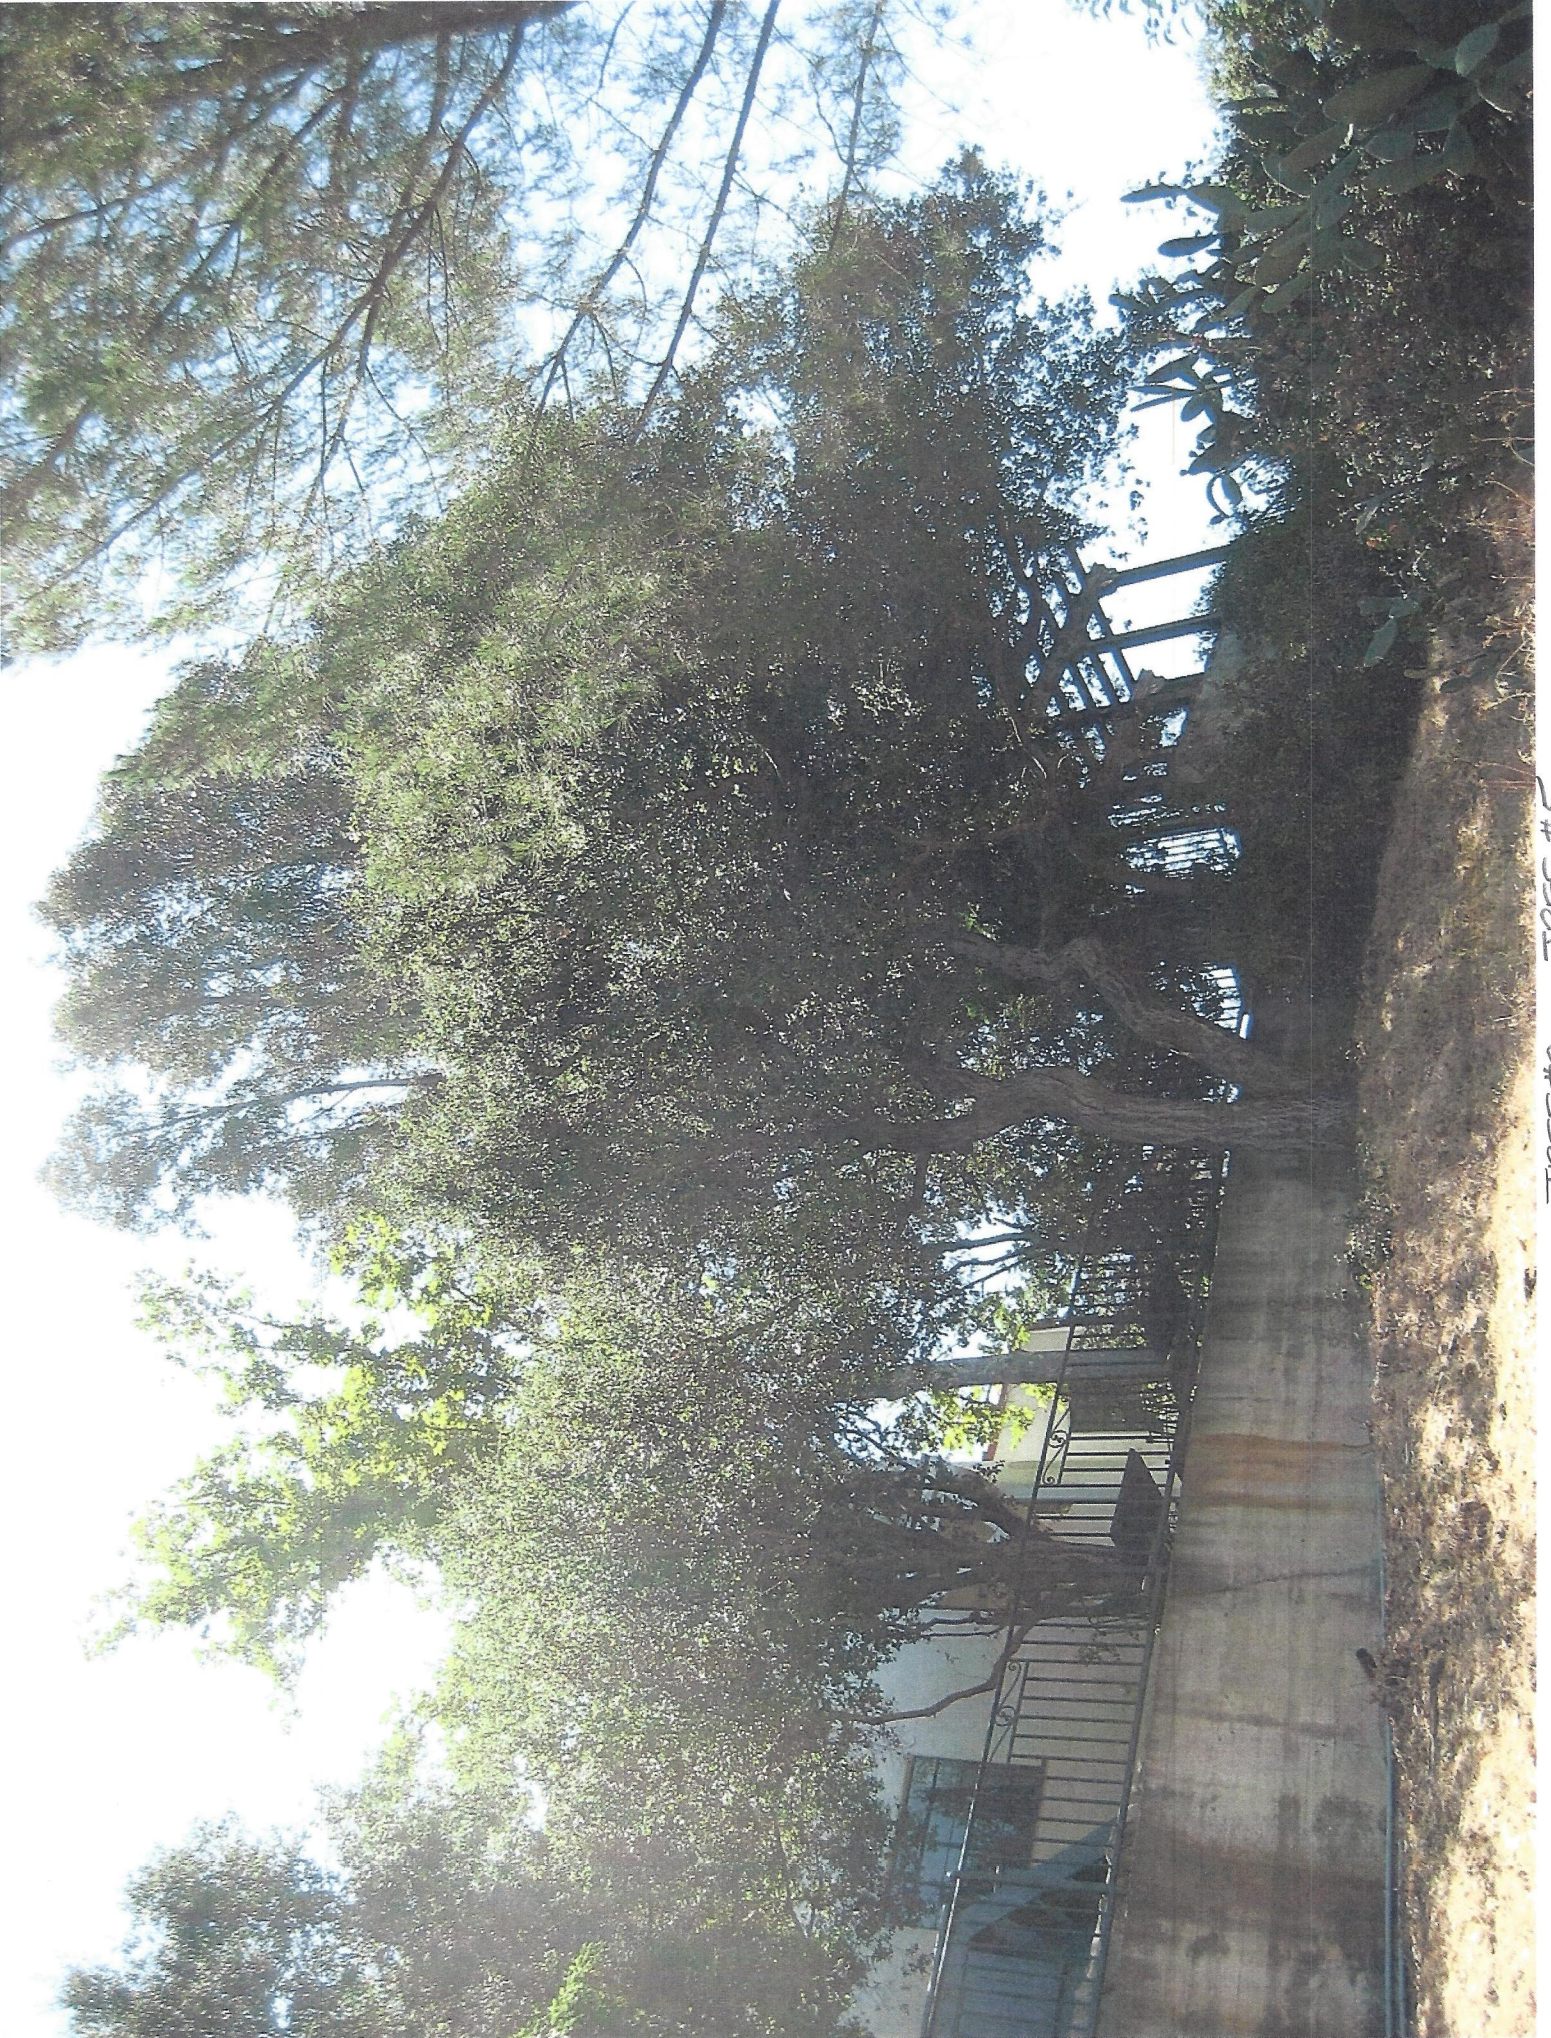
TREE #2 TREE #5

**Tree #2** is a Quercus agrifolia or Coast Live Oak. The tree measures 12 and 12 inches in diameter at D.B.H. The tree has a drip line, which measures roughly 25 feet from the tree's trunk. The spread of the tree is approximately 35 feet. The height of the tree is estimated to be roughly 40 feet tall. It is located one foot west of the neighbor's block wall at the top of a steep uphill slope. Jade Plant, Poison Oak and annual grasses grow nearby. No irrigation was observed. The tree has co-dominant stems and included bark. The majority of the tree's crown grows south and crowds another nearby Coast Live Oak. There is minor Western Sycamore Borer insect damage on the bark tissue along the lower trunk of the tree. The crown is unbalanced and asymmetrical. The neighbor's concrete patio covers 50% of the tree's root zone. The crown has been pruned and raised. The foliage size and color appear normal. The crown density is fair. The tree is in slightly below average health and condition. Rating: C-

**Tree #5** is a Quercus agrifolia or Coast Live Oak. The tree measures 6 inches in diameter at D.B.H. The tree has a drip line, which measures roughly 20 feet from the tree's trunk. The spread of the tree is approximately 20 feet. The height of the tree is estimated to be roughly 12 feet tall. It is located 5 feet south of Tree #2 and 2 feet west of the neighbor's wall and patio. It is surrounded by Jade Plant. No irrigation was observed. The tree's crown has been pruned and raised. The crown grows west. The tree is unbalanced and asymmetrical. The foliage size and color appear normal. The crown density is sparse. The tree is in poor health and condition. Rating: D

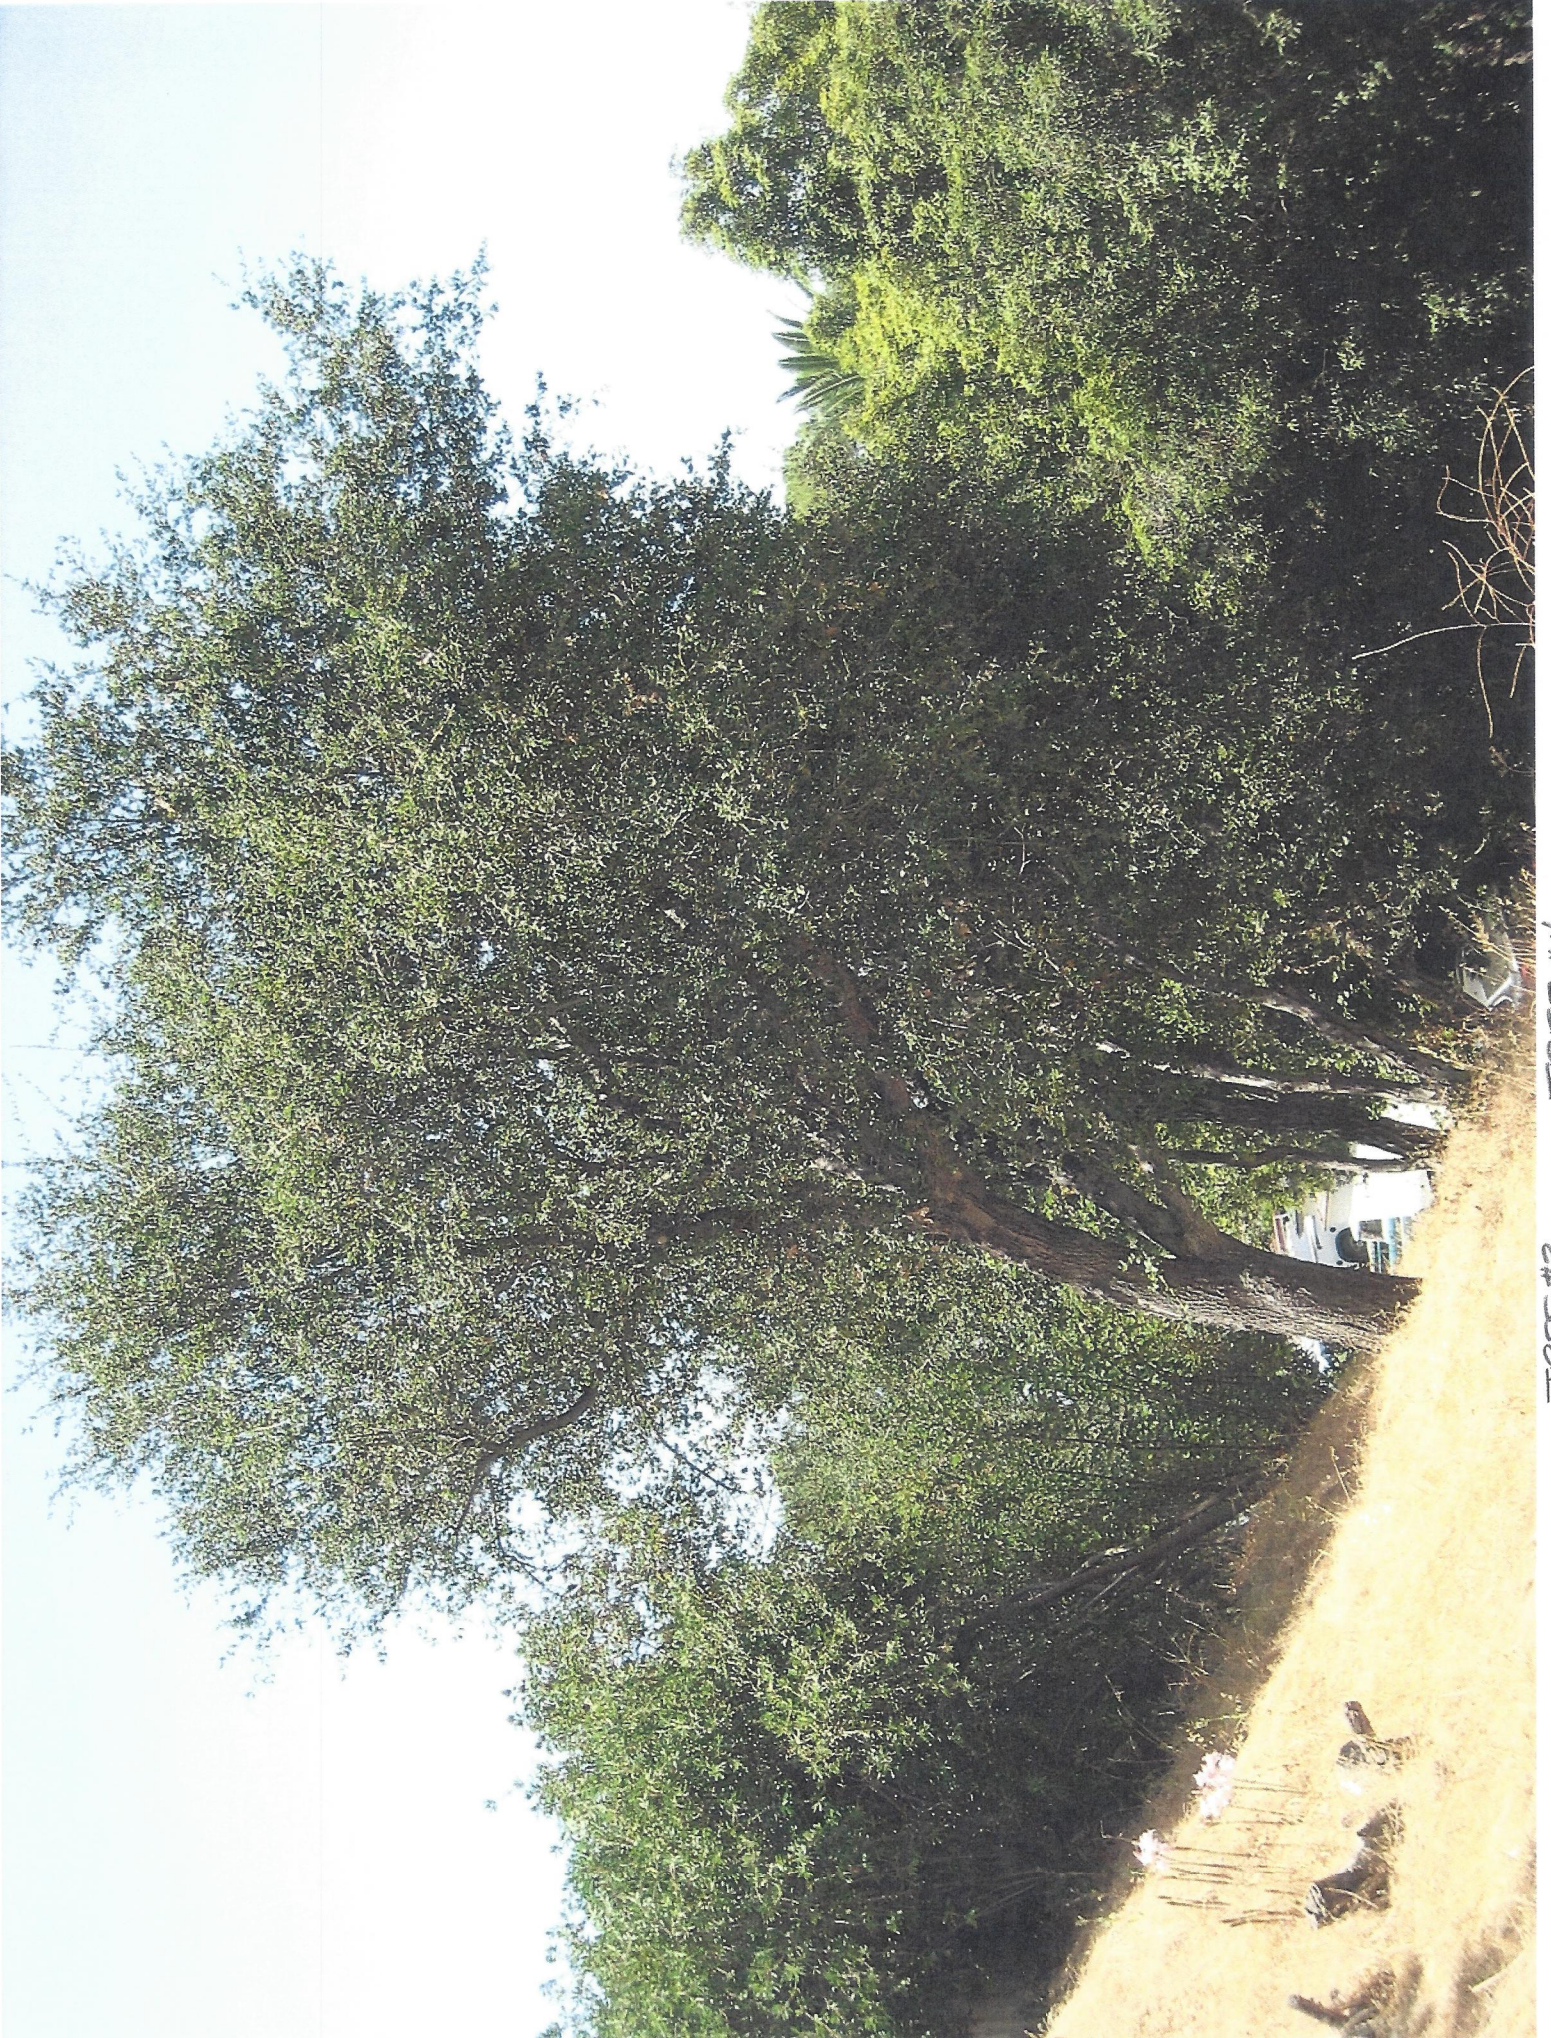
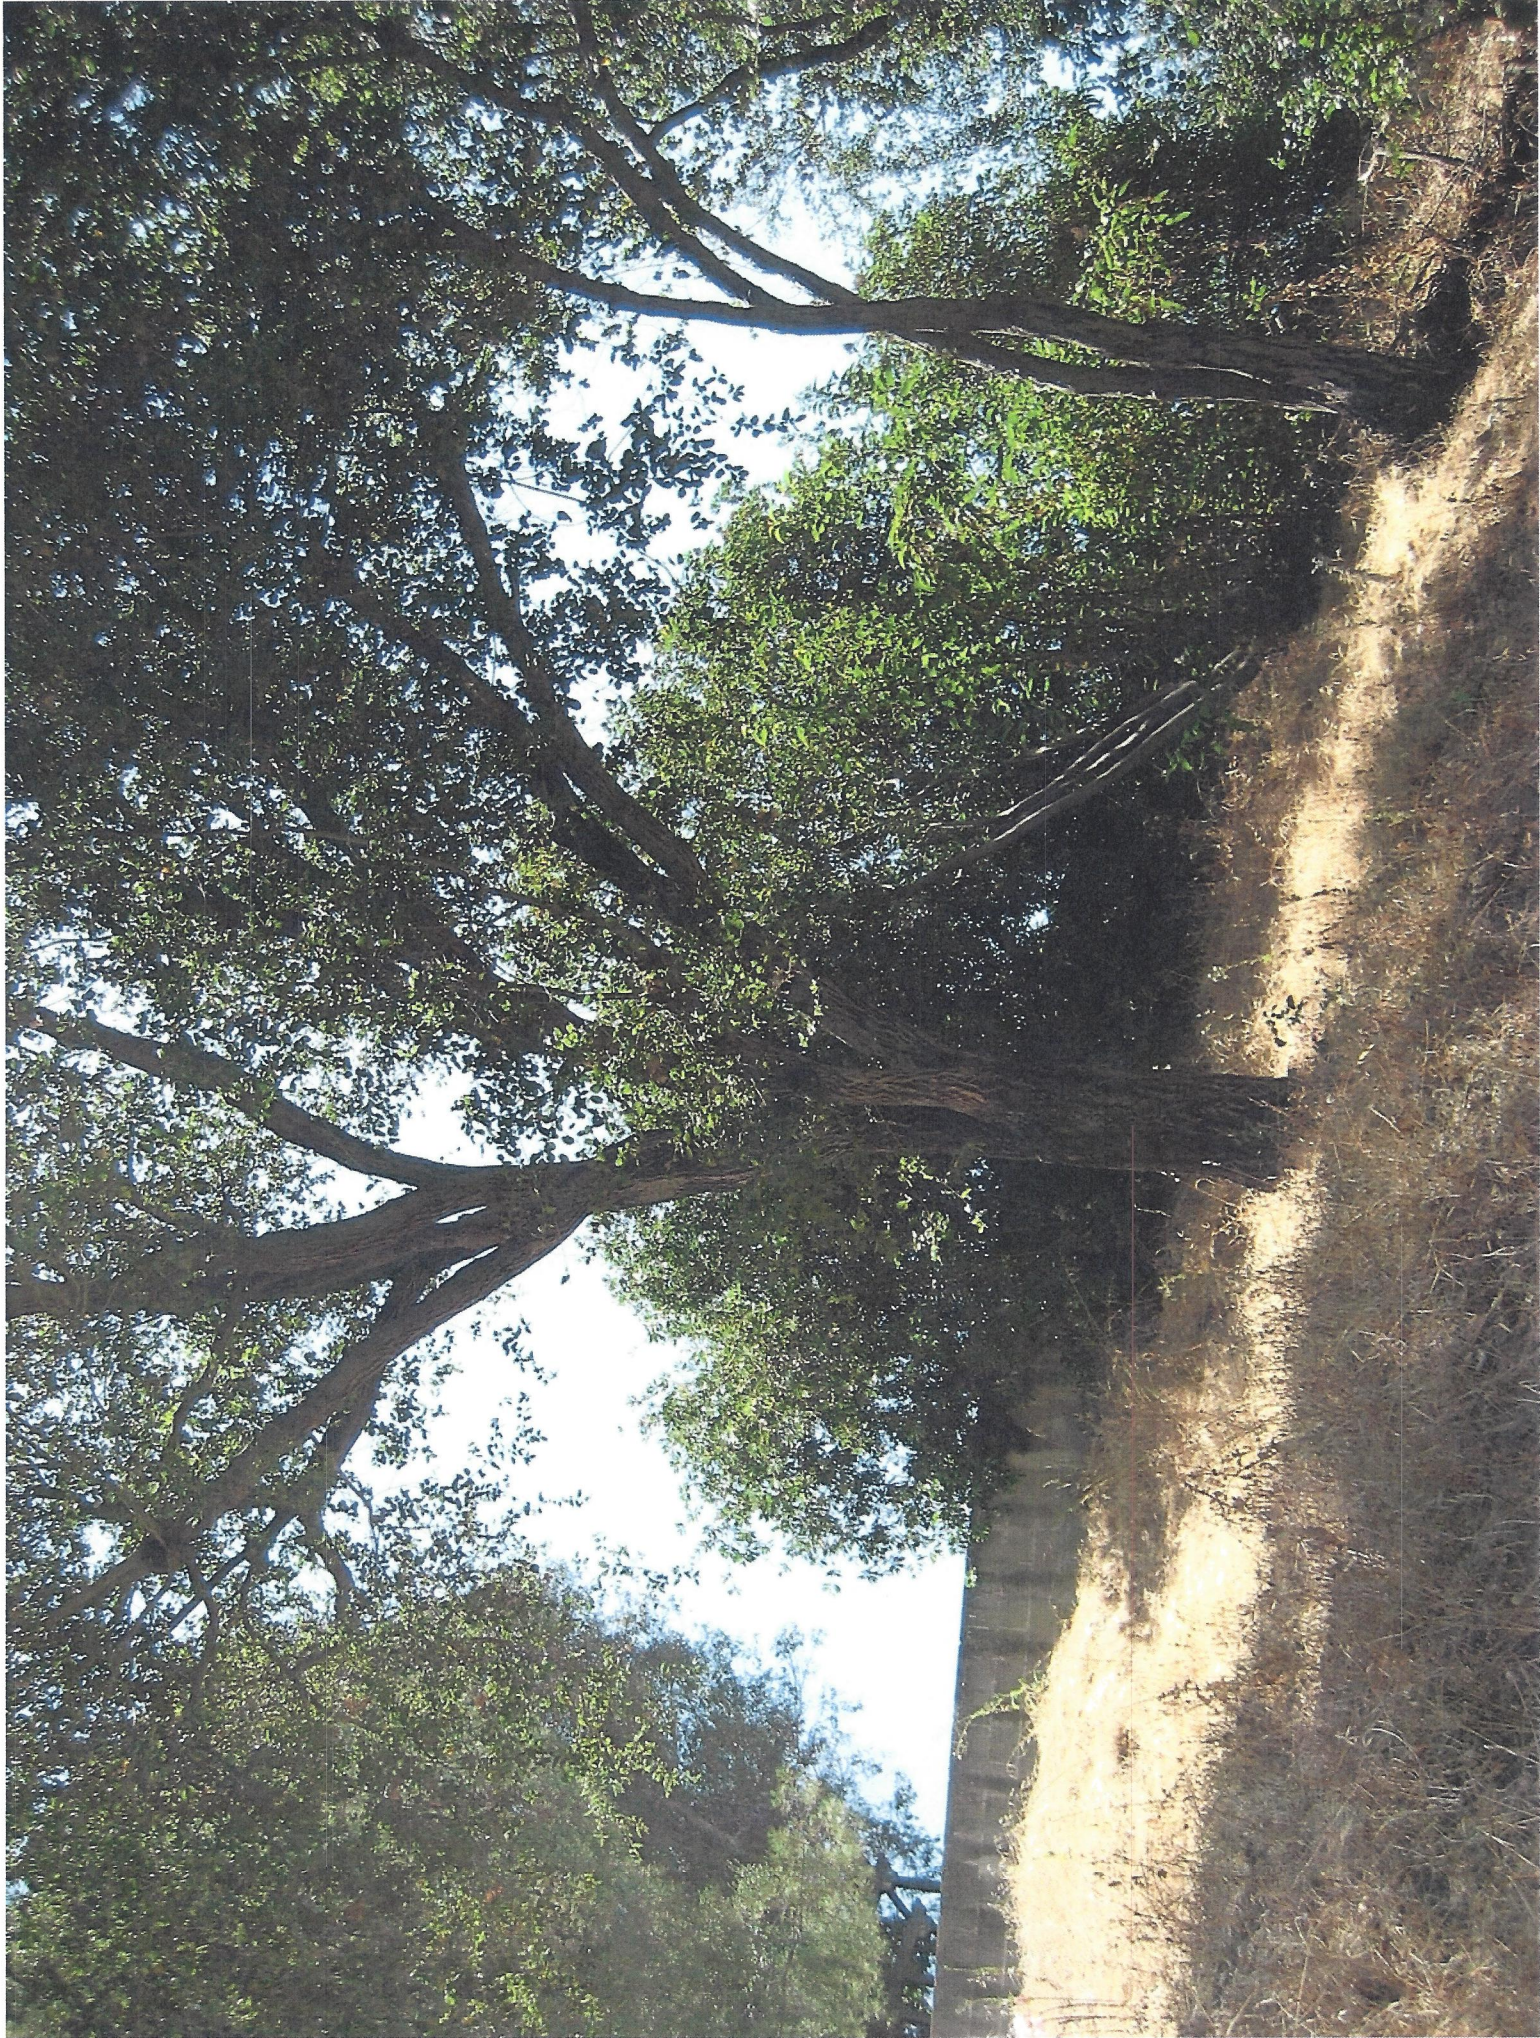
**Tree #3** is a Quercus agrifolia or Coast Live Oak. The tree measures 20 inches in diameter at D.B.H. The tree has a drip line, which measures roughly 14 feet from the tree's trunk. The spread of the tree is approximately 24 feet. The height of the tree is estimated to be roughly 25 feet tall. It is located near the southwest corner of the subject property. Poison Oak, Laurel Sumac and annual grasses grow nearby. The area is dry and therefore it appears the irrigation is not working. The crown has been pruned and raised. It appears that the tree has sustained fire damage. There is missing bark, heart rot and termite damage on the trunk. The majority of the tree's crown grows north. The crown is unbalanced and asymmetrical. It is crowded by other nearby trees. The foliage size and color appear normal. The crown density is fair. The tree is in poor condition. Rating: D

**Tree #4** is a Quercus agrifolia or Coast Live Oak. The tree measures 4 & 5 inches in diameter at D.B.H. The tree has a drip line, which measures roughly 15 feet from the tree's trunk. The spread of the tree is approximately 15 feet. The height of the tree is estimated to be roughly 15 feet tall. It is located downhill, 10 feet southwest of Tree #3. It appears to be the neighbor's tree. Poison Oak, Geranium, Laurel Sumac and annual

grasses grow nearby. The tree leans and grows west toward Charing Cross Road. The crown has been pruned and raised. The crown is unbalanced and asymmetrical. It has co-dominant stems, included bark and weak structure. The foliage size and color appear normal. The crown density is fair. The tree is in below average condition. Rating: D+
