## Arborist Report

3100 Block Charing Cross Road  
Glendale, California

August 25, 2020

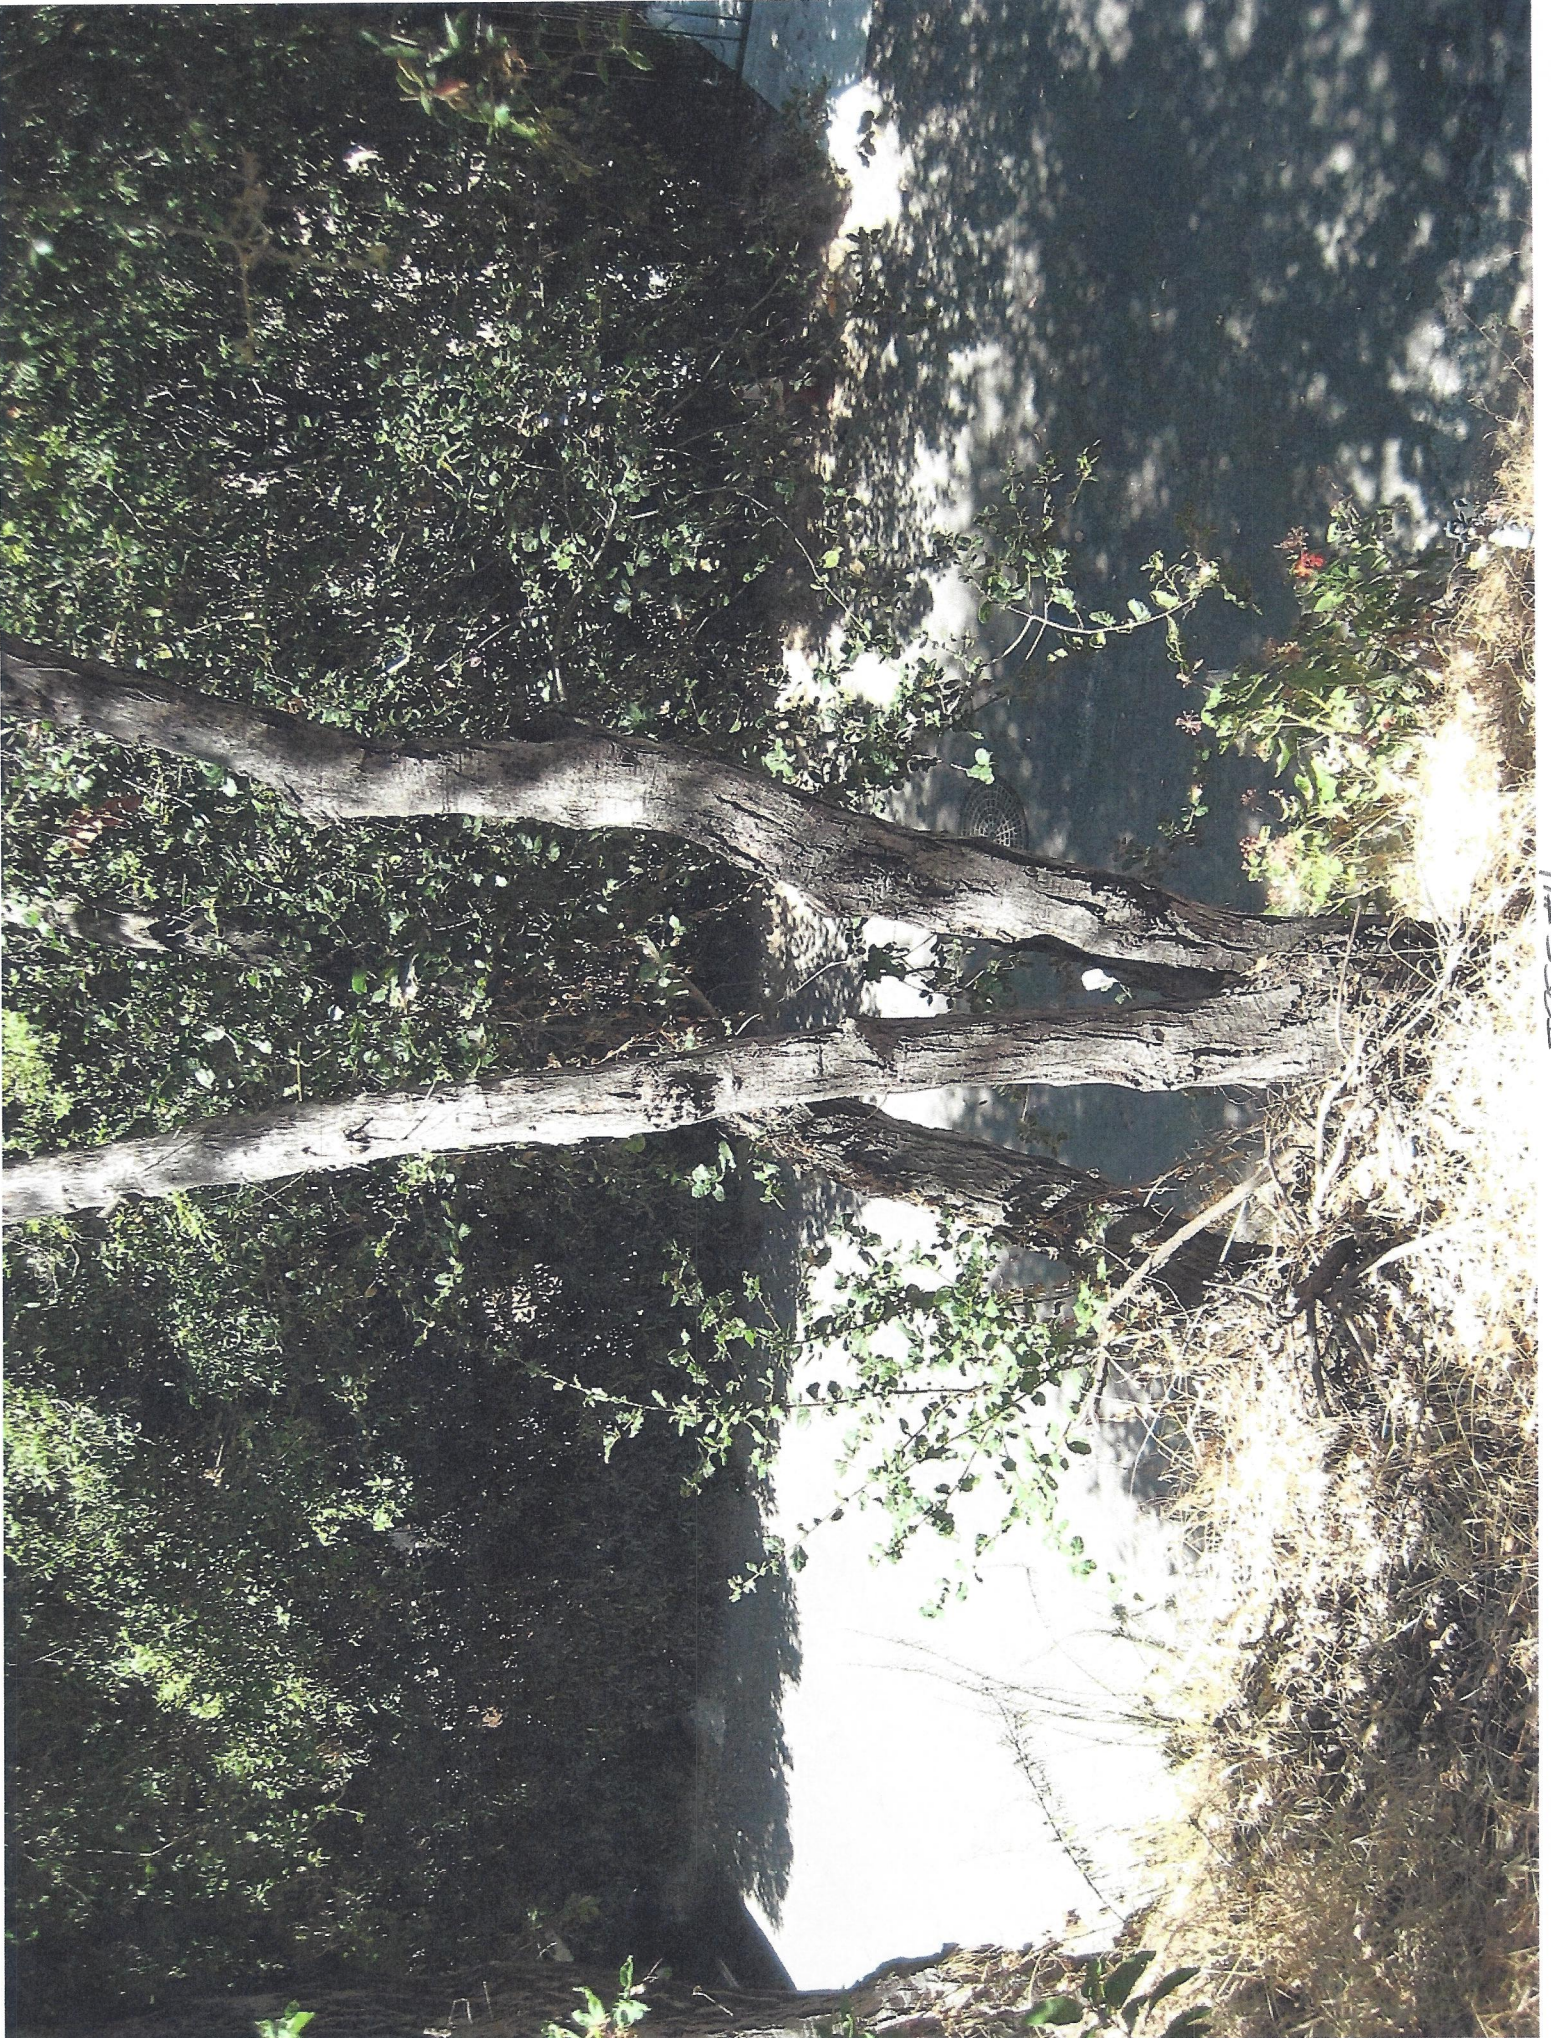
TREE #4

**Tree #4** is a Quercus agrifolia or Coast Live Oak. The tree measures 4 & 5 inches in diameter at D.B.H. The tree has a drip line, which measures roughly 15 feet from the tree's trunk. The spread of the tree is approximately 15 feet. The height of the tree is estimated to be roughly 15 feet tall. It is located downhill, 10 feet southwest of Tree #3. It appears to be the neighbor's tree. Poison Oak, Geranium, Laurel Sumac and annual

grasses grow nearby. The tree leans and grows west toward Charing Cross Road. The crown has been pruned and raised. The crown is unbalanced and asymmetrical. It has co-dominant stems, included bark and weak structure. The foliage size and color appear normal. The crown density is fair. The tree is in below average condition. Rating: D+
