**Photo Report**  
**Babe Herman Little League Field**  
**Programs, Services, and Activities**

**Finding:** The Babe Herman Little League Field, located at 1726 Canada Boulevard in Glendale California, was inspected by Disability Access Consultants, Inc., on June 12, 2007.

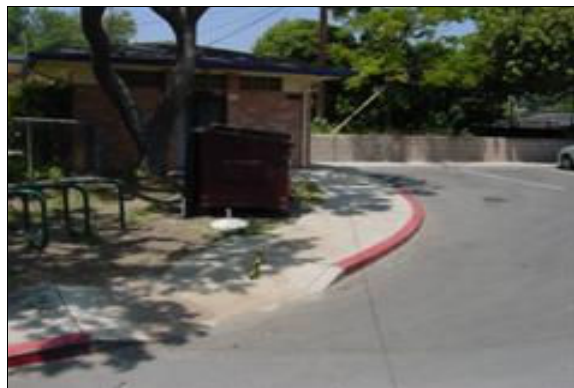
**Curb Ramp Next to the Restrooms**

**Finding:** The slope of each side of the concrete sidewalk curb ramp is greater than 8.33%. The curb ramp does not provide a grooved border along the top and sides of the ramp at the level of the sidewalk. The concrete curb ramp does not provide a detectable warning surface which includes truncated domes.

**Full Rec:** Replace the curb ramp with a compliant curb ramp at least 48 inches in width that provides a slope no greater than 8.33%. Install a detectable warning surface which extends the full length and width of the concrete curb ramp and its side flares with truncated domes that contrast visually by either light on dark or dark on light which is an integral part of the concrete curb ramp. The truncated domes may be cast in place or stamped or of a prefabricated surface treatment (see CBC 1127B.5.8).

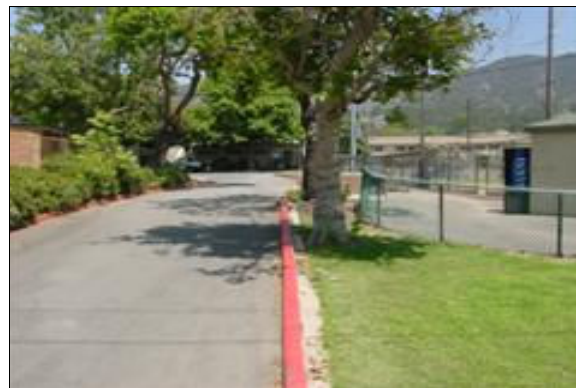
**Accessible Route from the Public Right of Way**

**Finding:** There is no crosswalk provided on the path of travel from the public right of way to the facility. The required accessible route crosses a vehicular way.

**Full Rec:** Stripe a crosswalk not less than 48 inches wide on the path of travel to the accessible entrance of the facility. Provide a level surface that does not exceed a slope greater than 5%. Cross slopes shall not exceed 2%. Detectable warnings should be placed at the entrance and exit of the crosswalk.

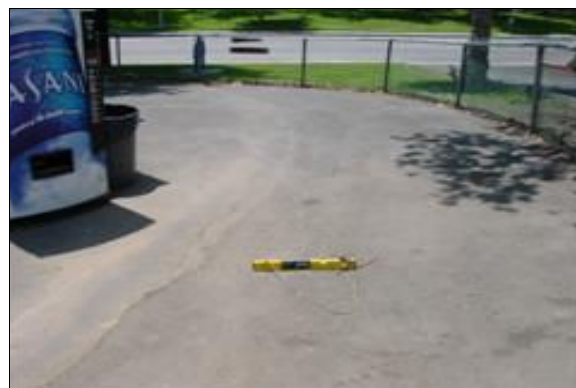
**Path of Travel at the Little League Field**

**Finding:** There are cross slopes greater than 2% on the primary path of travel next to the press box.

**Full Rec:** Resurface the path of travel to provide a level surface that does not exceed a slope greater than 5%. Cross slopes shall not exceed 2%.

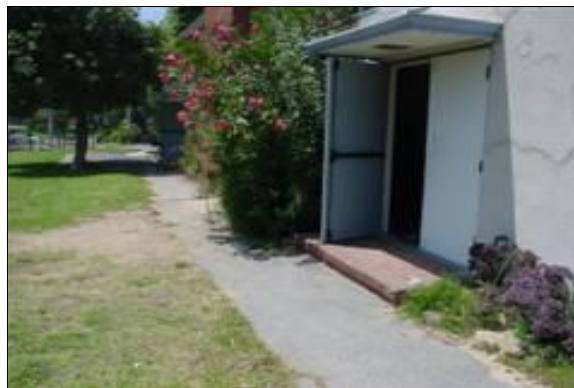
***Path of Travel to the Dad's Club***

**Finding:** There is a step on the primary path of travel to the Dad's Club, preventing access to individuals with mobility impairments.

**Full Rec:** Since programs, services and activities to staff and the public are provided in this location, those programs, services and activities are required to be made accessible. It is recommended that a ramp be installed or other means of vertical access.

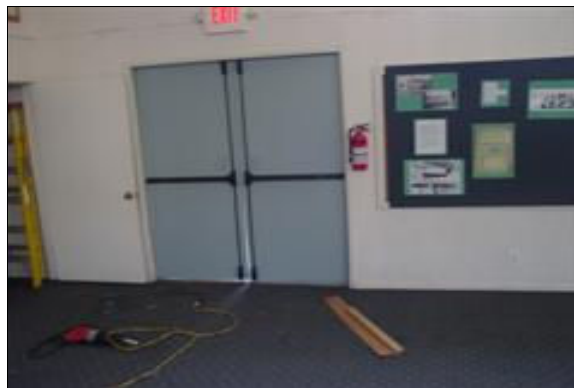
#### **Protruding Object**

**Finding:** The leading edge of the fire extinguisher in the Dad's Club is more than 4 inches from the wall and greater than 27 inches from the floor and protrudes into the primary path of travel.

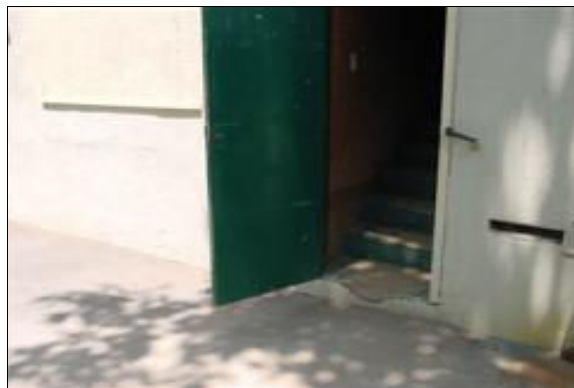
**Exterior Door to the Press Box**

**Finding:** The clear opening width of the door is less than 32 inches.

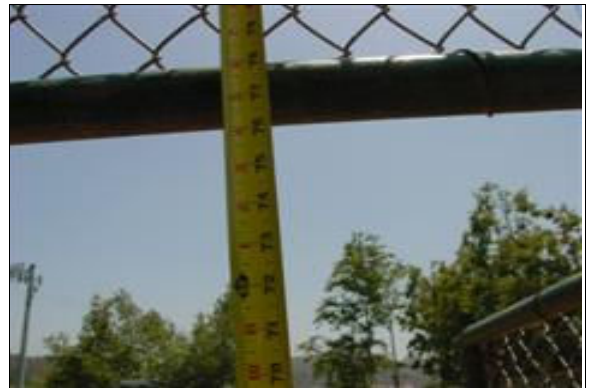
**Exterior Gate to the Dugouts**

**Finding:** The vertical clearance height of the entrance gate to the dugouts, at the left, provides less than 80 inches.

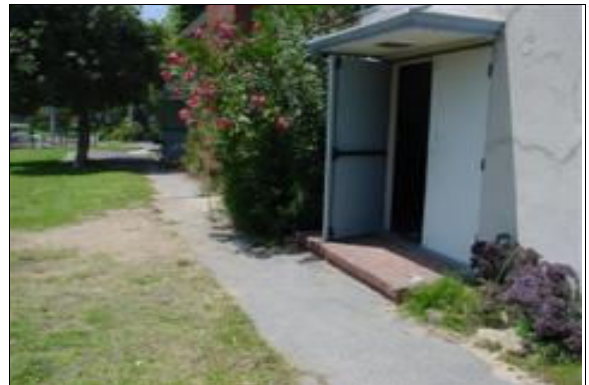
**Dad's Club**

**Finding:** There is no signage with the International Symbol of Accessibility on the entrance door to the facility designating it as accessible.

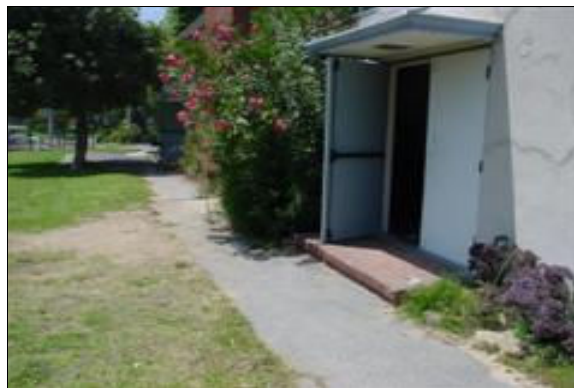
**Dad's Club**

**Finding:** The main entrance does not have accessible signage mounted on the wall adjacent to the latch side of the door.

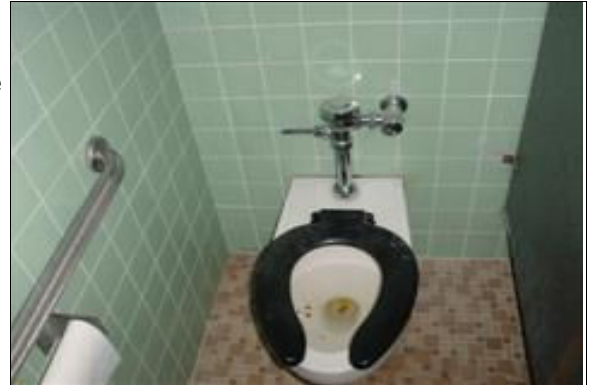
**Men's Restroom Across from the Little League Field**

**Finding:** The length of the side grab bar in the stall designated to be accessible in the restroom is less than 42 inches. The side grab bar in the stall designated to be accessible in the restroom does not extend 54 inches from the back wall.

**Full Rec:** Replace the side grab bar in the stall designated to be accessible in the restroom with a 42-inch/ 48 -inch side grab bar complying with ADAAG 4.26 and CBC 1115B.8. The front end of the grab bar shall extend at least 54 inches from the back wall and the back end of the grab bar shall be mounted within 12 inches from the back wall. Grab bars must be able to support a point load of at least 250 pounds and shall be less than the allowable shear stress of the grab bar material.

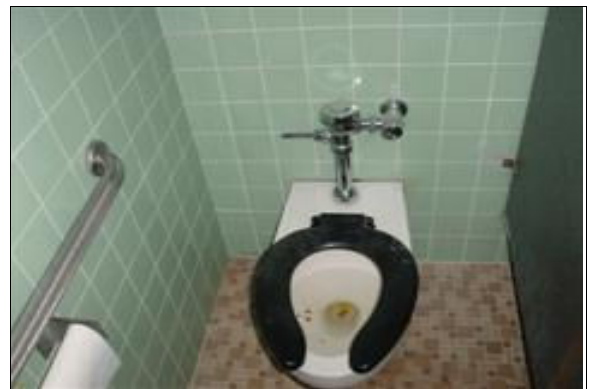
**Men's Restroom Across from the Little League Field**

**Finding:** The distance from the end of the side grab bar to the back wall in the stall designated to be accessible in the restroom is greater than 12 inches.

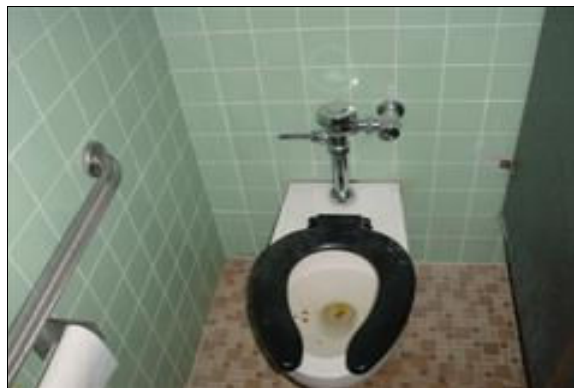
**Men's Restroom Across from the Little League Field**

**Finding:** The flush control on the toilet in the stall designated to be accessible in the restroom is not on the wide (approach) side of the toilet.

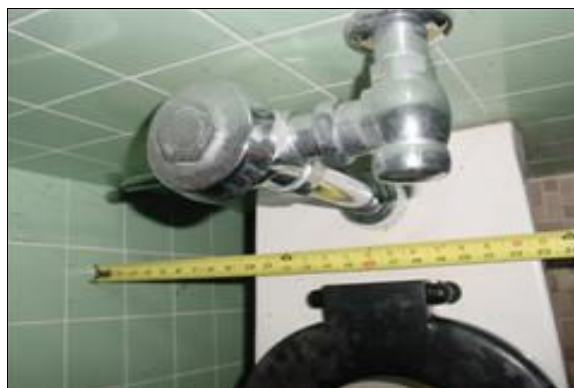
**Men's Restroom Across from the Little League Field**

**Finding:** The distance from the center of the toilet to the nearest side wall in the stall designated to be accessible in the restroom is less than 18 inches.

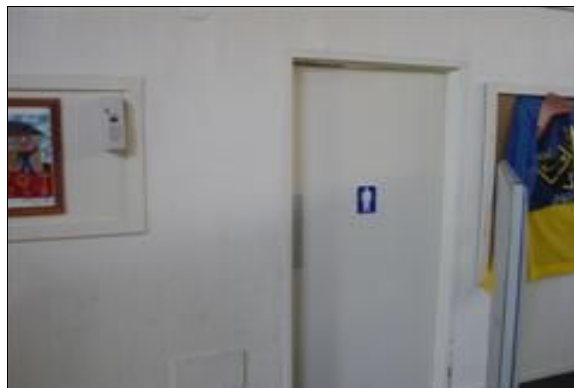
**Finding:** There is no signage indicating accessibility on the latch side of the entry door of the restroom. There is no Title 24 gender use signage on the entrance door.

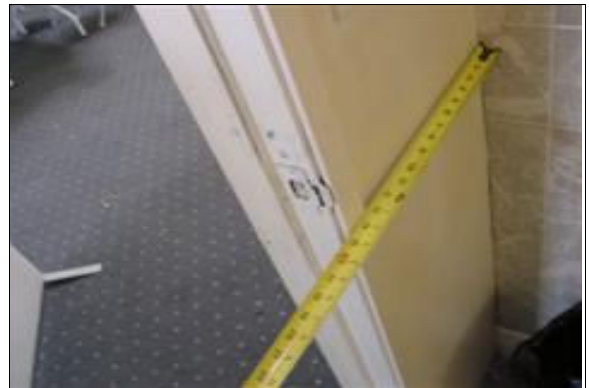
**Finding:** There is less than 18 inches of latch side clearance from the pull side of the interior entrance door.

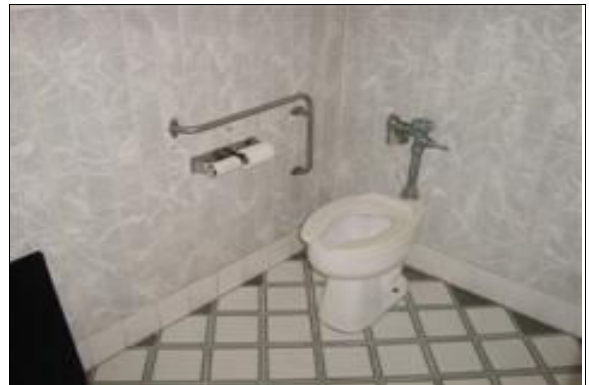
**Men's Restroom at the Dad's Club**

**Finding:** There is insufficient clear floor space in the stall designated to be accessible in the restroom. The door to the stall designated to be accessible in the restroom does not close automatically or have accessible hardware.

**Full Rec:** Modify or replace the stall designated to be accessible in the restroom so that it complies with ADAAG 4.17.3, CBC 1115B and CBC Figures 11B-1A and 1B. Standard accessible stalls require 60 inches in width with 56 inches depth for wall-mounted toilets or 59 inches depth for floor-mounted toilets to accommodate individuals in wheelchairs. The minimum width of a front-approach doorway shall provide at least 32 inches and a side-approach doorway shall provide at least 34 inches. The door shall swing outward, close automatically and provide accessible hardware.

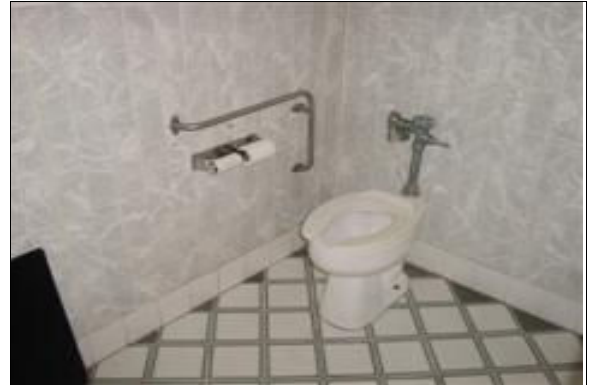
**Men's Restroom at the Dad's Club**

**Finding:** The height of the side grab bar in the stall designated to be accessible of the restroom is greater than 33 inches above the finished floor.

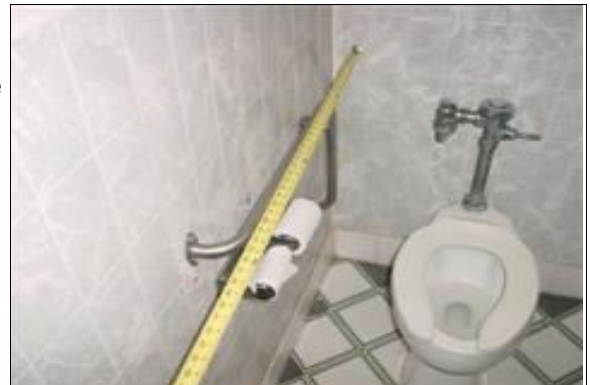
**Men's Restroom at the Dad's Club**

**Finding:** The length of the side grab bar in the stall designated to be accessible in the restroom is less than 42 inches. The side grab bar in the stall designated to be accessible in the restroom does not extend 54 inches from the back wall.

**Full Rec:** Replace the side grab bar in the stall designated to be accessible in the restroom with a 42-inch/ 48 -inch side grab bar complying with ADAAG 4.26 and CBC 1115B.8. The front end of the grab bar shall extend at least 54 inches from the back wall and the back end of the grab bar shall be mounted within 12 inches from the back wall. Grab bars must be able to support a point load of at least 250 pounds and shall be less than the allowable shear stress of the grab bar material.

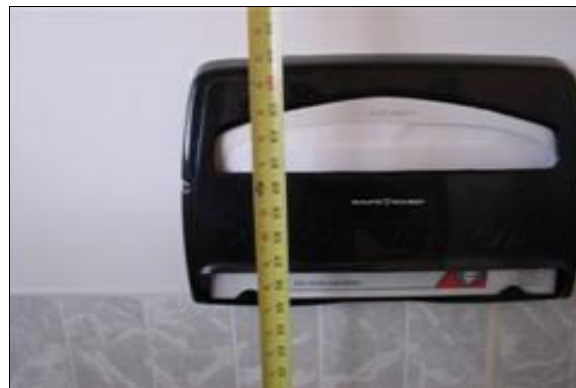
**Men's Restroom at the Dad's Club**

**Finding:** The seat cover dispenser in the stall designated to be accessible in the restroom is mounted at a height greater than 40 inches.

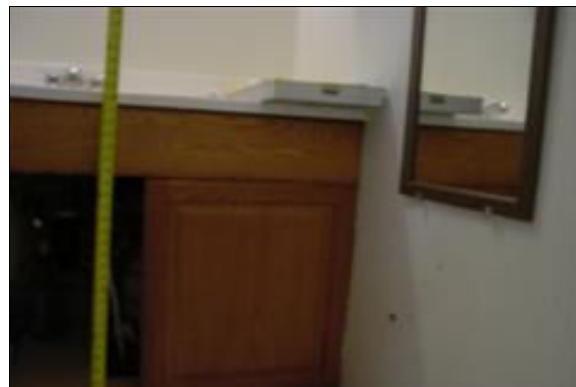
**Men's Restroom at the Dad's Club**

**Finding:** The faucet controls on the lavatory in the restroom require tight grasping, pinching, or twisting of the wrist and are not accessible.

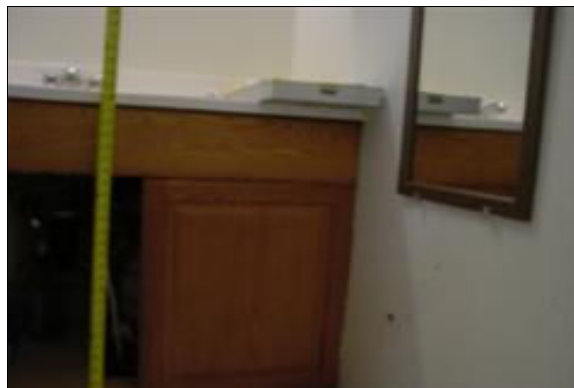
**Men's Restroom at the Dad's Club**

**Finding:** The lavatory in the restroom is in an enclosed cabinet, thereby preventing an accessible forward approach.

**Full Rec:** Lavatories in restrooms must provide clear floor space in front of the lavatory for an accessible forward approach and shall provide at least 29 inches clear knee space and a minimum of nine inches clear toe space (see ADAAG 4.19.2). If neither clear floor space and knee and toe clearance can be provided, remove the lavatory cabinet and replace with an accessible wall-mounted lavatory unit.

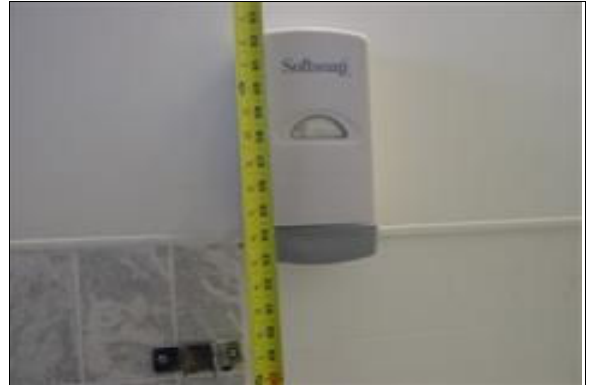
**Men's Restroom at the Dad's Club**

**Finding:** The height of the controls and operating mechanisms for the soap dispenser in the restroom is greater than 40 inches.

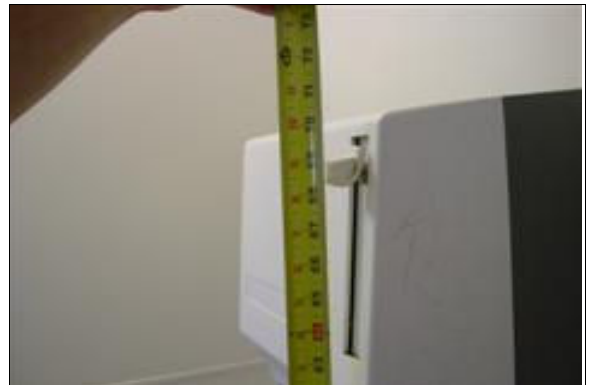
**Men's Restroom at the Dad's Club**

**Finding:** The height of the controls and operating mechanisms for the paper towel dispenser in the restroom is greater than 40 inches.

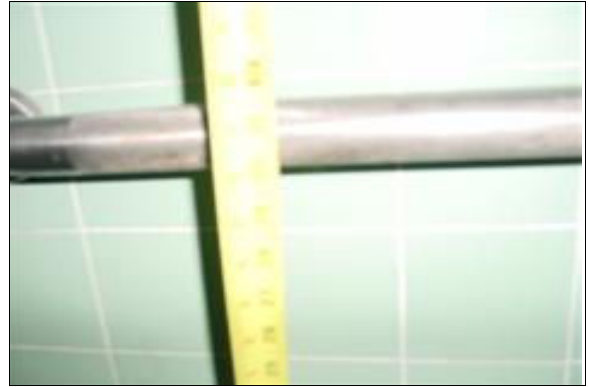
**Women's Restroom Across from the Little League Field**

**Finding:** The height of the side grab bar in the stall designated to be accessible of the restroom is less than 33 inches above the finished floor.

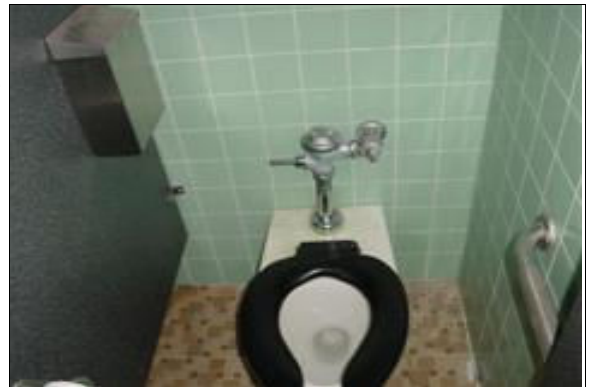
**Women's Restroom Across from the Little League Field**

**Finding:** The length of the side grab bar in the stall designated to be accessible in the restroom is less than 42 inches. The side grab bar in the stall designated to be accessible in the restroom does not extend 54 inches from the back wall.

**Full Rec:** Replace the side grab bar in the stall designated to be accessible in the restroom with a 42-inch/ 48 -inch side grab bar complying with ADAAG 4.26 and CBC 1115B.8. The front end of the grab bar shall extend at least 54 inches from the back wall and the back end of the grab bar shall be mounted within 12 inches from the back wall. Grab bars must be able to support a point load of at least 250 pounds and shall be less than the allowable shear stress of the grab bar material.

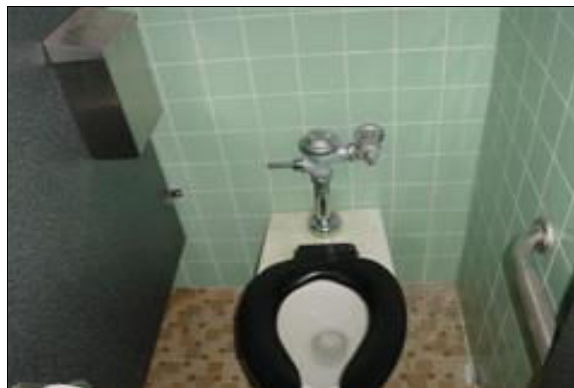
**Women's Restroom Across from the Little League Field**

**Finding:** The distance from the end of the side grab bar to the back wall in the stall designated to be accessible in the restroom is greater than 12 inches.

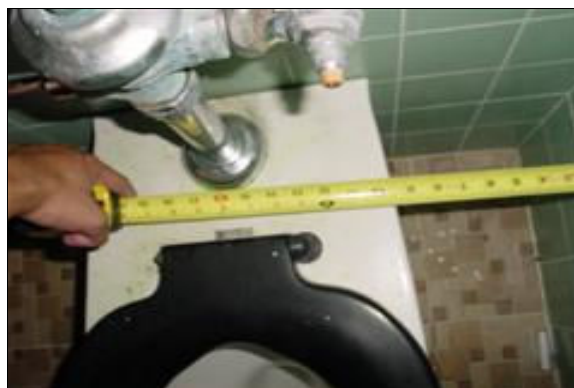
**Women's Restroom Across from the Little League Field**

**Finding:** The distance from the center of the toilet to the nearest side wall in the stall designated to be accessible in the restroom is less than 18 inches.

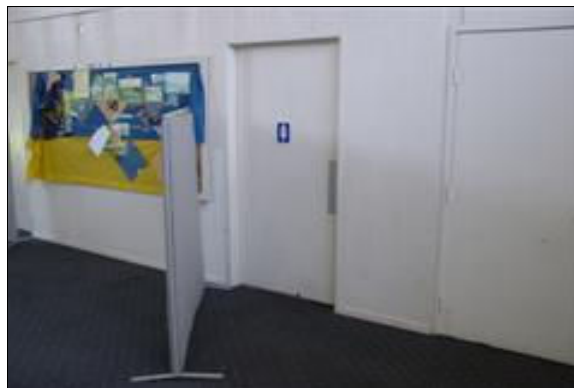
#### **Women's Restroom at the Dad's Club**

**Finding:** There is no signage indicating accessibility on the latch side of the entry door of the restroom. There is no Title 24 gender use signage on the entrance door.

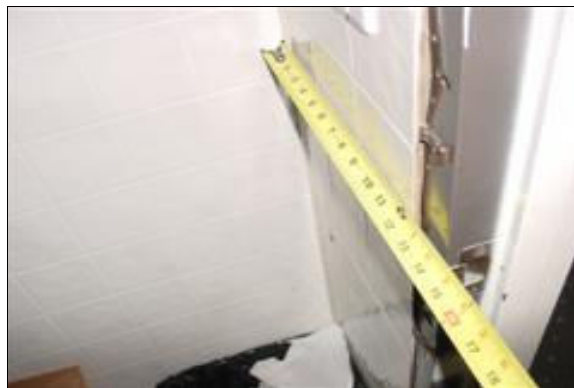
**Women's Restroom at the Dad's Club**

**Finding:** There is less than 18 inches of latch side clearance from the pull side of the interior entrance door.
