Public Works - Facilities Services
Rockhaven Sanitarium
Building Assessment Report
March 26, 2008

ASSESSMENT SUMMARY:

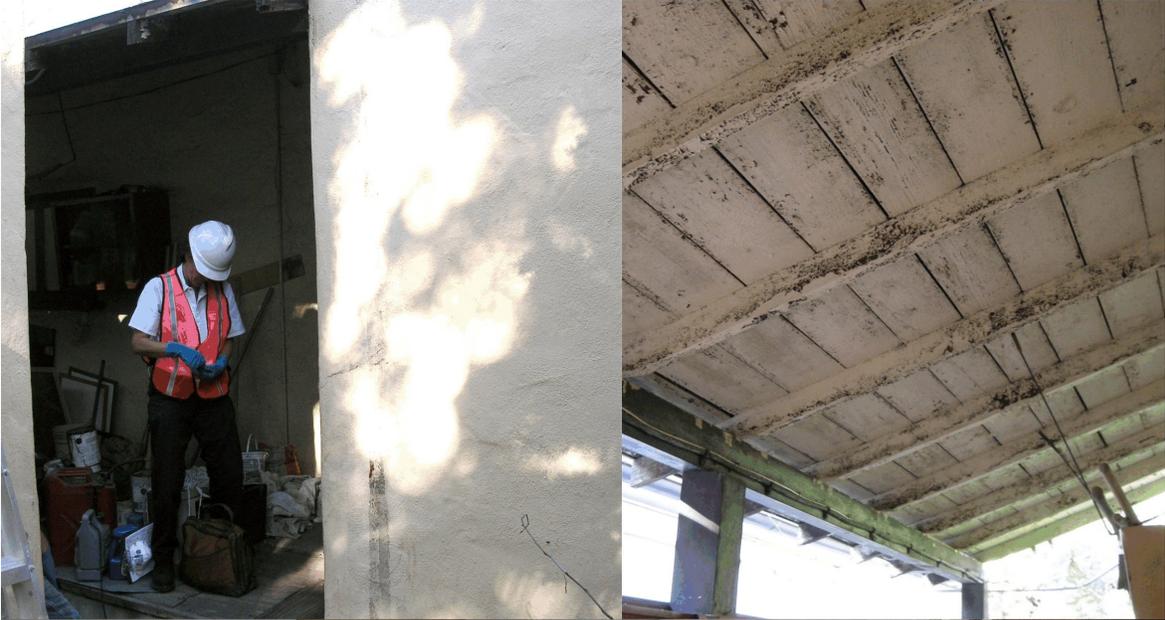
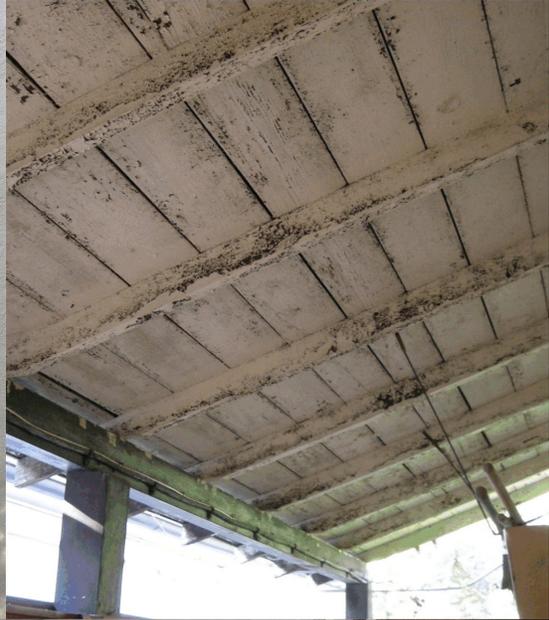
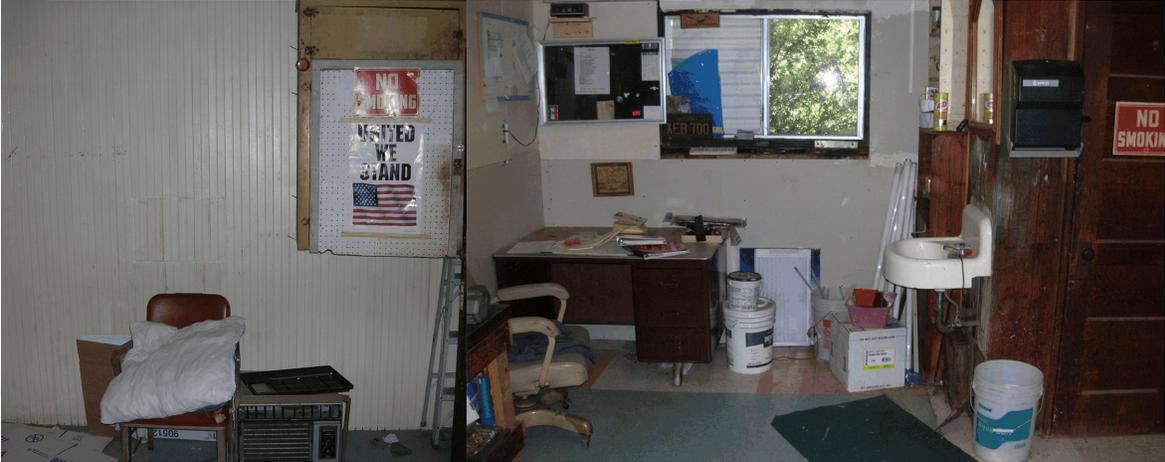
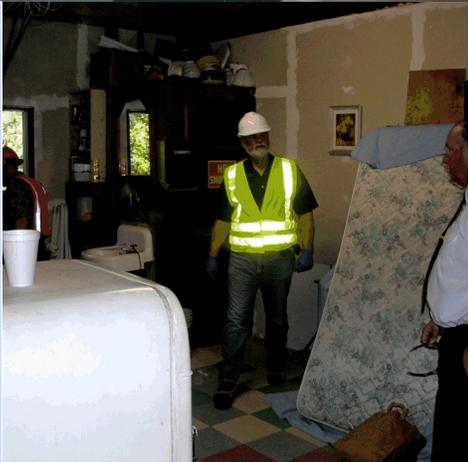
Public Works / Facilities Services
Photographs – Building B
March 26, 2008

The roof was in poor condition. It had multiple layers of composition roofing material which will need to be removed and replaced. Dry rot was found in the exposed area of the roof rafters. The foundation had numerous cracks as did the exterior stucco. The main garage door was rotted and could not be opened. The flooring on the porch was rotted and needed to be replaced. Wooden surfaces all need to be stripped and repainted. The interior of the shop had new drywall installed although it had not been finished as required by code. The shop had an open ceiling which exposed the insulation under the roof decking. One window had been replaced with an aluminum frame window although the installation did not appear to be according to code.

The building was fed from Building "C" and did not have its own service. The fixtures were old and in poor condition. Receptacles were not grounded and most of them had no covers.

Building B has been used to store shop and garden type of chemicals. Paints, thinners, pesticides and herbicides would need to be disposed of properly. The porch on the exterior of the shop wall was cluttered with trash, debris, and chemicals/containers. Caution should be taken when clearing the porch because of the deteriorated state of the decking.

1. Board up broken windows.
2. Repair broken door garage door for access in and out.
3. Remove paint cans and other chemical containers and dispose of as hazardous waste.

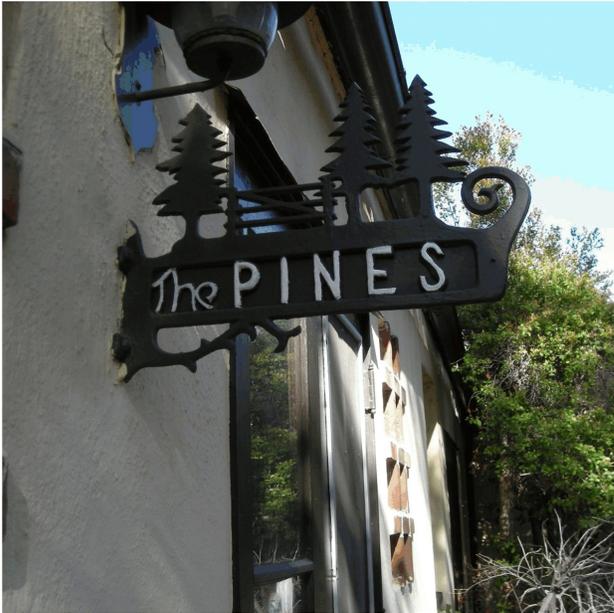
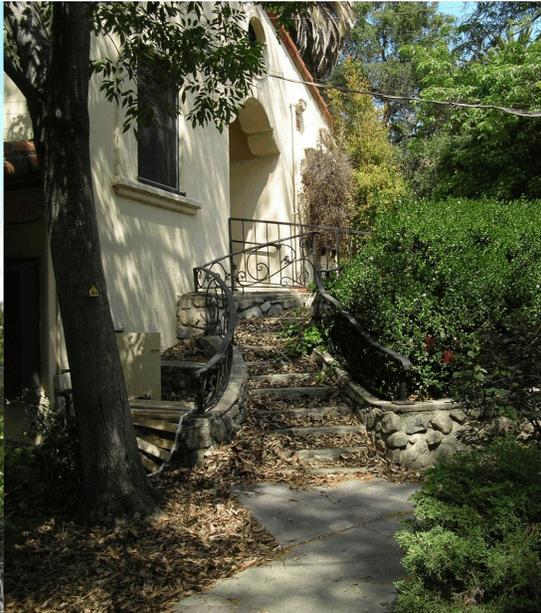
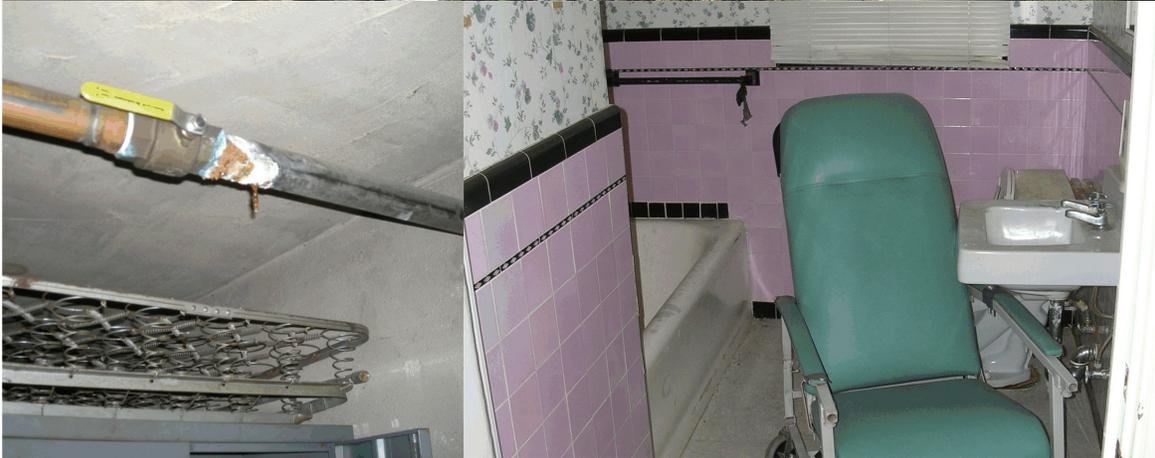
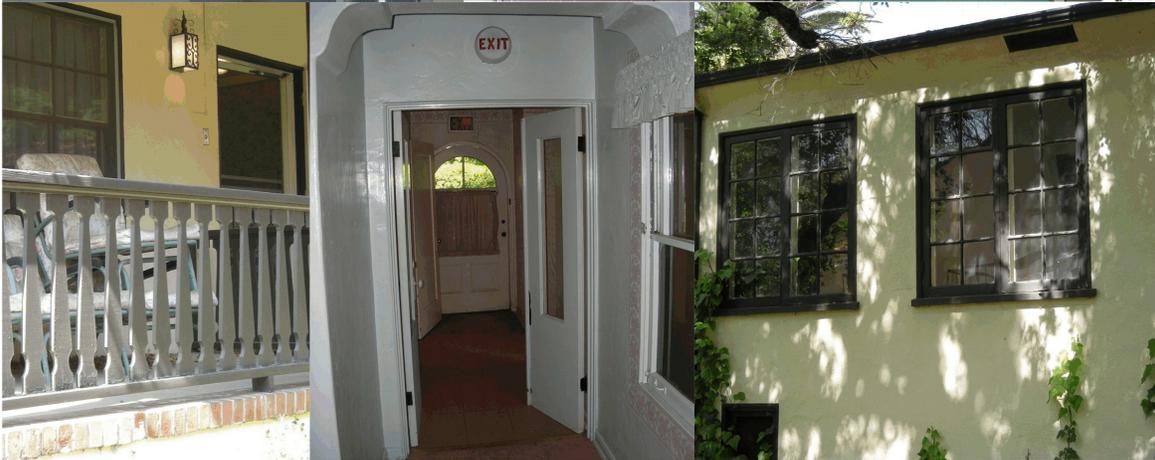
Public Works / Facilities Services
Photographs – Building C
March 26, 2008

Spanish tile roof that was in fair condition although it was covered with debris. Some of the tiles were loose but still in place. There were visible signs of deterioration on the exterior of the building; the stucco had cracks and damage at the foundation and below the windows. There were several exterior doors which had been nailed and painted shut. The doors were all dry-rotted on the lower portion and would need replacing. Interior walls, doors and ceilings were relatively good condition. There was mold found on ceiling and walls in the basement caused by leaking plumbing.

Structure had a newer General Electric sub-panel that was in good condition. Electrical in the attic was in good condition. The fixtures in the building were old and missing covers and guards. No ground fault circuit interrupters in the restrooms (per code). Some of the fixtures were grounded but the majority of them were not.

Building has a main water shut off valve located on its east side. Most of the plumbing was done in galvanized although some of it had been redone in copper. There were leaks in the basement on the main water supply. There are two water heaters for the building, a fifty gallon water heater in the basement and a thirty gallon located in the north side of the building. Fire sprinklers had been installed and appeared to be in good condition. The fire sprinkler main was also located on the east side.

Mold in the basement. There was large amount of discarded personal goods belonging to former residents, old medical supplies and old furniture stored in this basement. There is a potential of hazardous materials being stored along with the numerous discarded items. Numerous televisions were seen in the storage area.

1. Removal of Mold in the basement.
2. Removal of trash in basement (fire hazard).

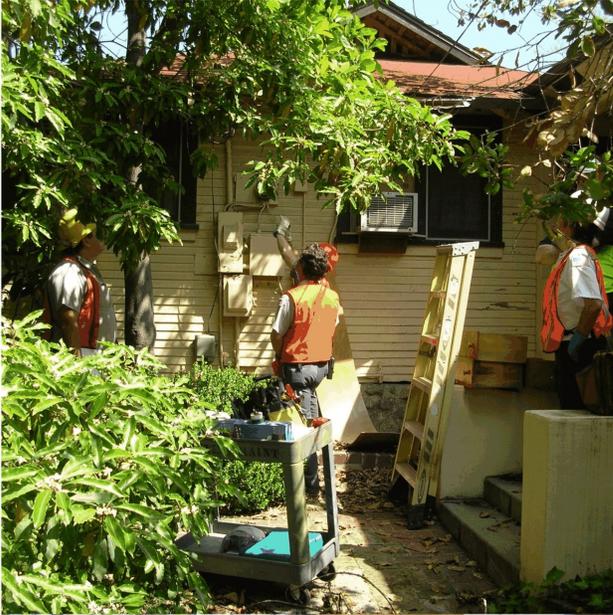
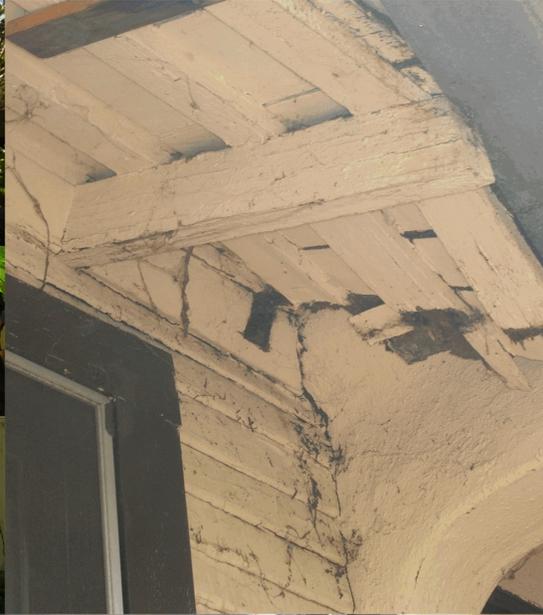
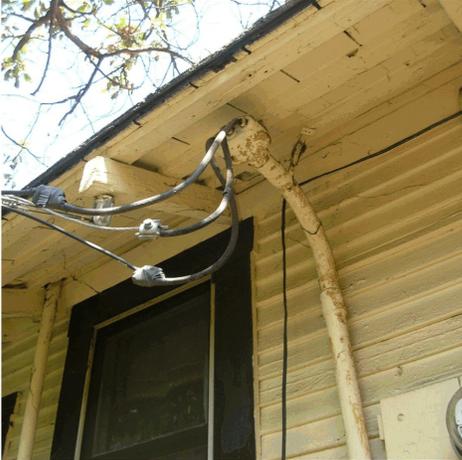
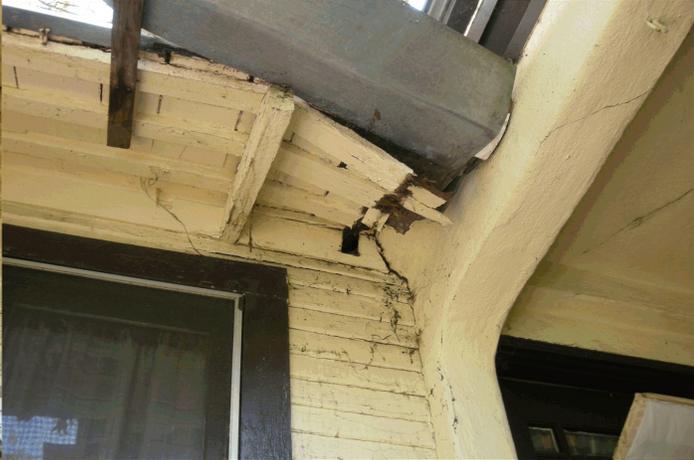
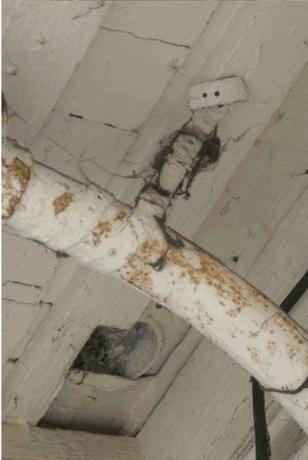
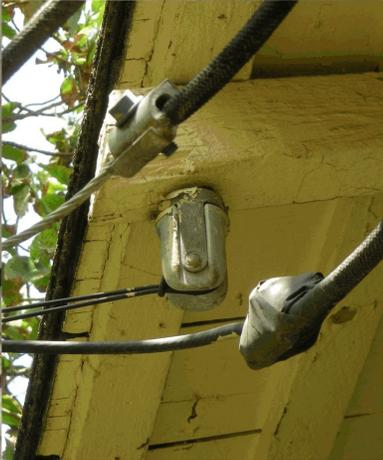
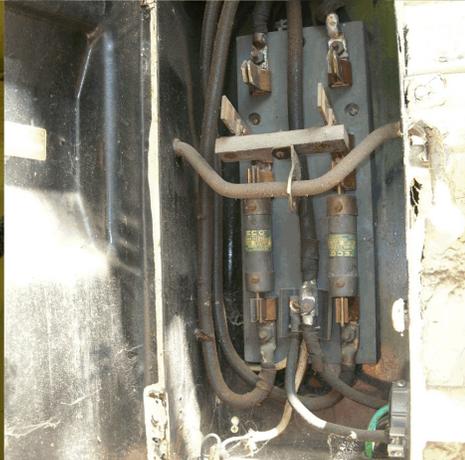
**Public Works / Facilities Services
Photographs – Building D
March 26, 2008**

Roof was in very poor condition. Several layers of composition roofing material had been applied over one another. The combined weight of these improperly installed roofing materials was causing visible sagging in several areas. There was extensive dryrot in most of the exterior wood. In some areas, the eaves were so deteriorated that they were falling. There was dryrot damage to all of the exterior doors and windows. The back porch was damaged extensively by either dryrot or termites. Interior doors all opened and closed well.

Electrical service to building needs immediate attention by GWP. The service drop to structure is being pulled away from building by tree branches. The porcelain knob securing the guide wire has been almost completely pulled away from building. The riser/weather head is tied to the building using plumber's tape and is not secure. The fusible disconnect is old and corroded and unsafe. Much of the electrical located in the basement of the building is illegal and unsafe. The interior fixtures were old but serviceable but were improperly grounded.

The electrical service drop is potentially a serious fire hazard. Facilities would have cut power to this building had it not been currently occupied. The enclosed back porch area was tightly packed with possessions and we were unable to inspect thoroughly. Area needs to be cleared of all debris and re-inspected.

1. Power needs to be disconnected from building by GWP until service can be repaired.
2. Building needs to be closed and "Red Tagged" until structural and electrical repairs are completed.

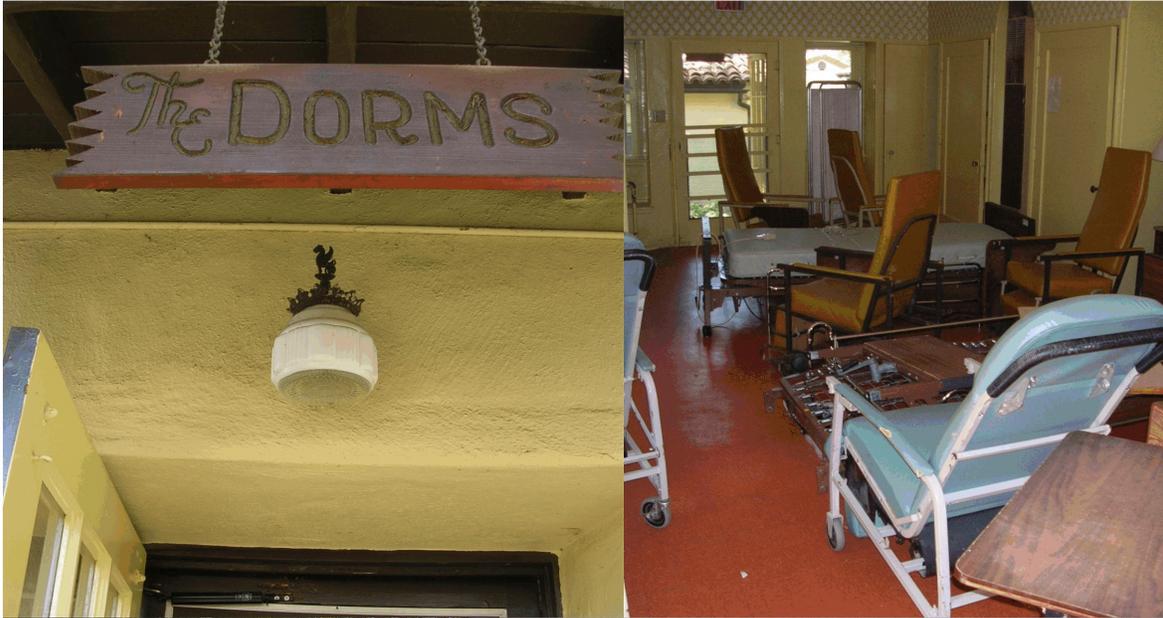
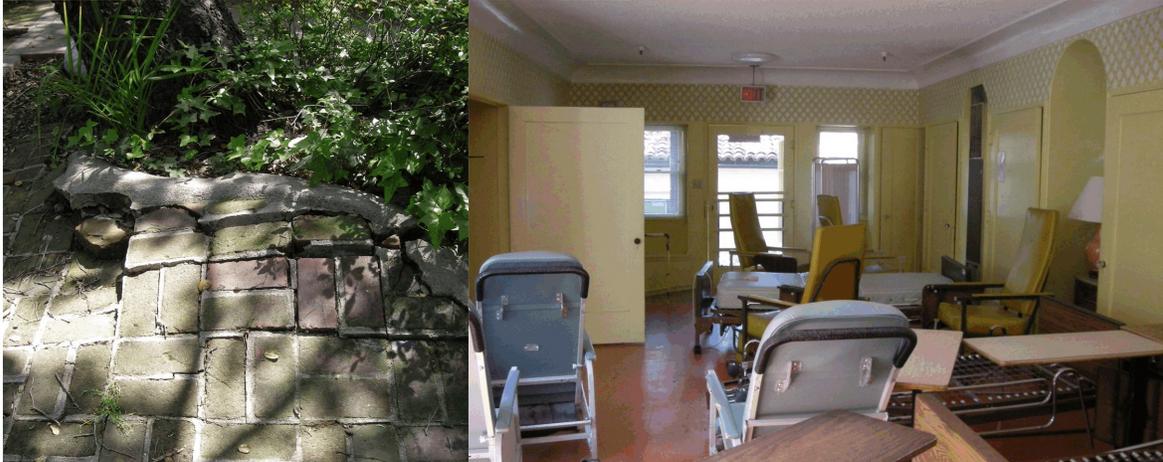
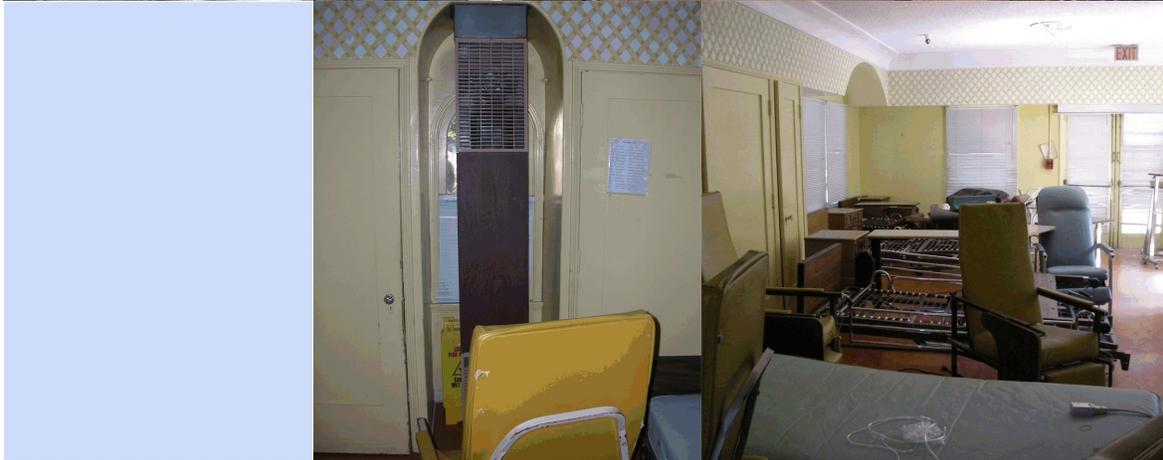
Public Works / Facilities Services
Photographs – Building E
March 26, 2008

Spanish tile roof that was in fair condition although it was covered with debris. Some of the tiles were loose but still in place. Water intrusion inside suggests that the roof layers under the tile require replacement. There were visible signs of deterioration on the exterior of the building; the stucco had cracks and damage at the foundation and there was noticeable dry rot on some of the eaves. There was dry rot and mold in the restrooms and in the hallway. In some of the rooms the plaster had fallen from the ceiling as a result of water intrusion. Interior doors were still in good condition but most of the exterior doors had damage of to one degree or another.

Structure was fed from building "J" and would require a new service. Interior fixtures were old, missing covers and lacked grounding. Restrooms lacked GFCI receptacles as per code.

Water lines are galvanized and in poor condition. Water pressure was significantly lower than other structures. Restrooms had old fixtures that need replacing. Gas main was located in the courtyard and also supplied building "J". Fire sprinklers appeared to be in good condition. There was a forty gallon water heater located in building.

1. Board up damaged exterior doors to avoid further water intrusion or infestation of vermin.

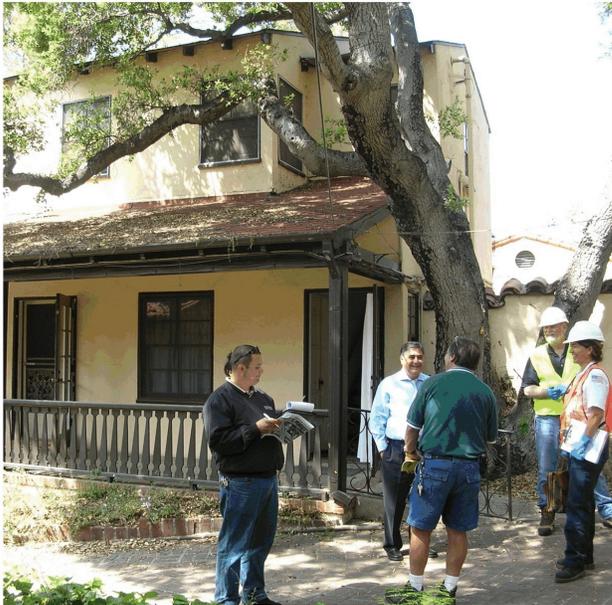
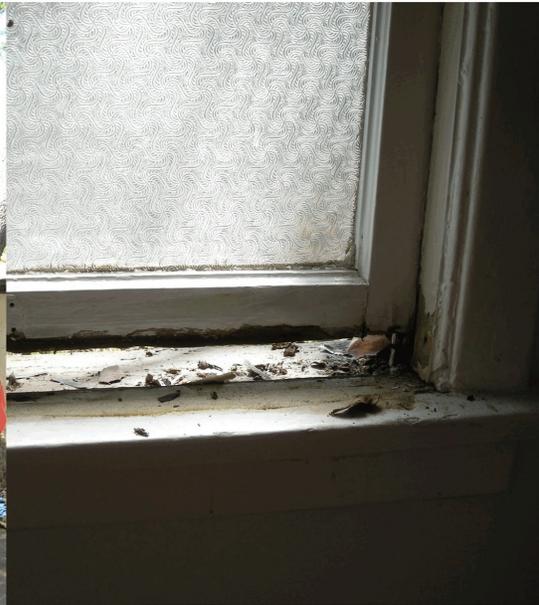
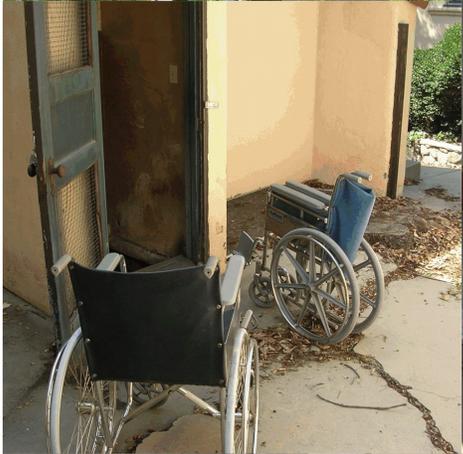
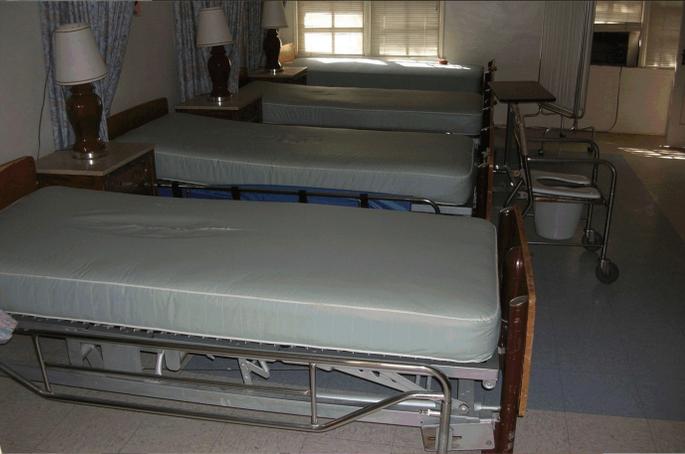
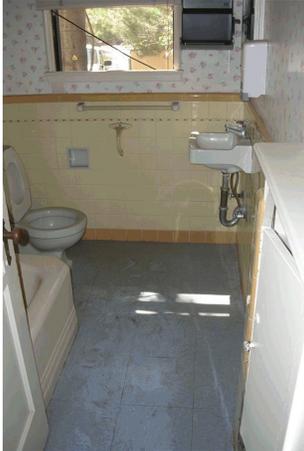
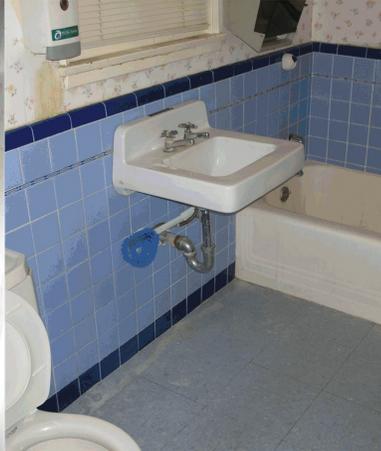
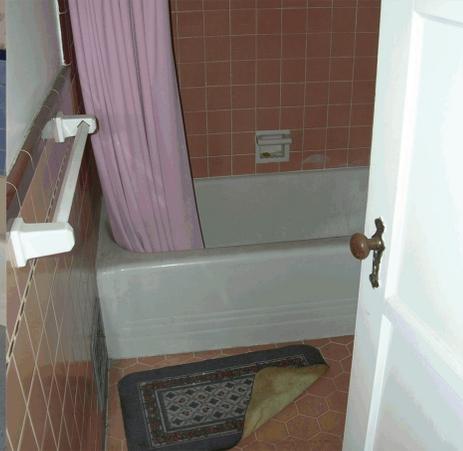
**Public Works / Facilities Services
Photographs – Building H
March 26, 2008**

Roof was composition with Spanish tile caps. The composition roof was old and deteriorated although there were no real noticeable signs of leaking. There was a minimum amount of sagging and most of the eaves were rotting. The exterior was in good condition, there was some peeling paint and areas the stucco needed repair. Windows and doors were in good condition on the lower level but had rotted sills and frames on the second level. Interior walls and ceilings were in good condition. There is an Oak tree that has grown into the foundation and exterior walls of this structure. This tree will continue to structurally damage the building until removed.

Building was fed with a 70 amp, single phase 240 volt service. There was a separate 100 amp sub panel, both of which were in good condition. There was however, a fuse hanging out of an old box in the basement that posed a serious fire/shock hazard. There were no GFCI receptacles in bathroom although for the most part grounding was ok throughout the rest of the structure. Fixtures were serviceable although covers were missing.

1. Electrical in basement area is a fire hazard and would cause injury if personnel working in the area came into contact with it. This needs immediate correction.

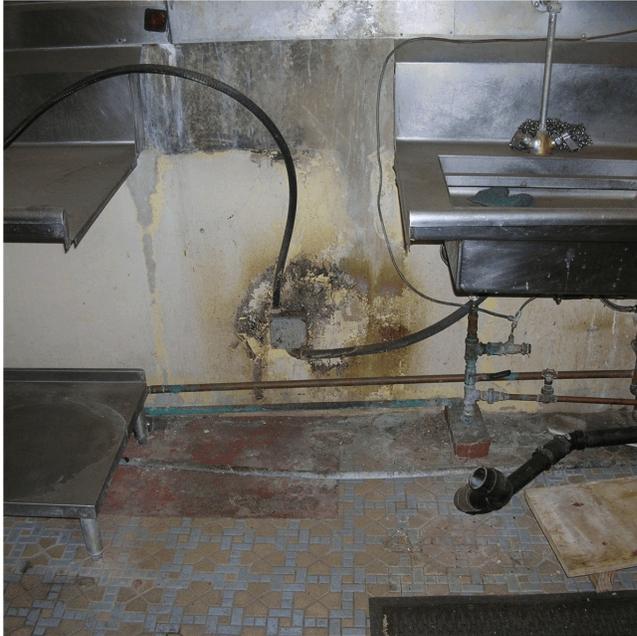
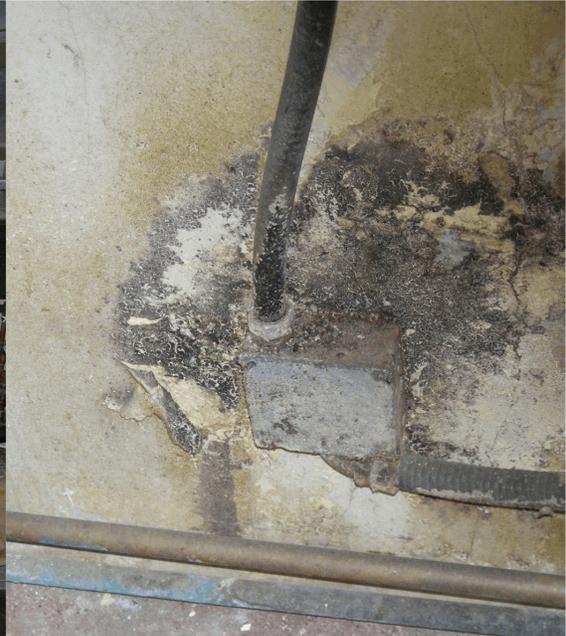
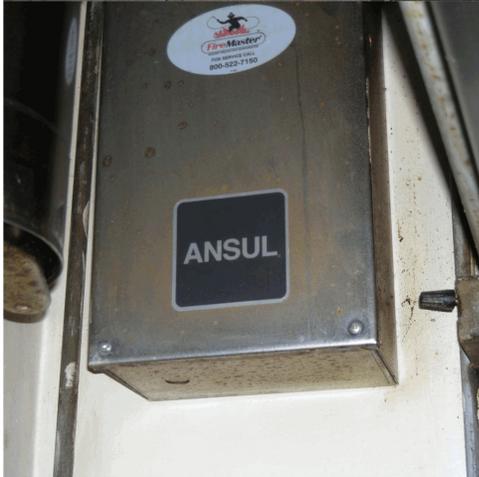
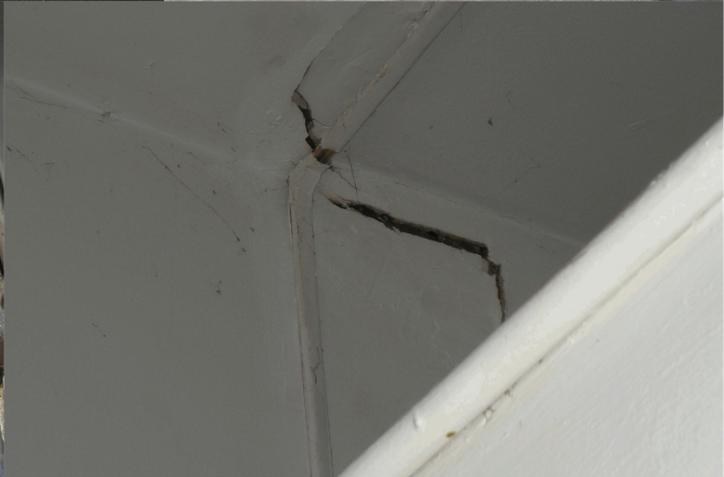
Public Works / Facilities Services
Photographs – Building I
March 26, 2008

Roof was composition with Spanish tile caps. The composition roof was old and had several layers of materials but the top layer appeared to be in fair condition. The exterior was in good condition, there was some peeling paint and in some areas the stucco needed repair. Windows and doors were in fair condition. Interior walls and ceilings were in good condition. In the ceiling over the walk in refrigeration unit, there was a crack in the ceiling and adjoining wall that had about one inch of separation. This may have been from a seismic event or building shift due to settling. There were large patches of mold on some of the interior walls in the area where a sink and dishwasher had been removed.

Building was fed from another building. There was unsafe and illegal wiring in the kitchen. Junction boxes showed signs of exposure to water over long periods of time. Fixtures were old and ungrounded with most of them missing covers.

Mold and unsafe electrical work in kitchen.

1. Remove Mold in kitchen area.
2. Make repairs to electrical system to make safe.

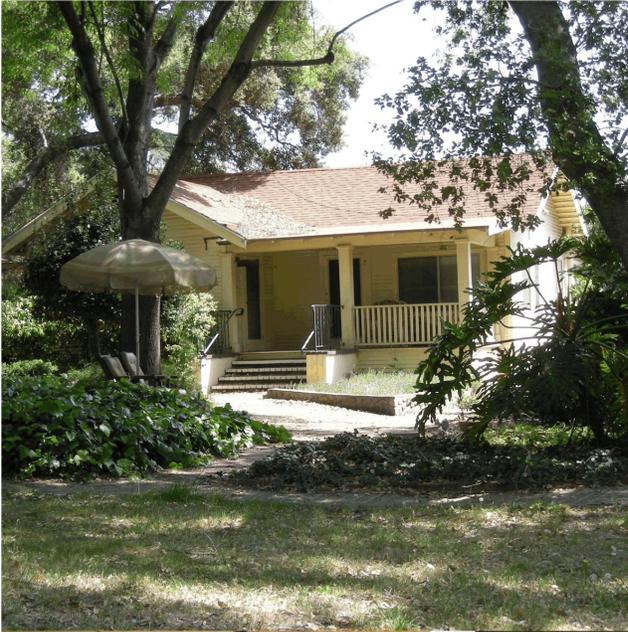
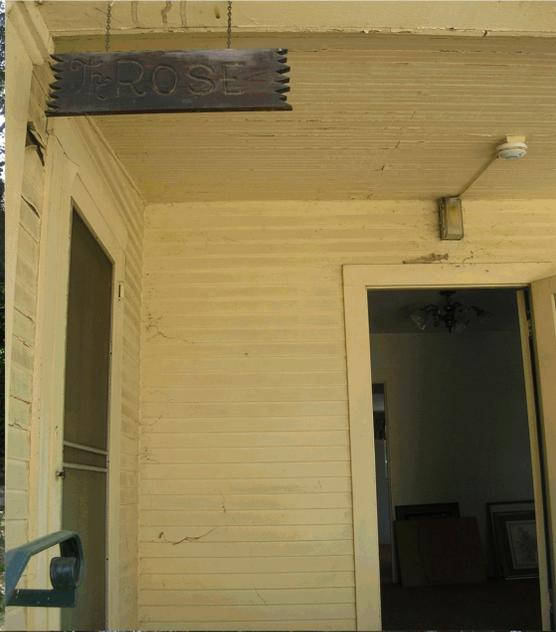
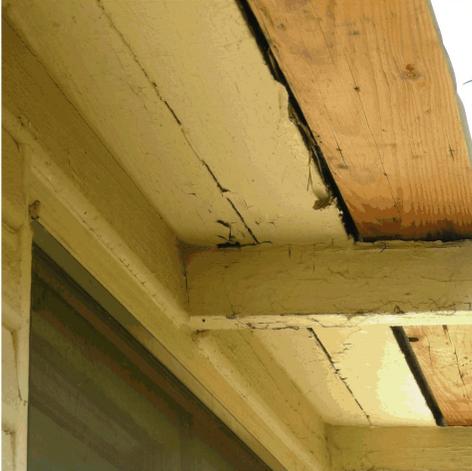
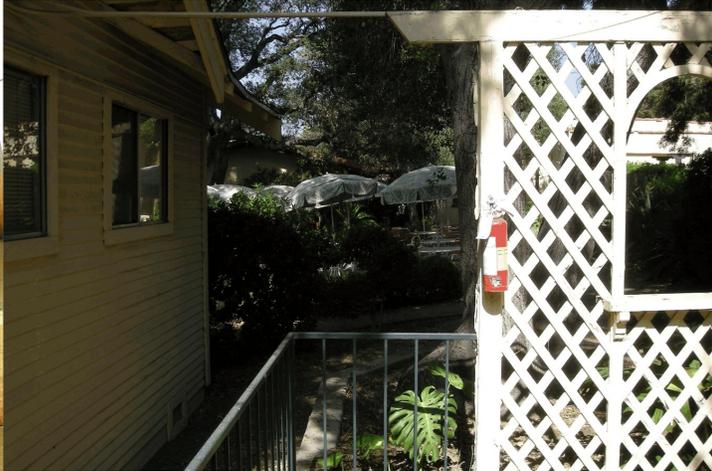
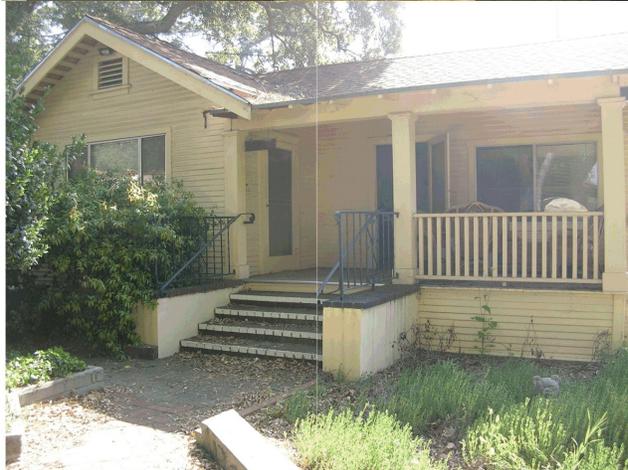
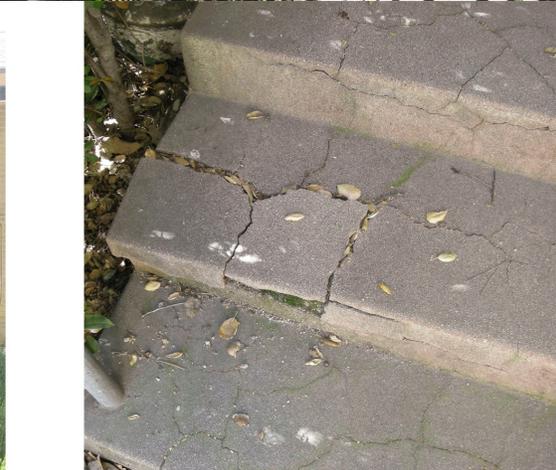
Public Works / Facilities Services
Photographs – Building M
March 26, 2008

Roof was composition and appeared in good condition. Much of the roof decking had been replaced and was in near new condition although much of the fascia roof rafters were rotten. There was minimal water damage in the bathroom on the wall and floor but otherwise interior was in good condition. Floor was solid and interior doors were still in good condition. Building was old and showed signs of wear but structurally, the entire building appeared to be in good condition.

Building was fed from a 50 amp service. The weather head was broken and there was still some knob and tube wiring. The exposed electrical "knob and tube" wiring is uninsulated in places and poses a serious fire hazard. There was a separate fuse box in a closet and the fixtures were all old, many of them missing covers. A disconnect for the A/C unit was located on the North East side of the building and it was in good condition. There were no GFCI receptacles in the restroom.

Electrical poses a serious hazard to this structure and structure "P".

1. Electrical wiring in the attic places this structure in imminent fire danger. The power was disconnected to this building by City staff and the on-site property representative was notified.
