Photo Report

Brand Park

Finding: Brand Park, located at 1601 West Mountain in Glendale California, was inspected by Disability Access Consultants, Inc., on June 8, 2007.

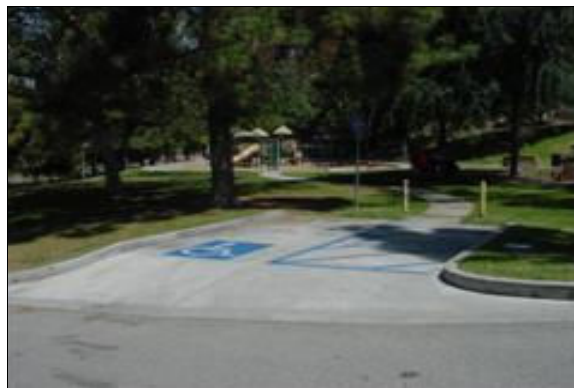
Finding: Parking Continued: The designated "van-accessible" parking space provides an access aisle, located on the passenger side (right side) of the parking space, measuring 98 inches wide. Two of the standard accessible parking spaces provide an adjacent access aisle measuring at least 60 inches wide. Two of the standard accessible parking spaces provide an adjacent access aisle measuring less than 60 inches wide. The access aisles do not contain "NO PARKING" in 12" high white letters.

Full Rec: Restripe the designated accessible parking spaces to create one van-accessible and four standard accessible parking spaces, each measuring at least 108 inches wide and 216 inches long. The van-accessible space shall provide an access aisle measuring at least 96 inches wide (8 feet) on the passenger side (right side) of the vehicle space (see CBC 1129B). The additional parking spaces shall each provide an access aisle measuring at least 60 inches wide, that may be shared. Add the words NO PARKING in 12 inch high white letters at the entrance to each accessible parking access aisle.

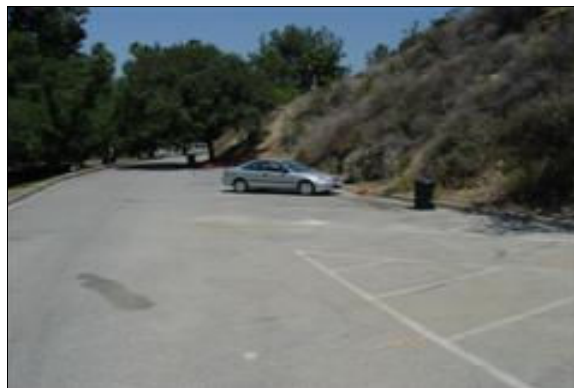
Finding: There is no crosswalk provided on the path of travel from three of the accessible parking spaces to the facility. The required accessible route crosses a vehicular way.

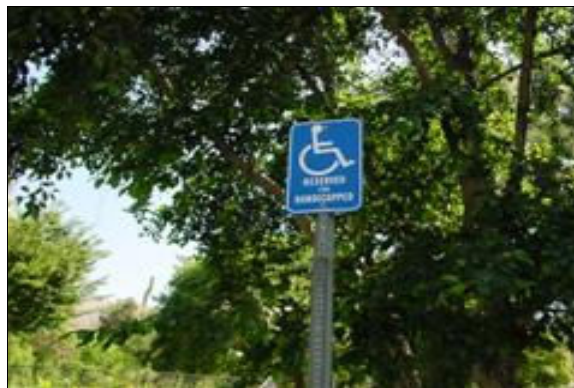
Finding: There is no vertically-mounted signage at one of the designated accessible parking spaces in the parking lot showing the International Symbol of Accessibility. The signage at three of the designated accessible parking spaces in the parking lot showing the International Symbol of Accessibility uses the word "handicapped".

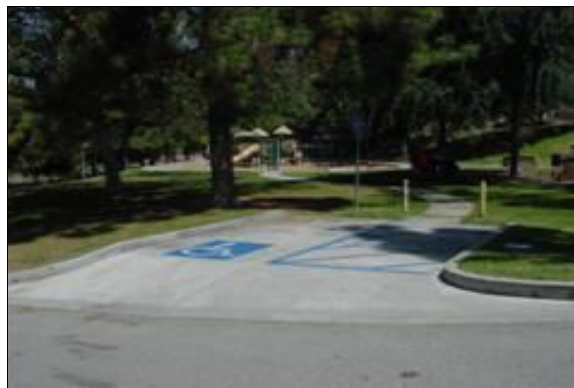
Finding: The access aisle at the one of the designated accessible parking spaces is not separated from the pedestrian walkway by a curb or railing or other elements between the pedestrian areas and vehicular areas. There is no detectable warning surface which includes truncated domes.

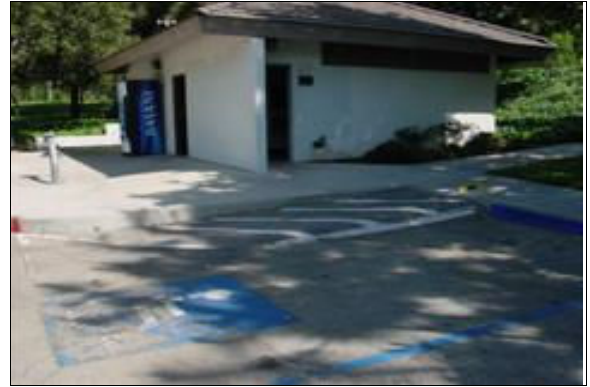
Finding: The built-up curb ramp at the accessible parking space next to the restrooms projects into an access aisle and interferes with individuals entering or exiting parked or standing vehicles. The slope at the top landing is greater than 2%. The slope at the bottom landing is greater than 2%. The curb ramp does not provide a grooved border along the top and sides of the ramp at the level of the sidewalk. The concrete curb ramp does not provide a detectable warning surface which includes truncated domes.

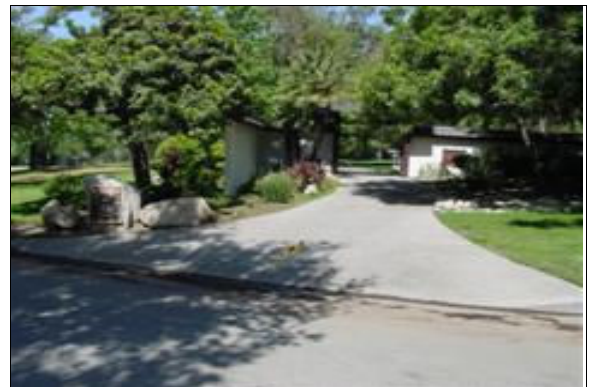
Finding: The slope at the bottom landing is greater than 2%. The curb ramp does not provide a grooved border along the top and sides of the ramp at the level of the sidewalk. The concrete curb ramp does not provide a detectable warning surface which includes truncated domes.

Full Rec: Replace the curb ramp with a compliant curb ramp at least 48 inches in width that provides a slope no greater than 8.33%. Install a detectable warning surface which extends the full length and width of the concrete curb ramp and its side flares with truncated domes that contrast visually by either light on dark or dark on light which is an integral part of the concrete curb ramp. The truncated domes may be cast in place or stamped or of a prefabricated surface treatment (see CBC 1127B.5.8).

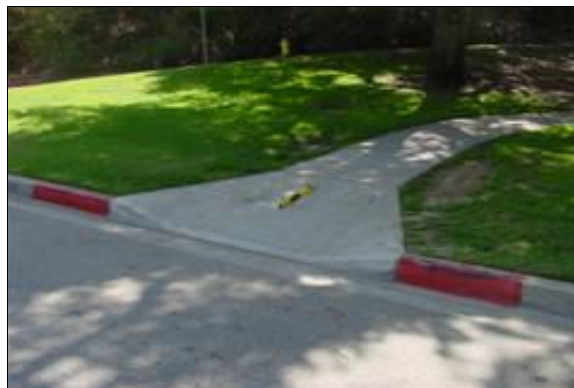
Finding: The slope of the curb ramp is greater than 8.33%. The cross slope is greater than 2%. The slope at the top landing is greater than 2%. The slope at the bottom landing is greater than 2%. The slope of the side flares is greater than 10%. The curb ramp does not provide a grooved border along the top and sides of the ramp at the level of the sidewalk. The concrete curb ramp does not provide a detectable warning surface which includes truncated domes.

Full Rec: Replace the curb ramp with a compliant curb ramp at least 48 inches in width that provides a slope no greater than 8.33%. Install a detectable warning surface which extends the full length and width of the concrete curb ramp and its side flares with truncated domes that contrast visually by either light on dark or dark on light which is an integral part of the concrete curb ramp. The truncated domes may be cast in place or stamped or of a prefabricated surface treatment (see CBC 1127B.5.8).

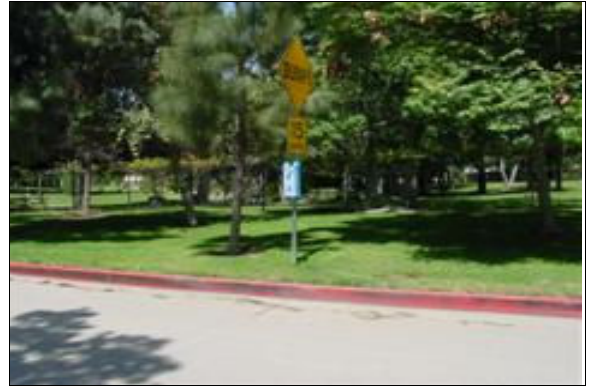
Path of Travel to the Dog Walk Bags

Finding: The accessible route to the dog walk bags next to the Library crosses a curb. There is no curb ramp provided.

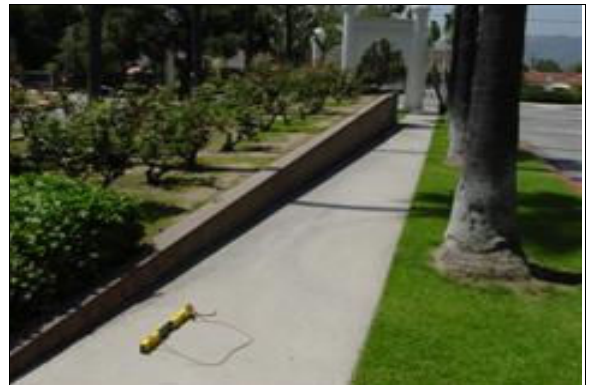
Accessible Route from the Public Right of Way

Finding: There is no accessible route from the public right of way to the accessible entrance of the facility. There are slopes greater than 5% along the accessible path of travel. The accessible route to the park crosses a curb. The required accessible route crosses a vehicular way.

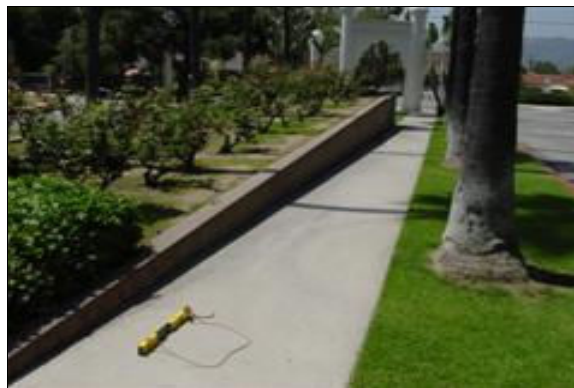
Accessible Route from the Public Right of Way

Finding: There are slopes greater than 5% on the primary path of travel from the public right of way to the park.

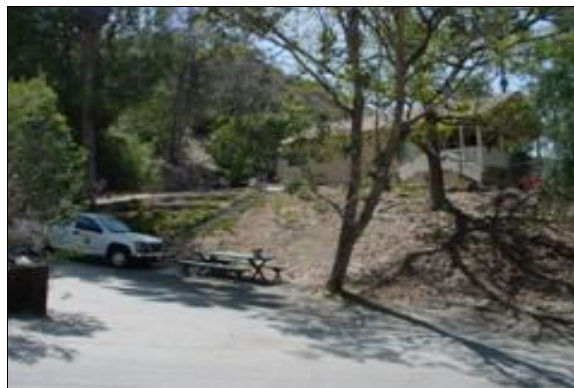
Finding: At the time of facility inspection, the Caretaker's House was locked and was unavailable for a complete ADA compliance inspection.

Full Rec: Due to the unavailability of a specific element at the time of the facility inspection process, it is recommended that upon availability all elements should be inspected for ADA compliance.

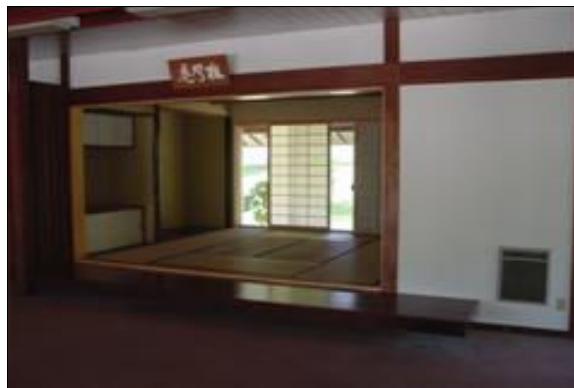
Path of Travel in the Tea House

Finding: There is a raised platform in the Tea House, preventing access to individuals with mobility impairments.

Full Rec: Since programs, services and activities to staff and the public are provided in this location, those programs, services and activities are required to be made accessible. It is recommended that a ramp be installed or other means of vertical access.

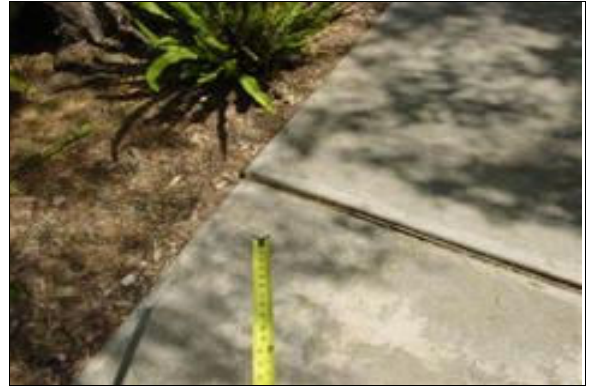
Path of Travel Outside of the Doctor's House

Finding: There is a change in elevation greater than 1/2 inch on the primary path of travel to the accessible ramp at the rear of the Doctor's House.

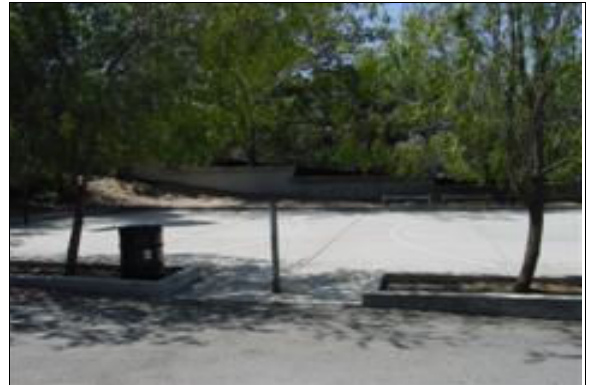
Path of Travel to the Basketball Court

Finding: There is no crosswalk provided on the path of travel to the basketball court. The required accessible route crosses a vehicular way.

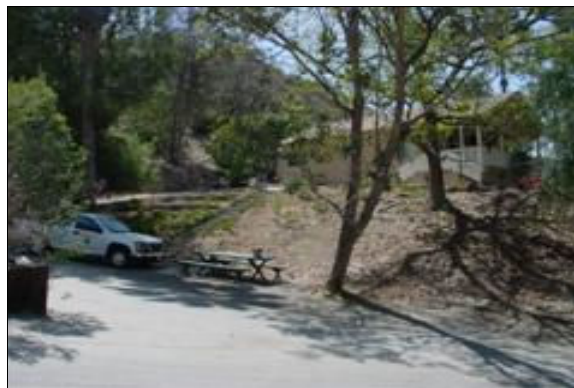
Path of Travel to the Caretaker's House

Finding: There is no crosswalk provided on the path of travel to the Caretaker's House. The required accessible route crosses a vehicular way.

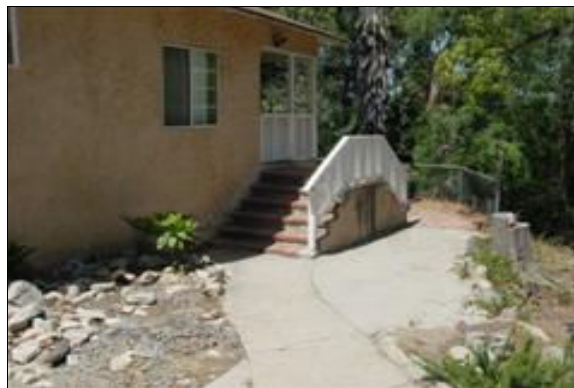
Path of Travel to the Caretaker's House

Finding: There are only stairs to the primary functions provided, preventing access to individuals with mobility impairments.

Full Rec: Since programs, services and activities to staff and the public (volunteers, etc.) are provided in this location, those programs, services and activities are required to be made accessible. It is recommended that a ramp be installed or other means of vertical access.

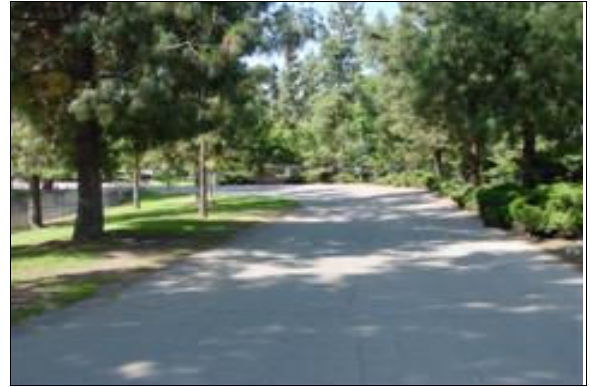
Path of Travel to the Doctor's House

Finding: There is no crosswalk provided on the path of travel to the Doctor's House. The required accessible route crosses a vehicular way. There are slopes greater than 5% on the primary path of travel to the Doctor's House.

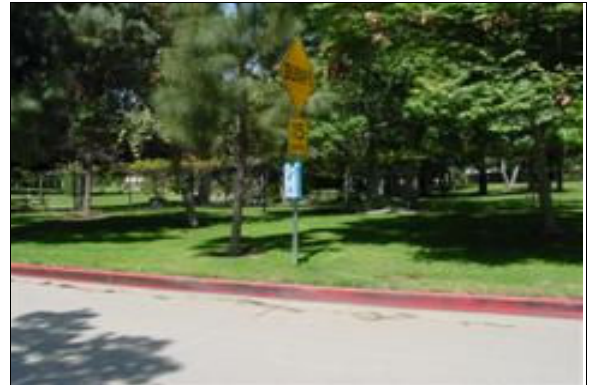
Path of Travel to the Dog Walk Bags

Finding: The path of travel to the dog walk bags next to the Library is grass, preventing access to individuals with mobility impairments.

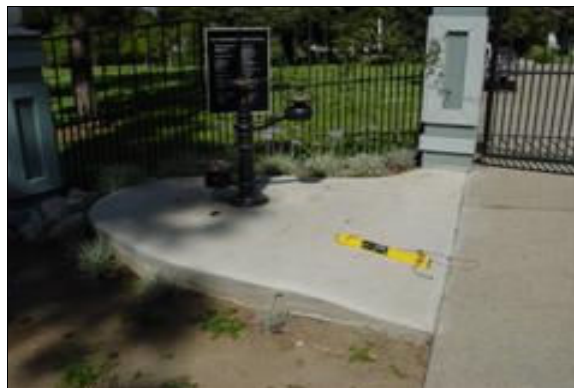
Path of Travel to the Drinking Fountain

Finding: There are slopes greater than 5% on the primary path of travel to the drinking fountain at the Doctor's House.

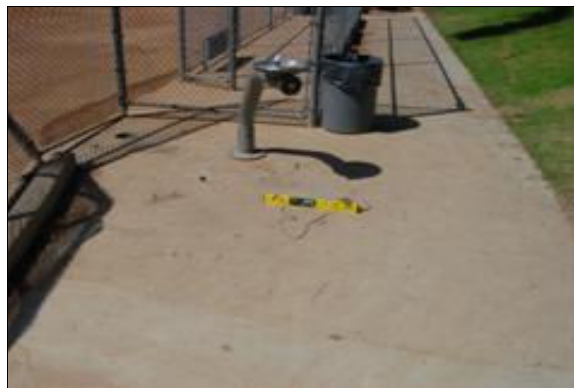
Path of Travel to the Drinking Fountain at the Baseball Field

Finding: There are cross slopes greater than 2% on the primary path of travel to the drinking fountain, at the right, at the baseball field.

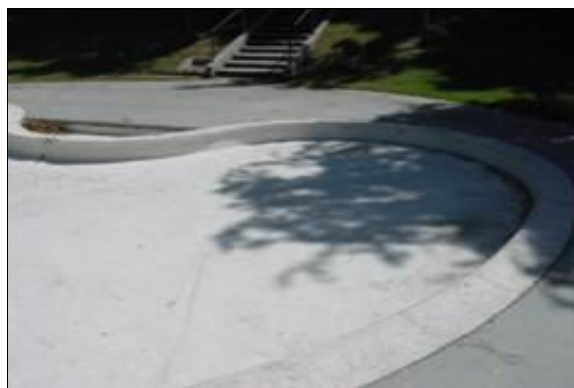
Path of Travel to the Lower Play Area

Finding: There are only stairs to the primary functions provided, preventing access to individuals with mobility impairments.

Full Rec: Since programs, services and activities to staff and the public are provided in this location, those programs, services and activities are required to be made accessible. It is recommended that a ramp be installed or other means of vertical access.

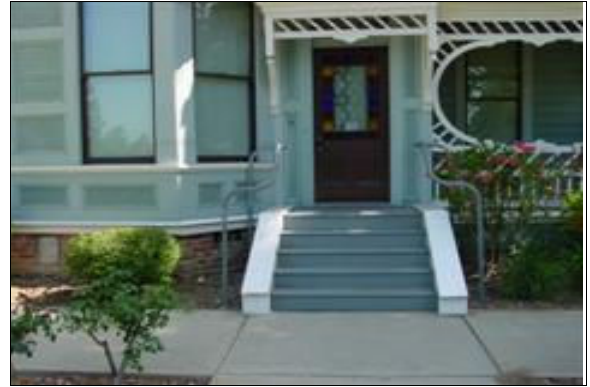
Path of Travel to the Main Entrance at the Doctor's House

Finding: There are only stairs on the path of travel to the primary entrance, preventing access to individuals with mobility impairments. There is no signage posted directing individuals with disabilities to the accessible entrance.

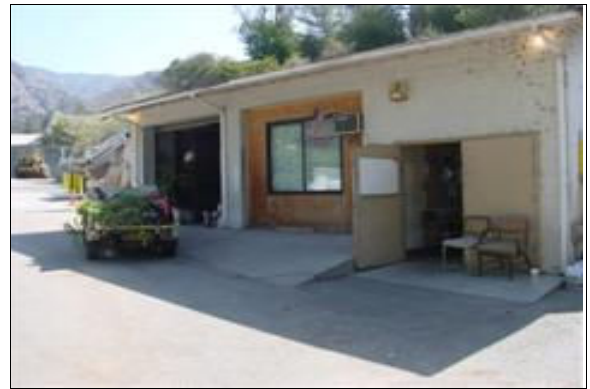
Path of Travel to the Maintenance Office

Finding: There are slopes greater than 5% on the primary path of travel to the Maintenance Office.

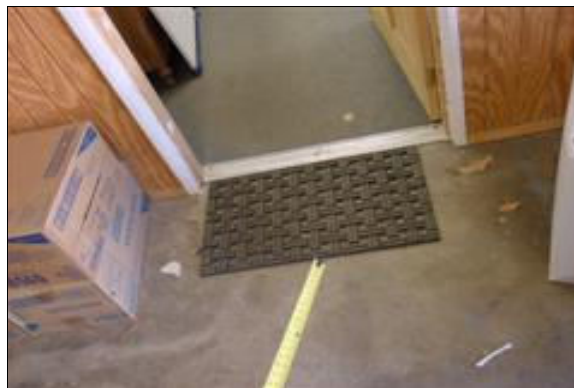
Path of Travel to the Maintenance Office

Finding: The mat at the entrance does not adhere to the underlying floor surface and creates a hazardous path of travel.

Full Rec: Securely fasten the mats or replace with a mat that grips to the underlying floor surface to provide a firm, stable, continuous and relatively smooth path of travel surface (see CBC 1124B.3 and ADAAG 4.5.3). Mats along the primary path of travel shall provide beveled edges on all sides to prevent roll over.

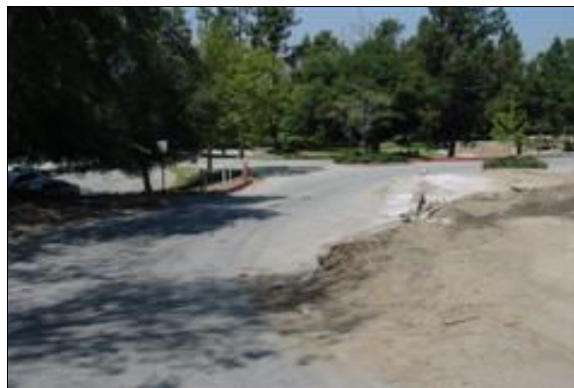
Finding: There is no crosswalk provided on the path of travel to the play equipment. The required accessible route crosses a vehicular way.

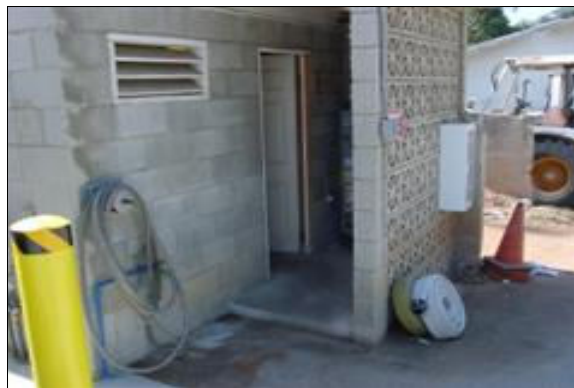
Path of Travel to the Restroom at the Maintenance Yard

Finding: There is a step on the primary path of travel to the restroom at the maintenance yard, preventing access to individuals with mobility impairments.

Full Rec: Since programs, services and activities to staff and the public (volunteers, etc.) are provided in this location, those programs, services and activities are required to be made accessible. It is recommended that a ramp be installed or other means of vertical access.

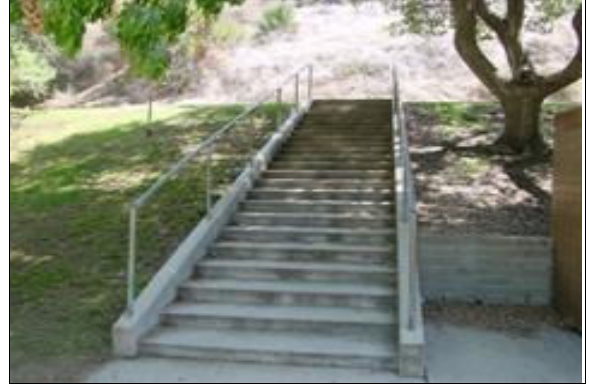
Exterior Stairs at the Restrooms Next to the Play Equipment

Finding: There is no detectable striping on each tread of the exterior stairway.

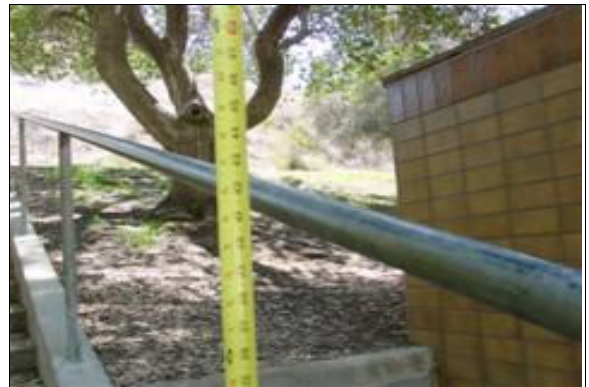
Exterior Stairs at the Restrooms Next to the Play Equipment

Finding: The handrails do not provide 12-inch extensions beyond the top and bottom treads. The handrails are mounted at a height greater than 38 inches.

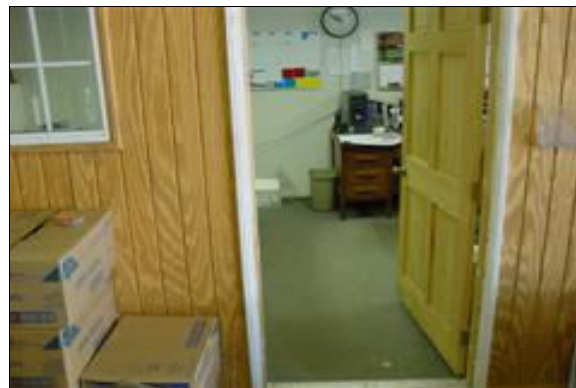
Maintenance Office

Finding: There is no signage with the International Symbol of Accessibility on the entrance door designating it as accessible.

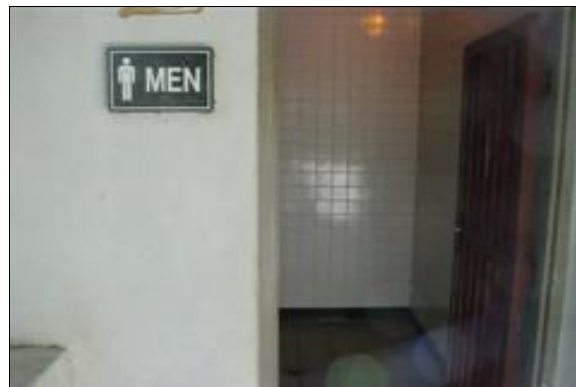
Men's Restroom Next to the Baseball Field

Finding: There is no signage indicating accessibility on the latch side of the entry door of the restroom. There is no Title 24 gender use signage on the entrance door.

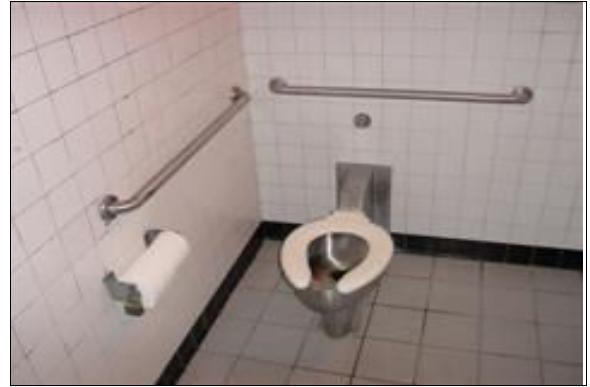
Men's Restroom Next to the Baseball Field

Finding: There is insufficient clear floor space in the stall designated to be accessible in the restroom. The door to the stall designated to be accessible in the restroom does not close automatically or have accessible hardware.

Full Rec: Modify or replace the stall designated to be accessible in the restroom so that it complies with ADAAG 4.17.3, CBC 1115B and CBC Figures 11B-1A and 1B. Standard accessible stalls require 60 inches in width with 56 inches depth for wall-mounted toilets or 59 inches depth for floor-mounted toilets to accommodate individuals in wheelchairs. The minimum width of a front-approach doorway shall provide at least 32 inches and a side-approach doorway shall provide at least 34 inches. The door shall swing outward, close automatically and provide accessible hardware.

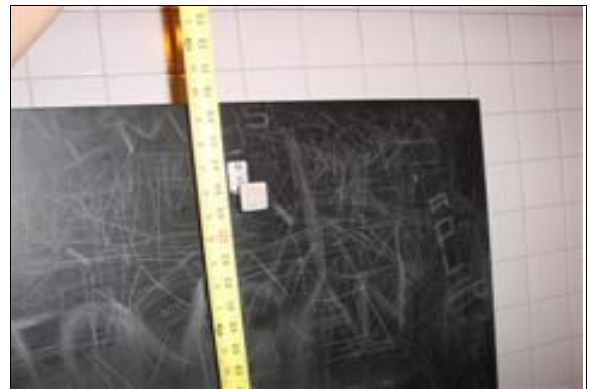
Men's Restroom Next to the Baseball Field

Finding: The height of the coat hook on the stall door designated to be accessible in the restroom is greater than 48 inches above the floor surface.

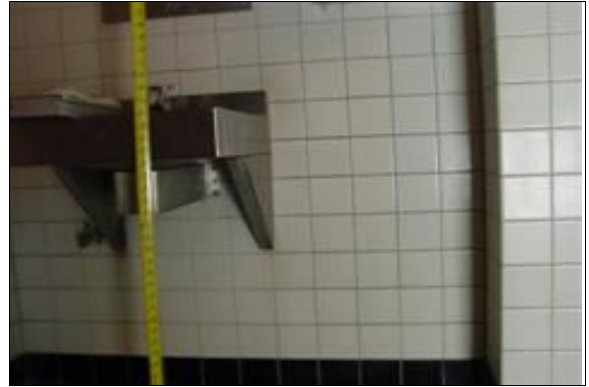
Men's Restroom Next to the Baseball Field

Finding: The knee depth space under the lavatory designated to be accessible in the restroom is less than 27 inches at 8 inches under the lavatory apron.

Full Rec: Raise or replace the lavatory designated to be accessible in the restroom to provide at least 27 inches at 8 inches under the apron. Make sure to provide at least 29 inches of clear knee space between the finished floor and bottom of the lavatory apron and a rim surface height no greater than 34 inches (see ADAAG 4.19.2).

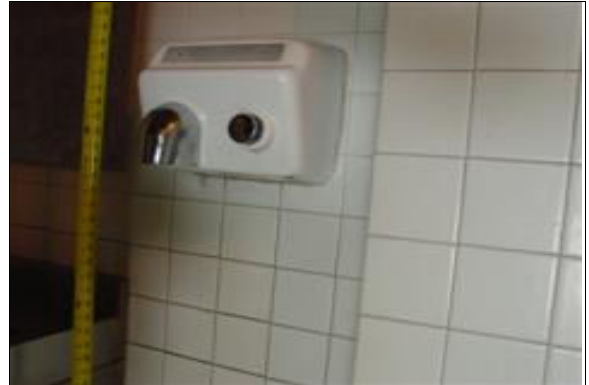
Men's Restroom Next to the Baseball Field

Finding: The height of the controls and operating mechanisms for the hand dryer in the restroom is greater than 40 inches.

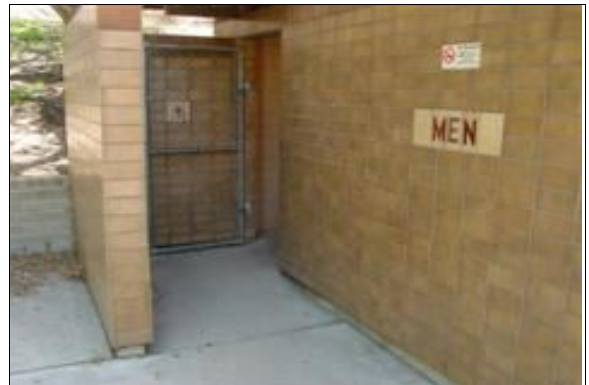
Men's Restroom Next to the Play Equipment

Finding: There is no signage indicating accessibility on the latch side of the entry door of the restroom. There is no Title 24 gender use signage on the entrance door.

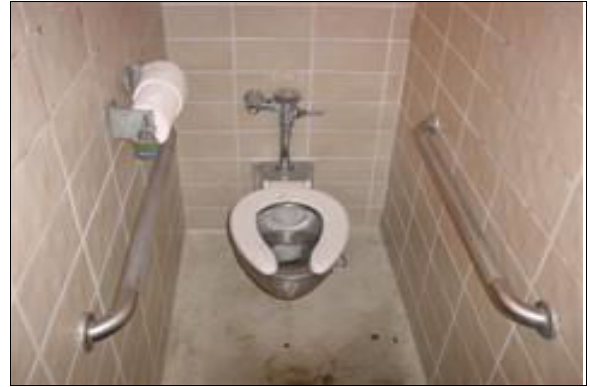
Men's Restroom Next to the Play Equipment

Finding: There is insufficient clear floor space in the stall designated to be accessible in the restroom.

Full Rec: Modify or replace the stall designated to be accessible in the restroom so that it complies with ADAAG 4.17.3, CBC 1115B and CBC Figures 11B-1A and 1B. Standard accessible stalls require 60 inches in width with 56 inches depth for wall-mounted toilets or 59 inches depth for floor-mounted toilets to accommodate individuals in wheelchairs. The minimum width of a front-approach doorway shall provide at least 32 inches and a side-approach doorway shall provide at least 34 inches. The door shall swing outward, close automatically and provide accessible hardware.

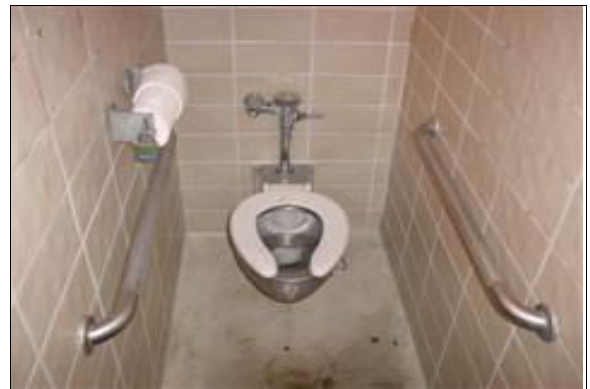
Men's Restroom Next to the Play Equipment

Finding: There is no back grab bar in the stall designated to be accessible in the restroom.

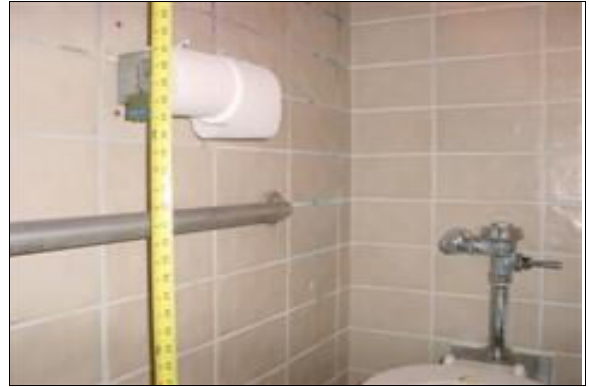
Men's Restroom Next to the Play Equipment

Finding: The height of the side grab bars in the stall designated to be accessible of the restroom is less than 33 inches above the finished floor.

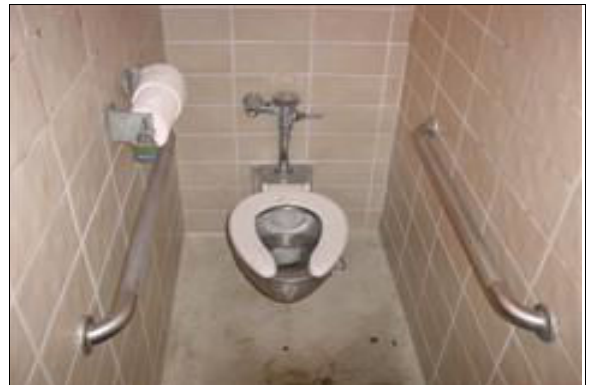
Men's Restroom Next to the Play Equipment

Finding: The length of the side grab bars in the stall designated to be accessible in the restroom is less than 42 inches. The side grab bars in the stall designated to be accessible in the restroom do not extend 54 inches from the back wall.

Full Rec: Replace the side grab bars in the stall designated to be accessible in the restroom with a 42-inch/ 48 -inch side grab bar complying with ADAAG 4.26 and CBC 1115B.8. The front end of the grab bars shall extend at least 54 inches from the back wall and the back end of the grab bar shall be mounted within 12 inches from the back wall. Grab bars must be able to support a point load of at least 250 pounds and shall be less than the allowable shear stress of the grab bar material.

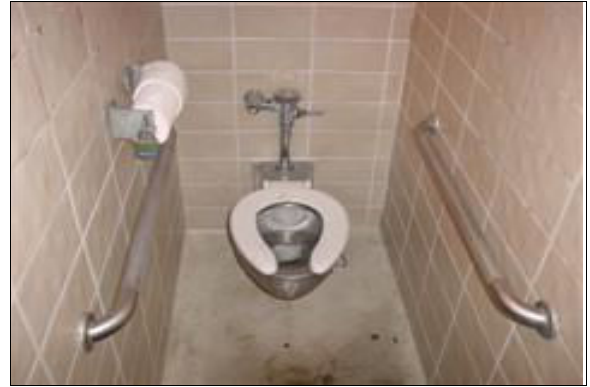
Men's Restroom Next to the Play Equipment

Finding: The distance from the end of the side grab bars to the back wall in the stall designated to be accessible in the restroom is greater than 12 inches.

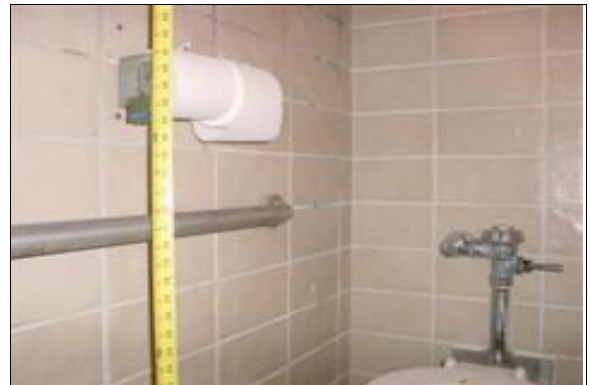
Men's Restroom Next to the Play Equipment

Finding: The toilet paper dispenser in the stall designated to be accessible in the restroom interferes with the use of the side grab bar.

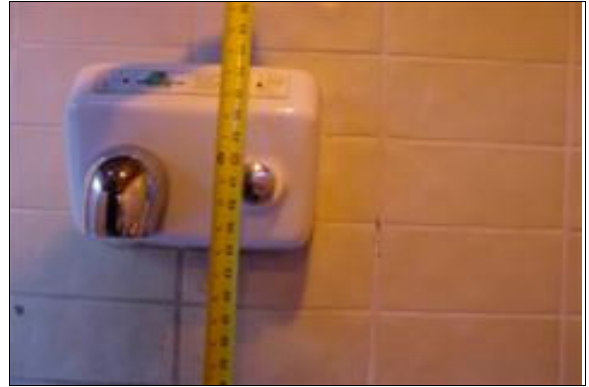
Finding: The height of the controls and operating mechanisms for the hand dryer in the restroom is greater than 40 inches.

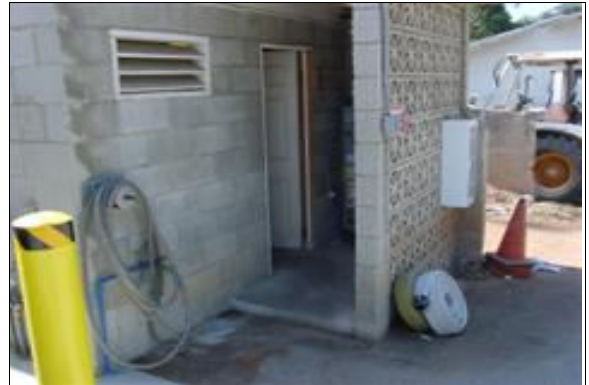
Finding: There is no signage indicating accessibility on the latch side of the entry door of the restroom. There is no Title 24 gender use signage on the entrance door.

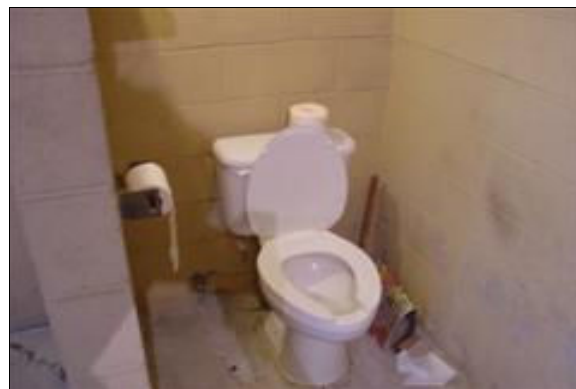
Unisex Restroom at the Maintenance Yard

Finding: There are no grab bars in the stall designated to be accessible in the restroom.

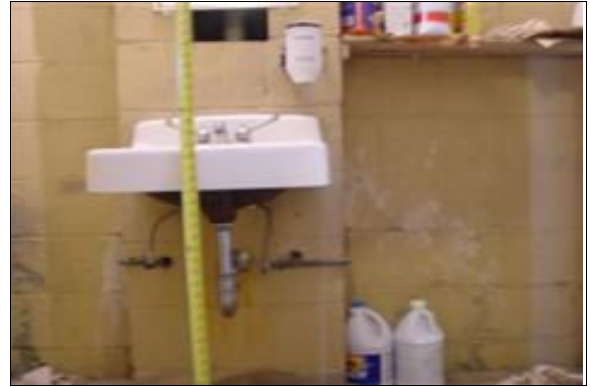
Unisex Restroom at the Maintenance Yard

Finding: The pipes under the lavatory in the restroom do not provide protection against contact.

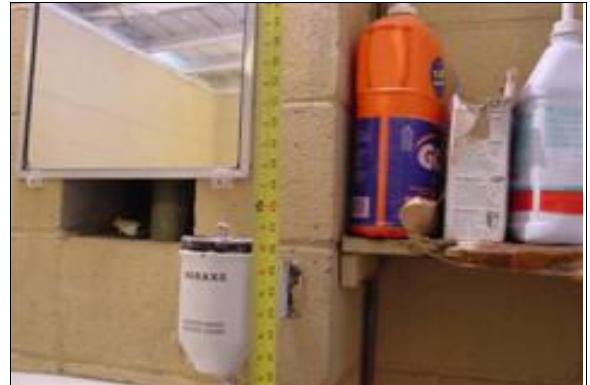
Unisex Restroom at the Maintenance Yard

Finding: The bottom edge of the reflecting surface of the mirror in the restroom is greater than 40 inches above the finished floor.

Full Rec: Lower the mirror in the restroom so that the bottom edge of the reflecting surface is no higher than 40 inches above the finished floor and the topmost portion of the reflecting surface extends at least 74 inches above the finished floor (see ADAAG A4.19.6). A single, full-length mirror is recommended since it can accommodate all people. Make certain to provide a minimum clear floor space in front of the mirror of 30 inches in width and 48 inches in length.

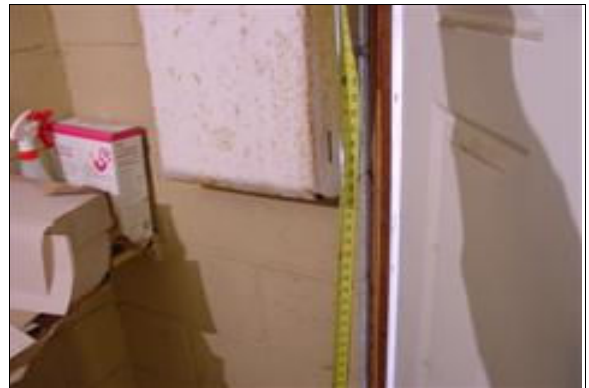
Unisex Restroom at the Maintenance Yard

Finding: The height of the controls and operating mechanisms for the paper towel dispenser in the restroom is greater than 40 inches.

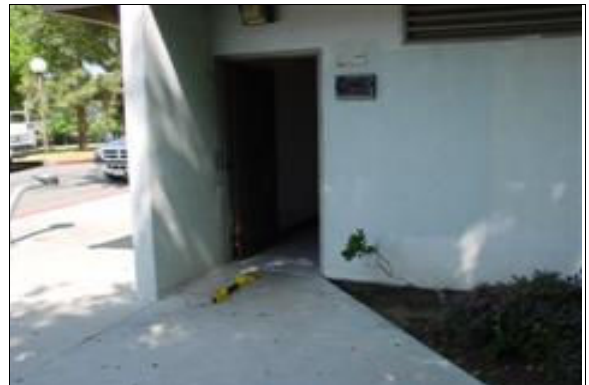
Women's Restroom Next to the Baseball Field

Finding: There is no signage indicating accessibility on the latch side of the entry door of the restroom. There is no Title 24 gender use signage on the entrance door.

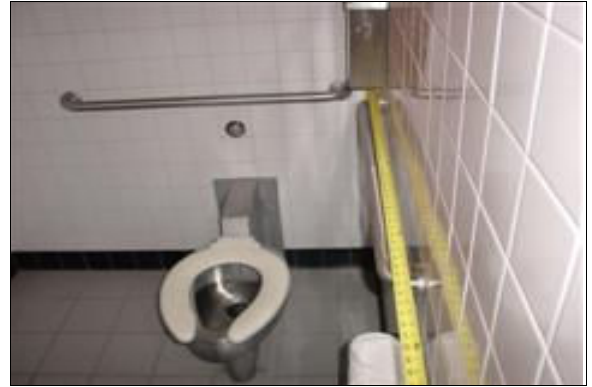
Women's Restroom Next to the Baseball Field

Finding: The feminine product disposal in the stall designated to be accessible in the restroom interferes with the use of the side grab bar.

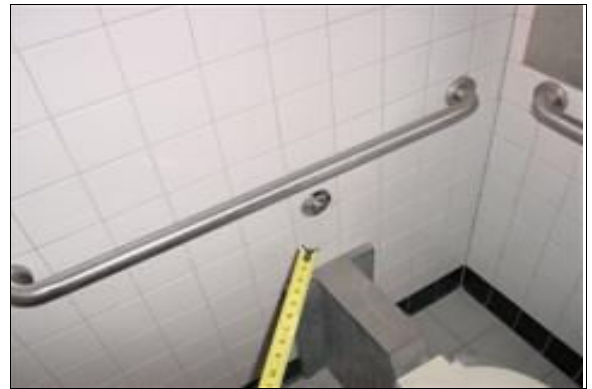
Women's Restroom Next to the Baseball Field

Finding: The flush control on the toilet in the stall designated to be accessible in the restroom is not on the wide (approach) side of the toilet.

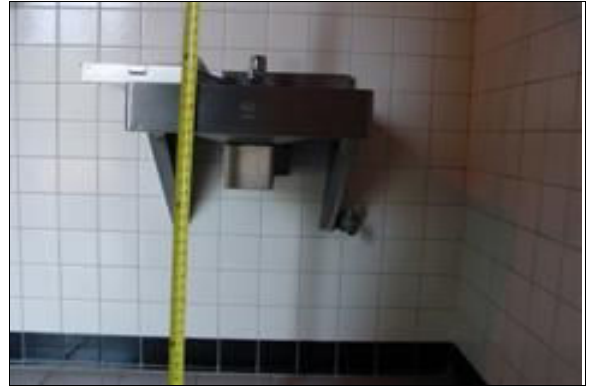
Women's Restroom Next to the Baseball Field

Finding: The knee depth space under the lavatory designated to be accessible in the restroom is less than 27 inches at 8 inches under the lavatory apron.

Full Rec: Raise or replace the lavatory designated to be accessible in the restroom to provide at least 27 inches at 8 inches under the apron. Make sure to provide at least 29 inches of clear knee space between the finished floor and bottom of the lavatory apron and a rim surface height no greater than 34 inches (see ADAAG 4.19.2).
