Chess Park

Programs, Services, and Activities

Finding: Chess Park, located at 227 North Brand in Glendale California, was inspected by Disability Access Consultants, Inc., on June 18, 2007.

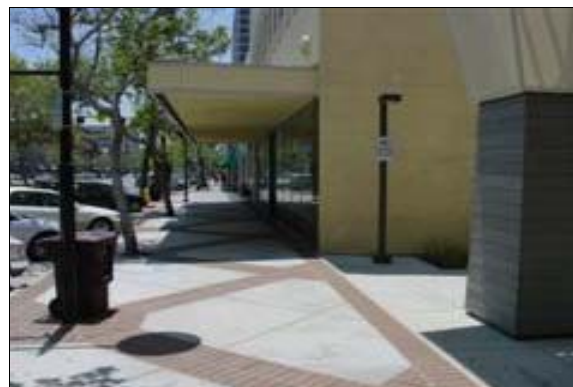
Accessible Route from the Public Right of Way

Finding: There is an accessible route from the public right of way to the accessible entrance of the facility.

Full Rec: Post directional signage. Make certain to post signage indicating the direction to accessible building entrances at every major junction along the accessible route. Signs shall include the International Symbol of Accessibility.

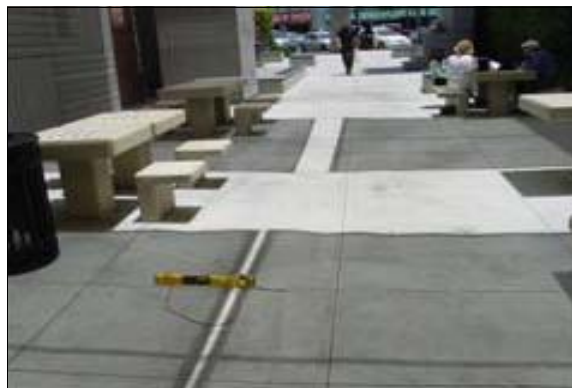
Path of Travel Along Chess Park

Finding: There are cross slopes greater than 2% on the primary path of travel along Chess Park.

Full Rec: Resurface the path of travel to provide a level surface that does not exceed a slope greater than 5%. Cross slopes shall not exceed 2%.

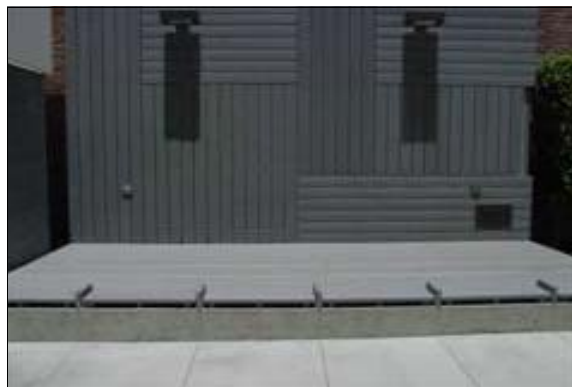
Path of Travel to the Stage

Finding: There is a step on the primary path of travel to the stage, preventing access to individuals with mobility impairments.

Full Rec: Since programs, services and activities to staff and the public are provided in this location, those programs, services and activities are required to be made accessible. It is recommended that a ramp be installed or other means of vertical access.

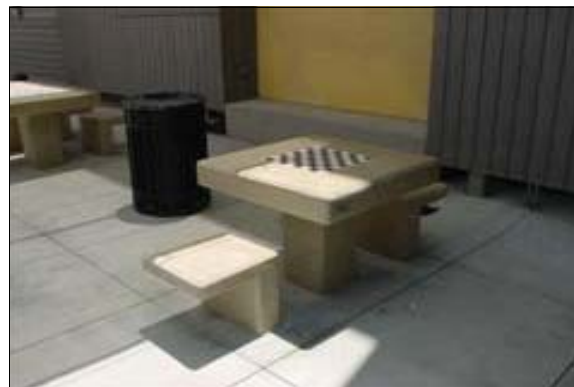
Chess Tables

Finding: The knee space at the tables is less than 19 inches deep.

Full Rec: Modify or replace one of the tables to provide knee clearance of at least 27 inches in height, 30 inches in width and 19 inches in depth (see CBC 1122B.3, ADAAG 4.32.2 and ADAAG Figure 45). The table top height shall not exceed 34 inches above the finished floor.
