Photo Report
Deukmejian Wilderness Park
Programs, Services, and Activities

Finding: The Deukmejian Wilderness Park, located at 5142 Dunsmore Avenue in Glendale California, was inspected by Disability Access Consultants, Inc., on June 5, 2007.

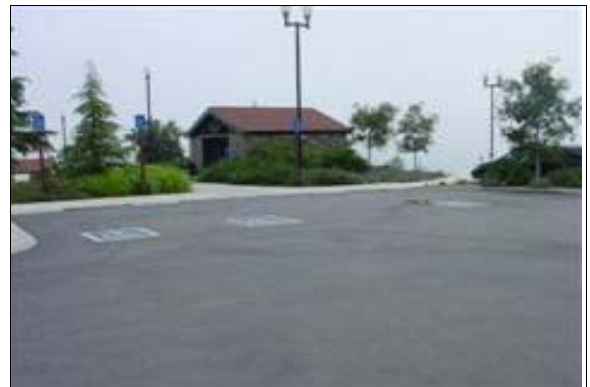
Finding: There are two parking lots provided at the facility. The paved parking lots are located next to the restrooms and next to the Ranger Station.

Full Rec: Accessible paved parking spaces shall be located on the shortest accessible route of travel to the facility and shall coincide with the primary route and primary entrances used by the general public (see CBC 1129B.4, ADAAG 4.3.2(1) and ADAAG 4.14.1).

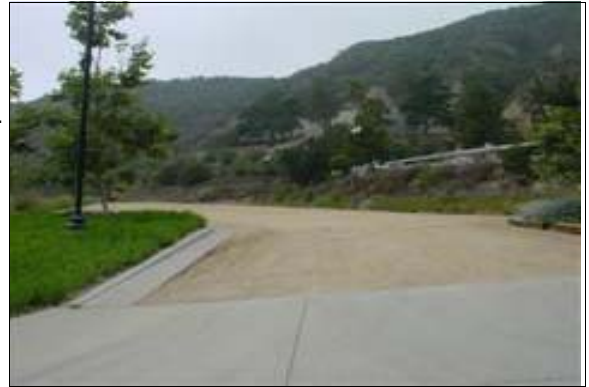
Parking Lot Next to the Ranger Station

Finding: Parking is provided off-street to the public and/or employees next to the Ranger Station, though the parking lot surface is dirt and nonaccessible. The parking lot can provide approximately 40 parking spaces.

Full Rec: Pave the parking lot and stripe parking spaces with an appropriate number of accessible parking spaces designated to comply with CBC 1129B and ADAAG 4.6.

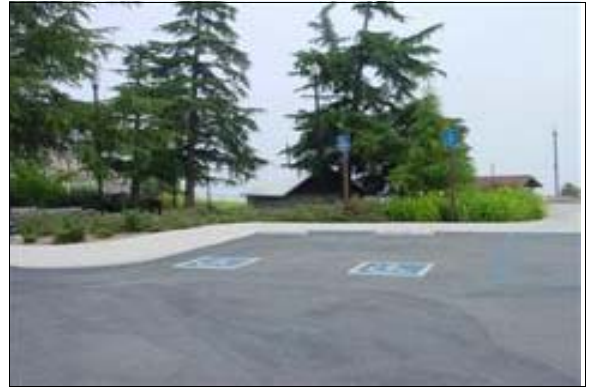
Parking Lot Next to the Restrooms

Finding: There are three accessible parking spaces out of 21 parking spaces which is sufficient in number as required for compliance. The accessible parking space at the left measures 105 inches wide and 217 inches long. There is no access aisle provided adjacent to the accessible parking space. The van-accessible parking space and the adjacent standard accessible parking space measure at least 108 inches wide and 216 inches long. The accessible parking spaces share a common access aisle measuring at least 96 inches wide. The access aisle does not contain "NO PARKING" in 12" high white letters.

Full Rec: Three out of the 21 total number of marked parking spaces meets the number required to be designated exclusively for accessible parking according to ADAAG and CBC 1129B. Restripe the designated accessible parking spaces to create one van-accessible and two standard accessible parking space, each measuring at least 108 inches wide and 216 inches long. The van-accessible space shall provide an access aisle measuring at least 96 inches wide (8 feet) on the passenger side (right side) of the vehicle space (see CBC 1129B). The additional parking spaces shall each provide an access aisle measuring at least 60 inches wide, that may be shared. Add the words NO PARKING in 12 inch high white letters at the entrance to each accessible parking access aisle.

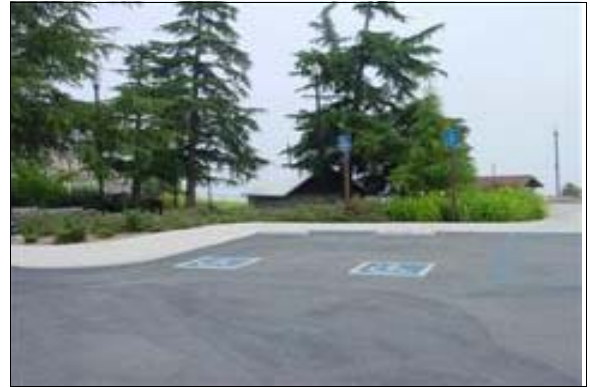
Parking Lot Next to the Restrooms

Finding: The surface of the accessible parking space at the right has a slope greater than 2%.

Full Rec: Pave the parking lot at the accessible spaces to provide a level surface. Parking surfaces and access aisles shall be located in areas not exceeding 2% slope in all directions (see CBC 1129B and ADAAG 4.6.3).

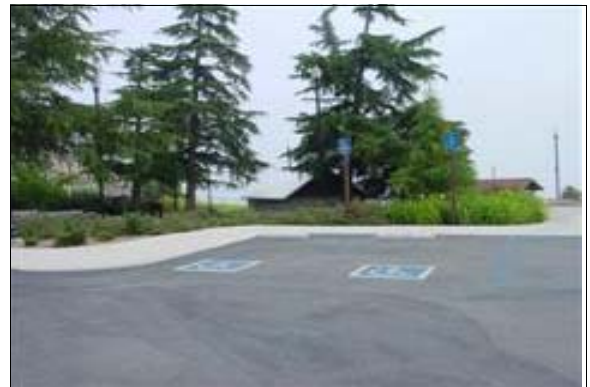
Parking Lot Next to the Restrooms

Finding: The designated accessible parking space at the left is not outlined on the left side.

Full Rec: Each designated accessible parking space shall be identified with a pavement marking consisting of outlining the accessible space in blue and outlining an ISA symbol in white; or outlining a 36 inch by 36 inch white on blue ISA symbol positioned where it can be viewed when a vehicle is parked in the space.

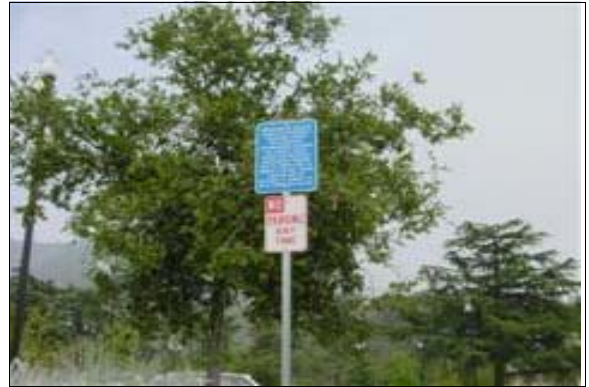
Parking Lot Next to the Restrooms

Finding: There is warning signage posted at the entrance to the parking lot regarding unauthorized use of accessible parking spaces in the parking lot, though the sign uses the word "handicapped" and the CVC 22511.8(a)(d) has not been added.

Full Rec: Post a sign in a conspicuous place to the entrance of the parking lot, or immediately adjacent to and visible from each accessible parking space. The warning sign shall measure at least 17 inches by 22 inches in size and consist of lettering at least 1 inch in height that clearly and conspicuously states the following; "Unauthorized vehicles parked in designated accessible spaces not displaying distinguishing placards or license plates issued for persons with disabilities may be towed away at owner's expense. Towed vehicles may be reclaimed at ____ or by telephoning ____ ." Fill in the blank spaces with appropriate information as a permanent part of the sign and maintain the currency of the information (see CBC 1129B.5). Be sure to add the CVC 22511.8(a)(d) to the sign.

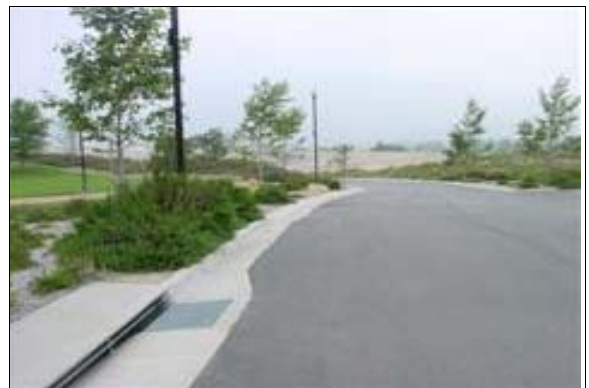
Accessible Route from the Public Right of Way

Finding: There is no accessible route from the public right of way to the accessible entrance of the facility. The width of the concrete walkway is less than 48 inches in width. There are slopes greater than 5% along the path of travel. The accessible route crosses and adjoins vehicular traffic.

Full Rec: Provide at least one accessible route from the public right of way to the accessible entrance of the facility. Make certain to post signage indicating the direction to accessible building entrances at every major junction along the accessible route. Signs shall include the International Symbol of Accessibility.

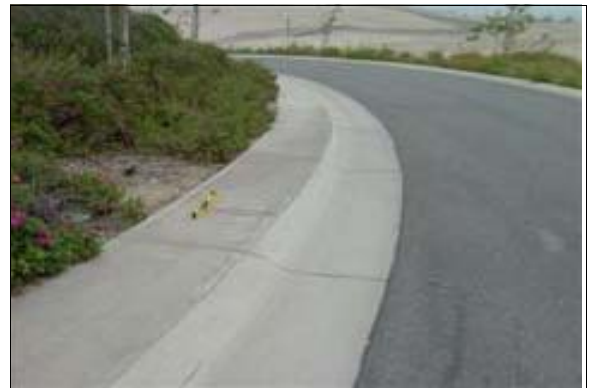
Accessible Route from the Public Right of Way

Finding: There is no crosswalk provided on the path of travel from the public right of way to the facility. The required accessible route crosses a vehicular way.

Full Rec: Stripe a crosswalk not less than 48 inches wide on the path of travel to the accessible entrance of the facility. Provide a level surface that does not exceed a slope greater than 5%. Cross slopes shall not exceed 2%. Detectable warnings should be placed at the entrance and exit of the crosswalk.

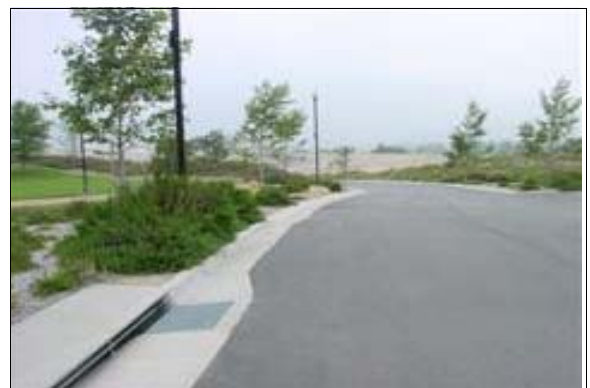
Accessible Route from the Public Right of Way

Finding: The concrete walkway serves as a primary path of travel. The width of the concrete walkway is less than 48 inches in width. There are slopes greater than 5% on the primary path of travel from the public right of way to the Deukmejian Wilderness Park.

Full Rec: Modify the exterior primary path of travel by extending the width of the concrete walkway to at least 48 inches (see CBC 1118B.2 and ADAAG 4.3.3). Since the accessible route is less than 60 inches in width, provide passing spaces at least 60 inches by 60 inches at reasonable intervals every 200 feet. Provide a level surface that does not exceed a slope greater than 5%. Cross slopes shall not exceed 2%.

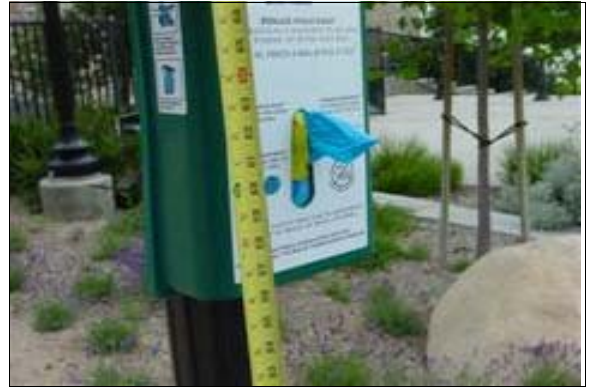
Dog Walk Bags

Finding: The highest operable part of the dog walk bags exceeds the forward reach range of 48 inches.

Full Rec: Lower the dog walk bags to provide an accessible forward approach reach height no greater than 48 inches above the finished floor.

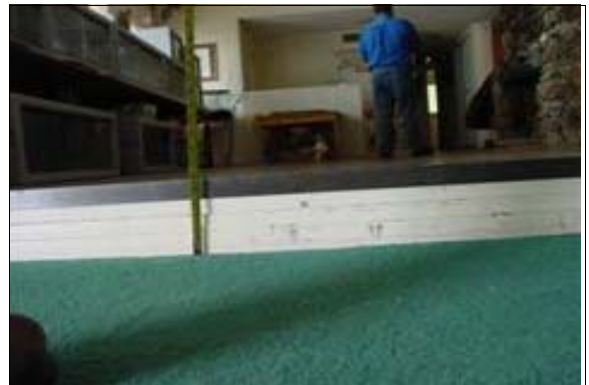
Path of Travel in the Ranger Station

Finding: There is a step on the primary path of travel in the Ranger Station, preventing access to individuals with mobility impairments.

Full Rec: Since programs, services and activities to staff and the public (volunteers, etc.) are provided in this location, those programs, services and activities are required to be made accessible. It is recommended that a ramp be installed or other means of vertical access.

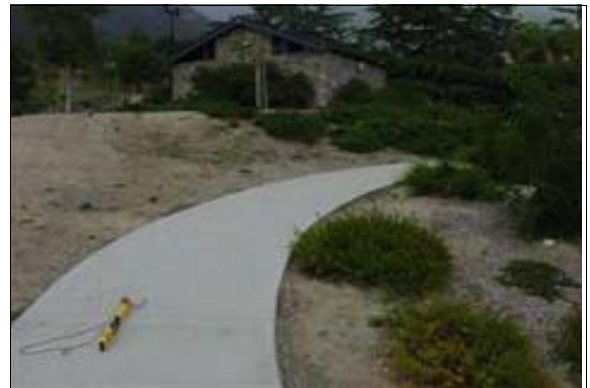
Path of Travel to the Outdoor Dining Area

Finding: There are slopes greater than 5% on the primary path of travel to the lower level outdoor dining area. There are cross slopes greater than 2% on the primary path of travel.

Full Rec: Resurface the path of travel to provide a level surface that does not exceed a slope greater than 5%. Cross slopes shall not exceed 2%.

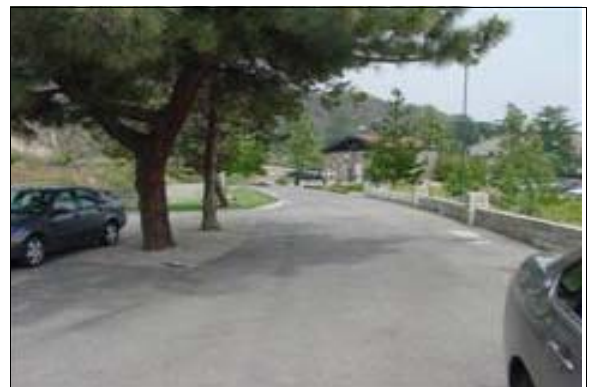
Path of Travel to the Ranger Station

Finding: There is no crosswalk provided on the path of travel to the Ranger Station. The required accessible route crosses a vehicular way.

Full Rec: Stripe a crosswalk not less than 48 inches wide on the path of travel to the accessible entrance of the facility. Provide a level surface that does not exceed a slope greater than 5%. Cross slopes shall not exceed 2%. Detectable warnings should be placed at the entrance and exit of the crosswalk.

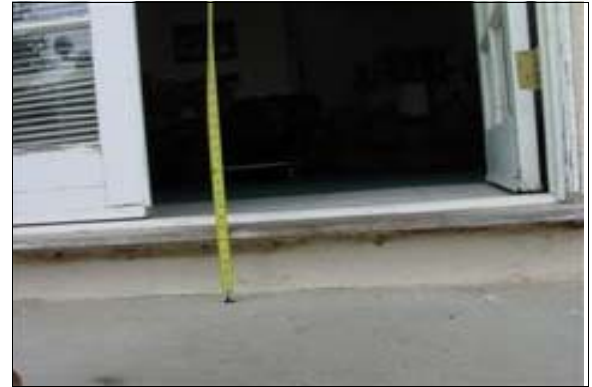
Path of Travel to the Ranger Station

Finding: There is a step on the primary path of travel to the Ranger Station, preventing access to individuals with mobility impairments.

Full Rec: Since programs, services and activities to staff and the public (volunteers, etc.) are provided in this location, those programs, services and activities are required to be made accessible. It is recommended that a ramp be installed or other means of vertical access.

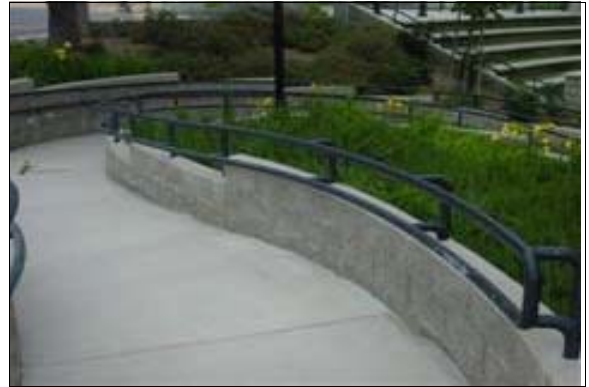
Exterior Ramp Next to the Amphitheater

Finding: The length of the ramp exceeds the maximum distance allowed for its slope (rise).

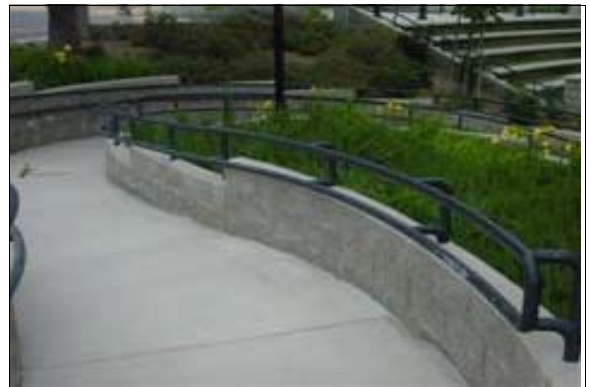
Exterior Ramp Next to the Amphitheater

Finding: The slope of the concrete ramp is greater than 8.33%.

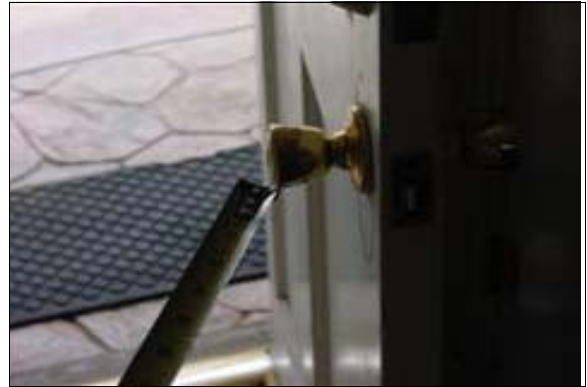
Ranger Station (Side Entrance)

Finding: The exterior passage door has a round doorknob, which requires twisting of the wrist to operate.

Full Rec: Replace the existing door hardware with accessible hardware (see ADAAG 4.13.9).

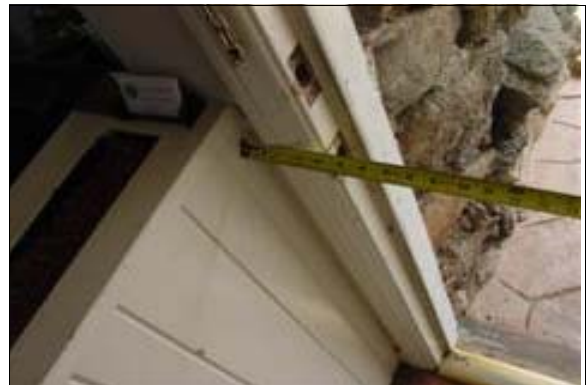
Ranger Station (Side Entrance)

Finding: There is less than 24 inches of clearance on the latch side of the exterior entrance door.

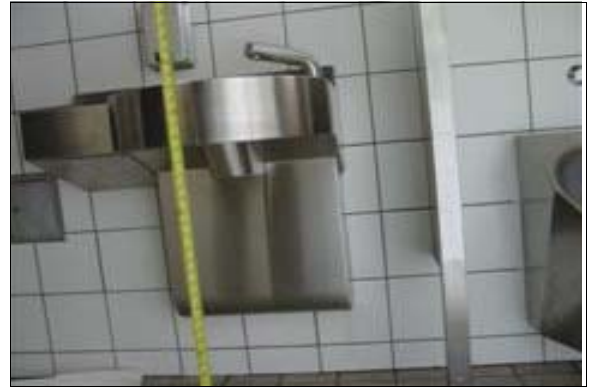
Men's Restroom

Finding: The knee depth space under the lavatory designated to be accessible in the restroom is less than 27 inches at 8 inches under the lavatory apron.

Full Rec: Raise or replace the lavatory designated to be accessible in the restroom to provide at least 27 inches at 8 inches under the apron. Make sure to provide at least 29 inches of clear knee space between the finished floor and bottom of the lavatory apron and a rim surface height no greater than 34 inches (see ADAAG 4.19.2).

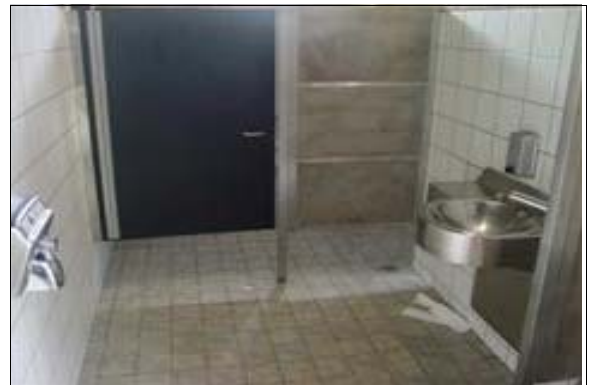
Men's Restroom

Finding: The height of the controls and operating mechanisms for the hand dryer in the restroom is greater than 40 inches in height.

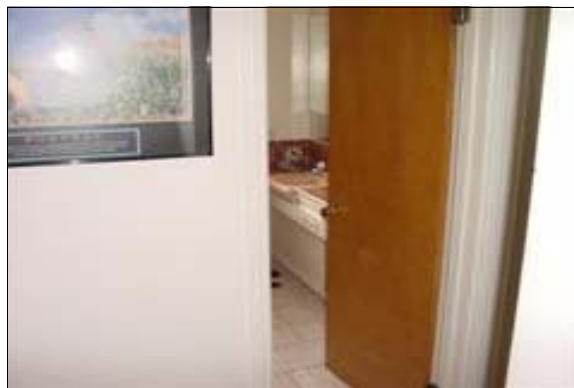
Unisex Restroom in the Ranger Station

Finding: There is no signage indicating accessibility on the latch side of the entry door of the restroom. There is no Title 24 gender use signage on the entrance door.

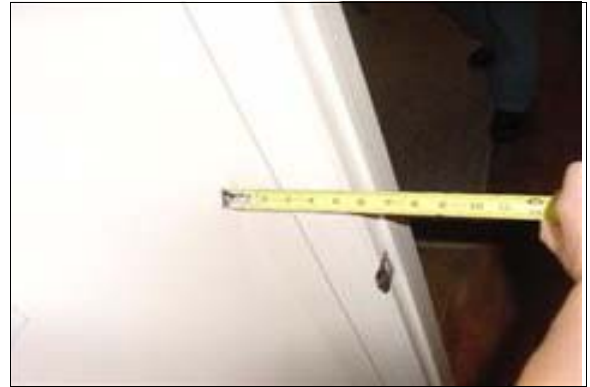
**Unisex Restroom in the Ranger Station
Locker Room**

Finding: There is less than 18 inches of latch side clearance from the pull side of the interior entrance door.

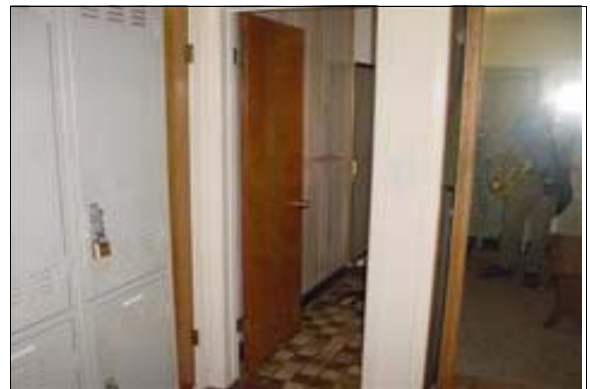
**Unisex Restroom in the Ranger Station
Locker Room**

Finding: The clear opening width of the entrance doorway to the restroom is less than 32 inches.

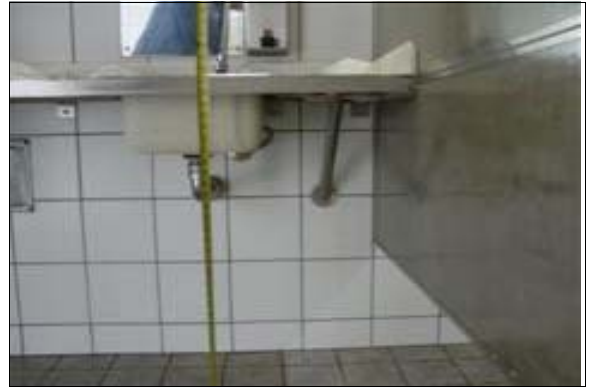
Women's Restroom

Finding: The pipes under the lavatory in the restroom do not provide protection against contact.

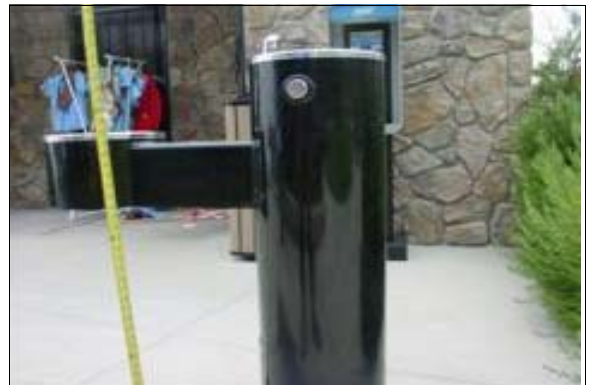
Finding: There are three drinking fountains on primary paths of travel.
