Photo Report
Dunsmore Park
Programs, Services, and Activities

Finding: Dunsmore Park, located at 4700 Dunsmore Avenue in Glendale California, was inspected by Disability Access Consultants, Inc., on June 6, 2007. Facilities include the Dunsmore Park Community Center, Maintenance Building, North and South restrooms, and the Dunsmore Park Office/Electrical Vault.

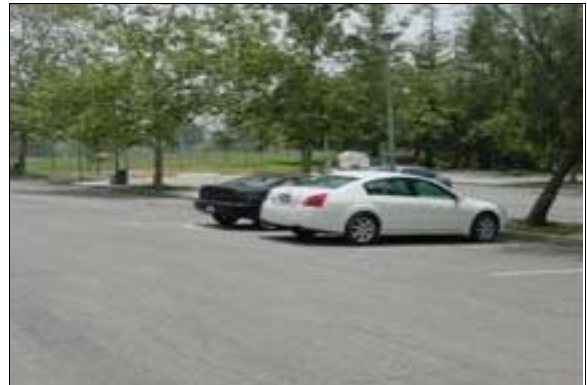
Finding: There are two parking lots provided at the facility. The paved parking lots are located north and south of the Community Center.

Full Rec: Accessible paved parking spaces shall be located on the shortest accessible route of travel to the facility and shall coincide with the primary route and primary entrances used by the general public (see CBC 1129B.4, ADAAG 4.3.2(1) and ADAAG 4.14.1).

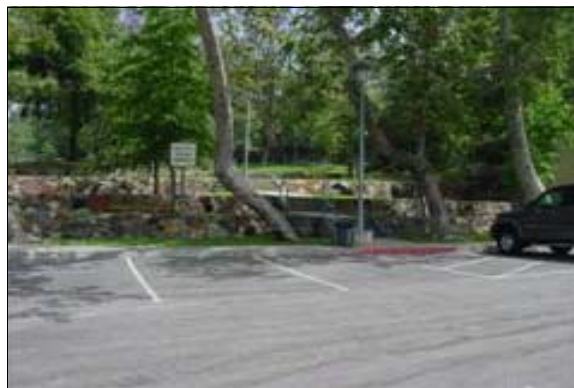
Employee Parking Lot North of the Community Center

Finding: Paved parking is provided outside of the Community Center. There are no accessible parking spaces designated out of 11 total parking spaces provided in the parking lot.

Full Rec: One out of the 11 total number of marked parking spaces is required to be designated exclusively for accessible parking, as required by CBC 1129B and ADAAG. Create one van-accessible parking space measuring at least 108 inches wide and 216 inches long with an access aisle measuring at least 96 inches wide (8 feet) located on the passenger side (right side) of the parking space (see CBC 1129B). Add the words NO PARKING in 12 inch high white letters at the entrance to the accessible parking access aisle.

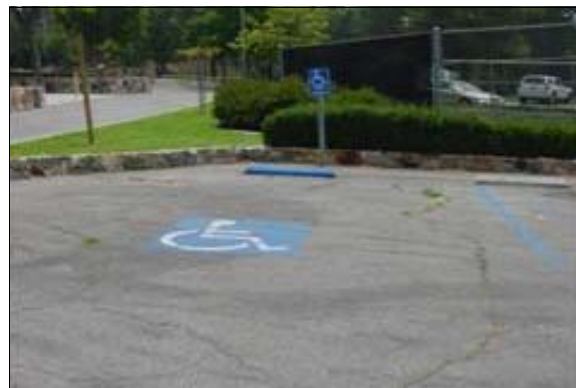
Parking Lot South of the Community Center

Finding: The surface of the accessible parking space in the parking lot has a slope greater than 2%.

Full Rec: Pave the parking lot at the accessible spaces to provide a level surface. Parking surfaces and access aisles shall be located in areas not exceeding 2% slope in all directions (see CBC 1129B and ADAAG 4.6.3).

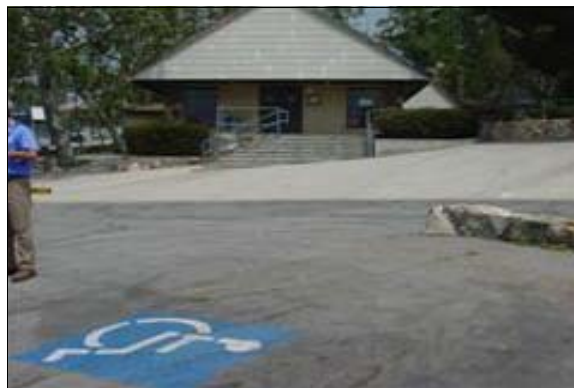
Parking Lot South of the Community Center

Finding: There is no crosswalk provided on the path of travel from the accessible parking space to the Community Center. The required accessible route crosses a vehicular way.

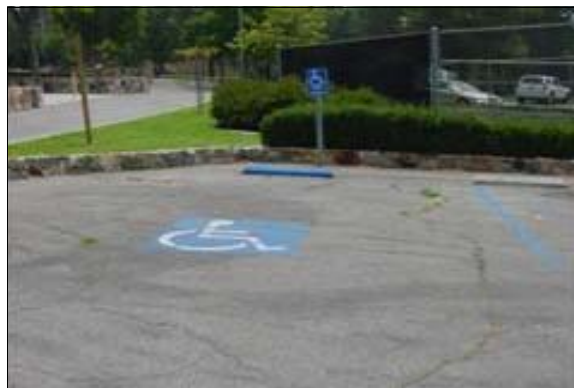
Parking Lot South of the Community Center

Finding: The designated accessible parking space in the parking lot is not outlined on the left side.

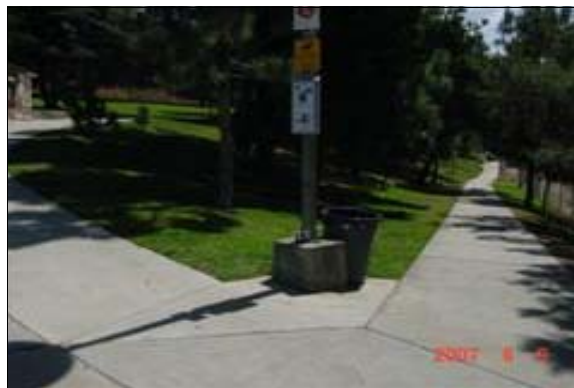
Dog Walk Bags

Finding: The reach height of the dog walk bags next to the south restrooms exceeds the side reach range of 54 inches.

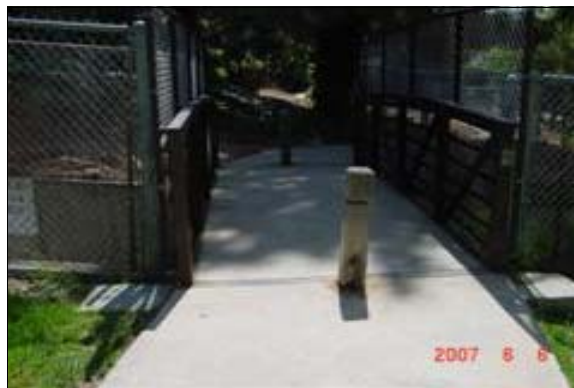
Finding: The bridge at the east end of the park serves as a primary path of travel. The width of the concrete walkway is less than 48 inches in width, due to the posts.

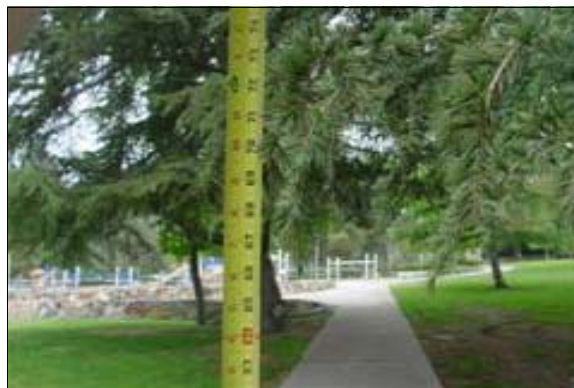
Path of Travel Between the North and South Restrooms

Finding: At the time of inspection, vegetation encroached into the primary path of travel, obstructing passage by reducing the clear width along the accessible route.

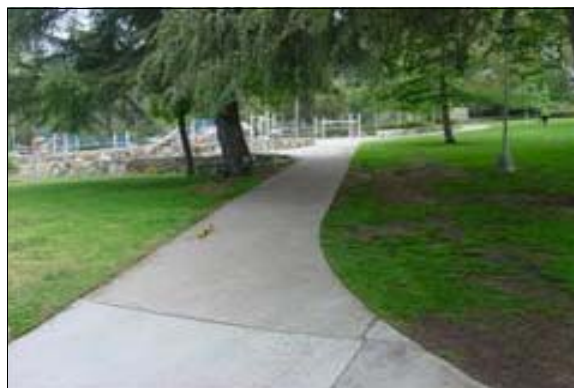
Path of Travel Between the North and South Restrooms

Finding: There are slopes greater than 5% on the primary path of travel between the north and south restrooms.

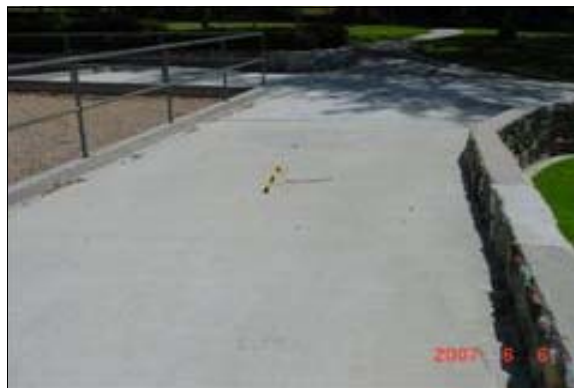
Path of Travel East of the Community Center

Finding: There are slopes greater than 5% on the primary path of travel between the outdoor dining area and the play equipment east of the Community Center.

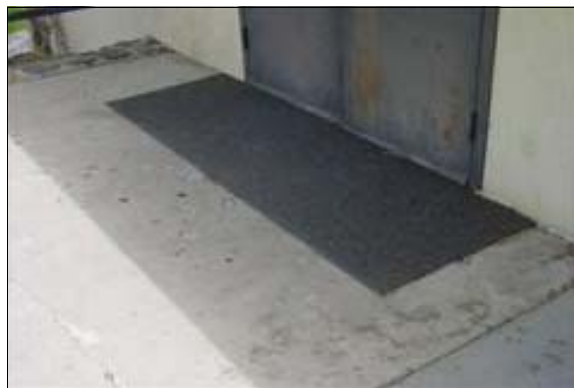
Path of Travel to the Community Center

Finding: The mat at the main entrance does not adhere to the underlying floor surface and creates a hazardous path of travel.

Full Rec: Securely fasten the mats or replace with a mat that grips to the underlying floor surface to provide a firm, stable, continuous and relatively smooth path of travel surface (see CBC 1124B.3 and ADAAG 4.5.3). Mats along the primary path of travel shall provide beveled edges on all sides to prevent roll over.

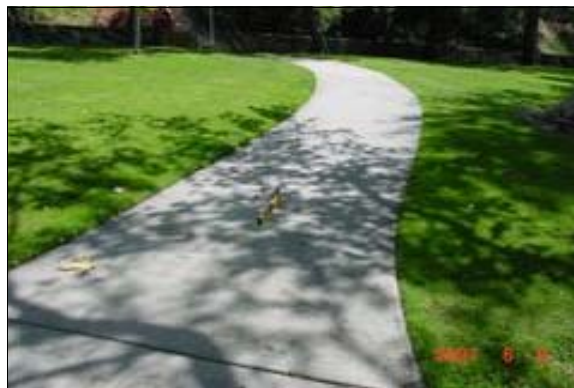
Path of Travel to the East End of the Park

Finding: There are slopes greater than 5% on the primary path of travel to the exterior stairway at the east end of the park.

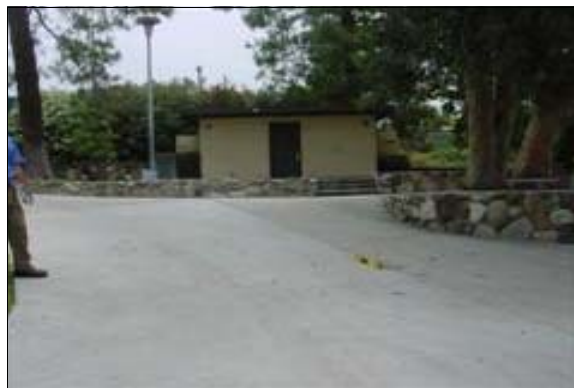
Path of Travel to the North Restrooms

Finding: There are slopes greater than 5% on the primary path of travel to the north restrooms.

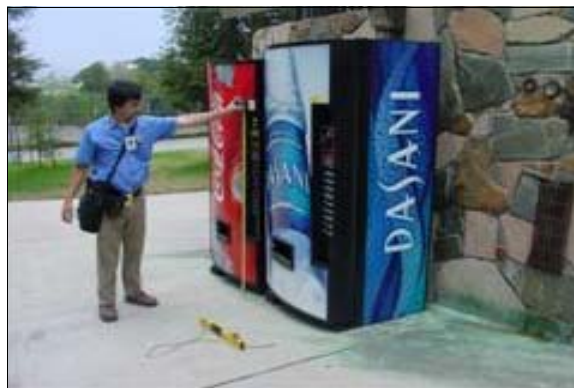
Path of Travel to the Vending Machines

Finding: There are cross slopes greater than 2% on the primary path of travel to the vending machines outside of the restrooms at the south end of the park.

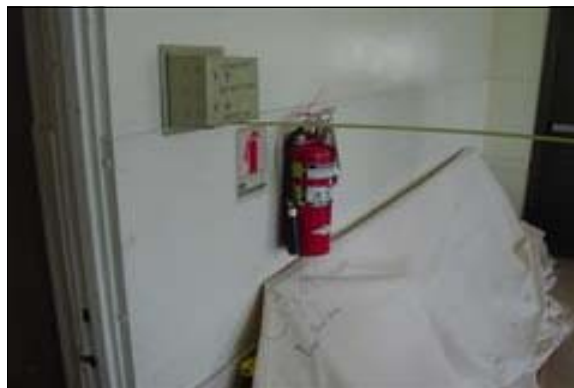
Finding: The leading edge of each fire extinguisher in the Community Center is more than 4 inches from the wall and greater than 27 inches from the floor and protrudes into the primary path of travel.

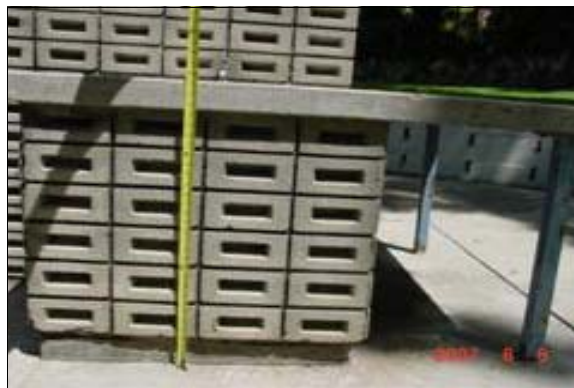
Sink at the Outdoor Dining Area

Finding: The sink at the outdoor dining area does not provide an accessible forward approach.

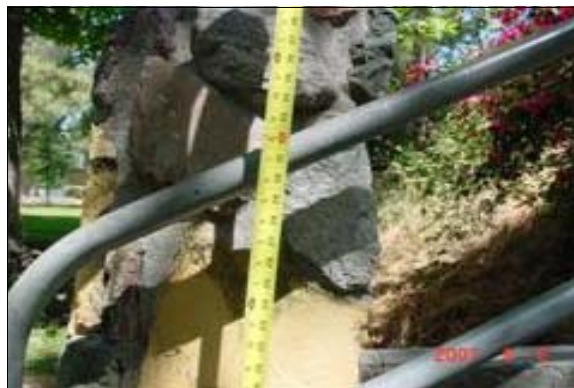
Exterior Stairs at the East End of the Park

Finding: The handrails do not provide 12-inch extensions beyond the top and bottom treads. The handrails are mounted at a height less than 34 inches.

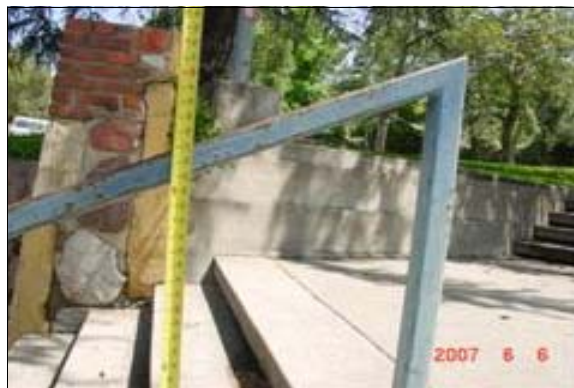
Exterior Stairs at the North End of the Park

Finding: The handrails do not provide 12-inch extensions beyond the top and bottom treads. The handrails are mounted at a height less than 34 inches.

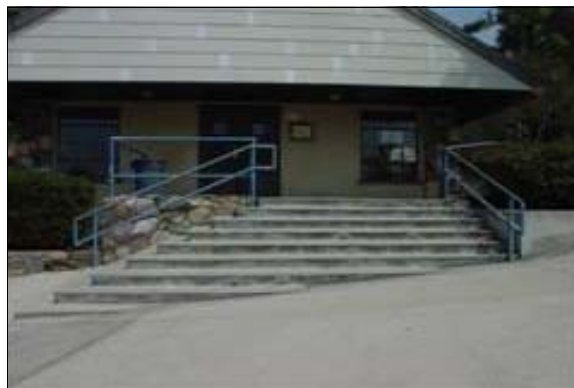
Exterior Stairs to the Community Center

Finding: The width of the stairway is greater than 88 inches.

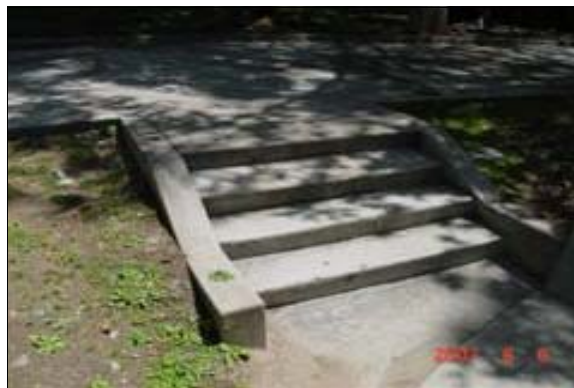
Exterior Stairs to the Outdoor Dining Area at the North End of the Park

Finding: There are no handrails provided on the stairway.

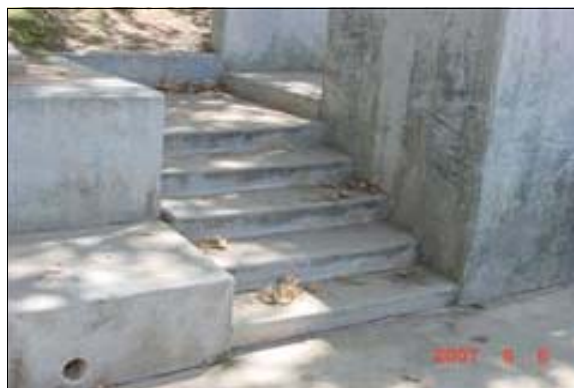
Exterior Stairs to the Press Box at the Baseball Field

Finding: There is no detectable striping on each tread of the exterior stairway.

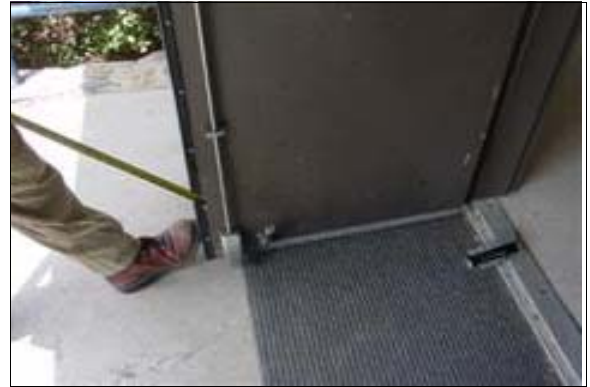
Community Center Main Entrance

Finding: The bottom 10 inches of the door does not provide a smooth, uninterrupted surface, or panel to allow the door to be opened by a wheelchair footrest without creating a trap or hazardous condition, due to the doorstop.

Full Rec: Install a panel or replace the door to provide a smooth, uninterrupted surface for the bottom 10 inches of the door.

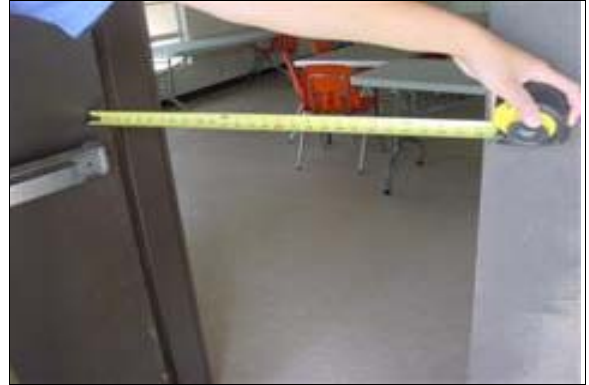
Finding: The clear opening width of the double doors is less than 32 inches.

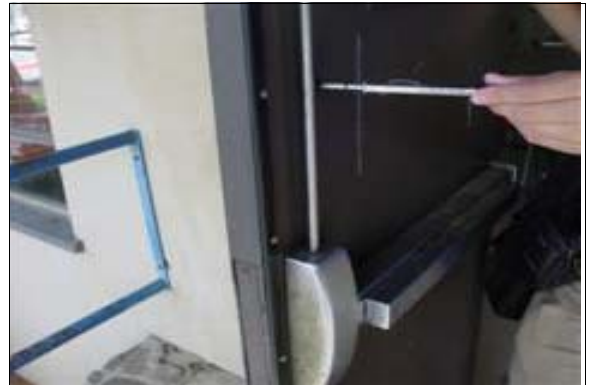
Finding: The door opening force for the exterior door is greater than 5 pounds of force.

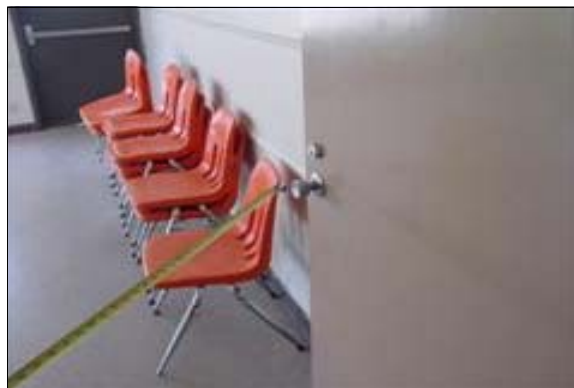
Interior Doors in the Community Center

Finding: Interior passage doors have round doorknobs, which require twisting of the wrist to operate.

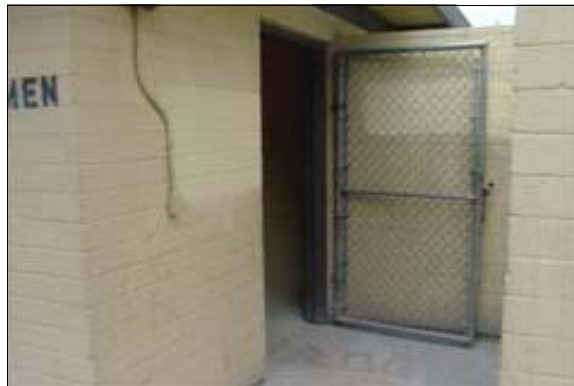
Men's Restroom at the North End of the Park

Finding: The bottom 10 inches of the door does not provide a smooth, uninterrupted surface, or panel to allow the door to be opened by a wheelchair footrest without creating a trap or hazardous condition.

Full Rec: Install a panel or replace the door to provide a smooth, uninterrupted surface for the bottom 10 inches of the door.

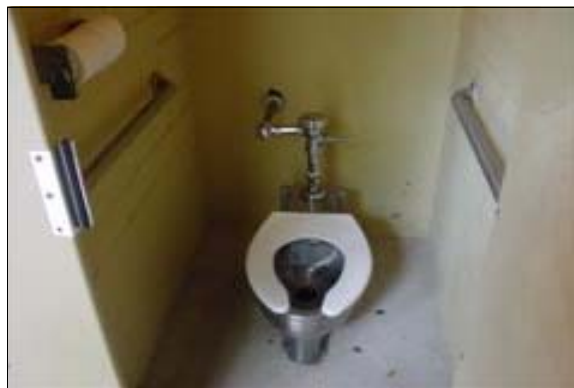
Men's Restroom at the North End of the Park

Finding: There is insufficient clear floor space in the stall designated to be accessible in the restroom. The door to the stall designated to be accessible in the restroom does not close automatically or have accessible hardware.

Full Rec: Modify or replace the stall designated to be accessible in the restroom so that it complies with ADAAG 4.17.3, CBC 1115B and CBC Figures 11B-1A and 1B. Standard accessible stalls require 60 inches in width with 56 inches depth for wall-mounted toilets or 59 inches depth for floor-mounted toilets to accommodate individuals in wheelchairs. The minimum width of a front-approach doorway shall provide at least 32 inches and a side-approach doorway shall provide at least 34 inches. The door shall swing outward, close automatically and provide accessible hardware.

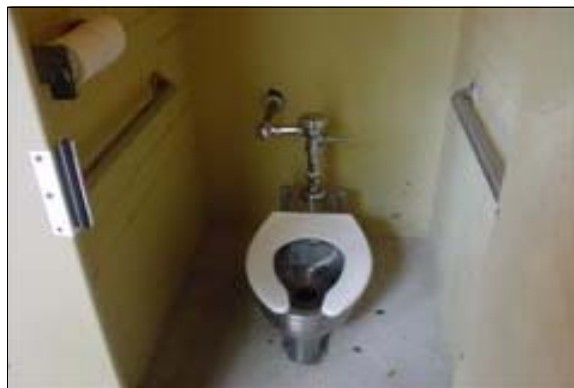
Men's Restroom at the North End of the Park

Finding: There is no back grab bar in the stall designated to be accessible in the restroom.

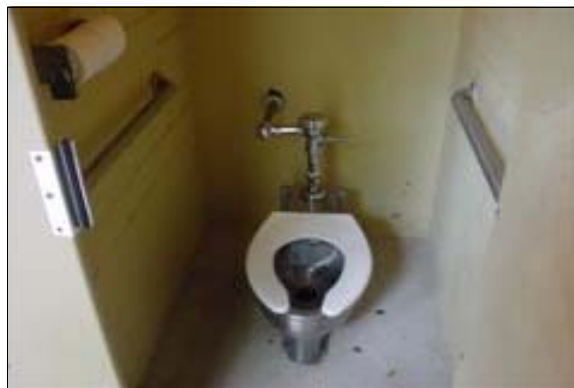
Men's Restroom at the North End of the Park

Finding: The length of the side grab bars in the stall designated to be accessible in the restroom is less than 42 inches. The side grab bars in the stall designated to be accessible in the restroom do not extend 54 inches from the back wall.

Full Rec: Replace the side grab bars in the stall designated to be accessible in the restroom with a 42-inch/ 48 -inch side grab bar complying with ADAAG 4.26 and CBC 1115B.8. The front end of the grab bar shall extend at least 54 inches from the back wall and the back end of the grab bar shall be mounted within 12 inches from the back wall. Grab bars must be able to support a point load of at least 250 pounds and shall be less than the allowable shear stress of the grab bar material.

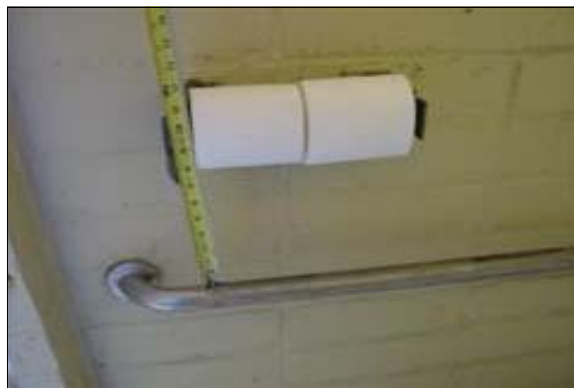
Men's Restroom at the North End of the Park

Finding: The toilet paper dispenser in the stall designated to be accessible in the restroom interferes with the use of the side grab bar.

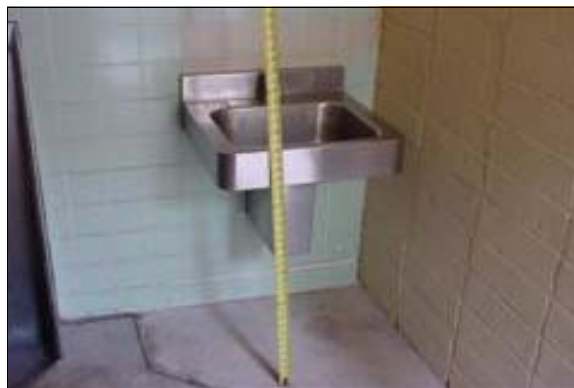
Men's Restroom at the North End of the Park

Finding: The pipes under the lavatory in the restroom do not provide protection against contact.

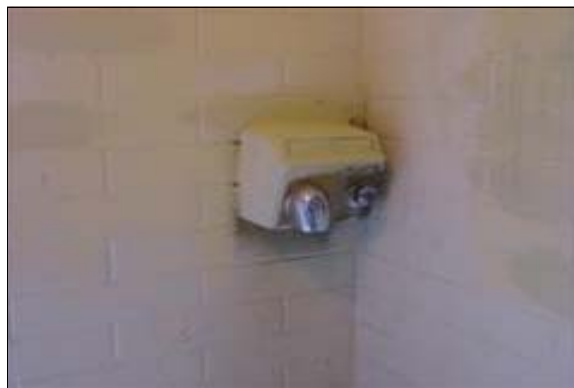
Men's Restroom at the North End of the Park

Finding: The height of the controls and operating mechanisms for the hand dryer in the restroom is greater than 40 inches in height.

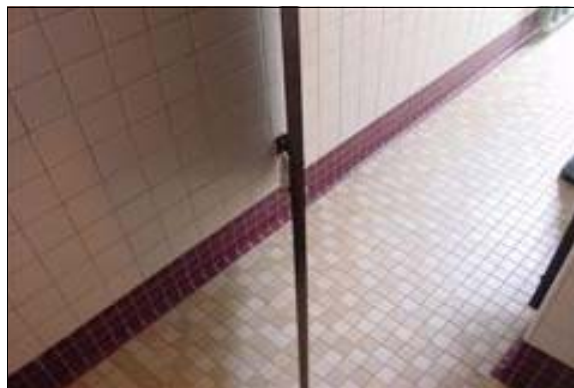
Men's Restroom at the South End of the Park

Finding: The door to the stall designated to be accessible in the restroom does not close automatically or have accessible hardware.

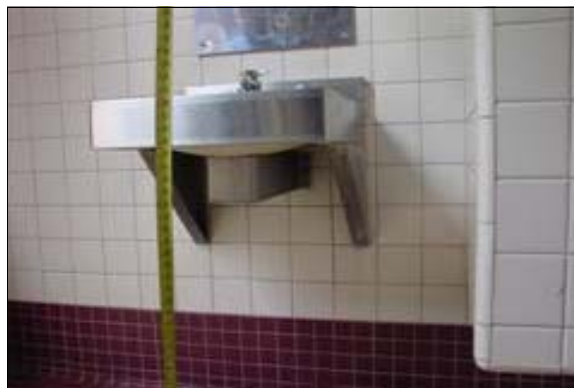
Men's Restroom at the South End of the Park

Finding: The faucet controls on the lavatory in the restroom require tight grasping, pinching, or twisting of the wrist and are not accessible.

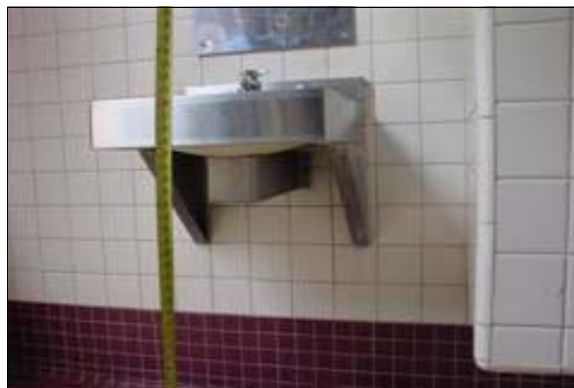
Men's Restroom at the South End of the Park

Finding: The pipes under the lavatory in the restroom do not provide protection against contact.

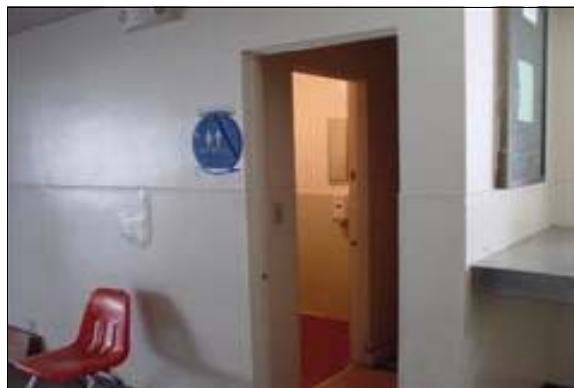
Unisex Restroom in the Community Center

Finding: There is no signage indicating accessibility on the latch side of the entry door of the restroom. There is no Title 24 gender use signage on the entrance door.

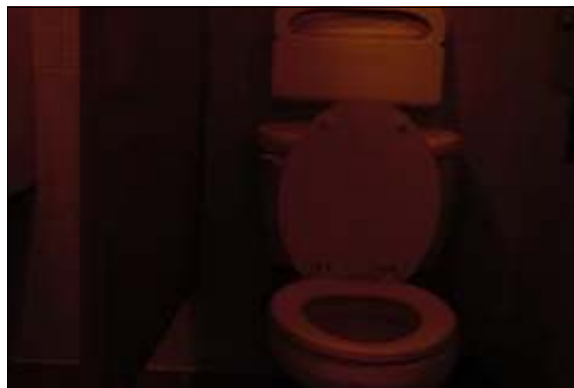
Unisex Restroom in the Community Center

Finding: There are no grab bars in the stall designated to be accessible in the restroom.

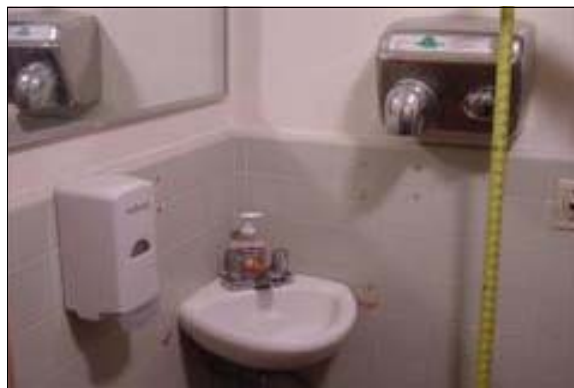
Unisex Restroom in the Community Center

Finding: The height of the controls and operating mechanisms for the hand dryer in the restroom is greater than 40 inches in height.

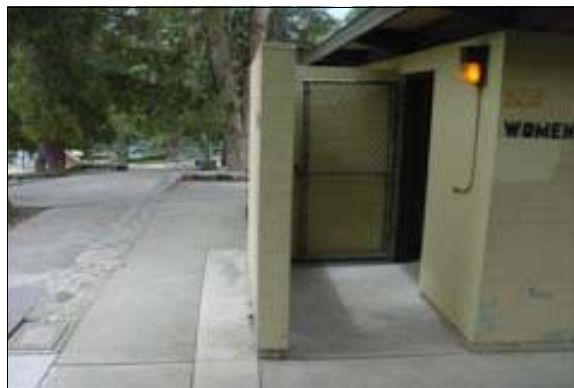
Women's Restroom at the North End of the Park

Finding: The landing at the entrance door does not provide sufficient clear floor space.

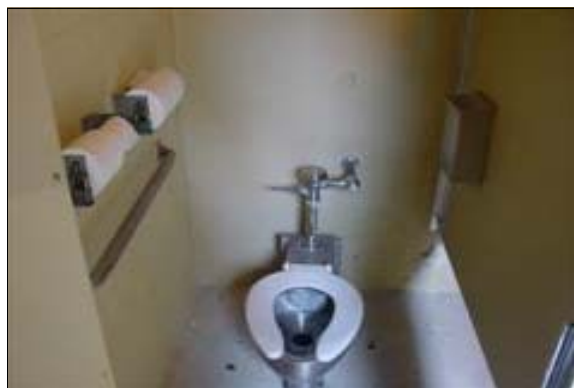
Women's Restroom at the North End of the Park

Finding: There is insufficient clear floor space in the stall designated to be accessible in the restroom. The door to the stall designated to be accessible in the restroom does not close automatically or have accessible hardware.

Full Rec: Modify or replace the stall designated to be accessible in the restroom so that it complies with ADAAG 4.17.3, CBC 1115B and CBC Figures 11B-1A and 1B. Standard accessible stalls require 60 inches in width with 56 inches depth for wall-mounted toilets or 59 inches depth for floor-mounted toilets to accommodate individuals in wheelchairs. The minimum width of a front-approach doorway shall provide at least 32 inches and a side-approach doorway shall provide at least 34 inches. The door shall swing outward, close automatically and provide accessible hardware.

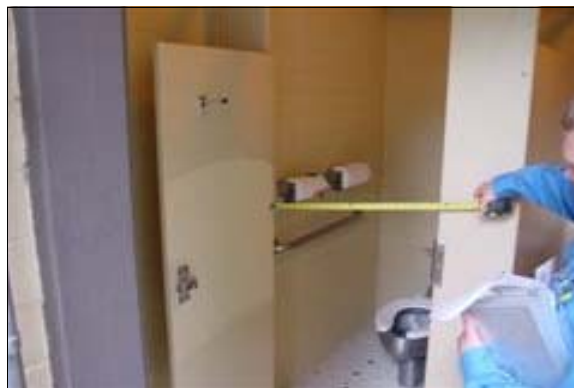
Women's Restroom at the North End of the Park

Finding: The height of the coat hook on the stall door designated to be accessible in the restroom is greater than 48 inches above the floor surface.

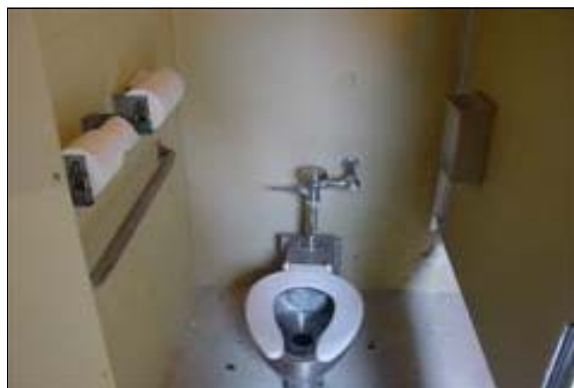
Women's Restroom at the North End of the Park

Finding: There is no back grab bar in the stall designated to be accessible in the restroom.

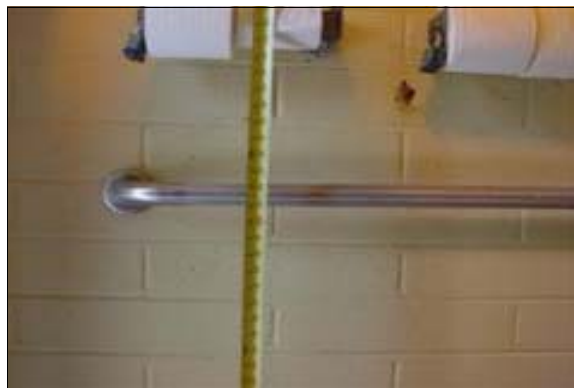
Women's Restroom at the North End of the Park

Finding: The height of the side grab bar in the stall designated to be accessible of the restroom is greater than 33 inches above the finished floor.

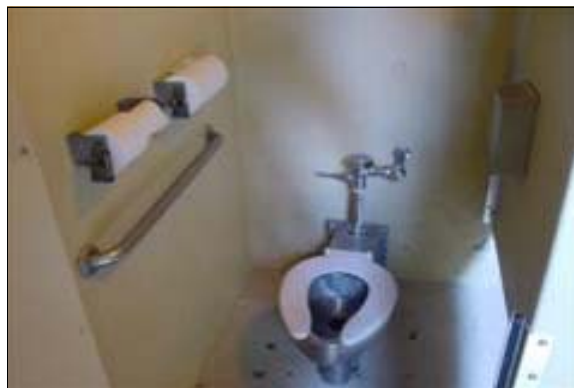
Women's Restroom at the North End of the Park

Finding: The distance from the end of the side grab bar to the back wall in the stall designated to be accessible in the restroom is greater than 12 inches.

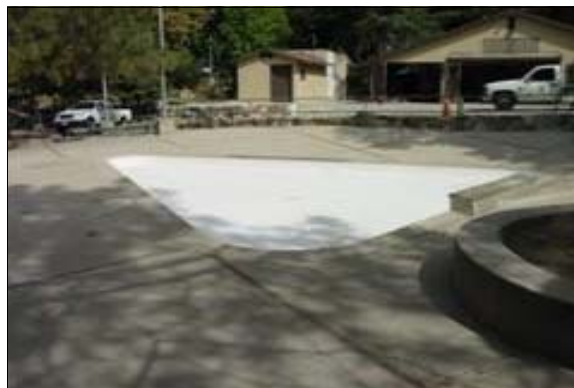
Wading Pool

Finding: The wading pool is not accessible by a hydraulic chair, ramp, transfer tier, or other means. During the periods when the wading pools do not contain water they may become a tripping hazard.
