**Photo Report**  
**Emerald Isle**  
**Programs, Services, and Activities**

**Finding:** Emerald Isle, located at 2310 Lenore Drive in Glendale California, was inspected by Disability Access Consultants, Inc., on June 7, 2007.

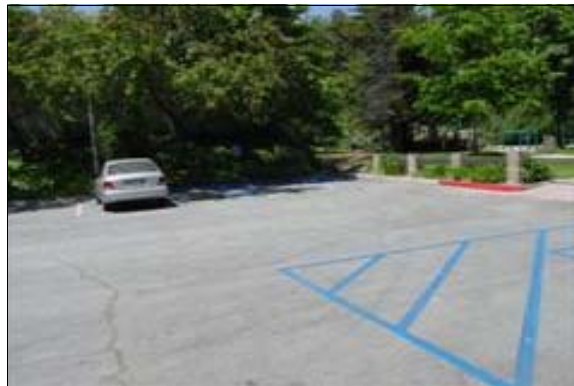
**Finding:** There are three accessible parking spaces out of 29 parking spaces which is sufficient in number as required for compliance. The van-accessible parking space provided in the parking lot measures 108 inches wide and 232 inches long. The van-accessible parking space provides an access aisle, located on the passenger side (right side) of the parking space, measuring 115 inches wide. The access aisle does not contain "NO PARKING" in 12" high white letters. Each standard accessible parking space measures at least 108 inches wide and less than 216 inches long. There is no access aisle provided adjacent to the standard accessible parking spaces.

**Full Rec:** Three out of the 29 total number of marked parking spaces meets the number required to be designated exclusively for accessible parking according to ADAAG and CBC 1129B. Restripe the standard accessible parking spaces, each measuring at least 108 inches wide and 216 inches long. The standard additional parking spaces shall each provide an access aisle measuring at least 60 inches wide, that may be shared. Add the words NO PARKING in 12 inch high white letters at the entrance to each accessible parking access aisle.

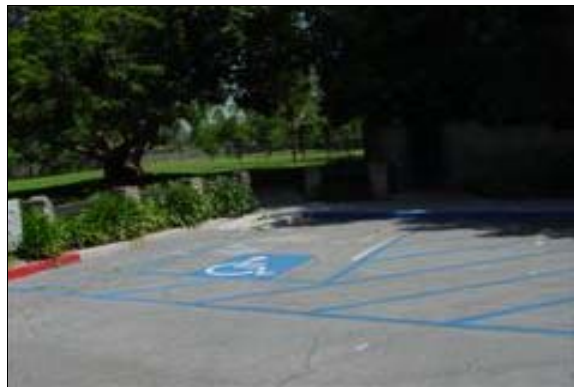
**Finding:** The surface of the van-accessible parking space in the parking lot has a slope greater than 2%.

**Full Rec:** Pave the parking lot at the accessible spaces to provide a level surface. Parking surfaces and access aisles shall be located in areas not exceeding 2% slope in all directions (see CBC 1129B and ADAAG 4.6.3).

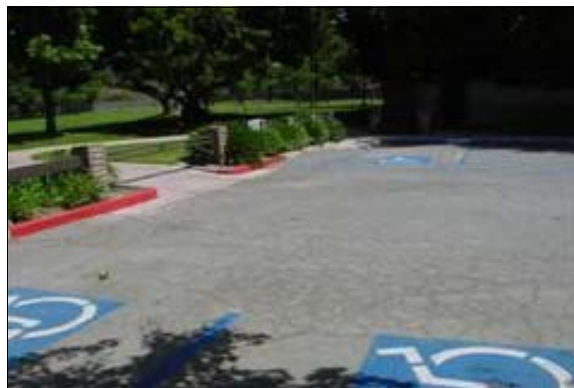
**Finding:** There is no crosswalk provided on the path of travel from two of the accessible parking spaces to the facility. The required accessible route crosses a vehicular way.

**Full Rec:** Stripe a crosswalk not less than 48 inches wide on the path of travel to the accessible entrance. Provide a level surface that does not exceed a slope greater than 5%. Cross slopes shall not exceed 2%. Detectable warnings should be placed at the entrance and exit of the crosswalk.

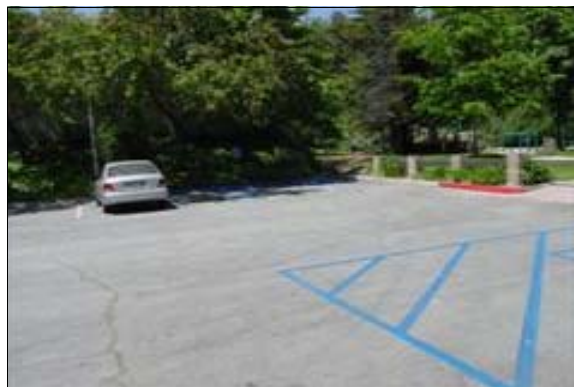
**Finding:** There is no vertically-mounted signage at two of the designated accessible parking spaces in the parking lot showing the International Symbol of Accessibility. There is no additional signage marked "van-accessible" at the van-accessible parking space. The signage designating one of the standard accessible parking spaces in the parking lot uses the word "handicapped". The bottom edge of the post-mounted signage designating one of the standard accessible parking spaces is less than 80 inches above the level of the parking space and cannot be viewed when a vehicle is parked in the space.

**Full Rec:** Install a permanently posted reflectorized sign measuring 70 square inches that includes an ISA symbol adjacent to and visible from the accessible parking spaces (see CBC 1129B.5). The bottom edge of the sign must be mounted 80 inches from the ground surface so that it cannot be obscured by a parked vehicle (see CBC 1129B.5). The "van-accessible" parking space shall provide an additional sign marked "van-accessible" mounted below the sign (see CBC 1129B.5 and ADAAG 4.6.4).

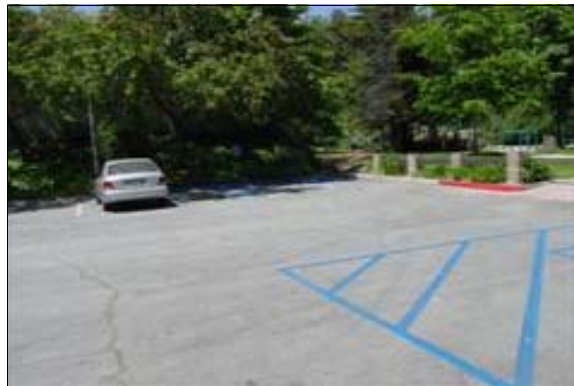
**Finding:** The standard accessible parking space, at the right, is not outlined on the right side.

**Full Rec:** Each designated accessible parking space shall be identified with a pavement marking consisting of outlining the accessible space in blue and outlining an ISA symbol in white; or outlining a 36 inch by 36 inch white on blue ISA symbol positioned where it can be viewed when a vehicle is parked in the space.

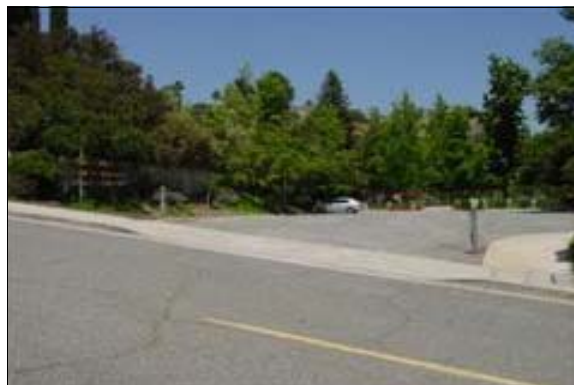
**Finding:** There is no warning signage posted at the entrance to the parking lot regarding unauthorized use of accessible parking spaces in the parking lot.

**Full Rec:** Post a sign in a conspicuous place to the entrance of the parking lot, or immediately adjacent to and visible from each accessible parking space. The warning sign shall measure at least 17 inches by 22 inches in size and consist of lettering at least 1 inch in height that clearly and conspicuously states the following; "Unauthorized vehicles parked in designated accessible spaces not displaying distinguishing placards or license plates issued for persons with disabilities may be towed away at owner's expense. Towed vehicles may be reclaimed at \_\_\_\_ or by telephoning \_\_\_\_ ." Fill in the blank spaces with appropriate information as a permanent part of the sign and maintain the currency of the information (see CBC 1129B.5). Be sure to add the CVC 22511.8(a)(d) to the sign.

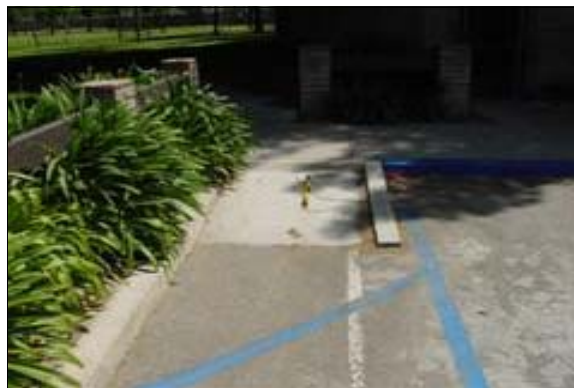
**Curb Ramp at the Accessible Parking Space**

**Finding:** The curb ramp projects into vehicular traffic and interferes with individuals entering or exiting parked or standing vehicles. The concrete curb ramp does not provide a detectable warning surface which includes truncated domes.

**Full Rec:** Remove the curb ramp and install a compliant curb ramp at least 48 inches in width that provides a slope no greater than 8.33%. Install a detectable warning surface which extends the full length and width of the concrete curb ramp and its side flares with truncated domes that contrast visually by either light on dark or dark on light which is an integral part of the concrete curb ramp. The truncated domes may be cast in place or stamped or of a prefabricated surface treatment (see CBC 1127B.5.8).

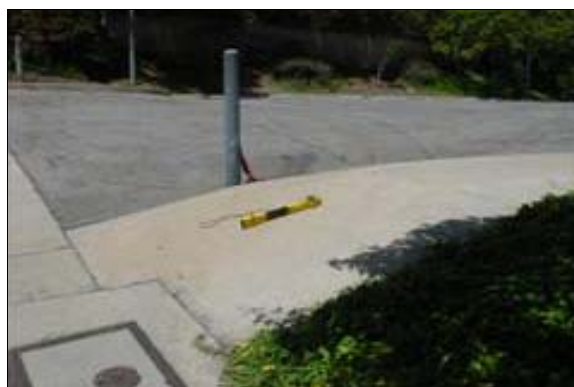
**Accessible Route from the Public Right of Way**

**Finding:** There is no accessible route from the public right of way to the accessible entrance of the facility. There are slopes greater than 5% along the path of travel.

**Alternative** Post directional signage.

**Full Rec:** Provide at least one accessible route from the public right of way to the accessible entrance of the facility. Make certain to post signage indicating the direction to accessible building entrances at every major junction along the accessible route. Signs shall include the International Symbol of Accessibility.

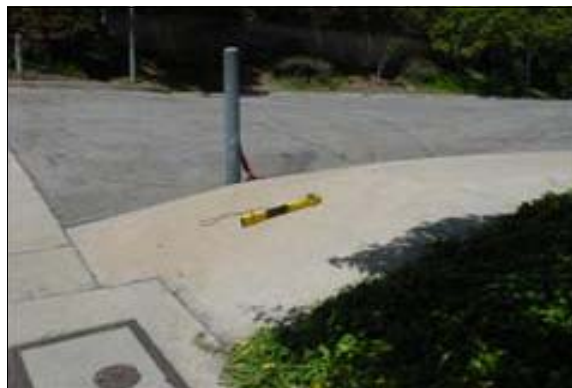
***Accessible Route from the Public Right of Way***

**Finding:** There are slopes greater than 5% on the primary path of travel from the public right of way to the park.

**Full Rec:** Resurface the path of travel to provide a level surface that does not exceed a slope greater than 5%. Cross slopes shall not exceed 2%.

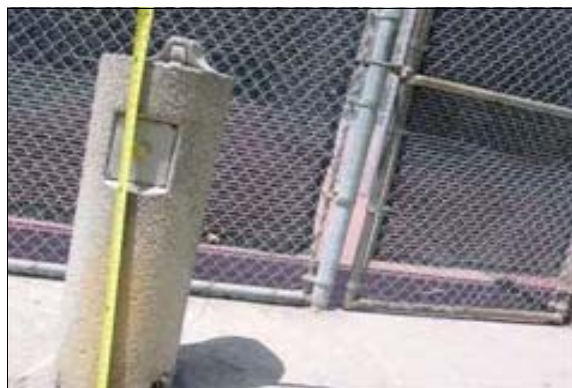
***Path of Travel to the Drinking Fountain***

**Finding:** The path of travel to the drinking fountain next to the tennis courts is grass, preventing access to individuals with mobility impairments.

**Full Rec:** Install an accessible route to where programs, services and activities are provided (see CBC 1114B.1.2 and ADAAG 4.3.2). The minimum width of the path of travel shall be 48 inches with a firm, stable and slip-resistant surface. No protruding objects are permitted on the accessible path of travel and slopes shall not exceed 5% in the direction of travel.

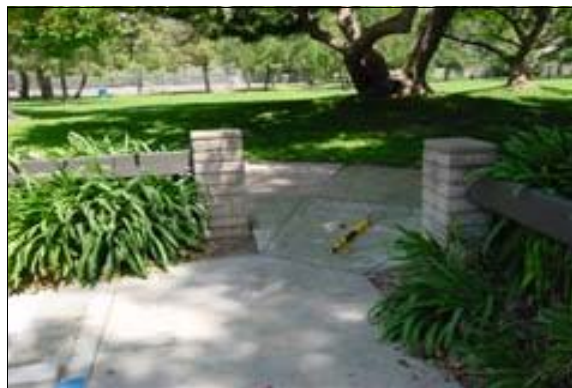
***Path of Travel to the Park***

**Finding:** The concrete walkway serves as a primary path of travel from the public right of way and the van-accessible parking space to the park. The width of the concrete walkway is less than 48 inches in width.

**Full Rec:** Modify the exterior primary path of travel by extending the width of the concrete walkway to at least 48 inches (see CBC 1118B.2 and ADAAG 4.3.3). Since the accessible route is less than 60 inches in width, provide passing spaces at least 60 inches by 60 inches at reasonable intervals every 200 feet.

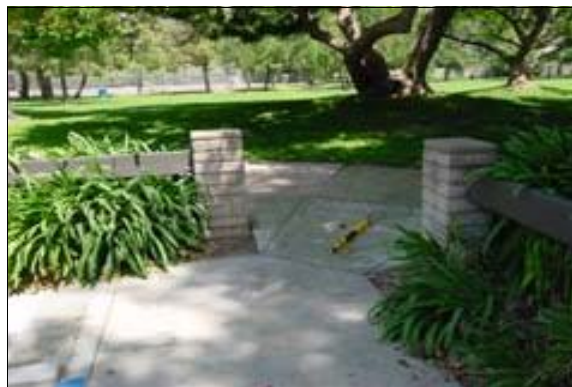
***Path of Travel to the Park***

**Finding:** There are slopes greater than 5% on the primary path of travel from the public right of way and van-accessible parking space to the park.

**Full Rec:** Resurface the path of travel to provide a level surface that does not exceed a slope greater than 5%. Cross slopes shall not exceed 2%.

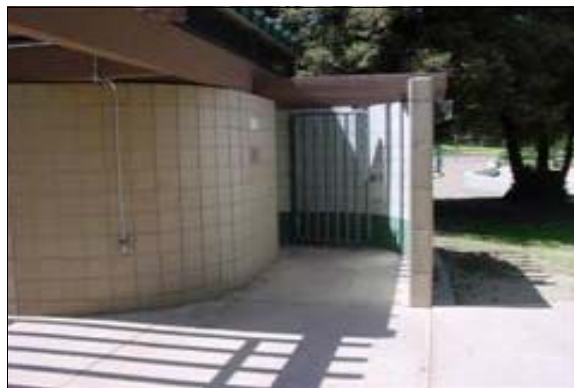
#### **Men's Restroom**

**Finding:** There is no signage indicating accessibility on the latch side of the entry door of the restroom. There is no Title 24 gender use signage on the entrance door.

**Full Rec:** The restroom is designated accessible and should be made accessible for the facility. Post signage centered 60 inches above the ground surface on the latch side of the entrance door identifying the restroom as accessible upon completion of the following items (see CBC 1115B., ADAAG 4.1.2(7) and ADAAG 4.1.6(3)(e). Signage shall include Braille and raised lettering, the gender or unisex use symbol and the ISA symbol. Post Title 24 gender use signage on the door @ 60" o.c. a.f.f.

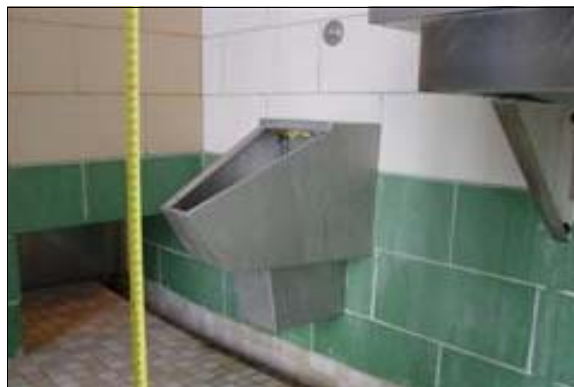
#### **Men's Restroom**

**Finding:** The height of the urinal rim in the restroom is greater than 17 inches above the finished floor.

**Full Rec:** Lower the urinal designated to be accessible in the restroom so that the rim height is not more than 17 inches above the finished floor.

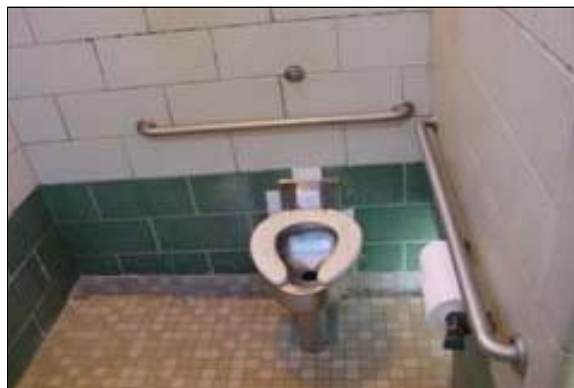
**Men's Restroom**

**Finding:** There is insufficient clear floor space in the stall designated to be accessible in the restroom. The door to the stall designated to be accessible in the restroom does not close automatically or have accessible hardware.

**Full Rec:** Modify or replace the stall designated to be accessible in the restroom so that it complies with ADAAG 4.17.3, CBC 1115B and CBC Figures 11B-1A and 1B. Standard accessible stalls require 60 inches in width with 56 inches depth for wall-mounted toilets or 59 inches depth for floor-mounted toilets to accommodate individuals in wheelchairs. The minimum width of a front-approach doorway shall provide at least 32 inches and a side-approach doorway shall provide at least 34 inches. The door shall swing outward, close automatically and provide accessible hardware.

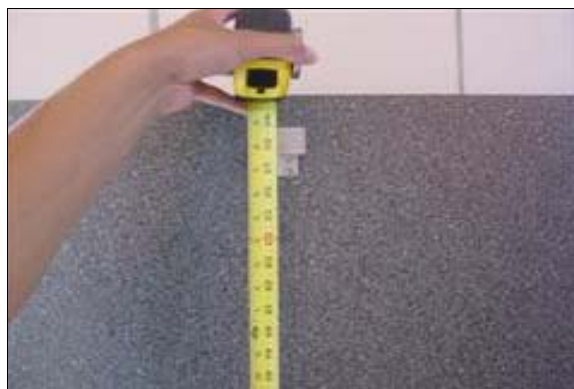
**Men's Restroom**

**Finding:** The height of the coat hook on the stall door designated to be accessible in the restroom is greater than 48 inches above the floor surface.

**Full Rec:** Remount the coat hook on the stall door designated to be accessible in the restroom to a maximum height of 48 inches above the floor surface.

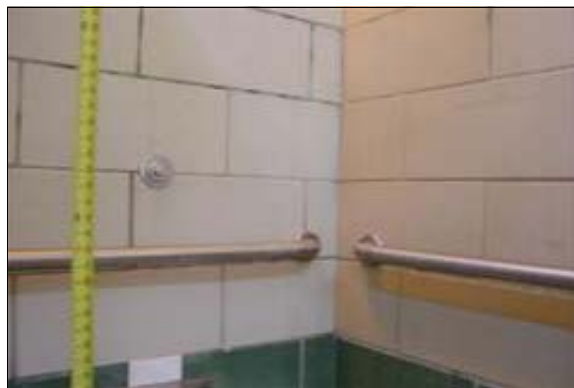
**Men's Restroom**

**Finding:** The height of the side and back grab bar in the stall designated to be accessible of the restroom is less than 33 inches above the finished floor.

**Full Rec:** Remount the side and back grab bar in the stall designated to be accessible in the restroom so that the height of the gripping surface is centered at 33 inches above finished floor. Grab bars must be able to support a point load of at least 250 pounds and shall be less than the allowable shear stress of the grab bar material.

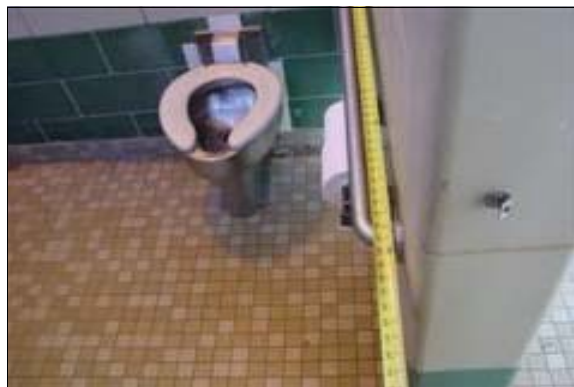
**Men's Restroom**

**Finding:** The side grab bar in the stall designated to be accessible in the restroom does not extend 54 inches from the back wall.

**Full Rec:** The front end of the grab bar shall extend at least 54 inches from the back wall and the back end of the grab bar shall be mounted within 12 inches from the back wall. Grab bars must be able to support a point load of at least 250 pounds and shall be less than the allowable shear stress of the grab bar material.

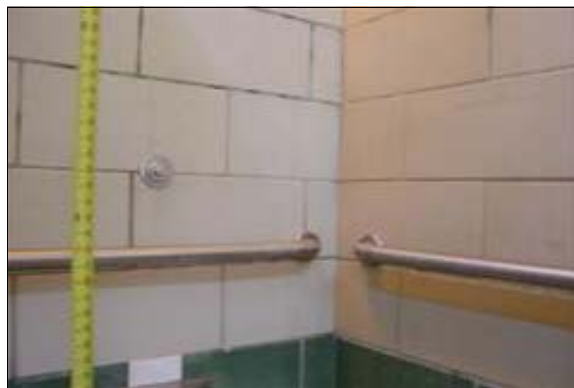
**Men's Restroom**

**Finding:** The flush control on the toilet in the stall designated to be accessible in the restroom is not on the wide (approach) side of the toilet.

**Full Rec:** Relocate the flush control on the toilet in the stall designated to be accessible in the restroom so that it is on the wide (approach) side of the toilet area (see ADAAG 4.16.5). Flush controls shall be hand-operated or automatic mechanisms.

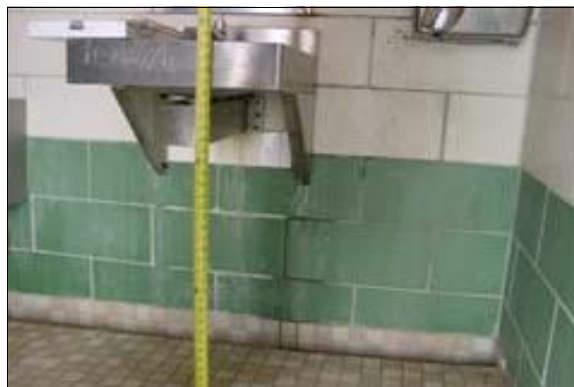
**Men's Restroom**

**Finding:** The knee depth space under the lavatory designated to be accessible in the restroom is less than 27 inches at 8 inches under the lavatory apron.

**Full Rec:** Raise or replace the lavatory designated to be accessible in the restroom to provide at least 27 inches at 8 inches under the apron. Make sure to provide at least 29 inches of clear knee space between the finished floor and bottom of the lavatory apron and a rim surface height no greater than 34 inches (see ADAAG 4.19.2).

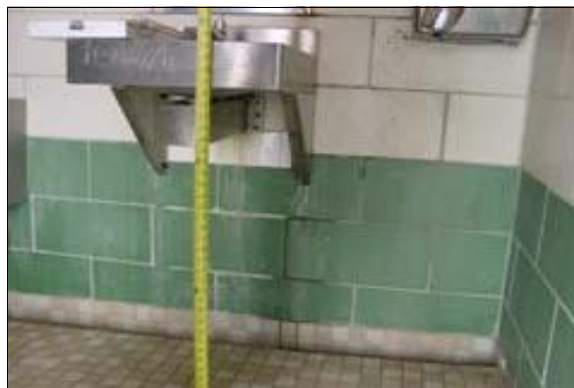
**Men's Restroom**

**Finding:** The height of the rim surface of the lavatory designated to be accessible in the restroom is greater than 34 inches above the finished floor.

**Full Rec:** Relocate or replace the lavatory designated to be accessible in the restroom to provide a maximum rim surface height of no greater than 34 inches above the finished floor (see ADAAG 4.19.2).

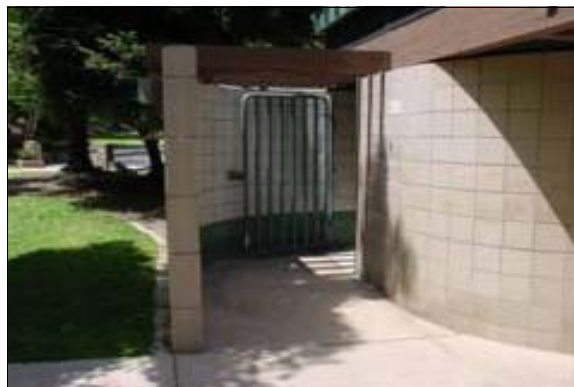
**Women's Restroom**

**Finding:** There is no signage indicating accessibility on the latch side of the entry door of the restroom. There is no Title 24 gender use signage on the entrance door.

**Full Rec:** The restroom is designated accessible and should be made accessible for the facility. Post signage centered 60 inches above the ground surface on the latch side of the entrance door identifying the restroom as accessible upon completion of the following items (see CBC 1115B., ADAAG 4.1.2(7) and ADAAG 4.1.6(3)(e). Signage shall include Braille and raised lettering, the gender or unisex use symbol and the ISA symbol. Post Title 24 gender use signage on the door @ 60" o.c. a.f.f.

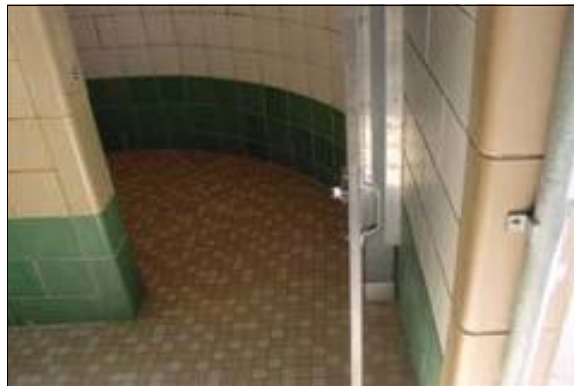
**Women's Restroom**

**Finding:** The door to the stall designated to be accessible in the restroom does not close automatically or have accessible hardware.

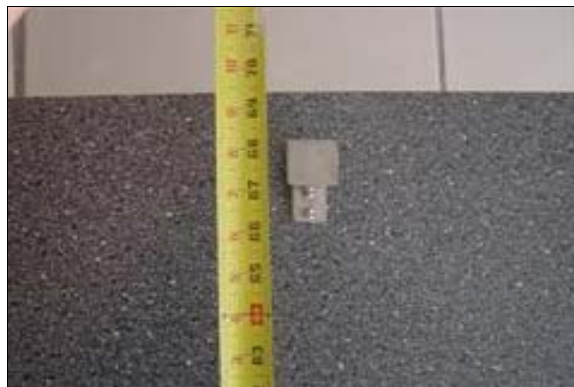
**Women's Restroom**

**Finding:** The height of the coat hook on the stall door designated to be accessible in the restroom is greater than 48 inches above the floor surface.

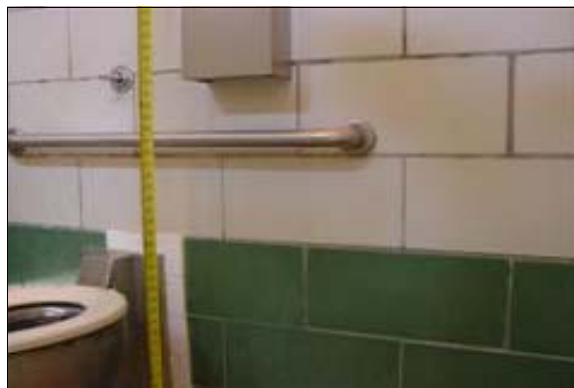
**Women's Restroom**

**Finding:** The height of the side and back grab bar in the stall designated to be accessible of the restroom is less than 33 inches above the finished floor.

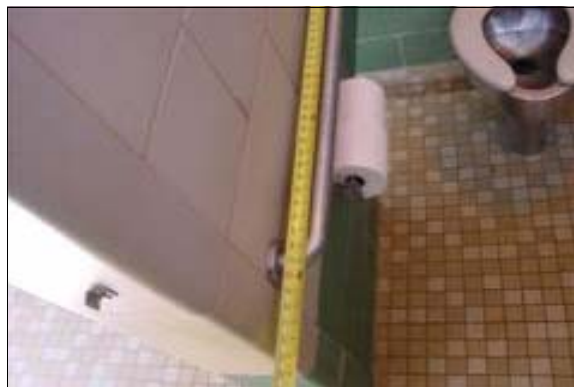
**Women's Restroom**

**Finding:** The side grab bar in the stall designated to be accessible in the restroom does not extend 54 inches from the back wall.

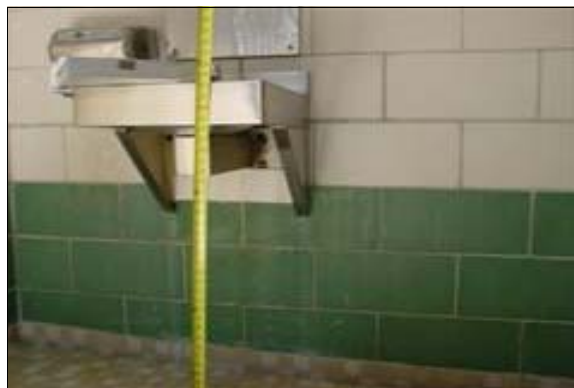
**Women's Restroom**

**Finding:** The knee depth space under the lavatory designated to be accessible in the restroom is less than 27 inches at 8 inches under the lavatory apron.

**Full Rec:** Raise or replace the lavatory designated to be accessible in the restroom to provide at least 27 inches at 8 inches under the apron. Make sure to provide at least 29 inches of clear knee space between the finished floor and bottom of the lavatory apron and a rim surface height no greater than 34 inches (see ADAAG 4.19.2).

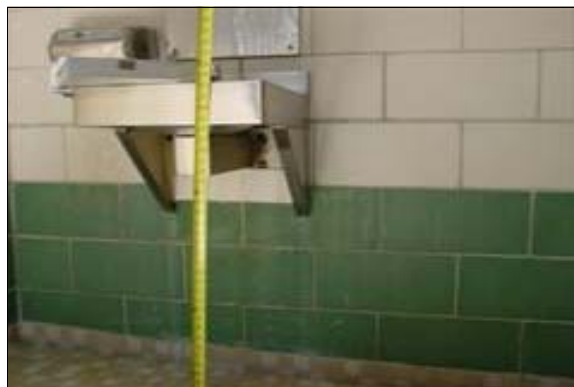
**Women's Restroom**

**Finding:** The height of the rim surface of the lavatory designated to be accessible in the restroom is greater than 34 inches above the finished floor.

**Full Rec:** Relocate or replace the lavatory designated to be accessible in the restroom to provide a maximum rim surface height of no greater than 34 inches above the finished floor (see ADAAG 4.19.2).

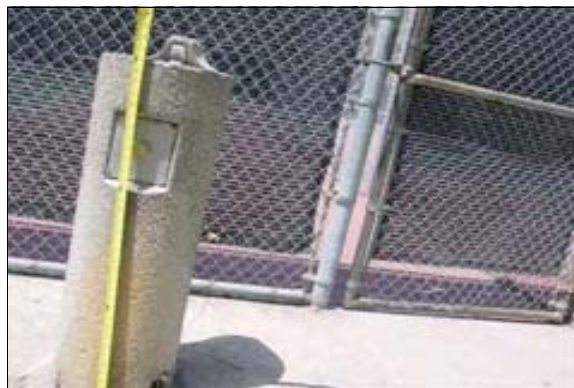
**Finding:** There are two drinking fountains on primary paths of travel.

**Full Rec:** Fifty percent of the drinking fountains on primary paths of travel shall be accessible (see CBC 1117B.1 and ADAAG 4.15). Install a "high-low" fountain design to comply with both state and federal requirement. Fountains not located in alcoves need side rails or wing walls on both sides.

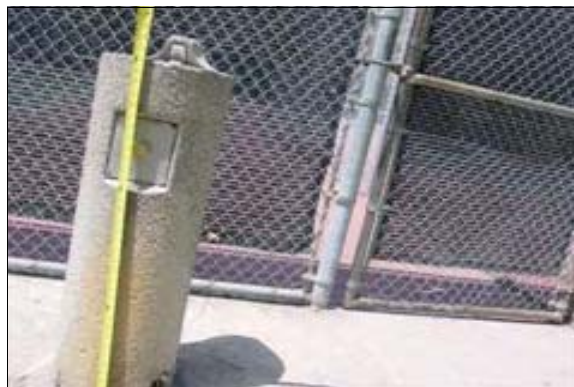
**Finding:** The drinking fountain is not a "high-low" design. The spout outlet height is greater than 36 inches. There is less than 27 inches knee clearance height.

**Full Rec:** Fifty percent of the drinking fountains on primary paths of travel shall be accessible (see CBC 1117B.1 and ADAAG 4.15). Install a "high-low" fountain design to comply with both state and federal requirements and install a side rail or wing wall next to each side of the fountain. The height of the spout outlet shall not exceed 36 inches in height. Wall-mounted drinking fountains shall provide a minimum knee clearance height of 27 inches, 30 inches in width and between 18 inches and 19 inches in fountain depth.

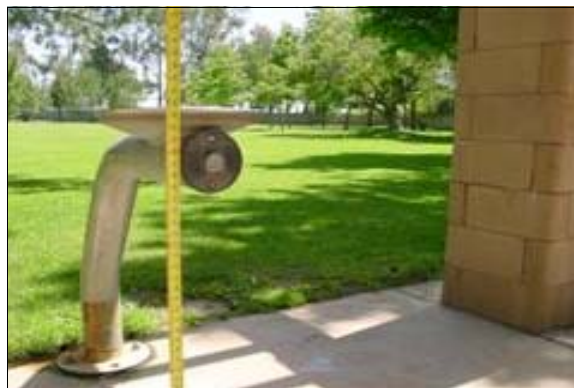
**Drinking Fountain Next to the Restrooms**

**Finding:** The drinking fountain is not a "high-low" design. The spout outlet height is greater than 36 inches.

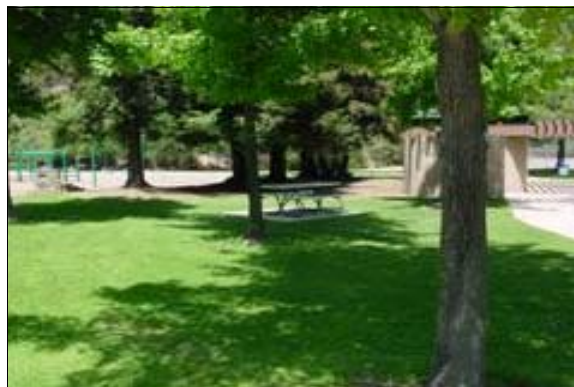
**Outdoor Dining Area**

**Finding:** There is no accessible route to the picnic tables in the outdoor dining area. The surface under and around the outdoor dining area picnic tables is grass, preventing access of individuals with mobility impairments.

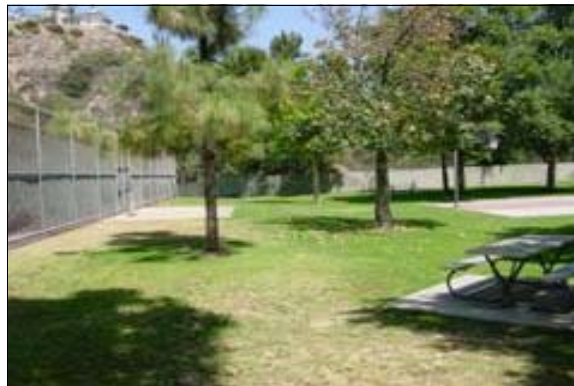
#### **Basketball Courts**

**Finding:** The path of travel to the basketball courts consists of grass, making the area nonaccessible to individuals with mobility impairments.

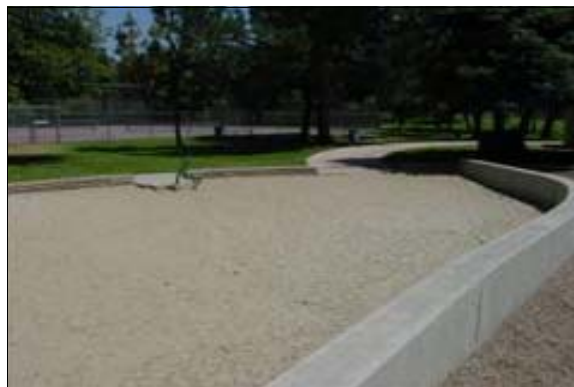
#### **Play Area**

**Finding:** The surface at the play area is sand, making the area nonaccessible to individuals with mobility impairments.

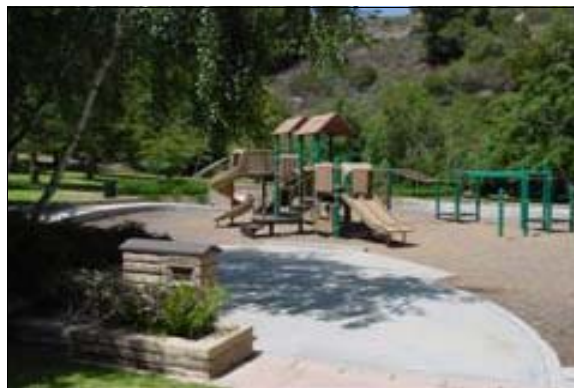
#### ***Play Equipment***

**Finding:** The surface beneath the play equipment is wood chips, making the area nonaccessible to individuals with mobility impairments.

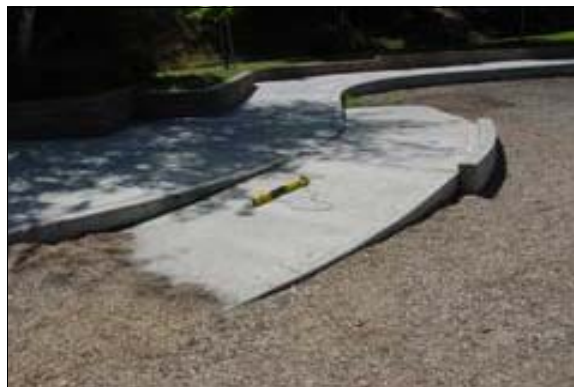
#### ***Play Equipment***

**Finding:** There are slopes greater than 6.33% at the entrance to the play area.

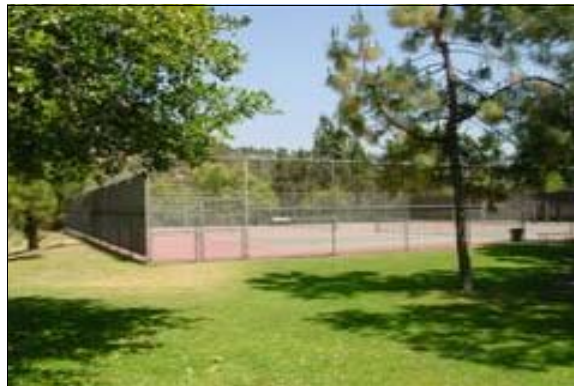
**Tennis Courts**

**Finding:** The path of travel to the tennis courts consists of grass, making the area nonaccessible to individuals with mobility impairments.
