Photo Report

Fremont

Finding: The Fremont Park, located at 600 West Hahn Avenue in Glendale California, was inspected by Disability Access Consultants, Inc., on June 7, 2007.

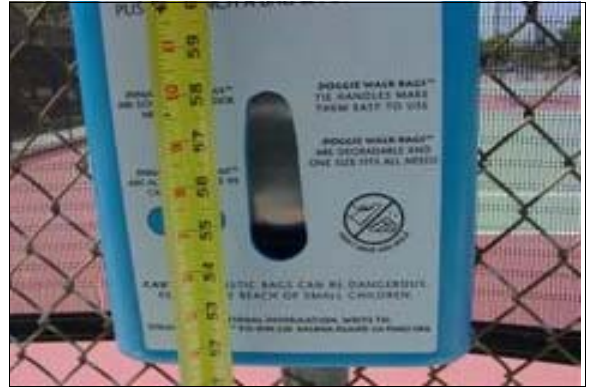
Dog Walk Bags

Finding: The highest operable part of the dog walk bags exceeds the forward reach range of 48 inches.

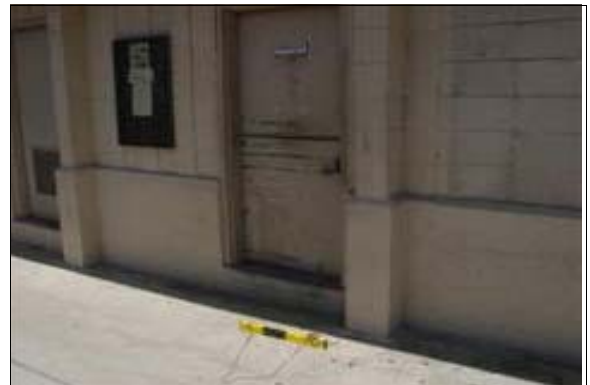
Finding: There is a step on the primary path of travel to the Tennis Office, preventing access to individuals with mobility impairments.

Full Rec: Since programs, services and activities to staff and the public (volunteers, etc.) are provided in this location, those programs, services and activities are required to be made accessible. It is recommended that a ramp be installed or other means of vertical access.

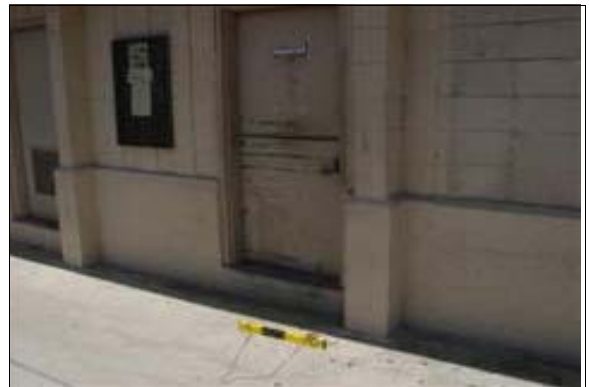
Tennis Office

Finding: There is no level landing provided at the entrance door.

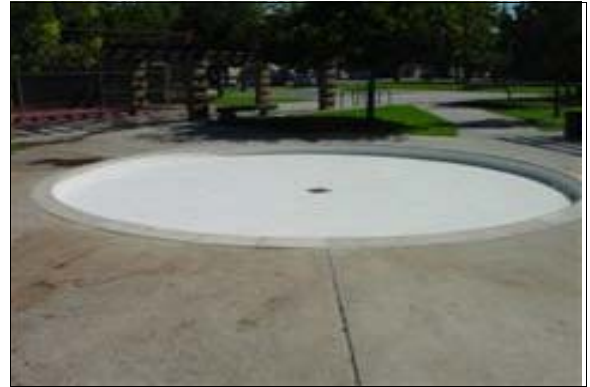
Wading Pool

Finding: The wading pool is not accessible by a hydraulic chair, ramp, transfer tier, or other means. During periods when the pools do not contain water they may become a tripping hazard.
