Photo Report
Glenoaks Park
Programs, Services, and Activities

Finding: The Glenoaks Park, located at 2531 East Glenoaks Boulevard in Glendale California, was inspected by Disability Access Consultants, Inc., on August 14 and 17, 2007.

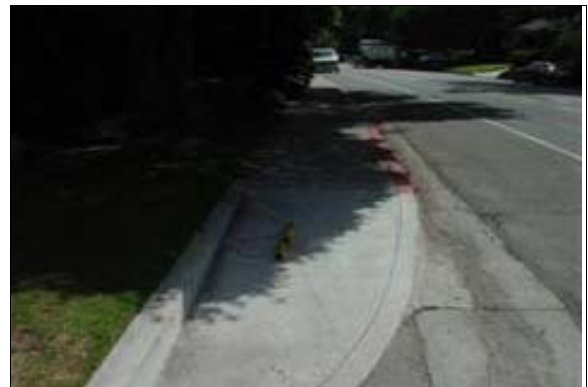
Curb Ramp at the Corner of Arcade and Glenoaks Boulevard
 Citations: CBC 1127B.5.3; ADAAG 4.7.2 & 4.29
 Minimum Quantity: 1
 Maximum Quantity: 1
Minimum Estimated Cost: \$1,033.00
Maximum Estimated Cost: \$1,033.00
 Record Number: 665
 Priority:

Finding: The slope of the curb ramp is greater than 8.33%. The concrete curb ramp does not provide a detectable warning surface which includes truncated domes.

Full Rec: Replace the curb ramp with a compliant curb ramp at least 48 inches in width that provides a slope no greater than 8.33%. Install a detectable warning surface which extends the full length and width of the concrete curb ramp and its side flares with truncated domes that contrast visually by either light on dark or dark on light which is an integral part of the concrete curb ramp. The truncated domes may be cast in place or stamped or of a prefabricated surface treatment (see CBC 1127B.5.8).

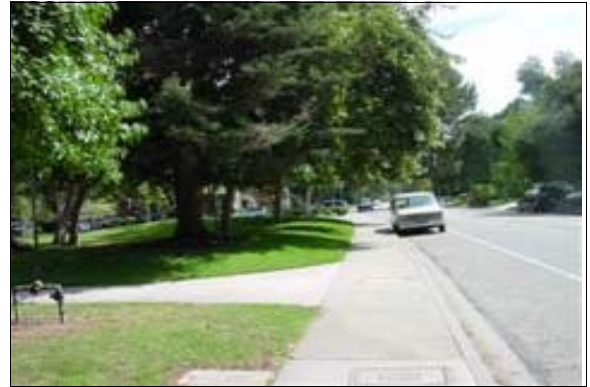
Accessible Route from the Public Right of Way

Finding: There is an accessible route from the public right of way to the accessible entrance of the facility.

Full Rec: Post directional signage. Make certain to post signage indicating the direction to accessible building entrances at every major junction along the accessible route. Signs shall include the International Symbol of Accessibility.

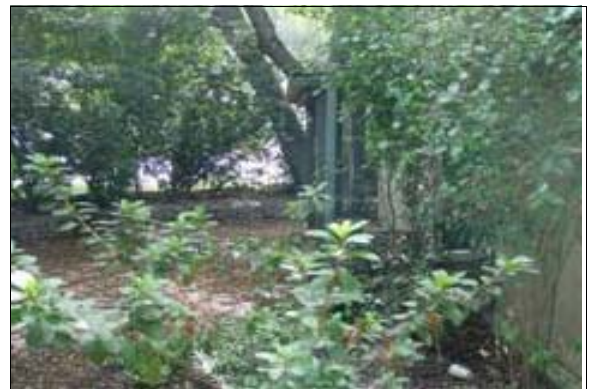
Path of Travel to the Caretaker's House

Finding: The path of travel to the Caretaker's House is grass and dirt, preventing access to individuals with mobility impairments.

Full Rec: Install an accessible route to where programs, services and activities are provided (see CBC 1114B.1.2 and ADAAG 4.3.2). The minimum width of the path of travel shall be 48 inches with a firm, stable and slip-resistant surface. No protruding objects are permitted on the accessible path of travel and slopes shall not exceed 5% in the direction of travel.

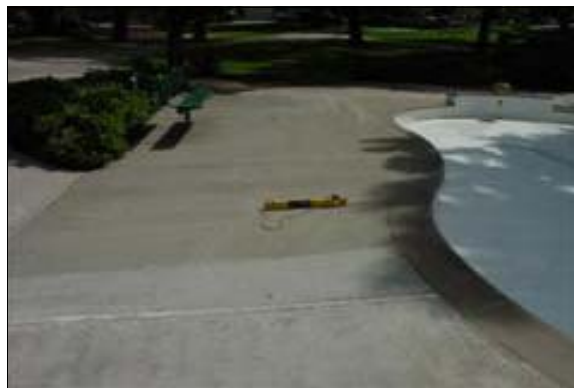
Path of Travel to the Wading Pool

Finding: There are slopes greater than 5% on the primary path of travel to the wading pool.

Full Rec: Resurface the path of travel to provide a level surface that does not exceed a slope greater than 5%. Cross slopes shall not exceed 2%.

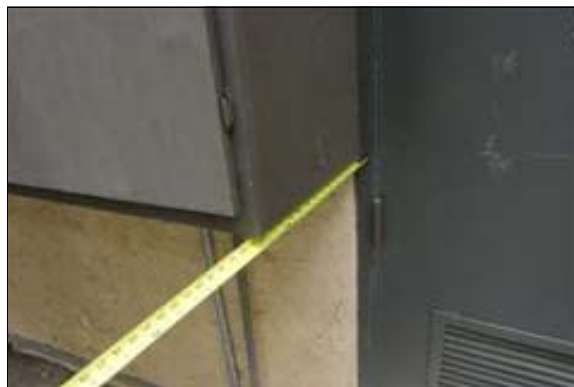
Protruding Object

Finding: The leading edge of the wall-mounted electrical box outside of the men's restroom is more than 4 inches from the wall and greater than 27 inches from the floor and protrudes into the primary path of travel.

Full Rec: Install side extensions, modify, relocate, or lower the electrical box so that the leading edge protrudes less than 4 inches from the wall, or are less than 27 inches from the floor (see CBC 1121B.1 and ADAAG 4.4).

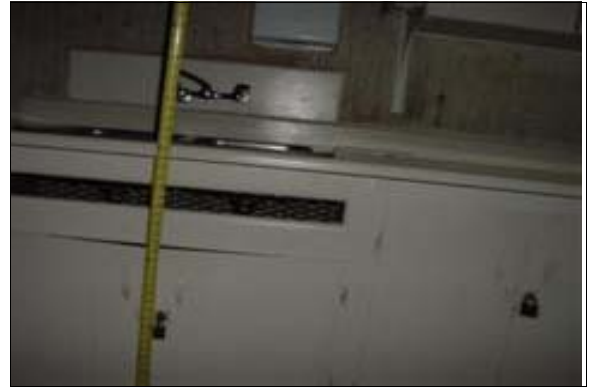
Sink in the Community Center

Finding: The sink in the Kitchen is in an enclosed cabinet, thereby preventing an accessible forward approach. The height of the counter surface of the sink is greater than 34 inches above the finished floor.

Full Rec: Sinks in rooms must provide clear floor space in front of the sink for an accessible forward approach and shall provide at least 27 inches clear knee space and a minimum of nine inches clear toe space (see ADAAG 4.19.2). If neither clear floor space and knee and toe clearance can be provided, remove the sink cabinet and replace with an accessible wall-mounted sink unit.

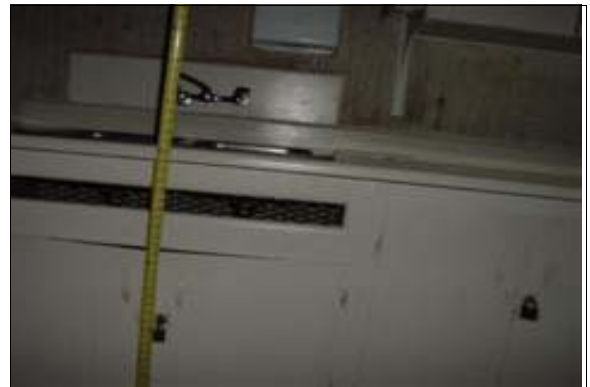
Sink in the Community Center

Finding: The pipes under the sink in the Kitchen do not provide protection against contact.

Full Rec: Insulate or otherwise configure pipes under the sink designated to be accessible in the room to protect against contact (see ADAAG 4.19.4). Make certain there are no sharp or abrasive surfaces under the sink.

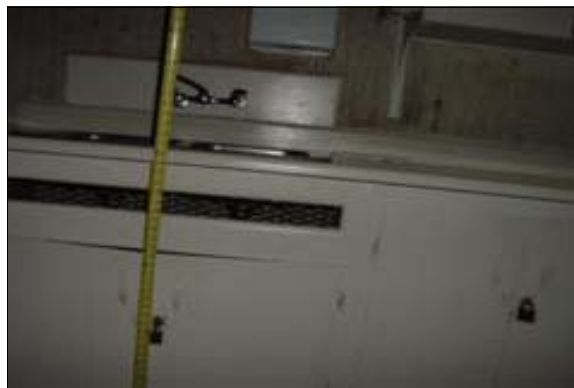
Sink in the Community Center

Finding: The faucet controls on the sink in the Kitchen require tight grasping, pinching, or twisting of the wrist and are not accessible.

Full Rec: Install faucet controls complying with ADAAG 4.19.5 on the sink designated to be accessible in the Kitchen. Lever-operated, push-type, touch-type or electronically controlled mechanisms are acceptable elements (see ADAAG 4.19.5). If self-closing valves are used the faucet shall remain open for at least 10 seconds.

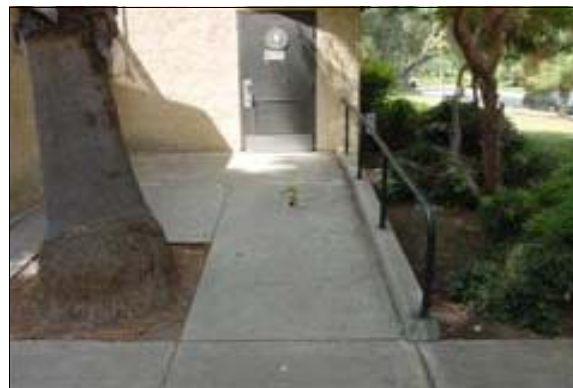
Exterior Ramp to the Women's Restroom

Finding: There is only one handrail provided on the ramp. There are no 12-inch extensions beyond the bottom of the ramp.

Full Rec: Install a handrail on each side of the ramp that provide a continuous and smooth gripping surface diameter between 1 1/4 inches to 1 7/8 inches, mounted at a height between 34 inches and 38 inches and shall be at a distance no less than 1 1/2 inches from the adjacent wall. The ends of the handrail shall extend 12 inches in a parallel height from the top and bottom of the ramp and return smoothly to the post or wall.

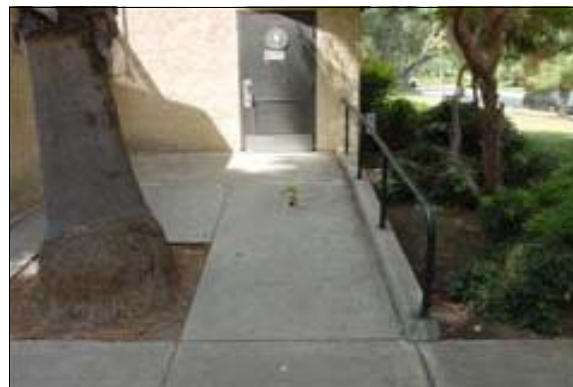
Exterior Ramp to the Women's Restroom

Finding: The left side of the ramp is not bounded by a wall or fence, thus not providing any edge protection to prevent individuals from slipping off the ramp.

Full Rec: Install edge protection on each side of the ramp consisting of 3-inch high guide curb or wheel guide rails centered 3 inches (plus or minus one inch) above the surface of the ramp (see CBC 1133B.5.4.9 and ADAAG 4.8.7).

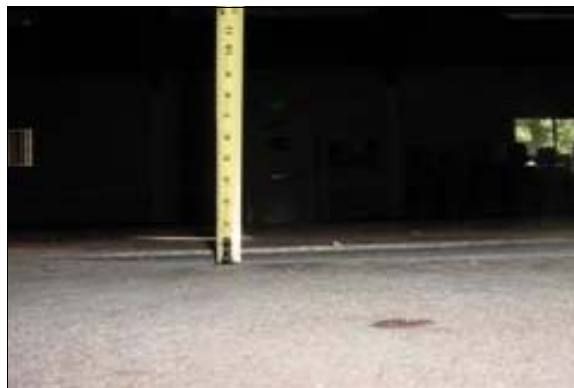
Community Center

Finding: The height of the threshold at the entrance door is greater than 1/2 inch.

Full Rec: Modify or replace the threshold to provide a smooth transition. The threshold should not exceed a beveled 1/2 inch. Provide a 60 inch level landing in the direction of the door swing.

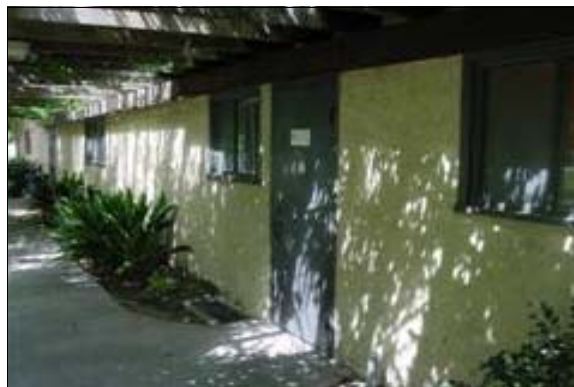
Community Center (Side Entrance)

Finding: There is less than 24 inches of clearance on the latch side of the exterior entrance door.

Full Rec: Consult a design professional to determine if it is technically feasible to provide at least 24 inches of latch side clearance at the entrance door (see ADAAG 4.13.6 and Figure 25). Otherwise, install an automatic door opening device to the primary entrance complying with ADAAG 4.13.12 and ANSI/BHMA A156.10, 1985, standards.

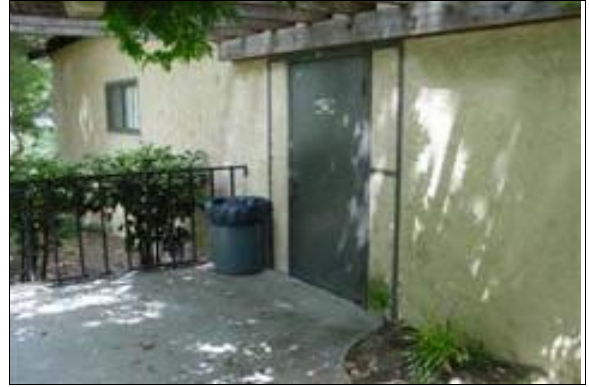
Community Center

Finding: There is no signage with the International Symbol of Accessibility on the entrance door to the facility designating it as accessible.

Full Rec: The International Symbol of Accessibility shall be the standard used to identify facilities that are accessible to and usable by physically disabled persons (see CBC 1117B.5.1). All building entrances that are accessible to and usable by persons with disabilities shall be identified with an ISA symbol (see CBC 1117B.5.7).

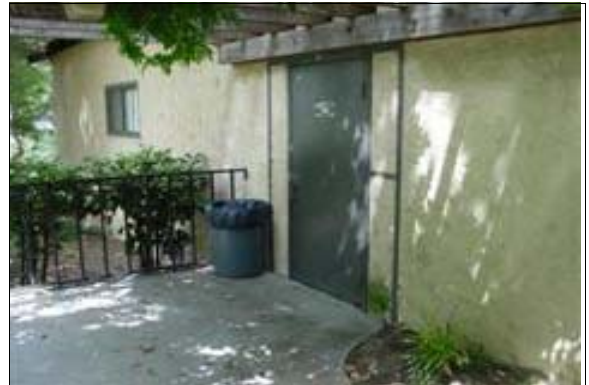
Community Center

Finding: The main entrance does not have accessible signage mounted on the wall adjacent to the latch side of the door.

Full Rec: Install signage centered at 60 inches above the finished floor on the wall adjacent to the latch side of the entry doorway stating ENTRANCE from the outside and EXIT from the inside, with raised UPPERCASE letters between 5/8 inch and 2 inches in height and Grade 2 Braille characters. The sign shall comply with the finish and contrast requirements set forth in CBC 1117B.5 and ADAAG 4.30.5. Signage should be located where a person may approach within three inches of the sign without encountering protruding objects or standing within the swing of the door.

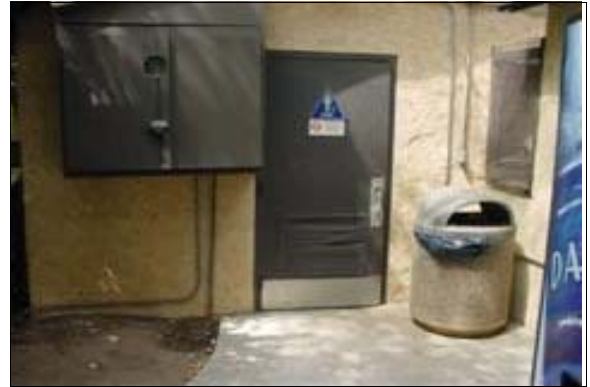
Men's Restroom

Finding: There is no signage indicating accessibility on the latch side of the exterior entry door of the restroom.

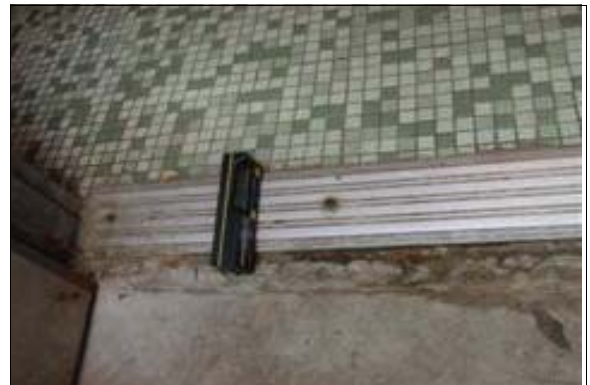
Men's Restroom

Finding: There is no level landing provided at the exterior entrance door.

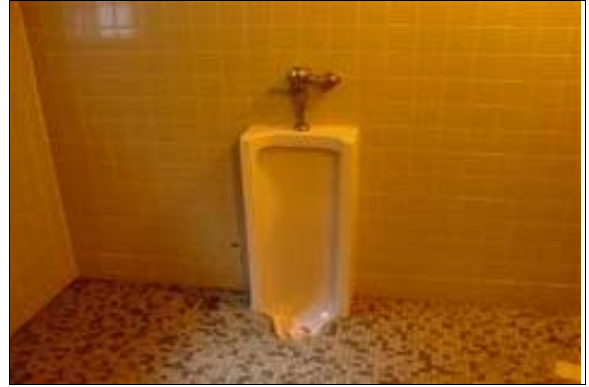
Men's Restroom

Finding: The urinal in the restroom is floor mounted and does not provide a tapered, elongated rim. The flush control valve on the urinal is greater than 44 inches above the finished floor.

Full Rec: Replace the urinal designated to be accessible in the restroom with a wall-mounted or stall-type tapered, elongated rim unit complying with ADAAG 4.18.2. The height of the rim surface of the urinal designated to be accessible shall not exceed 17 inches above the finished floor and the flush control valve shall not exceed a height of 44 inches above the finished floor.

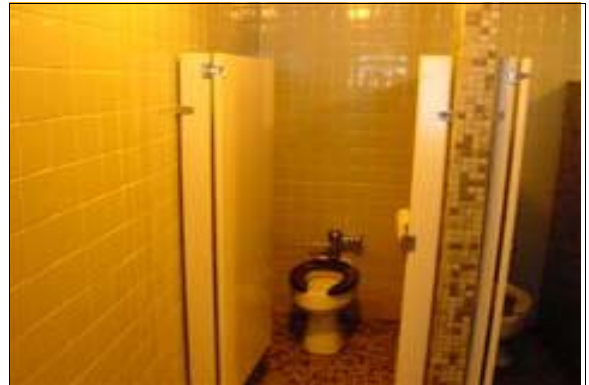
Men's Restroom

Finding: There is insufficient clear floor space in the stall designated to be accessible in the restroom. The stall door to the stall designated to be accessible in the restroom swings inward limiting the clear floor space in the stall designated to be accessible. The door to the stall designated to be accessible in the restroom does not close automatically or have accessible hardware.

Full Rec: Modify or replace the stall designated to be accessible in the restroom so that it complies with ADAAG 4.17.3, CBC 1115B and CBC Figures 11B-1A and 1B. Standard accessible stalls require 60 inches in width with 56 inches depth for wall-mounted toilets or 59 inches depth for floor-mounted toilets to accommodate individuals in wheelchairs. The minimum width of a front-approach doorway shall provide at least 32 inches and a side-approach doorway shall provide at least 34 inches. The door shall swing outward, close automatically and provide accessible hardware.

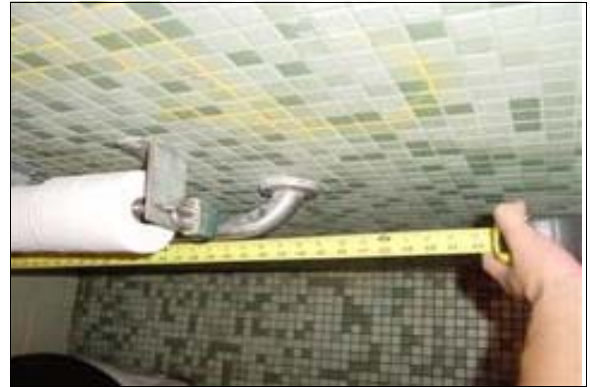
Men's Restroom

Finding: The length of the side grab bars in the stall designated to be accessible in the restroom is less than 42 inches. The side grab bars in the stall designated to be accessible in the restroom do not extend 54 inches from the back wall.

Full Rec: Replace the side grab bars in the stall designated to be accessible in the restroom with a 42-inch/ 48 -inch side grab bar complying with ADAAG 4.26 and CBC 1115B.8. The front end of the grab bar shall extend at least 54 inches from the back wall and the back end of the grab bar shall be mounted within 12 inches from the back wall. Grab bars must be able to support a point load of at least 250 pounds and shall be less than the allowable shear stress of the grab bar material.

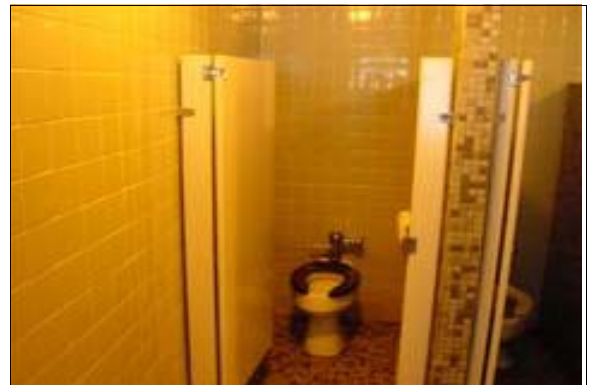
Men's Restroom

Finding: The distance from the end of the side grab bars to the back wall in the stall designated to be accessible in the restroom is greater than 12 inches.

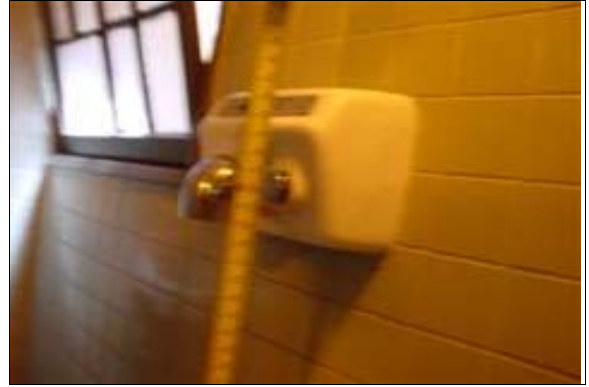
Finding: The height of the controls and operating mechanisms for the hand dryer in the restroom is greater than 40 inches.

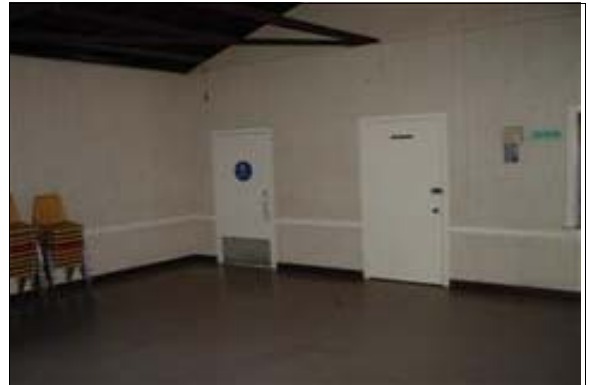
Finding: There is no signage indicating accessibility on the latch side of the interior entry door of the restroom. There is no Title 24 gender use signage on the interior entrance door.

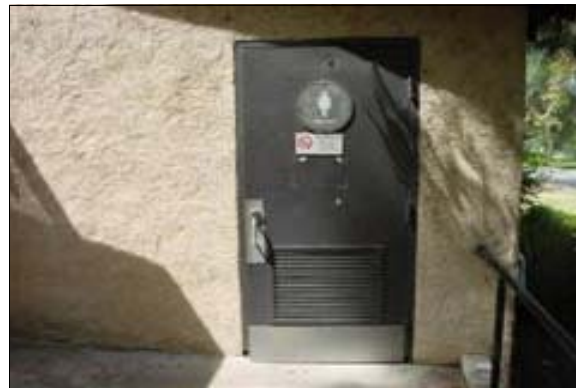
Women's Restroom

Finding: There is no signage indicating accessibility on the latch side of the exterior entry door of the restroom.

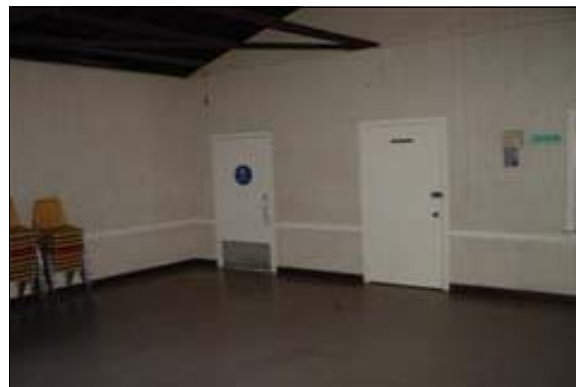
Women's Restroom

Finding: There is no signage indicating accessibility on the latch side of the interior entry door of the restroom. The gender use signage on the interior entrance door is not centered at 60 inches above the floor surface.

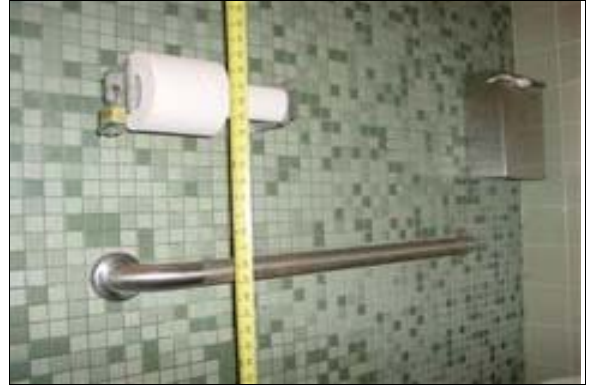
Women's Restroom

Finding: The height of the side grab bars in the stall designated to be accessible of the restroom is less than 33 inches above the finished floor.

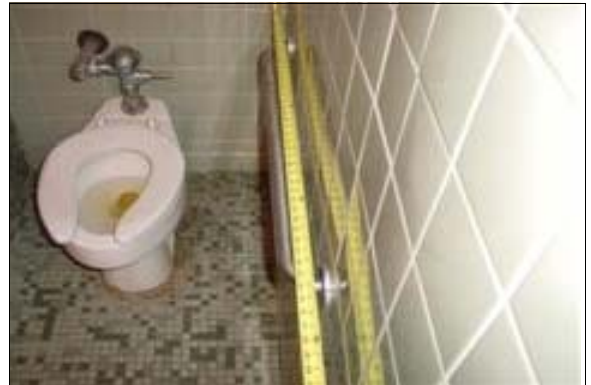
Women's Restroom

Finding: The length of the side grab bars in the stall designated to be accessible in the restroom is less than 42 inches. The side grab bars in the stall designated to be accessible in the restroom do not extend 54 inches from the back wall.

Full Rec: Replace the side grab bars in the stall designated to be accessible in the restroom with a 42-inch/ 48 -inch side grab bar complying with ADAAG 4.26 and CBC 1115B.8. The front end of the grab bar shall extend at least 54 inches from the back wall and the back end of the grab bar shall be mounted within 12 inches from the back wall. Grab bars must be able to support a point load of at least 250 pounds and shall be less than the allowable shear stress of the grab bar material.

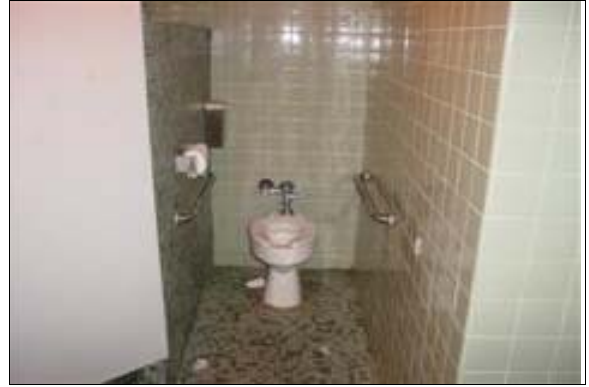
Women's Restroom

Finding: The distance from the end of the side grab bars to the back wall in the stall designated to be accessible in the restroom is greater than 12 inches.

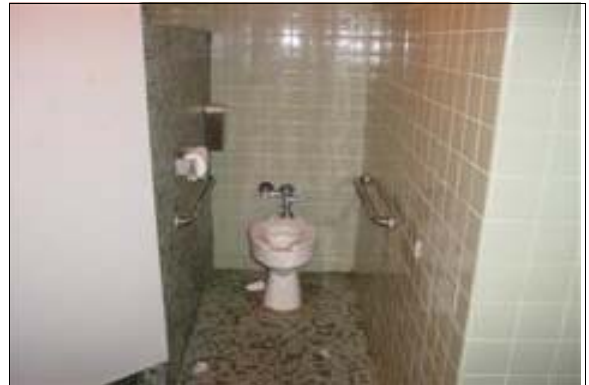
Women's Restroom

Finding: The flush control on the toilet in the stall designated to be accessible in the restroom is not on the wide (approach) side of the toilet.

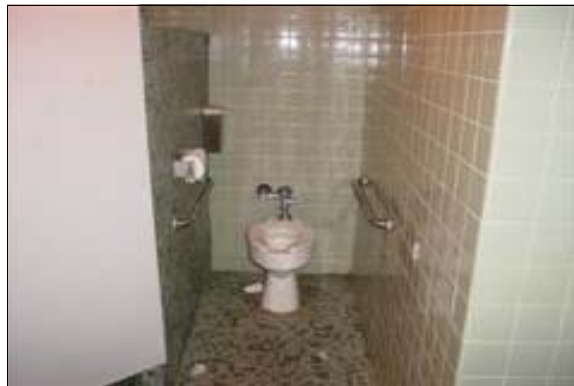
Women's Restroom

Finding: The distance from the center of the toilet to the nearest side wall in the stall designated to be accessible in the restroom is less than 18 inches.

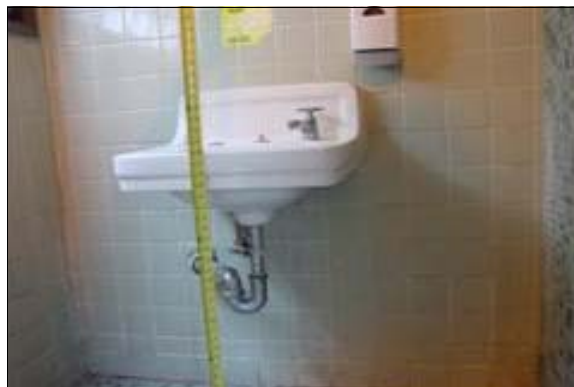
Women's Restroom

Finding: The faucet controls on the lavatory in the restroom require tight grasping, pinching, or twisting of the wrist and are not accessible.

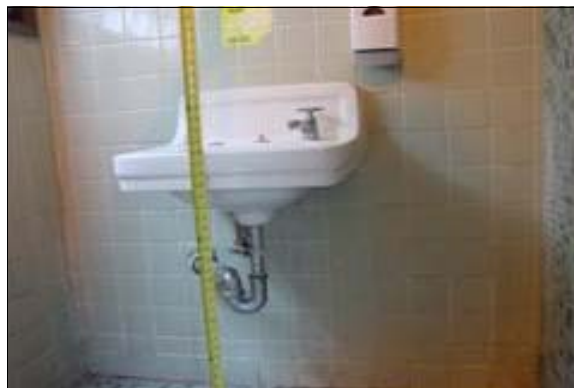
Women's Restroom

Finding: The pipes under the lavatory in the restroom do not provide protection against contact.

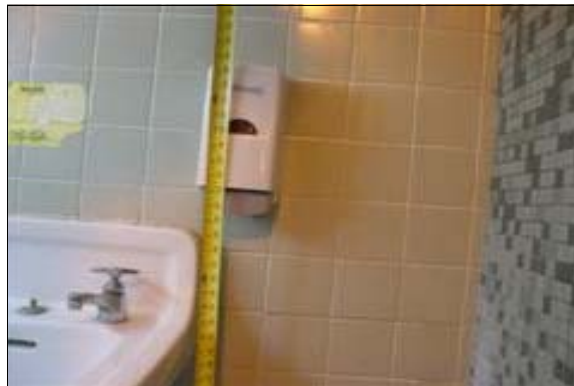
Women's Restroom

Finding: The height of the controls and operating mechanisms for the soap dispenser in the restroom is greater than 40 inches.

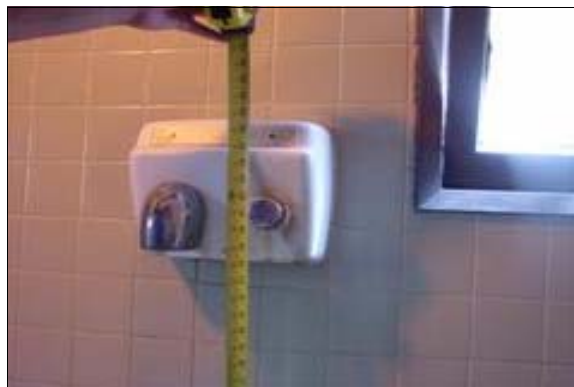
Women's Restroom

Finding: The height of the controls and operating mechanisms for the hand dryer in the restroom is greater than 40 inches.

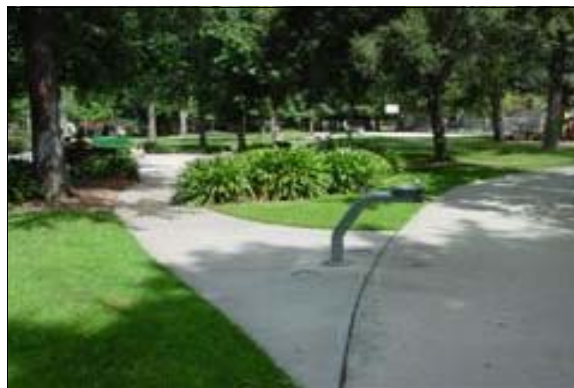
Finding: There are two drinking fountains on primary paths of travel.

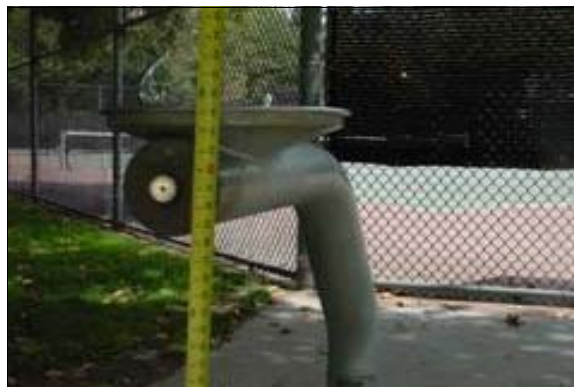
Drinking Fountain Next to the Tennis Court

Finding: The drinking fountain is not a "high-low" design. The spout outlet height is greater than 36 inches.

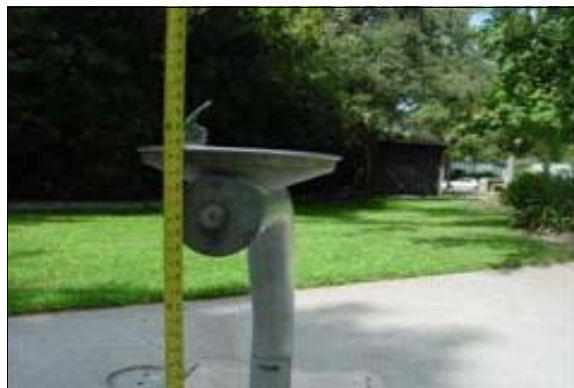
Drinking Fountain Next to the Wading Pool

Finding: The drinking fountain is not a "high-low" design. The spout outlet height is greater than 36 inches.

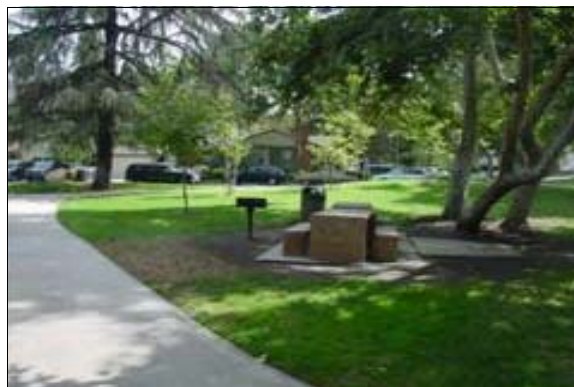
Outdoor Dining Area

Finding: There is no accessible route to the picnic tables in the outdoor dining area. The surface around the outdoor dining area picnic tables is dirt and grass, preventing access of individuals with mobility impairments.

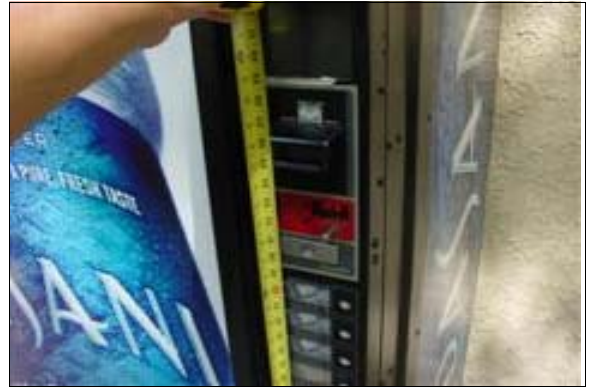
Vending Machine

Finding: The side reach height of the controls on the vending machine outside of the men's restroom is greater than 54 inches above the ground surface.

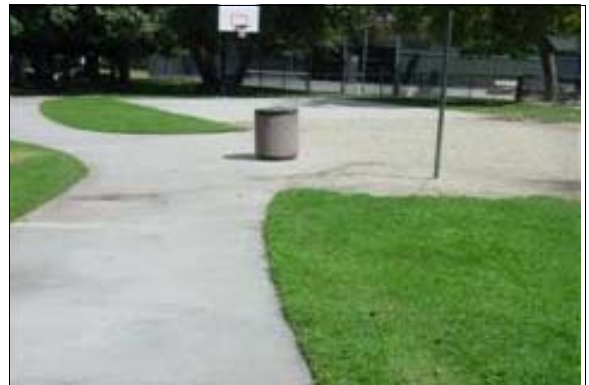
Basketball Court

Finding: The path of travel to the basketball court consists of sand, making the area nonaccessible to individuals with mobility impairments.

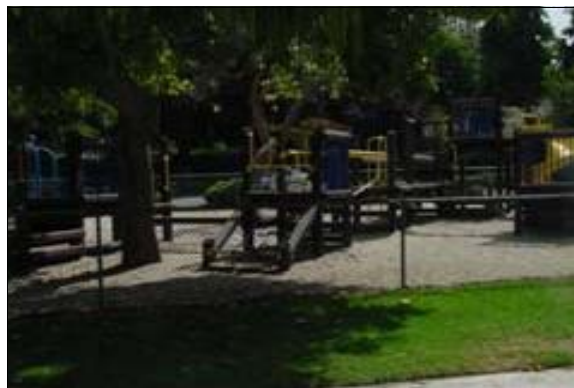
Play Equipment

Finding: The surface beneath the play equipment is sand, making the area nonaccessible to individuals with mobility impairments.

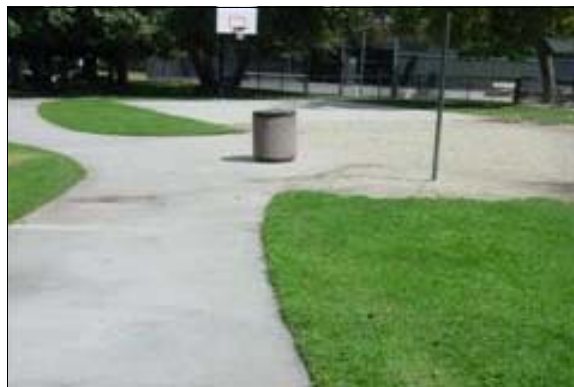
Volleyball Court

Finding: The sand surface of the volleyball court at the facility prevents access to individuals with mobility impairments.

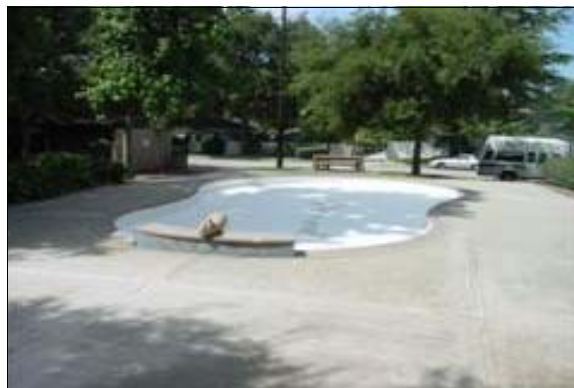
Wading Pool

Finding: The wading pool is not accessible by a hydraulic chair, ramp, transfer tier, or other means. During the periods when the pools do not contain water they may become a tripping hazard.
