Photo Report
Glorietta Park
Programs, Services, and Activities

Finding: Glorietta Park, located at 2801 North Verdugo in Glendale California, was inspected by Disability Access Consultants, Inc., on June 7, 2007.

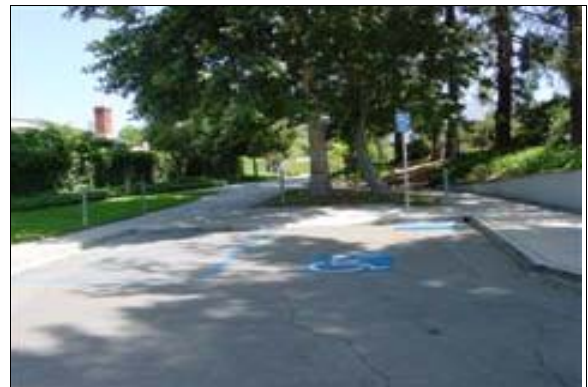
Finding: There is one accessible parking space out of 16 parking spaces marked, which is sufficient for compliance. The accessible parking space measures 160 inches wide and 211 inches long. The access aisle, located on the driver's side (left side) of the parking space, measures 135 inches wide. The parking space is not "van-accessible". The access aisle does not contain "NO PARKING" in 12" high white letters.

Full Rec: One out of the 16 total number of marked parking space meets the number required to be designated exclusively for accessible parking, according to ADAAG and CBC 1129B. Restripe the existing parking space marked accessible to create one van-accessible parking space measuring at least 108 inches wide and 216 inches long with an access aisle measuring at least 96 inches wide (8 feet) located on the passenger side (right side) of the parking space (see CBC 1129B). Add the words NO PARKING in 12 inch high white letters at the entrance to the accessible parking access aisle.

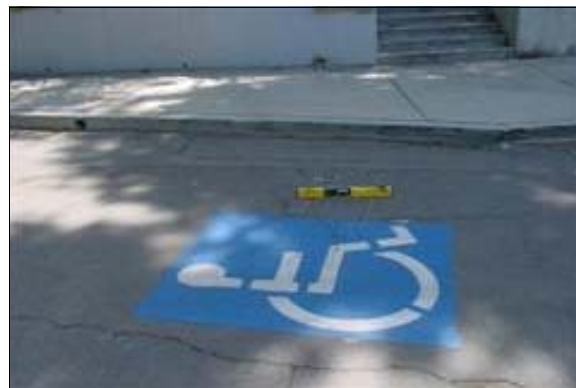
Finding: The surface of the accessible parking space in the parking lot has a slope greater than 2%.

Full Rec: Pave the parking lot at the accessible spaces to provide a level surface. Parking surfaces and access aisles shall be located in areas not exceeding 2% slope in all directions (see CBC 1129B and ADAAG 4.6.3).

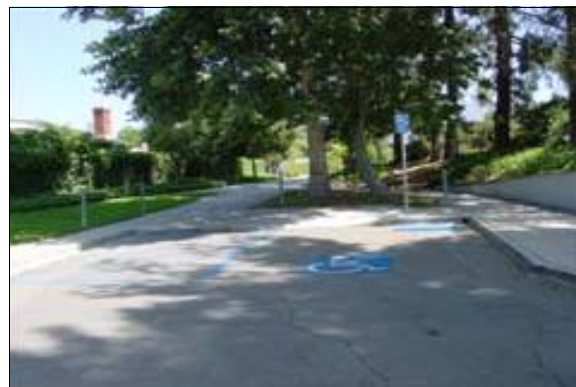
Finding: The device at the accessible parking space to prevent vehicles from encroaching into the minimum width of the accessible walkway is not at the head of the accessible parking space.

Full Rec: Install a wheelstop at the head of the accessible parking space. Wheelstops shall be used to prevent vehicles from encroaching into accessible aisles or walkways, but shall not present additional encroachment into those areas (see CBC 1129B.4.3).

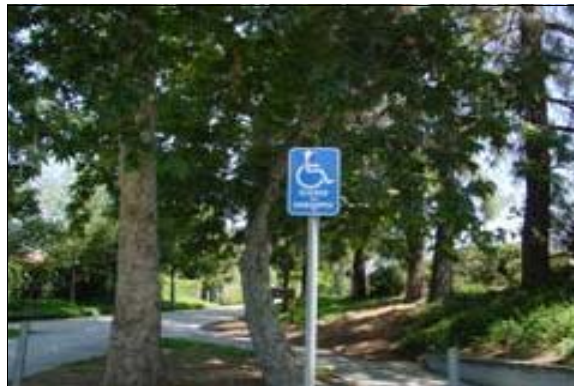
Finding: The vertically-mounted signage at the designated accessible parking space in the parking lot showing the International Symbol of Accessibility uses the word "handicapped".

Full Rec: Install a permanently posted reflectorized sign measuring 70 square inches that includes an ISA symbol adjacent to and visible from the accessible parking space (see CBC 1129B.5). The bottom edge of the sign must be mounted 80 inches from the ground surface so that it cannot be obscured by a parked vehicle (see CBC 1129B.5). The "van-accessible" parking space shall provide an additional sign marked "van-accessible" mounted below the sign (see CBC 1129B.5 and ADAAG 4.6.4).

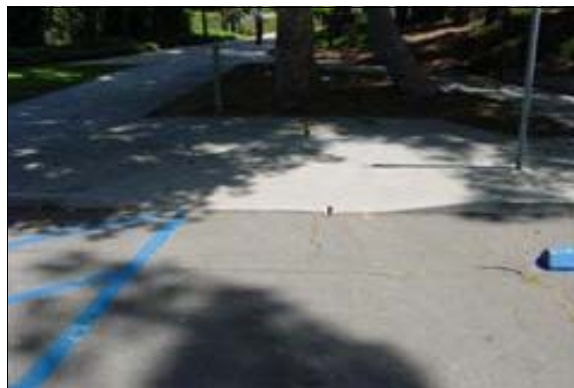
Curb Ramp at the Accessible Parking Space

Finding: The curb ramp is not wholly contained within the access aisle lines. The slope at the top landing is greater than 2%. The concrete curb ramp does not provide a detectable warning surface which includes truncated domes.

Full Rec: Replace the curb ramp with a compliant curb ramp at least 48 inches in width that provides a slope no greater than 8.33%. Install a detectable warning surface which extends the full length and width of the concrete curb ramp and its side flares with truncated domes that contrast visually by either light on dark or dark on light which is an integral part of the concrete curb ramp. The truncated domes may be cast in place or stamped or of a prefabricated surface treatment (see CBC 1127B.5.8).

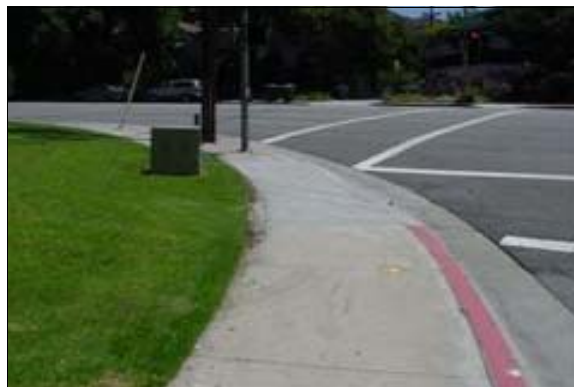
Curb Ramp at the Corner of Glorietta and Verdugo

Finding: The slope of the right side of the concrete sidewalk curb ramp is greater than 8.33%. The concrete curb ramp does not provide a detectable warning surface which includes truncated domes.

Full Rec: Replace the curb ramp with a compliant curb ramp at least 48 inches in width that provides a slope no greater than 8.33%. Install a detectable warning surface which extends the full length and width of the concrete curb ramp and its side flares with truncated domes that contrast visually by either light on dark or dark on light which is an integral part of the concrete curb ramp. The truncated domes may be cast in place or stamped or of a prefabricated surface treatment (see CBC 1127B.5.8).

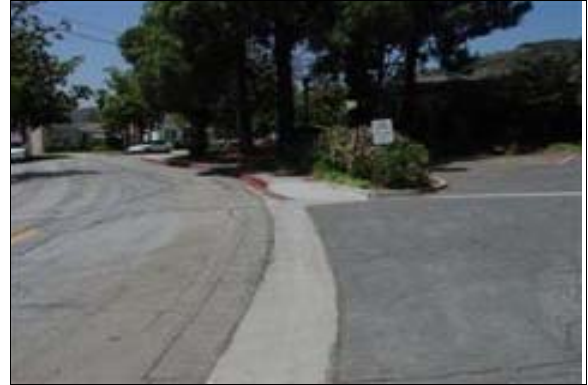
Curb Ramp off of Glorietta (Left)

Finding: The cross slope of the curb ramp is greater than 2%. The concrete curb ramp does not provide a detectable warning surface which includes truncated domes.

Full Rec: Replace the curb ramp with a compliant curb ramp at least 48 inches in width that provides a slope no greater than 8.33%. Install a detectable warning surface which extends the full length and width of the concrete curb ramp and its side flares with truncated domes that contrast visually by either light on dark or dark on light which is an integral part of the concrete curb ramp. The truncated domes may be cast in place or stamped or of a prefabricated surface treatment (see CBC 1127B.5.8).

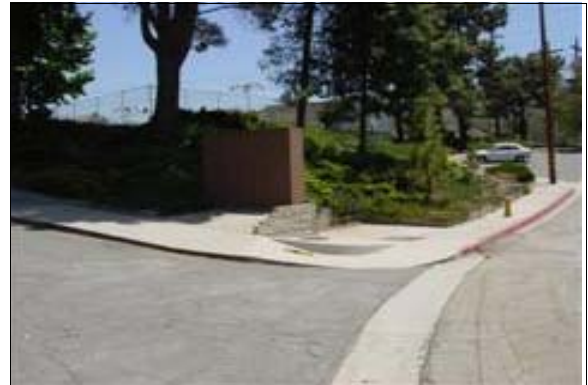
Curb Ramp off of Glorietta (Right)

Finding: The slope of each side of the concrete sidewalk curb ramp is greater than 8.33%. The concrete curb ramp does not provide a detectable warning surface which includes truncated domes.

Full Rec: Replace the curb ramp with a compliant curb ramp at least 48 inches in width that provides a slope no greater than 8.33%. Install a detectable warning surface which extends the full length and width of the concrete curb ramp and its side flares with truncated domes that contrast visually by either light on dark or dark on light which is an integral part of the concrete curb ramp. The truncated domes may be cast in place or stamped or of a prefabricated surface treatment (see CBC 1127B.5.8).

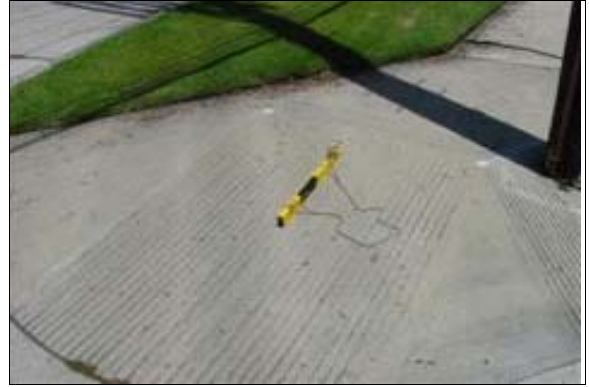
Curb Ramp off of Verdugo (Center Left)

Finding: The slope of the curb ramp is greater than 8.33%. There is less than 48 inches in length of maneuvering clearance at the top landing. The concrete curb ramp does not provide a detectable warning surface which includes truncated domes.

Full Rec: Replace the curb ramp with a compliant curb ramp at least 48 inches in width that provides a slope no greater than 8.33%. Install a detectable warning surface which extends the full length and width of the concrete curb ramp and its side flares with truncated domes that contrast visually by either light on dark or dark on light which is an integral part of the concrete curb ramp. The truncated domes may be cast in place or stamped or of a prefabricated surface treatment (see CBC 1127B.5.8).

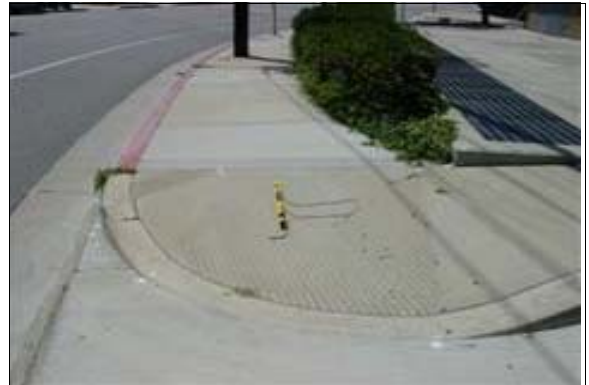
Curb Ramp off of Verdugo (Center Right)

Finding: The slope of the curb ramp is greater than 8.33%. The concrete curb ramp does not provide a detectable warning surface which includes truncated domes.

Full Rec: Replace the curb ramp with a compliant curb ramp at least 48 inches in width that provides a slope no greater than 8.33%. Install a detectable warning surface which extends the full length and width of the concrete curb ramp and its side flares with truncated domes that contrast visually by either light on dark or dark on light which is an integral part of the concrete curb ramp. The truncated domes may be cast in place or stamped or of a prefabricated surface treatment (see CBC 1127B.5.8).

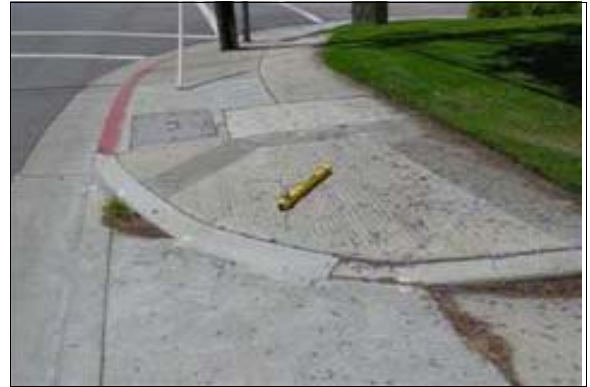
Curb Ramp off of Verdugo (Left)

Finding: The slope of the curb ramp is greater than 8.33%. The slope at the top landing is greater than 2%. The concrete curb ramp does not provide a detectable warning surface which includes truncated domes.

Full Rec: Replace the curb ramp with a compliant curb ramp at least 48 inches in width that provides a slope no greater than 8.33%. Install a detectable warning surface which extends the full length and width of the concrete curb ramp and its side flares with truncated domes that contrast visually by either light on dark or dark on light which is an integral part of the concrete curb ramp. The truncated domes may be cast in place or stamped or of a prefabricated surface treatment (see CBC 1127B.5.8).

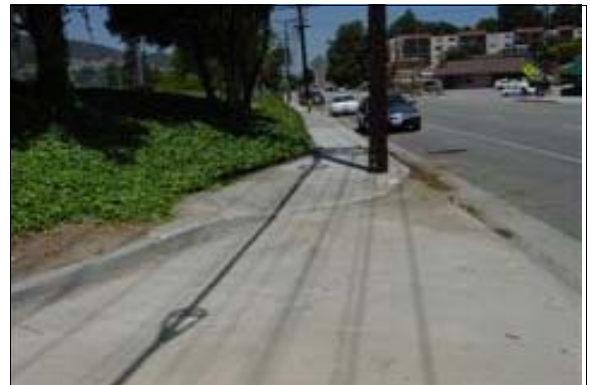
Curb Ramp off of Verdugo (Right)

Finding: There is less than 48 inches in length of maneuvering clearance at the top landing. The concrete curb ramp does not provide a detectable warning surface which includes truncated domes.

Full Rec: Replace the curb ramp with a compliant curb ramp at least 48 inches in width that provides a slope no greater than 8.33%. Install a detectable warning surface which extends the full length and width of the concrete curb ramp and its side flares with truncated domes that contrast visually by either light on dark or dark on light which is an integral part of the concrete curb ramp. The truncated domes may be cast in place or stamped or of a prefabricated surface treatment (see CBC 1127B.5.8).

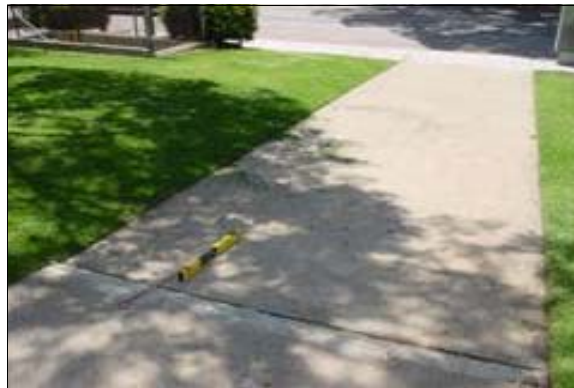
Path of Travel to the Baseball Field

Finding: There are slopes greater than 5% on the primary path of travel from the public right of way to the baseball field.

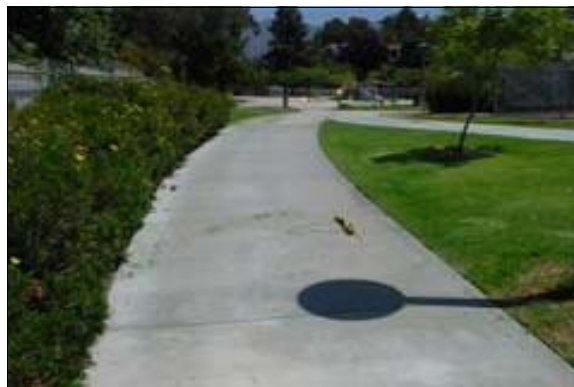
Path of Travel to the Park

Finding: There are slopes greater than 5% on the primary path of travel from the accessible parking space to the park.

Full Rec: Resurface the path of travel to provide a level surface that does not exceed a slope greater than 5%. Cross slopes shall not exceed 2%.

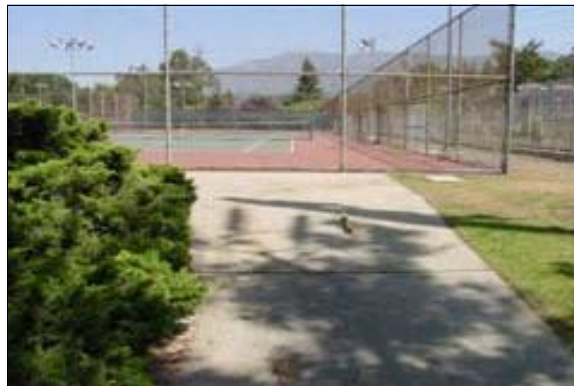
Path of Travel to the Tennis Courts

Finding: There are slopes greater than 5% on the primary path of travel to the tennis courts.

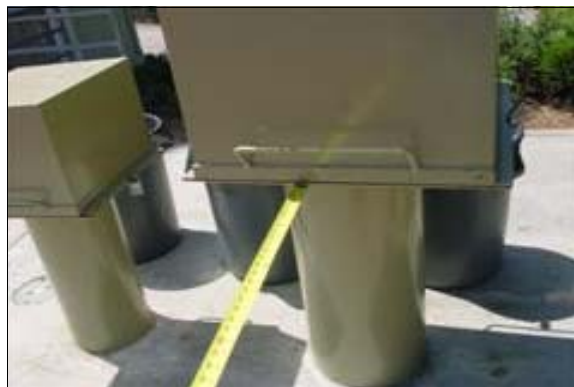
Protruding Objects

Finding: The leading edge of the control boxes next to the tennis courts is more than 4 inches from the wall and greater than 27 inches from the floor and protrudes into the primary path of travel.

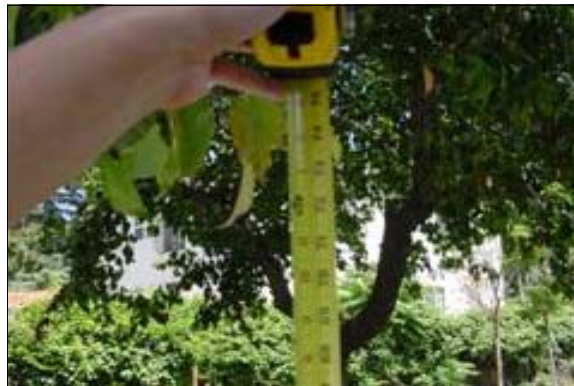
Finding: At the time of inspection, vegetation encroached into the primary path of travel to the women's restroom, obstructing passage by reducing the vertical clearance height to less than 80 inches.

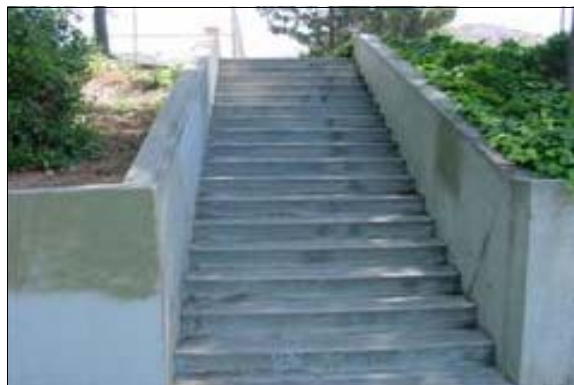
Finding: There is no detectable striping on each tread of the exterior stairway from the accessible parking to the tennis courts.

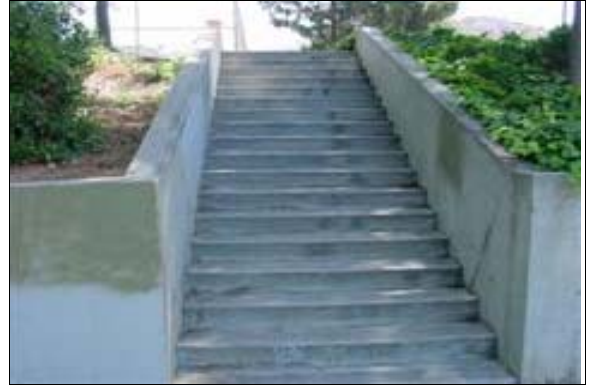
Exterior Stairs to the Tennis Courts

Finding: There are no handrails provided on the stairway.

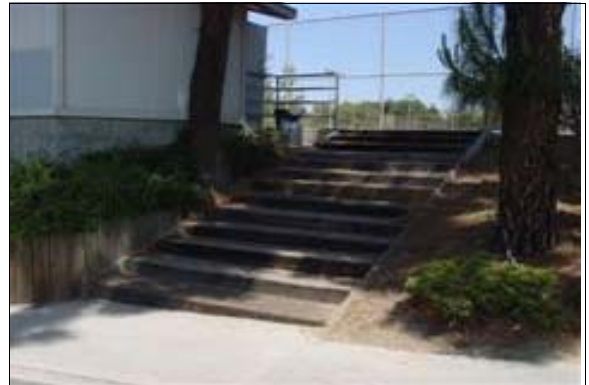
Exterior Stairs to the Tennis Courts

Finding: There is no detectable striping on each tread of the exterior stairway from the parking off of Woodland Avenue to the tennis courts.

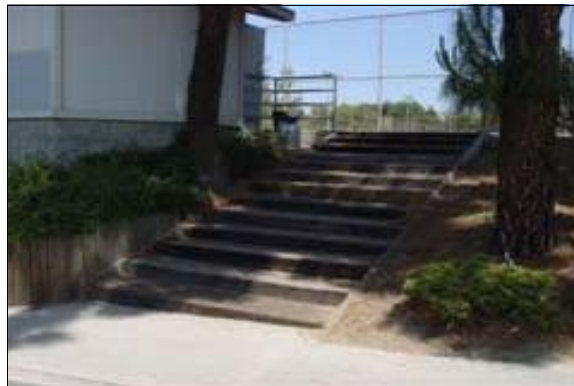
Exterior Stairs to the Tennis Courts

Finding: The width of the stairway is greater than 88 inches.

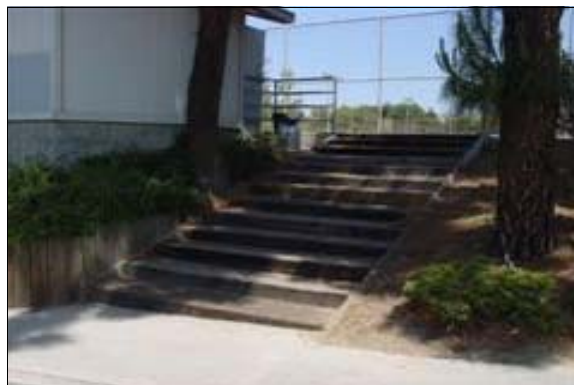
Exterior Stairs to the Tennis Courts

Finding: There are no handrails provided on the stairway.

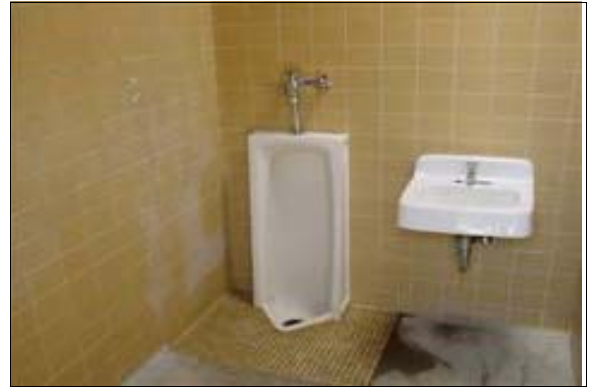
Men's Restroom

Finding: The urinal in the restroom is floor mounted and does not provide a tapered, elongated rim. The flush control valve on the urinal is greater than 44 inches above the finished floor.

Full Rec: Replace the urinal designated to be accessible in the restroom with a wall-mounted or stall-type tapered, elongated rim unit complying with ADAAG 4.18.2. The height of the rim surface of the urinal designated to be accessible shall not exceed 17 inches above the finished floor and the flush control valve shall not exceed a height of 44 inches above the finished floor.

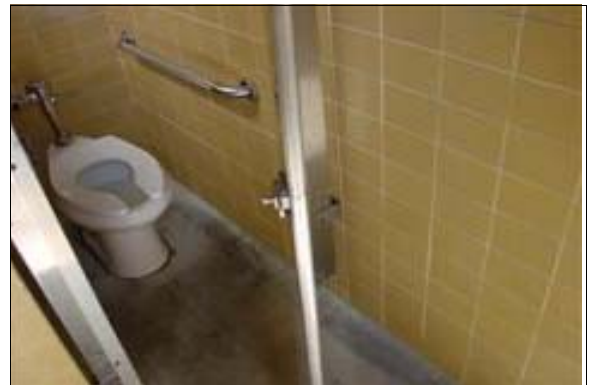
Men's Restroom

Finding: There is insufficient clear floor space in the stall designated to be accessible in the restroom. The door to the stall designated to be accessible in the restroom does not close automatically or have accessible hardware.

Full Rec: Modify or replace the stall designated to be accessible in the restroom so that it complies with ADAAG 4.17.3, CBC 1115B and CBC Figures 11B-1A and 1B. Standard accessible stalls require 60 inches in width with 56 inches depth for wall-mounted toilets or 59 inches depth for floor-mounted toilets to accommodate individuals in wheelchairs. The minimum width of a front-approach doorway shall provide at least 32 inches and a side-approach doorway shall provide at least 34 inches. The door shall swing outward, close automatically and provide accessible hardware.

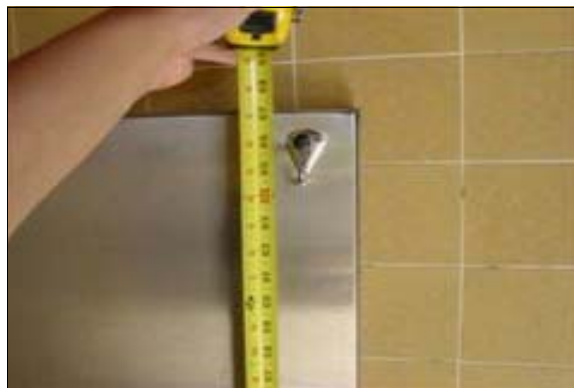
Finding: The height of the coat hook on the stall door designated to be accessible in the restroom is greater than 48 inches above the floor surface.

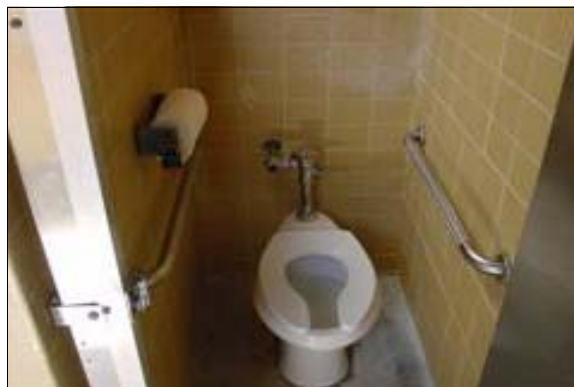
Finding: There is no back grab bar in the stall designated to be accessible in the restroom.

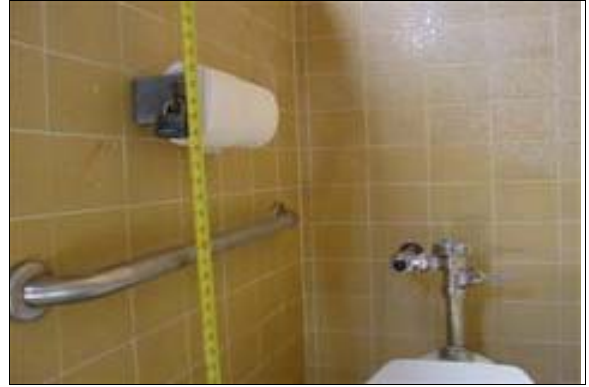
Men's Restroom

Finding: The height of the side grab bars in the stall designated to be accessible of the restroom is less than 33 inches above the finished floor.

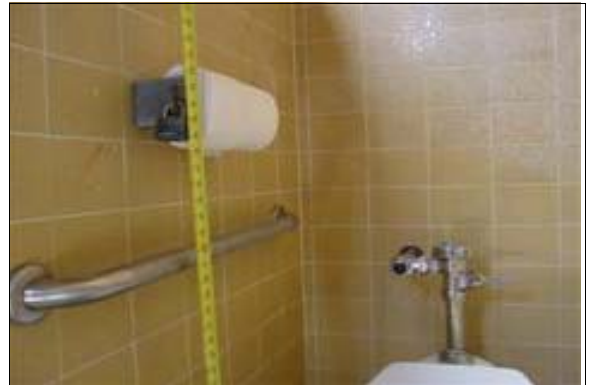
Men's Restroom

Finding: The length of the side grab bars in the stall designated to be accessible in the restroom is less than 42 inches. The side grab bars in the stall designated to be accessible in the restroom do not extend 54 inches from the back wall.

Full Rec: Replace the side grab bar in the stall designated to be accessible in the restroom with a 42-inch/ 48 -inch side grab bar complying with ADAAG 4.26 and CBC 1115B.8. The front end of the grab bar shall extend at least 54 inches from the back wall and the back end of the grab bar shall be mounted within 12 inches from the back wall. Grab bars must be able to support a point load of at least 250 pounds and shall be less than the allowable shear stress of the grab bar material.

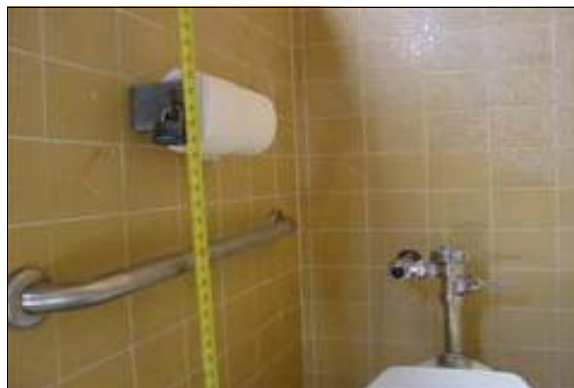
Men's Restroom

Finding: The toilet paper dispenser in the stall designated to be accessible in the restroom interferes with the use of the side grab bar.

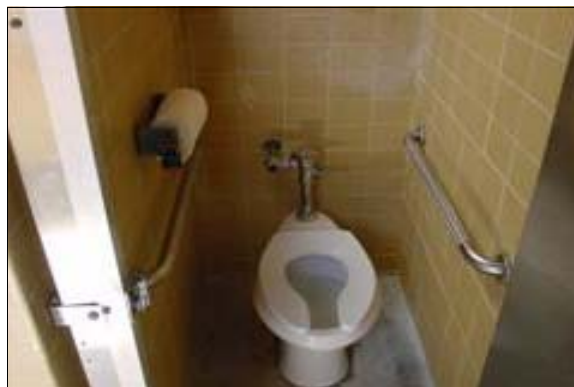
Men's Restroom

Finding: The flush control on the toilet in the stall designated to be accessible in the restroom is not on the wide (approach) side of the toilet.

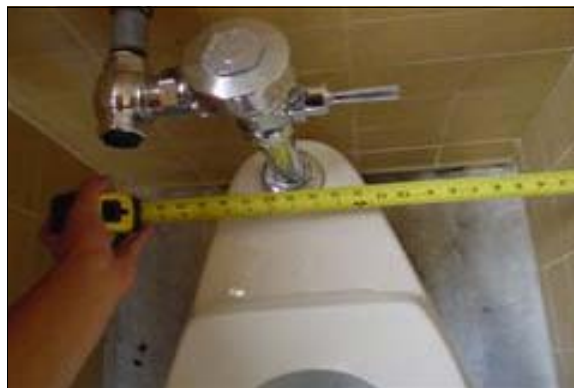
Finding: The distance from the center of the toilet to the nearest side wall in the stall designated to be accessible in the restroom is less than 18 inches.

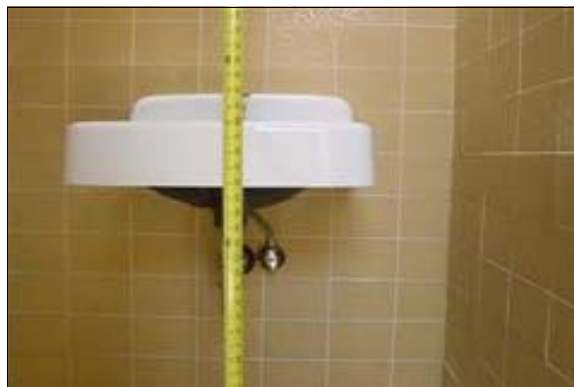
Finding: The faucet controls on the lavatory in the restroom require tight grasping, pinching, or twisting of the wrist and are not accessible.

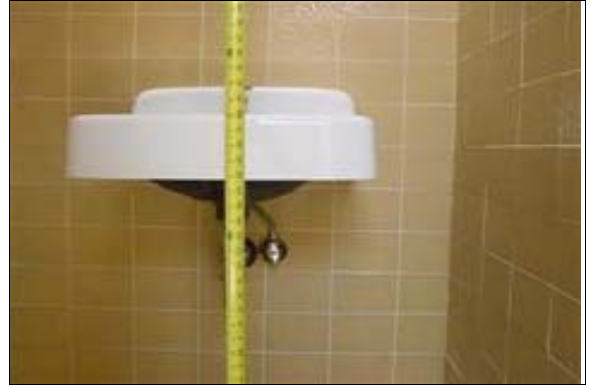
Men's Restroom

Finding: The knee clearance space under the lavatory designated to be accessible in the restroom is less than 29 inches. The knee depth space under the lavatory designated to be accessible in the restroom is less than 27 inches at 8 inches under the lavatory apron.

Full Rec: Replace the lavatory designated to be accessible in the restroom to provide at least 29 inches of clear knee space between the finished floor and bottom of the lavatory apron. Make sure to provide at least 27 inches at 8 inches under the apron (see ADAAG 4.19.2).

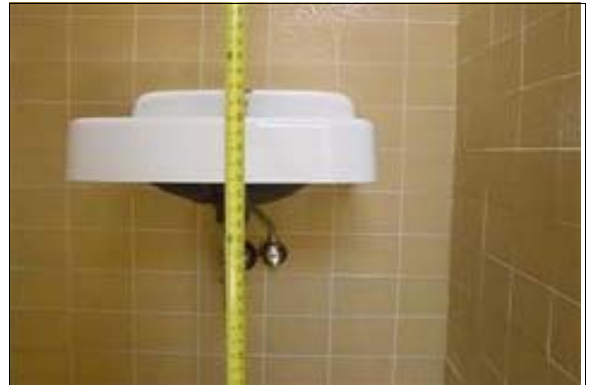
Men's Restroom

Finding: The pipes under the lavatory in the restroom do not provide protection against contact.

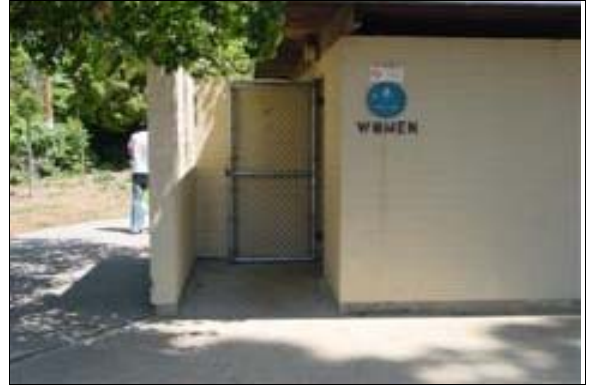
Finding: There is no signage indicating accessibility on the latch side of the entry door of the restroom. The gender use signage is not mounted on the entrance door.

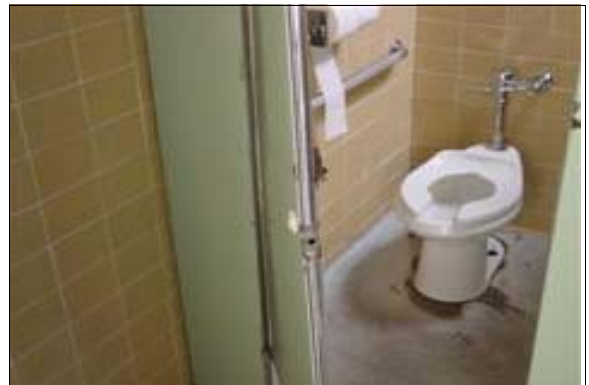
Finding: There is insufficient clear floor space in the stall designated to be accessible in the restroom. The door to the stall designated to be accessible in the restroom does not close automatically or have accessible hardware.

Full Rec: Modify or replace the stall designated to be accessible in the restroom so that it complies with ADAAG 4.17.3, CBC 1115B and CBC Figures 11B-1A and 1B. Standard accessible stalls require 60 inches in width with 56 inches depth for wall-mounted toilets or 59 inches depth for floor-mounted toilets to accommodate individuals in wheelchairs. The minimum width of a front-approach doorway shall provide at least 32 inches and a side-approach doorway shall provide at least 34 inches. The door shall swing outward, close automatically and provide accessible hardware.

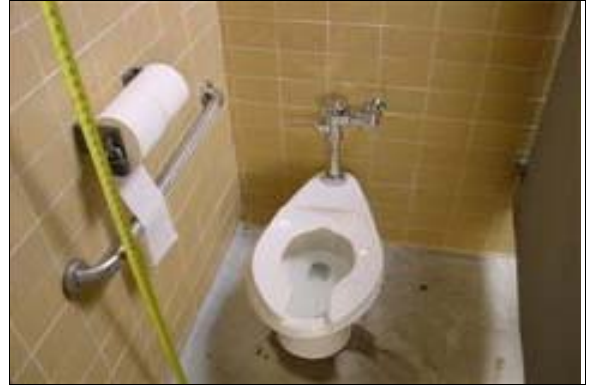
Women's Restroom

Finding: The height of the side grab bar in the stall designated to be accessible of the restroom is less than 33 inches above the finished floor.

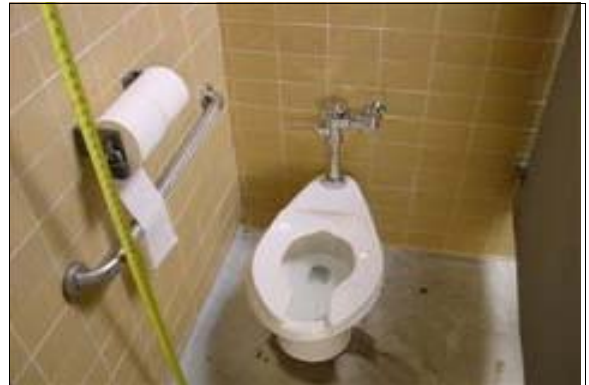
Women's Restroom

Finding: The length of the side grab bar in the stall designated to be accessible in the restroom is less than 42 inches. The side grab bar in the stall designated to be accessible in the restroom does not extend 54 inches from the back wall.

Full Rec: Replace the side grab bar in the stall designated to be accessible in the restroom with a 42-inch/ 48 -inch side grab bar complying with ADAAG 4.26 and CBC 1115B.8. The front end of the grab bar shall extend at least 54 inches from the back wall and the back end of the grab bar shall be mounted within 12 inches from the back wall. Grab bars must be able to support a point load of at least 250 pounds and shall be less than the allowable shear stress of the grab bar material.

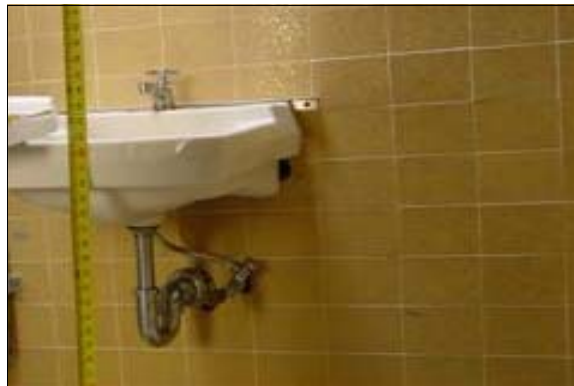
Women's Restroom

Finding: The pipes under the lavatory in the restroom do not provide protection against contact.

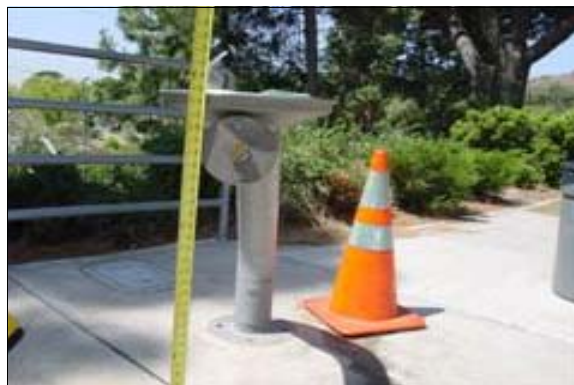
Finding: There are four drinking fountains on primary paths of travel.

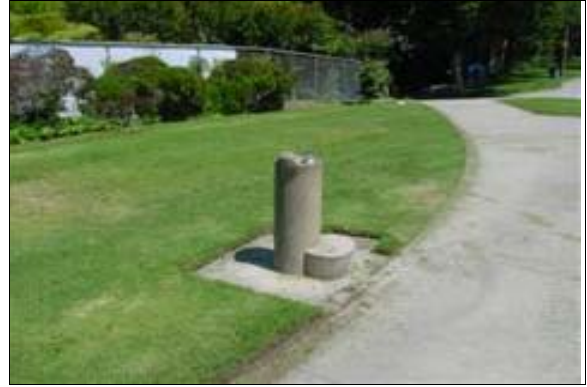
Drinking Fountain Between the Parking Lot and the Restrooms

Finding: The drinking fountain is not a "high-low" design. There is less than 27 inches knee clearance height.

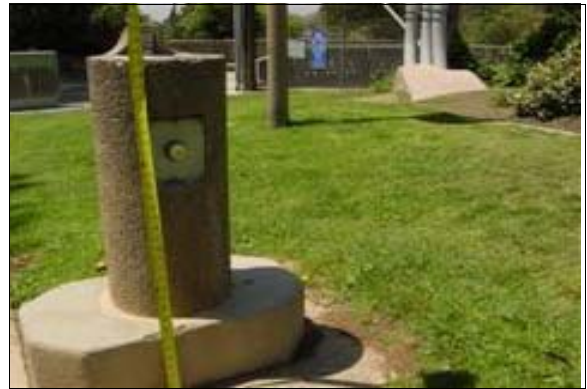
Drinking Fountain Next to the Baseball Field

Finding: The drinking fountain is not a "high-low" design. There is less than 27 inches knee clearance height.
