Photo Report
Griffith Manor Park
Programs, Services, and Activities

Finding: The Griffith Manor Park, located at 1551 Flower Street in Glendale California, was inspected by Disability Access Consultants, Inc., on June 12 and 14, 2007.

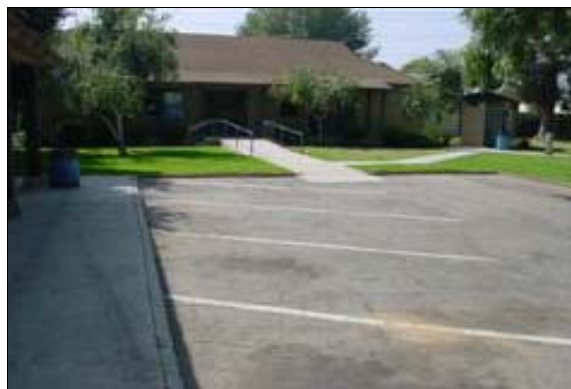
Parking Lot Next to the Community Center
 Citations: CBC 1129B; ADAAG 4.3.2(1); ADAAG 4.6.2; ADAAG 4.1.2(5)
 Minimum Quantity: 1
 Maximum Quantity: 1
Minimum Estimated Cost: \$270.00
Maximum Estimated Cost: \$270.00
 Record Number: 795
 Priority:

Finding: Paved parking is provided next to the Community Center. There are no accessible parking spaces designated out of 10 total parking spaces provided in the parking lot.

Full Rec: One out of the 10 total number of marked parking spaces is required to be designated exclusively for accessible parking, as required by CBC 1129B and ADAAG. Create one van-accessible parking space measuring at least 108 inches wide and 216 inches long with an access aisle measuring at least 96 inches wide (8 feet) located on the passenger side (right side) of the parking space (see CBC 1129B). Add the words NO PARKING in 12 inch high white letters at the entrance to the accessible parking access aisle.

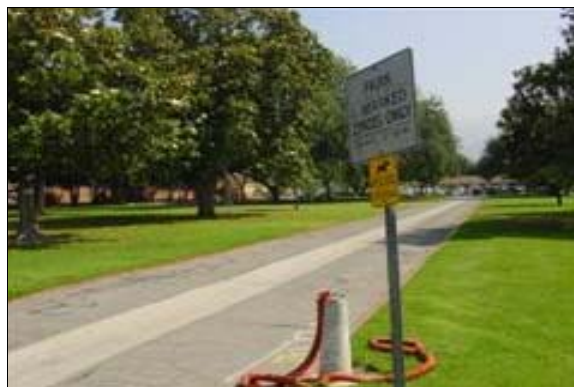
Parking Lot Next to the Community Center

Finding: There is no warning signage posted at the entrance to the parking lot regarding unauthorized use of accessible parking spaces in the parking lot.

Full Rec: Post a sign in a conspicuous place to the entrance of the parking lot, or immediately adjacent to and visible from each accessible parking space. The warning sign shall measure at least 17 inches by 22 inches in size and consist of lettering at least 1 inch in height that clearly and conspicuously states the following; "Unauthorized vehicles parked in designated accessible spaces not displaying distinguishing placards or license plates issued for persons with disabilities may be towed away at owner's expense. Towed vehicles may be reclaimed at ____ or by telephoning ____ ." Fill in the blank spaces with appropriate information as a permanent part of the sign and maintain the currency of the information (see CBC 1129B.5). Be sure to add the CVC 22511.8(a)(d) to the sign.

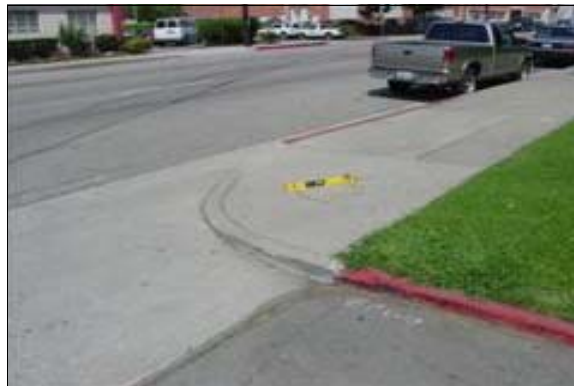
Curb Ramp off of Flower Street (Left)

Finding: The slope of the curb ramp is greater than 8.33%. The slope of the side flares is greater than 10%. There is less than 48 inches in length of maneuvering clearance at the top landing. The curb ramp does not provide a grooved border along the top and sides of the ramp at the level of the sidewalk. The concrete curb ramp does not provide a detectable warning surface which includes truncated domes. The curb ramp is not parallel with the direction of pedestrian traffic.

Full Rec: Replace the curb ramp with a compliant curb ramp at least 48 inches in width that provides a slope no greater than 8.33%. Install a detectable warning surface which extends the full length and width of the concrete curb ramp and its side flares with truncated domes that contrast visually by either light on dark or dark on light which is an integral part of the concrete curb ramp. The truncated domes may be cast in place or stamped or of a prefabricated surface treatment (see CBC 1127B.5.8).

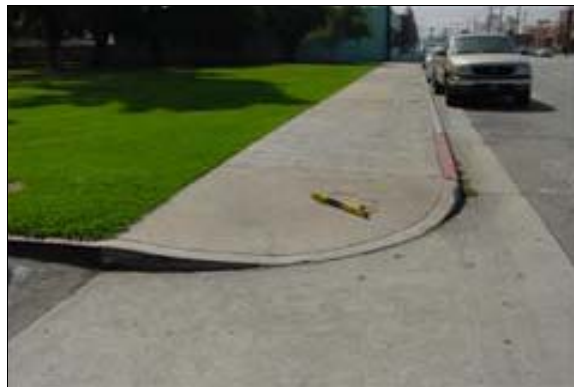
Curb Ramp off of Flower Street (Right)

Finding: The slope of the curb ramp is greater than 8.33%. The slope at the bottom landing is greater than 2%. There is less than 48 inches in length of maneuvering clearance at the top landing. The slope of the side flares is greater than 10%. The curb ramp does not provide a grooved border along the top and sides of the ramp at the level of the sidewalk. The concrete curb ramp does not provide a detectable warning surface which includes truncated domes.

Full Rec: Replace the curb ramp with a compliant curb ramp at least 48 inches in width that provides a slope no greater than 8.33%. Install a detectable warning surface which extends the full length and width of the concrete curb ramp and its side flares with truncated domes that contrast visually by either light on dark or dark on light which is an integral part of the concrete curb ramp. The truncated domes may be cast in place or stamped or of a prefabricated surface treatment (see CBC 1127B.5.8).

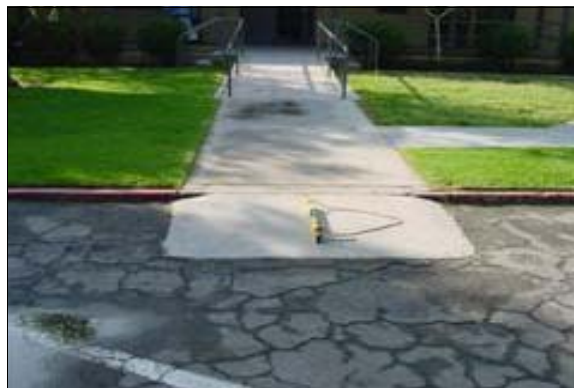
Curb Ramp Outside of the Community Center

Finding: The built-up curb ramp projects into vehicular traffic and interferes with individuals entering or exiting parked or standing vehicles. The slope of the curb ramp is greater than 8.33%. The curb ramp does not provide a grooved border along the top and sides of the ramp at the level of the sidewalk. The concrete curb ramp does not provide a detectable warning surface which includes truncated domes.

Full Rec: Remove the built-up curb ramp and install a compliant curb ramp at least 48 inches in width that provides a slope no greater than 8.33%. Install a detectable warning surface which extends the full length and width of the concrete curb ramp and its side flares with truncated domes that contrast visually by either light on dark or dark on light which is an integral part of the concrete curb ramp. The truncated domes may be cast in place or stamped or of a prefabricated surface treatment (see CBC 1127B.5.8).

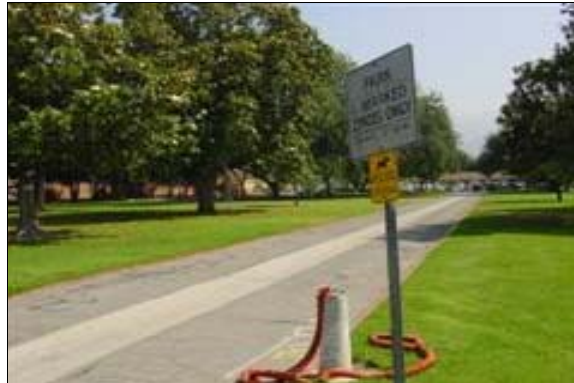
Accessible Route from the Public Right of Way

Finding: There is no accessible route from the public right of way to the accessible entrance of the facility. The accessible route crosses vehicular traffic.

Alternative Post directional signage.
Rec:
(Where Available)

Full Rec: Provide at least one accessible route from the public right of way to the accessible entrance of the facility. Make certain to post signage indicating the direction to accessible building entrances at every major junction along the accessible route. Signs shall include the International Symbol of Accessibility.

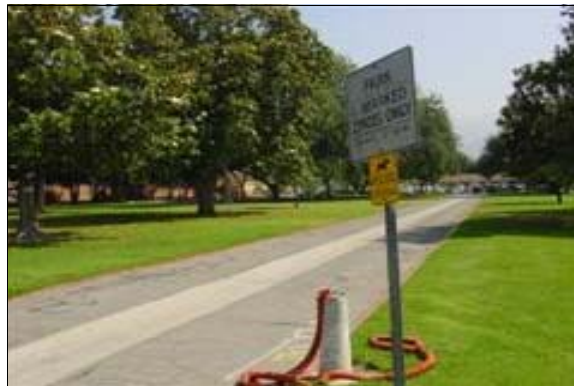
Accessible Route from the Public Right of Way

Finding: There is no crosswalk provided on the path of travel from the public right of way to the facility. The required accessible route crosses a vehicular way.

Full Rec: Stripe a crosswalk not less than 48 inches wide on the path of travel to the accessible entrance of the facility. Provide a level surface that does not exceed a slope greater than 5%. Cross slopes shall not exceed 2%. Detectable warnings should be placed at the entrance and exit of the crosswalk.

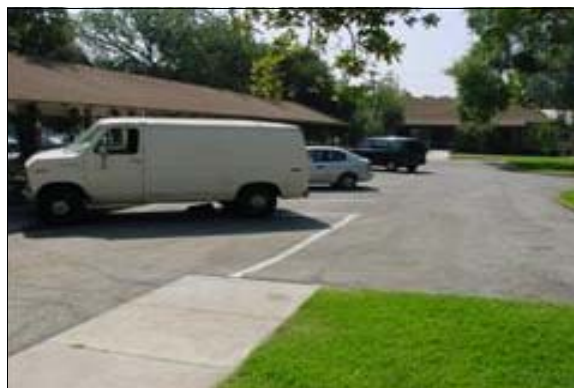
Path of Travel to the Community Center

Finding: There is no crosswalk provided on the path of travel from the play equipment and/or the covered outdoor dining area to the Community Center. The required accessible route crosses a vehicular way.

Full Rec: Stripe a crosswalk not less than 48 inches wide on the path of travel to the accessible entrance of the facility. Provide a level surface that does not exceed a slope greater than 5%. Cross slopes shall not exceed 2%. Detectable warnings should be placed at the entrance and exit of the crosswalk.

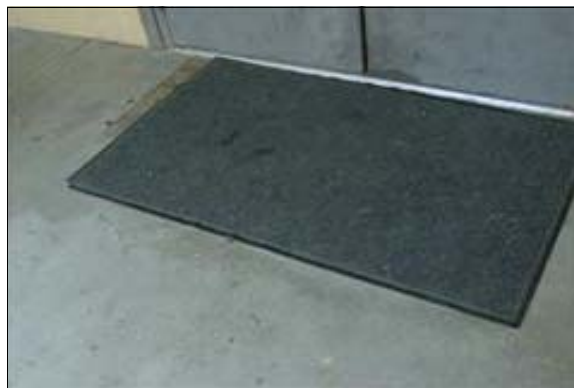
Path of Travel to the Community Center

Finding: The mat at the entrance does not adhere to the underlying floor surface and creates a hazardous path of travel.

Full Rec: Securely fasten the mats or replace with a mat that grips to the underlying floor surface to provide a firm, stable, continuous and relatively smooth path of travel surface (see CBC 1124B.3 and ADAAG 4.5.3). Mats along the primary path of travel shall provide beveled edges on all sides to prevent roll over.

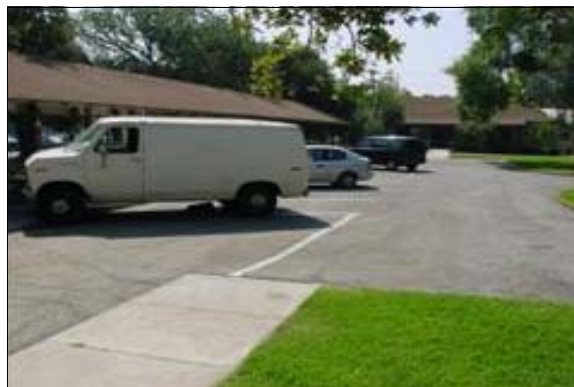
Path of Travel to the Covered Outdoor Dining Area

Finding: There is no crosswalk provided on the path of travel from the from the play equipment and/or the Community Center to the covered outdoor dining area. The required accessible route crosses a vehicular way.

Full Rec: Stripe a crosswalk not less than 48 inches wide on the path of travel to the accessible entrance of the facility. Provide a level surface that does not exceed a slope greater than 5%. Cross slopes shall not exceed 2%. Detectable warnings should be placed at the entrance and exit of the crosswalk.

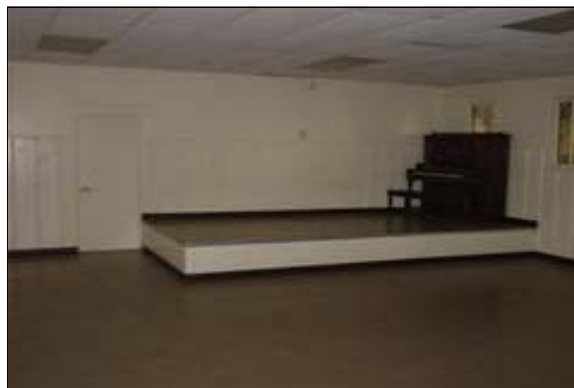
Path of Travel to the Stage in the Community Center

Finding: There is a step to the primary functions provided on the stage in the Community Center, preventing access to individuals with mobility impairments.

Full Rec: Install a vertical platform lift to provide a direct path between the stage and level seating area in the Community Center, allowing individuals with mobility impairments to participate in programs, services and activities provided by the facility on the stage. The ADA mandates accessibility to programs, services and activities which serve the public.

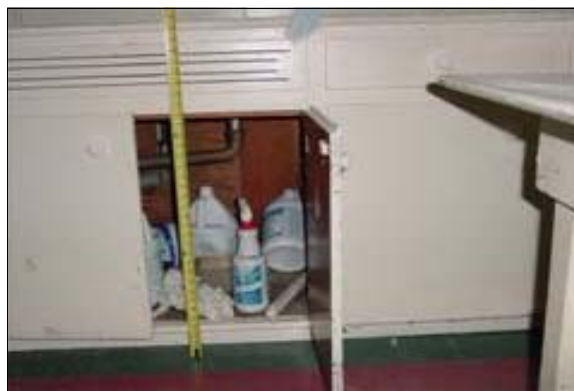
Sink in the Community Center

Finding: The sink in the Kitchen is in an enclosed cabinet, thereby preventing an accessible forward approach. The height of the counter surface of the sink is greater than 34 inches above the finished floor.

Full Rec: Sinks in rooms must provide clear floor space in front of the sink for an accessible forward approach and shall provide at least 27 inches clear knee space and a minimum of nine inches clear toe space (see ADAAG 4.19.2). If neither clear floor space and knee and toe clearance can be provided, remove the sink cabinet and replace with an accessible wall-mounted sink unit.

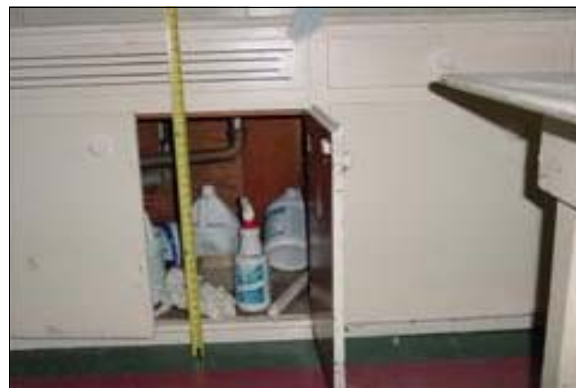
Sink in the Community Center

Finding: The pipes under the sink in the Kitchen do not provide protection against contact.

Full Rec: Insulate or otherwise configure pipes under the sink designated to be accessible in the room to protect against contact (see ADAAG 4.19.4). Make certain there are no sharp or abrasive surfaces under the sink.

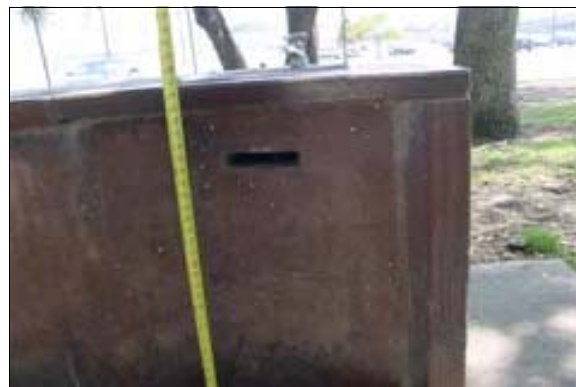
Sinks at the Covered Outdoor Dining Area

Finding: The sink at the outdoor dining area does not provide an accessible forward approach.

Full Rec: Sinks must provide clear floor space in front of the sink for an accessible forward approach and shall provide at least 27 inches clear knee space and a minimum of nine inches clear toe space (see ADAAG 4.19.2). If neither clear floor space and knee and toe clearance can be provided, remove the sink and replace with an accessible wall-mounted sink unit.

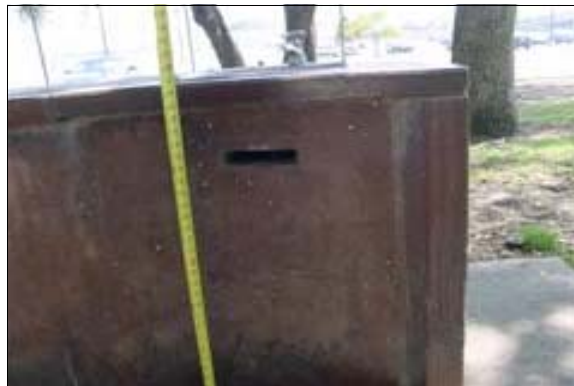
Sinks at the Covered Outdoor Dining Area

Finding: The faucet controls on the sink at the outdoor dining area require tight grasping, pinching, or twisting of the wrist and are not accessible.

Full Rec: Install faucet controls complying with ADAAG 4.19.5 on the sink designated to be accessible at the outdoor dining area. Lever-operated, push-type, touch-type or electronically controlled mechanisms are acceptable elements (see ADAAG 4.19.5). If self-closing valves are used the faucet shall remain open for at least 10 seconds.

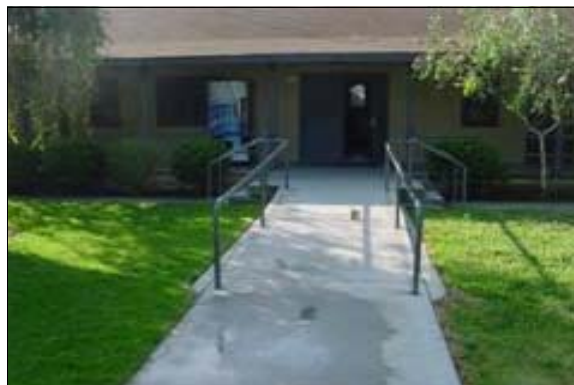
Exterior Ramp to the Community Center

Finding: The handrails are mounted at a height less than 34 inches. There are no 12-inch extensions beyond the top and bottom of the ramp.

Full Rec: Replace the handrails on each side of the ramp to provide a height between 34 inches and 38 inches. The handrails shall provide 12-inch extensions, extending beyond the top and bottom of the ramp, that are parallel to the ground surface and return smoothly to the post or wall.

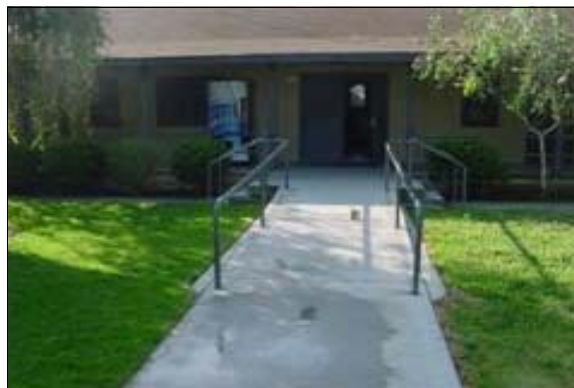
Exterior Ramp to the Community Center

Finding: The ramp is not bounded by a wall or fence, thus not providing any edge protection to prevent individuals from slipping off the ramp.

Full Rec: Install edge protection on each side of the ramp consisting of 3-inch high guide curb or wheel guide rails centered 3 inches (plus or minus one inch) above the surface of the ramp (see CBC 1133B.5.4.9 and ADAAG 4.8.7).

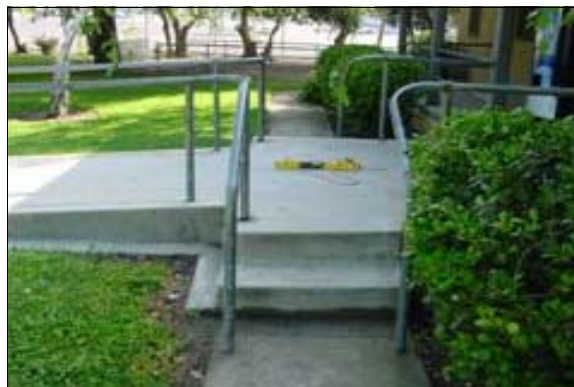
Exterior Stairs to the Community Center

Finding: There is no detectable striping on each tread of the exterior stairway.

Full Rec: Affix detectable contrasting striping to each tread of the stairway that clearly contrasts in color from the tread and is at least 2 inches in width placed no more than 1 inch from the tread nose or landing.

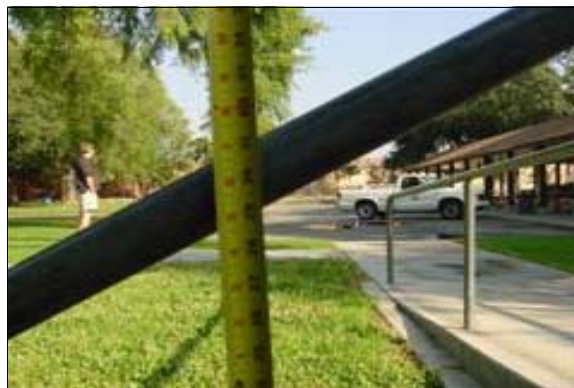
Exterior Stairs to the Community Center

Finding: The handrails do not provide 12-inch extensions beyond the top and bottom treads. The handrails are mounted at a height less than 34 inches.

Full Rec: Install handrails on each side of stairway that provide 12-inch top and bottom handrail extensions that extend beyond the top and bottom treads of the stairway which are parallel to the ground surface and return smoothly to the post or wall. Handrails shall be mounted at a height between 34 and 38 inches.

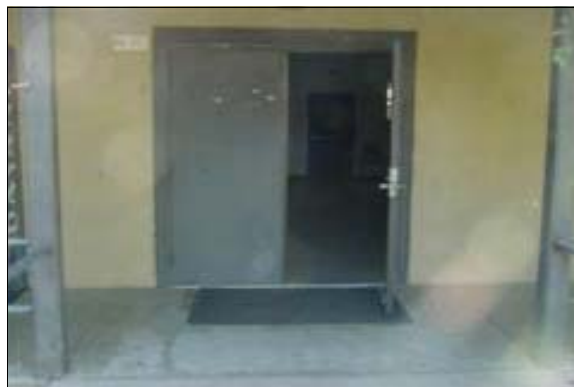
Community Center

Finding: The bottom 10 inches of the door does not provide a smooth, uninterrupted surface, or panel to allow the door to be opened by a wheelchair footrest without creating a trap or hazardous condition, due to the doorstop.

Full Rec: Install a panel or replace the door to provide a smooth, uninterrupted surface for the bottom 10 inches of the door.

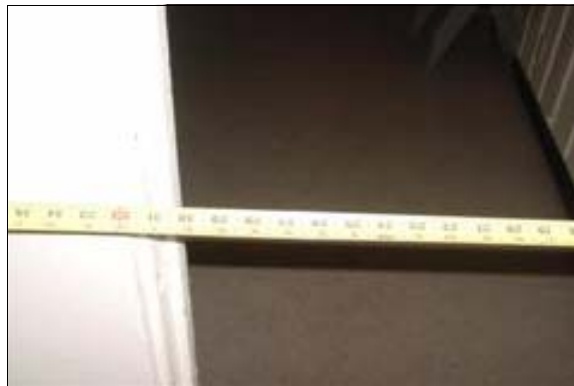
Interior Door in the Community Center

Finding: The clear opening width of the door to the Kitchen is less than 32 inches.

Full Rec: Widen the door opening and install a door that provides at least 32 inches of clear width with the door open 90 degrees (see CBC 1133B.2.3.1 and ADAAG 4.13.5).

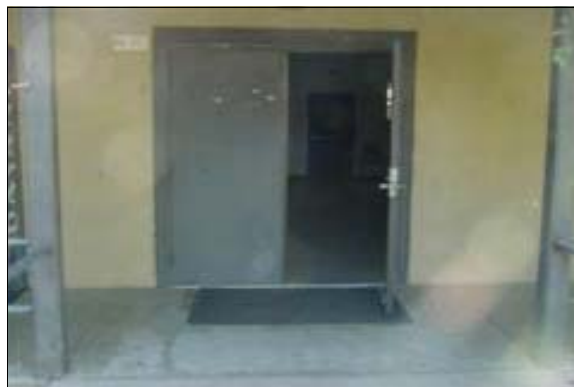
Community Center

Finding: There is no signage with the International Symbol of Accessibility on the entrance door to the facility designating it as accessible.

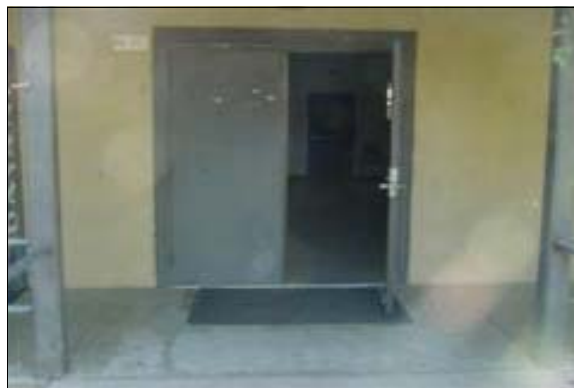
Community Center

Finding: The main entrance does not have accessible signage mounted on the wall adjacent to the latch side of the door.

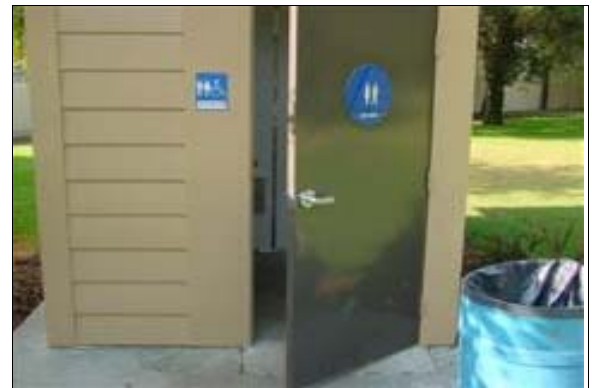
Unisex Restroom Next to the Community Center

Finding: The signage indicating accessibility on the latch side of the entry door of the restroom is not centered at 60 inches above the floor surface. The gender use signage on the entrance door is not centered at 60 inches above the floor surface.

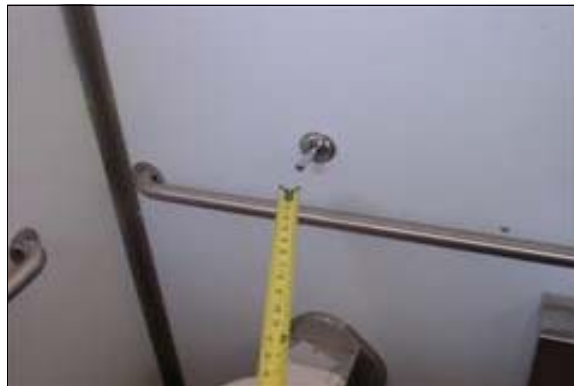
Unisex Restroom Next to the Community Center

Finding: The flush control on the toilet in the restroom is not on the wide (approach) side of the toilet.

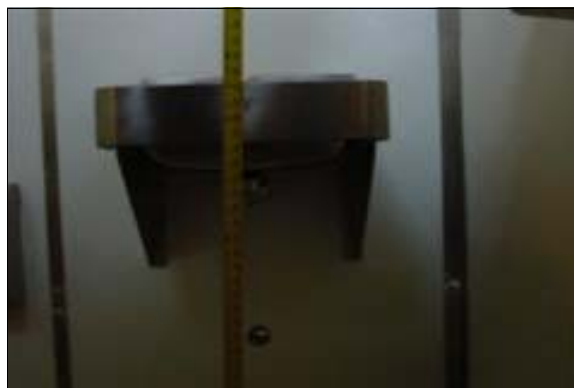
Unisex Restroom Next to the Community Center

Finding: The pipes under the lavatory in the restroom do not provide protection against contact.

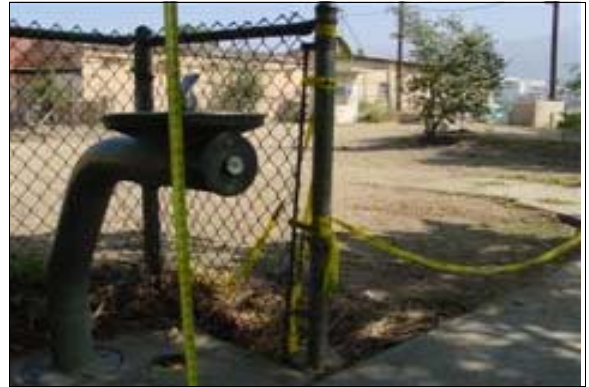
Finding: There are two drinking fountains on primary paths of travel.

Full Rec: Fifty percent of the drinking fountains on primary paths of travel shall be accessible (see CBC 1117B.1 and ADAAG 4.15). Install a "high-low" fountain design to comply with both state and federal requirement. Fountains not located in alcoves need side rails or wing walls on both sides.

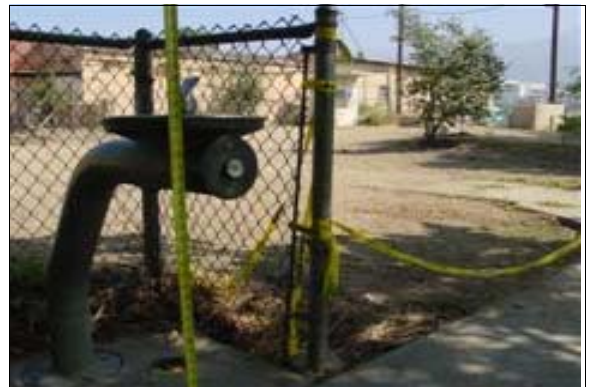
Drinking Fountain Next to the Play Equipment

Finding: The drinking fountain is not a "high-low" design. The spout outlet height is greater than 36 inches.

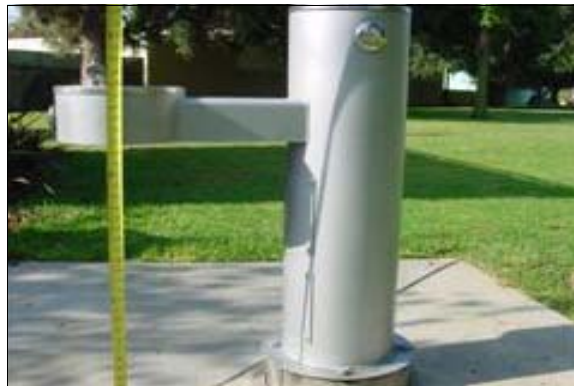
Drinking Fountain Outside of the Community Center (Low)

Finding: There is less than 27 inches knee clearance height.

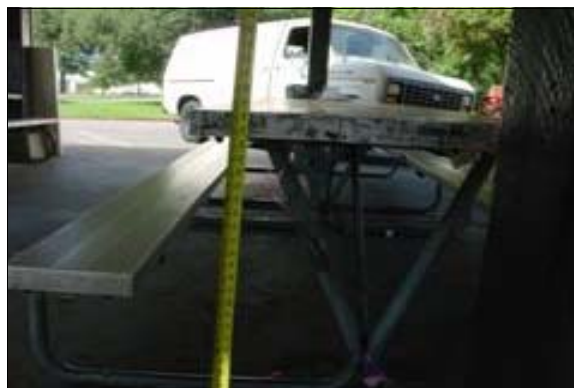
Covered Outdoor Dining Area

Finding: The knee space at the tables in the outdoor dining area is less than 19 inches deep.

Full Rec: Modify or replace one of the tables in the outdoor dining area to provide knee clearance of at least 27 inches in height, 30 inches in width and 19 inches in depth (see CBC 1122B.3, ADAAG 4.32.2 and ADAAG Figure 45). The table top height shall not exceed 34 inches above the finished floor.

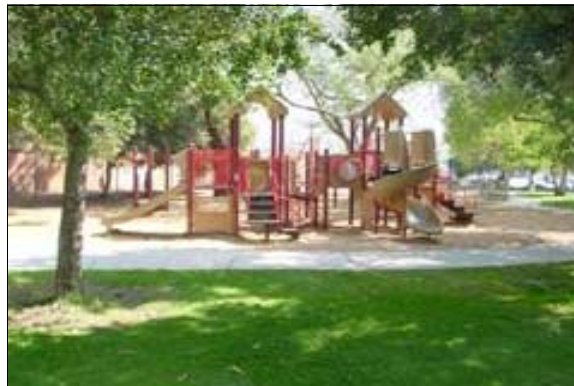
Finding: There are slopes greater than 6.33% along the path of travel to the play equipment. The surface beneath the play area is wood chips, making the area nonaccessible to individuals with mobility impairments.

Full Rec: Provide an accessible route to the play area (CBC 1104B.1.2 and ADAAG 4.3.2). The minimum width of the path of travel is 48 inches with 60 inch by 60 inch passing spaces provided every 200 feet and shall not exceed a slope greater than 6.33%. Provide a maneuvering space with an accessible resilient surface beneath the play components and adjacent to the play components where technically feasible. An adequate maneuvering space has an accessible surface and is not less than 60 inches by 60 inches where an individual with a mobility impairment can be a part of the activities provided at the play components.
