Photo Report
Harvard Mini Park
Programs, Services, and Activities

Harvard Mini Park

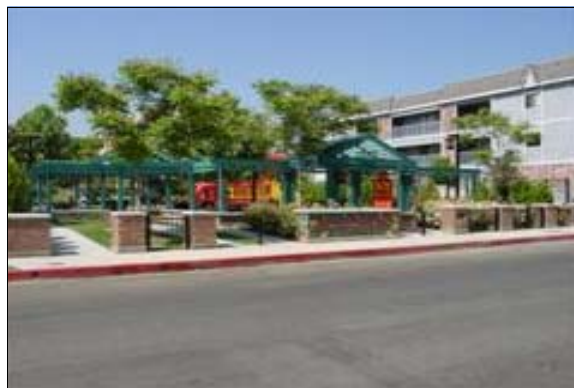
Finding: The Harvard Mini Park, located at 425 West Harvard in Glendale California, was inspected by Disability Access Consultants, Inc., on June 7, 2007.

Full Rec: Any renovation or new construction that occurred after January 26, 1992, is subject to meet full code specifications for the California Building Code and ADAAG requirements. All recommendations in this report are based on ADAAG and CBC title 24 requirements. Consult with your design professional to determine which elements are affected by these requirements. It is recommended that Disability Access Consultants, Inc. is consulted for inspection of any new construction or renovation at the facility.

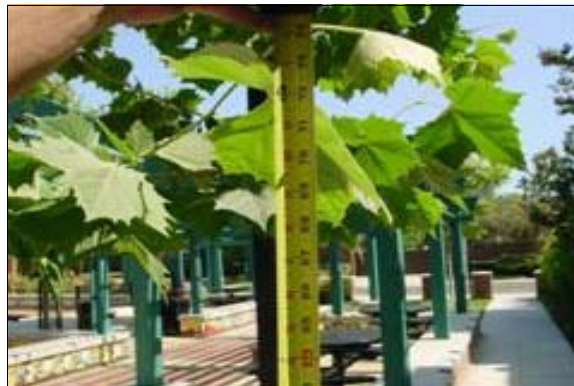
Path of Travel Throughout the Park

Finding: At the time of inspection, vegetation encroached into the primary path of travel, obstructing passage by reducing the vertical clearance height to less than 80 inches along the accessible route.

Full Rec: Maintain grass or landscaping adjacent to primary path of travel walkways to eliminate any encroachment into the accessible route.

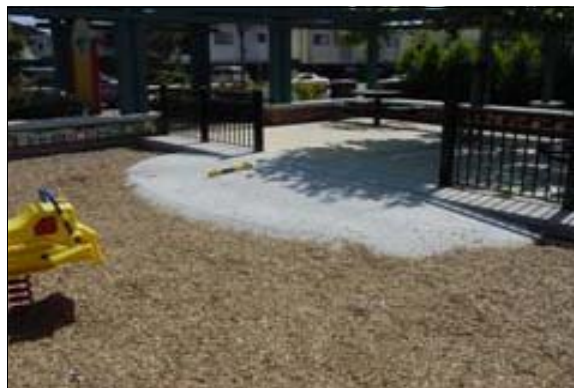
Play Equipment

Finding: There are slopes greater than 6.33% along the path of travel to the play area.

Full Rec: Provide an accessible route to the play area (CBC 1104B.1.2 and ADAAG 4.3.2). The minimum width of the path of travel is 48 inches with 60 inch by 60 inch passing spaces provided every 200 feet and shall not exceed a slope greater than 6.33%. No protruding objects are permitted on the accessible path of travel. Accessible surfaces shall comply with CBC 1124B.1 and ADAAG 4.5 and shall be firm, stable and slip resistant.
