**Photo Report**  
**Lower Scholl Canyon Park**  
**Programs, Services, and Activities**

17-Jul-07

**Finding:** The Lower Scholl Canyon Park, located at 2849 East Glenoaks in Glendale California, was inspected by Disability Access Consultants, Inc., on June 12, 2007.

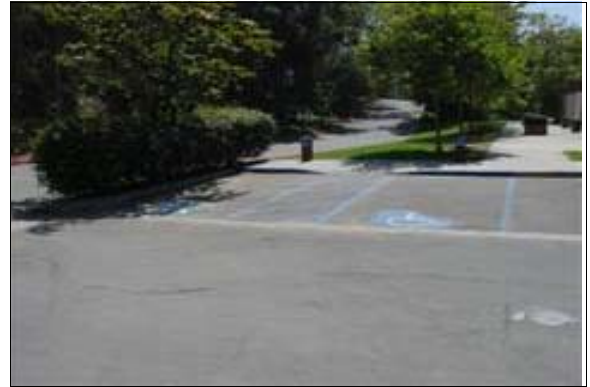
**Finding:** There are two accessible parking spaces out of 49 parking spaces which is sufficient in number as required for compliance. The accessible parking space at the right measures 108 inches wide and 228 inches long. The accessible parking space at the left measures 107 1/2 inches wide and 228 inches long. The accessible parking spaces share a common access aisle measuring 60 inches wide. The access aisle does not contain "NO PARKING" in 12" high white letters. There is no van-accessible parking space provided in the parking lot.

**Full Rec:** Two out of the 49 total number of marked parking spaces meets the number required to be designated exclusively for accessible parking according to ADAAG and CBC 1129B. Restripe the designated accessible parking spaces to create one van-accessible and one standard accessible parking space, each measuring at least 108 inches wide and 216 inches long with an access aisle measuring at least 96 inches wide (8 feet) shared between the two accessible parking spaces (see CBC 1129B). The accessible parking space with the access aisle to the right of the space shall be designated "van-accessible." Add the words NO PARKING in 12 inch high white letters at the entrance to each accessible parking access aisle.

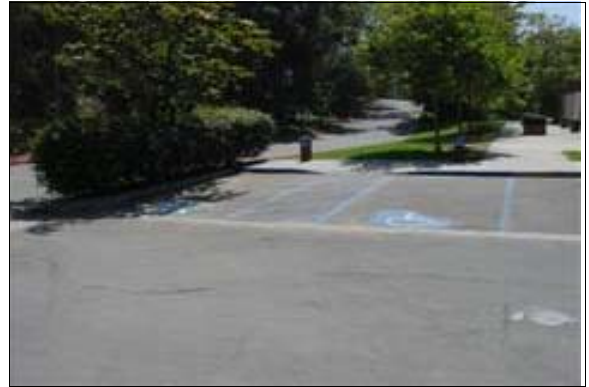
**Finding:** The surface of the accessible parking spaces in the parking lot has a slope greater than 2%.

**Full Rec:** Pave the parking lot at the accessible spaces to provide a level surface. Parking surfaces and access aisles shall be located in areas not exceeding 2% slope in all directions (see CBC 1129B and ADAAG 4.6.3).

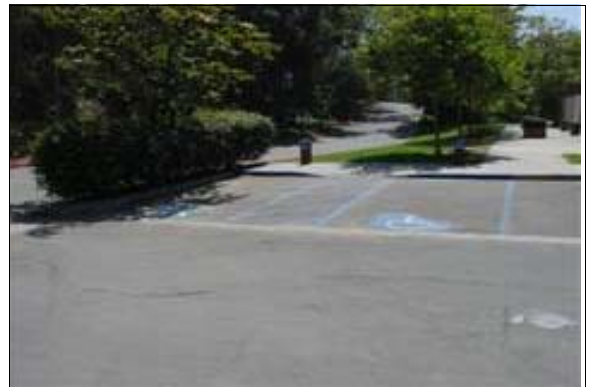
**Finding:** There is no device at the head of the accessible parking space at the right to prevent vehicles from encroaching into the minimum width of the accessible walkway.

**Full Rec:** Install a wheelstop at the head of the accessible parking space at the right. Wheelstops shall be used to prevent vehicles from encroaching into accessible aisles or walkways, but shall not present addition encroachment into those areas (see CBC 1129B.4.3).

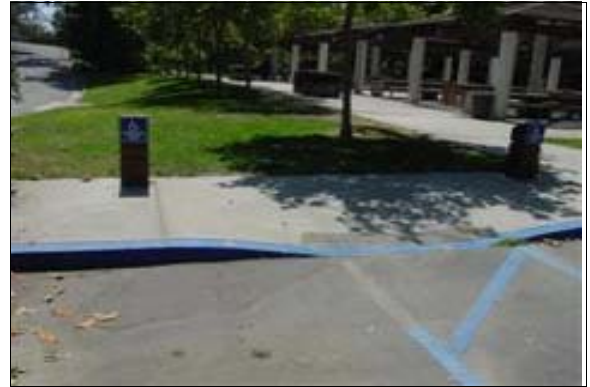
**Finding:** The bottom edge of the post-mounted signage designating the accessible parking spaces is less than 80 inches above the level of the parking space and cannot be viewed when a vehicle is parked in the space.

**Full Rec:** Modify the height or replace the post-mounted signage designating the accessible parking spaces to provide at least 80 inches from the parking space finished grade to the bottom edge of the sign. The sign shall be located so that it cannot be obscured by a vehicle parked in the space (see CBC 1129B.5).

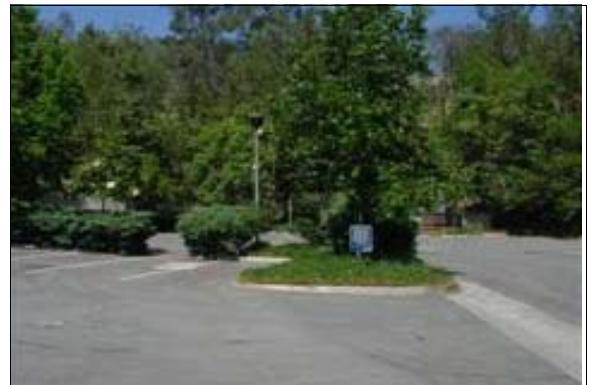
**Finding:** There is warning signage posted at the entrance to the parking lot regarding unauthorized use of accessible parking spaces in the parking lot, though the blank spaces which should furnish the point of contact and telephone number for reclaiming towed vehicles have been left blank.

**Full Rec:** Fill in the blank spaces which are required to furnish the point of contact and telephone number for reclaiming towed vehicles with the appropriate information as a permanent part of the sign and maintain the currency of the information (see CBC 1129B.5). Make sure to add the CVC22511.8(a)(d) to the sign.

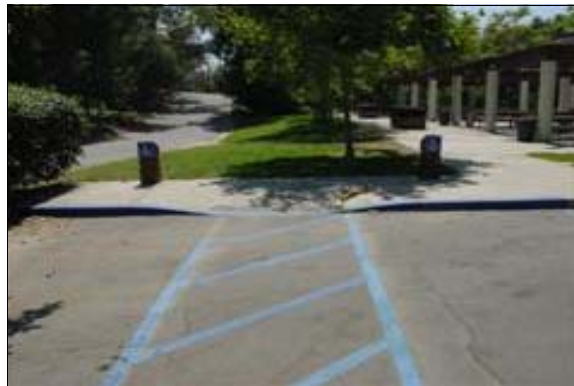
### ***Curb Ramp at the Accessible Parking Spaces***

**Finding:** The slope of the curb ramp is greater than 8.33%. The slope at the bottom landing is greater than 2%. There is less than 48 inches in length of maneuvering clearance at the top landing. The slope of the side flares is greater than 10%. The curb ramp does not provide a grooved border along the top and sides of the ramp at the level of the sidewalk. The concrete curb ramp does not provide a detectable warning surface which includes truncated domes.

**Full Rec:** Replace the curb ramp with a compliant curb ramp at least 48 inches in width that provides a slope no greater than 8.33%. Install a detectable warning surface which extends the full length and width of the concrete curb ramp and its side flares with truncated domes that contrast visually by either light on dark or dark on light which is an integral part of the concrete curb ramp. The truncated domes may be cast in place or stamped or of a prefabricated surface treatment (see CBC 1127B.5.8).

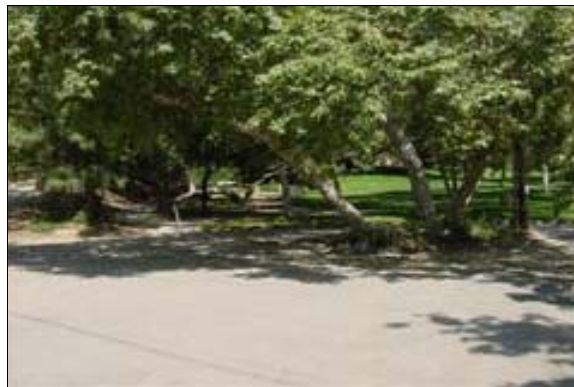
### ***Path of Travel to the Lower Outdoor Dining Area***

**Finding:** The accessible route from the public right of way to the lower outdoor dining area crosses a curb. There is no curb ramp provided.

**Full Rec:** Install a compliant curb ramp at least 48 inches in width that provides a slope no greater than 8.33%. Install a detectable warning surface which extends the full length and width of the concrete curb ramp and its side flares with truncated domes that contrast visually by either light on dark or dark on light which is an integral part of the concrete curb ramp. The truncated domes may be cast in place or stamped or of a prefabricated surface treatment (see CBC 1127B.5.8).

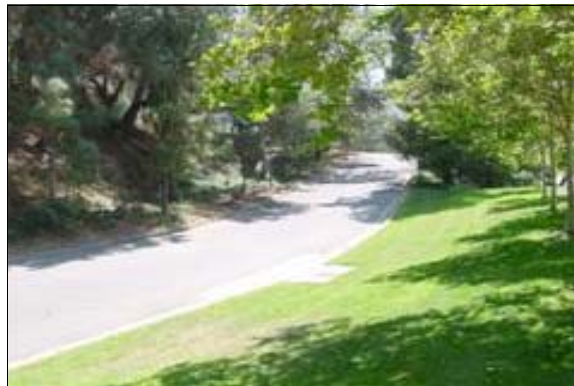
**Accessible Route from the Public Right of Way**

**Finding:** There is no accessible route from the public right of way to the accessible entrance of the facility. The required accessible route crosses a vehicular way.

**Full Rec:** Provide at least one accessible route from the public right of way to the accessible entrance of the facility. Make certain to post signage indicating the direction to accessible building entrances at every major junction along the accessible route. Signs shall include the International Symbol of Accessibility.

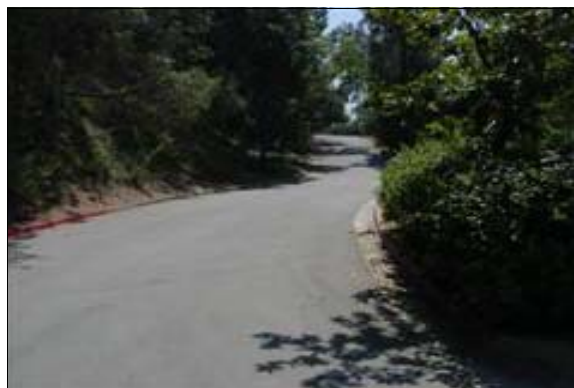
**Accessible Route from the Public Right of Way**

**Finding:** There is no crosswalk provided on the path of travel from the public right of way to the facility. The required accessible route crosses a vehicular way.

**Full Rec:** Stripe a crosswalk not less than 48 inches wide on the path of travel to the accessible entrance of the facility. Provide a level surface that does not exceed a slope greater than 5%. Cross slopes shall not exceed 2%. Detectable warnings should be placed at the entrance and exit of the crosswalk.

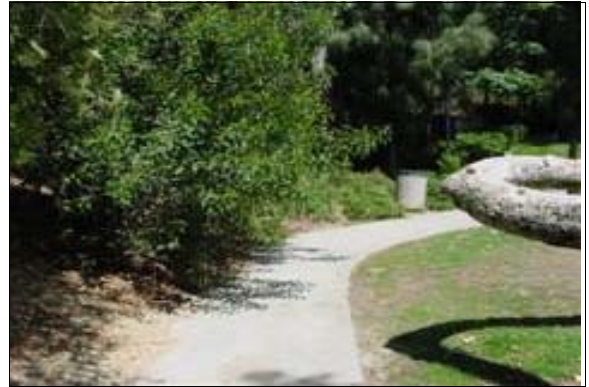
***Path of Travel at the Lower Outdoor Dining Area***

**Finding:** At the time of inspection, vegetation encroached into the primary path of travel, obstructing passage by reducing the clear width along the accessible route.

**Full Rec:** Maintain grass or landscaping adjacent to primary path of travel walkways to eliminate any encroachment into the accessible route.

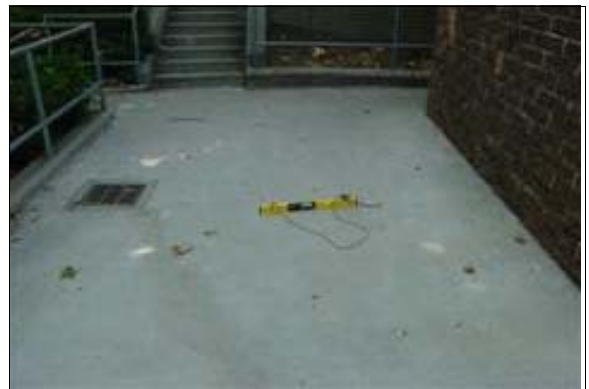
***Path of Travel Between the Men's and Women's Restrooms***

**Finding:** There are cross slopes greater than 2% on the primary path of travel between the men's and women's restrooms.

**Full Rec:** Resurface the path of travel to provide a level surface that does not exceed a slope greater than 5%. Cross slopes shall not exceed 2%.

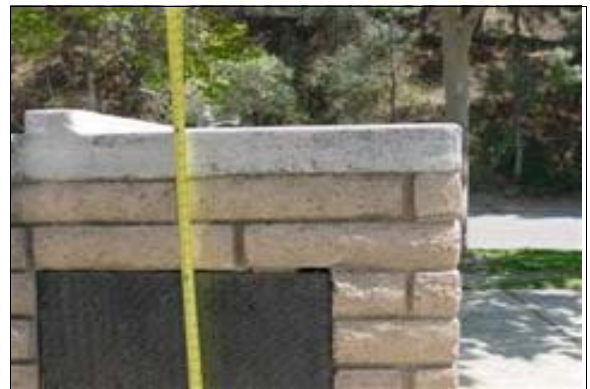
**Sink at the Outdoor Dining Area**

**Finding:** The sink at the outdoor dining area next to the parking lot does not provide an accessible forward approach. The height of the counter surface of the sink is greater than 34 inches above the finished floor.

**Full Rec:** Sinks must provide clear floor space in front of the sink for an accessible forward approach and shall provide at least 27 inches clear knee space and a minimum of nine inches clear toe space (see ADAAG 4.19.2). If neither clear floor space and knee and toe clearance can be provided, remove the sink and replace with an accessible wall-mounted sink unit.

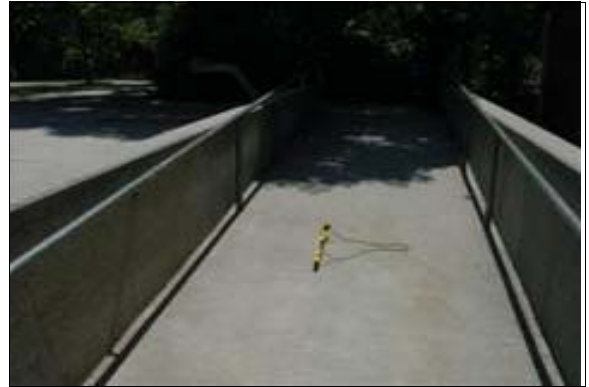
**Exterior Ramp Next to the Restrooms**

**Finding:** The handrails are mounted at a height less than 34 inches. There are no 12-inch extensions beyond the top of the ramp.

**Full Rec:** Replace the handrails on each side of the ramp to provide a height between 34 inches and 38 inches. The handrails shall provide 12-inch extensions, extending beyond the top and bottom of the ramp, that are parallel to the ground surface and return smoothly to the post or wall.

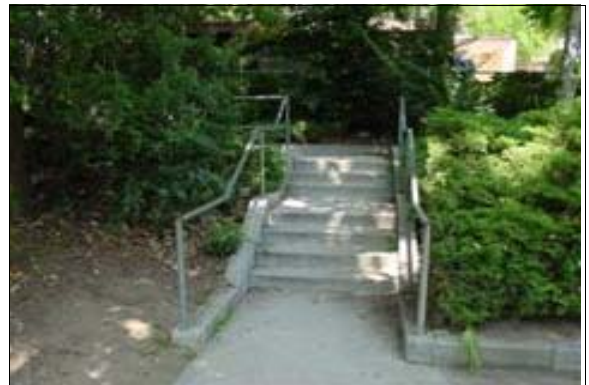
**Exterior Stairs to the Lower Outdoor Dining Area (North)**

**Finding:** There is no detectable striping on each tread of the exterior stairway.

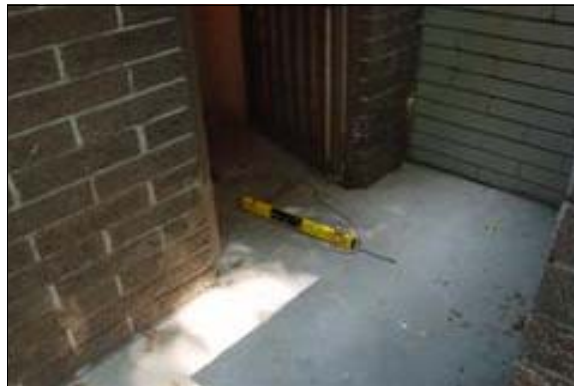
**Men's Restroom**

**Finding:** There is no level landing provided at the entrance door.

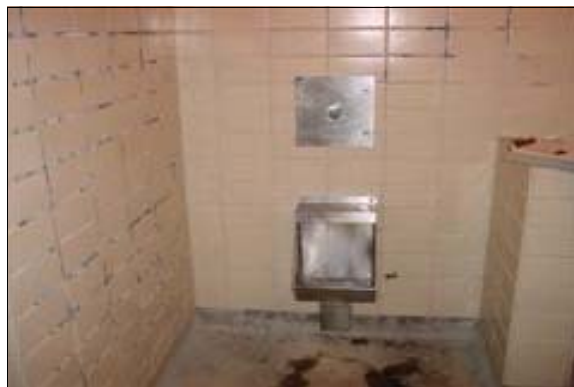
**Men's Restroom**

**Finding:** The height of the urinal rim in the restroom is greater than 17 inches above the finished floor. The height of the urinal flush control in the restroom is greater than 44 inches above the finished floor.

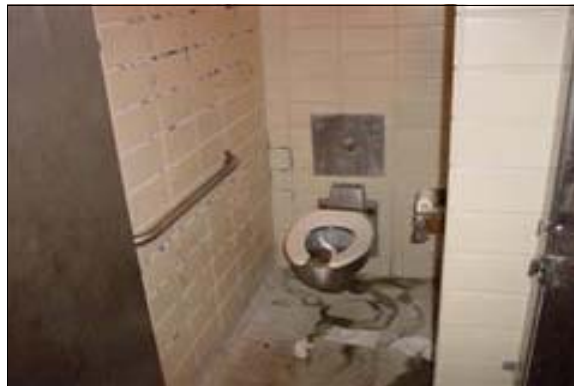
**Men's Restroom**

**Finding:** There is insufficient clear floor space in the stall designated to be accessible in the restroom. The door to the stall designated to be accessible in the restroom does not close automatically or have accessible hardware.

**Full Rec:** Modify or replace the stall designated to be accessible in the restroom so that it complies with ADAAG 4.17.3, CBC 1115B and CBC Figures 11B-1A and 1B. Standard accessible stalls require 60 inches in width with 56 inches depth for wall-mounted toilets or 59 inches depth for floor-mounted toilets to accommodate individuals in wheelchairs. The minimum width of a front-approach doorway shall provide at least 32 inches and a side-approach doorway shall provide at least 34 inches. The door shall swing outward, close automatically and provide accessible hardware.

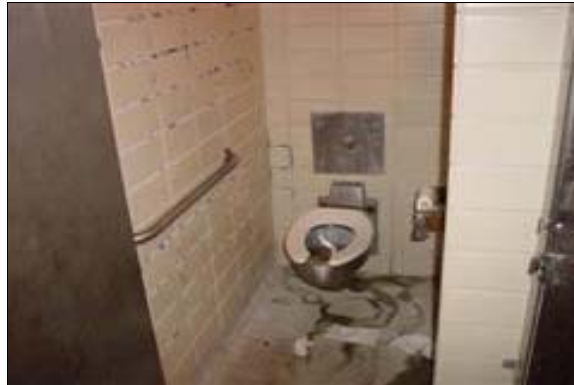
**Men's Restroom**

**Finding:** There is no back grab bar in the stall designated to be accessible in the restroom.

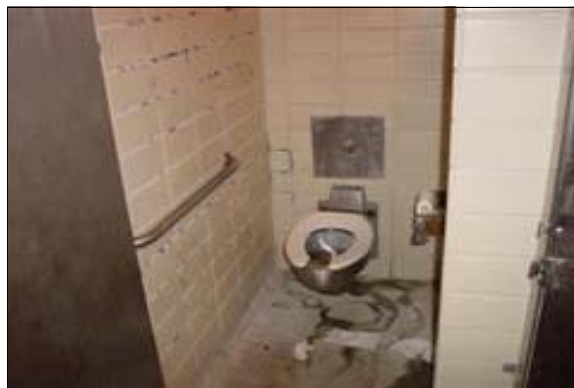
**Men's Restroom**

**Finding:** The height of the side grab bar in the stall designated to be accessible of the restroom is greater than 33 inches above the finished floor.

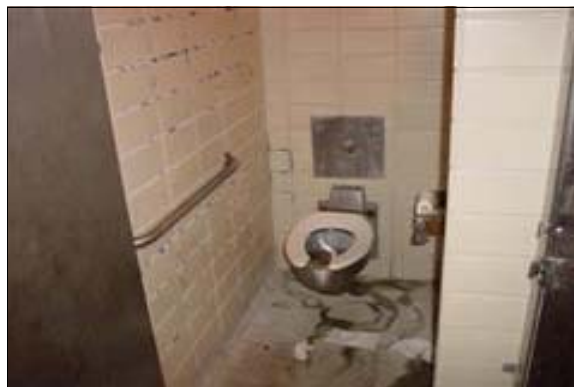
**Men's Restroom**

**Finding:** The length of the side grab bar in the stall designated to be accessible in the restroom is less than 42 inches.

**Full Rec:** Replace the side grab bar in the stall designated to be accessible in the restroom with a 42-inch/ 48 -inch side grab bar complying with ADAAG 4.26 and CBC 1115B.8. The front end of the grab bar shall extend at least 54 inches from the back wall and the back end of the grab bar shall be mounted within 12 inches from the back wall. Grab bars must be able to support a point load of at least 250 pounds and shall be less than the allowable shear stress of the grab bar material.

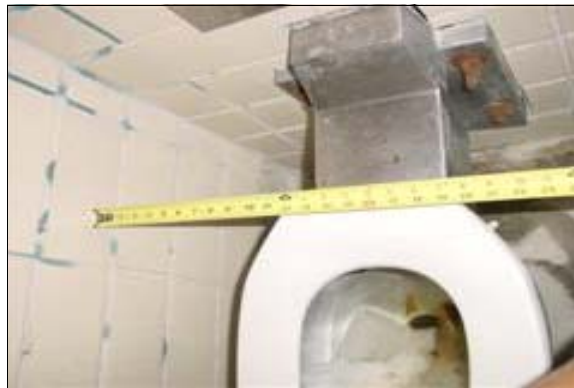
**Men's Restroom**

**Finding:** The distance from the center of the toilet to the nearest side wall in the stall designated to be accessible in the restroom is less than 18 inches.

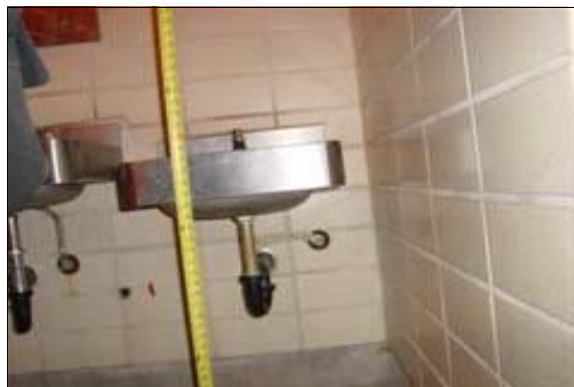
**Men's Restroom**

**Finding:** The knee clearance space under the lavatory designated to be accessible in the restroom is less than 29 inches. The knee depth space under the lavatory designated to be accessible in the restroom is less than 27 inches at 8 inches under the lavatory apron.

**Full Rec:** Replace the lavatory designated to be accessible in the restroom to provide at least 29 inches of clear knee space between the finished floor and bottom of the lavatory apron. Make sure to provide at least 27 inches at 8 inches under the apron (see ADAAG 4.19.2).

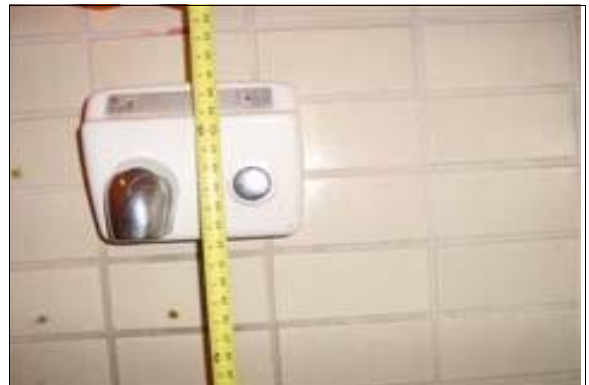
**Men's Restroom**

**Finding:** The height of the controls and operating mechanisms for the hand dryer in the restroom is greater than 40 inches.

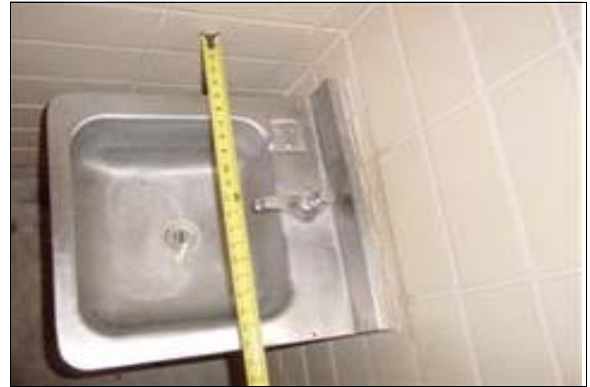
**Women's Restroom**

**Finding:** The distance from the center of the lavatory to the adjacent side wall in the restroom is less than 18 inches.

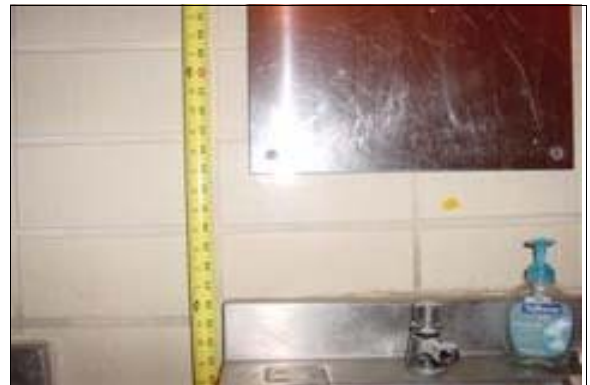
**Women's Restroom**

**Finding:** The bottom edge of the reflecting surface of the mirror in the restroom is greater than 40 inches above the finished floor.

**Full Rec:** Lower the mirror in the restroom so that the bottom edge of the reflecting surface is no higher than 40 inches above the finished floor and the topmost portion of the reflecting surface extends at least 74 inches above the finished floor (see ADAAG A4.19.6). A single, full-length mirror is recommended since it can accommodate all people. Make certain to provide a minimum clear floor space in front of the mirror of 30 inches in width and 48 inches in length.
