Photo Report
Milford Mini Park
Programs, Services, and Activities

Finding: Milford Mini Park, located at 601 West Milford in Glendale California, was inspected by Disability Access Consultants, Inc., on August 13, 2007.

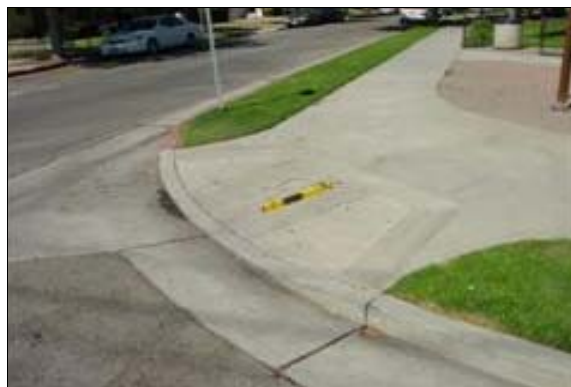
Curb Ramp at the Corner of Milford and Kenliworth

Finding: The slope of the curb ramp is greater than 8.33%. The slope at the top landing is greater than 2%. The slope of the side flares is greater than 10%. The transition at the bottom landing is abrupt. The concrete curb ramp does not provide a detectable warning surface which includes truncated domes.

Full Rec: Replace the curb ramp with a compliant curb ramp at least 48 inches in width that provides a slope no greater than 8.33%. Install a detectable warning surface which extends the full length and width of the concrete curb ramp and its side flares with truncated domes that contrast visually by either light on dark or dark on light which is an integral part of the concrete curb ramp. The truncated domes may be cast in place or stamped or of a prefabricated surface treatment (see CBC 1127B.5.8).

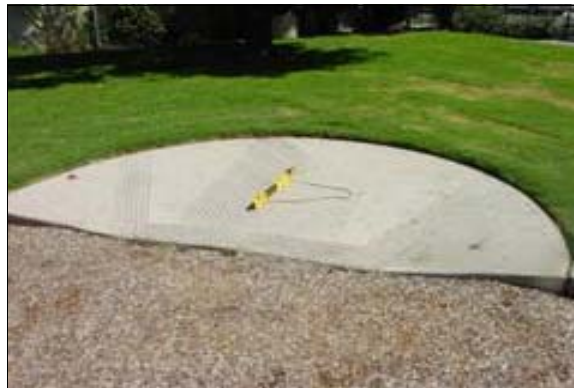
Curb Ramp at the Play Equipment

Finding: The slope of the curb ramp is greater than 8.33%. The top landing is grass, preventing access to individuals with mobility impairments. The bottom landing is woodchips, preventing access to individuals with mobility impairments. The concrete curb ramp does not provide a detectable warning surface which includes truncated domes.

Full Rec: Replace the curb ramp with a compliant curb ramp at least 48 inches in width that provides a slope no greater than 8.33%. Install a detectable warning surface which extends the full length and width of the concrete curb ramp and its side flares with truncated domes that contrast visually by either light on dark or dark on light which is an integral part of the concrete curb ramp. The truncated domes may be cast in place or stamped or of a prefabricated surface treatment (see CBC 1127B.5.8).

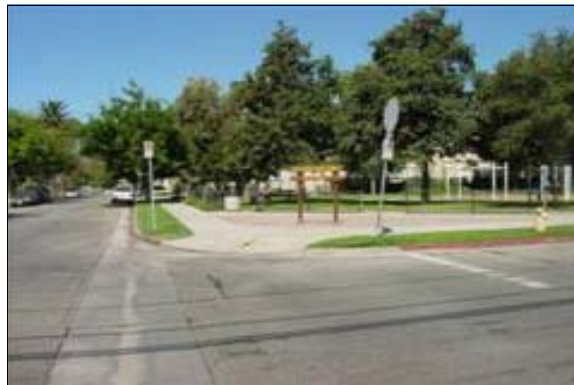
Accessible Route from the Public Right of Way

Finding: There is an accessible route from the public right of way to the accessible entrance of the facility.

Full Rec: Post directional signage. Make certain to post signage indicating the direction to accessible building entrances at every major junction along the accessible route. Signs shall include the International Symbol of Accessibility.

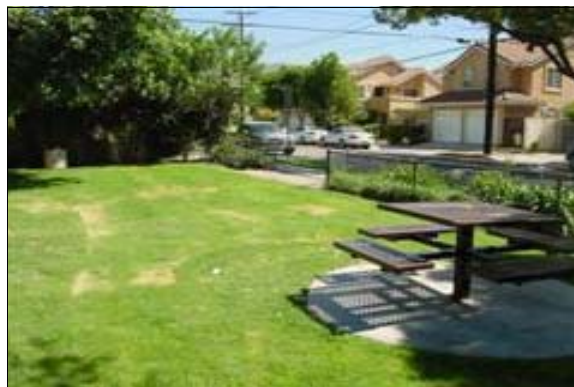
Outdoor Dining Area

Finding: There is no accessible route to the picnic tables in the outdoor dining area. The surface around the outdoor dining area is grass, preventing access of individuals with mobility impairments.

Full Rec: Install a 48-inch wide path to the picnic tables in the outdoor dining area that provides a smooth, stable, firm and slip resistant surface. Provide a maneuvering space sufficient to provide a 60-inch diameter turning radius adjacent to at least one of the picnic tables in the outdoor dining area.
