# Photo Report

17-Jul-07

## Montrose Park

**Finding:** The Montrose Park, located at 3529 Clifton Place in Glendale California, was inspected by Disability Access Consultants, Inc., on June 4, 2007. Facilities include the Maintenance Building, concession stand, and restroom.

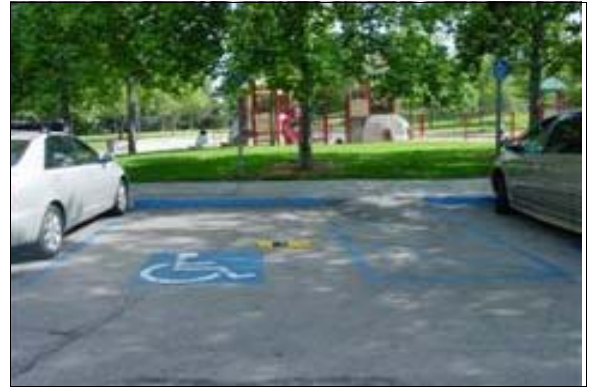
### ***Parking Lot Next to the Tennis Courts***

**Finding:** There are three accessible parking spaces out of 34 parking spaces which is sufficient in number as required for compliance. Two of the designated accessible parking spaces provided in the parking lot measure at least 108 inches wide and less than 216 inches long. One of the designated accessible parking spaces measures less than 108 inches wide and less than 216 inches long. Each accessible parking space provides an adjacent access aisle measuring at least 60 inches wide. The access aisles do not contain "NO PARKING" in 12" high white letters. There is no van-accessible parking space provided in the parking lot.

**Full Rec:** Three out of the 34 total number of marked parking spaces meets the number required to be designated exclusively for accessible parking according to ADAAG and CBC 1129B. Restripe the designated accessible parking spaces to create one van-accessible and two standard accessible parking spaces, each measuring at least 108 inches wide and 216 inches long. Designate one parking space as "van-accessible". The van-accessible space shall provide an access aisle measuring at least 96 inches wide (8 feet) on the passenger side (right side) of the vehicle space (see CBC 1129B). The additional parking spaces shall each provide an access aisle measuring at least 60 inches wide, that may be shared. Add the words NO PARKING in 12 inch high white letters at the entrance to each accessible parking access aisle.

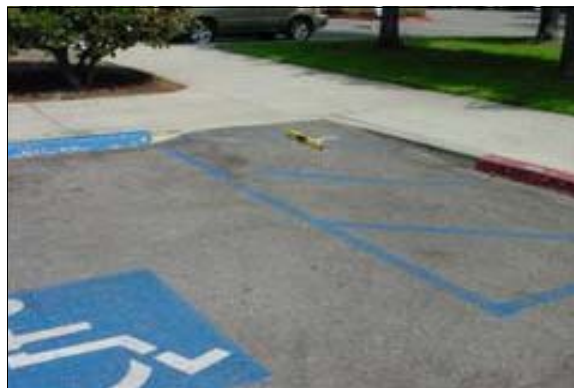
**Parking Lot Next to the Tennis Courts**

**Finding:** The surface of the accessible parking spaces in the parking lot has a slope greater than 2%.

**Full Rec:** Pave the parking lot at the accessible spaces to provide a level surface. Parking surfaces and access aisles shall be located in areas not exceeding 2% slope in all directions (see CBC 1129B and ADAAG 4.6.3).

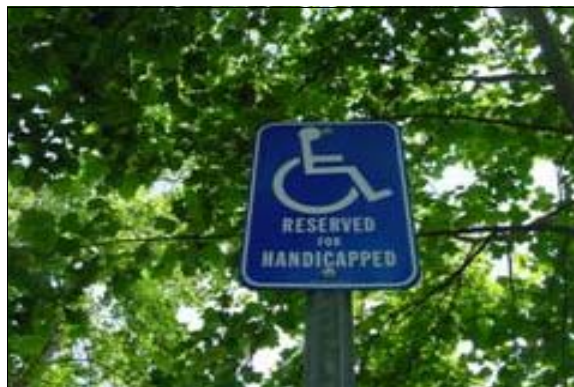
**Parking Lot Next to the Tennis Courts**

**Finding:** The vertically-mounted signage at the designated accessible parking spaces in the parking lot showing the International Symbol of Accessibility uses the word "handicapped".

**Full Rec:** Install a permanently posted reflectorized sign measuring 70 square inches that includes an ISA symbol adjacent to and visible from the accessible parking space (see CBC 1129B.5). The bottom edge of the sign must be mounted 80 inches from the ground surface so that it cannot be obscured by a parked vehicle (see CBC 1129B.5). The "van-accessible" parking space shall provide an additional sign marked "van-accessible" mounted below the sign (see CBC 1129B.5 and ADAAG 4.6.4).

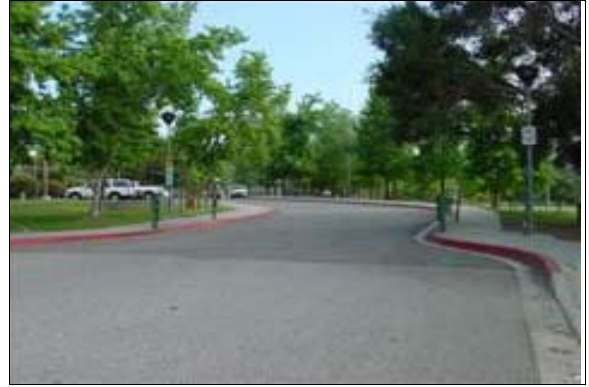
#### ***Parking Lot Next to the Tennis Courts***

**Finding:** There is no warning signage posted at the entrance to the parking lot regarding unauthorized use of accessible parking spaces in the parking lot.

**Full Rec:** Post a sign in a conspicuous place to the entrance of the parking lot, or immediately adjacent to and visible from each accessible parking space. The warning sign shall measure at least 17 inches by 22 inches in size and consist of lettering at least 1 inch in height that clearly and conspicuously states the following;  
"Unauthorized vehicles parked in designated accessible spaces not displaying distinguishing placards or license plates issued for persons with disabilities may be towed away at owner's expense. Towed vehicles may be reclaimed at \_\_\_\_ or by telephoning \_\_\_\_ ." Fill in the blank spaces with appropriate information as a permanent part of the sign and maintain the currency of the information (see CBC 1129B.5). Be sure to add the CVC 22511.8(a)(d) to the sign.

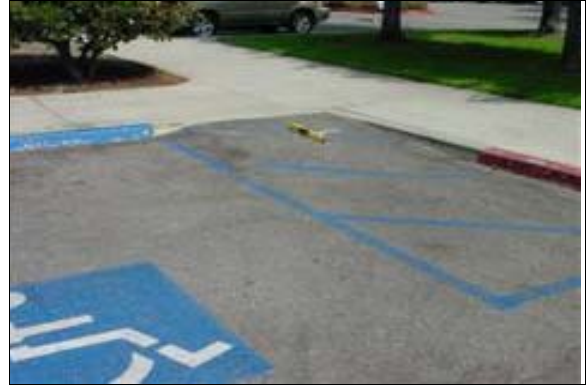
***Curb Ramp at the Accessible Parking Space Next to the Tennis Courts***

**Finding:** The built-up curb ramp projects into an access aisle and interferes with individuals entering or exiting parked or standing vehicles. The slope of the curb ramp is greater than 8.33%. The cross slope is greater than 2%. The slope of the side flares is greater than 10%. The curb ramp does not provide a grooved border along the top and sides of the ramp at the level of the sidewalk. The concrete curb ramp does not provide a detectable warning surface which includes truncated domes.

**Full Rec:** Remove the asphalt built-up curb ramp and install a compliant curb ramp at least 48 inches in width that provides a slope no greater than 8.33%. Install a detectable warning surface which extends the full length and width of the concrete curb ramp and its side flares with truncated domes that contrast visually by either light on dark or dark on light which is an integral part of the concrete curb ramp. The truncated domes may be cast in place or stamped or of a prefabricated surface treatment (see CBC 1127B.5.8).

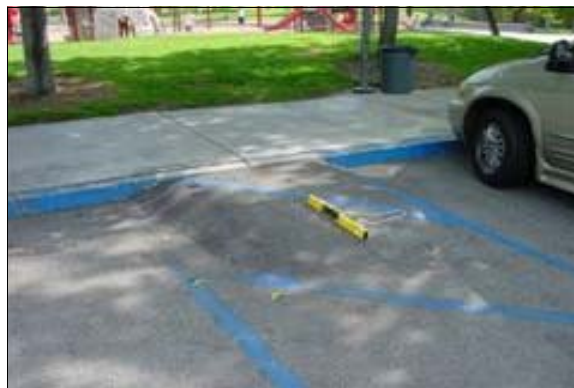
***Curb Ramp at the Accessible Parking Spaces Next to the Play Equipment***

**Finding:** The built-up curb ramp projects into an access aisle and interferes with individuals entering or exiting parked or standing vehicles. The slope of the curb ramp is greater than 8.33%. The cross slope of the curb ramp is greater than 2%. The slope of the side flares is greater than 10%. The curb ramp does not provide a grooved border along the top and sides of the ramp at the level of the sidewalk. The concrete curb ramp does not provide a detectable warning surface which includes truncated domes.

**Full Rec:** Remove the asphalt built-up curb ramp and install a compliant curb ramp at least 48 inches in width that provides a slope no greater than 8.33%. Install a detectable warning surface which extends the full length and width of the concrete curb ramp and its side flares with truncated domes that contrast visually by either light on dark or dark on light which is an integral part of the concrete curb ramp. The truncated domes may be cast in place or stamped or of a prefabricated surface treatment (see CBC 1127B.5.8).

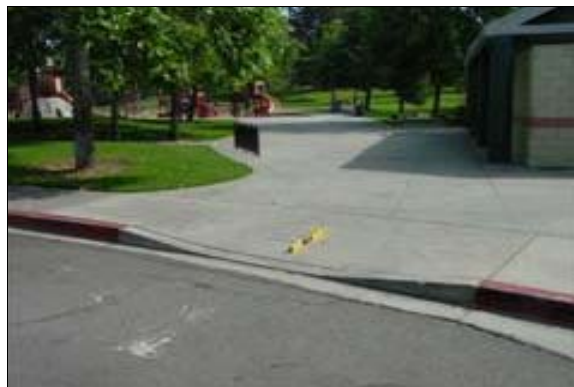
***Curb Ramp Outside of the Restrooms***

**Finding:** The slope of the curb ramp is greater than 8.33%. The slope at the bottom landing is greater than 2%. The slope of the side flares is greater than 10%. The curb ramp does not provide a grooved border along the top and sides of the ramp at the level of the sidewalk. The concrete curb ramp does not provide a detectable warning surface which includes truncated domes.

**Full Rec:** Replace the curb ramp with a compliant curb ramp at least 48 inches in width that provides a slope no greater than 8.33%. Install a detectable warning surface which extends the full length and width of the concrete curb ramp and its side flares with truncated domes that contrast visually by either light on dark or dark on light which is an integral part of the concrete curb ramp. The truncated domes may be cast in place or stamped or of a prefabricated surface treatment (see CBC 1127B.5.8).

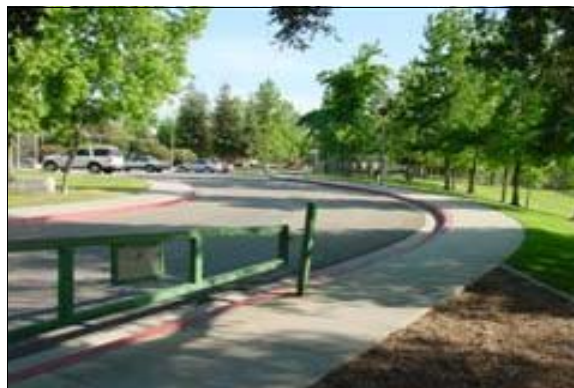
**Accessible Route from the Public Right of Way**

**Finding:** There is an accessible route from the public right of way to the accessible entrance of the facility.

**Full Rec:** Post directional signage. Make certain to post signage indicating the direction to accessible building entrances at every major junction along the accessible route. Signs shall include the International Symbol of Accessibility.

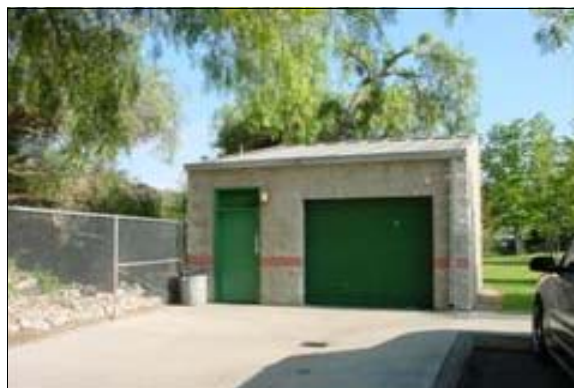
**Maintenance Building**

**Finding:** The Maintenance Building was locked at the time of inspection. A complete inspection of the Maintenance Building could not be conducted at the time of inspection.

**Full Rec:** Due to the unavailability of a specific element at the time of the facility inspection process, it is recommended that upon all elements should be inspected for ADA compliance as they become available.

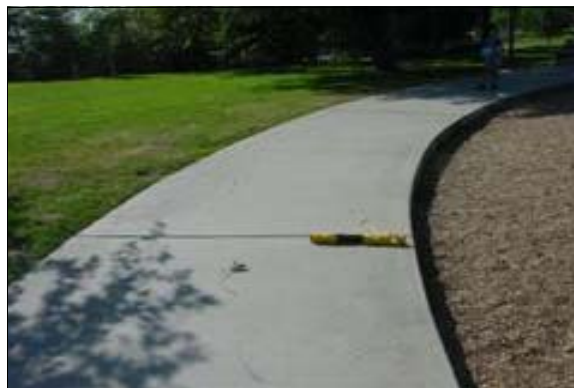
***Path of Travel Around Play Equipment***

**Finding:** There are cross slopes greater than 2% on the primary path of travel around the play equipment.

**Full Rec:** Resurface the path of travel to provide a level surface that does not exceed a slope greater than 5%. Cross slopes shall not exceed 2%.

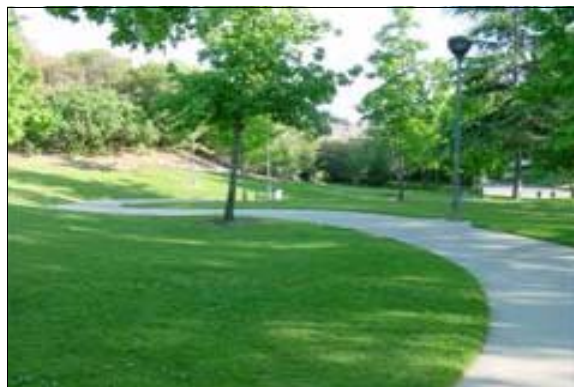
***Path of Travel to the Baseball Fields***

**Finding:** There are slopes greater than 5% on the primary path of travel from the public right of way to the baseball fields.

**Full Rec:** Resurface the path of travel to provide a level surface that does not exceed a slope greater than 5%. Cross slopes shall not exceed 2%.

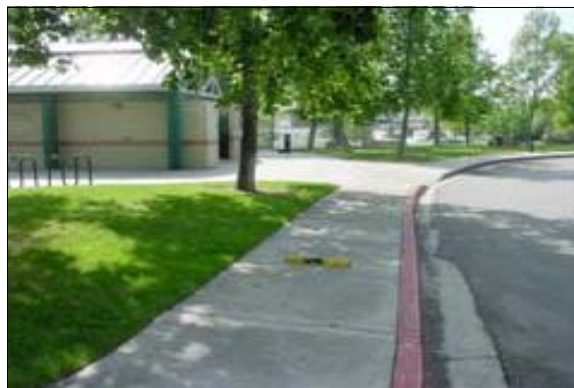
***Path of Travel to the Restrooms***

**Finding:** There are cross slopes greater than 2% on the primary path of travel from the public right of way to the restrooms.

**Full Rec:** Resurface the path of travel to provide a level surface that does not exceed a slope greater than 5%. Cross slopes shall not exceed 2%.

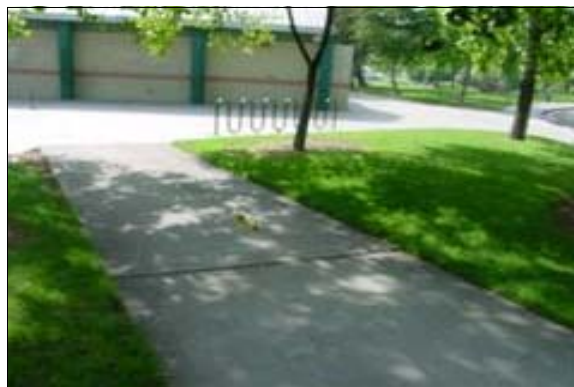
***Path of Travel to the Restrooms***

**Finding:** There are slopes greater than 5% on the primary path of travel from the accessible parking spaces to the restrooms.

**Full Rec:** Resurface the path of travel to provide a level surface that does not exceed a slope greater than 5%. Cross slopes shall not exceed 2%.

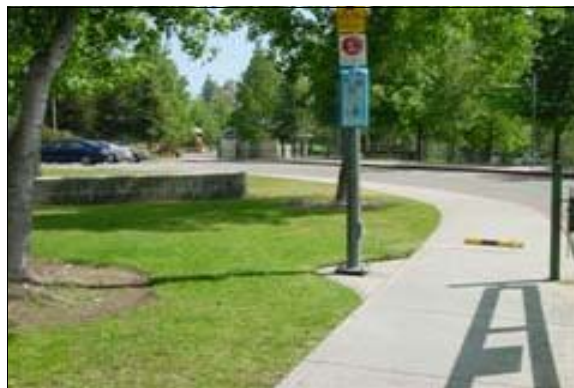
***Path of Travel to the Tennis Courts***

**Finding:** There are cross slopes greater than 2% on the primary path of travel from the public right of way to the tennis courts.

**Full Rec:** Resurface the path of travel to provide a level surface that does not exceed a slope greater than 5%. Cross slopes shall not exceed 2%.

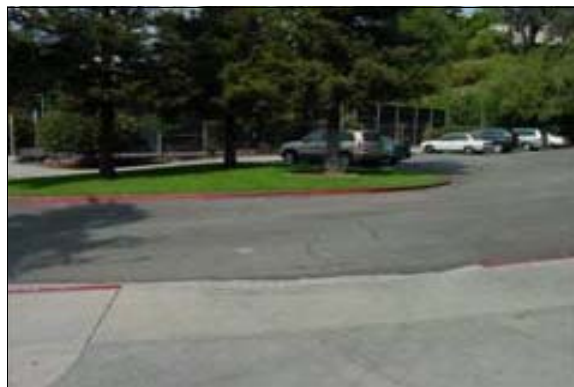
***Path of Travel to the Tennis Courts***

**Finding:** There is no crosswalk provided on the path of travel from the restrooms, play equipment, or baseball fields to the tennis courts. The required accessible route crosses a vehicular way.

**Full Rec:** Stripe a crosswalk not less than 48 inches wide on the path of travel to the accessible entrance of the facility. Provide a level surface that does not exceed a slope greater than 5%. Cross slopes shall not exceed 2%. Detectable warnings should be placed at the entrance and exit of the crosswalk.

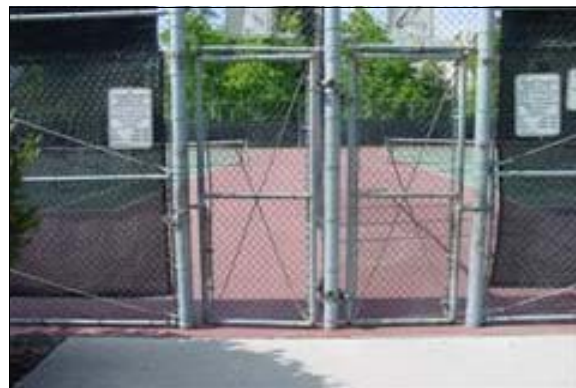
**Entrance Gate to the Tennis Courts**

**Finding:** The bottom 10 inches of the gate does not provide a smooth, uninterrupted surface, or panel to allow the door to be opened by a wheelchair footrest without creating a trap or hazardous condition.

**Full Rec:** Install a panel or replace the gate to provide a smooth, uninterrupted surface for the bottom 10 inches of the door.

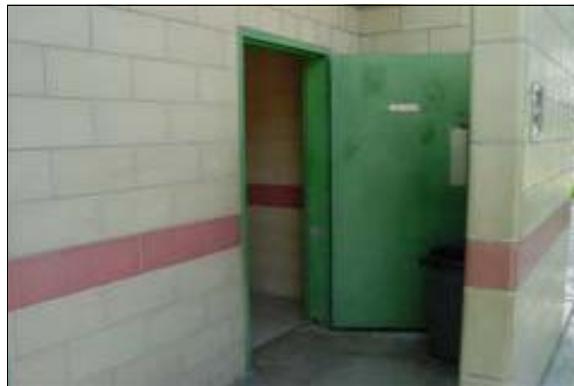
**Men's Restroom**

**Finding:** There is no signage indicating accessibility on the latch side of the entry door of the restroom. There is no Title 24 gender use signage on the entrance door.

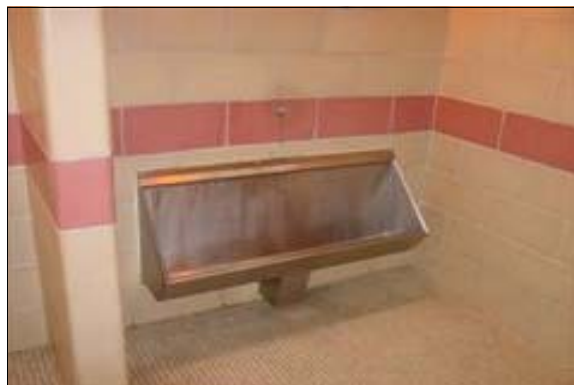
**Men's Restroom**

**Finding:** The urinal in the restroom does not provide a tapered, elongated rim.

**Full Rec:** Replace the urinal designated to be accessible in the restroom with a wall-mounted or stall-type tapered, elongated rim unit complying with ADAAG 4.18.2. The height of the rim surface of the urinal designated to be accessible shall not exceed 17 inches above the finished floor and the flush control valve shall not exceed a height of 44 inches above the finished floor.

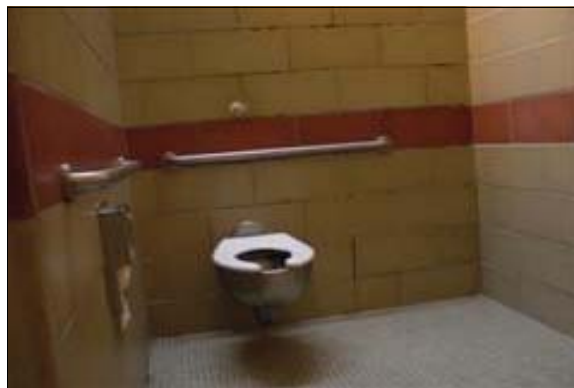
**Men's Restroom**

**Finding:** The flush control on the toilet in the stall designated to be accessible in the restroom is not on the wide (approach) side of the toilet.

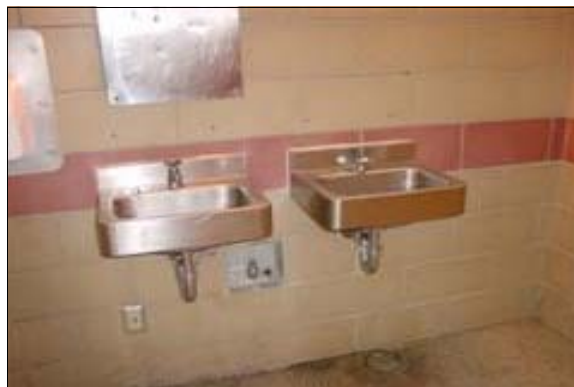
**Men's Restroom**

**Finding:** The height of the rim surface of the lavatory designated to be accessible in the restroom is greater than 34 inches above the finished floor.

**Full Rec:** Relocate or replace the lavatory designated to be accessible in the restroom to provide a maximum rim surface height of no greater than 34 inches above the finished floor (see ADAAG 4.19.2).

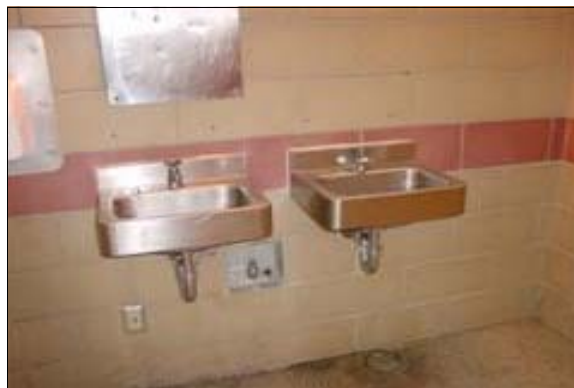
**Men's Restroom**

**Finding:** The knee depth space under the lavatory designated to be accessible in the restroom is less than 27 inches at 8 inches under the lavatory apron.

**Full Rec:** Raise or replace the lavatory designated to be accessible in the restroom to provide at least 27 inches at 8 inches under the apron. Make sure to provide at least 29 inches of clear knee space between the finished floor and bottom of the lavatory apron and a rim surface height no greater than 34 inches (see ADAAG 4.19.2).

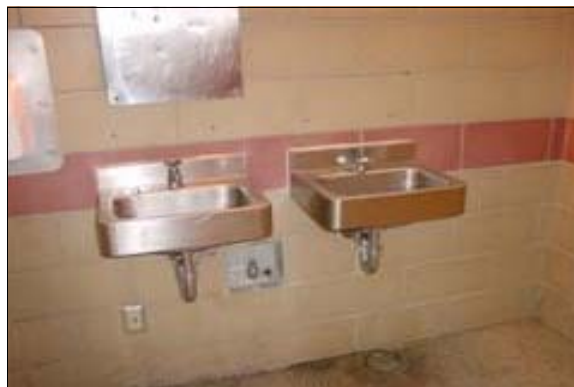
**Men's Restroom**

**Finding:** The pipes under the lavatory in the restroom do not provide protection against contact.

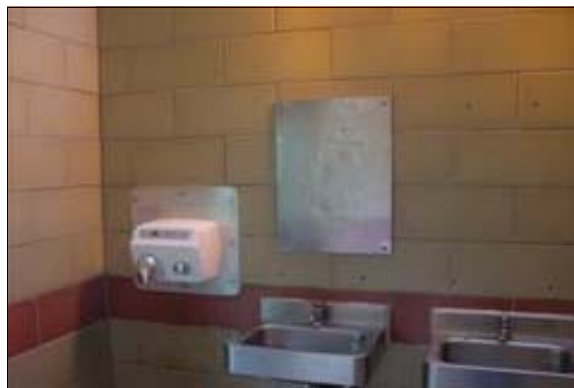
**Men's Restroom**

**Finding:** The bottom edge of the reflecting surface of the mirror in the restroom is greater than 40 inches above the finished floor.

**Full Rec:** Lower the mirror in the restroom so that the bottom edge of the reflecting surface is no higher than 40 inches above the finished floor and the topmost portion of the reflecting surface extends at least 74 inches above the finished floor (see ADAAG A4.19.6). A single, full-length mirror is recommended since it can accommodate all people. Make certain to provide a minimum clear floor space in front of the mirror of 30 inches in width and 48 inches in length.

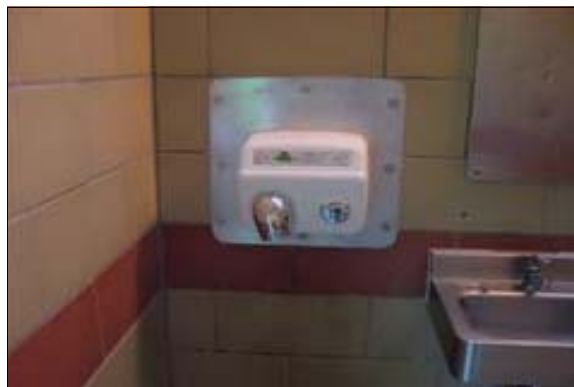
**Men's Restroom**

**Finding:** The height of the controls and operating mechanisms for the hand dryer in the restroom is greater than 40 inches in height.

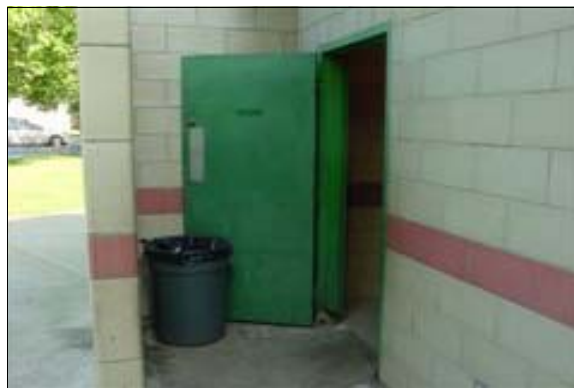
**Women's Restroom**

**Finding:** There is no signage indicating accessibility on the latch side of the entry door of the restroom. There is no Title 24 gender use signage on the entrance door.

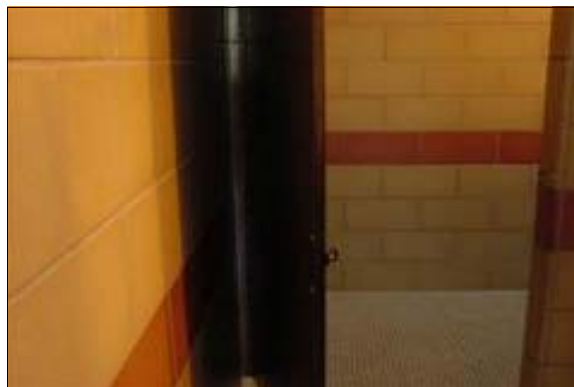
**Women's Restroom**

**Finding:** The door to the stall designated to be accessible in the restroom does not close automatically or have accessible hardware.

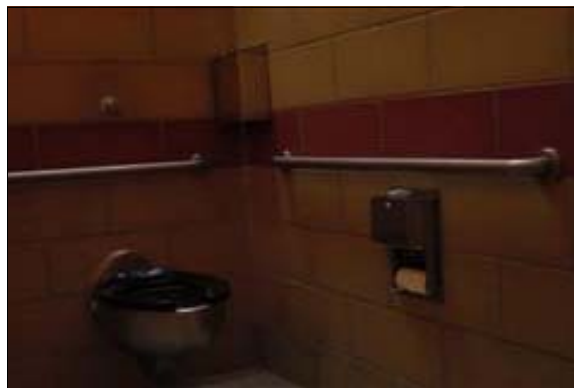
**Women's Restroom**

**Finding:** The height of the side and back grab bar in the stall designated to be accessible of the restroom is greater than 33 inches above the finished floor.

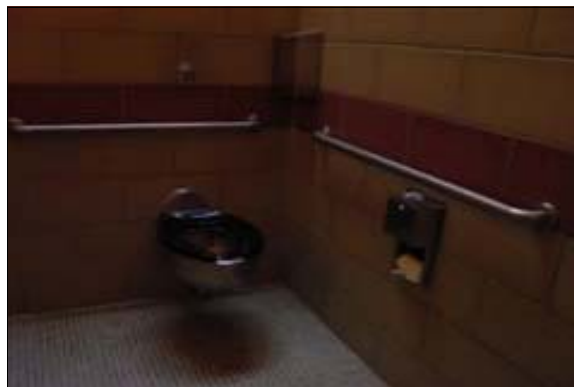
**Women's Restroom**

**Finding:** The flush control on the toilet in the stall designated to be accessible in the restroom is not on the wide (approach) side of the toilet.

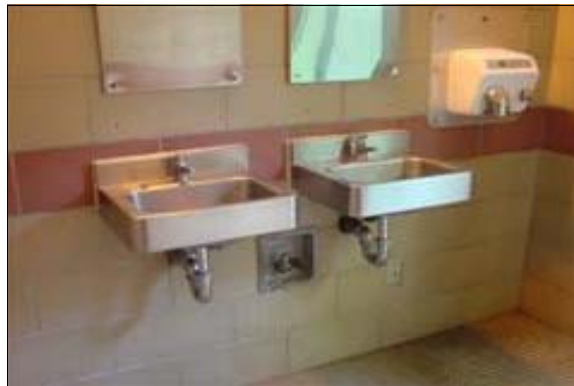
**Women's Restroom**

**Finding:** The pipes under the lavatory in the restroom do not provide protection against contact.

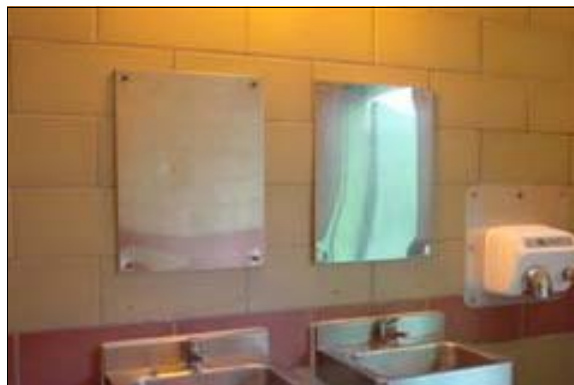
**Women's Restroom**

**Finding:** The bottom edge of the reflecting surface of the mirror in the restroom is greater than 40 inches above the finished floor.

**Full Rec:** Lower the mirror in the restroom so that the bottom edge of the reflecting surface is no higher than 40 inches above the finished floor and the topmost portion of the reflecting surface extends at least 74 inches above the finished floor (see ADAAG A4.19.6). A single, full-length mirror is recommended since it can accommodate all people. Make certain to provide a minimum clear floor space in front of the mirror of 30 inches in width and 48 inches in length.

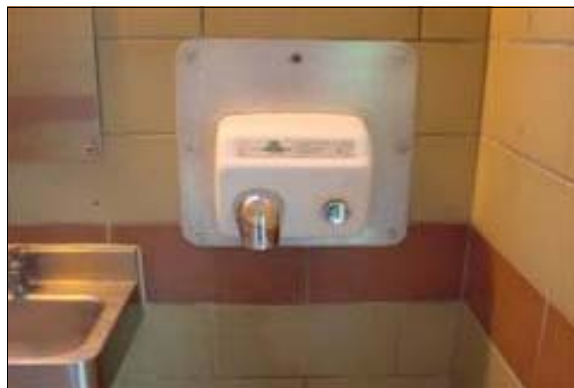
**Women's Restroom**

**Finding:** The height of the controls and operating mechanisms for the hand dryer in the restroom is greater than 40 inches in height.

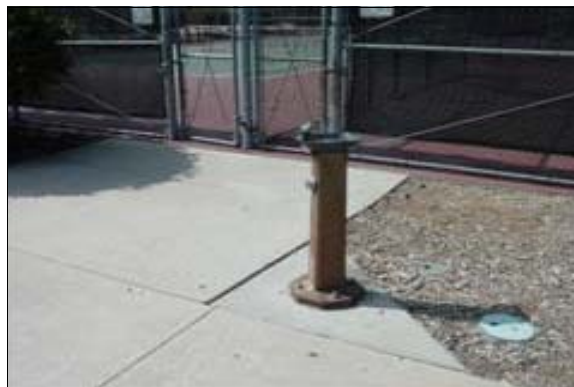
**Finding:** There are three drinking fountains on primary paths of travel.

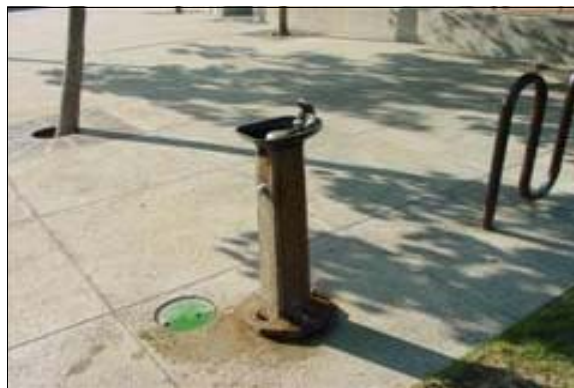
**Drinking Fountain at the Baseball Fields**

**Finding:** The drinking fountain is not a "high-low" design. The spout outlet height is greater than 36 inches. There is less than 27 inches knee clearance height.

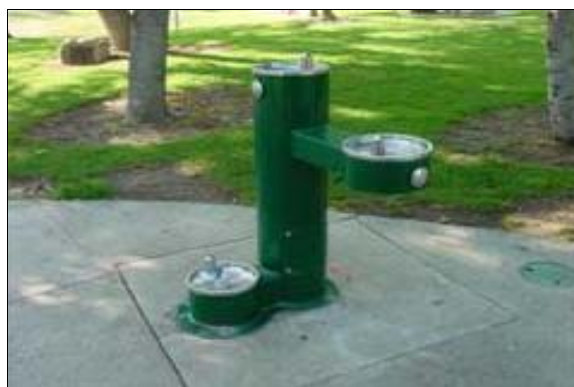
**Drinking Fountain at the Restrooms**

**Finding:** The leading edge of the drinking fountain is more than 4 inches from the wall and greater than 27 inches from the floor and protrudes into the primary path of travel.

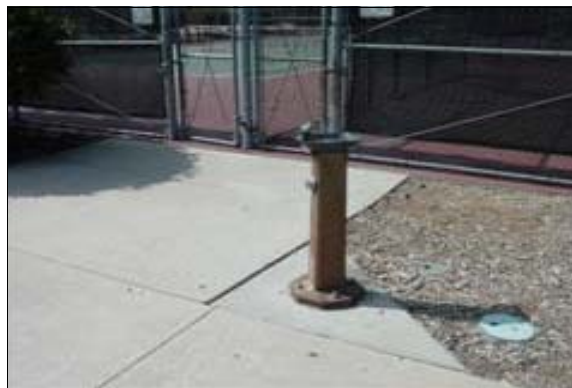
**Drinking Fountain at the Tennis Courts**

**Finding:** The drinking fountain is not a "high-low" design. The spout outlet height is greater than 36 inches. There is less than 27 inches knee clearance height.

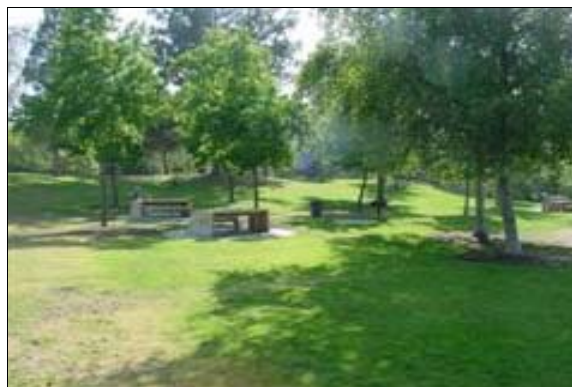
**Outdoor Dining Area**

**Finding:** There is no accessible route to the picnic tables in the outdoor dining area next to the play equipment. The surface under and around the outdoor dining area picnic tables is grass, preventing access of individuals with mobility impairments.

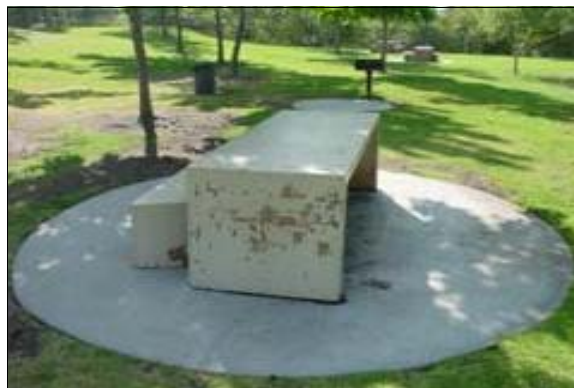
**Outdoor Dining Area**

**Finding:** The tables at the outdoor dining area next to the play equipment are nonaccessible by design.

**Full Rec:** Modify or replace one of the tables in the outdoor dining area to provide knee clearance of at least 27 inches in height, 30 inches in width and 19 inches in depth (see CBC 1122B.3, ADAAG 4.32.2 and ADAAG Figure 45). The table top height shall not exceed 34 inches above the finished floor.

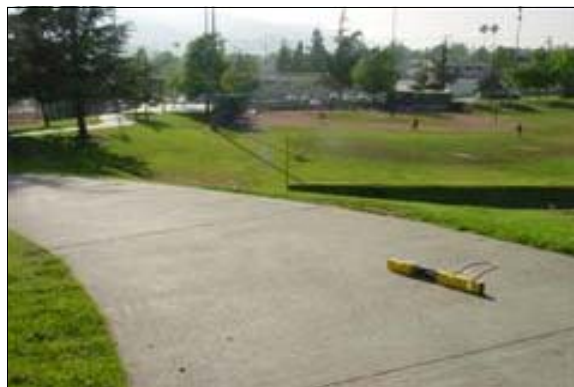
**Baseball Fields**

**Finding:** There are slopes greater than 6.33% along the path of travel to the baseball fields.

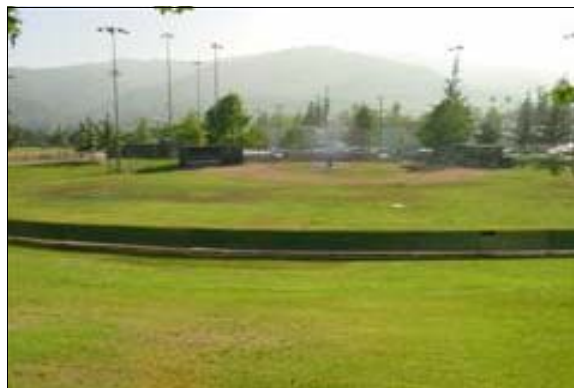
**Baseball Fields**

**Finding:** The grass and dirt surface of the baseball fields at the facility prevents access to individuals with mobility impairments.

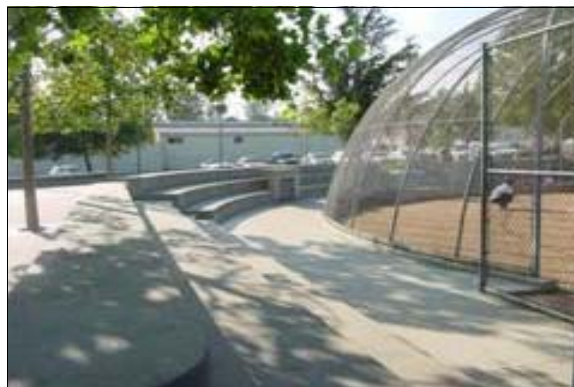
**Baseball Fields**

**Finding:** The surface under the bleachers is concrete. No wheelchair seating is provided next to the bleachers.
