Photo Report
New York Park
Programs, Services, and Activities

Finding: The New York Park, located at 4525 New York Avenue in Glendale California, was inspected by Disability Access Consultants, Inc., on August 14, 2007.

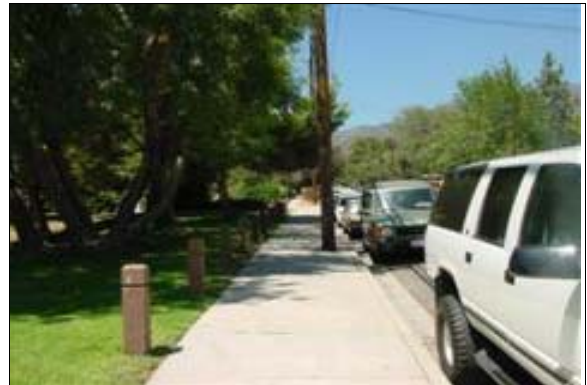
Accessible Route from the Public Right of Way

Finding: There is an accessible route from the public right of way to the accessible entrance of the facility.

Full Rec: Post directional signage. Make certain to post signage indicating the direction to accessible building entrances at every major junction along the accessible route. Signs shall include the International Symbol of Accessibility.

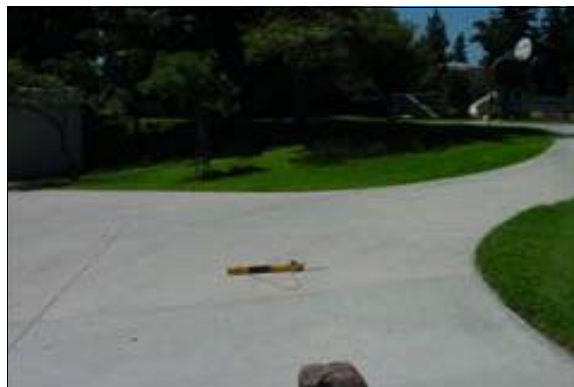
Path of Travel to the Play Equipment

Finding: There are cross slopes greater than 2% on the primary path of travel from the public right of way to the basketball courts and play equipment.

Full Rec: Resurface the path of travel to provide a level surface that does not exceed a slope greater than 5%. Cross slopes shall not exceed 2%.

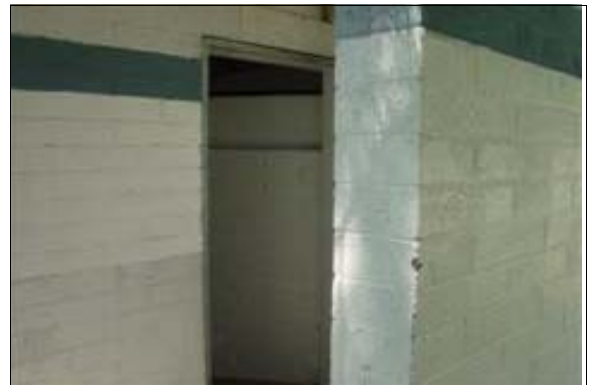
Men's Restroom

Finding: There is no signage indicating accessibility on the latch side of the entry door of the restroom. There is no Title 24 gender use signage on the entrance door.

Full Rec: The restroom is designated accessible and should be made accessible for the facility. Post signage centered 60 inches above the ground surface on the latch side of the entrance door identifying the restroom as accessible upon completion of the following items (see CBC 1115B., ADAAG 4.1.2(7) and ADAAG 4.1.6(3)(e). Signage shall include Braille and raised lettering, the gender or unisex use symbol and the ISA symbol. Post Title 24 gender use signage on the door @ 60" o.c. a.f.f.

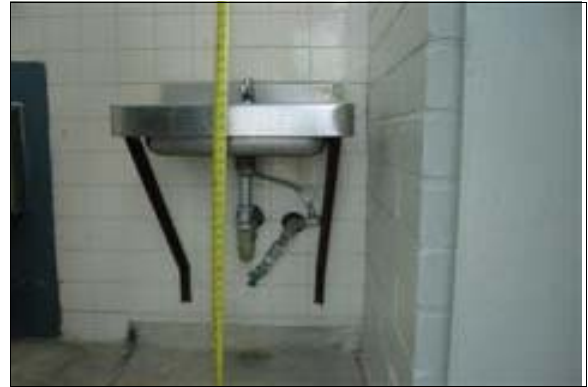
Men's Restroom

Finding: The knee clearance space under the lavatory designated to be accessible in the restroom is less than 29 inches. The knee depth space under the lavatory designated to be accessible in the restroom is less than 27 inches at 8 inches under the lavatory apron.

Full Rec: Replace the lavatory designated to be accessible in the restroom to provide at least 29 inches of clear knee space between the finished floor and bottom of the lavatory apron. Make sure to provide at least 27 inches at 8 inches under the apron (see ADAAG 4.19.2).

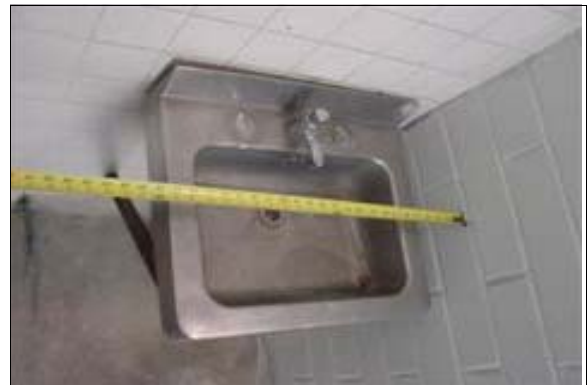
Men's Restroom

Finding: The distance from the center of the lavatory to the adjacent side wall in the restroom is less than 18 inches.

Full Rec: Relocate the lavatory to provide a centerline of at least 18 inches. Make sure to provide at least 30 inches in width and 48 inch length of clear floor space to allow an accessible forward approach (see ADAAG 4.19.3).

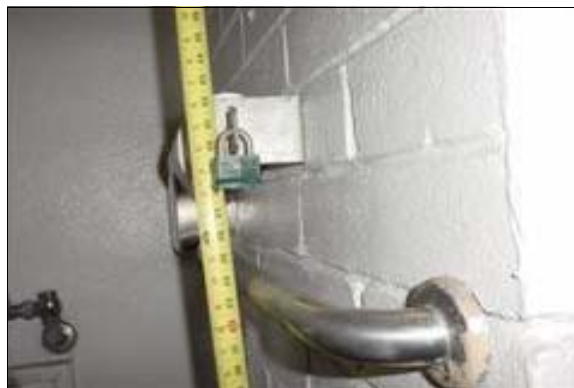
Women's Restroom

Finding: The height of the side grab bars in the stall designated to be accessible of the restroom is greater than 33 inches above the finished floor.

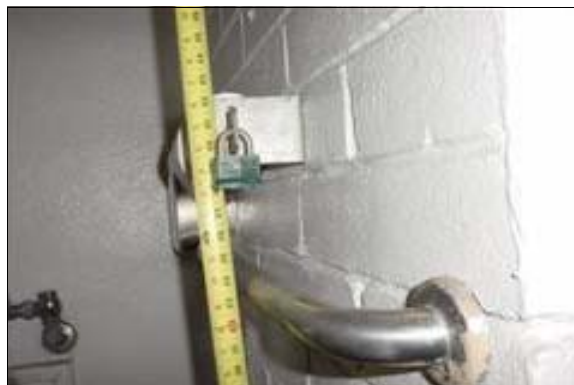
Women's Restroom

Finding: The toilet paper dispenser in the stall designated to be accessible in the restroom interferes with the use of the side grab bar.
