Photo Report
Nibley Park
Programs, Services, and Activities

Finding: The Nibley Park, located at 1103 East Mountain in Glendale California, was inspected by Disability Access Consultants, Inc., on June 7, 2007.

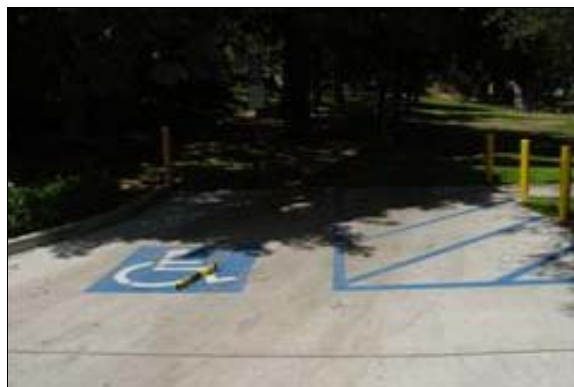
Finding: There is one accessible parking space out of one parking space marked, which is sufficient for compliance. The accessible parking space measures 113 inches wide and 222 inches long. The access aisle, located on the passenger's side (right side) of the parking space, measures 98 inches wide. The access aisle does not contain "NO PARKING" in 12" high white letters.

Full Rec: One out of the one total number of marked parking space meets the number required to be designated exclusively for accessible parking, according to ADAAG and CBC 1129B. Add the words NO PARKING in 12 inch high white letters at the entrance to the accessible parking access aisle.

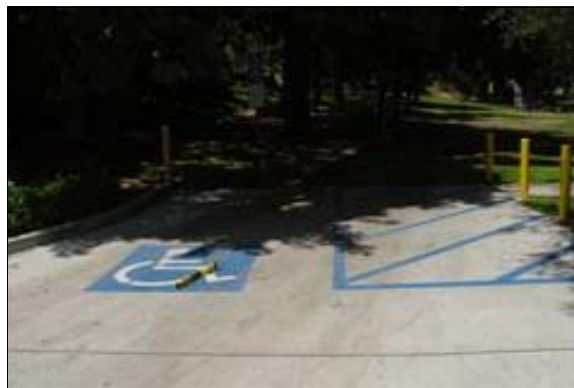
Finding: The surface of the accessible parking space in the parking lot has a slope greater than 2%.

Full Rec: Pave the parking lot at the accessible spaces to provide a level surface. Parking surfaces and access aisles shall be located in areas not exceeding 2% slope in all directions (see CBC 1129B and ADAAG 4.6.3).

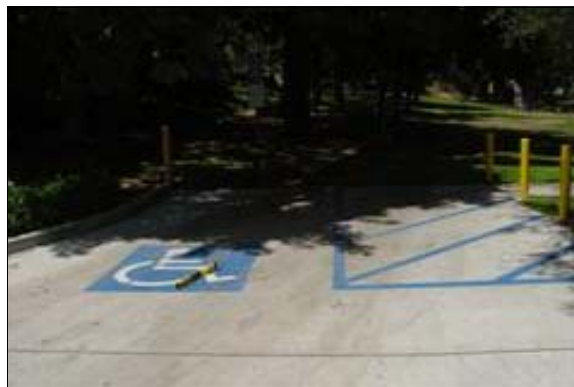
Finding: The designated accessible parking space in the parking lot is not outlined on the left side.

Full Rec: Each designated accessible parking space shall be identified with a pavement marking consisting of outlining the accessible space in blue and outlining an ISA symbol in white; or outlining a 36 inch by 36 inch white on blue ISA symbol positioned where it can be viewed when a vehicle is parked in the space.

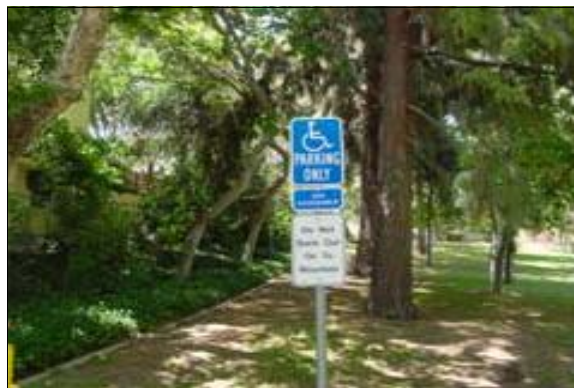
Finding: The bottom edge of the post-mounted signage designating the accessible parking space is less than 80 inches above the level of the parking space and cannot be viewed when a vehicle is parked in the space.

Full Rec: Modify the height or replace the post-mounted signage designating the accessible parking space to provide at least 80 inches from the parking space finished grade to the bottom edge of the sign. The sign shall be located so that it cannot be obscured by a vehicle parked in the space (see CBC 1129B.5).

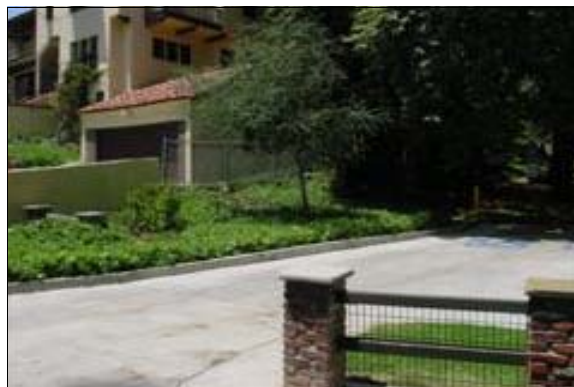
Finding: There is no warning signage posted at the entrance to the parking lot regarding unauthorized use of accessible parking spaces in the parking lot.

Full Rec: Post a sign in a conspicuous place to the entrance of the parking lot, or immediately adjacent to and visible from each accessible parking space. The warning sign shall measure at least 17 inches by 22 inches in size and consist of lettering at least 1 inch in height that clearly and conspicuously states the following; "Unauthorized vehicles parked in designated accessible spaces not displaying distinguishing placards or license plates issued for persons with disabilities may be towed away at owner's expense. Towed vehicles may be reclaimed at ____ or by telephoning ____ ." Fill in the blank spaces with appropriate information as a permanent part of the sign and maintain the currency of the information (see CBC 1129B.5). Be sure to add the CVC 22511.8(a)(d) to the sign.

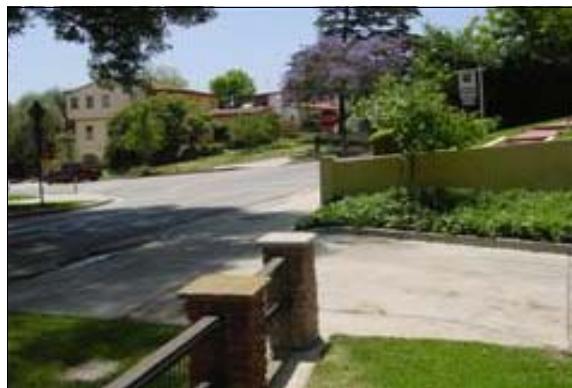
Accessible Route from the Public Right of Way

Finding: There is no accessible route from the public right of way to the accessible entrance of the facility. The accessible route crosses and adjoins vehicular traffic.

Full Rec: Provide at least one accessible route from the public right of way to the accessible entrance of the facility. Make certain to post signage indicating the direction to accessible building entrances at every major junction along the accessible route. Signs shall include the International Symbol of Accessibility.

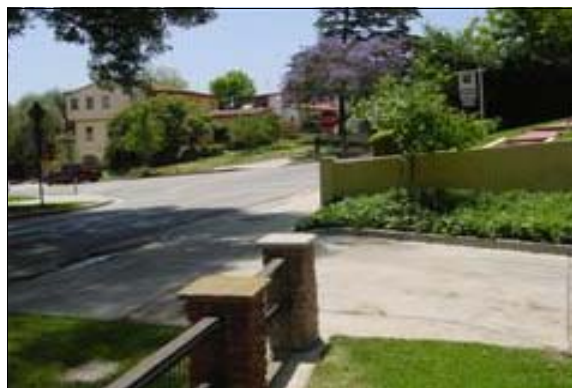
Accessible Route from the Public Right of Way

Finding: There is no crosswalk provided on the path of travel from the public right of way to the facility. The required accessible route crosses a vehicular way.

Full Rec: Stripe a crosswalk not less than 48 inches wide on the path of travel to the accessible entrance of the facility. Provide a level surface that does not exceed a slope greater than 5%. Cross slopes shall not exceed 2%. Detectable warnings should be placed at the entrance and exit of the crosswalk.

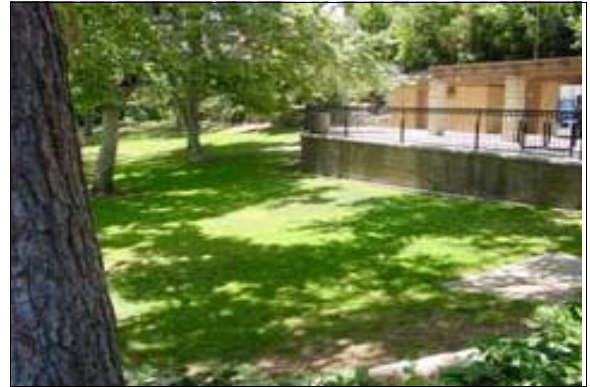
Path of Travel to the Restrooms

Finding: The path of travel from the public right of way to the restrooms is grass, preventing access to individuals with mobility impairments.

Full Rec: Install an accessible route to where programs, services and activities are provided (see CBC 1114B.1.2 and ADAAG 4.3.2). The minimum width of the path of travel shall be 48 inches with a firm, stable and slip-resistant surface. No protruding objects are permitted on the accessible path of travel and slopes shall not exceed 5% in the direction of travel.

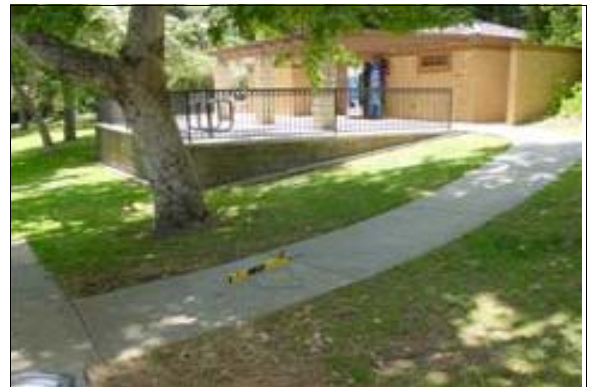
Path of Travel to the Restrooms

Finding: There are slopes greater than 5% on the primary path of travel from the tennis courts to the restrooms.

Full Rec: Resurface the path of travel to provide a level surface that does not exceed a slope greater than 5%. Cross slopes shall not exceed 2%.

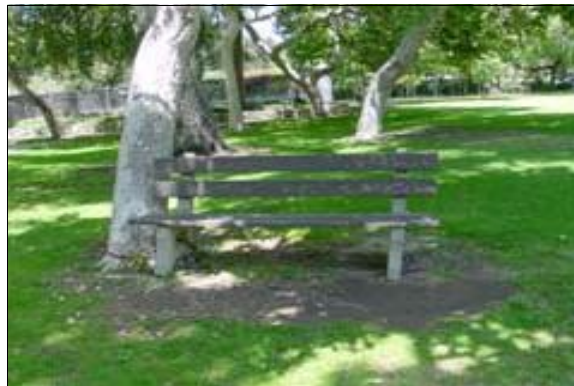
Path of Travel to the Seating Areas

Finding: The path of travel to the seating areas throughout the park is grass, preventing access to individuals with mobility impairments.

Full Rec: Install an accessible route to where programs, services and activities are provided (see CBC 1114B.1.2 and ADAAG 4.3.2). The minimum width of the path of travel shall be 48 inches with a firm, stable and slip-resistant surface. No protruding objects are permitted on the accessible path of travel and slopes shall not exceed 5% in the direction of travel.

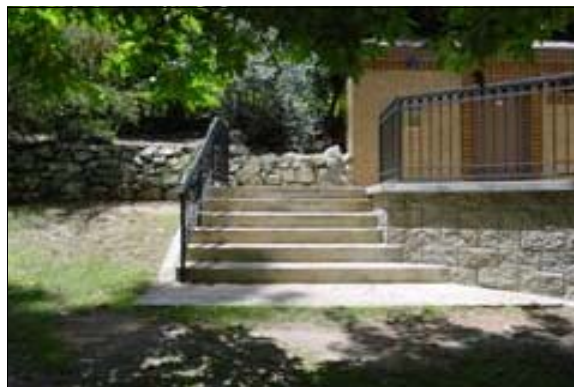
Exterior Stairs to the Restrooms

Finding: There is no detectable striping on each tread of the exterior stairway.

Full Rec: Affix detectable contrasting striping to each tread of the stairway that clearly contrasts in color from the tread and is at least 2 inches in width placed no more than 1 inch from the tread nose or landing.

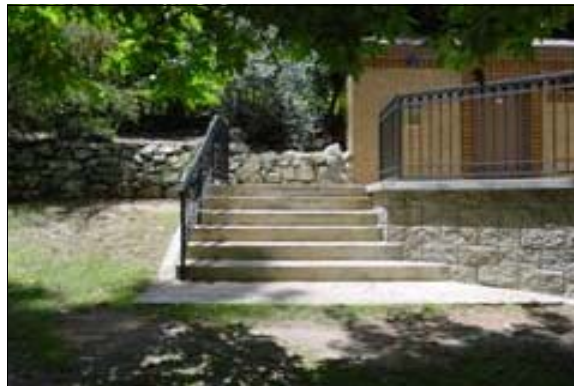
Exterior Stairs to the Restrooms

Finding: There is only one handrail on the stairway. The handrail does not provide 12-inch extensions beyond the bottom treads.

Full Rec: Install handrails on each side of stairway that provide a gripping surface between 1 1/4 to 1 7/8 inches with 12-inch top and bottom handrail extensions that extend beyond the top and bottom treads of the stairway which are parallel to the ground surface and return smoothly to the post or wall. Handrails shall be mounted at a height between 34 and 38 inches at a distance no less than 1 1/2 inches from the adjacent wall.

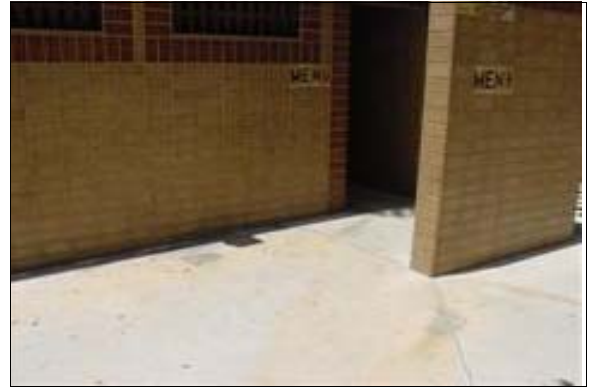
Men's Restroom

Finding: There is no signage indicating accessibility on the latch side of the entry door of the restroom. There is no Title 24 gender use signage on the entrance door.

Full Rec: The restroom is designated accessible and should be made accessible for the facility. Post signage centered 60 inches above the ground surface on the latch side of the entrance door identifying the restroom as accessible upon completion of the following items (see CBC 1115B., ADAAG 4.1.2(7) and ADAAG 4.1.6(3)(e). Signage shall include Braille and raised lettering, the gender or unisex use symbol and the ISA symbol. Post Title 24 gender use signage on the door @ 60" o.c. a.f.f.

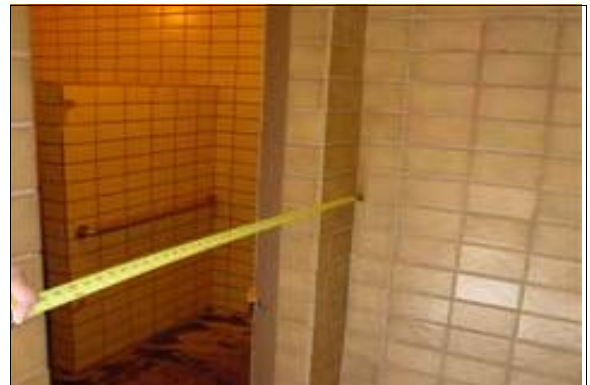
Men's Restroom

Finding: There is less than 24 inches of clearance on the latch side of the exterior entrance door.

Full Rec: Consult a design professional to determine if it is technically feasible to provide at least 24 inches of latch side clearance at the entrance door (see ADAAG 4.13.6 and Figure 25). Otherwise, install an automatic door opening device to the primary entrance complying with ADAAG 4.13.12 and ANSI/BHMA A156.10, 1985, standards.

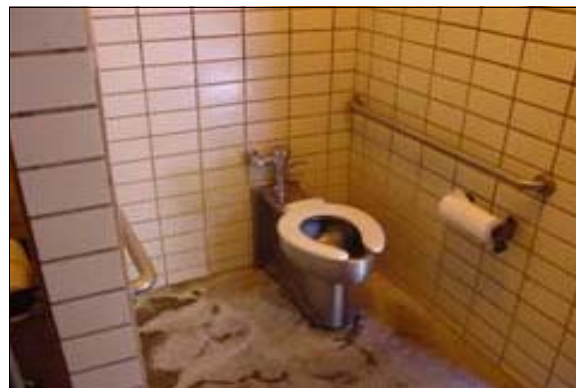
Men's Restroom

Finding: This restroom is not accessible and cannot be easily altered. There is not sufficient clear floor space in the restroom to accommodate an individual in a wheelchair.

Full Rec: Consult a design professional to modify the restroom. One or more walls may need to be moved to provide sufficient clear floor space to inscribe a 60-inch diameter turning radius in the restroom to accommodate an individual in a wheelchair.

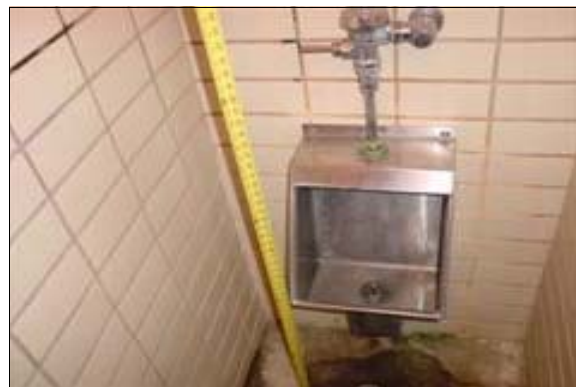
Men's Restroom

Finding: There is less than 30 inches by 48 inches of clear floor space provided in front of the urinal in the restroom to allow an accessible forward approach.

Full Rec: The minimum clear floor space in front of the urinal designated to be accessible in the restroom shall be at least 30 inches by 48 inches to provide an accessible forward approach (see CBC 1115B.9.4 and ADAAG 4.18.3). Consult a design professional to determine if elements or walls need to be removed to provide sufficient clear floor space in front of the urinal.

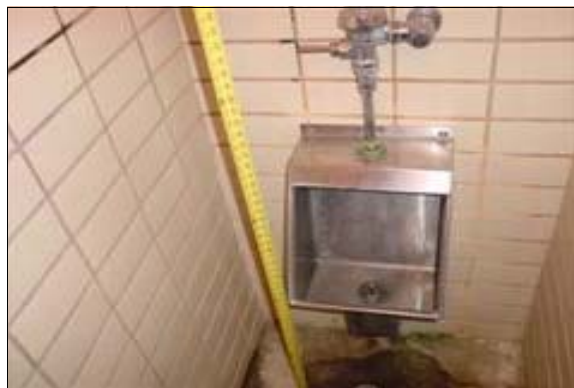
Men's Restroom

Finding: The urinal in the restroom does not provide a tapered, elongated rim. The height of the urinal rim is greater than 17 inches above the finished floor. The flush control valve on the urinal is greater than 44 inches above the finished floor.

Full Rec: Replace the urinal designated to be accessible in the restroom with a wall-mounted or stall-type tapered, elongated rim unit complying with ADAAG 4.18.2. The height of the rim surface of the urinal designated to be accessible shall not exceed 17 inches above the finished floor and the flush control valve shall not exceed a height of 44 inches above the finished floor.

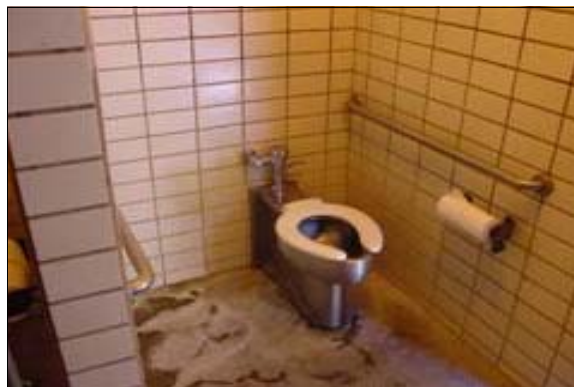
Men's Restroom

Finding: There is insufficient clear floor space in the stall designated to be accessible in the restroom. There is no door on the stall designated to be accessible in the restroom.

Full Rec: Modify or replace the stall designated to be accessible in the restroom so that it complies with ADAAG 4.17.3, CBC 1115B and CBC Figures 11B-1A and 1B. Standard accessible stalls require 60 inches in width with 56 inches depth for wall-mounted toilets or 59 inches depth for floor-mounted toilets to accommodate individuals in wheelchairs. The minimum width of a front-approach doorway shall provide at least 32 inches and a side-approach doorway shall provide at least 34 inches. The door shall swing outward, close automatically and provide accessible hardware.

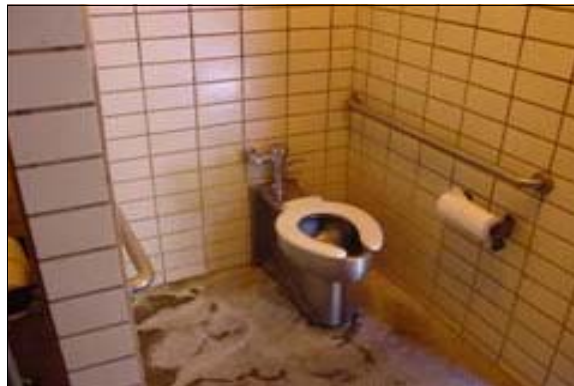
Men's Restroom

Finding: There is no back grab bar in the stall designated to be accessible in the restroom.

Full Rec: Install a 36-inch back grab bar at a height of 33 inches above the finished floor in the stall designated to be accessible of the restroom. Grab bars must be able to support a point load of at least 250 pounds and shall be less than the allowable shear stress of the grab bar material.

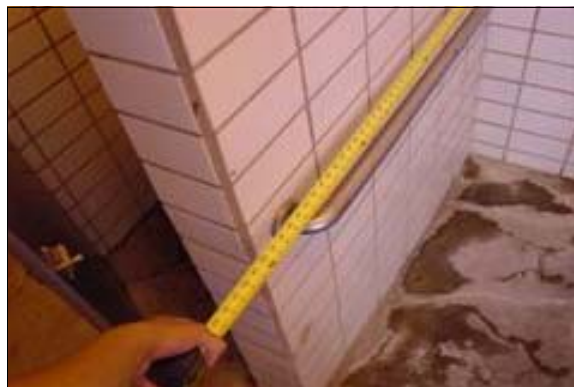
Men's Restroom

Finding: The side grab bars in the stall designated to be accessible in the restroom do not extend 54 inches from the back wall.

Full Rec: The front end of the grab bars shall extend at least 54 inches from the back wall and the back end of the grab bar shall be mounted within 12 inches from the back wall. Grab bars must be able to support a point load of at least 250 pounds and shall be less than the allowable shear stress of the grab bar material.

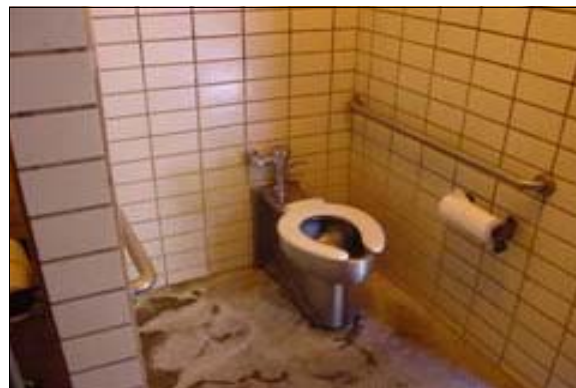
Men's Restroom

Finding: The flush control on the toilet in the stall designated to be accessible in the restroom is not on the wide (approach) side of the toilet.

Full Rec: Relocate the flush control on the toilet in the stall designated to be accessible in the restroom so that it is on the wide (approach) side of the toilet area (see ADAAG 4.16.5). Flush controls shall be hand-operated or automatic mechanisms.

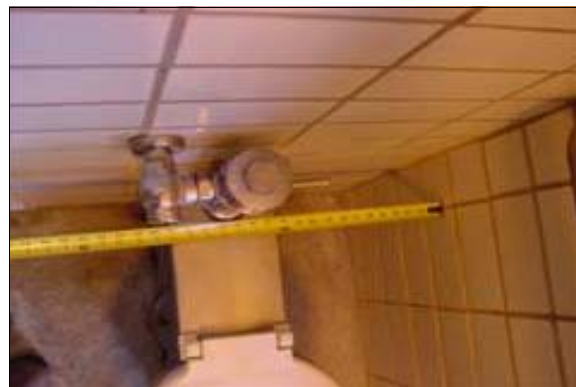
Men's Restroom

Finding: The distance from the center of the toilet to the nearest side wall in the stall designated to be accessible in the restroom is less than 18 inches.

Full Rec: Relocate the toilet or stall side wall so that the distance from the centerline of the toilet to the nearest side wall in the stall designated to be accessible in the restroom is exactly 18 inches (see ADAAG Figure 28).

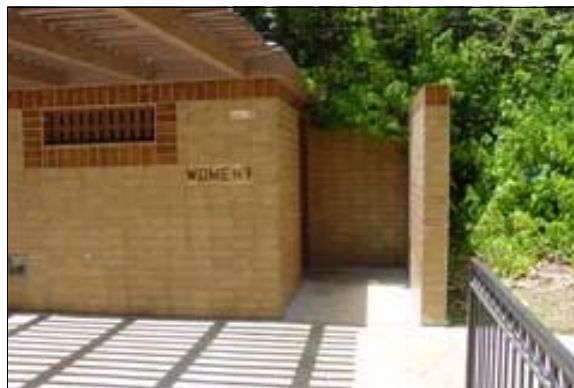
Women's Restroom

Finding: There is no signage indicating accessibility on the latch side of the entry door of the restroom. There is no Title 24 gender use signage on the entrance door.

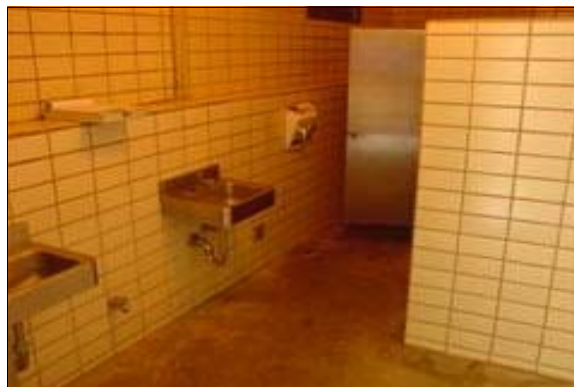
Women's Restroom

Finding: The latch side approach to the stall designated to be accessible in the restroom is less than 44 inches wide.

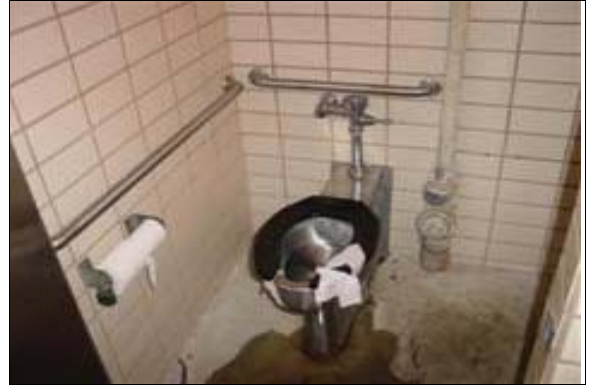
Women's Restroom

Finding: The length of the back grab bar in the stall designated to be accessible of the restroom is less than 36 inches.

Full Rec: Replace the back grab bar in the stall designated to be accessible of the restroom with a 36-inch back grab bar complying with ADAAG 4.26 and CBC 1115B.8. Grab bars must be able to support a point load of at least 250 pounds and shall be less than the allowable shear stress of the grab bar material.

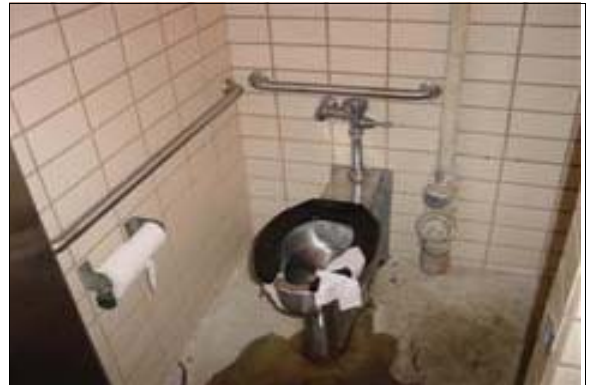
Women's Restroom

Finding: The side grab bar in the stall designated to be accessible in the restroom does not extend 54 inches from the back wall.

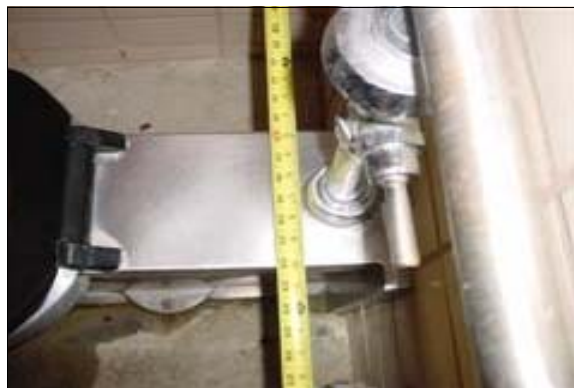
Women's Restroom

Finding: The distance from the center of the toilet to the nearest side wall in the stall designated to be accessible in the restroom is greater than 18 inches.

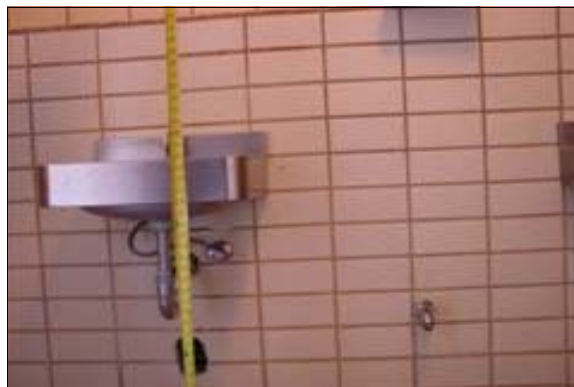
Women's Restroom

Finding: The knee clearance space under the lavatory designated to be accessible in the restroom is less than 29 inches. The knee depth space under the lavatory designated to be accessible in the restroom is less than 27 inches at 8 inches under the lavatory apron.

Full Rec: Replace the lavatory designated to be accessible in the restroom to provide at least 29 inches of clear knee space between the finished floor and bottom of the lavatory apron. Make sure to provide at least 27 inches at 8 inches under the apron (see ADAAG 4.19.2).

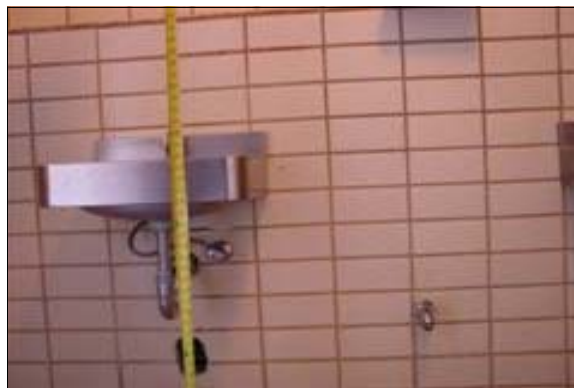
Women's Restroom

Finding: The pipes under the lavatory in the restroom do not provide protection against contact.

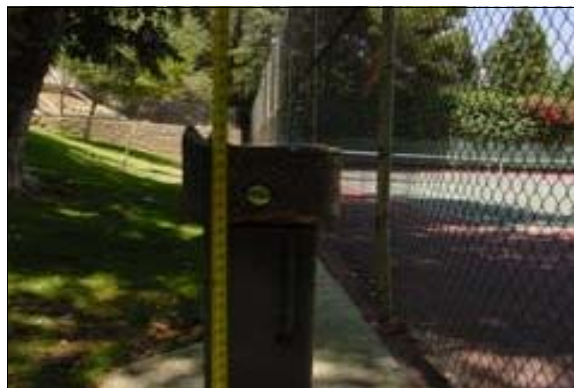
Finding: There are two drinking fountains on primary paths of travel.

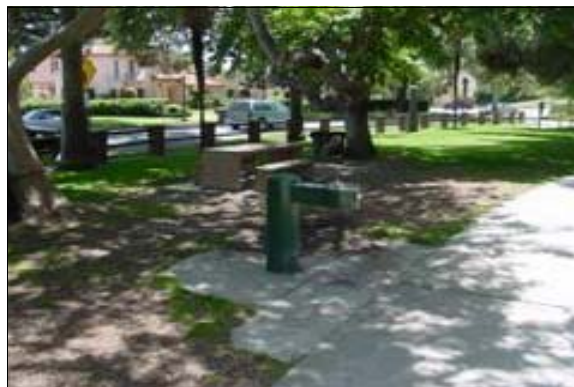
Drinking Fountain Next to the Play Equipment

Finding: The drinking fountain is not a "high-low" design.

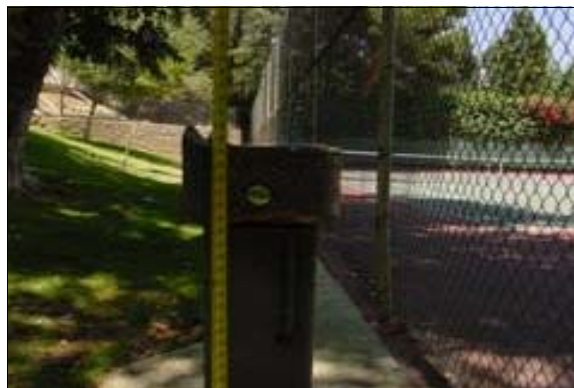
Drinking Fountain Next to the Tennis Courts

Finding: The drinking fountain is not a "high-low" design. There is insufficient clear floor space in front of the drinking fountain.

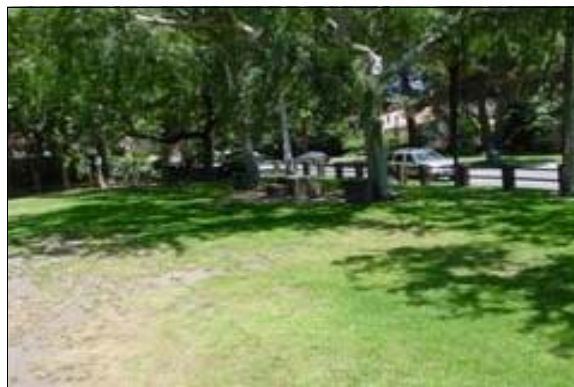
Outdoor Dining Area

Finding: There is no accessible route to the picnic tables in the outdoor dining area. The surface under and around the outdoor dining area picnic tables is grass, preventing access of individuals with mobility impairments.

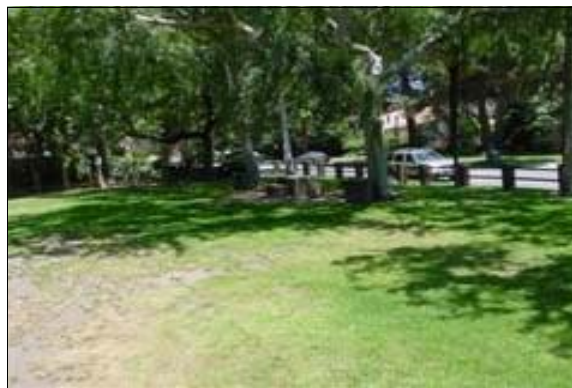
Outdoor Dining Area

Finding: The tables at the outdoor dining area are nonaccessible by design.

Full Rec: Modify or replace one of the tables in the outdoor dining area to provide knee clearance of at least 27 inches in height, 30 inches in width and 19 inches in depth (see CBC 1122B.3, ADAAG 4.32.2 and ADAAG Figure 45). The table top height shall not exceed 34 inches above the finished floor.

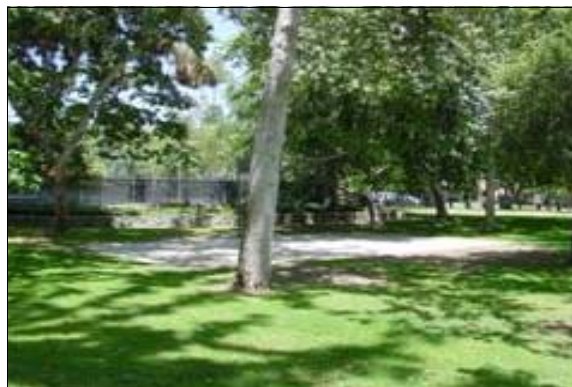
Basketball Courts

Finding: The path of travel to the basketball courts consists of grass, making the area nonaccessible to individuals with mobility impairments.
