**Photo Report**  
**Oakmont View Park**  
**Programs, Services, and Activities**

**Finding:** The Oakmont View Park, located at 2140 Oakmont View Drive in Glendale California, was inspected by Disability Access Consultants, Inc., on August 13, 2007.

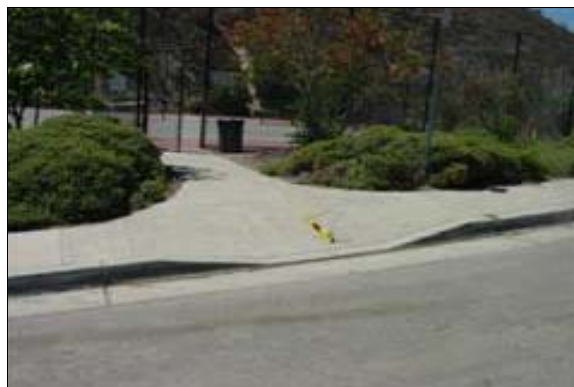
***Curb Ramp to the Tennis Courts***

**Finding:** The slope of the curb ramp is greater than 8.33%. The cross slope is greater than 2%. The slope at the bottom landing is greater than 2%. The cross slope at the top landing is greater than 2%. The width of the curb ramp is less than 48 inches. The slope of the side flares is greater than 10%. The curb ramp does not provide a grooved border along the top and sides of the ramp at the level of the sidewalk. The concrete curb ramp does not provide a detectable warning surface which includes truncated domes.

Citations: CBC 1127B.5.3; ADAAG 4.7.2 & 4.29

**Full Rec:** Replace the curb ramp with a compliant curb ramp at least 48 inches in width that provides a slope no greater than 8.33%. Install a detectable warning surface which extends the full length and width of the concrete curb ramp and its side flares with truncated domes that contrast visually by either light on dark or dark on light which is an integral part of the concrete curb ramp. The truncated domes may be cast in place or stamped or of a prefabricated surface treatment (see CBC 1127B.5.8).

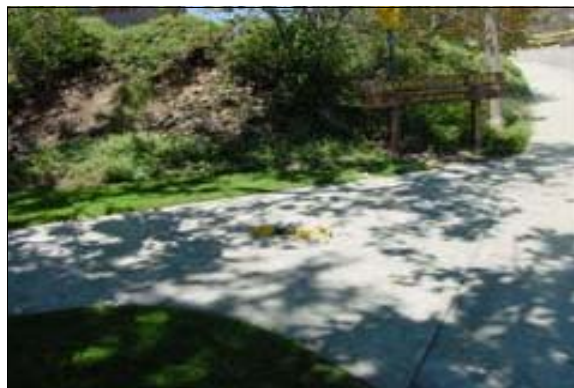
**Accessible Route from the Public Right of Way**

**Finding:** There is no accessible route from the public right of way to the accessible entrance of the facility. There are slopes greater than 5% along the path of travel.

Citations: CBC 1114B.1.2; CBC 1117B.5.7; CBC 1127B.3; ADAAG 4.1.2(7); ADAAG 4.3.2; ADAAG 4.14.1

**Alternative** Post directional signage.

**Full Rec:** Provide at least one accessible route from the public right of way to the accessible entrance of the facility. Make certain to post signage indicating the direction to accessible building entrances at every major junction along the accessible route. Signs shall include the International Symbol of Accessibility.

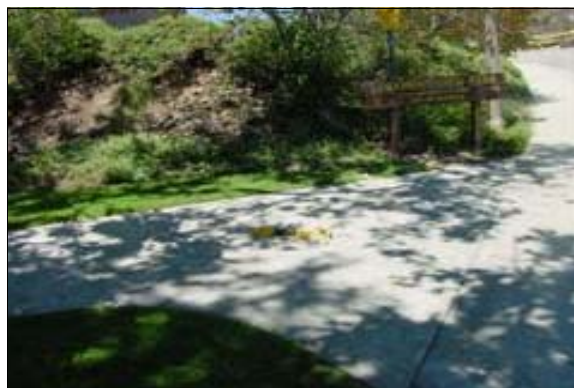
**Accessible Route from the Public Right of Way**

**Finding:** There are slopes greater than 5% on the primary path of travel to the park.

Citations: CBC 1133B.7.1.3; CBC 1133B.7.3; ADAAG 4.3.7

**Full Rec:** Resurface the path of travel to provide a level surface that does not exceed a slope greater than 5%. Cross slopes shall not exceed 2%.

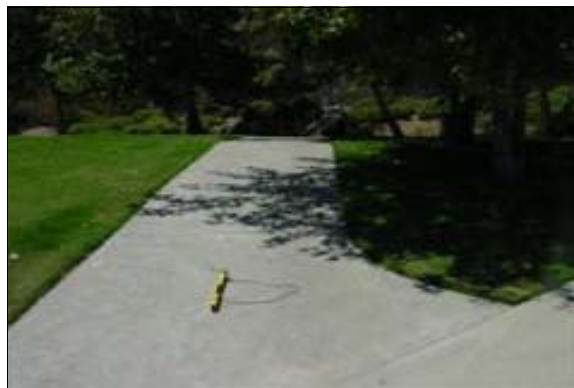
***Path of Travel to the Tennis Courts***

**Finding:** There are slopes greater than 5% on the primary path of travel from the public right of way to the tennis courts.

Citations: CBC 1133B.7.1.3; CBC 1133B.7.3; ADAAG 4.3.7

**Full Rec:** Resurface the path of travel to provide a level surface that does not exceed a slope greater than 5%. Cross slopes shall not exceed 2%.

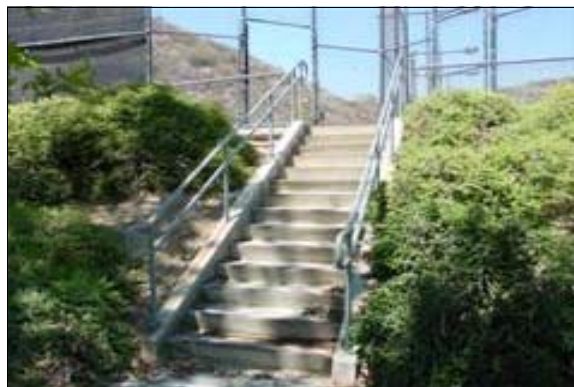
***Exterior Stairs to the Tennis Courts***

**Finding:** There is no detectable striping on each tread of the exterior stairway.

Citations: CBC 1006.16.1; CBC 11133B.4.4; ADAAG 4.9.5

**Full Rec:** Affix detectable contrasting striping to each tread of the stairway that clearly contrasts in color from the tread and is at least 2 inches in width placed no more than 1 inch from the tread nose or landing.

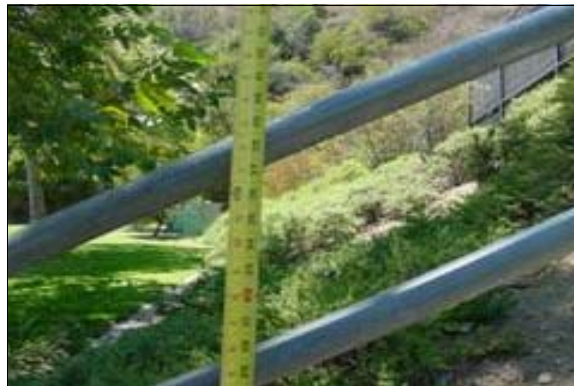
#### ***Exterior Stairs to the Tennis Courts***

**Finding:** The handrails are mounted at a height greater than 38 inches above the nosing of the treads.

Citations: CBC 1006.9.2.1; ADAAG 4.9.4(5)

**Full Rec:** Remount the handrails on the stairway so that the gripping surface of the handrails are at a consistent height between 34 inches and 38 inches above the stair nosings.

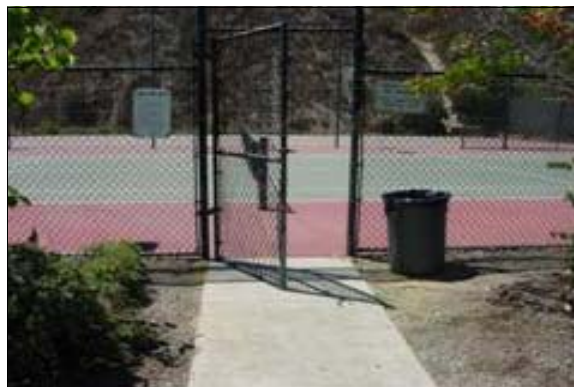
#### ***Exterior Gate to the Tennis Courts***

**Finding:** There is less than 24 inches of clearance on the latch side of the exterior entrance gate from the public right of way to the tennis courts.

Citations: ADAAG 4.13.6

**Full Rec:** Consult a design professional to determine if it is technically feasible to provide at least 24 inches of latch side clearance at the entrance gate (see ADAAG 4.13.6 and Figure 25). Otherwise, install an automatic door opening device to the primary entrance complying with ADAAG 4.13.12 and ANSI/BHMA A156.10, 1985, standards.

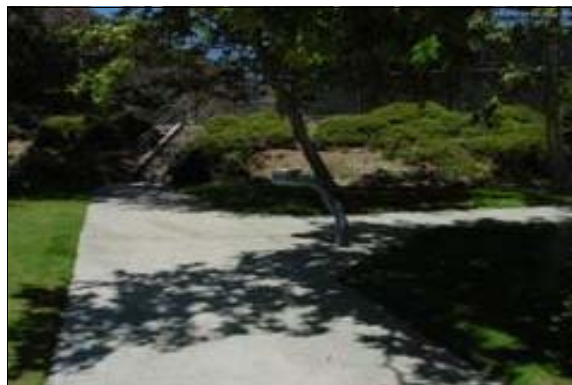
**Finding:** There is one drinking fountain on primary paths of travel.

Citations: CBC 1117B.1; ADAAG 4.15

**Full Rec:** Fifty percent of the drinking fountains on primary paths of travel shall be accessible (see CBC 1117B.1 and ADAAG 4.15). Install a "high-low" fountain design to comply with both state and federal requirement. Fountains not located in alcoves need side rails or wing walls on both sides.

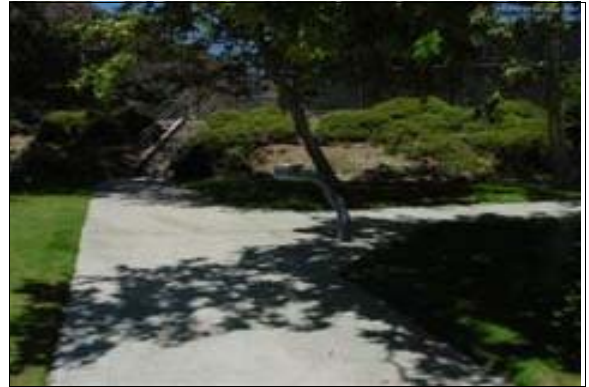
***Drinking Fountain Next to the Tennis Courts***

**Finding:** The drinking fountain is not a "high-low" design.

Citations: CBC 1117B.1; ADAAG 4.15

**Full Rec:** Fifty percent of the drinking fountains on primary paths of travel shall be accessible (see CBC 1117B.1 and ADAAG 4.15). Install a "high-low" fountain design to comply with both state and federal requirements and install a side rail or wing wall next to each side of the fountain.
