Photo Report
Palmer Park
Programs, Services, and Activities

Finding: Palmer Park, located at 610 East Palmer in Glendale California, was inspected by Disability Access Consultants, Inc., on June 12, 2007.

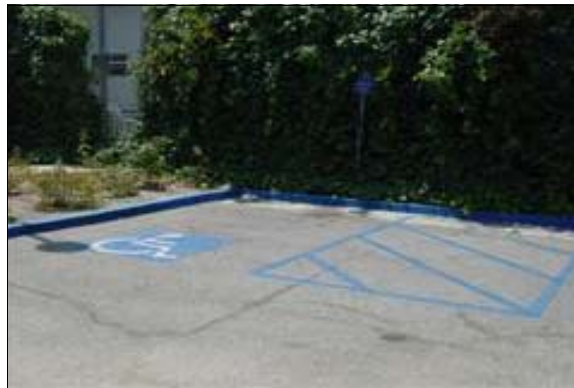
Finding: There are two accessible parking spaces out of 33 parking spaces which is sufficient in number as required for compliance. The designated "van-accessible" parking space provided in the parking lot measures 109 inches wide and 180 inches long. The van-accessible parking space provides an access aisle, located on the passenger side (right side) of the parking space measuring 98 inches wide. The standard accessible parking space measures 112 inches wide and 179 inches long. The standard accessible parking space provides an adjacent access aisle measuring 92 inches wide. The access aisles do not contain "NO PARKING" in 12" high white letters.

Full Rec: Two out of the 33 total number of marked parking spaces meets the number required to be designated exclusively for accessible parking according to ADAAG and CBC 1129B. Restripe the designated accessible parking spaces to create one van-accessible and one standard accessible parking space, each measuring at least 108 inches wide and 216 inches long with an access aisle measuring at least 96 inches wide (8 feet) shared between the two accessible parking spaces (see CBC 1129B). The accessible parking space with the access aisle to the right of the space shall be designated "van-accessible." Add the words NO PARKING in 12 inch high white letters at the entrance to each accessible parking access aisle.

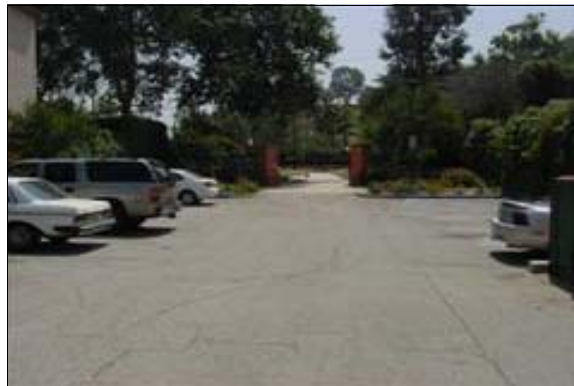
Finding: There is no crosswalk provided on the path of travel from the accessible parking spaces to the facility. The required accessible route crosses a vehicular way.

Full Rec: Stripe a crosswalk not less than 48 inches wide on the path of travel to the accessible entrance. Provide a level surface that does not exceed a slope greater than 5%. Cross slopes shall not exceed 2%. Detectable warnings should be placed at the entrance and exit of the crosswalk.

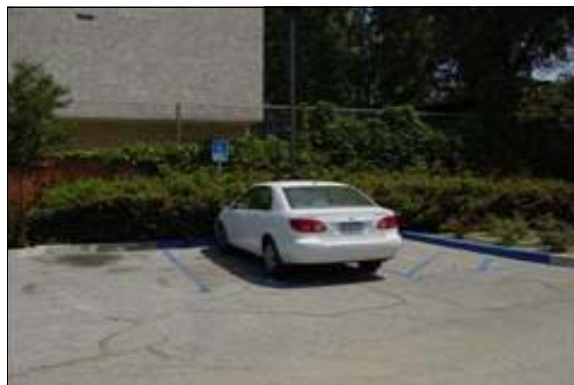
Finding: The bottom edge of the post-mounted signage designating the accessible parking spaces is less than 80 inches above the level of the parking space and cannot be viewed when a vehicle is parked in the space.

Full Rec: Modify the height or replace the post-mounted signage designating the accessible parking spaces to provide at least 80 inches from the parking space finished grade to the bottom edge of the sign. The sign shall be located so that it cannot be obscured by a vehicle parked in the space (see CBC 1129B.5).

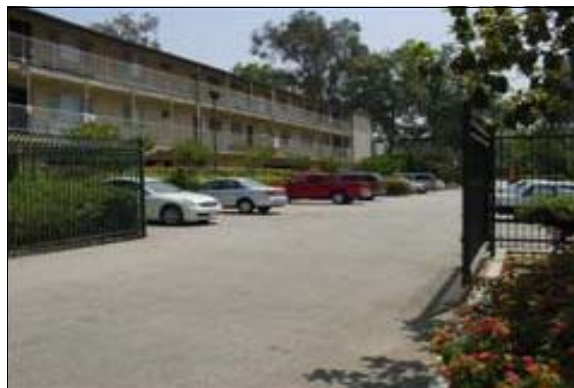
Finding: There is no warning signage posted at the entrance to the parking lot regarding unauthorized use of accessible parking spaces in the parking lot.

Full Rec: Post a sign in a conspicuous place to the entrance of the parking lot, or immediately adjacent to and visible from each accessible parking space. The warning sign shall measure at least 17 inches by 22 inches in size and consist of lettering at least 1 inch in height that clearly and conspicuously states the following; "Unauthorized vehicles parked in designated accessible spaces not displaying distinguishing placards or license plates issued for persons with disabilities may be towed away at owner's expense. Towed vehicles may be reclaimed at ____ or by telephoning ____ ." Fill in the blank spaces with appropriate information as a permanent part of the sign and maintain the currency of the information (see CBC 1129B.5). Be sure to add the CVC 22511.8(a)(d) to the sign.

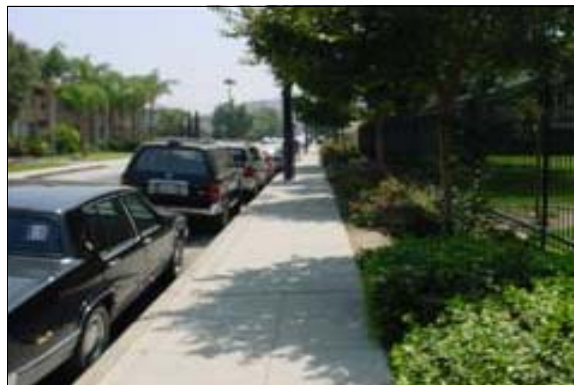
Accessible Route from the Public Right of Way

Finding: There is an accessible route from the public right of way to the accessible entrance of the facility.

Full Rec: Post directional signage. Make certain to post signage indicating the direction to accessible building entrances at every major junction along the accessible route. Signs shall include the International Symbol of Accessibility.

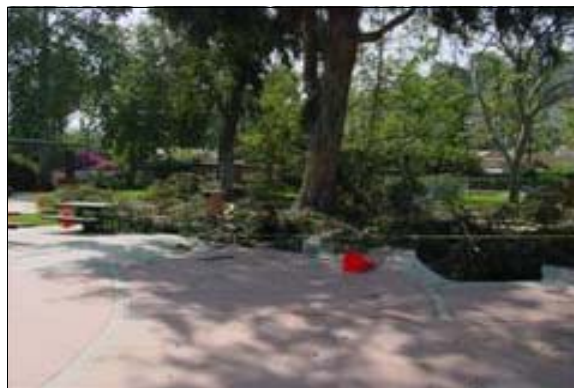
Construction

Finding: At the time of facility inspection, the facility was undergoing renovation/construction and was unavailable for a complete ADA compliance inspection.

Full Rec: All new construction or renovation shall comply with CBC 1101B.1 and ADAAG 4.1.2, ADAAG 4.1.3 and ADAAG 4.1.6. Due to the unavailability of a specific element at the time of the facility inspection process, it is recommended that upon completion of the construction/renovation all elements should be inspected for ADA compliance.

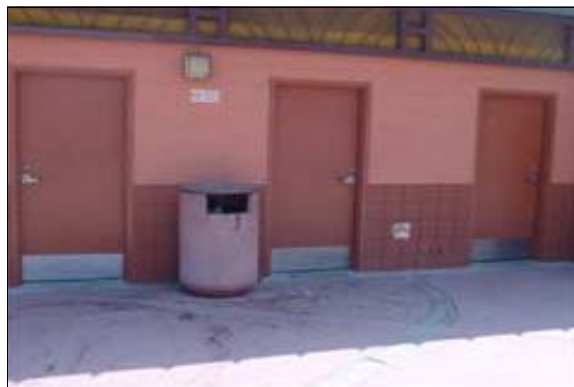
Maintenance Building

Finding: At the time of facility inspection, the facility was locked and was unavailable for a complete ADA compliance inspection.

Full Rec: Due to the unavailability of a specific element at the time of the facility inspection process, it is recommended that upon availability all elements should be inspected for ADA compliance.

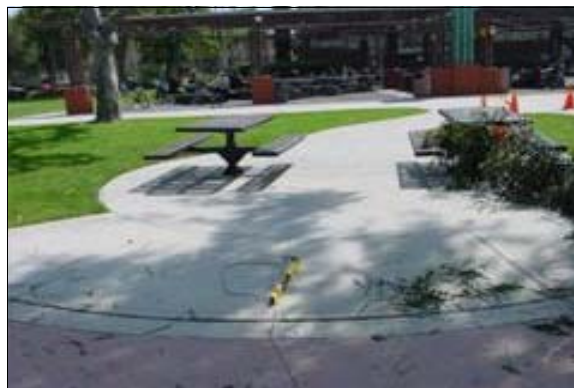
Path of Travel to the Outdoor Dining Area

Finding: There are slopes greater than 5% on the primary path of travel from the play equipment to the outdoor dining area.

Full Rec: Resurface the path of travel to provide a level surface that does not exceed a slope greater than 5%. Cross slopes shall not exceed 2%.

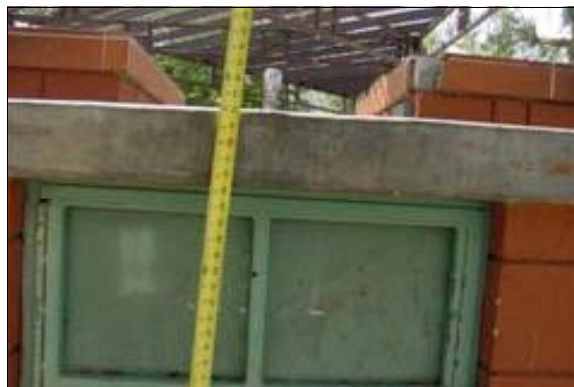
Sink at the Outdoor Dining Area

Finding: The sink at the outdoor dining area does not provide an accessible forward approach.

Full Rec: Sinks must provide clear floor space in front of the sink for an accessible forward approach and shall provide at least 27 inches clear knee space and a minimum of nine inches clear toe space (see ADAAG 4.19.2). If neither clear floor space and knee and toe clearance can be provided, remove the sink and replace with an accessible wall-mounted sink unit.

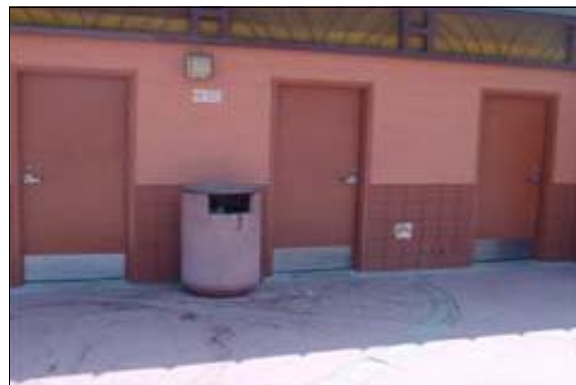
Maintenance Building

Finding: The main entrance does not have accessible signage mounted on the wall adjacent to the latch side of the door.

Full Rec: Install signage centered at 60 inches above the finished floor on the wall adjacent to the latch side of the entry doorway stating ENTRANCE from the outside and EXIT from the inside, with raised UPPERCASE letters between 5/8 inch and 2 inches in height and Grade 2 Braille characters. The sign shall comply with the finish and contrast requirements set forth in CBC 1117B.5 and ADAAG 4.30.5. Signage should be located where a person may approach within three inches of the sign without encountering protruding objects or standing within the swing of the door.

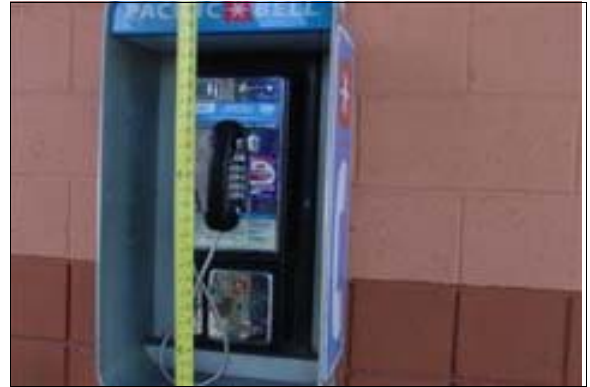
Pay Telephone

Finding: There is one pay telephone at the facility, located next to the restrooms.

Full Rec: Contact the telephone company that owns the pay telephone regarding following items that do not comply with ADA requirements. The telephone company is responsible for ADA compliance, if the facility has no ownership in the pay telephone.

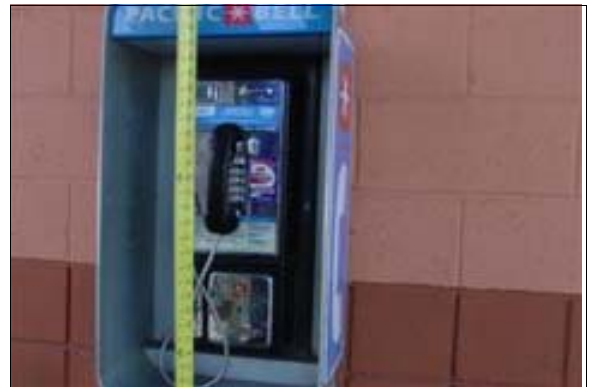
Pay Telephone Next to the Restrooms

Finding: The highest operable part of the pay telephone exceeds the side reach range of 54 inches. There is no electrical outlet within or adjacent to the telephone enclosure.

Full Rec: Contact the telephone company that owns the pay telephone regarding the height of all the operating devices on the telephone. Electrical outlets within or adjacent to the telephone enclosure are required at pay telephones designed to accommodate a portable text telephone.

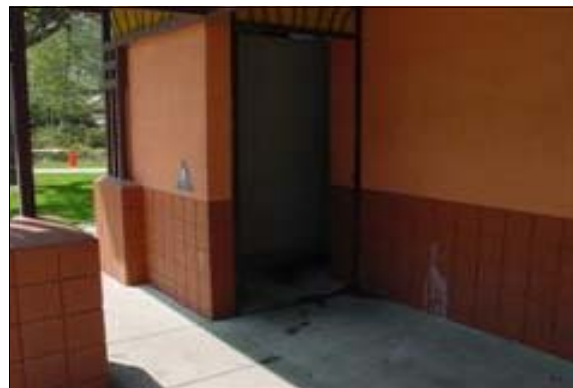
Men's Restroom

Finding: There is no signage indicating accessibility on the latch side of the entry door of the restroom. There is no Title 24 gender use signage on the entrance door.

Full Rec: The restroom is designated accessible and should be made accessible for the facility. Post signage centered 60 inches above the ground surface on the latch side of the entrance door identifying the restroom as accessible upon completion of the following items (see CBC 1115B., ADAAG 4.1.2(7) and ADAAG 4.1.6(3)(e). Signage shall include Braille and raised lettering, the gender or unisex use symbol and the ISA symbol. Post Title 24 gender use signage on the door @ 60" o.c. a.f.f.

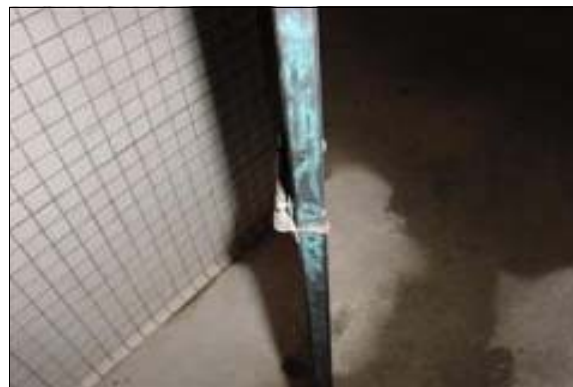
Men's Restroom

Finding: The door to the stall designated to be accessible in the restroom does not close automatically or have accessible hardware.

Full Rec: Provide an automatic door closer, spring hinge, pull bar or accessible handle mounted on the inside of the stall door to the stall designated to be accessible in the restroom (see ADAAG A4.17.5). Accessible hardware on the inside and outside of the stall designated to be accessible door shall be equipped with a loop or U-shaped handle mounted immediately below the latch. The latch shall be flip-over style, sliding or other hardware not requiring grasping or twisting. Make certain that the inside and outside door hardware is mounted no more than 48 inches above the finished floor (see CBC 115B.7.1.3 and ADAAG 4.13.9).

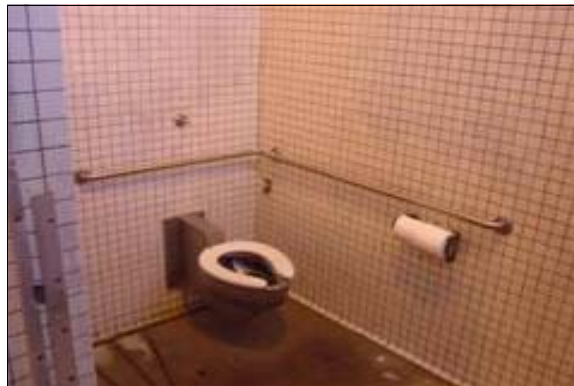
Men's Restroom

Finding: The height of the side grab bar in the stall designated to be accessible of the restroom is greater than 33 inches above the finished floor.

Full Rec: Remount the side grab bar in the stall designated to be accessible in the restroom so that the height of the gripping surface is centered at 33 inches above finished floor. Grab bars must be able to support a point load of at least 250 pounds and shall be less than the allowable shear stress of the grab bar material.

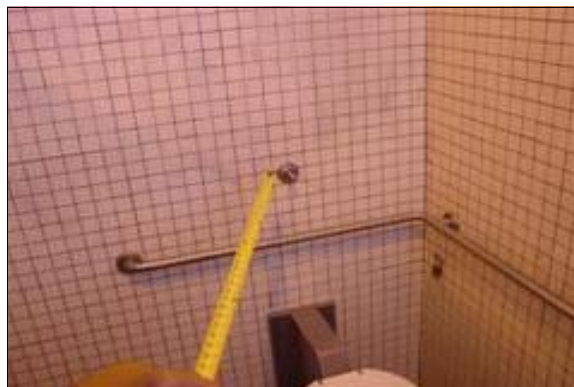
Men's Restroom

Finding: The flush control on the toilet in the stall designated to be accessible in the restroom is not on the wide (approach) side of the toilet.

Full Rec: Relocate the flush control on the toilet in the stall designated to be accessible in the restroom so that it is on the wide (approach) side of the toilet area (see ADAAG 4.16.5). Flush controls shall be hand-operated or automatic mechanisms.

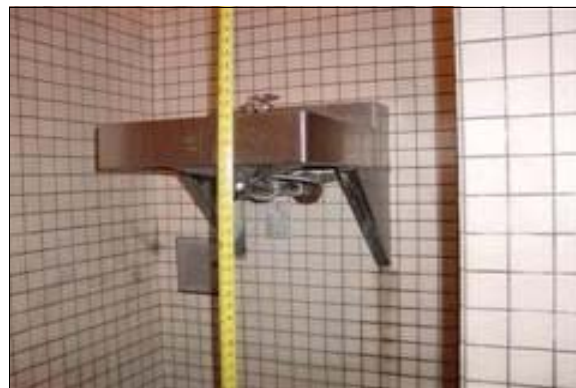
Men's Restroom

Finding: The faucet controls on the lavatory in the restroom require tight grasping, pinching, or twisting of the wrist and are not accessible.

Full Rec: Install faucet controls complying with ADAAG 4.19.5 on the lavatory designated to be accessible in the restroom. Lever-operated, push-type, touch-type or electronically controlled mechanisms are acceptable elements (see ADAAG 4.19.5). If self-closing valves are used the faucet shall remain open for at least 10 seconds.

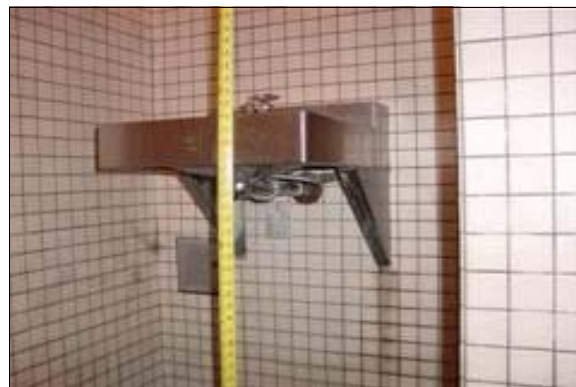
Men's Restroom

Finding: The height of the rim surface of the lavatory designated to be accessible in the restroom is greater than 34 inches above the finished floor.

Full Rec: Relocate or replace the lavatory designated to be accessible in the restroom to provide a maximum rim surface height of no greater than 34 inches above the finished floor (see ADAAG 4.19.2).

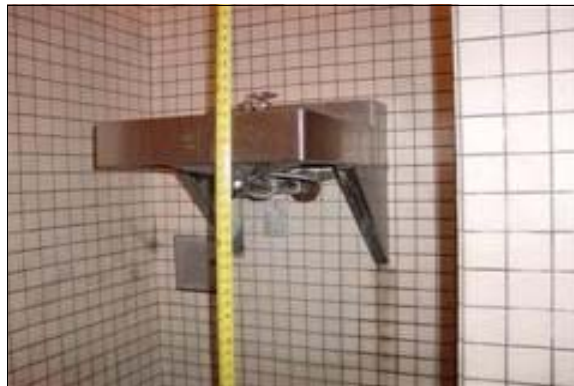
Men's Restroom

Finding: The pipes under the lavatory in the restroom do not provide protection against contact.

Full Rec: Insulate or otherwise configure pipes under the lavatory designated to be accessible in the restroom to protect against contact (see ADAAG 4.19.4). Make certain there are no sharp or abrasive surfaces under the lavatory.

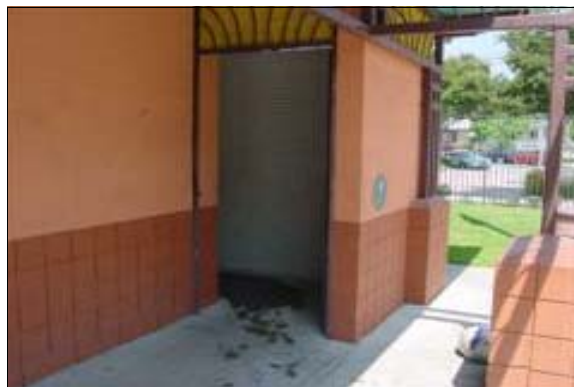
Women's Restroom

Finding: There is no signage indicating accessibility on the latch side of the entry door of the restroom. There is no Title 24 gender use signage on the entrance door.

Full Rec: The restroom is designated accessible and should be made accessible for the facility. Post signage centered 60 inches above the ground surface on the latch side of the entrance door identifying the restroom as accessible upon completion of the following items (see CBC 1115B., ADAAG 4.1.2(7) and ADAAG 4.1.6(3)(e). Signage shall include Braille and raised lettering, the gender or unisex use symbol and the ISA symbol. Post Title 24 gender use signage on the door @ 60" o.c. a.f.f.

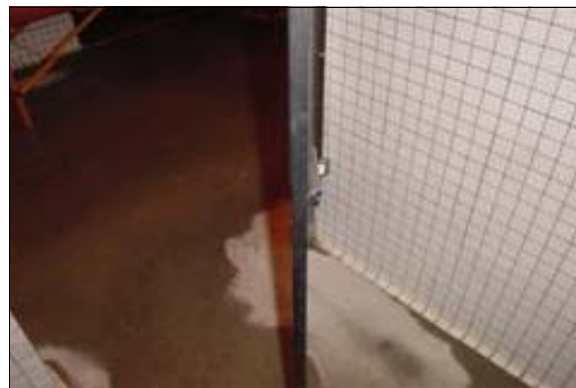
Women's Restroom

Finding: The door to the stall designated to be accessible in the restroom does not close automatically or have accessible hardware.

Full Rec: Provide an automatic door closer, spring hinge, pull bar or accessible handle mounted on the inside of the stall door to the stall designated to be accessible in the restroom (see ADAAG A4.17.5). Accessible hardware on the inside and outside of the stall designated to be accessible door shall be equipped with a loop or U-shaped handle mounted immediately below the latch. The latch shall be flip-over style, sliding or other hardware not requiring grasping or twisting. Make certain that the inside and outside door hardware is mounted no more than 48 inches above the finished floor (see CBC 115B.7.1.3 and ADAAG 4.13.9).

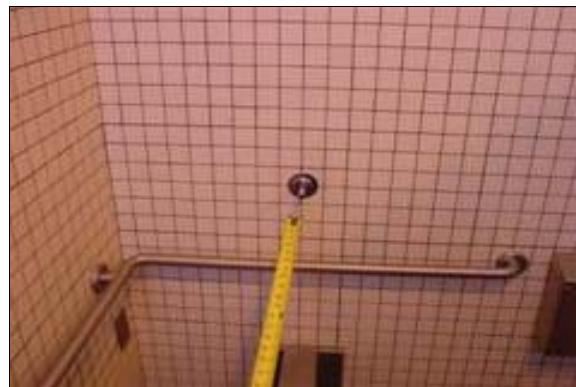
Women's Restroom

Finding: The flush control on the toilet in the stall designated to be accessible in the restroom is not on the wide (approach) side of the toilet.

Full Rec: Relocate the flush control on the toilet in the stall designated to be accessible in the restroom so that it is on the wide (approach) side of the toilet area (see ADAAG 4.16.5). Flush controls shall be hand-operated or automatic mechanisms.

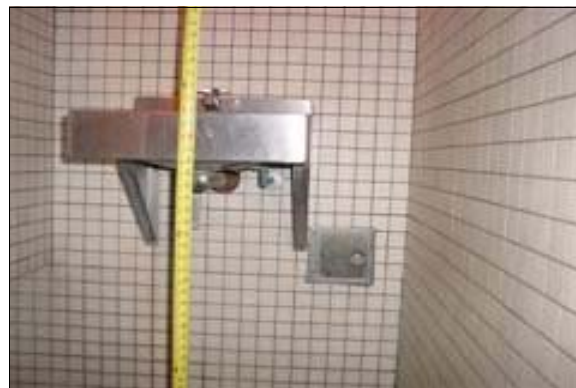
Women's Restroom

Finding: The faucet controls on the lavatory in the restroom require tight grasping, pinching, or twisting of the wrist and are not accessible.

Full Rec: Install faucet controls complying with ADAAG 4.19.5 on the lavatory designated to be accessible in the restroom. Lever-operated, push-type, touch-type or electronically controlled mechanisms are acceptable elements (see ADAAG 4.19.5). If self-closing valves are used the faucet shall remain open for at least 10 seconds.

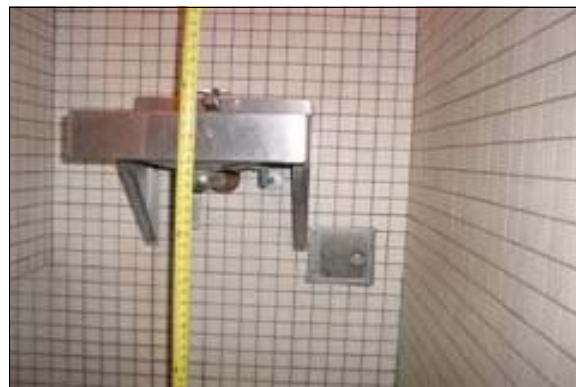
Women's Restroom

Finding: The pipes under the lavatory in the restroom do not provide protection against contact.

Full Rec: Insulate or otherwise configure pipes under the lavatory designated to be accessible in the restroom to protect against contact (see ADAAG 4.19.4). Make certain there are no sharp or abrasive surfaces under the lavatory.

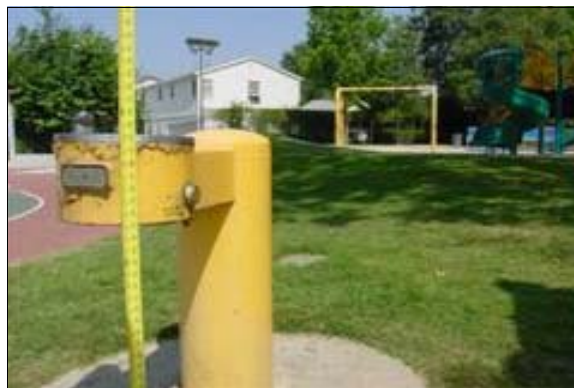
Finding: There are three drinking fountains on primary paths of travel.

Full Rec: Fifty percent of the drinking fountains on primary paths of travel shall be accessible (see CBC 1117B.1 and ADAAG 4.15). Install a "high-low" fountain design to comply with both state and federal requirement. Fountains not located in alcoves need side rails or wing walls on both sides.

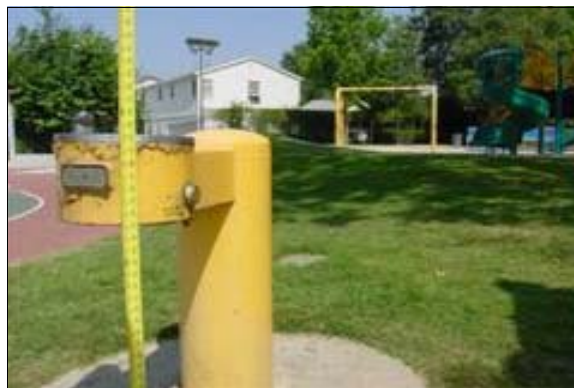
Drinking Fountain Next to the Basketball Courts

Finding: The drinking fountain is not a "high-low" design.

Full Rec: Fifty percent of the drinking fountains on primary paths of travel shall be accessible (see CBC 1117B.1 and ADAAG 4.15). Install a "high-low" fountain design to comply with both state and federal requirements and install a side rail or wing wall next to each side of the fountain.

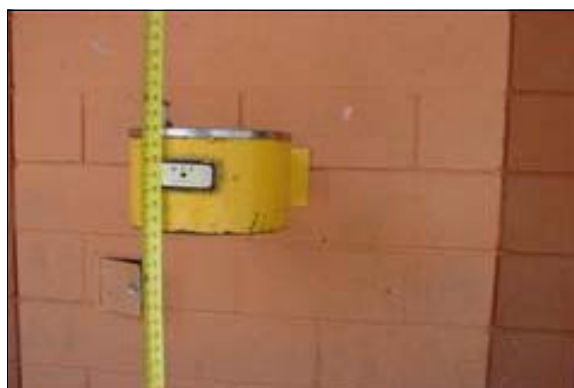
Drinking Fountain Outside of the Restrooms

Finding: The drinking fountain is not a "high-low" design.

Full Rec: Fifty percent of the drinking fountains on primary paths of travel shall be accessible (see CBC 1117B.1 and ADAAG 4.15). Install a "high-low" fountain design to comply with both state and federal requirements and install a side rail or wing wall next to each side of the fountain.

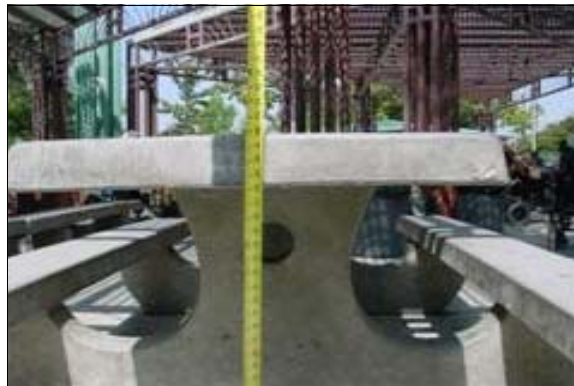
Outdoor Dining Area

Finding: The knee space at the tables in the outdoor dining area is less than 19 inches deep.

Full Rec: Modify or replace one of the tables in the outdoor dining area to provide knee clearance of at least 27 inches in height, 30 inches in width and 19 inches in depth (see CBC 1122B.3, ADAAG 4.32.2 and ADAAG Figure 45). The table top height shall not exceed 34 inches above the finished floor.

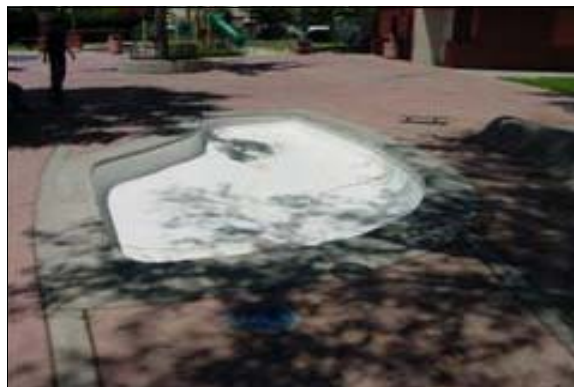
Wading Pool

Finding: The wading pool is not accessible by a hydraulic chair, ramp, transfer tier, or other means. During the period when the pool does not contain water they may become a tripping hazard.

Full Rec: Install a hydraulic chair, ramp, transfer tier or other means of access to the pool (see the Final Report, July, 1997, Architectural and Transportation Barriers Compliance Board).
