**Photo Report**  
**Pelanconi Park**  
**Programs, Services, and Activities**

**Finding:** Pelanconi Park, located at 1000 Grandview Avenue in Glendale California, was inspected by Disability Access Consultants, Inc., on June 8, 2007.

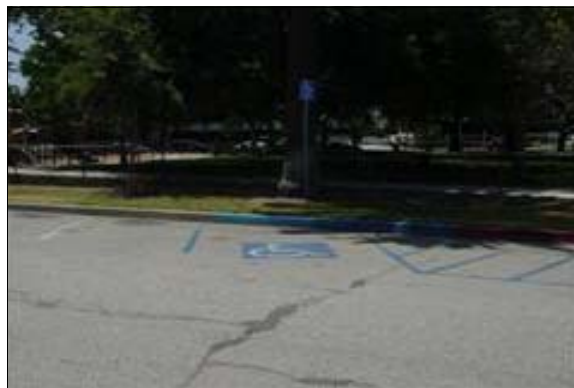
#### ***Parking on Cleveland***

**Finding:** There is one accessible parking space out of ## parking spaces which does not meet the minimum number of accessible parking spaces for compliance. The accessible parking space measures 108 inches wide and 175 inches long. The access aisle, located on the passenger's side (right side) of the parking space, measures 96 inches wide. The access aisle does not contain "NO PARKING" in 12" high white letters.

**Full Rec:** Three out of the 52 total number of parking spaces are required to be designated exclusively for accessible parking, as required by ADAAG and CBC 1129B. Restripe the existing parking space marked accessible and create two additional accessible parking spaces, each measuring at least 108 inches wide and 216 inches long. Designate one parking space as "van-accessible". The van-accessible space shall provide an access aisle measuring at least 96 inches wide (8 feet) on the passenger side (right side) of the vehicle space (see CBC 1129B). The additional parking spaces shall each provide an access aisle measuring at least 60 inches wide, that may be shared. Add the words NO PARKING in 12 inch high white letters at the entrance to the accessible parking access aisle.

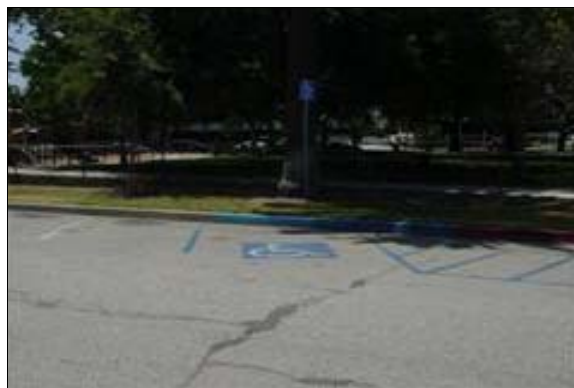
#### ***Parking on Cleveland***

**Finding:** The surface of the accessible parking space in the parking lot has a slope greater than 2%.

**Full Rec:** Pave the parking lot at the accessible spaces to provide a level surface. Parking surfaces and access aisles shall be located in areas not exceeding 2% slope in all directions (see CBC 1129B and ADAAG 4.6.3).

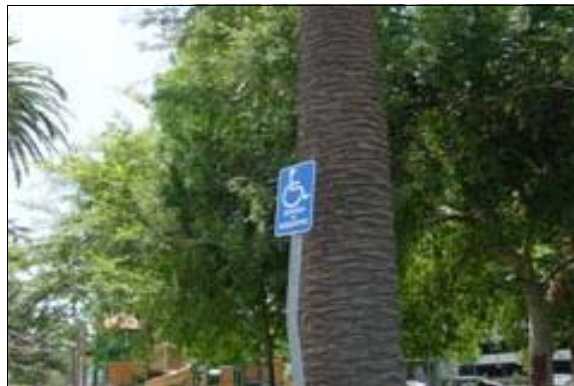
**Parking on Cleveland**

**Finding:** The vertically-mounted signage at the designated accessible parking space in the parking lot showing the International Symbol of Accessibility uses the word "handicapped". There is no additional signage marked "van-accessible" at the accessible parking space.

**Full Rec:** Install a permanently posted reflectorized sign measuring 70 square inches that includes an ISA symbol adjacent to and visible from the accessible parking space (see CBC 1129B.5). The bottom edge of the sign must be mounted 80 inches from the ground surface so that it cannot be obscured by a parked vehicle (see CBC 1129B.5). The "van-accessible" parking space shall provide an additional sign marked "van-accessible" mounted below the sign (see CBC 1129B.5 and ADAAG 4.6.4).

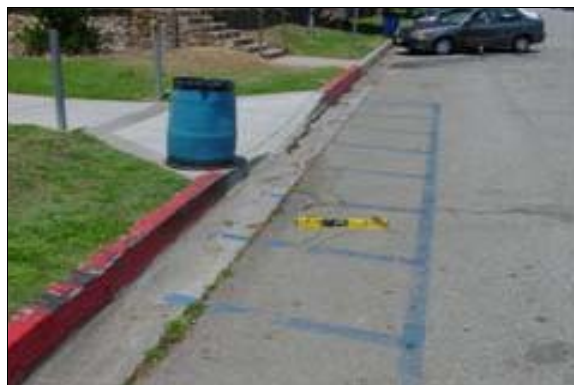
**Parking on Cleveland**

**Finding:** There is a crosswalk provided on the path of travel from the accessible parking space to the facility, however the cross slope of the crosswalk is greater than 2%. The crosswalk does not provide detectable warnings at the entrance and exit of the crosswalk.

**Full Rec:** Stripe a crosswalk not less than 48 inches wide on the path of travel to the accessible entrance. Provide a level surface that does not exceed a slope greater than 5%. Cross slopes shall not exceed 2%. Detectable warnings should be placed at the entrance and exit of the crosswalk.

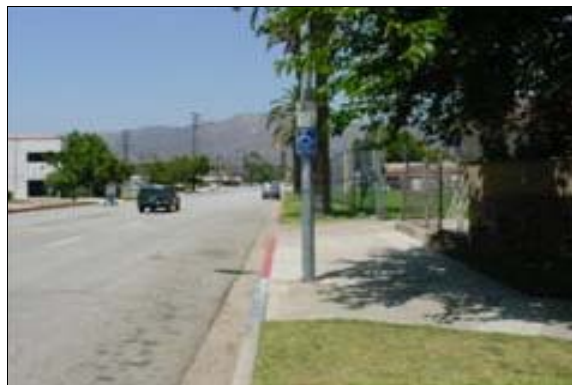
#### ***Parking on San Fernando***

**Finding:** There is one parallel parking space designated accessible on San Fernando. There is signage designating the parallel parking space as accessible.

**Full Rec:** Discontinue designating parallel parking spaces as accessible. Parallel parking spaces do not meet the requirements set forth by ADAAG regarding access aisle and encroachment of other vehicles or objects and requires individuals to travel behind vehicles other than their own in some situations. If no other off-street parking is available, make certain that the facility provides an accessible passenger loading zone located on the shortest route to the primary entrance.

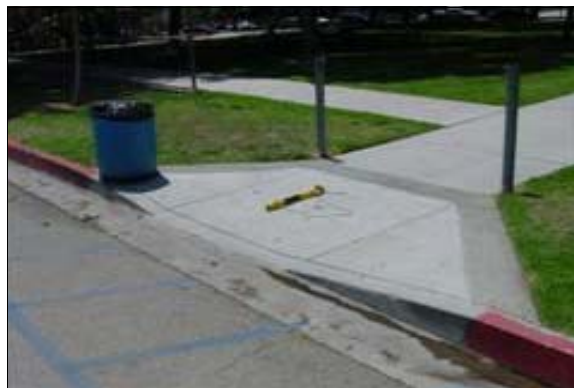
**Curb Ramp Next to the Accessible Parking Space**

**Finding:** The slope at the bottom landing is greater than 2%. The slope of the side flares is greater than 10%. The concrete curb ramp does not provide a detectable warning surface which includes truncated domes.

**Full Rec:** Replace the curb ramp with a compliant curb ramp at least 48 inches in width that provides a slope no greater than 8.33%. Install a detectable warning surface which extends the full length and width of the concrete curb ramp and its side flares with truncated domes that contrast visually by either light on dark or dark on light which is an integral part of the concrete curb ramp. The truncated domes may be cast in place or stamped or of a prefabricated surface treatment (see CBC 1127B.5.8).

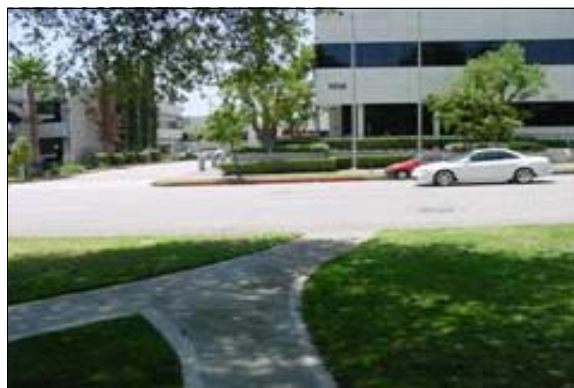
**Public Right of Way off of San Fernando**

**Finding:** The accessible route from the public right of way off of San Fernando to the park crosses a curb. There is no curb ramp provided.

**Full Rec:** Install a compliant curb ramp at least 48 inches in width that provides a slope no greater than 8.33%. Install a detectable warning surface which extends the full length and width of the concrete curb ramp and its side flares with truncated domes that contrast visually by either light on dark or dark on light which is an integral part of the concrete curb ramp. The truncated domes may be cast in place or stamped or of a prefabricated surface treatment (see CBC 1127B.5.8).

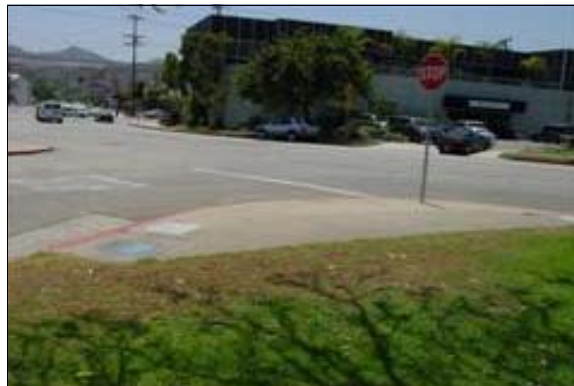
**Accessible Route from the Public Right of Way**

**Finding:** There is no accessible route from the public right of way to the accessible entrance of the facility. The accessible route crosses and adjoins vehicular traffic.

**Alternative** Post directional signage.

**Full Rec:** Provide at least one accessible route from the public right of way to the accessible entrance of the facility. Make certain to post signage indicating the direction to accessible building entrances at every major junction along the accessible route. Signs shall include the International Symbol of Accessibility.

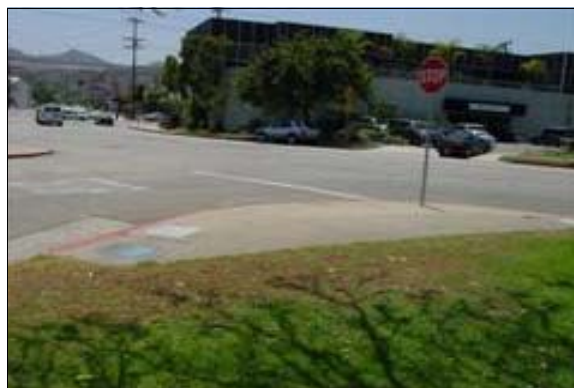
**Accessible Route from the Public Right of Way**

**Finding:** There is no crosswalk provided on the path of travel from the public right of way to the facility. The required accessible route crosses a vehicular way.

**Full Rec:** Stripe a crosswalk not less than 48 inches wide on the path of travel to the accessible entrance of the facility. Provide a level surface that does not exceed a slope greater than 5%. Cross slopes shall not exceed 2%. Detectable warnings should be placed at the entrance and exit of the crosswalk.

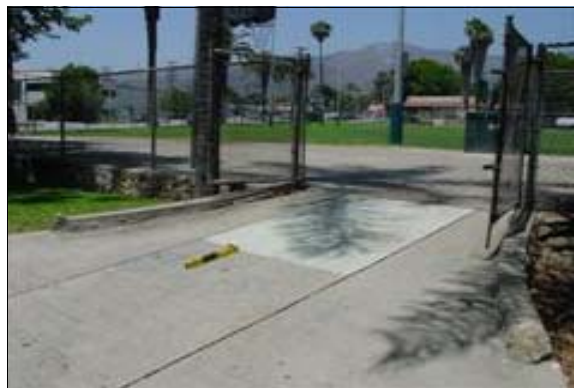
***Path of Travel to the Between the Restrooms and the Softball Field***

**Finding:** There are slopes greater than 5% on the primary path of travel between the restrooms and the softball field.

**Full Rec:** Resurface the path of travel to provide a level surface that does not exceed a slope greater than 5%. Cross slopes shall not exceed 2%.

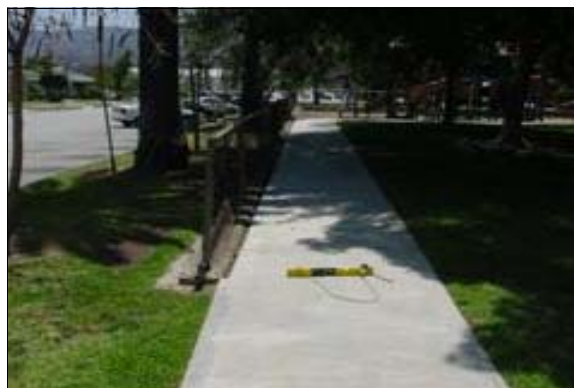
***Path of Travel to the Play Equipment***

**Finding:** There are cross slopes greater than 2% on the primary path of travel from the accessible parking to the play equipment.

**Full Rec:** Resurface the path of travel to provide a level surface that does not exceed a slope greater than 5%. Cross slopes shall not exceed 2%.

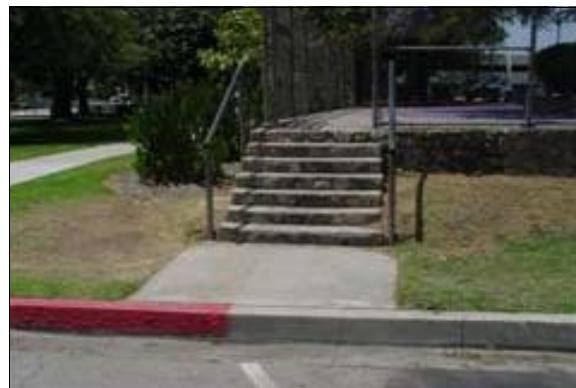
**Exterior Stairs off of Cleveland**

**Finding:** There is no detectable striping on each tread of the exterior stairway.

**Full Rec:** Affix detectable contrasting striping to each tread of the stairway that clearly contrasts in color from the tread and is at least 2 inches in width placed no more than 1 inch from the tread nose or landing.

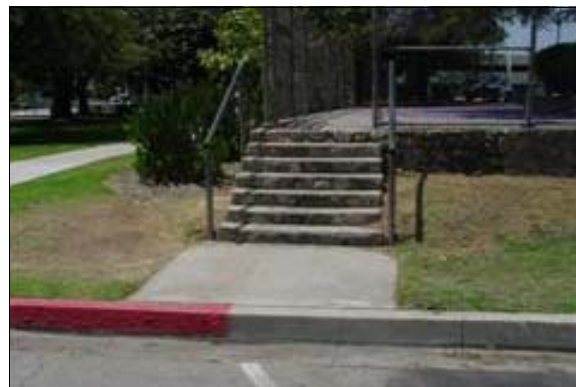
**Exterior Stairs off of Cleveland**

**Finding:** The handrails do not provide 12-inch extensions beyond the top and bottom treads.

**Full Rec:** Install handrails on each side of stairway that provide 12-inch top and bottom handrail extensions that extend beyond the top and bottom treads of the stairway which are parallel to the ground surface and return smoothly to the post or wall.

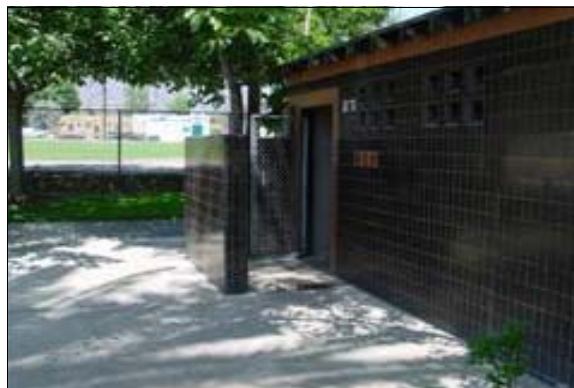
#### **Men's Restroom**

**Finding:** There is no signage indicating accessibility on the latch side of the entry door of the restroom. There is no Title 24 gender use signage on the entrance door.

**Full Rec:** The restroom is designated accessible and should be made accessible for the facility. Post signage centered 60 inches above the ground surface on the latch side of the entrance door identifying the restroom as accessible upon completion of the following items (see CBC 1115B., ADAAG 4.1.2(7) and ADAAG 4.1.6(3)(e). Signage shall include Braille and raised lettering, the gender or unisex use symbol and the ISA symbol. Post Title 24 gender use signage on the door @ 60" o.c. a.f.f.

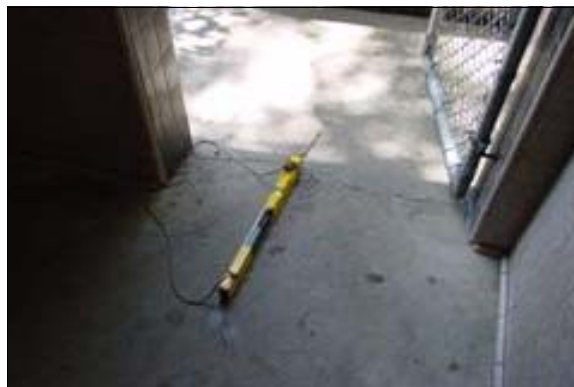
#### **Men's Restroom**

**Finding:** The landing at the entrance door does not provide sufficient clear floor space, due to the privacy wall. There is no level landing provided at the entrance door.

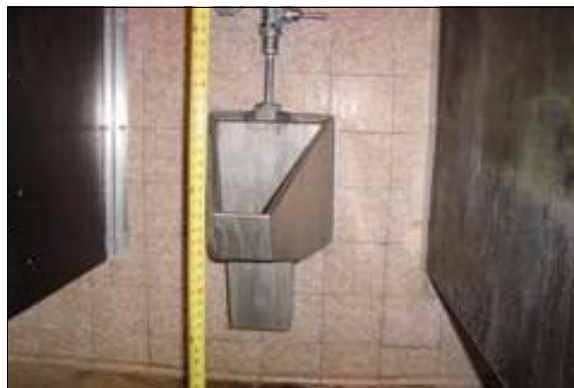
**Men's Restroom**

**Finding:** The height of the urinal rim in the restroom is greater than 17 inches above the finished floor.

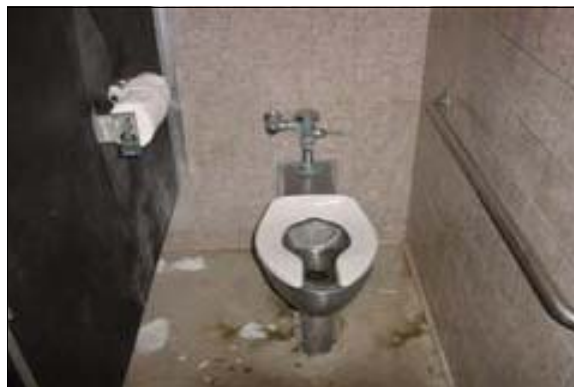
**Men's Restroom**

**Finding:** There is insufficient clear floor space in the stall designated to be accessible in the restroom. The door to the stall designated to be accessible in the restroom does not close automatically or have accessible hardware.

**Full Rec:** Modify or replace the stall designated to be accessible in the restroom so that it complies with ADAAG 4.17.3, CBC 1115B and CBC Figures 11B-1A and 1B. Standard accessible stalls require 60 inches in width with 56 inches depth for wall-mounted toilets or 59 inches depth for floor-mounted toilets to accommodate individuals in wheelchairs. The minimum width of a front-approach doorway shall provide at least 32 inches and a side-approach doorway shall provide at least 34 inches. The door shall swing outward, close automatically and provide accessible hardware.

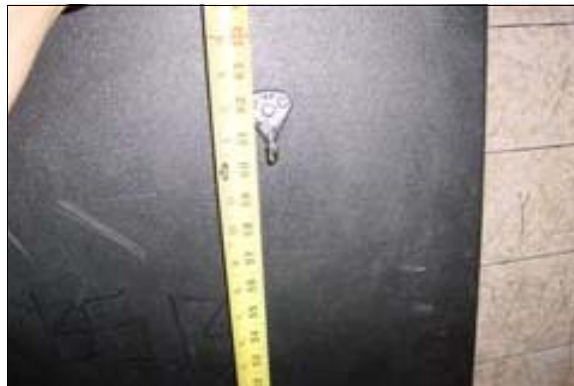
#### **Men's Restroom**

**Finding:** The height of the coat hook on the stall door designated to be accessible in the restroom is greater than 48 inches above the floor surface.

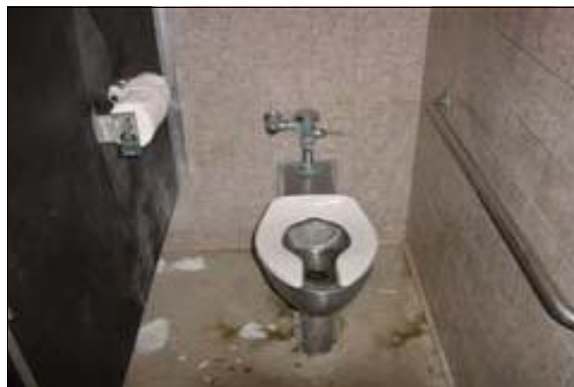
#### **Men's Restroom**

**Finding:** There is no back grab bar in the stall designated to be accessible in the restroom.

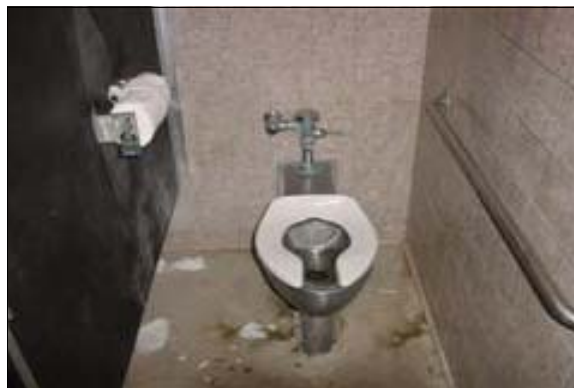
**Men's Restroom**

**Finding:** The flush control on the toilet in the stall designated to be accessible in the restroom is not on the wide (approach) side of the toilet.

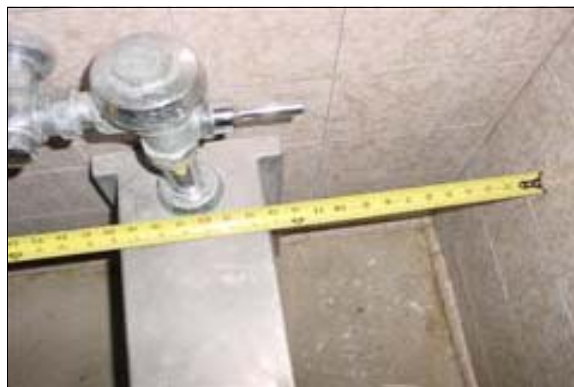
**Men's Restroom**

**Finding:** The distance from the center of the toilet to the nearest side wall in the stall designated to be accessible in the restroom is less than 18 inches.

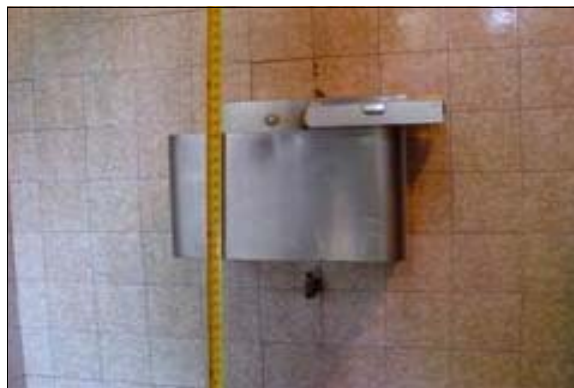
**Men's Restroom**

**Finding:** The knee clearance space under the lavatory designated to be accessible in the restroom is less than 29 inches. The knee depth space under the lavatory designated to be accessible in the restroom is less than 27 inches at 8 inches under the lavatory apron.

**Full Rec:** Replace the lavatory designated to be accessible in the restroom to provide at least 29 inches of clear knee space between the finished floor and bottom of the lavatory apron. Make sure to provide at least 27 inches at 8 inches under the apron (see ADAAG 4.19.2).

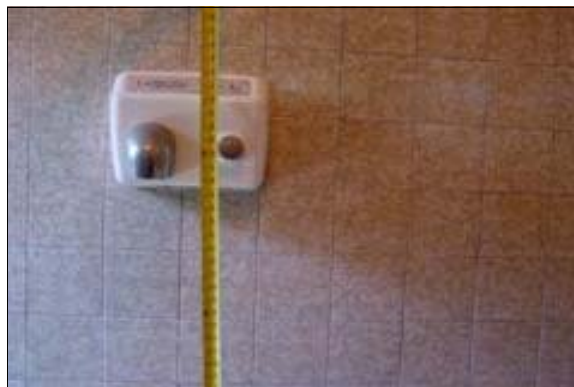
**Men's Restroom**

**Finding:** The height of the controls and operating mechanisms for the hand dryer in the restroom is greater than 40 inches.

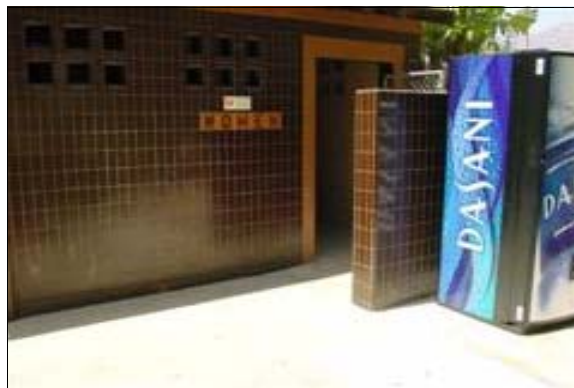
### Women's Restroom

**Finding:** There is no signage indicating accessibility on the latch side of the entry door of the restroom. There is no Title 24 gender use signage on the entrance door.

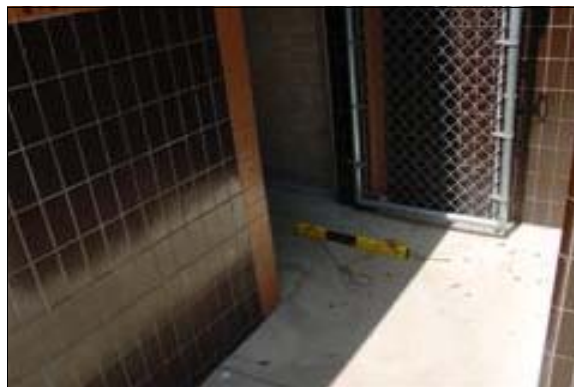
### Women's Restroom

**Finding:** The landing at the entrance door does not provide sufficient clear floor space.

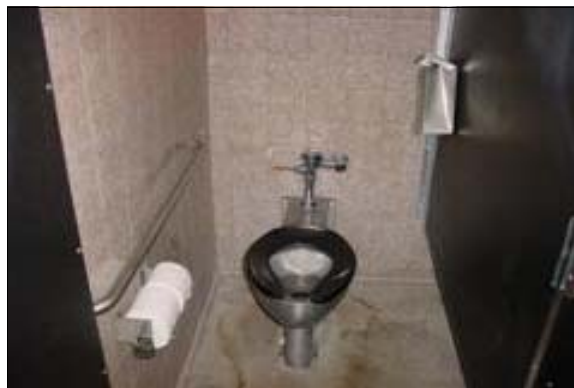
**Women's Restroom**

**Finding:** There is no back grab bar in the stall designated to be accessible in the restroom.

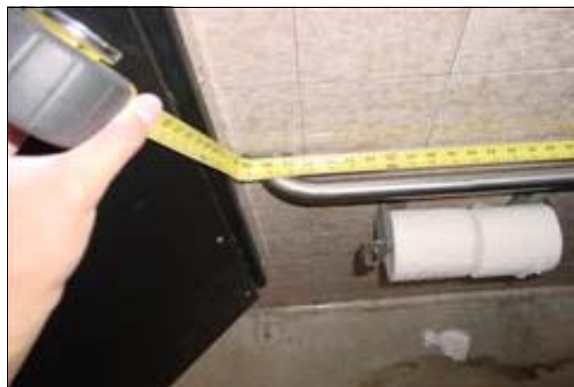
**Women's Restroom**

**Finding:** The side grab bar in the stall designated to be accessible in the restroom does not extend 54 inches from the back wall.

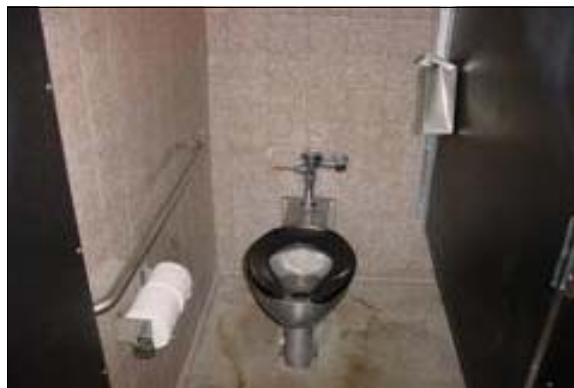
**Women's Restroom**

**Finding:** The flush control on the toilet in the stall designated to be accessible in the restroom is not on the wide (approach) side of the toilet.

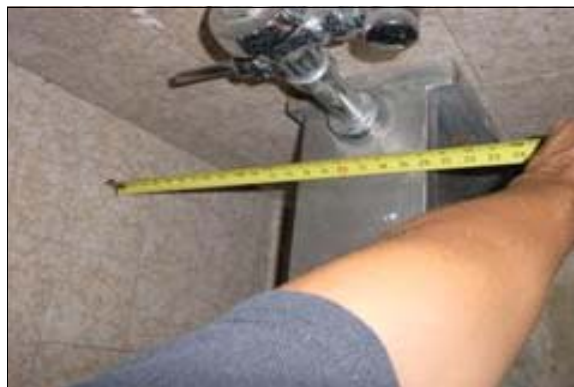
**Women's Restroom**

**Finding:** The distance from the center of the toilet to the nearest side wall in the stall designated to be accessible in the restroom is less than 18 inches.

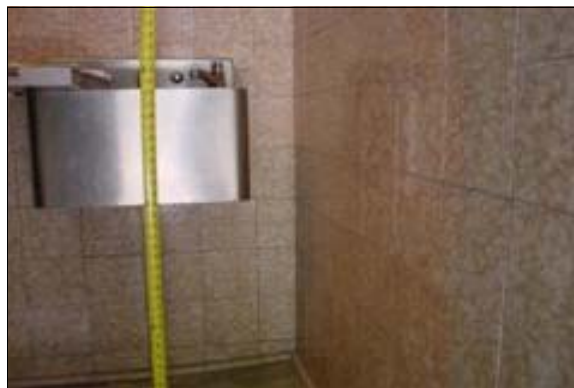
**Women's Restroom**

**Finding:** The knee clearance space under the lavatory designated to be accessible in the restroom is less than 29 inches. The knee depth space under the lavatory designated to be accessible in the restroom is less than 27 inches at 8 inches under the lavatory apron.

**Full Rec:** Replace the lavatory designated to be accessible in the restroom to provide at least 29 inches of clear knee space between the finished floor and bottom of the lavatory apron. Make sure to provide at least 27 inches at 8 inches under the apron (see ADAAG 4.19.2).

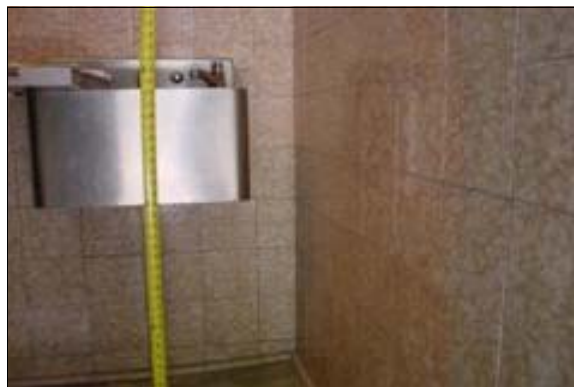
**Women's Restroom**

**Finding:** The height of the rim surface of the lavatory designated to be accessible in the restroom is greater than 34 inches above the finished floor.

**Full Rec:** Relocate or replace the lavatory designated to be accessible in the restroom to provide a maximum rim surface height of no greater than 34 inches above the finished floor (see ADAAG 4.19.2).

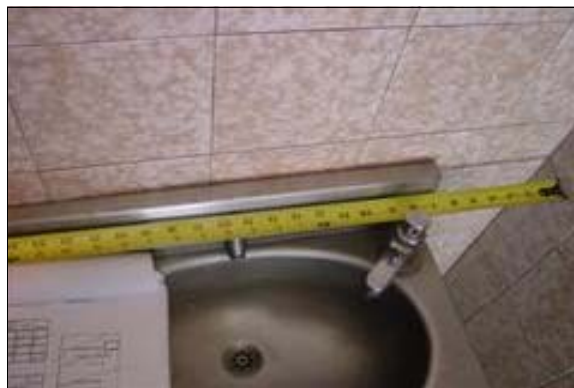
**Women's Restroom**

**Finding:** The distance from the center of the lavatory to the adjacent side wall in the restroom is less than 18 inches.

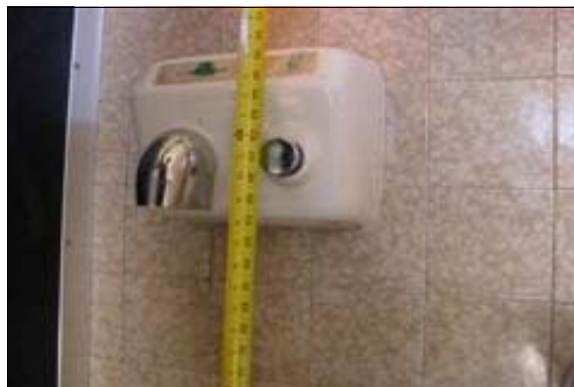
**Women's Restroom**

**Finding:** The height of the controls and operating mechanisms for the hand dryer in the restroom is greater than 40 inches.

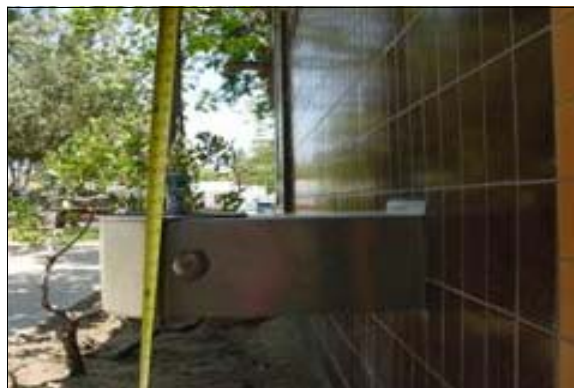
**Finding:** There are two drinking fountains on primary paths of travel.

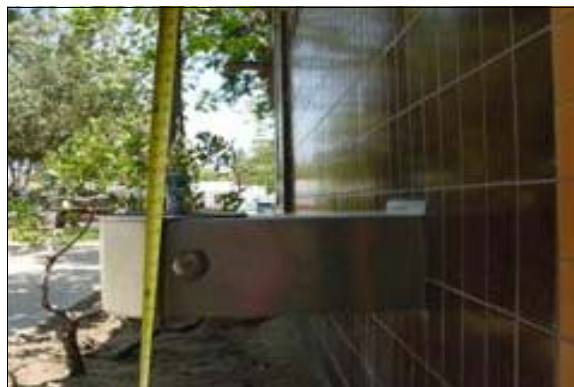
***Drinking Fountain at the Restrooms***

**Finding:** The drinking fountain is not a "high-low" design. There is less than 27 inches knee clearance height.

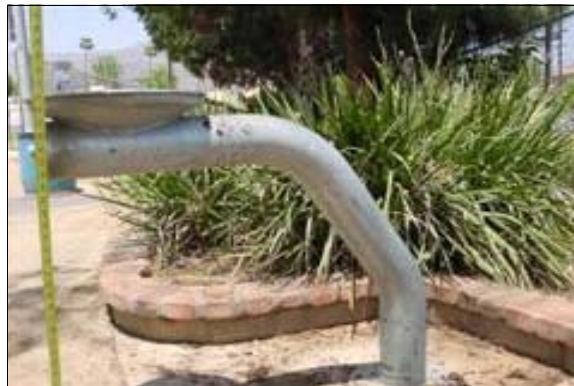
**Drinking Fountain at the Softball Field**

**Finding:** The drinking fountain is not a "high-low" design. The spout outlet height is greater than 36 inches.

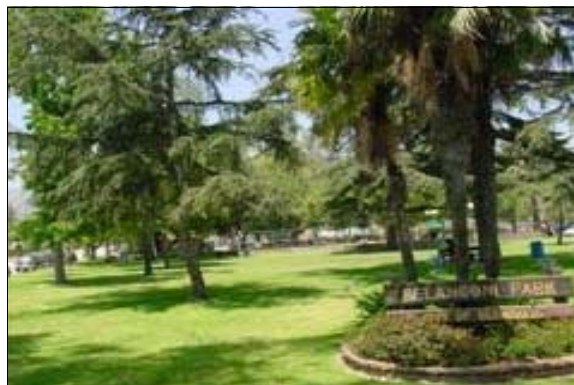
**Outdoor Dining Area at the South End of the Park**

**Finding:** There is no accessible route to the picnic tables in the outdoor dining area. The surface under and around the outdoor dining area picnic tables is grass, preventing access of individuals with mobility impairments.

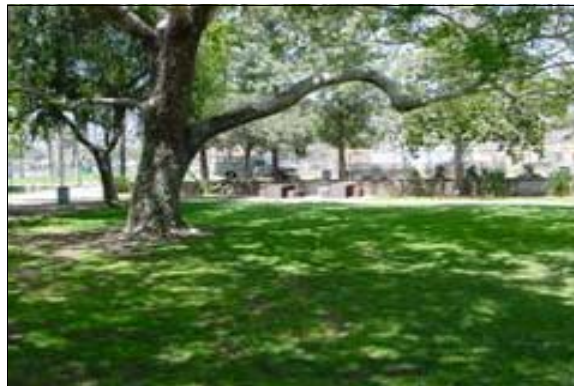
**Outdoor Dining Areas**

**Finding:** The knee space at the tables in the outdoor dining area is less than 19 inches deep.

**Full Rec:** Modify or replace one of the tables in the outdoor dining area to provide knee clearance of at least 27 inches in height, 30 inches in width and 19 inches in depth (see CBC 1122B.3, ADAAG 4.32.2 and ADAAG Figure 45). The table top height shall not exceed 34 inches above the finished floor.

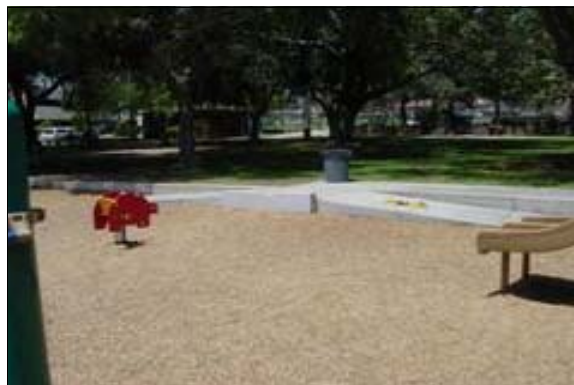
**Play Equipment**

**Finding:** There are slopes greater than 6.33% along the path of travel to the play equipment. The surface beneath the play area is wood chips, making the area nonaccessible to individuals with mobility impairments.

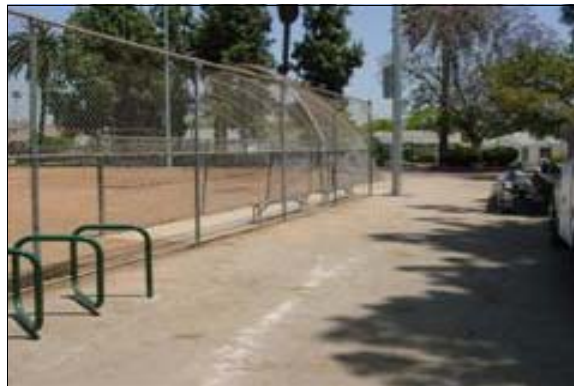
**Softball Field**

**Finding:** The grass and dirt surface of the softball field at the facility prevents access to individuals with mobility impairments.

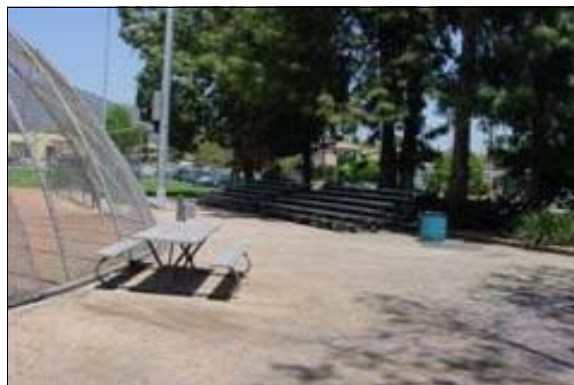
**Softball Field**

**Finding:** The surface under the bleachers is concrete. No wheelchair seating is provided next to the bleachers.
