Photo Report
Piedmont Park
Programs, Services, and Activities

Finding: Piedmont Park, located at 1145 Lexington Drive in Glendale California, was inspected by Disability Access Consultants, Inc., on August 13, 2007.

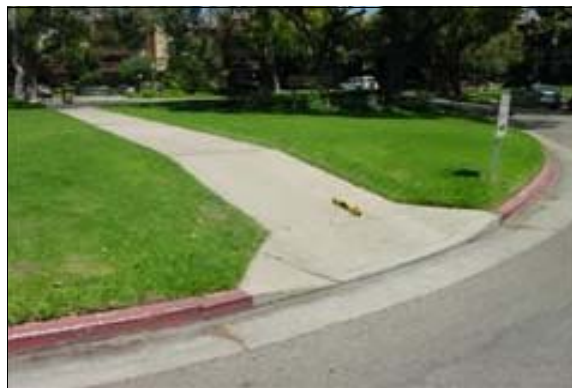
Curb Ramp (South)

Finding: The slope of the curb ramp is greater than 8.33%. The transition at the bottom landing is abrupt. The curb ramp does not provide a grooved border along the top and sides of the ramp at the level of the sidewalk. The concrete curb ramp does not provide a detectable warning surface which includes truncated domes.

Citations: CBC 1127B.5.3; ADAAG 4.7.2 & 4.29

Full Rec: Replace the curb ramp with a compliant curb ramp at least 48 inches in width that provides a slope no greater than 8.33%. Install a detectable warning surface which extends the full length and width of the concrete curb ramp and its side flares with truncated domes that contrast visually by either light on dark or dark on light which is an integral part of the concrete curb ramp. The truncated domes may be cast in place or stamped or of a prefabricated surface treatment (see CBC 1127B.5.8).

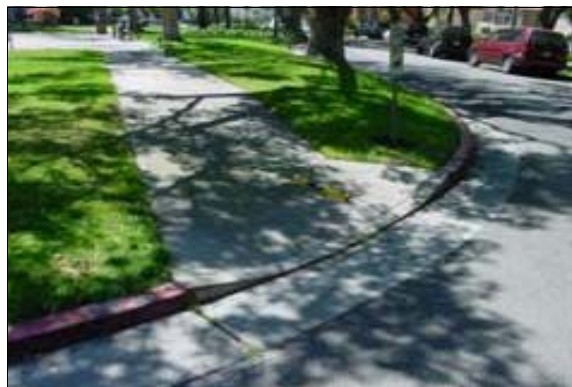
Curb Ramp (West)

Finding: The slope of the curb ramp is greater than 8.33%. The slope at the top landing is greater than 2%. The slope of the side flares is greater than 10%. The curb ramp does not provide a grooved border along the top and sides of the ramp at the level of the sidewalk. The concrete curb ramp does not provide a detectable warning surface which includes truncated domes.

Citations: CBC 1127B.5.3; ADAAG 4.7.2 & 4.29

Full Rec: Replace the curb ramp with a compliant curb ramp at least 48 inches in width that provides a slope no greater than 8.33%. Install a detectable warning surface which extends the full length and width of the concrete curb ramp and its side flares with truncated domes that contrast visually by either light on dark or dark on light which is an integral part of the concrete curb ramp. The truncated domes may be cast in place or stamped or of a prefabricated surface treatment (see CBC 1127B.5.8).

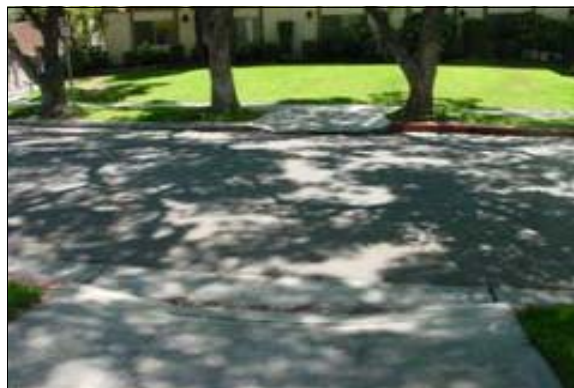
Path of Travel to the Park

Finding: There is no crosswalk provided on the path of travel to the (east) curb ramp. The required accessible route crosses a vehicular way.

Full Rec: Stripe a crosswalk not less than 48 inches wide on the path of travel to the accessible entrance of the park. Provide a level surface that does not exceed a slope greater than 5%. Cross slopes shall not exceed 2%. Detectable warnings should be placed at the entrance and exit of the crosswalk.

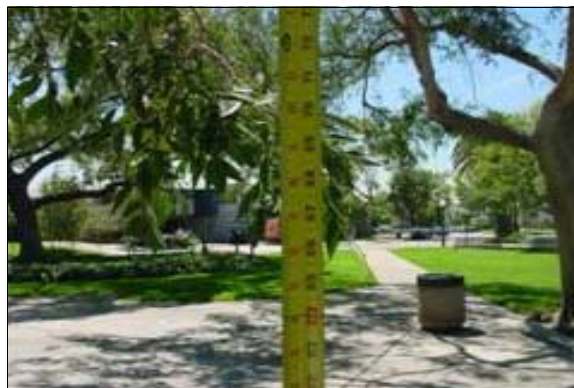
Protruding Object

Finding: At the time of inspection, vegetation encroached into the primary path of travel, obstructing passage by reducing the vertical clearance to less than 80 inches along the accessible route.

Full Rec: Maintain grass or landscaping adjacent to primary path of travel walkways to eliminate any encroachment into the accessible route.
