**Photo Report**  
**Scholl Canyon Ballfields**  
**Programs, Services, and Activities**

**Finding:** The Scholl Canyon Ballfields, located at 3200 East Glenoaks in Glendale California, was inspected by Disability Access Consultants, Inc., on June 14, 2007.

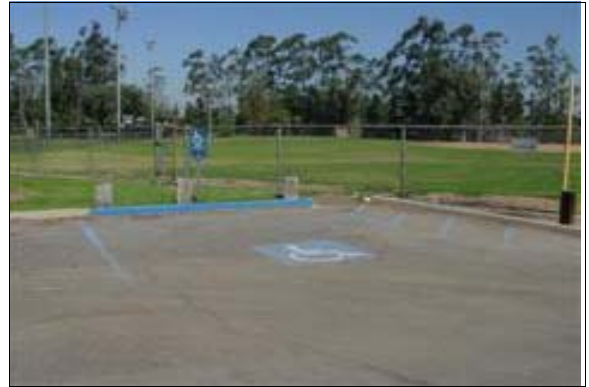
**Finding:** There is one accessible parking space out of 98 parking spaces which does not meet the minimum number of accessible parking spaces for compliance. The accessible parking space measures 172 inches wide and 181 inches long. The adjacent access aisle measures 61 inches wide. The access aisle does not contain "NO PARKING" in 12" high white letters. There is no van-accessible parking space provided in the parking lot.

**Full Rec:** Four out of the 98 total number of parking spaces are required to be designated exclusively for accessible parking, as required by ADAAG and CBC 1129B. Restripe the existing parking space marked accessible and create three additional accessible parking spaces, each measuring at least 108 inches wide and 216 inches long. Designate one parking space as "van-accessible". The van-accessible space shall provide an access aisle measuring at least 96 inches wide (8 feet) on the passenger side (right side) of the vehicle space (see CBC 1129B). The additional parking spaces shall each provide an access aisle measuring at least 60 inches wide, that may be shared. Add the words NO PARKING in 12 inch high white letters at the entrance to the accessible parking access aisle.

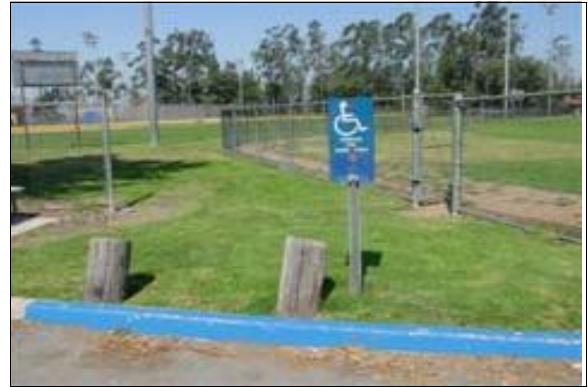
**Finding:** The vertically-mounted signage at the designated accessible parking space in the parking lot showing the International Symbol of Accessibility uses the word "handicapped". The bottom edge of the post-mounted signage designating the accessible parking space is less than 80 inches above the level of the parking space and cannot be viewed when a vehicle is parked in the space.

**Full Rec:** Install a permanently posted reflectorized sign measuring 70 square inches that includes an ISA symbol adjacent to and visible from the accessible parking space (see CBC 1129B.5). The bottom edge of the sign must be mounted 80 inches from the ground surface so that it cannot be obscured by a parked vehicle (see CBC 1129B.5). The "van-accessible" parking space shall provide an additional sign marked "van-accessible" mounted below the sign (see CBC 1129B.5 and ADAAG 4.6.4).

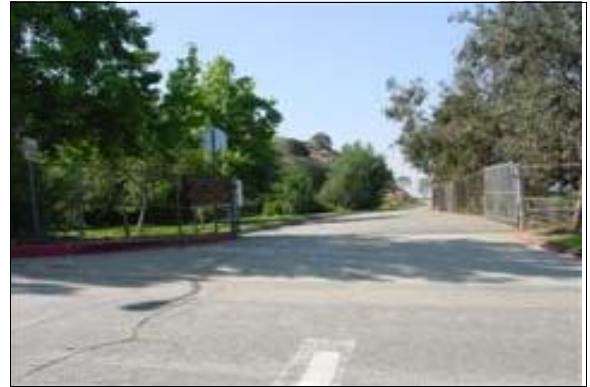
**Accessible Route from the Public Right of Way**

**Finding:** There is no accessible route from the public right of way to the accessible entrance of the facility. The accessible route crosses vehicular traffic.

**Alternative Rec:** Post directional signage.

**Full Rec:** Provide at least one accessible route from the public right of way to the accessible entrance of the facility. Make certain to post signage indicating the direction to accessible building entrances at every major junction along the accessible route. Signs shall include the International Symbol of Accessibility.

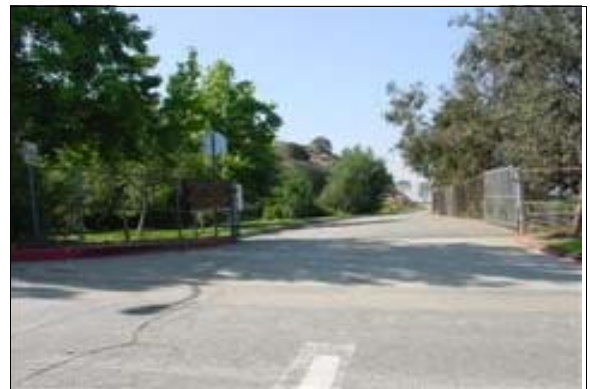
**Accessible Route from the Public Right of Way**

**Finding:** There is no crosswalk provided on the path of travel from the public right of way to the facility. The required accessible route crosses a vehicular way.

**Full Rec:** Stripe a crosswalk not less than 48 inches wide on the path of travel to the accessible entrance of the facility. Provide a level surface that does not exceed a slope greater than 5%. Cross slopes shall not exceed 2%. Detectable warnings should be placed at the entrance and exit of the crosswalk.

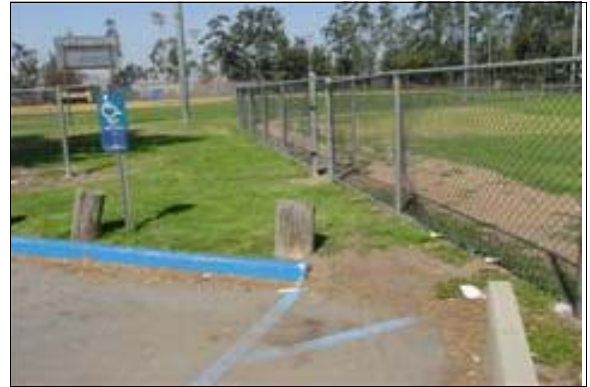
***Path of Travel to the Ballfields***

**Finding:** The path of travel from the accessible parking space to the ballfields is grass, preventing access to individuals with mobility impairments.

**Full Rec:** Install an accessible route to where programs, services and activities are provided (see CBC 1114B.1.2 and ADAAG 4.3.2). The minimum width of the path of travel shall be 48 inches with a firm, stable and slip-resistant surface. No protruding objects are permitted on the accessible path of travel and slopes shall not exceed 5% in the direction of travel.

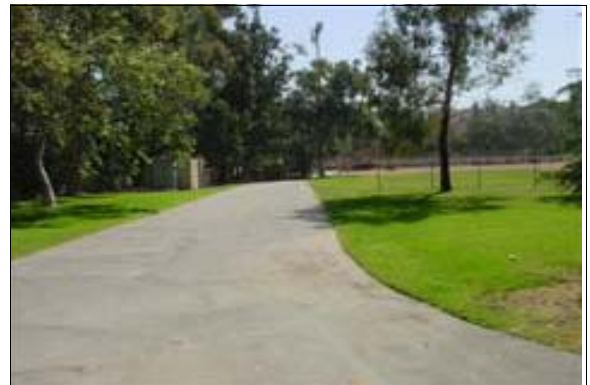
***Path of Travel to the Maintenance Building***

**Finding:** There is no crosswalk provided on the path of travel to the Maintenance Building. The required accessible route crosses a vehicular way.

**Full Rec:** Stripe a crosswalk not less than 48 inches wide on the path of travel to the accessible entrance of the facility. Provide a level surface that does not exceed a slope greater than 5%. Cross slopes shall not exceed 2%. Detectable warnings should be placed at the entrance and exit of the crosswalk.

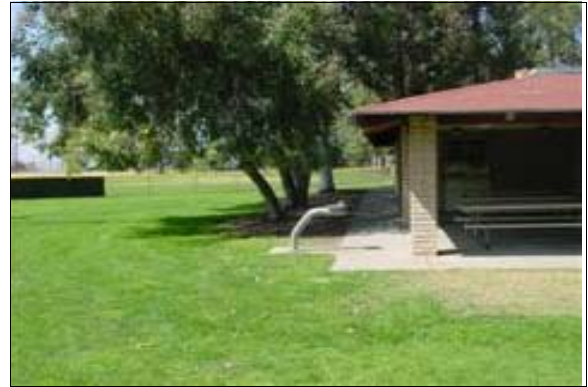
***Path of Travel to the Maintenance Building***

**Finding:** The path of travel from the ballfields to the Maintenance Building is grass,, preventing access to individuals with mobility impairments.

**Full Rec:** Install an accessible route to where programs, services and activities are provided (see CBC 1114B.1.2 and ADAAG 4.3.2). The minimum width of the path of travel shall be 48 inches with a firm, stable and slip-resistant surface. No protruding objects are permitted on the accessible path of travel and slopes shall not exceed 5% in the direction of travel.

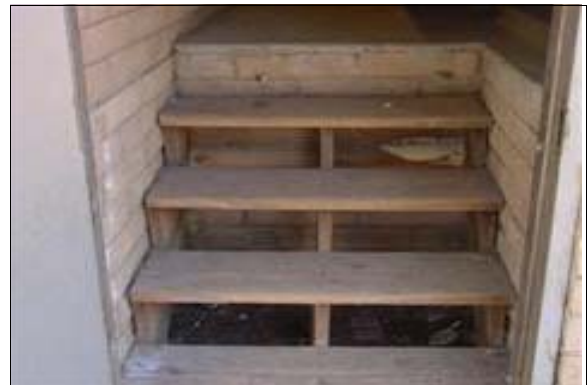
***Exterior Stairs to Press Box 1***

**Finding:** There is no detectable striping on the top and bottom treads of the interior stairway.

**Full Rec:** Affix detectable contrasting striping to the top and bottom treads of the stairway that clearly contrasts in color from the tread and is at least 2 inches in width placed no more than 1 inch from the tread nose or landing.

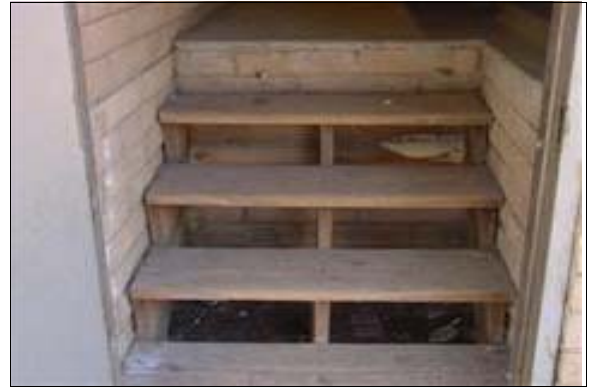
**Exterior Stairs to Press Box 1**

**Finding:** There are no handrails provided on the stairway.

**Full Rec:** Install pipe rail handrails on each side of stairway that provide a gripping surface between 1 1/4 to 1 7/8 inches with 12-inch top and bottom handrail extensions that extend beyond the top and bottom treads of the stairway which are parallel to the floor surface. Handrails shall be mounted at a height between 34 and 38 inches at a distance no less than 1 1/2 inches from the adjacent wall.

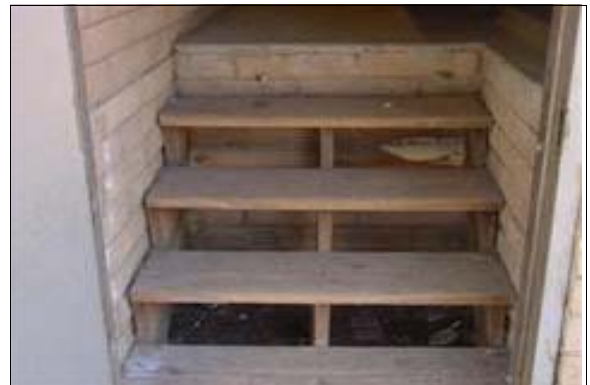
**Exterior Stairs to Press Box 1**

**Finding:** The risers on the stairway are open.

**Full Rec:** Close the riser openings on the stairway (see CBC 1006.16.3 and ADAAG 4.9.2). Open risers are not permitted.

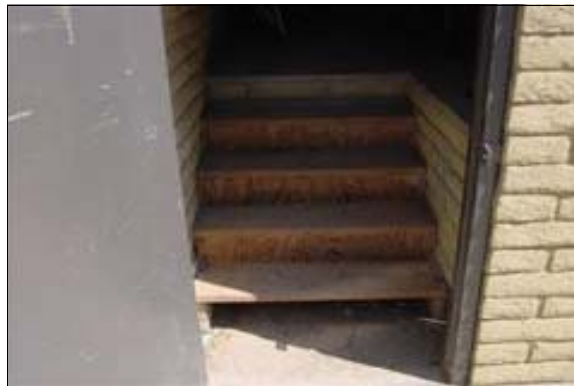
**Exterior Stairs to Press Box 3**

**Finding:** There is no detectable striping on the top and bottom treads of the interior stairway.

**Full Rec:** Affix detectable contrasting striping to the top and bottom treads of the stairway that clearly contrasts in color from the tread and is at least 2 inches in width placed no more than 1 inch from the tread nose or landing.

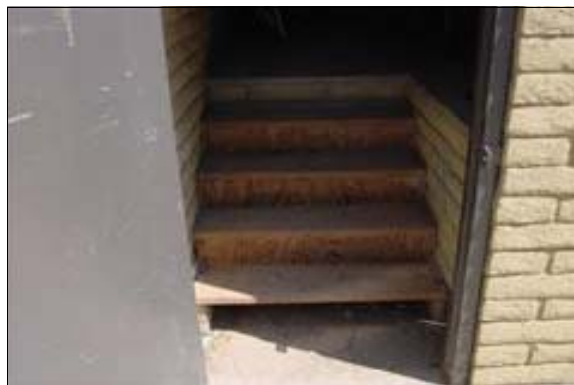
**Exterior Stairs to Press Box 3**

**Finding:** There are no handrails provided on the stairway.

**Full Rec:** Install pipe rail handrails on each side of stairway that provide a gripping surface between 1 1/4 to 1 7/8 inches with 12-inch top and bottom handrail extensions that extend beyond the top and bottom treads of the stairway which are parallel to the floor surface. Handrails shall be mounted at a height between 34 and 38 inches at a distance no less than 1 1/2 inches from the adjacent wall.

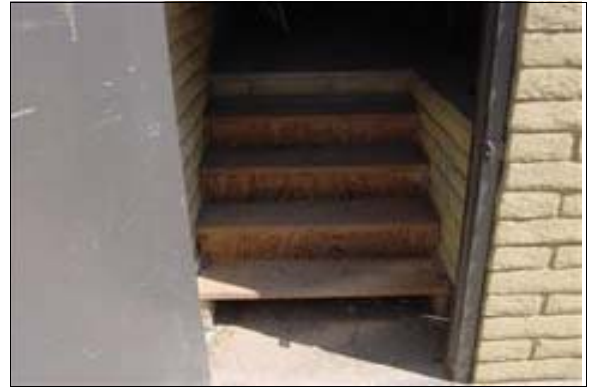
**Exterior Stairs to Press Box 3**

**Finding:** There is less than 11 inches of tread depth (width).

**Full Rec:** Modify or replace the stairs so that the tread depth (width) is at least 11 inches, measured from riser to riser, and uniform (see CBC 1006.3.4.9.2 and ADAAG 4.9.2).

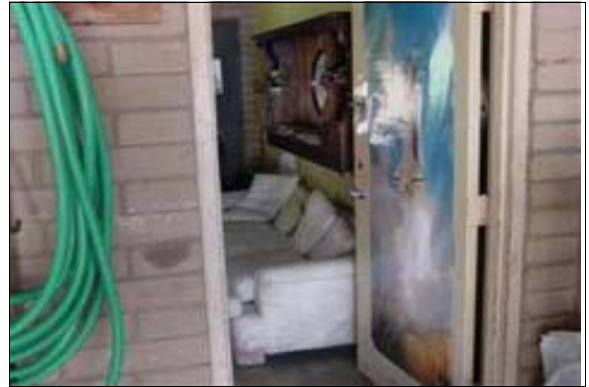
**Exterior Door to the Maintenance Office**

**Finding:** The exterior passage door has a round doorknob, which requires twisting of the wrist to operate.

**Full Rec:** Replace the existing door hardware with accessible hardware (see ADAAG 4.13.9).

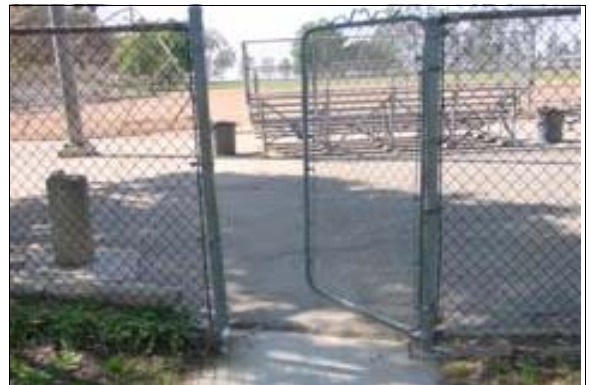
**Exterior Gate to Ballfield 1**

**Finding:** There is less than 24 inches of clearance on the latch side of the exterior entrance gate.

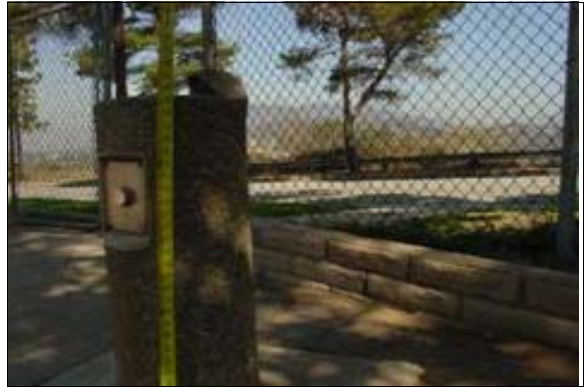
**Finding:** There are three drinking fountains on primary paths of travel.

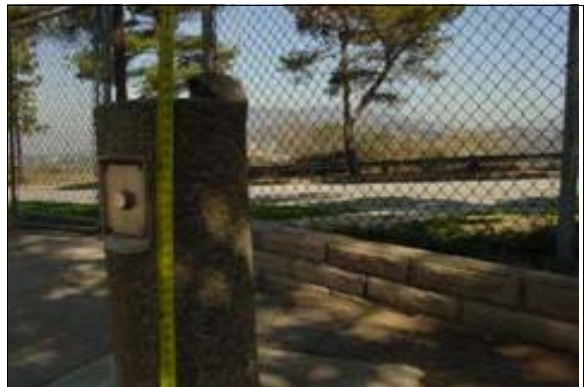
**Finding:** The drinking fountain is not a "high-low" design. There is less than 27 inches knee clearance height.

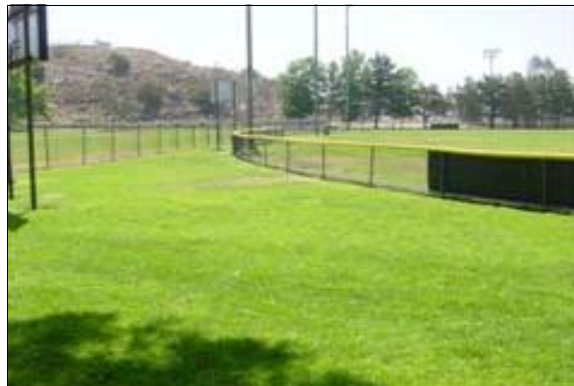
**Ballfield 1**

**Finding:** The grass and dirt surface of the baseball field at the facility prevents access to individuals with mobility impairments.

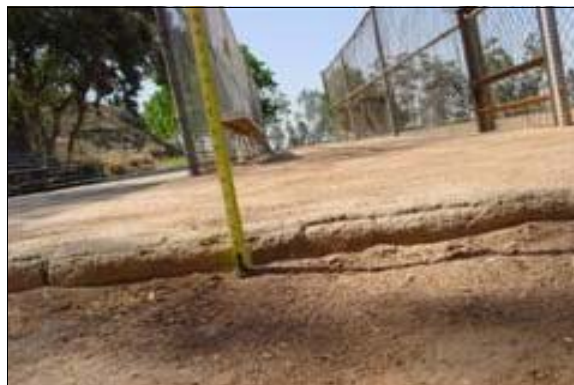
**Ballfield 1**

**Finding:** There is a change in elevation greater than 1/2 inch on the primary path of travel to the dugout (at the left) at ballfield 1.

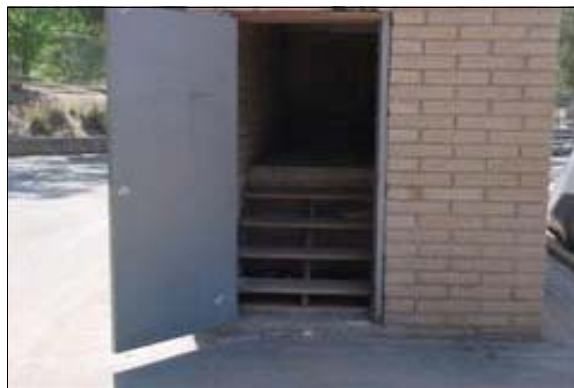
**Ballfield 1**

**Finding:** The press box is stair-access only and is not accessible to individuals with mobility impairments.

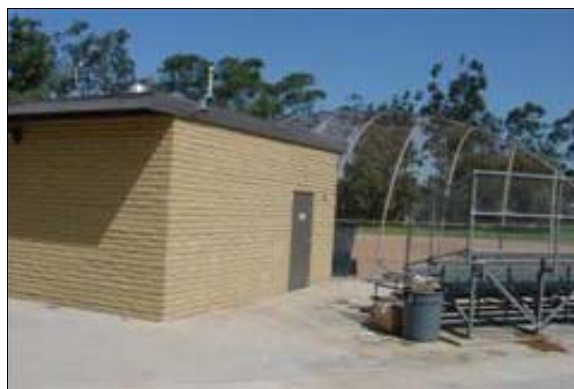
**Ballfield 2**

**Finding:** At the time of facility inspection, press box 2 was locked and was unavailable for a complete ADA compliance inspection.

**Full Rec:** Due to the unavailability of a specific element at the time of the facility inspection process, it is recommended that upon availability all elements should be inspected for ADA compliance.

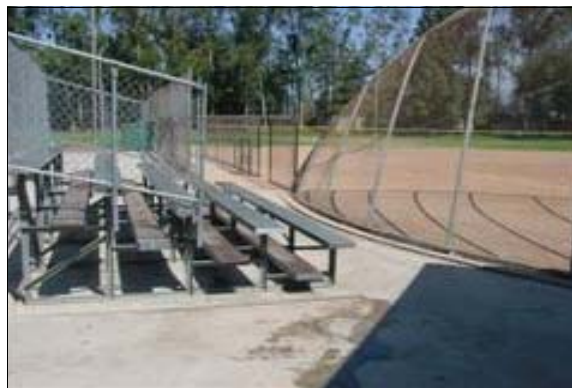
**Ballfield 2**

**Finding:** The surface under the bleachers is concrete. No wheelchair seating is provided next to the bleachers.

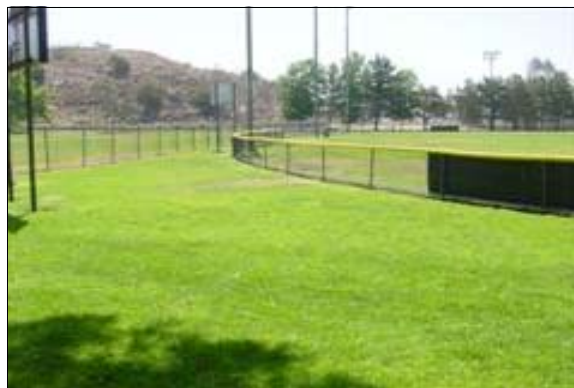
**Ballfield 2**

**Finding:** The grass and dirt surface of the baseball field at the facility prevents access to individuals with mobility impairments.
