Photo Report
Scholl Canyon Golf and Tennis
Programs, Services, and Activities

Finding: Scholl Canyon Golf and Tennis, located at 3800 East Glenoaks Boulevard in Glendale California, was inspected by Disability Access Consultants, Inc., on June 20, 2007.

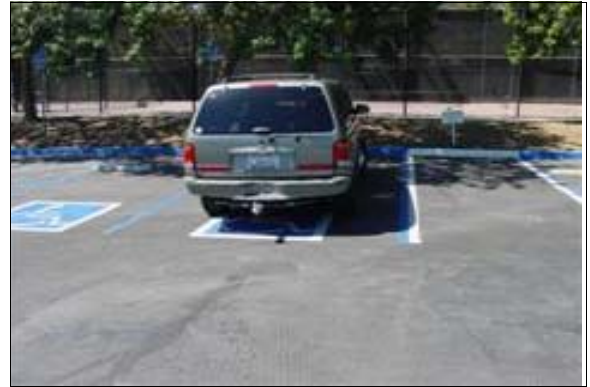
Finding: Parking Continued: Four of the designated accessible parking spaces provided in the parking lot measure at least 108 inches wide and at least 216 inches long. One of the designated accessible parking spaces measures less than 108 inches wide and at least 216 inches long. The designated "van-accessible" parking space provides an access aisle, located on the passenger side (right side) of the parking space, measuring at least 96 inches wide. Two of the standard accessible parking spaces provide an adjacent access aisle measuring 60 inches wide. One of the standard accessible parking spaces provides an adjacent access aisle measuring less than 60 inches wide. There is no access aisle provided adjacent to one of the accessible parking spaces. The access aisles do not contain "NO PARKING" in 12" high white letters.

Full Rec: Restripe the existing parking spaces marked accessible and create one additional accessible parking space, each measuring at least 108 inches wide and 216 inches long. The van-accessible space shall provide an access aisle measuring at least 96 inches wide (8 feet) on the passenger side (right side) of the vehicle space (see CBC 1129B). The additional parking spaces shall each provide an access aisle measuring at least 60 inches wide, that may be shared. Add the words NO PARKING in 12 inch high white letters at the entrance to each accessible parking access aisle.

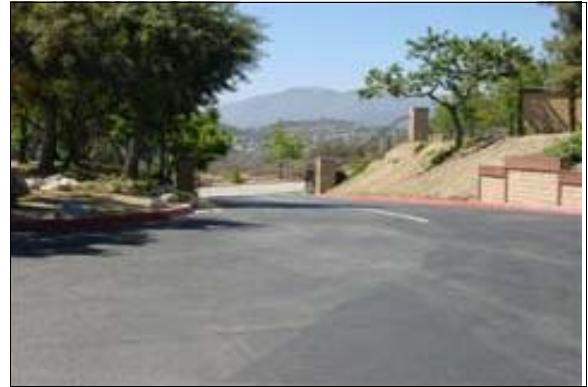
Accessible Route from the Public Right of Way

Finding: There is no crosswalk provided on the path of travel from the public right of way to the facility. The required accessible route crosses a vehicular way.

Full Rec: Stripe a crosswalk not less than 48 inches wide on the path of travel to the accessible entrance of the facility. Provide a level surface that does not exceed a slope greater than 5%. Cross slopes shall not exceed 2%. Detectable warnings should be placed at the entrance and exit of the crosswalk.

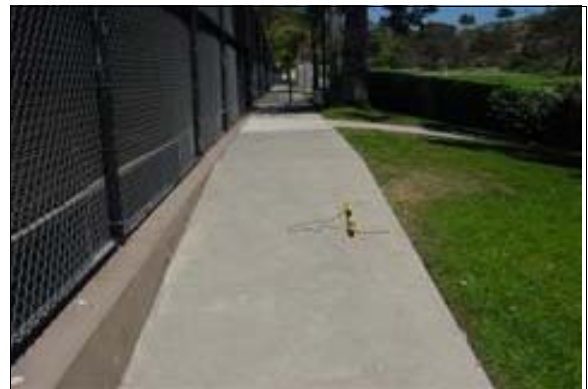
Path of Travel to Tennis Courts 7 thru 10

Finding: There are slopes greater than 5% on the primary path of travel from tennis courts 1 thru 6 to tennis courts 7 thru 10.

Full Rec: Resurface the path of travel to provide a level surface that does not exceed a slope greater than 5%. Cross slopes shall not exceed 2%.

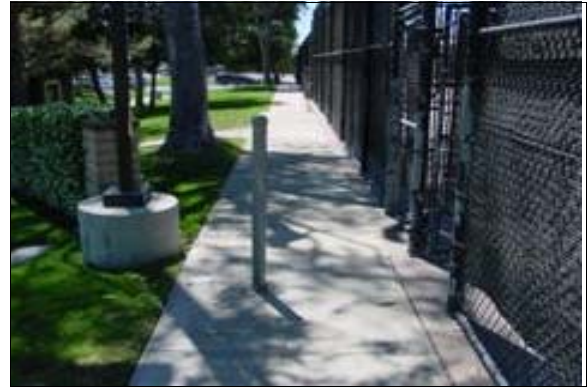
Path of Travel to Tennis Courts 8, 9, and 10

Finding: The concrete walkway serves as a primary path of travel. The width of the concrete walkway is less than 48 inches in width, due to a post in the path of travel.

Full Rec: Remove the post to provide at least 48 inches in width along the path of travel. Otherwise, modify the exterior primary path of travel by extending the width of the concrete walkway to at least 48 inches (see CBC 1118B.2 and ADAAG 4.3.3). Since the accessible route is less than 60 inches in width, provide passing spaces at least 60 inches by 60 inches at reasonable intervals every 200 feet.

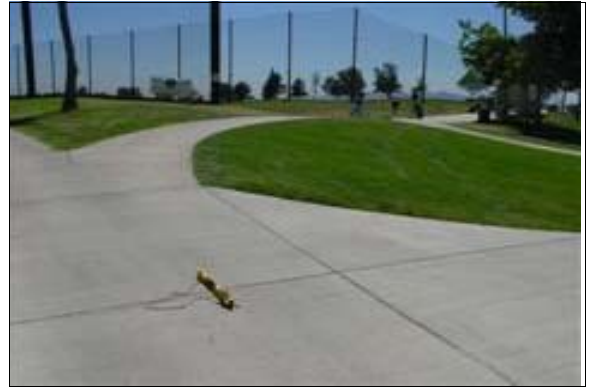
Path of Travel to the Driving Range

Finding: There are slopes greater than 5% on the primary path of travel from the Club House and Café to the driving range.

Full Rec: Resurface the path of travel to provide a level surface that does not exceed a slope greater than 5%. Cross slopes shall not exceed 2%.
