Photo Report
Sports Complex
Programs, Services, and Activities

Finding: The Sports Complex, located at 2200 Fern Lane in Glendale California, was inspected by Disability Access Consultants, Inc., on June 7, 2007. Facilities include the Sports Complex Operations Office and the Maintenance Building.

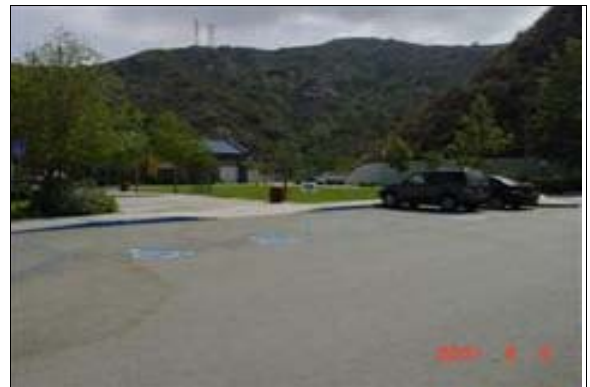
Finding: There are eight accessible parking spaces out of 242 parking spaces which is sufficient in number as required for compliance.

Full Rec: Eight out of the 242 total number of marked parking spaces meets the number required to be designated exclusively for accessible parking according to ADAAG and CBC 1129B.

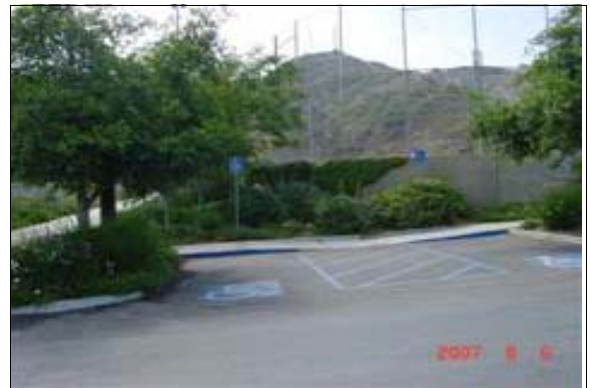
Finding: Two of the designated accessible parking spaces provided in the parking lot measure 108 inches wide and 216 inches long. Three of the designated accessible parking spaces measure less than 108 inches wide and at least 216 inches long. Three of the designated accessible parking spaces measure less than 108 inches wide and less than 216 inches long. The van-accessible parking spaces provide an access aisle, located on the passenger side (right side) of the parking space, measuring at least 96 inches wide. Three of the standard accessible parking spaces provide an adjacent access aisle measuring at least 60 inches wide. Two of the standard accessible parking spaces provide an adjacent access aisle measuring less than 60 inches wide. The access aisles do not contain "NO PARKING" in 12" high white letters.

Full Rec: Restripe the designated accessible parking spaces to create one van-accessible and seven standard accessible parking spaces, each measuring at least 108 inches wide and 216 inches long. Designate one parking space as "van-accessible". The van-accessible space shall provide an access aisle measuring at least 96 inches wide (8 feet) on the passenger side (right side) of the vehicle space (see CBC 1129B). The additional parking spaces shall each provide an access aisle measuring at least 60 inches wide, that may be shared. Add the words NO PARKING in 12 inch high white letters at the entrance to each accessible parking access aisle.

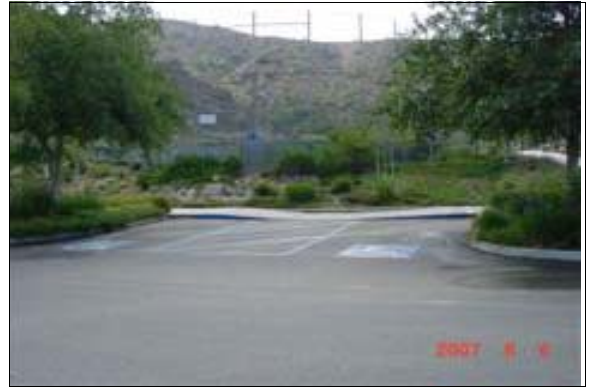
Finding: The surface of the accessible parking spaces and access aisles in the parking lot has a slope greater than 2%.

Full Rec: Pave the parking lot at the accessible spaces to provide a level surface. Parking surfaces and access aisles shall be located in areas not exceeding 2% slope in all directions (see CBC 1129B and ADAAG 4.6.3).

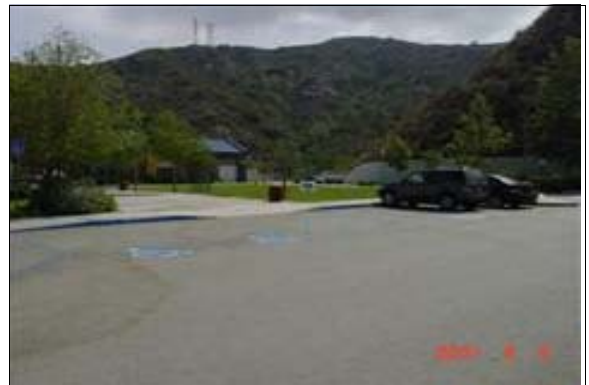
Finding: There is no device at the head of the accessible parking spaces to prevent vehicles from encroaching into the minimum width of the accessible walkway.

Full Rec: Install a wheelstop at the head of the accessible parking spaces and at the general parking spaces. Wheelstops shall be used to prevent vehicles from encroaching into accessible aisles or walkways, but shall not present additional encroachment into those areas (see CBC 1129B.4.3).

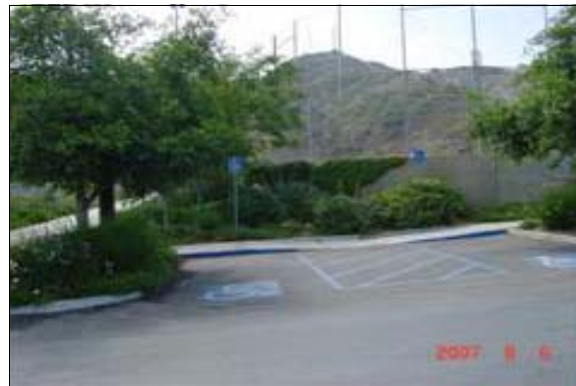
Finding: There is no vertically-mounted signage at two of the designated accessible parking spaces in the parking lot showing the International Symbol of Accessibility. There is no additional signage marked "van-accessible" at the van-accessible parking spaces. There is signage designating one of the standard accessible parking spaces as "van-accessible".

Full Rec: Install a permanently posted reflectorized sign measuring 70 square inches that includes an ISA symbol adjacent to and visible from the accessible parking space (see CBC 1129B.5). The bottom edge of the sign must be mounted 80 inches from the ground surface so that it cannot be obscured by a parked vehicle (see CBC 1129B.5). The "van-accessible" parking space shall provide an additional sign marked "van-accessible" mounted below the sign (see CBC 1129B.5 and ADAAG 4.6.4).

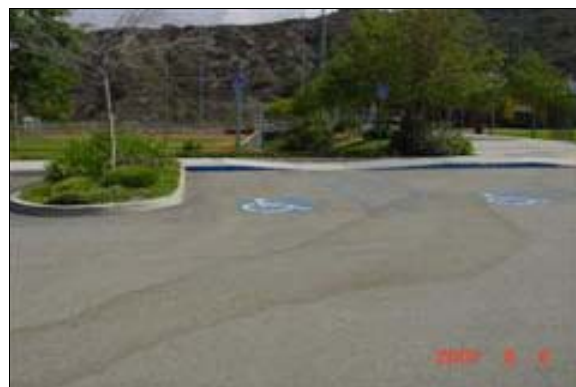
Finding: Five of the designated accessible parking spaces in the parking lot are not outlined on both sides.

Full Rec: Each designated accessible parking space shall be identified with a pavement marking consisting of outlining the accessible space in blue and outlining an ISA symbol in white; or outlining a 36 inch by 36 inch white on blue ISA symbol positioned where it can be viewed when a vehicle is parked in the space.

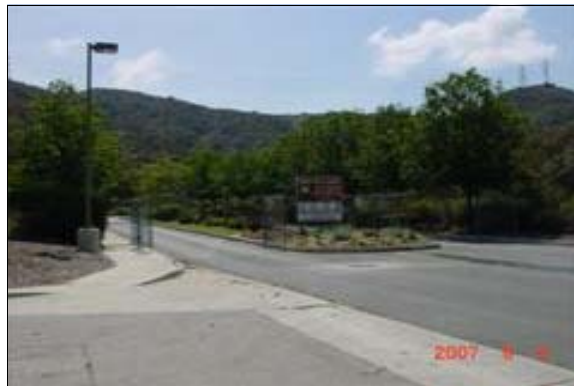
Finding: There is no warning signage posted at the entrance to the parking lot regarding unauthorized use of accessible parking spaces in the parking lot.

Full Rec: Post a sign in a conspicuous place to the entrance of the parking lot, or immediately adjacent to and visible from each accessible parking space. The warning sign shall measure at least 17 inches by 22 inches in size and consist of lettering at least 1 inch in height that clearly and conspicuously states the following; "Unauthorized vehicles parked in designated accessible spaces not displaying distinguishing placards or license plates issued for persons with disabilities may be towed away at owner's expense. Towed vehicles may be reclaimed at ____ or by telephoning ____ ." Fill in the blank spaces with appropriate information as a permanent part of the sign and maintain the currency of the information (see CBC 1129B.5). Be sure to add the CVC 22511.8(a)(d) to the sign.

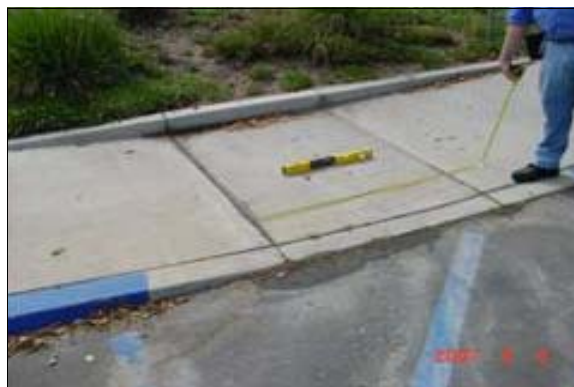
Curb Ramp at the Accessible Parking Spaces Next to the Baseball Field (Left)

Finding: The cross slope of the right side of the concrete sidewalk curb ramp is greater than 2%. The slope at the right top landing is greater than 2%. The concrete curb ramp does not provide a detectable warning surface which includes truncated domes.

Full Rec: Replace the curb ramp with a compliant curb ramp at least 48 inches in width that provides a slope no greater than 8.33%. Install a detectable warning surface which extends the full length and width of the concrete curb ramp and its side flares with truncated domes that contrast visually by either light on dark or dark on light which is an integral part of the concrete curb ramp. The truncated domes may be cast in place or stamped or of a prefabricated surface treatment (see CBC 1127B.5.8).

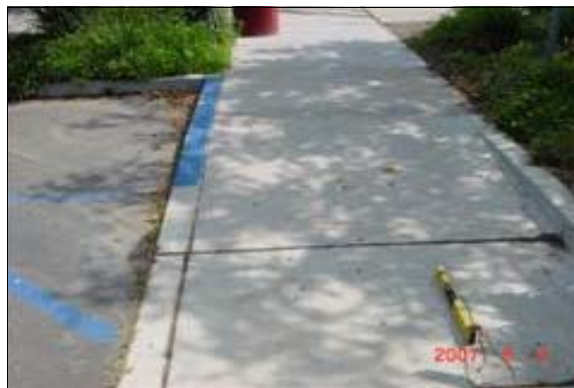
Curb Ramp at the Accessible Parking Spaces Next to the Baseball Field (Right)

Finding: The concrete curb ramp does not provide a detectable warning surface which includes truncated domes.

Full Rec: Install a detectable warning surface which extends the full length and width of the concrete curb ramp and its side flares with truncated domes that contrast visually by either light on dark or dark on light which is an integral part of the concrete curb ramp. The truncated domes may be cast in place or stamped or of a prefabricated surface treatment (see CBC 1127B.5.8).

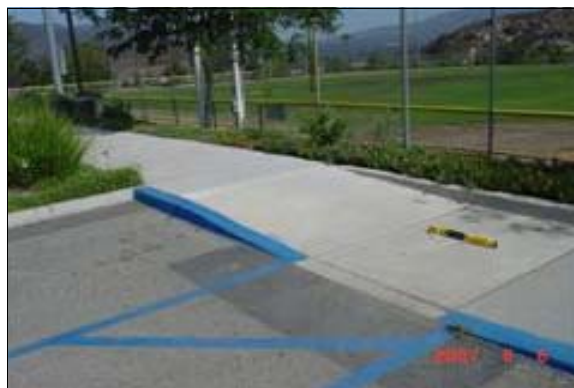
Curb Ramp at the Accessible Parking Spaces Outside of the Office (Left)

Finding: The cross slope of right side of the concrete sidewalk curb ramp is greater than 2%. The slope at the left top landing is greater than 2%. The concrete curb ramp does not provide a detectable warning surface which includes truncated domes.

Full Rec: Replace the curb ramp with a compliant curb ramp at least 48 inches in width that provides a slope no greater than 8.33%. Install a detectable warning surface which extends the full length and width of the concrete curb ramp and its side flares with truncated domes that contrast visually by either light on dark or dark on light which is an integral part of the concrete curb ramp. The truncated domes may be cast in place or stamped or of a prefabricated surface treatment (see CBC 1127B.5.8).

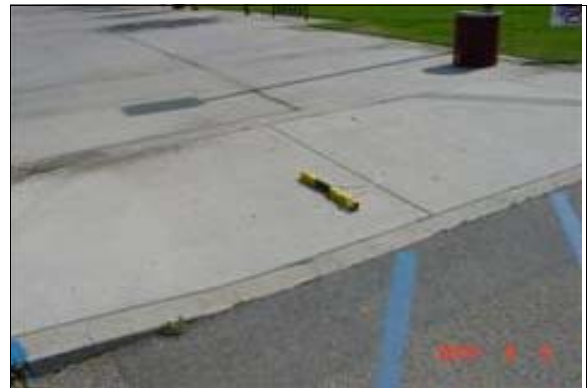
Curb Ramp at the Accessible Parking Spaces Outside of the Office (Right)

Finding: The slope of the curb ramp is greater than 8.33%. The slope at the bottom landing is greater than 2%. The slope of the side flares is greater than 10%. The concrete curb ramp does not provide a detectable warning surface which includes truncated domes.

Full Rec: Replace the curb ramp with a compliant curb ramp at least 48 inches in width that provides a slope no greater than 8.33%. Install a detectable warning surface which extends the full length and width of the concrete curb ramp and its side flares with truncated domes that contrast visually by either light on dark or dark on light which is an integral part of the concrete curb ramp. The truncated domes may be cast in place or stamped or of a prefabricated surface treatment (see CBC 1127B.5.8).

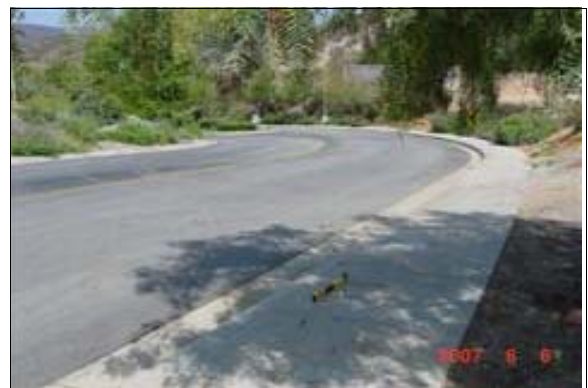
Accessible Route from the Public Right of Way

Finding: There is no accessible route from the public right of way to the accessible entrance of the facility. There are slopes greater than 5% along the path of travel.

Full Rec: Provide at least one accessible route from the public right of way to the accessible entrance of the facility. Make certain to post signage indicating the direction to accessible building entrances at every major junction along the accessible route. Signs shall include the International Symbol of Accessibility.

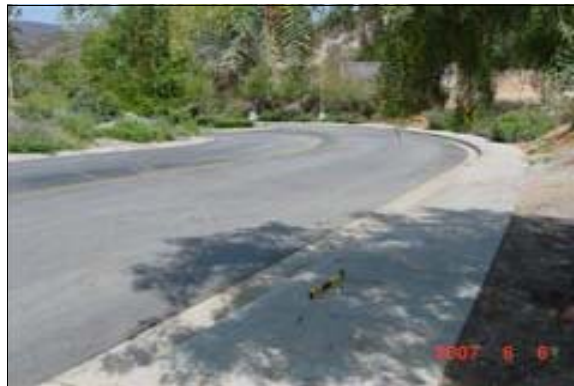
Accessible Route from the Public Right of Way

Finding: There are slopes greater than 5% on the primary path of travel from the public right of way to the Sports Complex.

Full Rec: Resurface the path of travel to provide a level surface that does not exceed a slope greater than 5%. Cross slopes shall not exceed 2%.

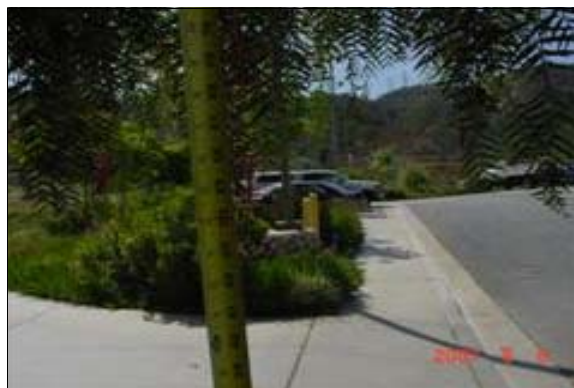
Accessible Route from the Public Right of Way

Finding: At the time of inspection, vegetation encroached into the primary path of travel, obstructing passage by reducing the vertical clearance height to less than 80 inches along the accessible route.

Full Rec: Maintain grass or landscaping adjacent to primary path of travel walkways to eliminate any encroachment into the accessible route.

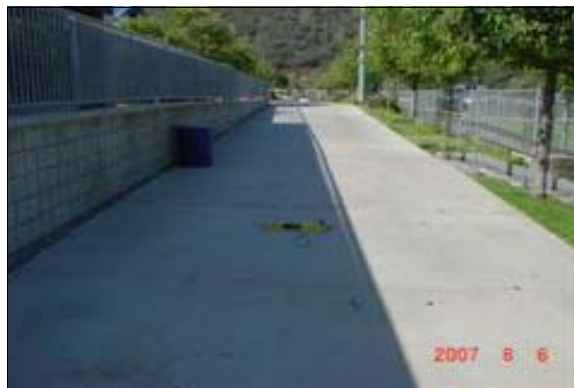
Path of Travel Next to the Outdoor Dining Area

Finding: There are cross slopes greater than 2% on the primary path of travel next to the outdoor dining area.

Full Rec: Resurface the path of travel to provide a level surface that does not exceed a slope greater than 5%. Cross slopes shall not exceed 2%.

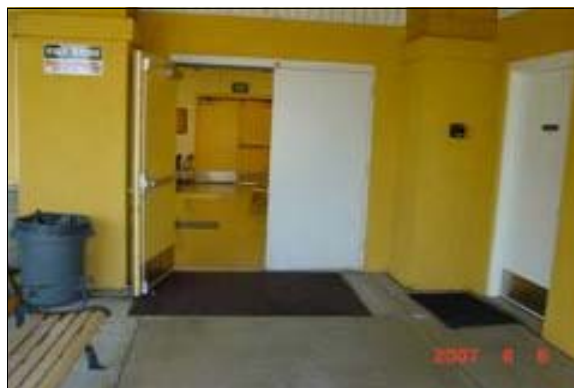
Path of Travel to the Conference Room

Finding: The mat at the entrance does not adhere to the underlying floor surface and creates a hazardous path of travel.

Full Rec: Securely fasten the mats or replace with a mat that grips to the underlying floor surface to provide a firm, stable, continuous and relatively smooth path of travel surface (see CBC 1124B.3 and ADAAG 4.5.3). Mats along the primary path of travel shall provide beveled edges on all sides to prevent roll over.

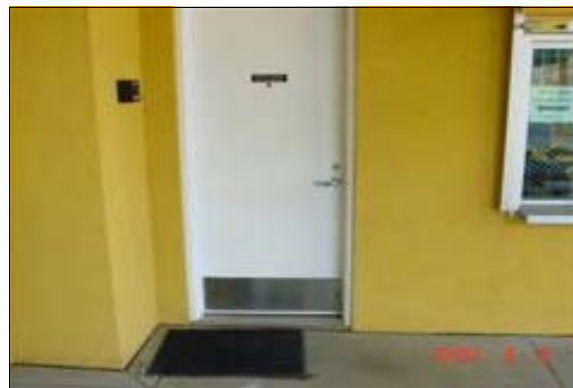
Path of Travel to the Main Entrance

Finding: The mat at the main entrance does not adhere to the underlying floor surface and creates a hazardous path of travel.

Full Rec: Securely fasten the mats or replace with a mat that grips to the underlying floor surface to provide a firm, stable, continuous and relatively smooth path of travel surface (see CBC 1124B.3 and ADAAG 4.5.3). Mats along the primary path of travel shall provide beveled edges on all sides to prevent roll over.

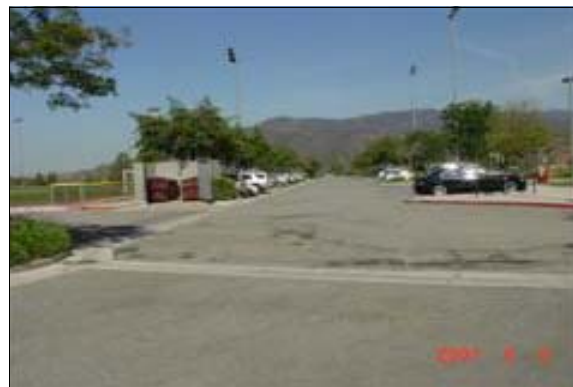
Path of Travel to the Soccer Field

Finding: There is no crosswalk provided on the path of travel from the accessible parking spaces to the soccer field. The required accessible route crosses a vehicular way.

Full Rec: Stripe a crosswalk not less than 48 inches wide on the path of travel to the accessible entrance of the facility. Provide a level surface that does not exceed a slope greater than 5%. Cross slopes shall not exceed 2%. Detectable warnings should be placed at the entrance and exit of the crosswalk.

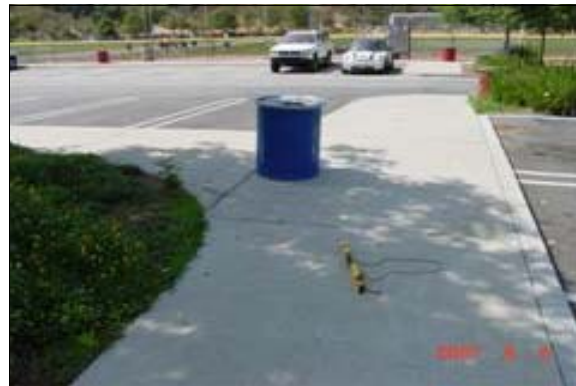
Path of Travel to the Sports Complex Operations Office

Finding: There are slopes greater than 5% on the primary path of travel from the public right of way to the Sports Complex Operations Office.

Full Rec: Resurface the path of travel to provide a level surface that does not exceed a slope greater than 5%. Cross slopes shall not exceed 2%.

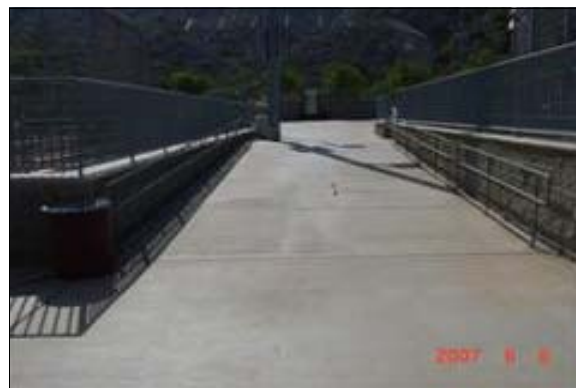
Exterior Ramp Between the Sports Fields

Finding: The length of the ramp exceeds the maximum distance allowed for its slope (rise).

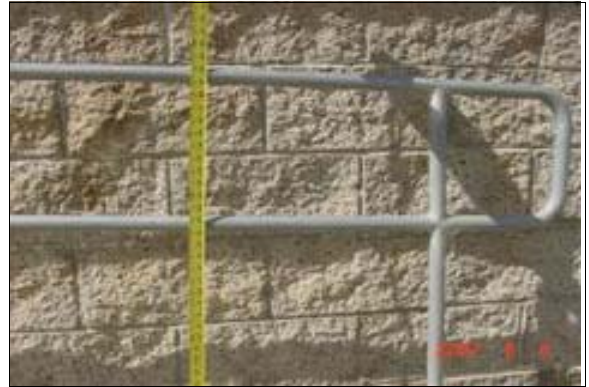
Exterior Ramp Between the Sports Fields

Finding: There are no 12-inch extensions beyond the bottom of the ramp.

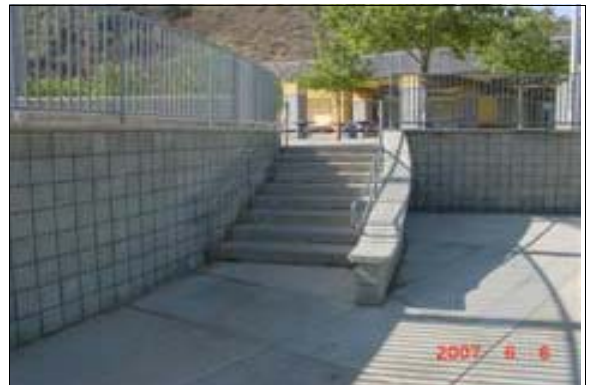
Exterior Stairs to the Outdoor Dining Area

Finding: The handrails are mounted at a height less than 34 inches above the nosing of the treads.

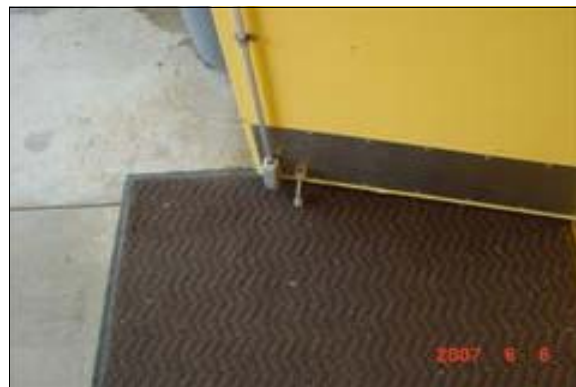
Sports Complex Operations Office

Finding: The bottom 10 inches of the doors do not provide a smooth, uninterrupted surface, or panel to allow the door to be opened by a wheelchair footrest without creating a trap or hazardous condition, due to the doorstop.

Full Rec: Install a panel or replace the door to provide a smooth, uninterrupted surface for the bottom 10 inches of the door.

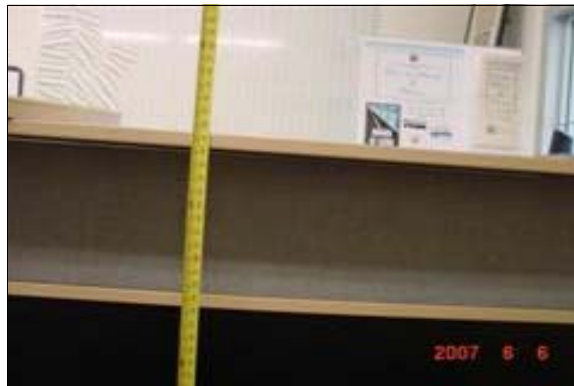
Finding: The facility does not provide accessible signage at the reception counter that indicates there is assistance provided upon request.

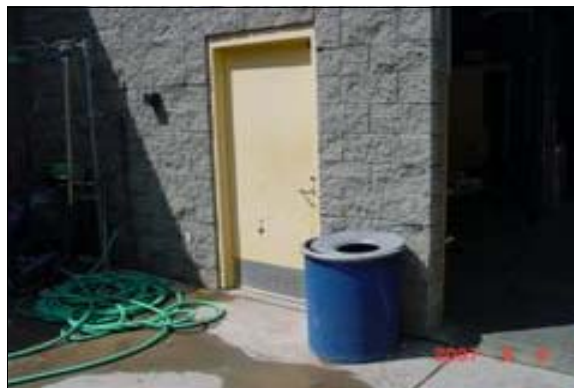
Maintenance Building

Finding: The main entrance does not have accessible signage mounted on the wall adjacent to the latch side of the door.

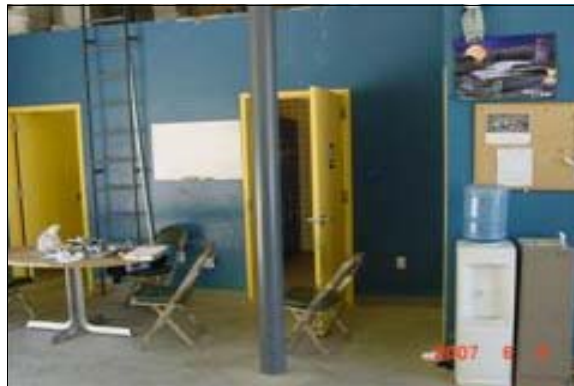
Unisex Restroom in the Maintenance Building

Finding: There is no signage indicating accessibility on the latch side of the entry door of the restroom. The gender use signage on the entrance door does not comply with Title 24.

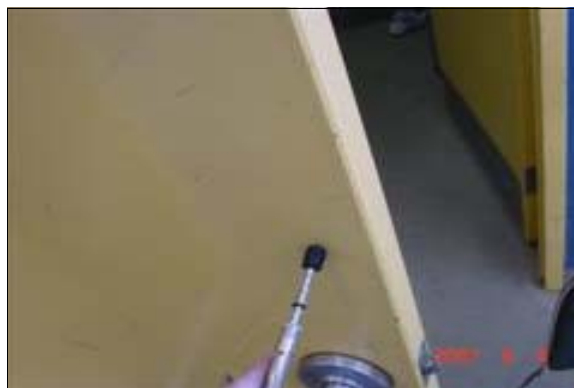
Unisex Restroom in the Maintenance Building

Finding: The door opening force for the interior door is greater than 5 pounds of force.

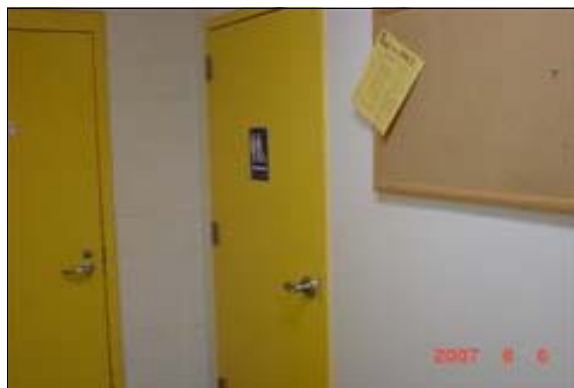
Unisex Restroom in the Sports Complex Operations Office

Finding: There is no signage indicating accessibility on the latch side of the entry door of the restroom. The gender use signage on the entrance door does not comply with Title 24.

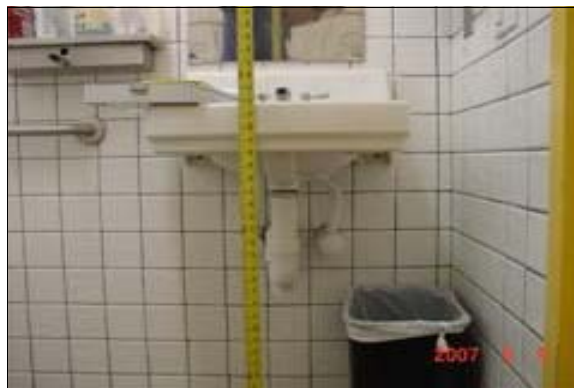
Unisex Restroom in the Sports Complex Operations Office

Finding: The height of the rim surface of the lavatory designated to be accessible in the restroom is greater than 34 inches above the finished floor.

Full Rec: Relocate or replace the lavatory designated to be accessible in the restroom to provide a maximum rim surface height of no greater than 34 inches above the finished floor (see ADAAG 4.19.2).

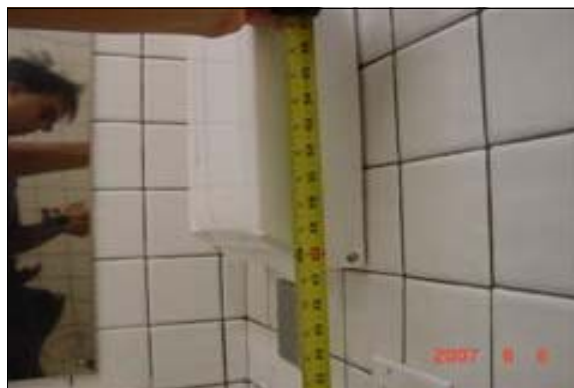
Unisex Restroom in the Sports Complex Operations Office

Finding: The height of the controls and operating mechanisms for the paper towel dispenser in the restroom is greater than 40 inches.

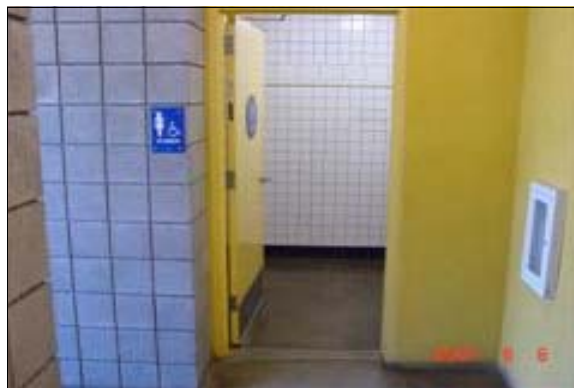
Women's Restroom at the Sports Complex Operations Office

Finding: The signage indicating accessibility at the entry door of the restroom is not mounted on the latch side of the entrance door and is not centered at 60 inches above the floor surface. The gender use signage on the entrance door is not centered at 60 inches above the floor surface.

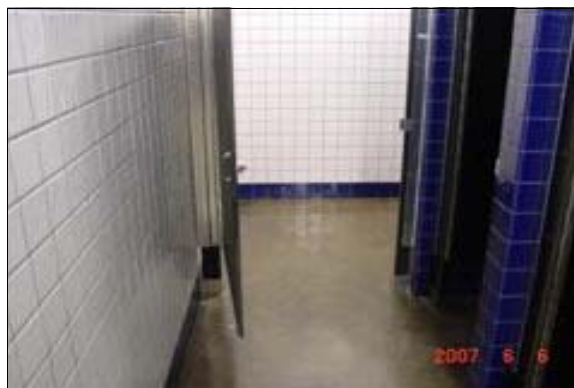
Women's Restroom at the Sports Complex Operations Office

Finding: The door to the stall designated to be accessible in the restroom does not close automatically or have accessible hardware.

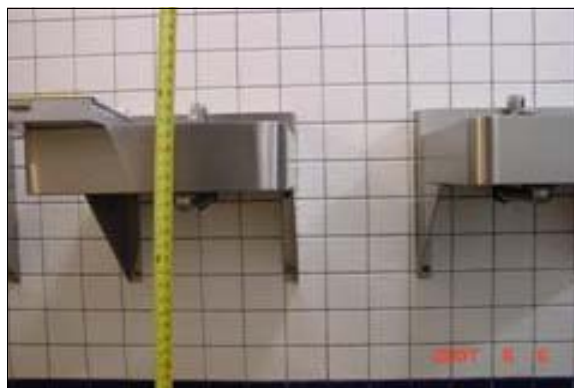
Women's Restroom at the Sports Complex Operations Office

Finding: The pipes under the lavatory in the restroom do not provide protection against contact.
