**Photo Report**  
**Verdugo Adobe Park**  
**Programs, Services, and Activities**

**Finding:** The Verdugo Adobe Park, located at 2211 Bonita Drive in Glendale California, was inspected by Disability Access Consultants, Inc., on June 12 and 14, 2007.

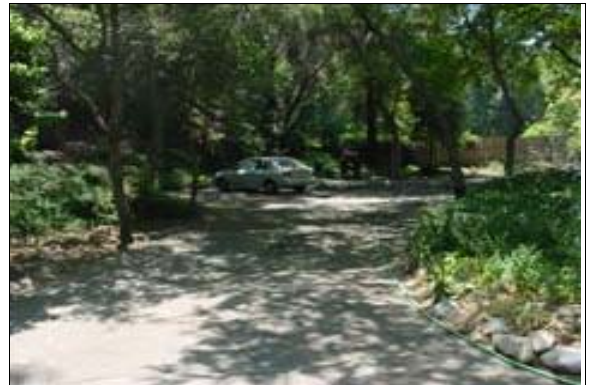
***Parking Lot Outside of the Museum***

**Finding:** Parking is provided off-street to the public and/or employees outside of the Museum, though no marked spaces are provided. The parking lot can provide approximately two parking spaces.

**Full Rec:** Stripe parking spaces with an appropriate number of accessible parking spaces designated to comply with CBC 1129B and ADAAG 4.6. Accessible parking spaces shall be located on the shortest accessible route of travel to the facility for which it serves and shall coincide with the primary route and entrances used by the general public (see CBC 1129B and ADAAG 4.3.2(1)). The access aisle and route to the primary facility entrance shall also be of an accessible surface.

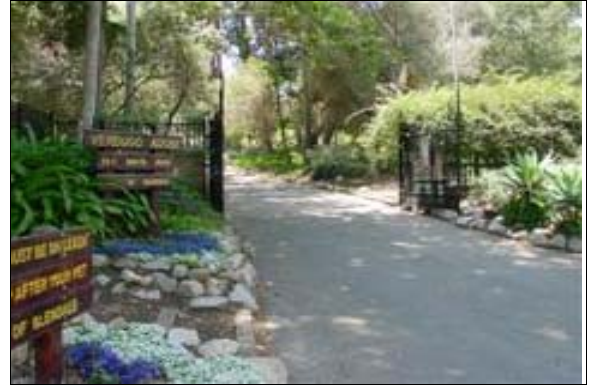
**Accessible Route from the Public Right of Way**

**Finding:** There is no accessible route from the public right of way to the accessible entrance of the facility. The accessible route crosses vehicular traffic.

**Full Rec:** Provide at least one accessible route from the public right of way to the accessible entrance of the facility. Make certain to post signage indicating the direction to accessible building entrances at every major junction along the accessible route. Signs shall include the International Symbol of Accessibility.

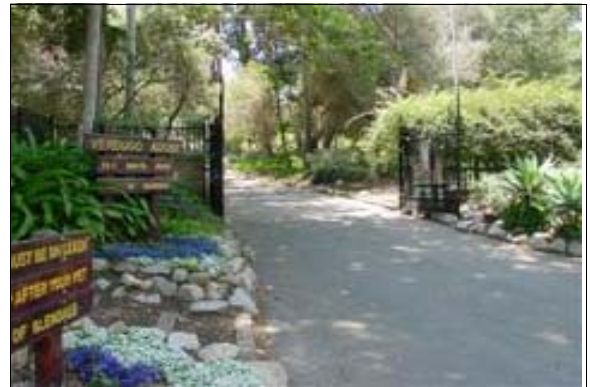
**Accessible Route from the Public Right of Way**

**Finding:** There is no crosswalk provided on the path of travel from the public right of way to the facility. The required accessible route crosses a vehicular way.

**Full Rec:** Stripe a crosswalk not less than 48 inches wide on the path of travel to the accessible entrance of the facility. Provide a level surface that does not exceed a slope greater than 5%. Cross slopes shall not exceed 2%. Detectable warnings should be placed at the entrance and exit of the crosswalk.

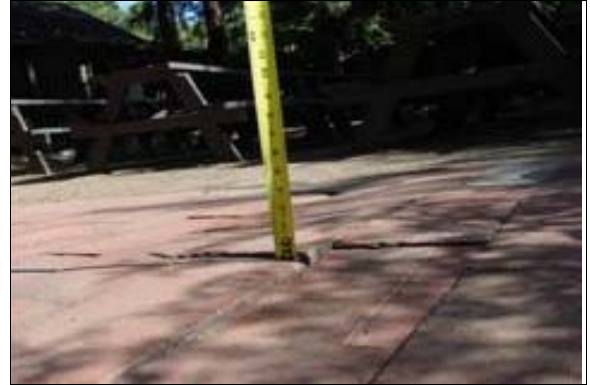
***Path of Travel at the Outdoor Dining Area***

**Finding:** There are changes in elevation greater than 1/2 inch on the primary path of travel.

**Full Rec:** Bevel the area or resurface the area to provide a smooth and level path of travel (see CBC 1133B.7.4 and ADAAG 4.3.8 and ADAAG 4.5.2).

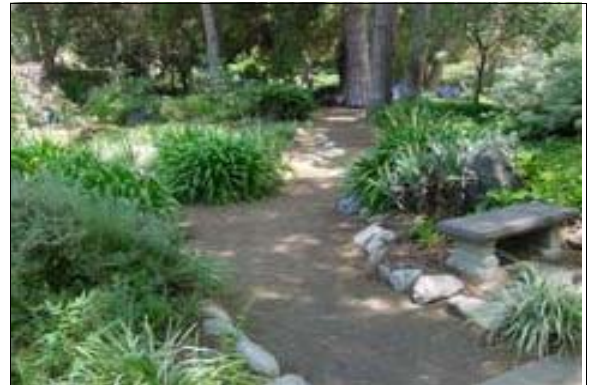
***Path of Travel Throughout the Park***

**Finding:** The path of travel throughout the park is dirt, preventing access to individuals with mobility impairments. There are slopes greater than 5% along the path of travel.

**Full Rec:** Install an accessible route to where programs, services and activities are provided (see CBC 1114B.1.2 and ADAAG 4.3.2). The minimum width of the path of travel shall be 48 inches with a firm, stable and slip-resistant surface. No protruding objects are permitted on the accessible path of travel and slopes shall not exceed 5% in the direction of travel.

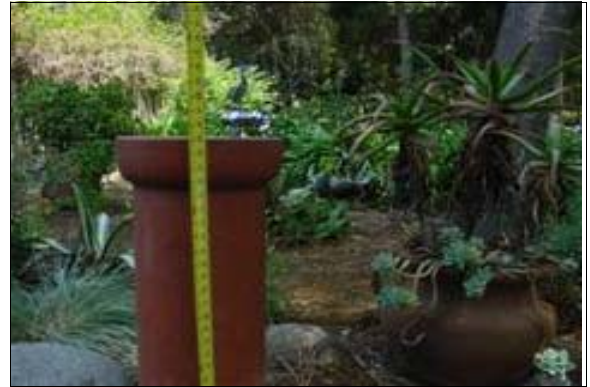
***Path of Travel to the Drinking Fountain***

**Finding:** The path of travel to the drinking fountain is dirt, preventing access to individuals with mobility impairments.

**Full Rec:** Install an accessible route to where programs, services and activities are provided (see CBC 1114B.1.2 and ADAAG 4.3.2). The minimum width of the path of travel shall be 48 inches with a firm, stable and slip-resistant surface. No protruding objects are permitted on the accessible path of travel and slopes shall not exceed 5% in the direction of travel.

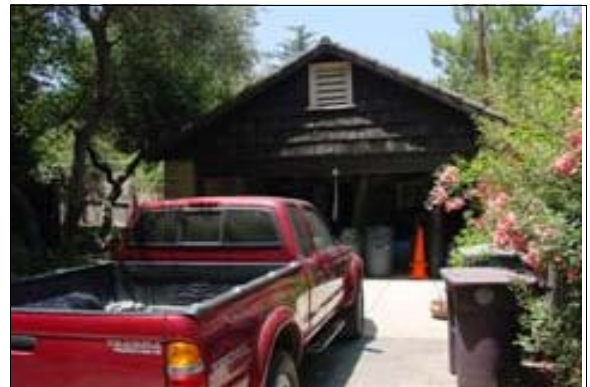
***Path of Travel to the Maintenance Garage***

**Finding:** There is no crosswalk provided on the path of travel to the Maintenance Garage. The required accessible route crosses a vehicular way.

**Full Rec:** Stripe a crosswalk not less than 48 inches wide on the path of travel to the accessible entrance of the facility. Provide a level surface that does not exceed a slope greater than 5%. Cross slopes shall not exceed 2%. Detectable warnings should be placed at the entrance and exit of the crosswalk.

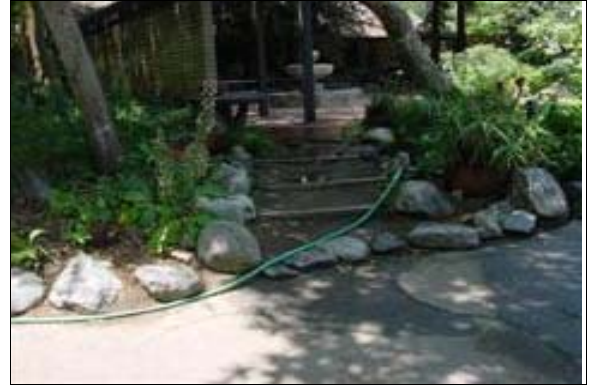
***Path of Travel to the Museum***

**Finding:** There are only stairs to the primary functions provided, preventing access to individuals with mobility impairments.

**Full Rec:** Since programs, services and activities to staff and the public are provided in this location, those programs, services and activities are required to be made accessible. It is recommended that a ramp be installed or other means of vertical access.

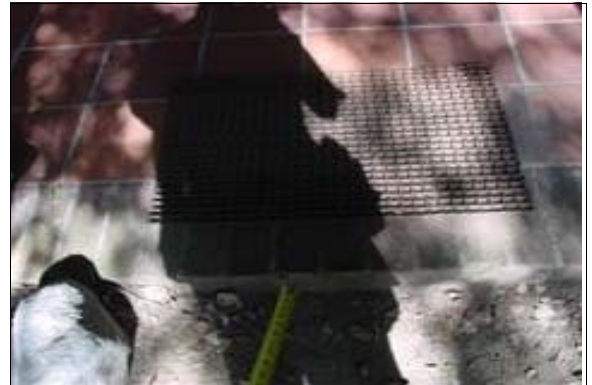
***Path of Travel to the Museum***

**Finding:** The mats at the porch do not adhere to the underlying floor surface and create a hazardous path of travel.

**Full Rec:** Securely fasten the mats or replace with a mat that grips to the underlying floor surface to provide a firm, stable, continuous and relatively smooth path of travel surface (see CBC 1124B.3 and ADAAG 4.5.3). Mats along the primary path of travel shall provide beveled edges on all sides to prevent roll over.

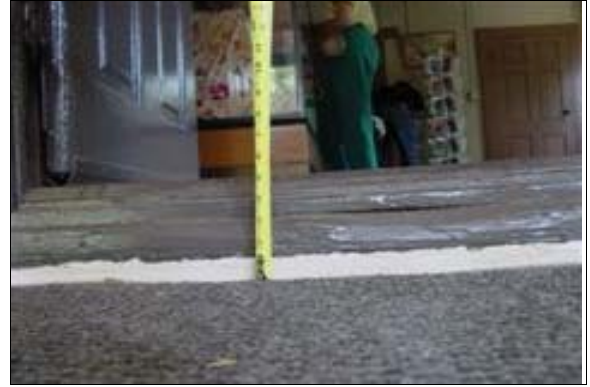
**Path of Travel to the Museum**

**Finding:** There is a step on the primary path of travel to the Museum, preventing access to individuals with mobility impairments.

**Full Rec:** Since programs, services and activities to staff and the public are provided in this location, those programs, services and activities are required to be made accessible. It is recommended that a ramp be installed or other means of vertical access.

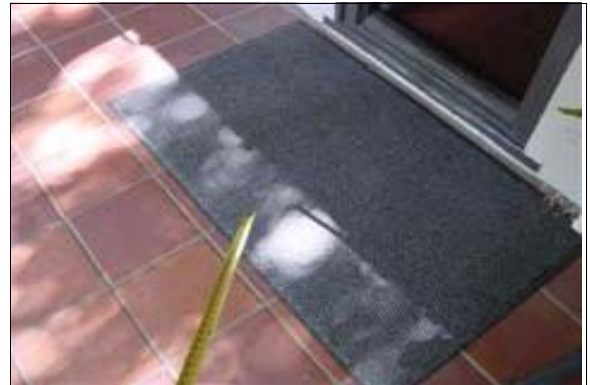
**Path of Travel to the Museum**

**Finding:** The mat at the entrance does not adhere to the underlying floor surface and creates a hazardous path of travel.

**Full Rec:** Securely fasten the mats or replace with a mat that grips to the underlying floor surface to provide a firm, stable, continuous and relatively smooth path of travel surface (see CBC 1124B.3 and ADAAG 4.5.3). Mats along the primary path of travel shall provide beveled edges on all sides to prevent roll over.

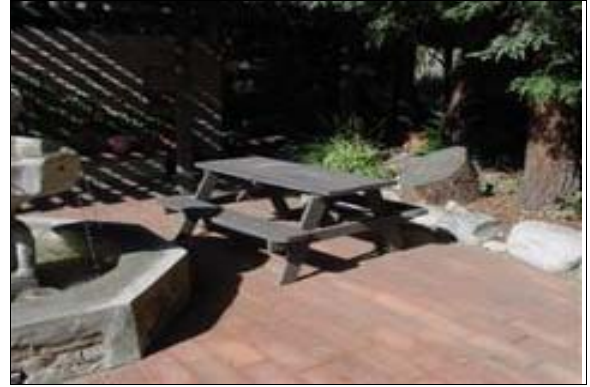
***Path of Travel to the Outdoor Dining Area***

**Finding:** There are only stairs to the primary functions provided at the outdoor dining area outside of the Museum, preventing access to individuals with mobility impairments.

**Full Rec:** Since programs, services and activities to staff and the public are provided in this location, those programs, services and activities are required to be made accessible. It is recommended that a ramp be installed or other means of vertical access.

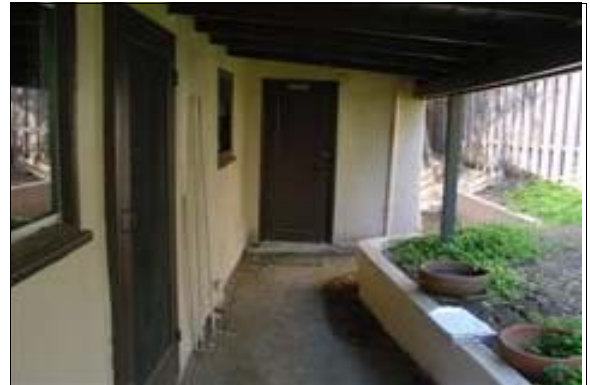
***Path of Travel to the Restroom at the Rear of the Museum***

**Finding:** The path of travel to the unisex restroom at the rear of the Museum is dirt, preventing access to individuals with mobility impairments.

**Full Rec:** Install an accessible route to where programs, services and activities are provided (see CBC 1114B.1.2 and ADAAG 4.3.2). The minimum width of the path of travel shall be 48 inches with a firm, stable and slip-resistant surface. No protruding objects are permitted on the accessible path of travel and slopes shall not exceed 5% in the direction of travel.

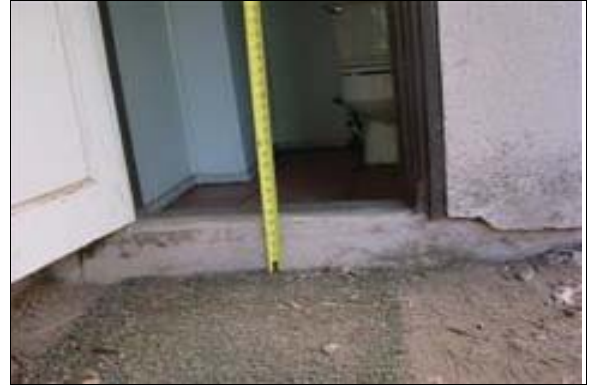
**Path of Travel to the Restroom at the Rear of the Museum**

**Finding:** There is a step on the primary path of travel to the unisex restroom at the rear of the Museum, preventing access to individuals with mobility impairments.

**Full Rec:** Since programs, services and activities to staff and the public are provided in this location, those programs, services and activities are required to be made accessible. It is recommended that a ramp be installed or other means of vertical access.

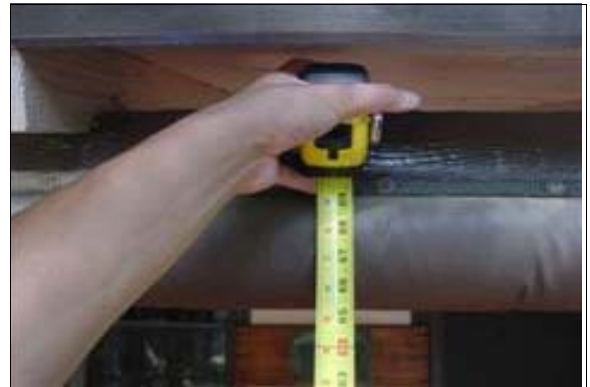
**Protruding Object**

**Finding:** The vertical headroom clearance outside of the Museum is less than 80 inches in height.

**Full Rec:** Install a barrier, where there is less than 80 inches of clear vertical headroom, to warn blind or visually impaired individuals. A planter or a permanent piece of furniture may be used (see CBC 1121B.2 and ADAAG 4.4.2).

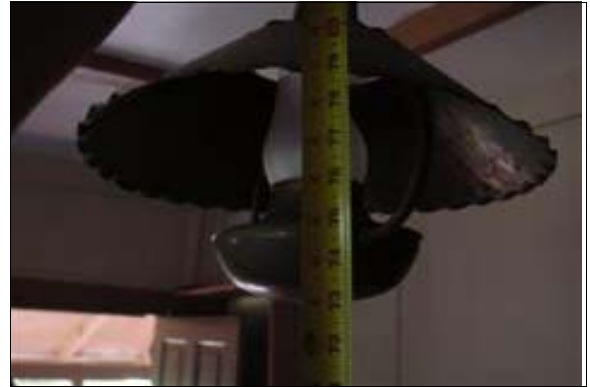
**Protruding Object**

**Finding:** The leading edge of the light in the lobby at the Museum is more than 4 inches from the wall and less than 80 inches above the floor and protrudes into the primary path of travel.

**Full Rec:** Modify or relocate the light so that the leading edge protrudes less than 4 inches from the wall and is at least 80 inches above the floor (see CBC 1121B.1 and ADAAG 4.4).

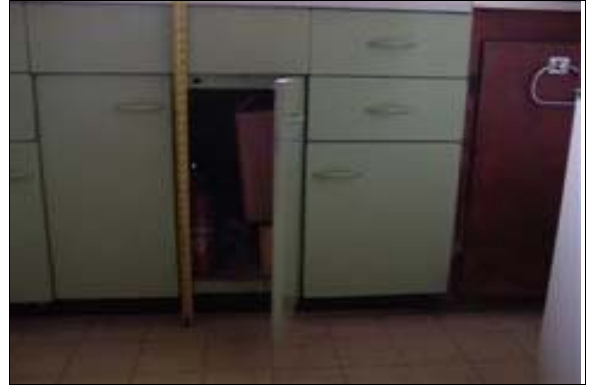
**Sink in the Museum**

**Finding:** The pipes under the sink in the Kitchen do not provide protection against contact.

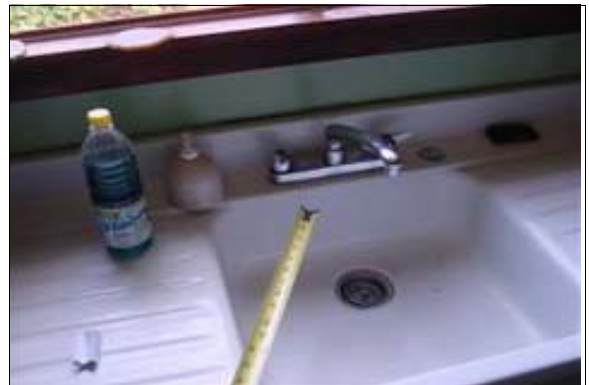
**Sink in the Museum**

**Finding:** The faucet controls on the sink in the Kitchen require tight grasping, pinching, or twisting of the wrist and are not accessible.

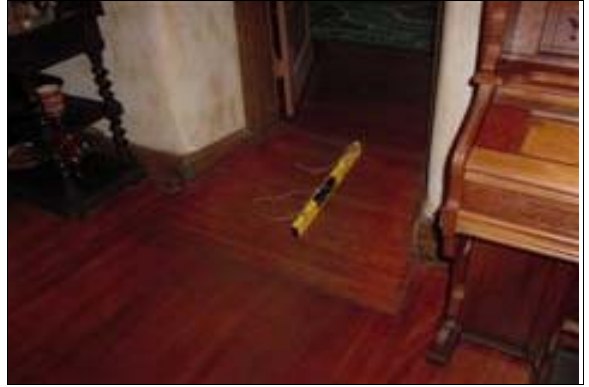
**Interior Door to the Dining Area in the Museum**

**Finding:** The clear opening width of the door is less than 32 inches.

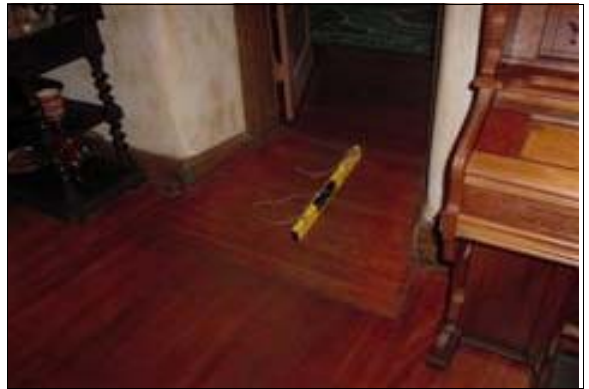
**Interior Door to the Dining Area in the Museum**

**Finding:** There is no level landing provided at the entrance door.

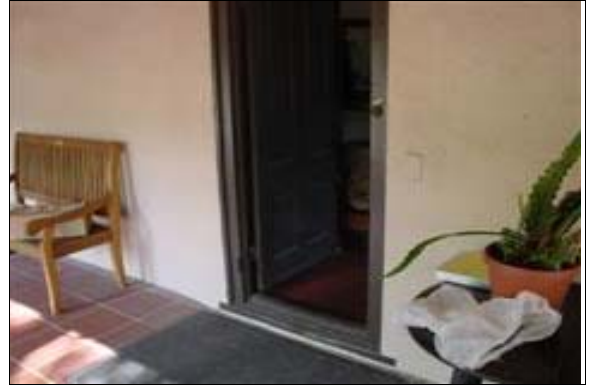
**Finding:** The exterior passage door has a round doorknob, which requires twisting of the wrist to operate.

**Full Rec:** Replace the existing door hardware with accessible hardware (see ADAAG 4.13.9).

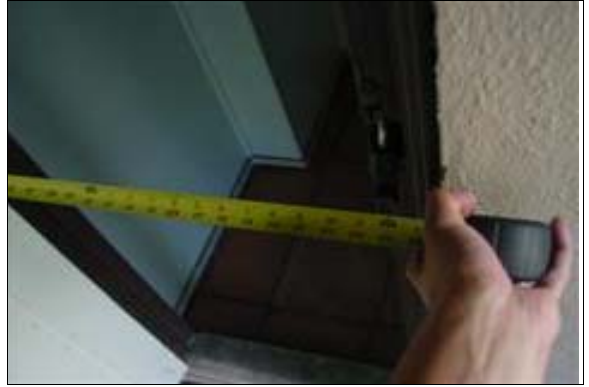
***Unisex Restroom at the Rear of the Museum***

**Finding:** The clear opening width of the entrance doorway to the restroom is less than 32 inches.

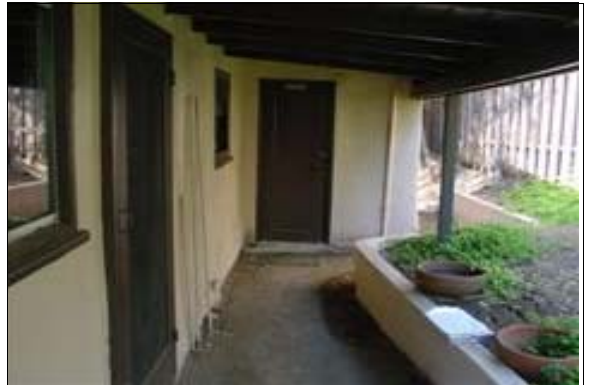
***Unisex Restroom at the Rear of the Museum***

**Finding:** The entrance door to the restroom has a round doorknob that requires tight grasping or twisting of the wrist to operate.

**Full Rec:** Replace the door hardware mounted on the restroom complying with ADAAG 4.13.9. Make certain accessible door hardware is mounted no higher than 48 inches above the finished floor.

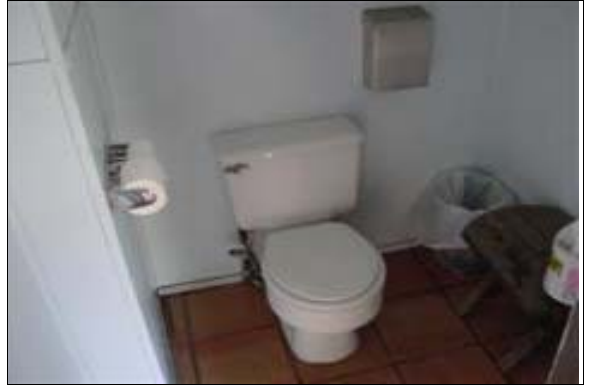
***Unisex Restroom at the Rear of the Museum***

**Finding:** The flush control on the toilet in the restroom is not on the wide (approach) side of the toilet.

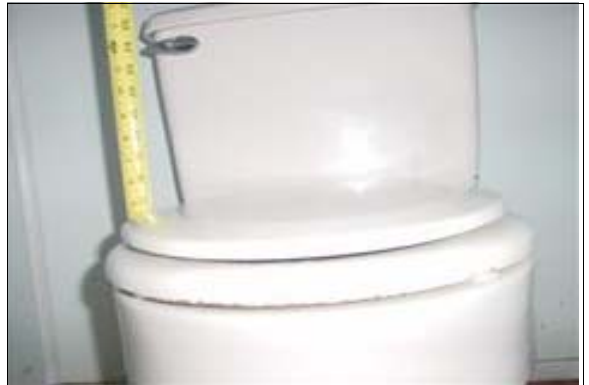
***Unisex Restroom at the Rear of the Museum***

**Finding:** The height of the toilet seat in the restroom is less than 17 inches above the finished floor.

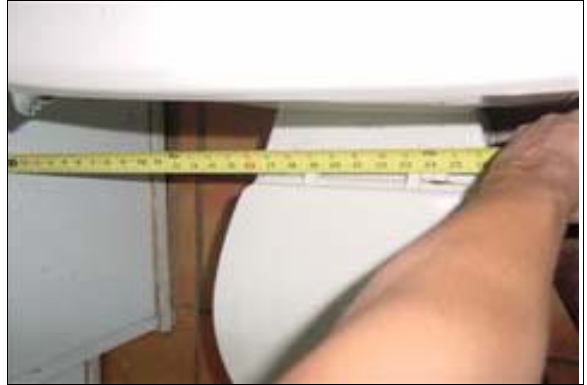
**Unisex Restroom at the Rear of the Museum**

**Finding:** The distance from the center of the toilet to the nearest side wall in the restroom is greater than 18 inches.

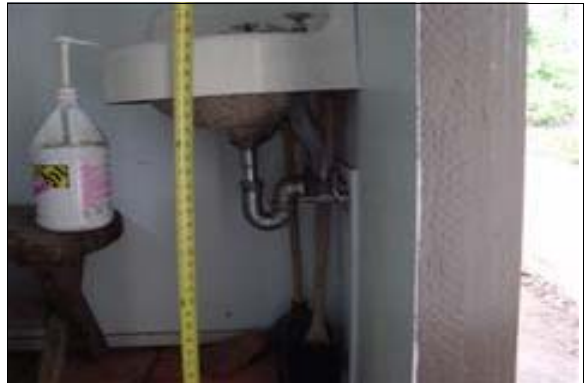
**Unisex Restroom at the Rear of the Museum**

**Finding:** The faucet controls on the lavatory in the restroom require tight grasping, pinching, or twisting of the wrist and are not accessible.

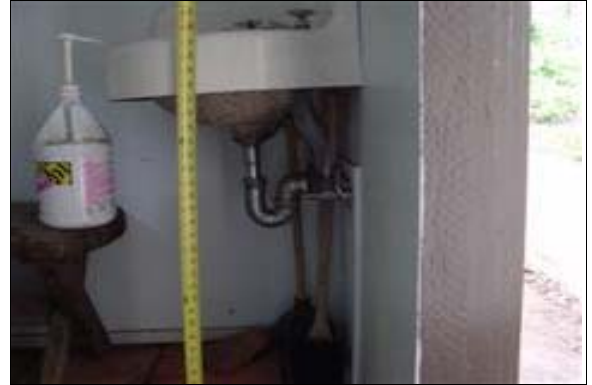
**Unisex Restroom at the Rear of the Museum**

**Finding:** The distance from the center of the lavatory to the adjacent side wall in the restroom is less than 18 inches.

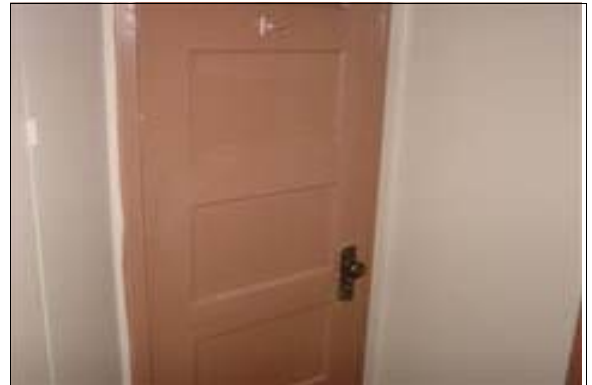
**Unisex Restroom in the Museum**

**Finding:** There is no signage indicating accessibility on the latch side of the entry door of the restroom. There is no Title 24 gender use signage on the entrance door.
