Photo Report

Verdugo Park

Finding: The Verdugo Park, located 1621 Canada Boulevard in Glendale California, was inspected by Disability Access Consultants, Inc., on June 5, 2007. Facilities include the Verdugo Park Skate Park Operations Office, Caretaker's House, Food Service Building, Maintenance Building, North and South restrooms, Stengel Field, and the Stengel Field Stadium.

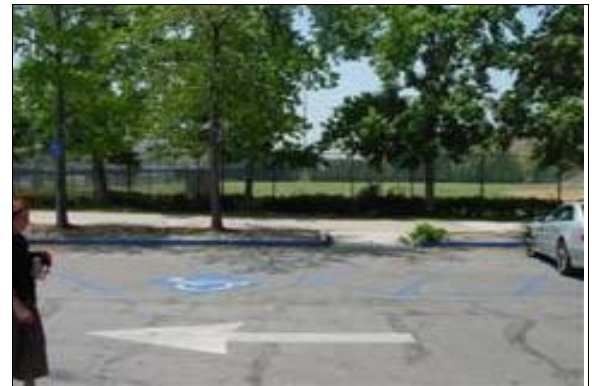
Parking Lot Next to the Skate Park Operations Office

Finding: There are two accessible parking spaces out of 26 parking spaces which is sufficient in number as required for compliance. Each accessible parking space provided measures at least 108 inches wide and 216 inches long. The accessible parking spaces share a "van-accessible" access aisle measuring 112 inches wide. The access aisle does not contain "NO PARKING" in 12" high white letters.

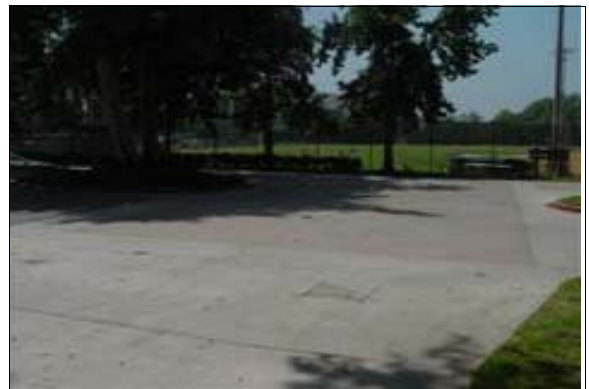
Parking Lot Next to the Skate Park Operations Office

Finding: There is no crosswalk provided on the path of travel from the accessible parking space to the facility. The required accessible route crosses a vehicular way.

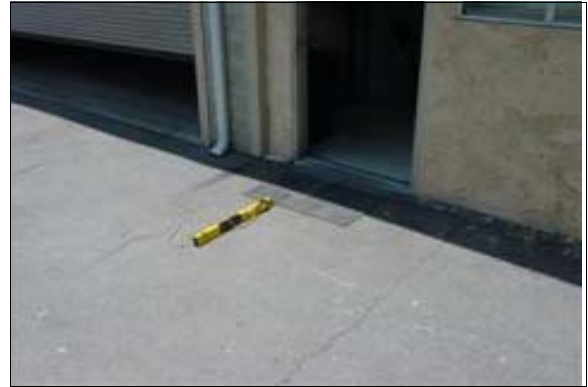
Path of Travel to the Maintenance Building

Finding: The mat at the entrance does not adhere to the underlying floor surface and creates a hazardous path of travel.

Full Rec: Securely fasten the mats or replace with a mat that grips to the underlying floor surface to provide a firm, stable, continuous and relatively smooth path of travel surface (see CBC 1124B.3 and ADAAG 4.5.3). Mats along the primary path of travel shall provide beveled edges on all sides to prevent roll over.
