**Photo Report**  
**Wilson Mini Park**  
**Programs, Services, and Activities**

**Finding:** The Wilson Mini Park, located at 1101 Wilson Avenue in Glendale California, was inspected by Disability Access Consultants, Inc., on August 13, 2007.

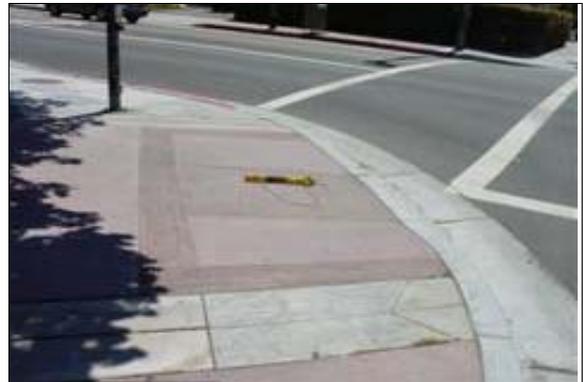
**Curb Ramp at the Corner of Wilson and Adams**  
 Citations: CBC 1127B.5.3; ADAAG 4.7.2 & 4.29  
 Minimum Quantity: 1  
 Maximum Quantity: 1  
**Minimum Estimated Cost:** \$1,033.00  
**Maximum Estimated Cost:** \$1,033.00  
 Record Number: 1744  
 Priority:

**Finding:** The slope of the curb ramp is greater than 8.33%. The slope at the bottom landing is greater than 2%. The slope at the top landing is greater than 2%. The slope of the side flares is greater than 10%. The concrete curb ramp does not provide a detectable warning surface which includes truncated domes.

**Full Rec:** Replace the curb ramp with a compliant curb ramp at least 48 inches in width that provides a slope no greater than 8.33%. Install a detectable warning surface which extends the full length and width of the concrete curb ramp and its side flares with truncated domes that contrast visually by either light on dark or dark on light which is an integral part of the concrete curb ramp. The truncated domes may be cast in place or stamped or of a prefabricated surface treatment (see CBC 1127B.5.8).

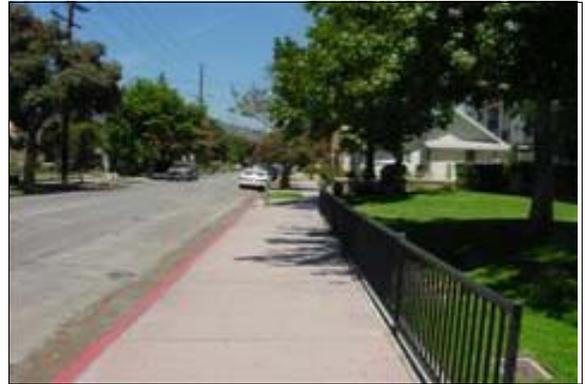
**Accessible Route from the Public Right of Way**

**Finding:** There is an accessible route from the public right of way to the accessible entrance of the facility.

**Full Rec:** Post directional signage. Make certain to post signage indicating the direction to accessible building entrances at every major junction along the accessible route. Signs shall include the International Symbol of Accessibility.

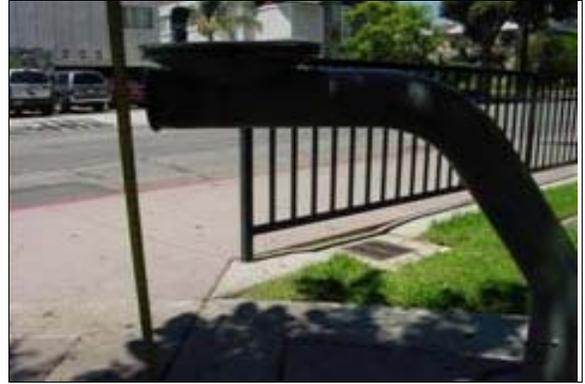
**Finding:** There is one drinking fountain on primary paths of travel.

**Full Rec:** Fifty percent of the drinking fountains on primary paths of travel shall be accessible (see CBC 1117B.1 and ADAAG 4.15). Install a "high-low" fountain design to comply with both state and federal requirement. Fountains not located in alcoves need side rails or wing walls on both sides.

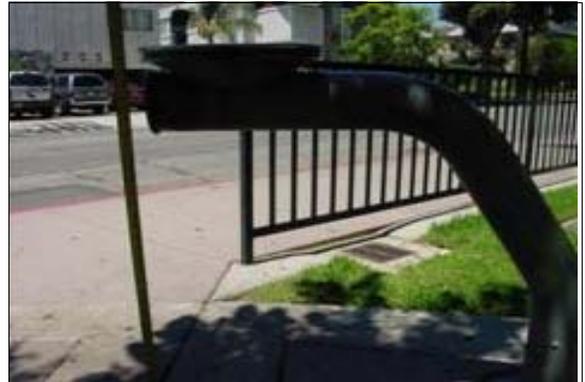
***Drinking Fountain Next to the Play Equipment***

**Finding:** The drinking fountain is not a "high-low" design.

**Full Rec:** Fifty percent of the drinking fountains on primary paths of travel shall be accessible (see CBC 1117B.1 and ADAAG 4.15). Install a "high-low" fountain design to comply with both state and federal requirements and install a side rail or wing wall next to each side of the fountain.

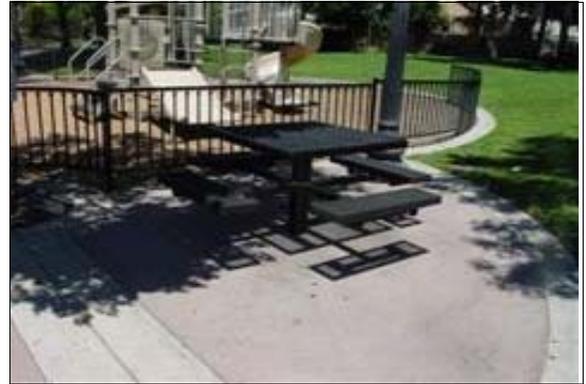
**Outdoor Dining Area**

**Finding:** The tables in the outdoor dining area are nonaccessible by design.

**Full Rec:** Modify or replace one of the tables in the outdoor dining area to provide knee clearance of at least 27 inches in height, 30 inches in width and 19 inches in depth (see CBC 1122B.3, ADAAG 4.32.2 and ADAAG Figure 45). The table top height shall not exceed 34 inches above the finished floor.

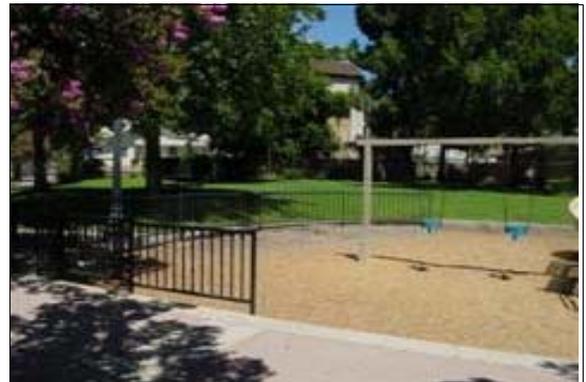
**Play Equipment**

**Finding:** The surface beneath the play equipment is wood chips, making the area nonaccessible to individuals with mobility impairments. There is a change in elevation greater than 1/2 inch at the entrance to the play equipment, due to the a lack of fill.

**Full Rec:** The play area should be made an accessible play area for the facility. Provide a maneuvering space with an accessible resilient surface beneath the play components and adjacent to the play components where technically feasible. An adequate maneuvering space has an accessible surface and is not less than 60 inches by 60 inches where an individual with a mobility impairment can be a part of the activities provided at the play components.
