Photo Report
Windsor Mini Park
Programs, Services, and Activities

Windsor Mini Park

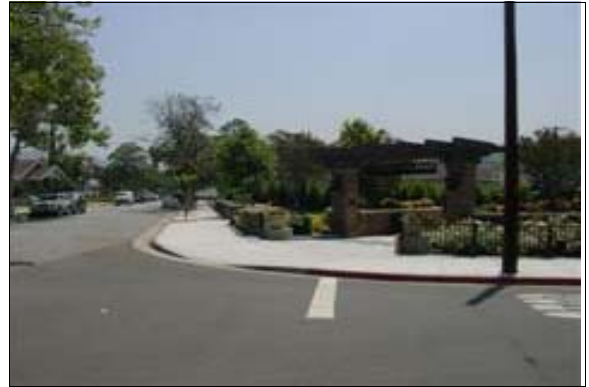
Finding: The Windsor Mini Park, located at 1300 East Windsor in Glendale California, was inspected by Disability Access Consultants, Inc., on June 12, 2007.

Full Rec: Any renovation or new construction that occurred after January 26, 1992, is subject to meet full code specifications for the California Building Code and ADAAG requirements. All recommendations in this report are based on ADAAG and CBC title 24 requirements. Consult with your design professional to determine which elements are affected by these requirements. It is recommended that Disability Access Consultants, Inc. is consulted for inspection of any new construction or renovation at the facility.

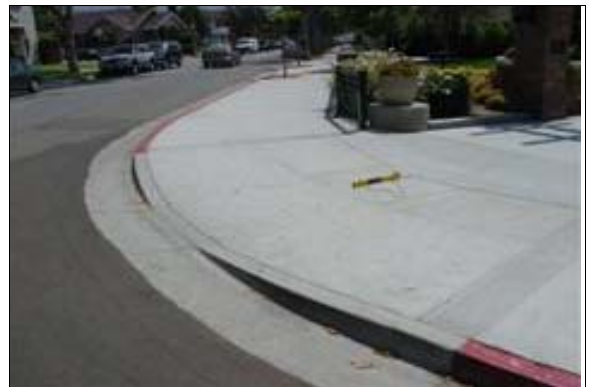
Curb Ramp at the Entrance to the Park
 Citations: CBC 1127B.5.3; ADAAG 4.7.2 & 4.29
 Minimum Quantity: 1
 Maximum Quantity: 1
Minimum Estimated Cost: \$1,033.00
Maximum Estimated Cost: \$1,033.00
 Record Number: 1752
 Priority:

Finding: The width of the curb-cut ramp is less than 48 inches. The slope at the bottom landing is greater than 2%. The concrete curb ramp does not provide a detectable warning surface which includes truncated domes.

Full Rec: Replace the curb ramp with a compliant curb ramp at least 48 inches in width that provides a slope no greater than 8.33%. Install a detectable warning surface which extends the full length and width of the concrete curb ramp and its side flares with truncated domes that contrast visually by either light on dark or dark on light which is an integral part of the concrete curb ramp. The truncated domes may be cast in place or stamped or of a prefabricated surface treatment (see CBC 1127B.5.8).

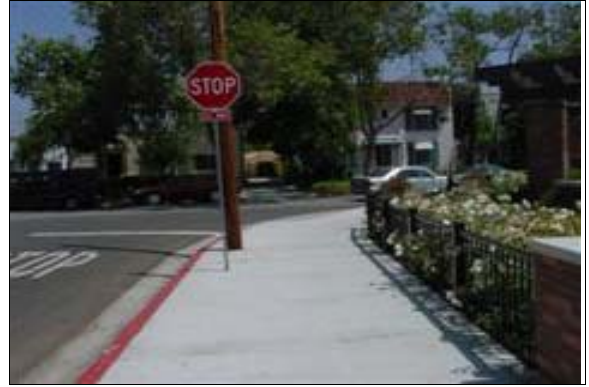
Accessible Route from the Public Right of Way

Finding: There is an accessible route from the public right of way to the accessible entrance of the facility.

Full Rec: Post directional signage. Make certain to post signage indicating the direction to accessible building entrances at every major junction along the accessible route. Signs shall include the International Symbol of Accessibility.

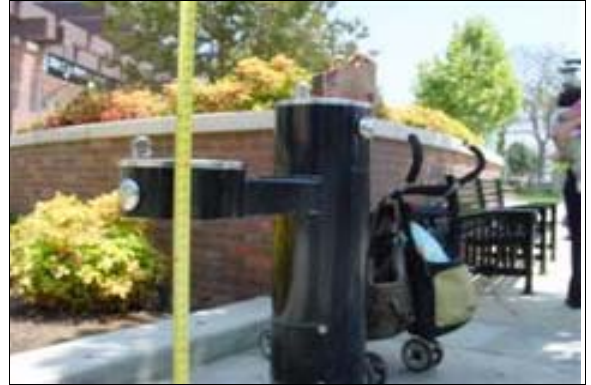
Finding: There is one drinking fountain on primary paths of travel.

Full Rec: Fifty percent of the drinking fountains on primary paths of travel shall be accessible (see CBC 1117B.1 and ADAAG 4.15). Install a "high-low" fountain design to comply with both state and federal requirement. Fountains not located in alcoves need side rails or wing walls on both sides.

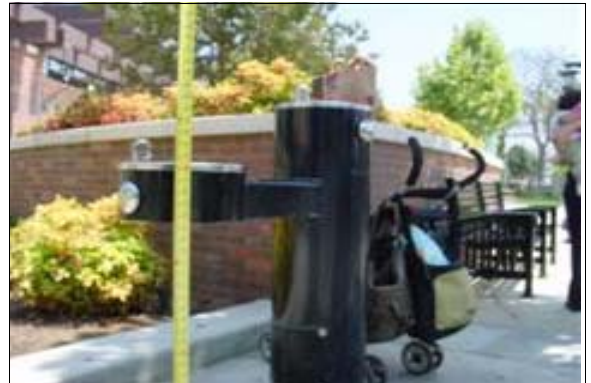
Drinking Fountain at the Outdoor Dining Area

Finding: The leading edge of the drinking fountain is more than 4 inches from the wall and greater than 27 inches from the floor and protrudes into the primary path of travel.

Full Rec: Fifty percent of the drinking fountains on primary paths of travel shall be accessible (see CBC 1117B.1 and ADAAG 4.15). Install a side rail or wing wall next to each side of the fountain.
