Photo Report
Youth and Family Services Office
Programs, Services, and Activities

Finding: The Youth and Family Services Office, located at 815 East Harvard in Glendale California, consists of one single story structure. The facility was inspected by Disability Access Consultants, Inc., on June 5, 2007.

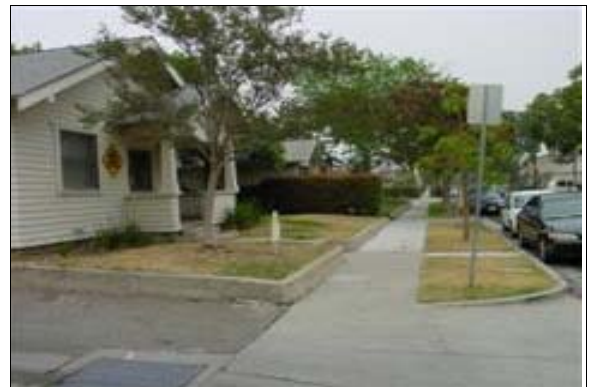
Accessible Route from the Public Right of Way

Finding: There is no accessible route from the public right of way to the accessible entrance of the facility. There are only stairs on the primary path of travel.

Alternative Post directional signage.
Rec:
(Where Available)

Full Rec: Provide at least one accessible route from the public right of way to the accessible entrance of the facility. Make certain to post signage indicating the direction to accessible building entrances at every major junction along the accessible route. Signs shall include the International Symbol of Accessibility.

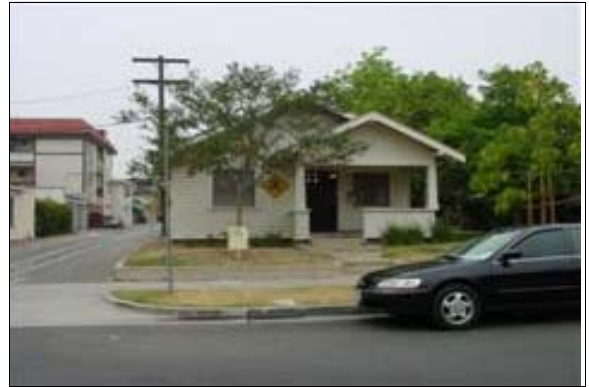
Path of Travel to the Youth and Family Services Office

Finding: There are only stairs to the primary functions provided, preventing access to individuals with mobility impairments.

Full Rec: Since programs, services and activities to staff and the public (volunteers, etc.) are provided in this location, those programs, services and activities are required to be made accessible. It is recommended that a ramp be installed or other means of vertical access.

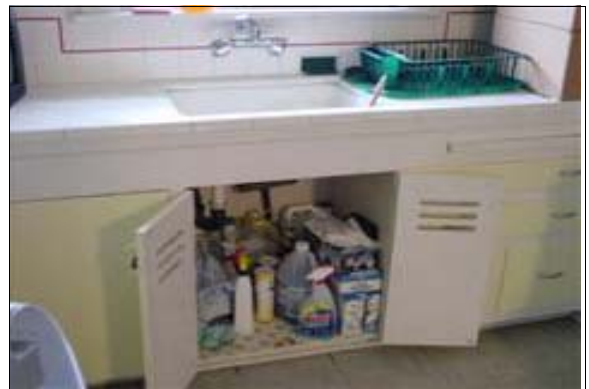
Sink in the Kitchen

Finding: The sink in the Kitchen is in an enclosed cabinet, thereby preventing an accessible forward approach. The height of the counter surface of the sink is greater than 34 inches above the finished floor.

Full Rec: Sinks in rooms must provide clear floor space in front of the sink for an accessible forward approach and shall provide at least 27 inches clear knee space and a minimum of nine inches clear toe space (see ADAAG 4.19.2). If neither clear floor space and knee and toe clearance can be provided, remove the sink cabinet and replace with an accessible wall-mounted sink unit.

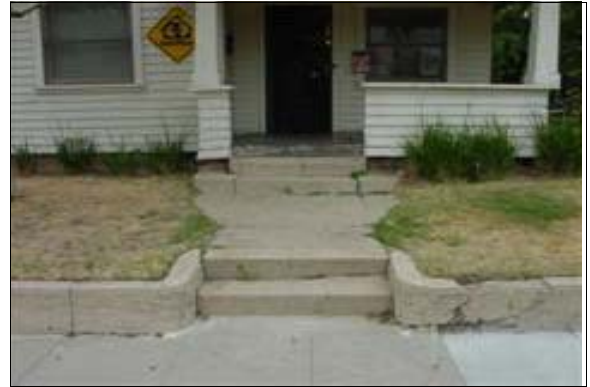
Exterior Stairs to the Main Entrance

Finding: There are no handrails provided on the stairway.

Full Rec: Install pipe rail handrails on each side of stairway that provide a gripping surface between 1 1/4 to 1 7/8 inches with 12-inch top and bottom handrail extensions that extend beyond the top and bottom treads of the stairway which are parallel to the floor surface. Handrails shall be mounted at a height between 34 and 38 inches at a distance no less than 1 1/2 inches from the adjacent wall.

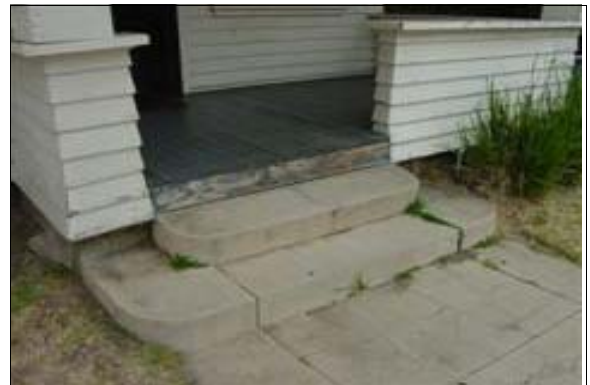
Exterior Stairs to the Main Entrance

Finding: The riser height is not uniform.

Full Rec: Modify or replace the stairs to provide a uniform riser height between 4 and 7 inches (see CBC 1006.3).

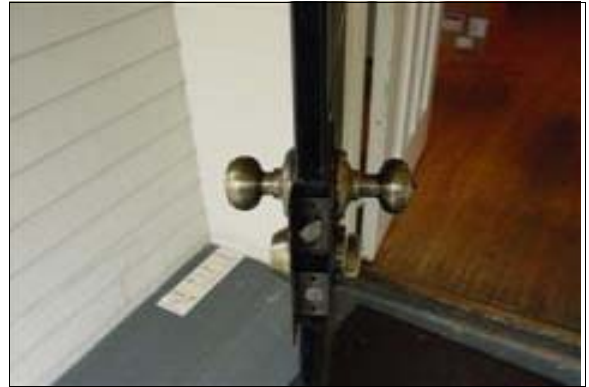
Main Entrance

Finding: The exterior passage door has a round doorknob, which requires twisting of the wrist to operate.

Full Rec: Replace the existing door hardware with accessible hardware (see ADAAG 4.13.9).

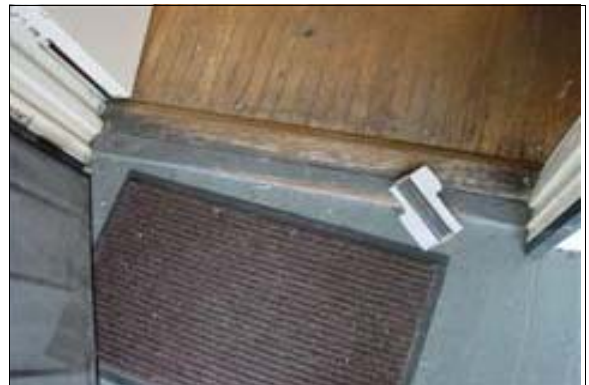
Main Entrance

Finding: The height of the threshold at the entrance door is greater than 1/2 inch.

Full Rec: Modify or replace the threshold to provide a smooth transition. The threshold should not exceed a beveled 1/2 inch. Provide a 60 inch level landing in the direction of the door swing.

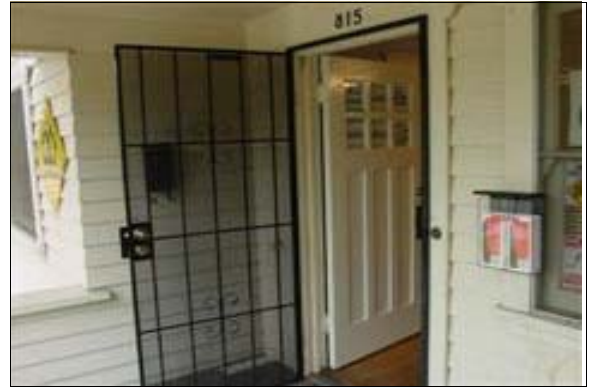
Main Entrance

Finding: The vertical clearance height of the entrance door provides less than 80 inches.

Full Rec: Consult a design professional to determine the feasibility of extending the height of the doorway to provide at least 80 inches clearance height (see CBC 1133B.2.3.1 and ADAAG 4.4.2).

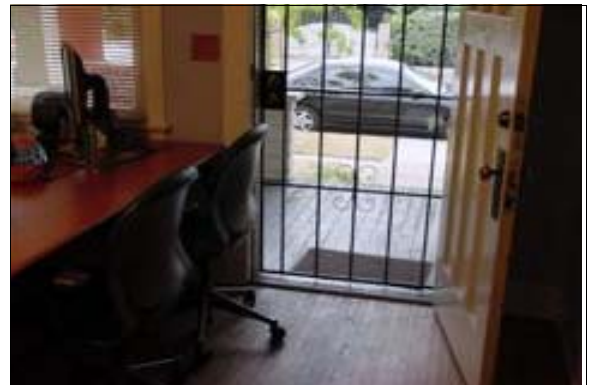
Main Entrance

Finding: There is less than 24 inches of clearance on the latch side of the exterior entrance door, due to the placement of the desk.

Full Rec: Relocate the desk to provide at least 24 inches of latch side clearance at the entrance door. Otherwise, install an automatic door opening device to the primary entrance complying with ADAAG 4.13.12 and ANSI/BHMA A156.10, 1985, standards.

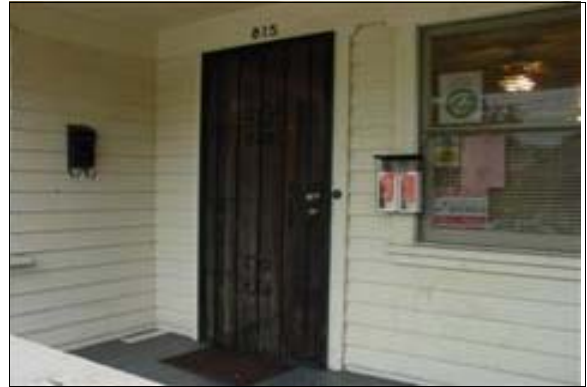
Main Entrance

Finding: The main entrance does not have accessible signage mounted on the wall adjacent to the latch side of the door.

Full Rec: Install signage centered at 60 inches above the finished floor on the wall adjacent to the latch side of the entry doorway stating ENTRANCE from the outside and EXIT from the inside, with raised UPPERCASE letters between 5/8 inch and 2 inches in height and Grade 2 Braille characters. The sign shall comply with the finish and contrast requirements set forth in CBC 1117B.5 and ADAAG 4.30.5. Signage should be located where a person may approach within three inches of the sign without encountering protruding objects or standing within the swing of the door.

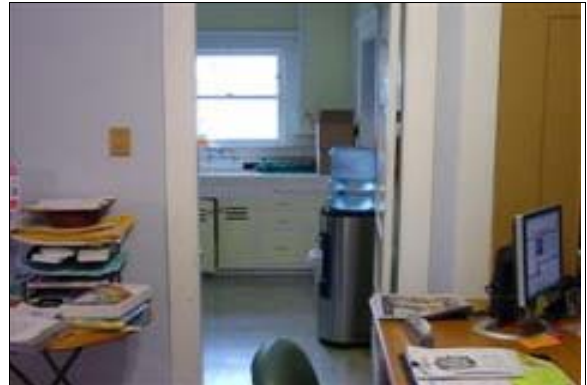
Room Signage

Finding: Rooms do not have accessible signage mounted on the wall adjacent to the latch side of the doors.

Full Rec: Install accessible signage identifying each room on the wall adjacent to the latch side of the doorway centered at 60 inches above the finished floor. Signage should be located where a person may approach within three inches of the sign without encountering protruding objects or standing within the swing of the door. Signs shall include raised UPPERCASE letters/numbers between 5/8 inch and 2 inches in height and Grade 2 Braille characters. Color and finish shall comply with CBC 1117B.5 and ADAAG 4.30.

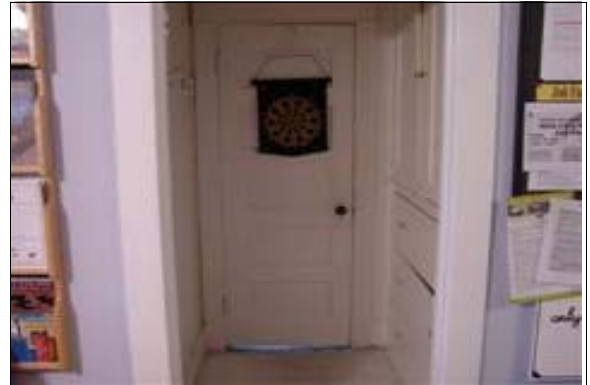
Unisex Restroom

Finding: There is no signage indicating accessibility on the latch side of the entry door of the restroom. There is no Title 24 gender use signage on the entrance door.

Full Rec: The restroom is designated accessible and should be made accessible for the facility. Post signage centered 60 inches above the ground surface on the latch side of the entrance door identifying the restroom as accessible upon completion of the following items (see CBC 1115B., ADAAG 4.1.2(7) and ADAAG 4.1.6(3)(e). Signage shall include Braille and raised lettering, the gender or unisex use symbol and the ISA symbol. Post Title 24 gender use signage on the door @ 60" o.c. a.f.f.

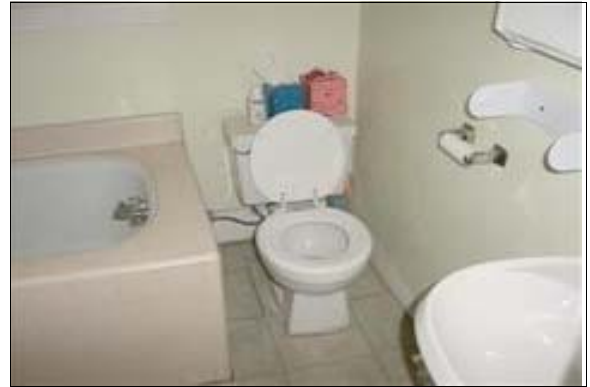
Unisex Restroom

Finding: The distance from the center of the toilet to the nearest side wall in the restroom is less than 18 inches.

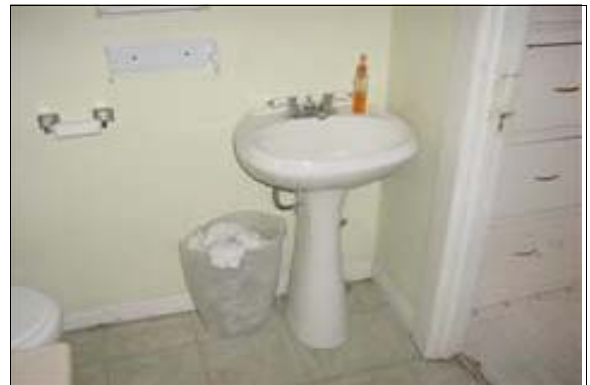
Unisex Restroom

Finding: The knee clearance space under the lavatory designated to be accessible in the restroom is less than 29 inches. The knee depth space under the lavatory designated to be accessible in the restroom is less than 27 inches at 8 inches under the lavatory apron.

Full Rec: Replace the lavatory designated to be accessible in the restroom to provide at least 29 inches of clear knee space between the finished floor and bottom of the lavatory apron. Make sure to provide at least 27 inches at 8 inches under the apron (see ADAAG 4.19.2).
