Accessibility Survey

City of Glendale

Downtown Parking Lot #10

Inspected January 2008

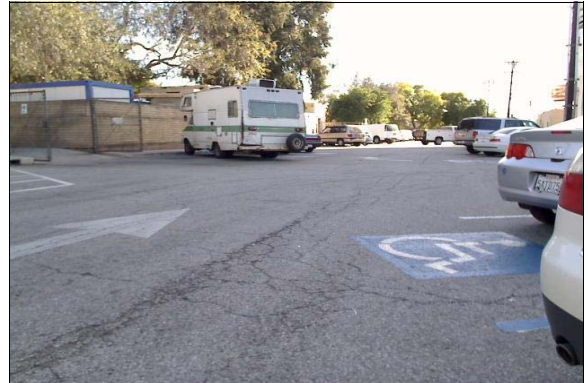
Finding: Parking Lot #10 is located at 101 East Harvard Street in Glendale, California. The parking lot was inspected by Disability Access Consultants, Inc., on January 15, 2008.

Full Rec: Any renovation or new construction that occurred after January 26, 1992, is subject to meet full code specifications for the California Building Code and ADAAG requirements. All recommendations in this report are based on ADAAG and CBC Title 24 requirements. Consult with your design professional to determine which elements are affected by these requirements. It is recommended that Disability Access Consultants, Inc. is consulted for inspection of any new construction or renovation at the facility.

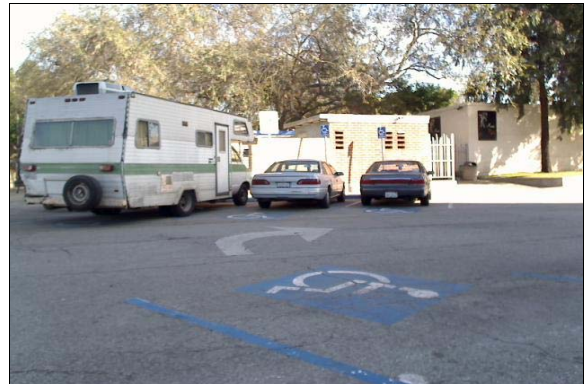
Accessible Parking

Finding: There are 6 accessible parking spaces out of 69 parking spaces which exceeds by three spaces the minimum needed for compliance. The accessible parking spaces do not measure at least 108 inches wide and do not have compliant access aisles. There is no designated "van-accessible" parking space.

Full Rec: Restripe the existing accessible spaces so each measures at least 108 inches wide and 216 inches long. Designate one parking space as "van-accessible". The van-accessible space shall provide a 96 inch wide access aisle on the passenger side the space. Each accessible space shall provide an access aisle measuring at least 60 inches wide. Add the words NO PARKING in 12 inch high white letters at the entrance to each accessible parking access aisle.

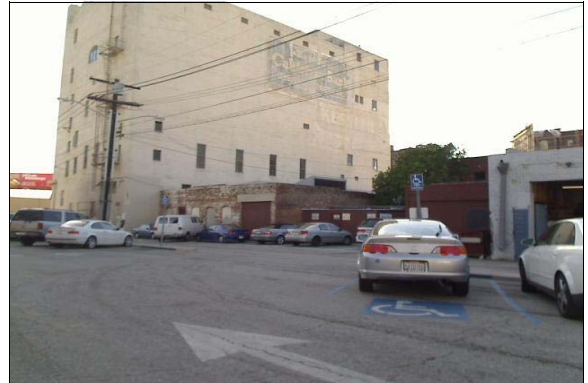
Accessible Parking

Finding: There is no accessible route between the accessible parking spaces and the public right of way.

Full Rec: Install a compliant path of travel from the sidewalk (public right of way) to the accessible parking space.

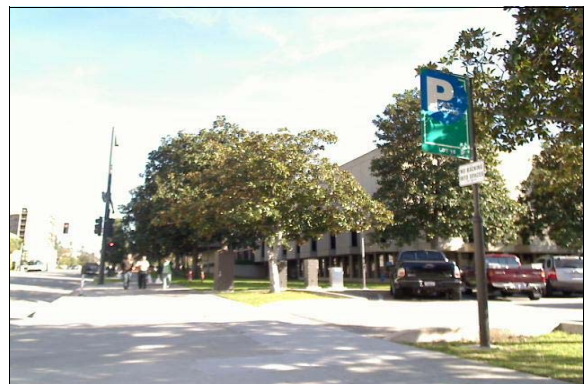
Accessible Parking

Finding: There is no warning signage posted at the parking lot entrance regarding unauthorized use of accessible parking spaces in the parking lot.

Full Rec: Post a sign in a conspicuous place at the entrance of the parking lot, or immediately adjacent to and visible from each accessible space. The warning sign shall measure at least 17 inches by 22 inches in size and consist of lettering at least 1 inch in height that states the following; "Unauthorized vehicles parked in designated accessible spaces not displaying distinguishing placards or license plates issued for persons with disabilities may be towed away at owner's expense. Towed vehicles may be reclaimed at _____ or by telephoning ____ ." Fill in the blank spaces with appropriate information as a permanent part of the sign and be sure to add the CVC 22511.8(a)(d) to the sign.

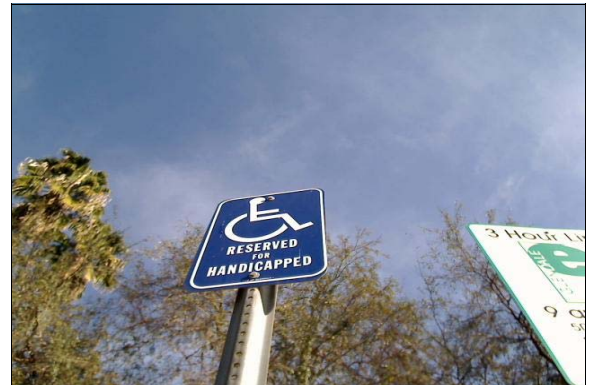
Accessible Parking

Finding: There is vertically-mounted signage at the accessible parking spaces, however, the signs use the word "Handicapped".

Full Rec: Install a permanently posted reflectorized sign measuring 70 square inches that includes an ISA symbol adjacent to and visible from the accessible parking space (see CBC 1129B.5). The bottom edge of the sign must be mounted 80 inches from the ground surface so that it cannot be obscured by a parked vehicle (see CBC 1129B.5). The "van-accessible" parking space shall provide an additional sign marked "van-accessible" mounted below the sign (see CBC 1129B.5 and ADAAG 4.6.4).

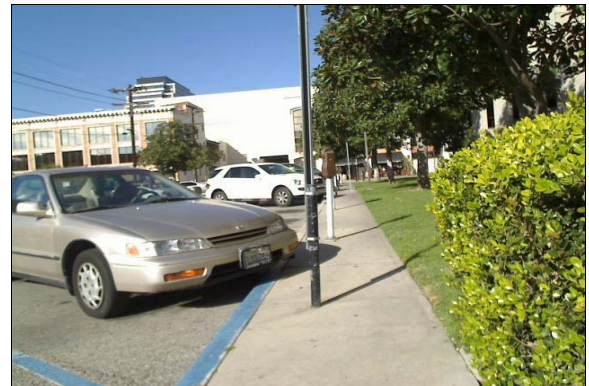
Accessible Parking

Finding: There is no device at the head of the accessible parking space and other general parking spaces to prevent vehicles from encroaching into the minimum width of the sidewalk,

Full Rec: Install a wheelstop at the head of the accessible parking spaces and the general parking spaces that are next to sidewalks. Wheelstops shall be used to prevent vehicles from encroaching into accessible aisles or walkways, but shall not present addition encroachment into those areas (see CBC 1129B.4.3).

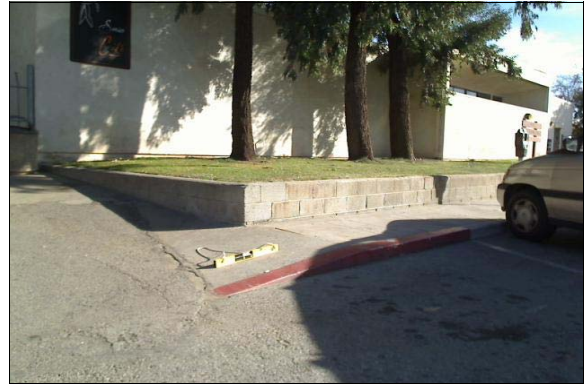
Curb Ramp in front of the Adult Recreation Center

Finding: The slope of the concrete curb-cut ramp is greater than 8.33%. The cross slope is greater than 2%. The width of the curb-cut ramp is less than 48 inches. The slope at the top and bottom landing is greater than 2%.

Full Rec: Replace the curb ramp with a compliant curb ramp that is at least 48 inches in width, slopes no greater than 8.33%, cross slopes no greater than 2%, and has a level top and bottom landing.

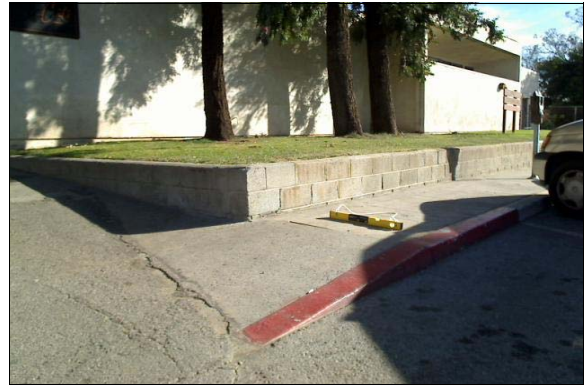
Curb Ramp in front of the Adult Recreation Center

Finding: The curb ramp does not provide a grooved border along the top and a detectable warning surface of truncated domes.

Full Rec: Provide a grooved border at least 12 inches wide along the top of the curb ramp and install a compliant detectable warning surface of truncated domes.

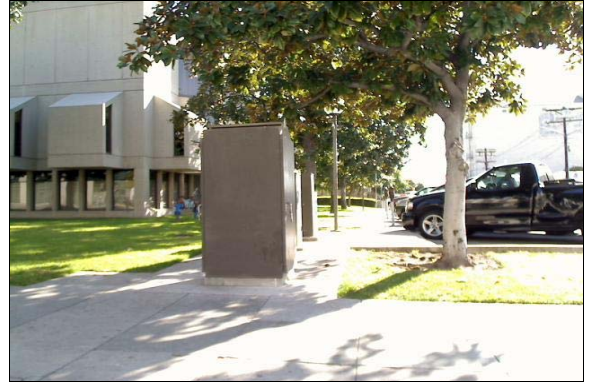
Accessible Route from the Public Right of Way

Finding: There is no accessible route from the public right of way to the parking lot or to the accessible parking spaces.

Full Rec: Provide at least one accessible route from the public right of way to the parking lot and to the accessible parking spaces. Make certain to post signage indicating the direction of the accessible route to the public right of way. Signs shall include the International Symbol of Accessibility.
