Accessibility Survey

City of Glendale

Montrose Parking Lot #5

Inspected January 2008

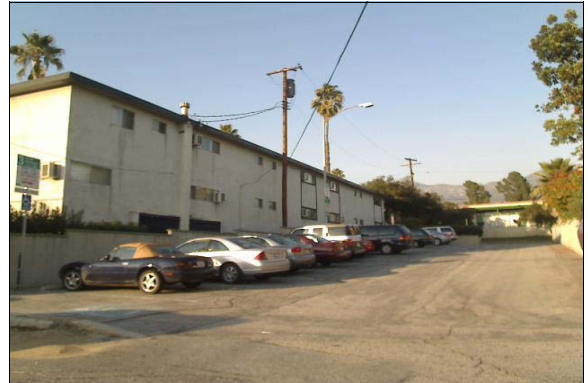
Finding: Parking Lot #5 is located on Florencita Avenue between Wickham and Orangedale in Glendale, California. The parking lot was inspected by Disability Access Consultants, Inc., on January 17, 2008.

Full Rec: Any renovation or new construction that occurred after January 26, 1992, is subject to meet full code specifications for the California Building Code and ADAAG requirements. All recommendations in this report are based on ADAAG and CBC Title 24 requirements. Consult with your design professional to determine which elements are affected by these requirements. It is recommended that Disability Access Consultants, Inc. is consulted for inspection of any new construction or renovation at the facility.

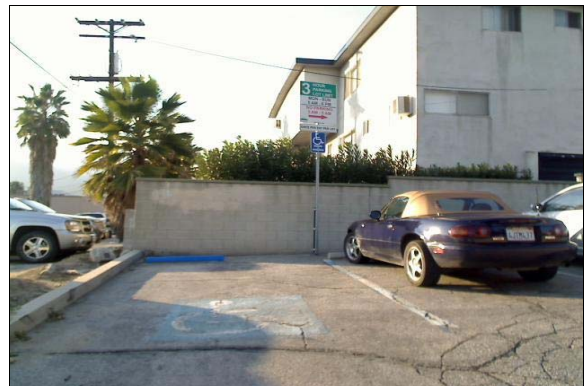
Accessible Parking

Finding: There is one accessible parking space out of 16 spaces which is sufficient for compliance. The space is not outlined on the left, the ISA pavement marking is faded, there is no access aisle and the space is not van-accessible.

Citations: CBC 1129B; ADAAG 4.6; ADAAG A4.6.

Full Rec: Restripe the existing accessible parking space to create a van-accessible space with a 96 inch wide passenger side access aisle. Add the words NO PARKING in 12 inch high white letters at the entrance to the access aisle.

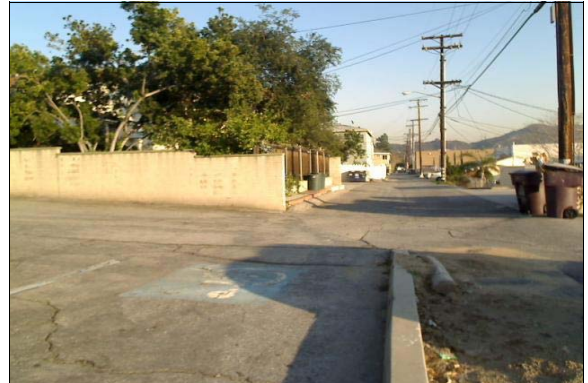
Accessible Parking

Finding: There is no accessible route between the accessible parking space and the public right of way.

Citations: CBC 1129B.4.3; ADAAG 4.7.1

Full Rec: Install a compliant path of travel from the sidewalk (public right of way) to the accessible parking space. Wheelchair users must not be forced to go behind parked cars other than their own.

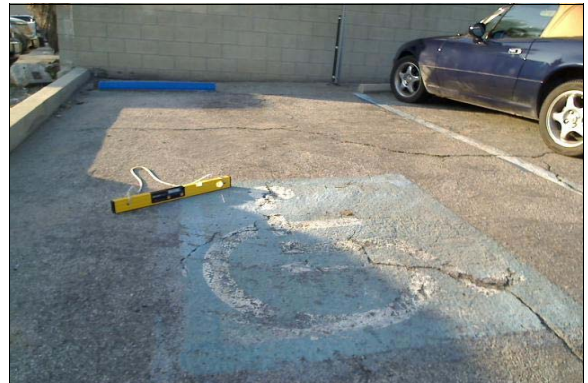
Accessible Parking

Finding: The surface of the accessible parking space has slopes greater than 2%.

Citations: CBC 1129B; ADAAG 4.6.3

Full Rec: Pave the parking lot at the accessible space to provide a level surface. Parking surfaces and access aisles shall be located in areas not exceeding a 2% slope in all directions (see CBC 1129B and ADAAG 4.6.3).

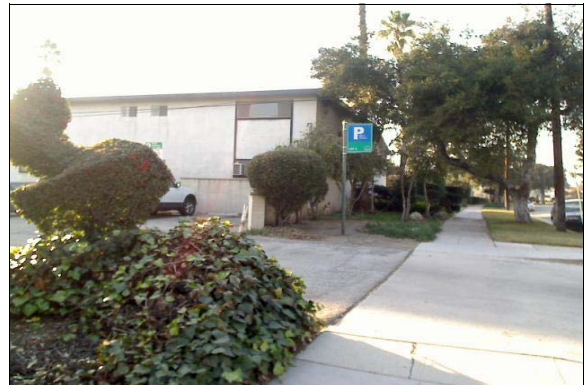
Accessible Parking

Finding: There is no warning signage posted at the entrance from Florencita Avenue regarding unauthorized use of accessible parking spaces in the parking lot.

Citations: CBC 1129B.5; ADAAG 4.6.4 CVC 22511.8(a)(d)

Full Rec: Post a sign in a conspicuous place at the entrance of the parking lot, or immediately adjacent to and visible from each accessible space. The warning sign shall measure at least 17 inches by 22 inches in size and consist of lettering at least 1 inch in height that states the following; "Unauthorized vehicles parked in designated accessible spaces not displaying distinguishing placards or license plates issued for persons with disabilities may be towed away at owner's expense. Towed vehicles may be reclaimed at _____ or by telephoning ____ ." Fill in the blank spaces with appropriate information as a permanent part of the sign and be sure to add the CVC 22511.8(a)(d) to the sign.

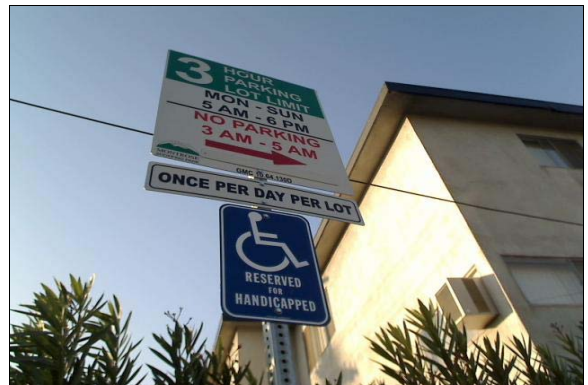
Accessible Parking

Finding: There is vertically-mounted signage at the accessible parking space, however, the signs use the word "Handicapped".

Citations: CBC 1129B.5; ADAAG 4.6.4

Full Rec: Install a permanently posted reflectorized sign measuring 70 square inches that includes an ISA symbol adjacent to and visible from the accessible parking space (see CBC 1129B.5). The bottom edge of the sign must be mounted 80 inches from the ground surface so that it cannot be obscured by a parked vehicle (see CBC 1129B.5). The "van-accessible" parking space shall provide an additional sign marked "van-accessible" mounted below the sign (see CBC 1129B.5 and ADAAG 4.6.4). Do not use the word "Handicapped" on signage.

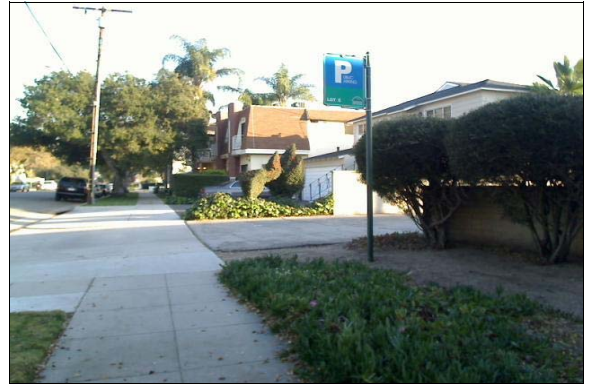
Accessible Route from the Public Right of Way

Finding: There is no accessible route from the public right of way to the parking lot or to the accessible parking space.

Citations: CBC 1114B.1.2; CBC 1117B.5.7; CBC 1127B.3; ADAAG 4.1.2(7); ADAAG 4.3.2; ADAAG 4.14.1

Full Rec: Provide at least one accessible route from the public right of way to the parking lot and to the accessible parking spaces. Make certain to post signage indicating the direction of the accessible route to the public right of way. Signs shall include the International Symbol of Accessibility.
