# **Accessibility Survey**

## **Americans with Disabilities Act And Title 24 of the California Building Code**

**City of Glendale**

**Montrose Parking Lot #6**

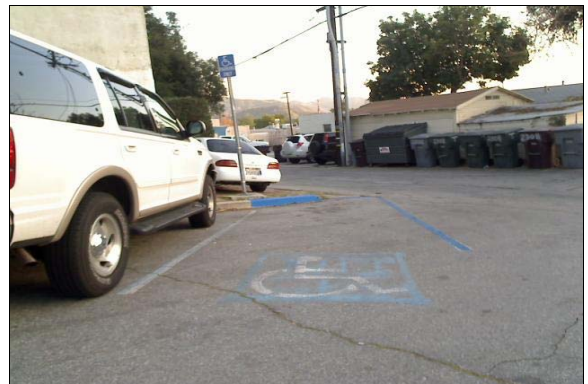
**Finding:** There is one (1) accessible parking space out of 23 parking spaces which is sufficient for compliance. The space is not van-accessible and does not measure at least 108 inches wide and 216 inches long. There is no access aisle and the pavement markings are faded.

Citations: CBC 1129B; ADAAG 4.6; ADAAG A4.6.

**Full Rec:** One (1) out of the 23 total number of marked parking space meets the number required for compliance. Restripe the existing parking space to create a van-accessible space measuring at least 108 inches wide and 216 inches long with an access aisle measuring at least 96 inches wide located on the passenger side (right side) of the parking space. Add the words NO PARKING in 12 inch high white letters at the entrance to the access aisle.

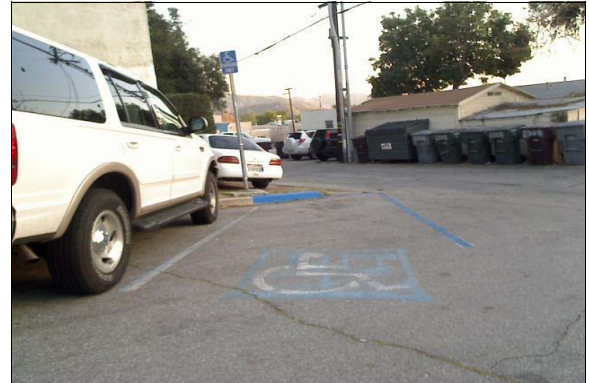
**Finding:** There is no accessible route between the accessible parking space and the public right of way.

Citations: CBC 1129B.4.3; ADAAG 4.7.1

**Full Rec:** Install a compliant path of travel from the sidewalk (public right of way) to the accessible parking space. Wheelchair users must not be forced to go behind parked cars other than their own.

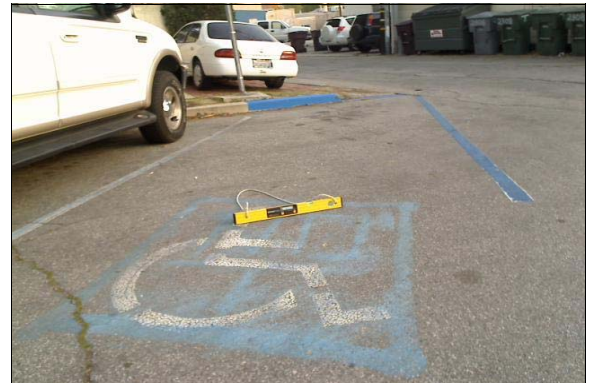
**Finding:** The surface of the accessible parking space has slopes greater than 2%.

Citations: CBC 1129B; ADAAG 4.6.3

**Full Rec:** Pave the parking lot at the accessible space to provide a level surface. Parking surfaces and access aisles shall be located in areas not exceeding a 2% slope in all directions (see CBC 1129B and ADAAG 4.6.3).

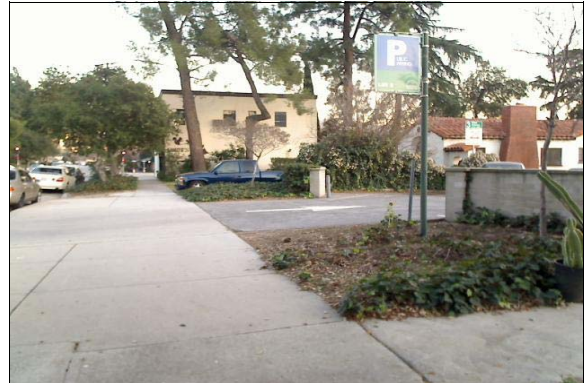
**Finding:** There is no warning signage posted at the entrance from Florencita Avenue regarding unauthorized use of accessible parking spaces in the parking lot.

Citations: CBC 1129B.5; ADAAG 4.6.4 CVC 22511.8(a)(d)

**Full Rec:** Post a sign in a conspicuous place at the entrance of the parking lot, or immediately adjacent to and visible from each accessible space. The warning sign shall measure at least 17 inches by 22 inches in size and consist of lettering at least 1 inch in height that states the following; "Unauthorized vehicles parked in designated accessible spaces not displaying distinguishing placards or license plates issued for persons with disabilities may be towed away at owner's expense. Towed vehicles may be reclaimed at \_\_\_\_\_ or by telephoning \_\_\_\_ ." Fill in the blank spaces with appropriate information as a permanent part of the sign and be sure to add the CVC 22511.8(a)(d) to the sign.

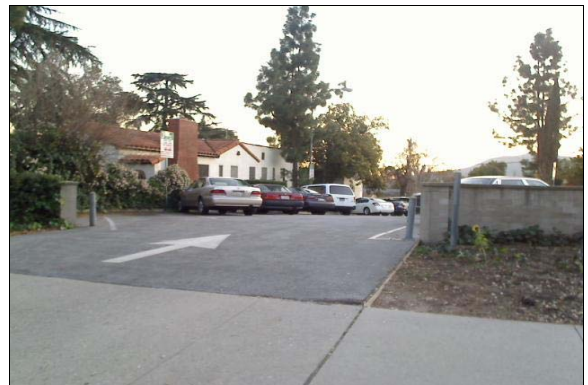
**Finding:** There is no accessible route from the public right of way to the parking lot or to the accessible parking space.

Citations: CBC 1114B.1.2; CBC 1117B.5.7; CBC 1127B.3; ADAAG 4.1.2(7); ADAAG 4.3.2; ADAAG 4.14.1

**Full Rec:** Provide at least one accessible route from the public right of way to the parking lot and to the accessible parking space. Make certain to post signage indicating the direction of the accessible route to the public right of way. Signs shall include the International Symbol of Accessibility.
