Accessibility Survey

City of Glendale

College Parking Lot #30

Inspected January 2008

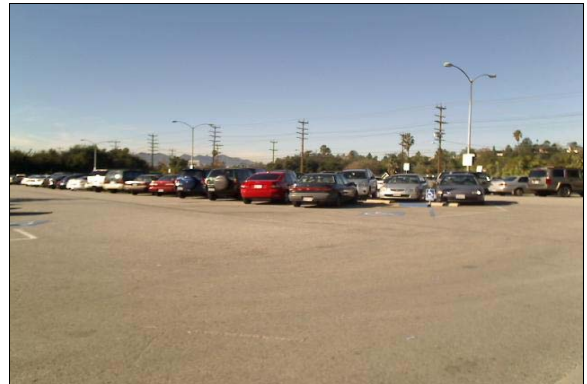
Finding: There are 4 accessible parking spaces out of 321 parking spaces which does not meet the minimum number for compliance. The accessible parking spaces measure less than the required 216 inches long by 108 inches wide and they do not have compliant access aisles. There is no designated "van-accessible" parking space.

Accessible Parking
Citations: CBC 1129B; ADAAG 4.6; ADAAG A4.6
Minimum Quantity: 1
Maximum Quantity: 3
Minimum Estimated Cost: \$270.00
Maximum Estimated Cost: \$810.00
Record Number:: 16
Priority:

Full Rec: Eight (8) out of 321 total parking spaces are required to be designated exclusively for accessible parking. Restripe the existing accessible space and create four additional accessible spaces, each measuring at least 108 inches wide and 216 inches long. Designate two parking space as "van-accessible". The van-accessible spaces shall provide an access aisle measuring at least 96 inches wide on the passenger side the space. The two additional parking spaces shall each provide an access aisle measuring at least 60 inches wide, that may be shared. Add the words NO PARKING in 12 inch high white letters at the entrance to each accessible parking access aisle.

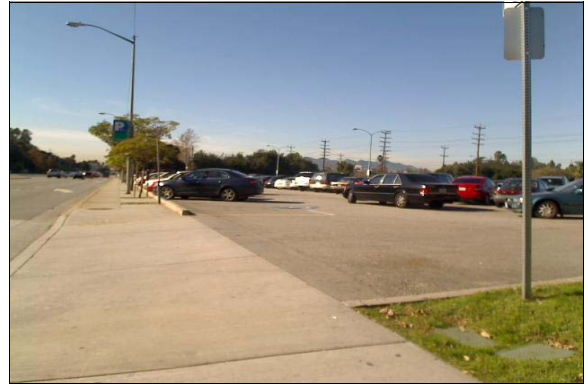
Finding: There is no accessible route between the accessible parking spaces and the public right of way. Three of the spaces require travel behind vehicles other than the wheelchair users own vehicle.

Citations: CBC 1129B.4.3; ADAAG 4.7.1

Full Rec: Install a compliant path of travel from the sidewalk (public right of way) to the accessible parking space. Wheelchair users must not be forced to go behind parked cars other than their own.

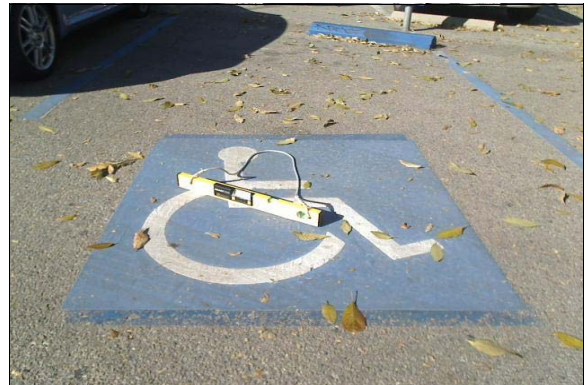
Finding: The surface of the accessible parking spaces slopes greater than 2%.

Citations: CBC 1129B; ADAAG 4.6.3

Full Rec: Pave the parking lot at the accessible spaces to provide a level surface. Parking surfaces and access aisles shall be located in areas not exceeding 2% slope in all directions (see CBC 1129B and ADAAG 4.6.3).

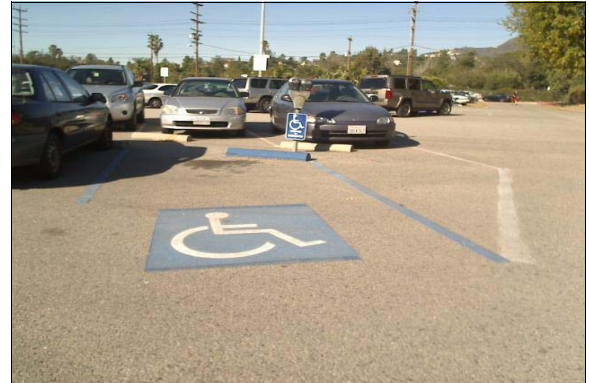
Finding: At three of the spaces, the signage designating the accessible parking space is less than 80 inches above the level of the parking space and cannot be viewed when a vehicle is parked in the space.

Citations: CBC 1129B.5; ADAAG 4.6.4

Full Rec: Modify the height or replace the post-mounted signage designating the accessible parking space to provide at least 80 inches from the parking spaces finished grade to the bottom edge of the sign. The sign shall be located so that it cannot be obscured by a vehicle parked in the space (see CBC 1129B.5).

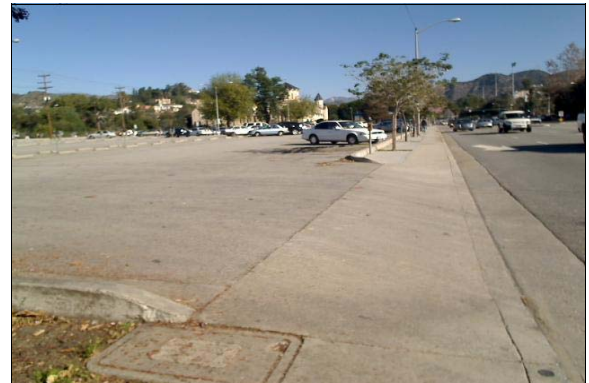
Finding: There is no warning signage posted at the entrance from North Verdugo Road regarding unauthorized use of accessible parking spaces in the parking lot.

Citations: CBC 1129B.5; ADAAG 4.6.4 CVC 22511.8(a)(d)

Full Rec: Post a sign in a conspicuous place at the entrance of the parking lot, or immediately adjacent to and visible from each accessible space. The warning sign shall measure at least 17 inches by 22 inches in size and consist of lettering at least 1 inch in height that states the following; "Unauthorized vehicles parked in designated accessible spaces not displaying distinguishing placards or license plates issued for persons with disabilities may be towed away at owner's expense. Towed vehicles may be reclaimed at _____ or by telephoning ____ ." Fill in the blank spaces with appropriate information as a permanent part of the sign and be sure to add the CVC 22511.8(a)(d) to the sign.

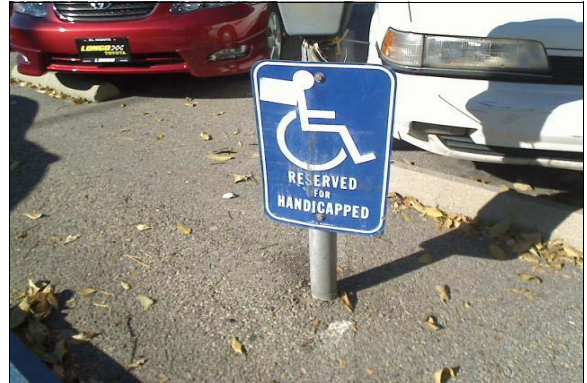
Finding: There is vertically-mounted signage at the designated accessible parking spaces, however, the signs use the word "Handicapped".

Citations: CBC 1129B.5; ADAAG 4.6.4

Full Rec: Install a permanently posted reflectorized sign measuring 70 square inches that includes an ISA symbol adjacent to and visible from the accessible parking space (see CBC 1129B.5). The bottom edge of the sign must be mounted 80 inches from the ground surface so that it cannot be obscured by a parked vehicle (see CBC 1129B.5). The "van-accessible" parking space shall provide an additional sign marked "van-accessible" mounted below the sign (see CBC 1129B.5 and ADAAG 4.6.4). Do not use signage with the word "Handicapped".

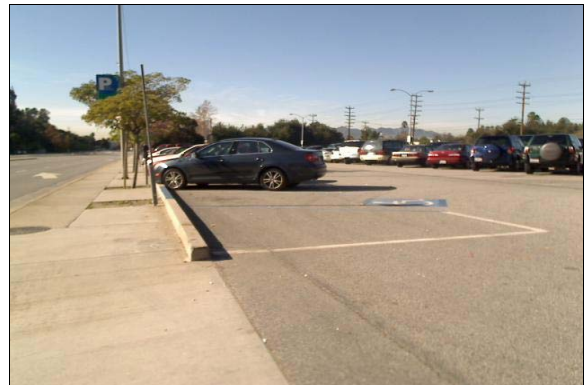
Finding: There is no accessible route from the public right of way to the parking lot or to the accessible parking spaces.

Citations: CBC 1114B.1.2; CBC 1117B.5.7; CBC 1127B.3; ADAAG 4.1.2(7); ADAAG 4.3.2; ADAAG 4.14.1	
Minimum Quantity:	1
Maximum Quantity	1
Minimum Estimated Cost:	\$107.00
Maximum Estimated Cost:	\$0.00
Record Number::	21
Priority:

Alternative Post directional signage.
Rec:
(Where Available)

Full Rec: Provide at least one accessible route from the public right of way to the parking lot and to the accessible parking spaces. Make certain to post signage indicating the direction of the accessible route to the public right of way. Signs shall include the International Symbol of Accessibility.
