Accessibility Survey

City of Glendale

College Parking Lot #31

Inspected January 2008

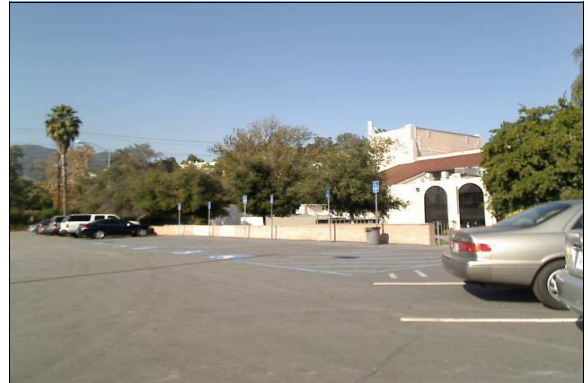
Finding: Parking Lot # 31 is located at the intersection of East Mountain Street and Verdugo Road in Glendale, California. The parking lot was inspected by Disability Access Consultants, Inc., on January 16, 2008.

Full Rec: Any renovation or new construction that occurred after January 26, 1992, is subject to meet full code specifications for the California Building Code and ADAAG requirements. All recommendations in this report are based on ADAAG and CBC Title 24 requirements. Consult with your design professional to determine which elements are affected by these requirements. It is recommended that Disability Access Consultants, Inc. is consulted for inspection of any new construction or renovation at the facility.

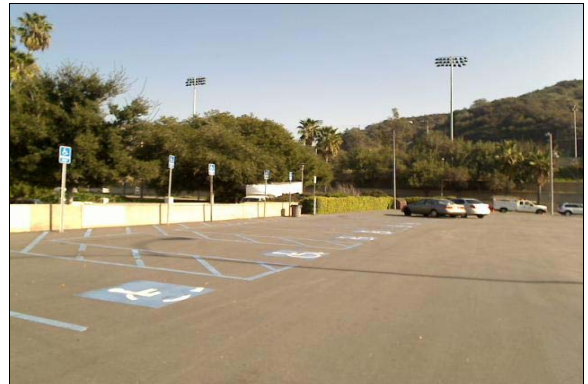
Accessible Parking

Finding: There are 6 accessible parking spaces out of 160 parking spaces which meets the minimum number for compliance. There is no "van-accessible" parking space and the access aisles does not contain "NO PARKING" in 12" high white letters.

Full Rec: After leveling the parking surface, restripe the existing accessible spaces so each measures at least 108 inches wide and 216 inches long. Designate one parking space as "van-accessible". The van-accessible space shall provide a 96 inches wide passenger side access aisle. Add the words NO PARKING in 12 inch high white letters at the entrance to each accessible parking access aisle.

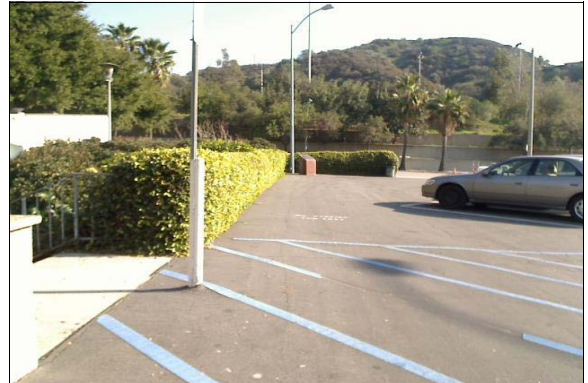
Accessible Parking

Finding: There is no accessible route between the accessible parking space and the public right of way.

Full Rec: Install a compliant path of travel from the sidewalk (public right of way) to the accessible parking space.

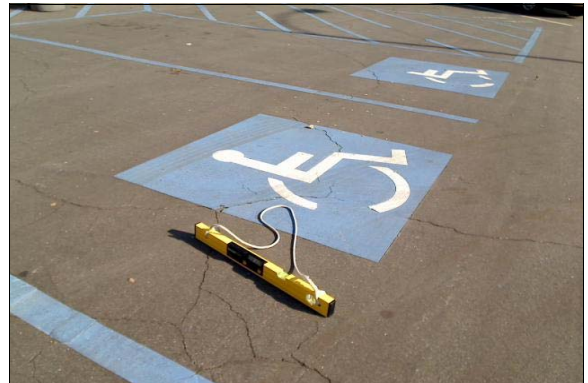
Accessible Parking

Finding: The surface of the accessible parking spaces has slopes greater than 2%.

Full Rec: Pave the parking lot at the accessible spaces to provide a level surface. Parking surfaces and access aisles shall be located in areas not exceeding 2% slope in all directions (see CBC 1129B and ADAAG 4.6.3).

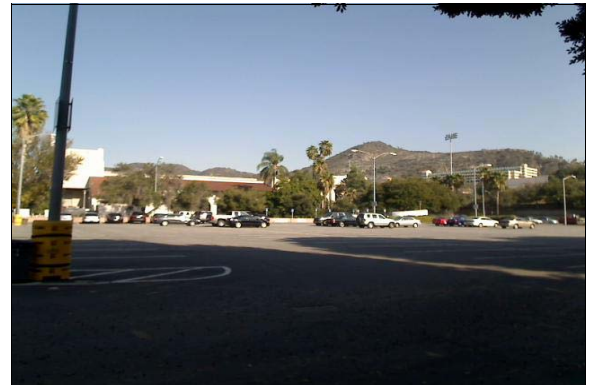
Accessible Parking

Finding: There is no warning signage posted at the entrance from East Mountain Street regarding unauthorized use of accessible parking spaces in the parking lot.

Full Rec: Post a sign in a conspicuous place at the entrance of the parking lot, or immediately adjacent to and visible from each accessible space. The warning sign shall measure at least 17 inches by 22 inches in size and consist of lettering at least 1 inch in height that states the following; "Unauthorized vehicles parked in designated accessible spaces not displaying distinguishing placards or license plates issued for persons with disabilities may be towed away at owner's expense. Towed vehicles may be reclaimed at _____ or by telephoning ____ ." Fill in the blank spaces with appropriate information as a permanent part of the sign and be sure to add the CVC 22511.8(a)(d) to the sign.

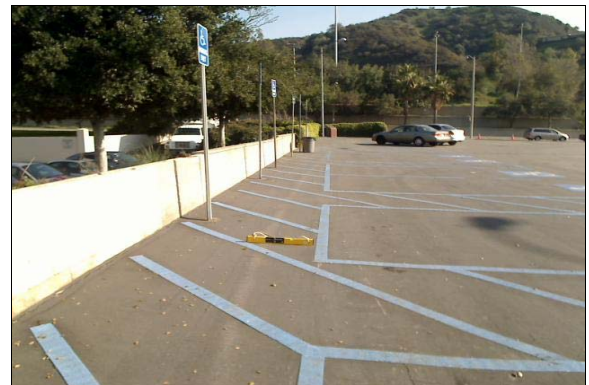
Accessible Parking

Finding: The pedestrian and vehicular traffic adjoin at the head of each accessible parking space access aisle. The head aisle and the accessible parking space access aisles are level and are not separated by a ramp, curb, rail, or other element.

Full Rec: Provide a detectable warning consisting of a 36 inch long strip of compliant truncated domes at the head aisle entrance to each accessible parking access aisle.

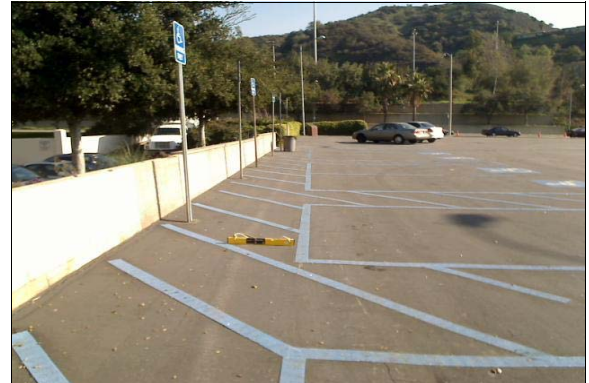
Accessible Parking

Finding: There is no wheelstop at the head of the each accessible parking space to prevent vehicles from encroaching into the head aisle.

Full Rec: Install a wheelstop at the head of each accessible parking space. Wheelstops shall be used to prevent vehicles from encroaching into accessible aisles or walkways, but shall not present addition encroachment into those areas (see CBC 1129B.4.3).

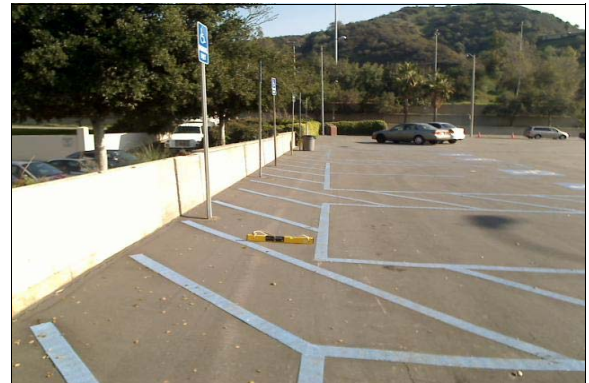
Accessible Parking

Finding: The pedestrian route at the head aisle has cross slopes greater than 2%.

Full Rec: Resurface the path of travel to provide a level surface that does not exceed a slope greater than 5%. Cross slopes shall not exceed 2%.

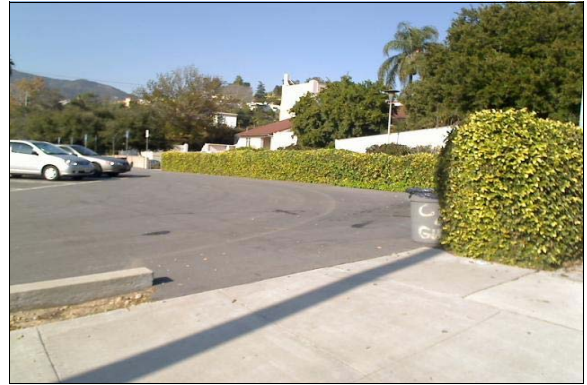
Accessible Route from the Public Right of Way

Finding: There is no accessible route from the public right of way to the parking lot or to the accessible parking space.

Alternative Provide directional signage to the accessible route.
Rec:
 (Where Available)

Full Rec: Provide at least one accessible route from the public right of way to the parking lot and to the accessible parking spaces. Make certain to post signage indicating the direction of the accessible route to the public right of way. Signs shall include the International Symbol of Accessibility.

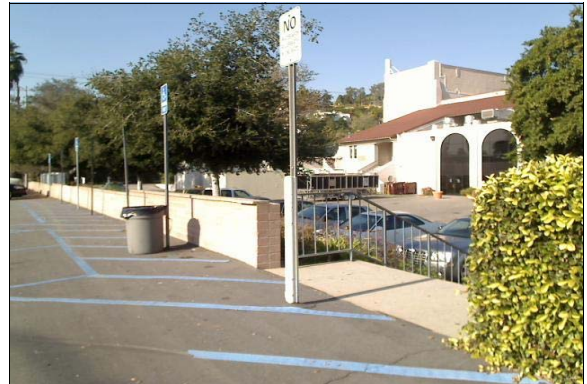
Stairs to the Civic Auditorium

Finding: There is stair access only on the general path of travel from the parking lot to the Civic Auditorium, preventing access to individuals with mobility impairments.

Alternative Post directional signage to the accessible route.
Rec:
 (Where Available)

Full Rec: Provide an accessible route from the parking lot to the Civic Auditorium and the public right of way. Vertical access may be accomplished by a ramp.
