APPENDIX K

Sewer Line Maintenance and Inspection Forms

City of Glendale

SEWER LINE MAINTENANCE AND INSPECTION

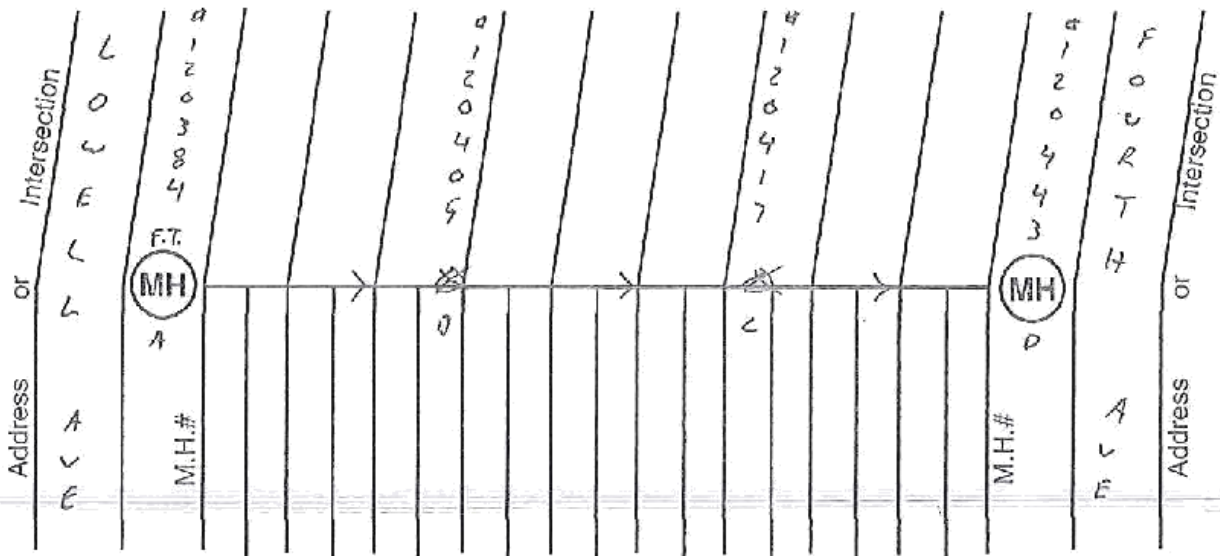
Approximate Footage: A-D = 762'

$C-D: 274'$
