APPENDIX K

Sewer Line Maintenance and Inspection Forms

City of Glendale

SEWER LINE MAINTENANCE AND INSPECTION

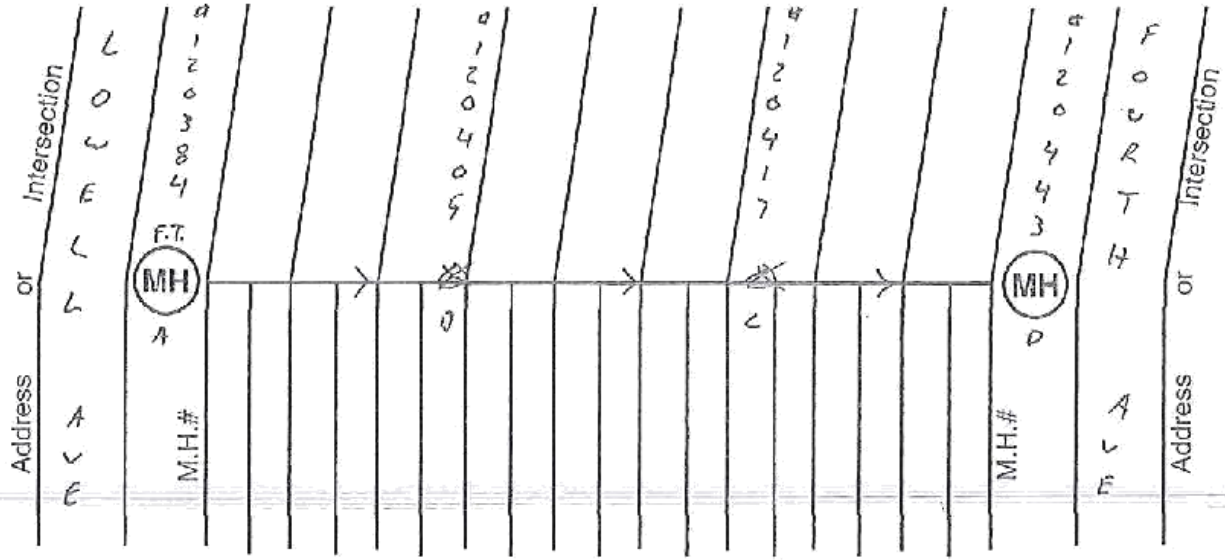
Good			Fair			Poor		
	Good	Fair	Poor	Good	Fair	Poor	Good	Fair	Poor
Cover	x		*	x		*	x		*
Ring	x		*	x		*	x		*
Brick				x		*	x		*
Facing				x		*	x		*
Inverts and/or Drops	x		*	x		*	x		*
Hydraulics	x		*	x		*	x		*
Rungs				x		*		x	*
Roots in M.H.	Y:			N:	x		Y:		N:

Approximate Footage: A-D = 762'

(M.H.) Location A-B = 282'
B-C = 206'
C-D = 274'

Type(s) of material found in this line: 6-0
