PROTECTED INDIGENOUS TREE REPORT

FOREST LAWN MEMORIAL-PARKS
CITY OF GLENDALE
LOS ANGELES COUNTY, CALIFORNIA

June 2015

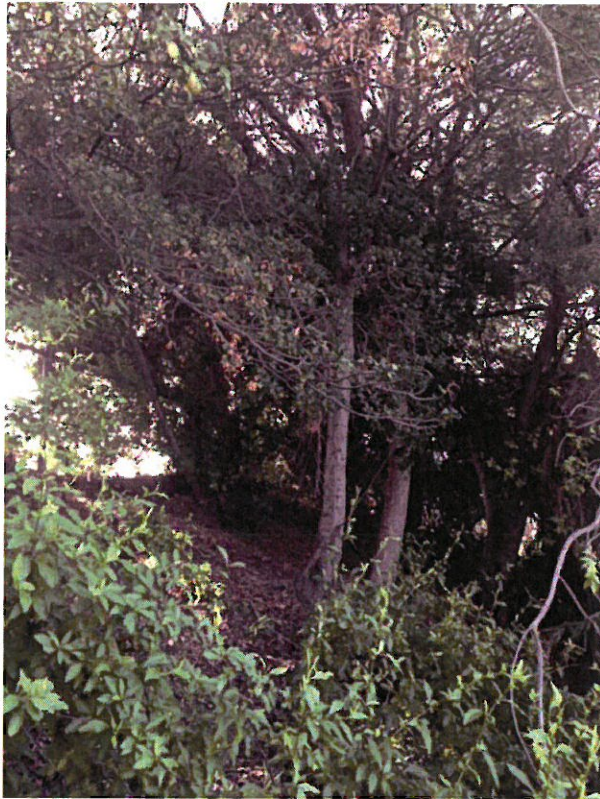
Oak No. 1. View looking south at 25' tall multi-trunk (5.5" and 6" stems = 11.5" diameter at breast height [DBH]) California live oak. Tree appears to be in good health.

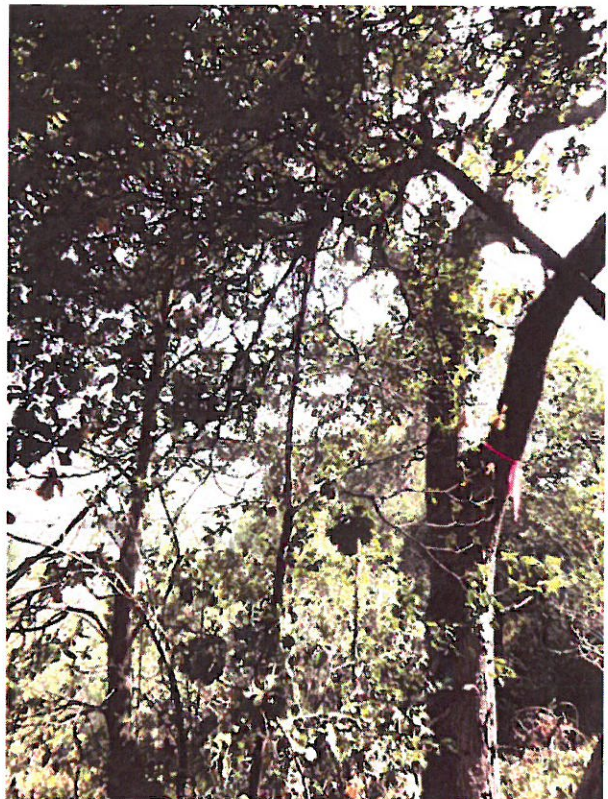
Oak No. 2. View looking in northerly direction at 50' tall single trunk (15" DBH) California live oak. Tree appears to be disease free and in good health.

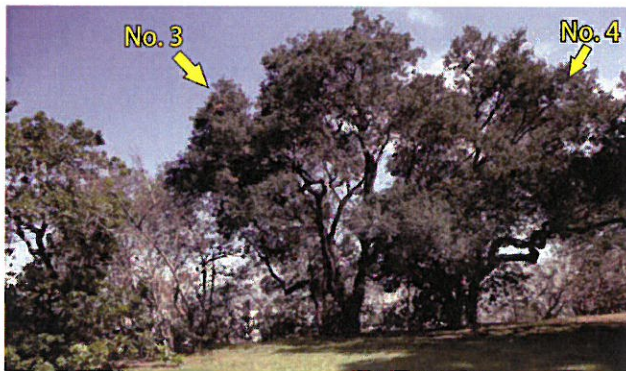
Oak Nos. 3 and 4. View looking north across lawn at two oak trees. Oak No. 3 is a 40' tall multi-trunk (4", 8", and 12" stems = 24" DBH) that appears to be disease free and in good health. Oak No. 4 is 70' tall single trunk (33" DBH) California live oak that appears disease free and in good health.

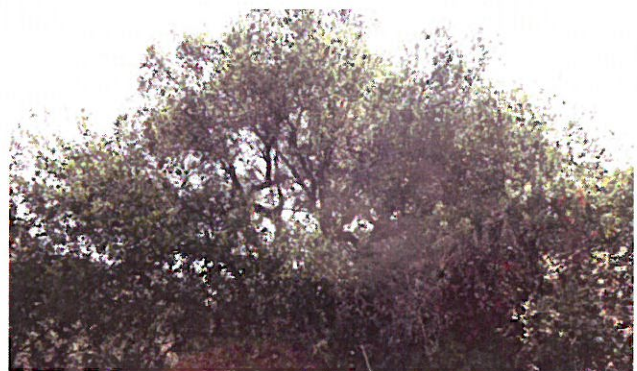
Oak No. 5. View looking in southerly direction at 50' tall multi-trunk (8", 9", 11", 11", and 13" stems = 52" DBH) California live oak. Tree is in fair health with included bark and some decay with multi-branching in response of past fire damage.

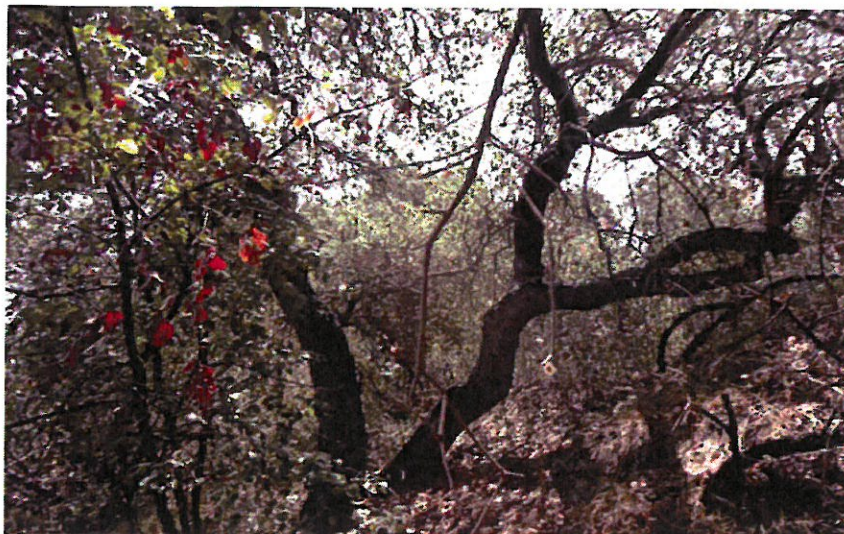
Oak No. 6. View looking in southerly direction at 40' tall multi-trunk (8", 9", and 12" stems = 29" DBH) California live oak. Tree is in fair health with horizontal branching, included bark, and some decay with multi-branching in response of past fire damage.

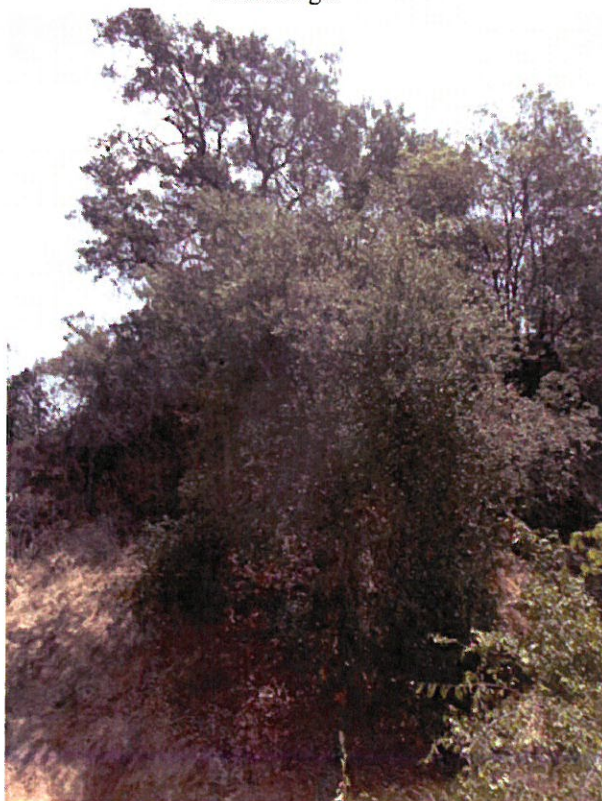
Oak Nos. 7 and 9. View looking in southerly direction at two oak trees. Oak No. 7 is a 20' tall multi-trunk (4", 5" and 7" stems = 16" DBH) and oak No. 9 is a 18' tall multi-trunk (5" and 7" stems = 12" DBH). Both trees are in fair health with included bark and some decay with multi-branching in response to past fire damage.

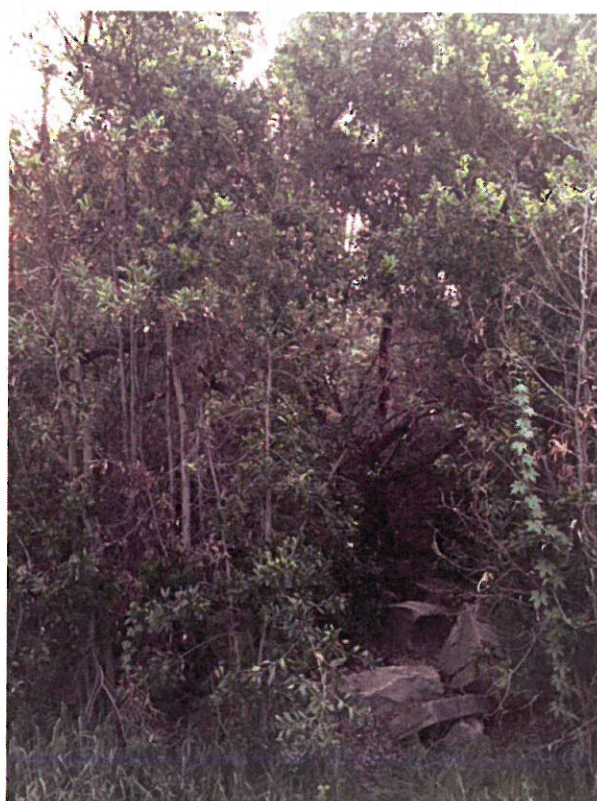
Oak No. 8. View looking south at 30' tall single trunk (20" DBH) California live oak. Tree appears to be stressed and in poor health with significant dieback to 1/3 of tree crown. Decay with multi-branching in response of past fire damage is evident.

All nine of the protected indigenous trees located within the project footprint will likely be encroached upon by excavation of the Sunset Grove Gardens project. Tree Nos. 1, 2, 3, and 4 were healthy and vigorous at the time of the survey and did not exhibit signs of infestation, disease, or structural defects. Tree Nos. 5, 6, 7, and 9 are in fair health, with decay and included bark among multi-branching in response to past fire damage. Tree No. 8 appears to be stressed and in poor health with significant dieback to 30 percent of the tree crown. Decay with multi-branching in response to past fire damage is also evident.
