March 24, 2016

Re: Biological Report: 3160 Linda Vista Road Glendale, California

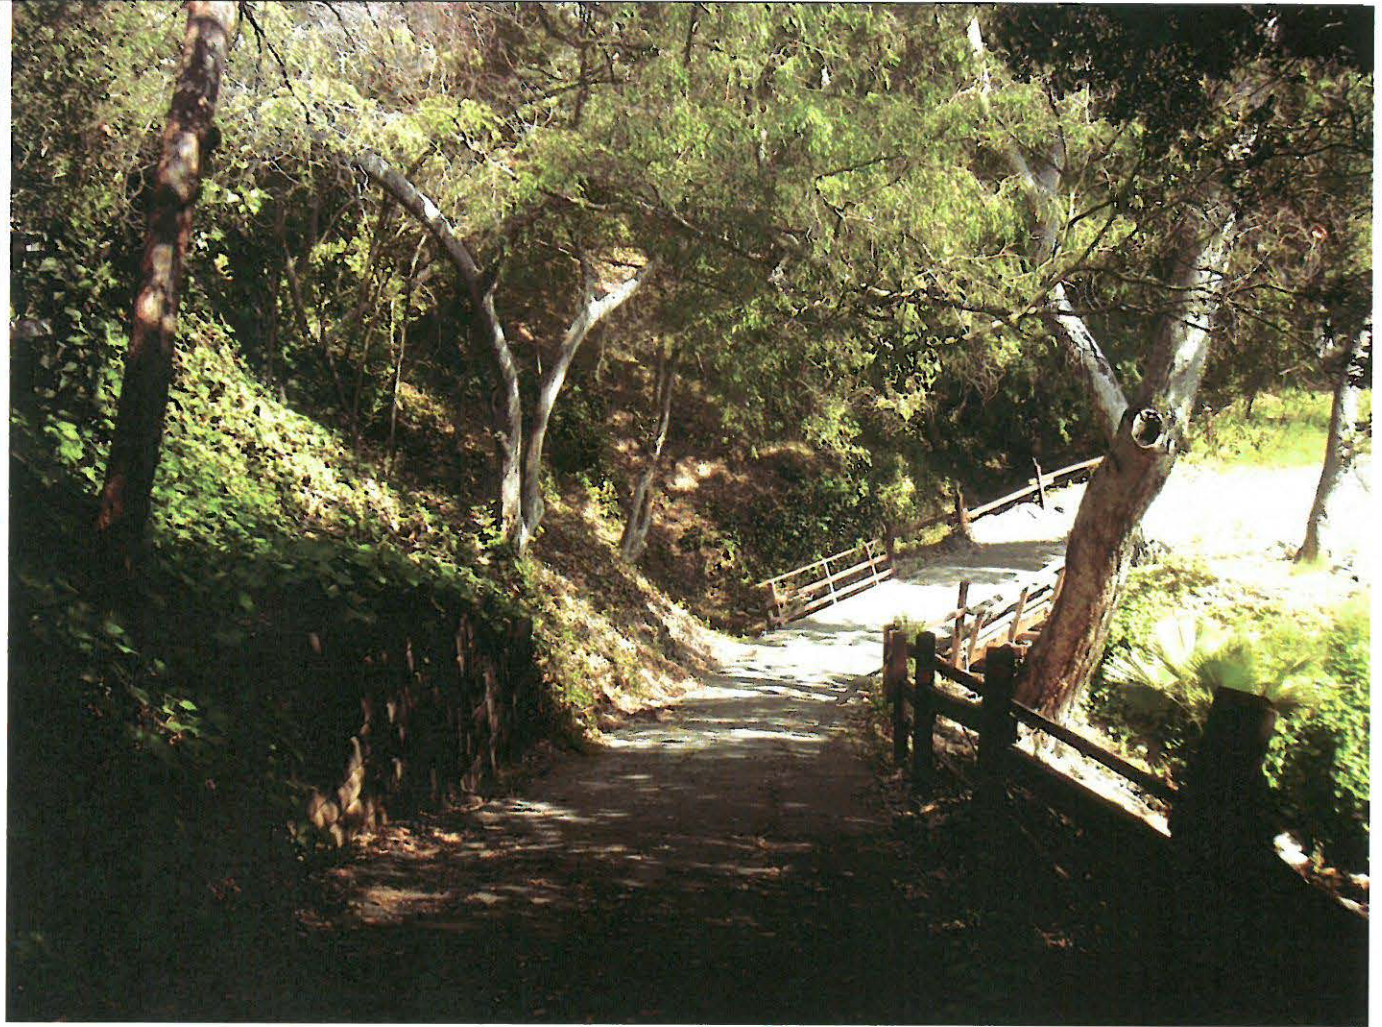
Photo 1. Viewing down the existing driveway toward the bridge over the creek (viewing generally east). Note the non-native acacia trees to left (north) and one western sycamore to right. Photo was taken from the gate at the top of the driveway.

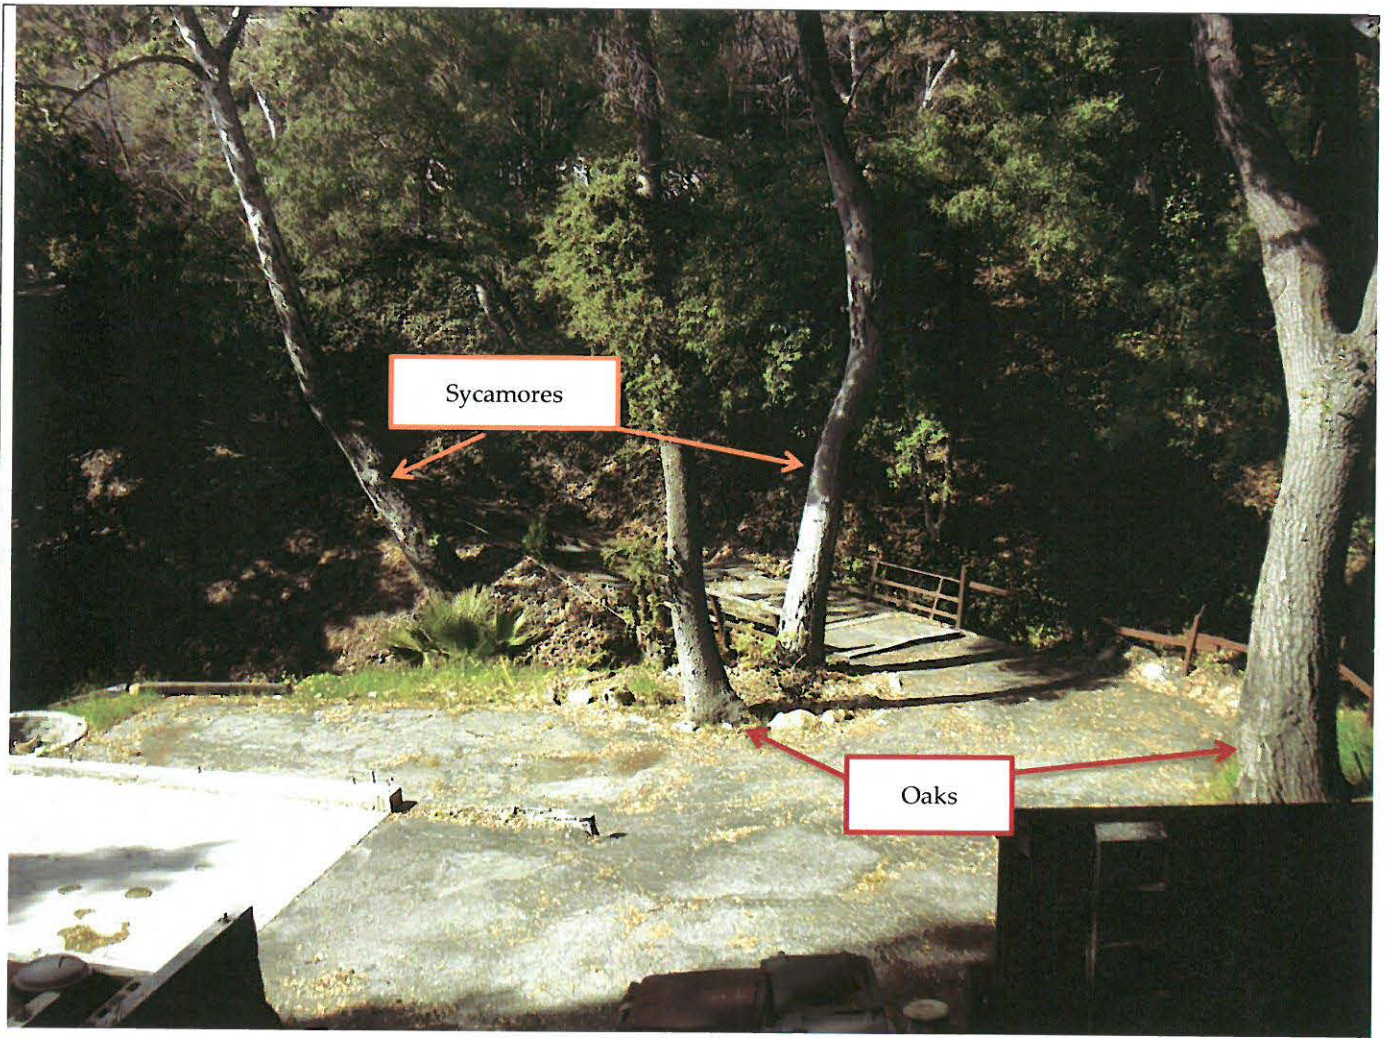
Photo 2. View from home site toward bridge & driveway, generally viewing north.

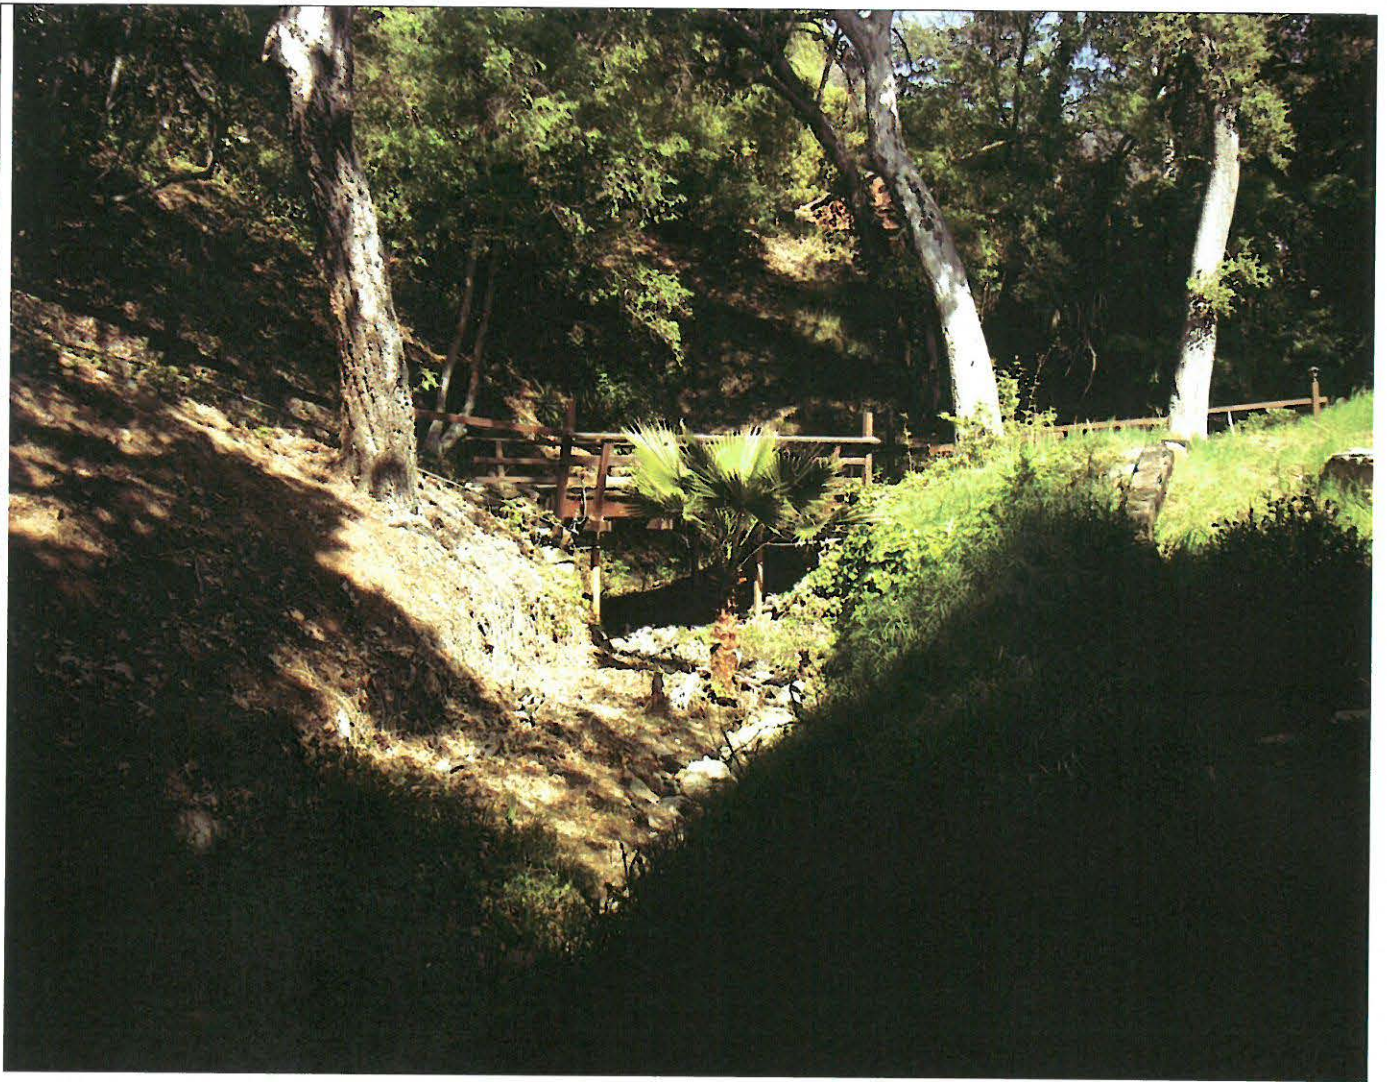
An un-named creek mapped as a blue-line stream flows westerly through the property. Water was present during the March 2016 site visit. As illustrated on the attached photo pages, the creek exhibits well-defined channel and bank boundaries. The banks were either unvegetated or covered with non-native species such as periwinkle (*Vinca* sp.), English ivy, and/or non-native annual grasses. Non-native fan palms are also present. The driveway wooden bridge that spans the creek is supported by stone abutments inset into the banks.

Photo 3. View of creek, facing east (upstream). Note clearly defined top of bank on both sides. The large-diameter tree to the right is a coast live oak; the other two are western sycamore.

Any work (alteration) within the bed, bank or channel of the creek will require a Streambed Alteration Agreement for the California Department of Fish & Wildlife. This would include alterations to the bridge to remove the existing abutments. Provided that any work in the creek vicinity occurs above the Ordinary High Flow Mark, permits will not be required from U.S. Army Corps of Engineers or the State Regional Water Quality Control Board.
